*Historic Building Recording at Farley Farm,  
Romsley, Worcestershire*

*A report for Mr Philip Marsh*

April 2005

**Project: PJ 137**

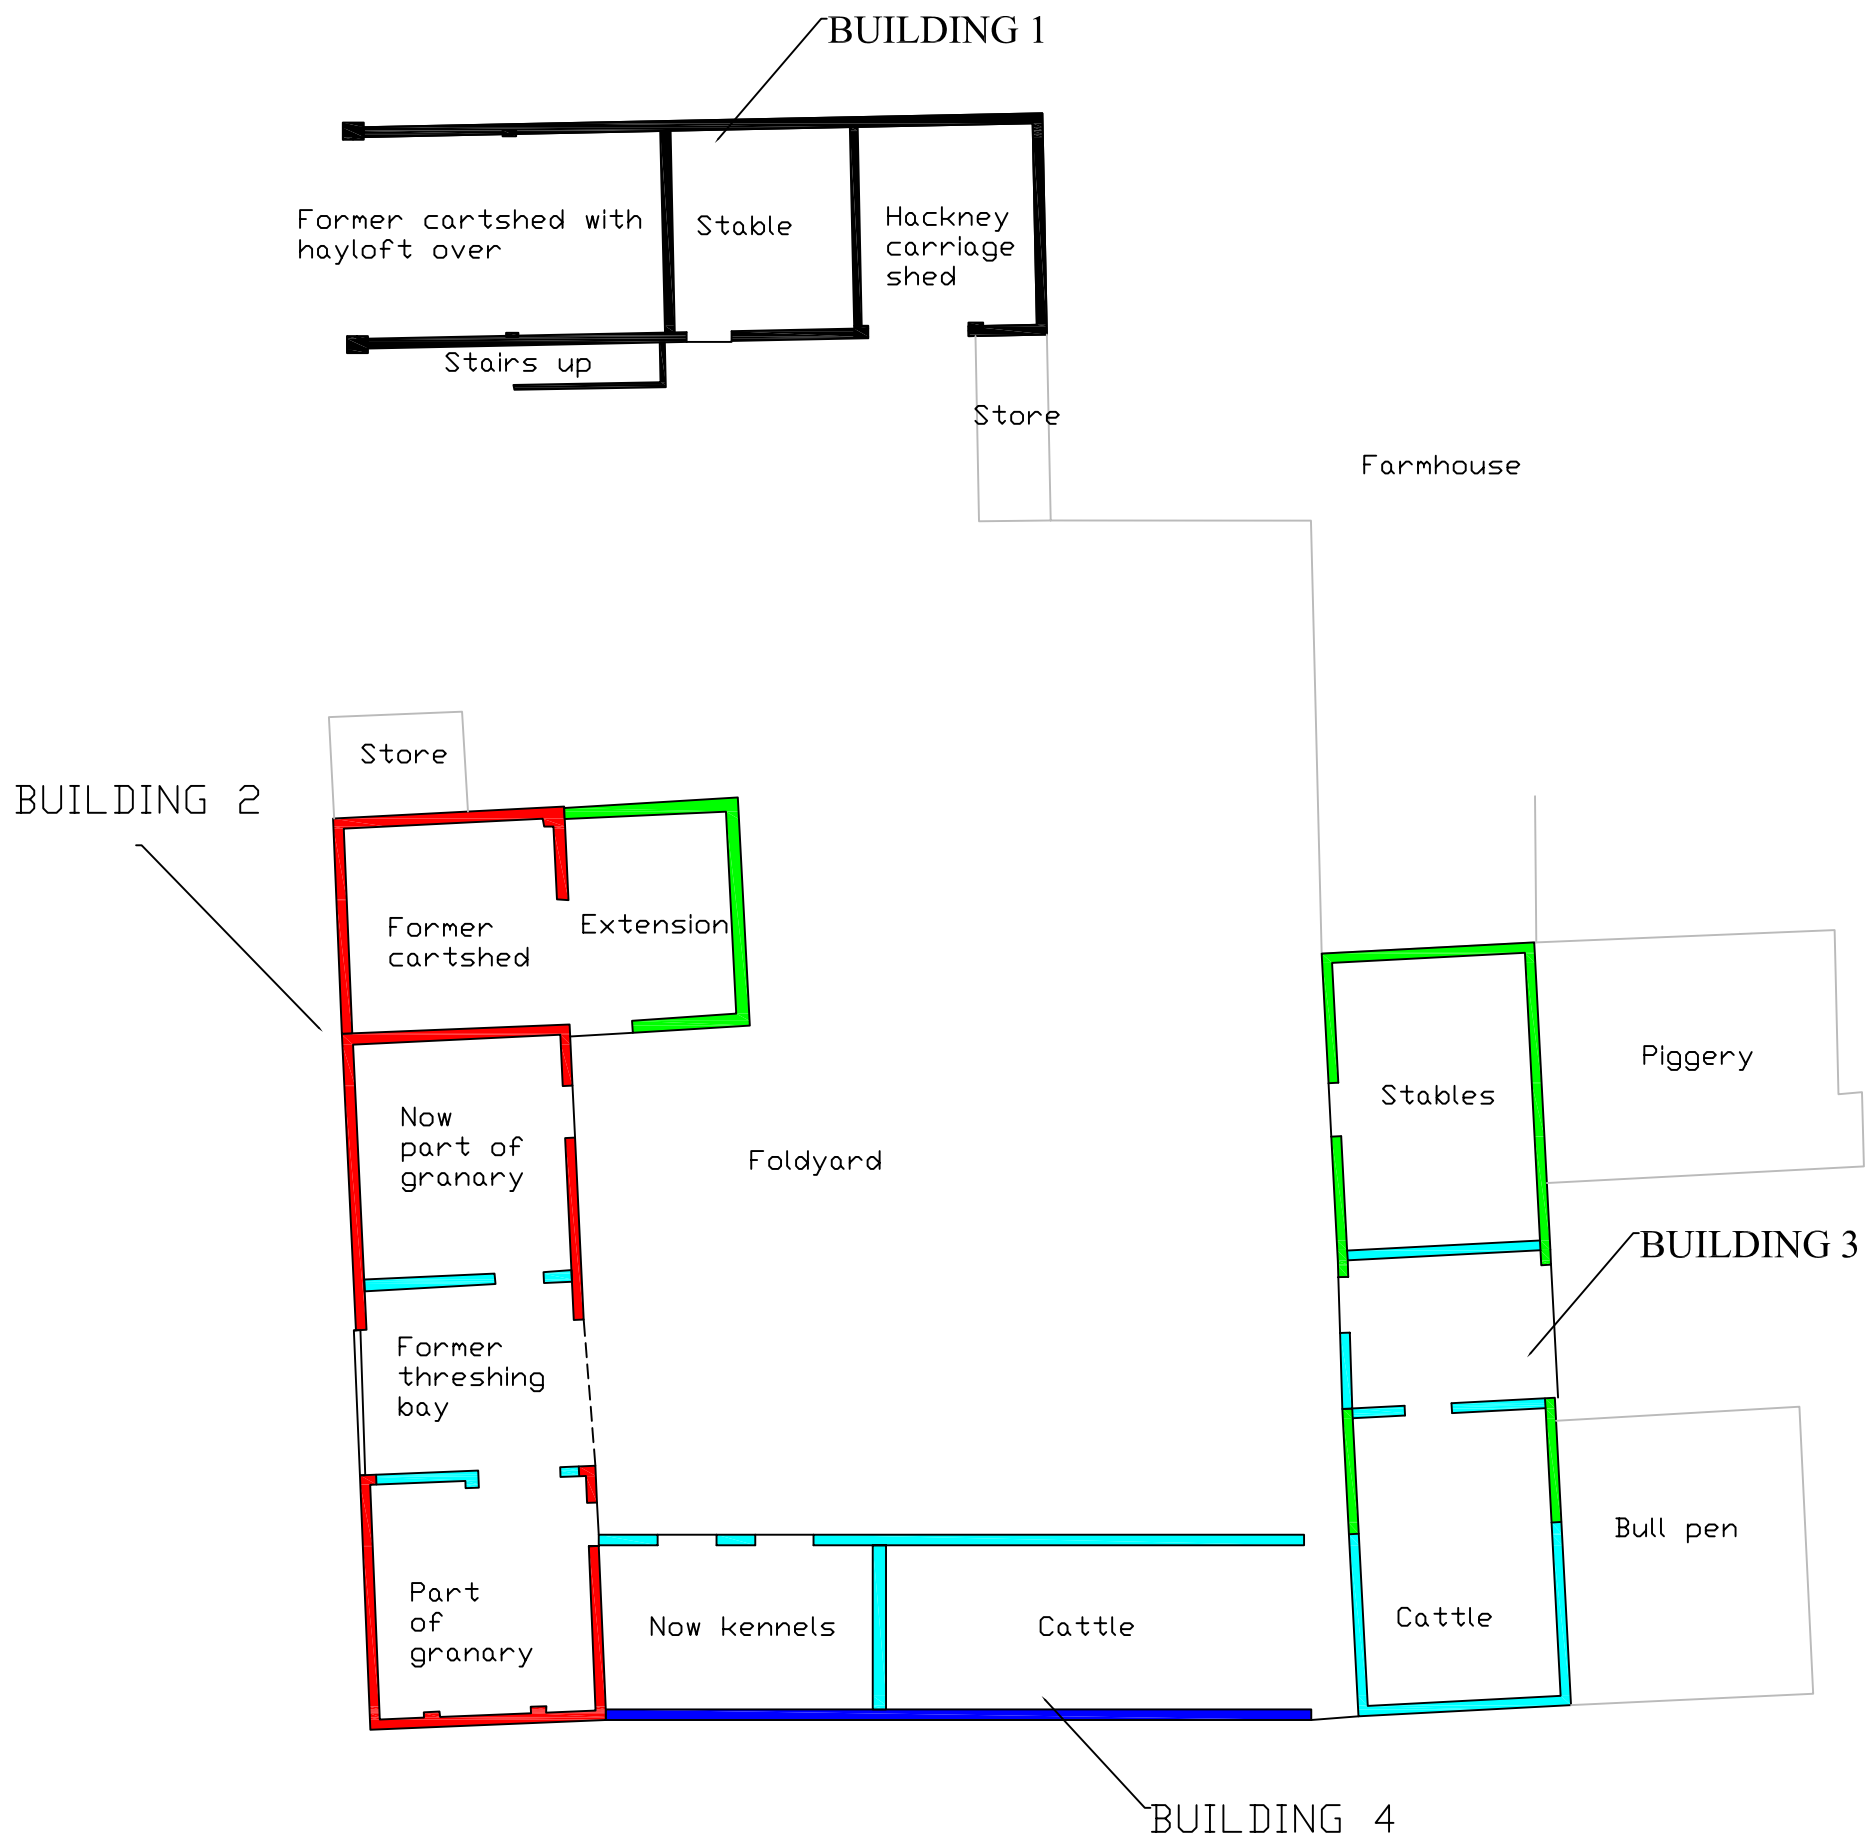
Figure 5: Building Identification and Phasing

COLOUR KEY	
	Mid 19th century circa 1860-80
	Mid to late 19th century
	Later than red
	Late 19th and 20th century

The subject buildings could be easily divided into four separate structures for ease of recording, these are shown in Figure 5. Recording the farmhouse itself was not part of this project, however, a brief analysis based on the accessible visible external elevations, was made.

Based on the evidence collected we are able to suggest the phases and dates for the buildings at Farley Farm as shown in Figure 5.

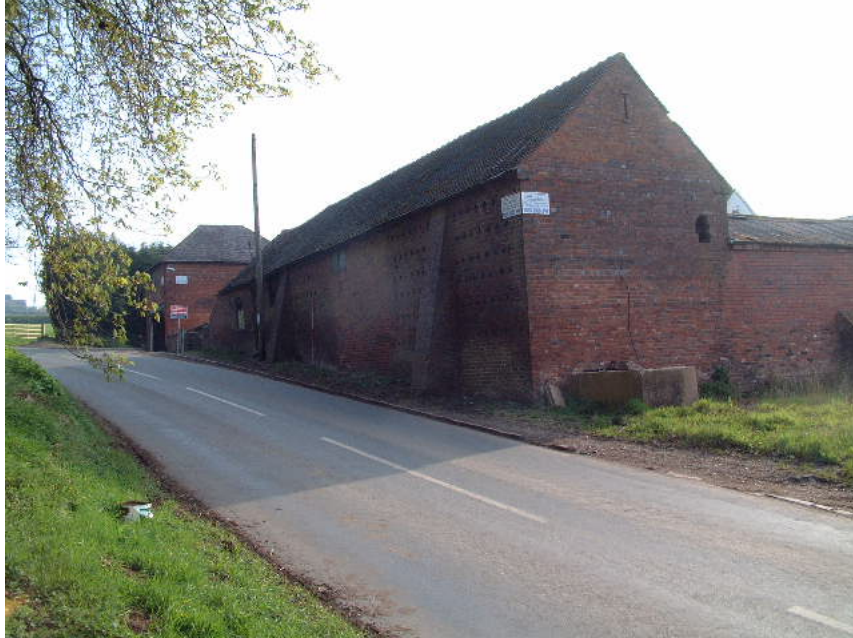
## Plate 3

*Building 2 viewed to the north-east*

Building Number 2 lies on the western side of the road fronting Farley Lane (Plate 3). The building is difficult to phase as the northern end has had much rebuilding, but it is proposed that the remaining fabric is of two periods. The structure is of tile over randomly coursed brick and mortar, the bricks being smaller than those used in Building 1, above earlier much thinner bricks measuring 2½". It is impossible to tell if the smaller bricks at lower level were simply re-used, or that an earlier building has been extensively rebuilt and it may be a combination of both. The earliest phase of the building, along the roadside (see Figure 5) was originally a four bay threshing barn with attached cart shed with granary above at the northern end. The barn had an offset stone flagged threshing floor, which is now partially concreted over (Plate 4) and storage bays to either side. Ventilation was supplied by pierced brickwork and access and exit was via a pair of opposed floor to wall plate opening cart doors (Plate 5), the aperture to the westernmost is now bricked up. The cartshed was accessed from below a Florentine arched lintel, which is now concealed inside the building by the added extension to the eastern elevation (Plate 6). Access to the granary above was via the doorway in the northern end gable, probably via timber steps, which are now gone and the doorway is bricked up when a later phase was added to the structure (Plate 9). The barn area has lately been used as a granary and the concrete storage bins are shown in Plate 10.

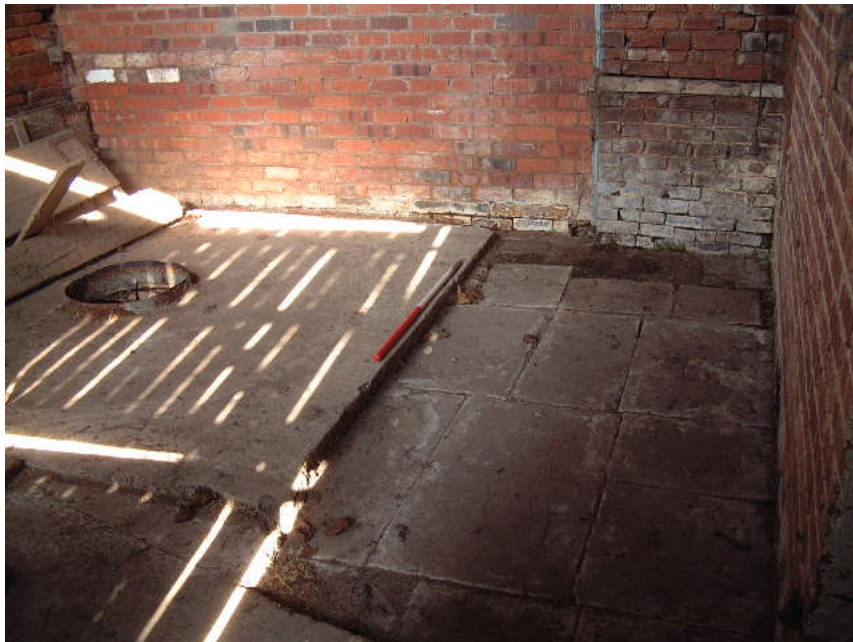
## Plate 4

*Threshing floor in Building 2 (scale 2 metres)*

The central threshing or 'thrashing' bay is where the threshing process would take place to separate the wheat from the chaff, or the grain from the stalks of the crop. This process involved thrashing the crop on the floor with hand flails. After the separation had taken place, the threshed crop would be thrown into the air to separate out the chaff. This was known as winnowing and the bay doors would be opened to allow a through draught, which would aid the process as the heavier grain would fall to the floor and the waste would be blown away. It has been logically suggested, that for this reason the barn, which was the most important building on the early farmstead, would be aligned to take advantage of the locally prevalent wind (Wade-Martins 1991, 167). However, little research has been carried out with respect to this suggestion (Kenworthy 1988). Winnowing was a lengthy process and may have taken several weeks a year to complete. The gradual introduction of mechanisation and acceptance of the 'improvements' by farm workers, meant that threshing floors became redundant by the

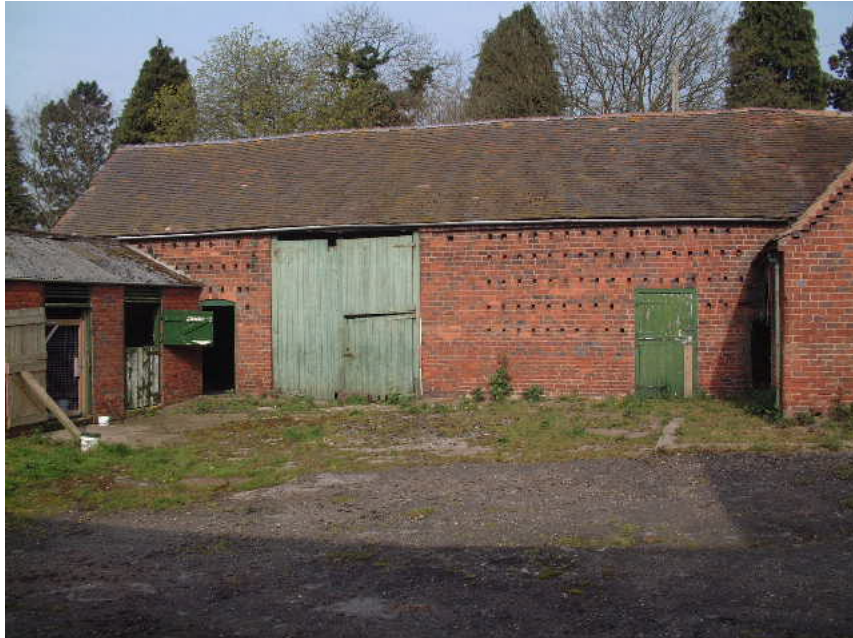
## Plate 5

*Building 2 viewed to the north-west*

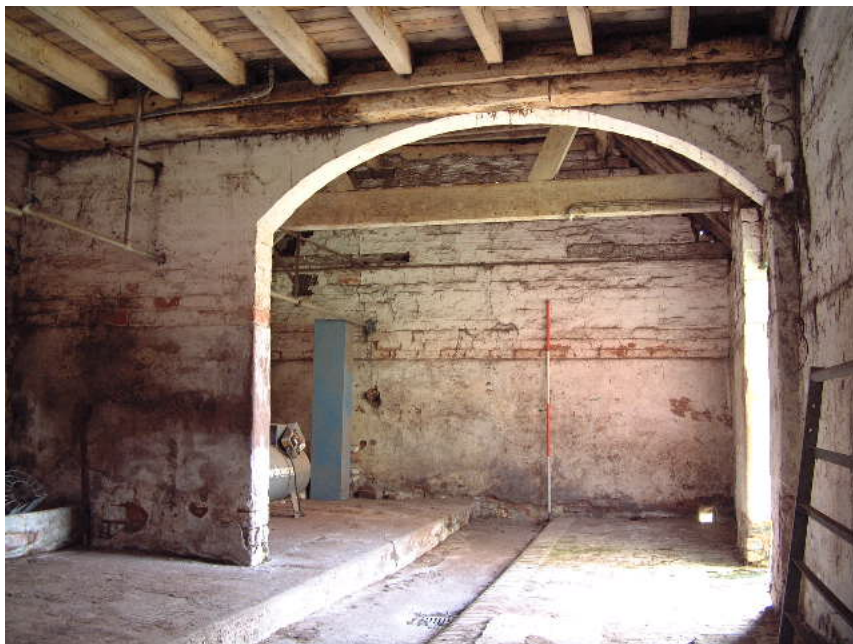
## Plate 6

*Former cart- door in the eastern elevation of Building 2. The doorway is now obscured by a later phase of building (scale 2 metres)*

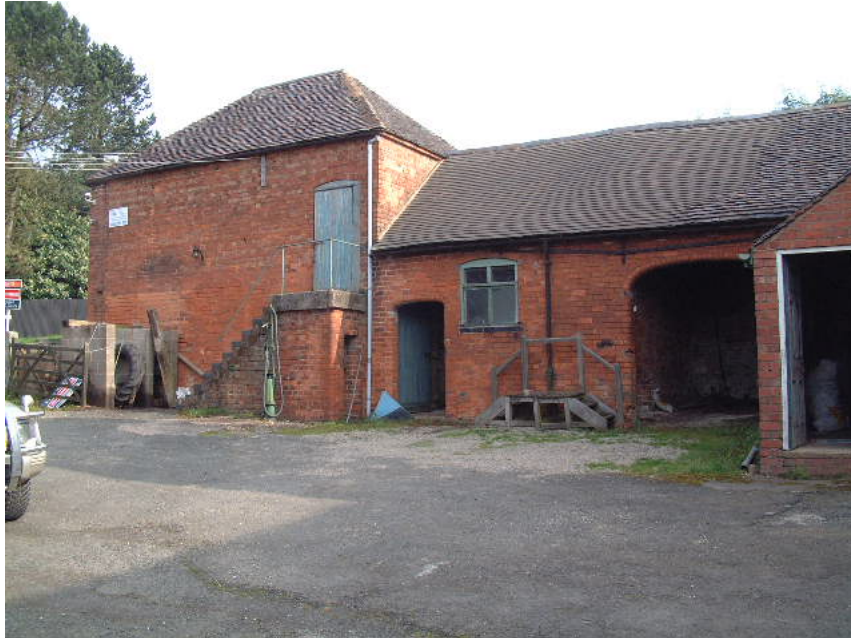
## Plate 7

*Building 1 viewed to the north*

Building Number 1 is of a single phase and is likely to date from the latter decades of the 19<sup>th</sup> century. Map evidence indicates a date of between 1842 and 1884. Lately the building has been used as garaging and storage, but originally the building contained three separate elements, a granary over cartshed at the north-western end, a hackney carriage shed at the opposite end and a central stable, probably for two hackney horses (Plate 7). It was fairly common in farms of the 19<sup>th</sup> century that the best horses and carriage were kept close to the farmhouse. The building is constructed of 9" solid brick walls with a clay tile hipped roof cover over the granary and pitched roof above the remainder. The bricks used are fairly large at 3 1/4" x 9 1/4", highlighting that the building was constructed after the introduction of the first brick tax in 1784 when larger bricks then became standard in order to reduce the tax outlay, although frequently this general rule may be disproved. The bricks are hand made orange bricks, probably from locally sourced clay. The bricks are bonded with a whitish sandy lime mortar in a mixed/random bond.

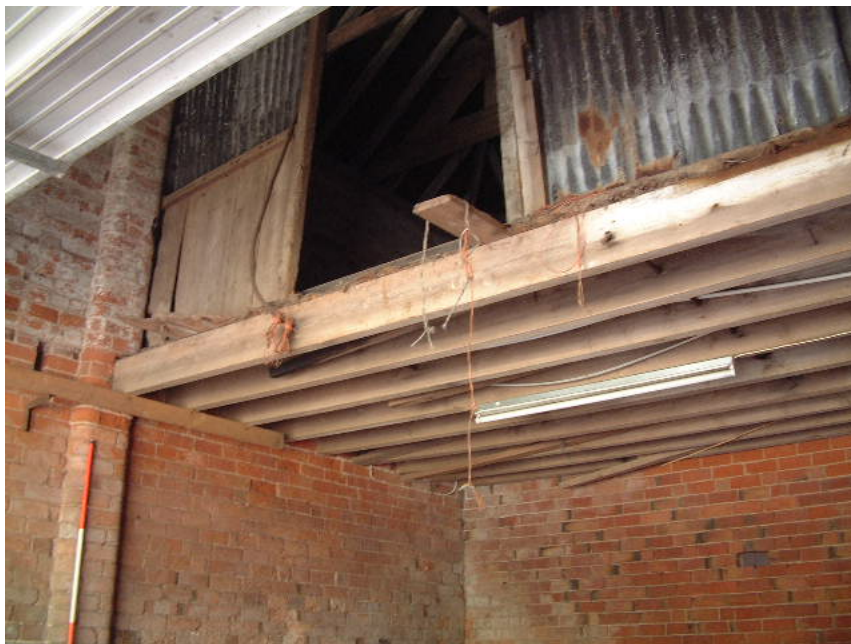
## Plate 8

*Upper floor (former granary) in Building 1 has been partially removed, note the gap for a joist (left) and sawn off floorboards (sections on scale 0.50 metres)*

Half of the upper floor of the granary (above the present garage) has been removed and it is only remnant in the central portion (Plate 8). There is a window over the garage doors to the north-western elevation, which was the only light source to the first floor; light and ventilation were important within a granary, as was the requirement to keep down vermin, hence they were always in an elevated position. Access to the granary is via an external flight of steps, which encompasses a dog kennel below, which was a common feature to a granary (Plate 8). Dogs would be used to guard the valuable produce. The entrances to the Hackney shed and stable are set below elliptical arched brick lintels. Internally, the stable has a brick floor with a central drain gully; the other bays have a more modern concrete floor. There are no other features of architectural significance within the building.

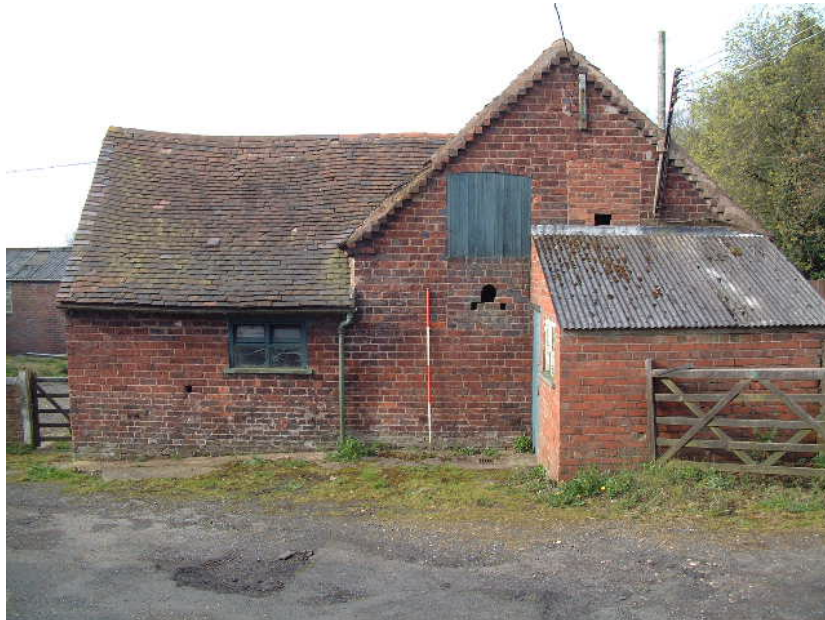
## Plate 9

*Later addition built against the eastern elevation of Building 1. Note the blocked doorway and window to the obsolete granary and the holes for shafts for portable steam engines (scale 2 metres)*

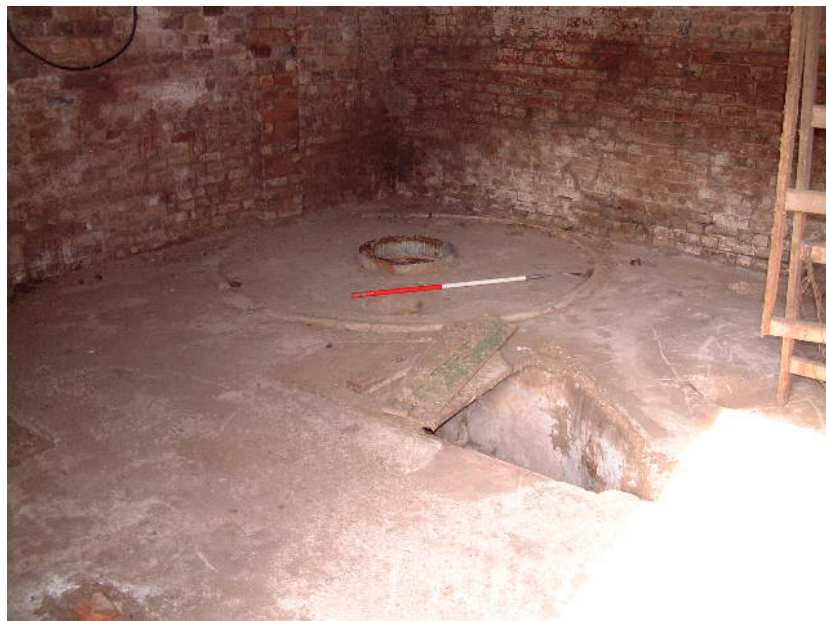
## Plate 10

*Modern grain processing infrastructure in Building 2 (scale 1 metre)*

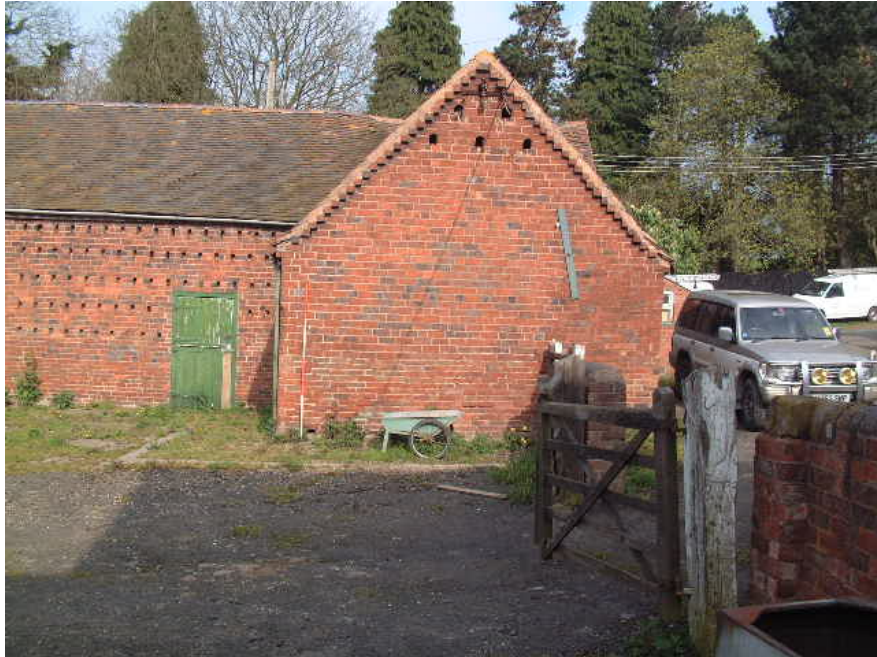
## Plate 11

*Pigeon loft in the gable of the northern projection of Building 2 (scale 2 metres)*

The later phase build juts off the northern end of the structure towards the farmhouse on the east. This space and the now redundant cartshed was then converted to a cowhouse, with a hay/fodder loft above, where grain was formerly stored. The external doorway (referred to above) would have been bricked up at this time when the cartshed became obsolete and access was made available from inside the building (second phase of build). At the same time that the door was bricked up, slots were created (Plate 9) to take a shaft or belt from a portable steam engine, which would have been hooked-up outside, this was probably used to power fodder processing machinery located in the floor above the cowhouse. There is also bricked-up window, or possibly a sack hoist opening at the upper level. A 20<sup>th</sup> century lean-to has been added to the building at this end. The later build has a pigeon loft inside the eastern gable at the upper level (Plate 11), pigeons eggs then being a valuable commodity.

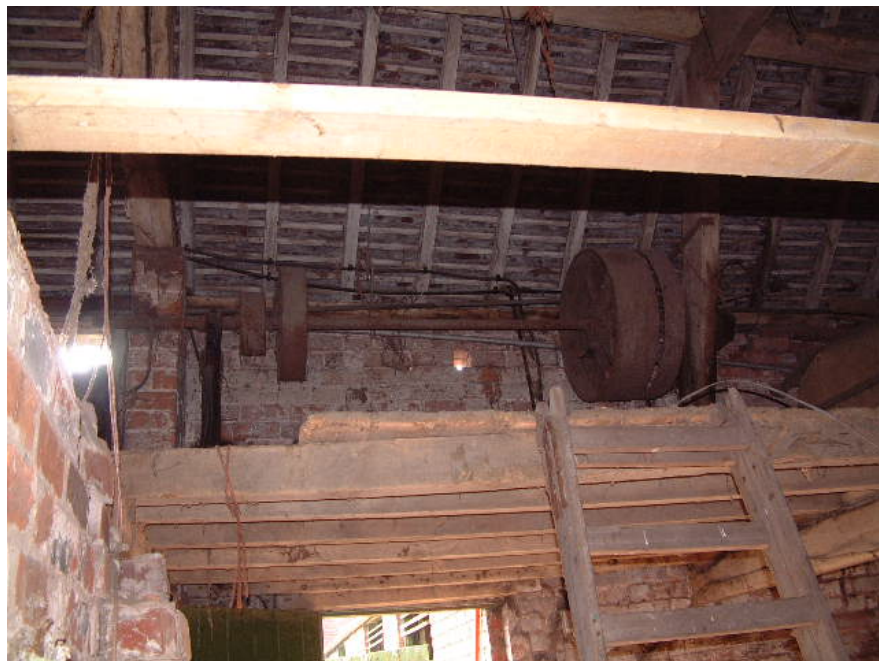
## Plate 12

*Flywheels and shaft for 19<sup>th</sup> century machinery power train in Building 2*

An upper half floor has been added to the southern end bay of the barn and there are remains of machinery located on this platform (Plate 12), with part of a central shaft carried though the southern end gable and several flywheels connected to the shaft. This set-up was progressively used to power threshing machinery and later, crop processing machinery such as belt driven threshing, dressing and winnowing machines. The machinery was not closely inspected, as the stability of the floor was unsure.

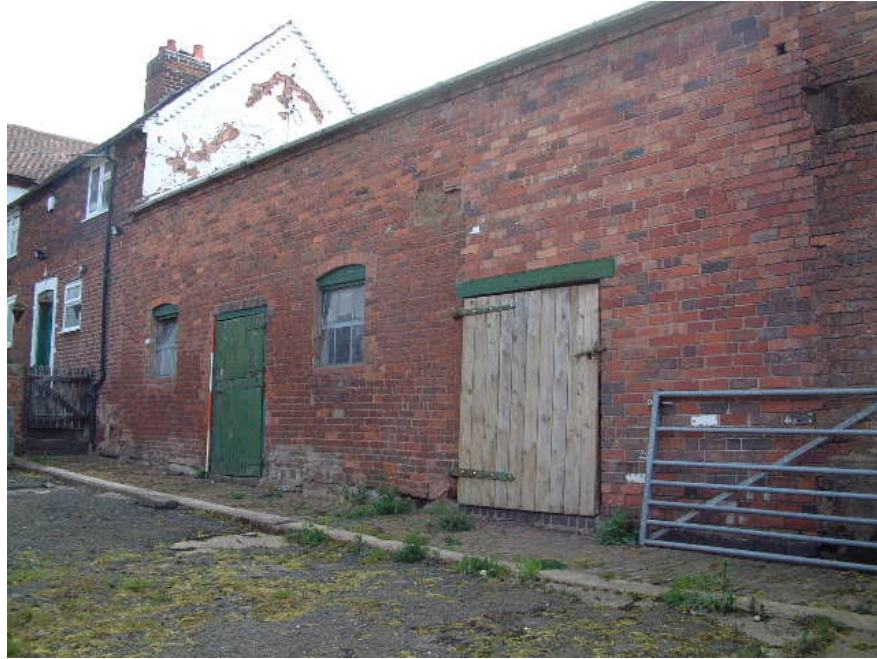
## Plate 13

*Building 3 looking north-east. Note the bricked up cartway (scale 2 metres)*

Building 3 is opposite Building 2 on the eastern side of the central yard (Plate 13). It is of randomly coursed brick construction with some sandstone at lower levels. Again, like Building 2, thinner bricks are used at lower levels indicating re-use of bricks (Plate 14), or extensive rebuilding. The roof has been replaced with corrugated sheet. The building (as it stands) was also mid-19<sup>th</sup> century three-bay storage barn with central cartway and storage to either side, the cartdoor opening in the western elevation has been bricked up and the opposite opening is still open, with timber cladding at the upper level (Plate 2). The northern end of the building was, probably during the late 19<sup>th</sup> or early 20<sup>th</sup> century (based on the style of inserted windows), converted to stables with a hayloft inserted above the stable area has a brick built manger with elliptical arches below and is now two separate units separated by a timber-constructed partition (Plate 15). There has been an extension added to the southern end, which was incorporated into the fabric of the barn and lately used as a cowhouse together with the southern bay of the former barn (Plate 16). The combined space was not originally used to house animals; there is a bricked-up doorway in the southern end gable through which, the central drain now runs and there is a large iron window above (Plate 16), indicating light was needed for the function of the space, not a usual trait for cowhouses. This end of the building is in poor condition. A modern breezeblock bullpen has been attached to the eastern elevation at this end (Plate 2) and an original piggery still remains attached to the barn further to the north past the cart door opening (Plate 17). This is of brick and tile construction and appears contemporary with the barn structure. The piggery houses a small 'swill processing house' with a hearth and chimney under which, pigswill would have been boiled up.

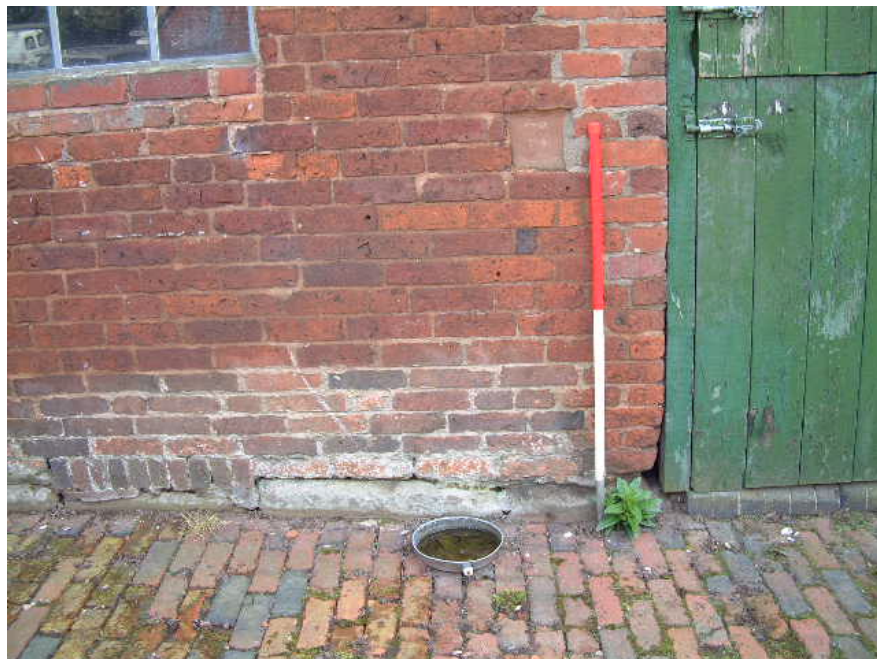
## Plate 14

*Smaller bricks used at the lower level of Building 3, indicating a possible earlier phase (scale 1 metre)*

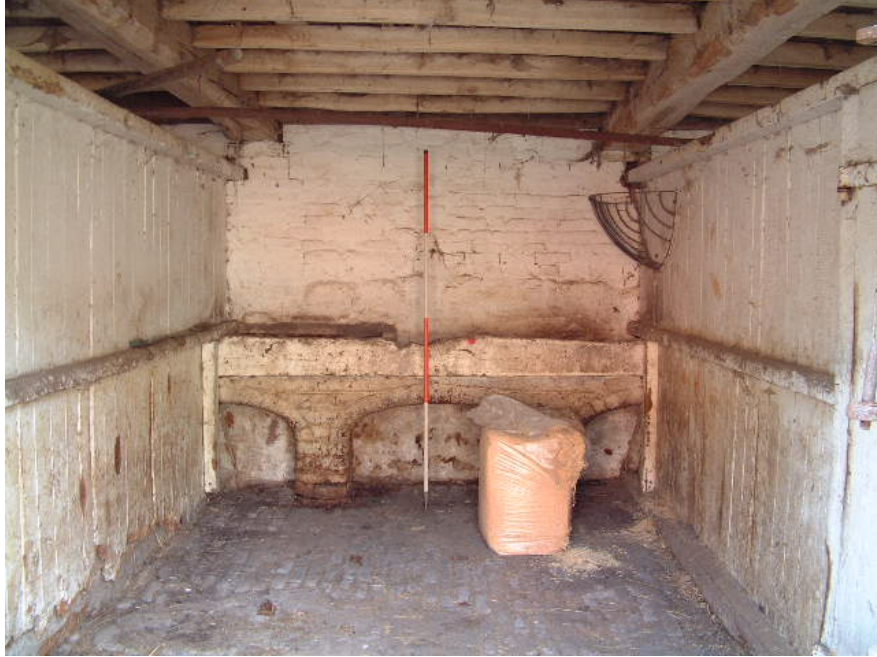
**Plate 15**

*Inside stable within Building 3 (scale 2 metres)*

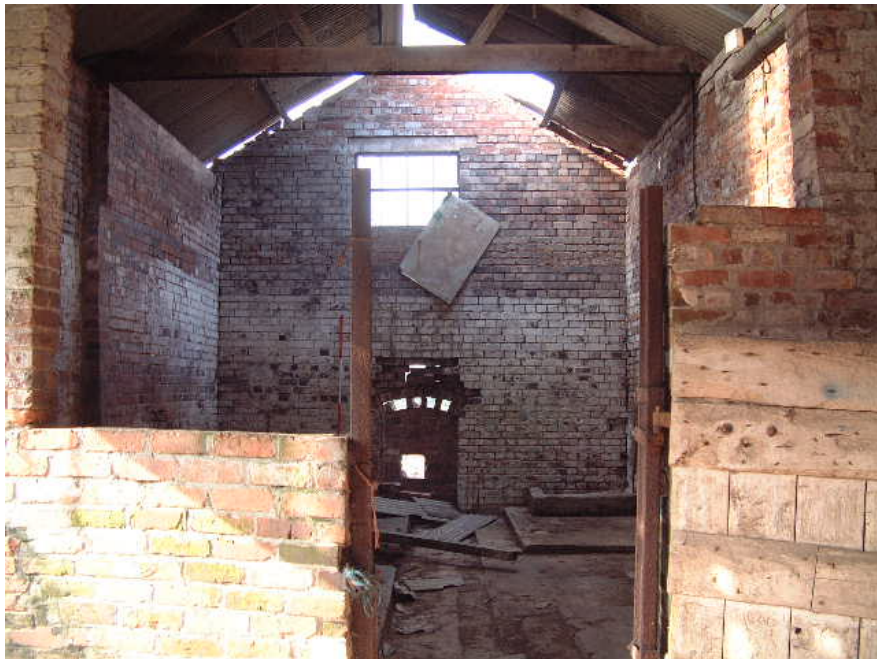
**Plate 16**

*Extension to the southern end of Building 3 (scale 2 metres)*

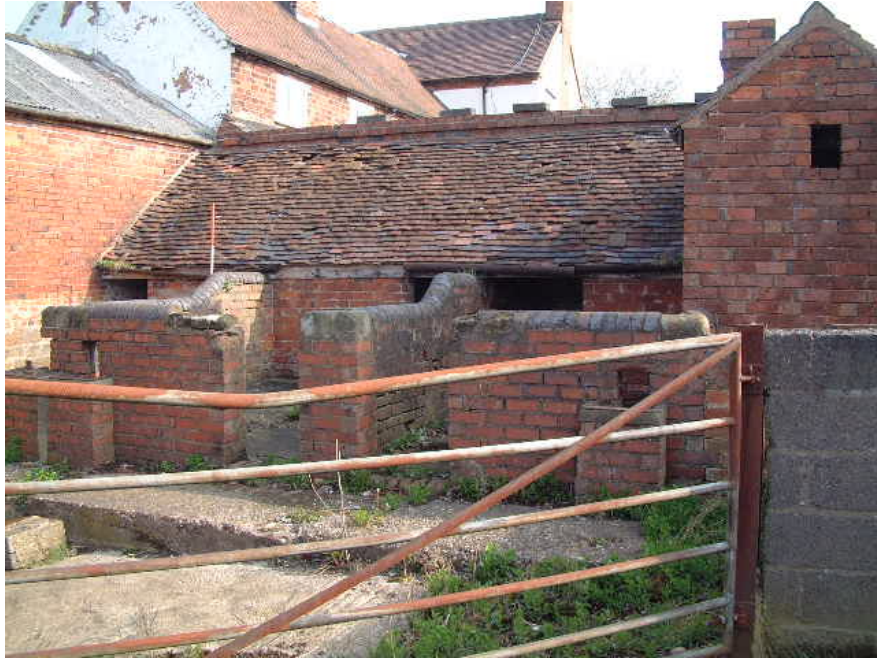
## Plate 17

*The piggery on the eastern side of Building 3 (red on scale 0.5 metres)*

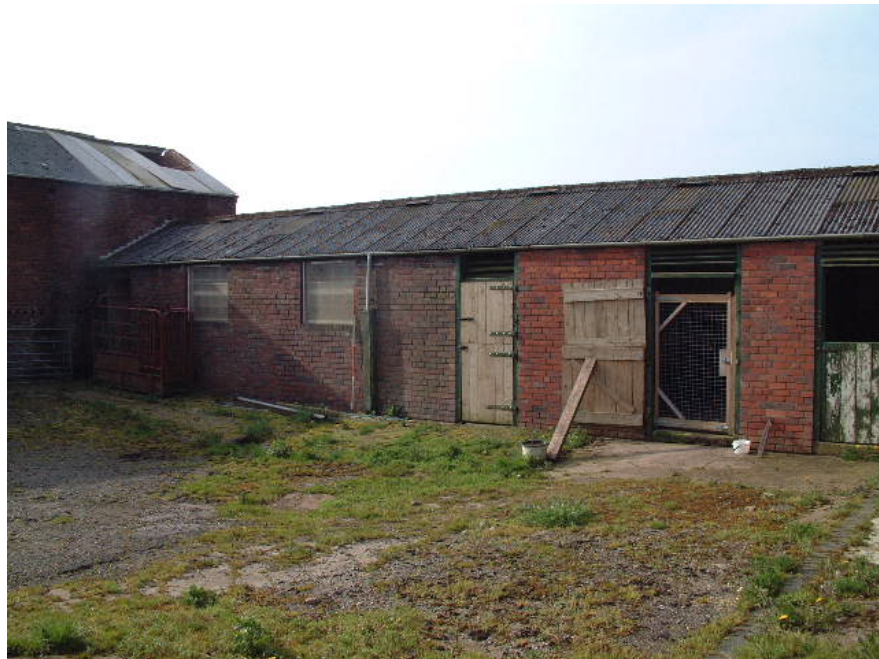
## Plate 18

*Building 4 looking south (scale 2 metres)*

Building 4 stands along the southern end of the complex, traversing the space between Building 2 and Building 3 (Plate 18). The building is now used partially as a kennel and this area was inaccessible. The eastern side of the building has been lately used as a cowhouse, and was probably converted for this purpose during the mid-20<sup>th</sup> century (Plate 19). Although the northern elevation of this building has been totally rebuilt, it is likely that it is on the footprint of a building formerly used as a shelter shed, with the northern (internal) side open. There is a substantial remnant sandstone wall to the rear (southern elevation) of the building and the original build may be 18<sup>th</sup> century or earlier (Plate 20).

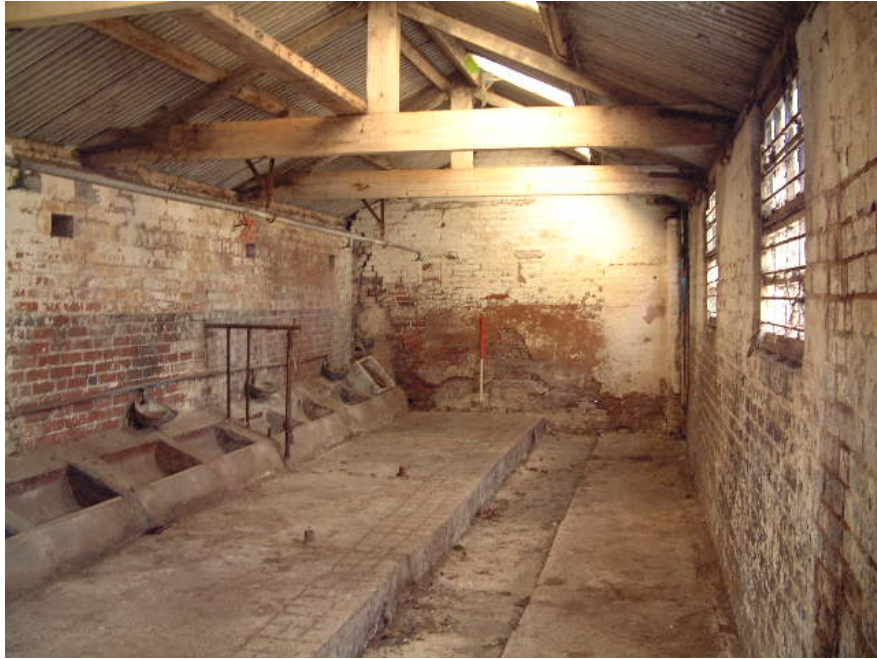
## Plate 19

*Interior of cowhouse, Building 4 (scale 1 metre)*

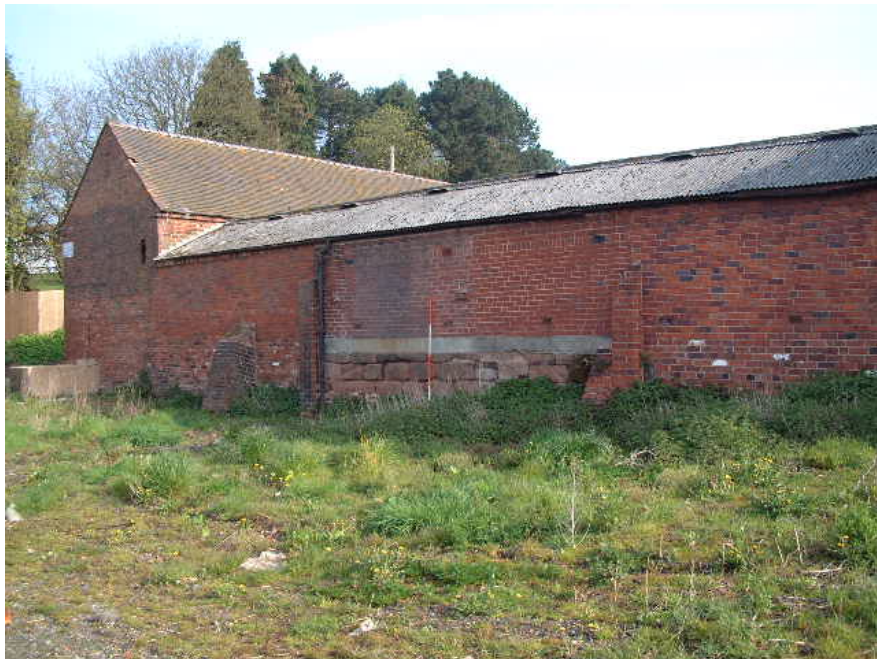
## Plate 20

*Sandstone wall within the fabric of Building 4, looking north (scale 2 metres)*

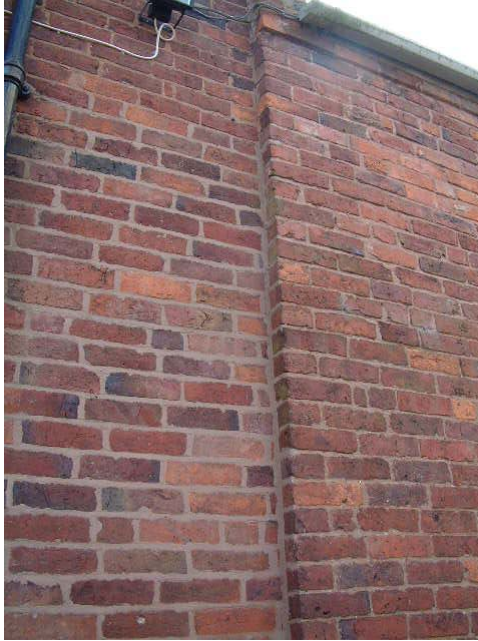
## Plate 21

*Joint between Building 3 and the farmhouse*

The association between Building 3 and the farmhouse may also be confused. At first sight the farmhouse (the section of it that joins Building 3) appears architecturally earlier than the farm building and may be dated on this basis to the late 18<sup>th</sup> or early 19<sup>th</sup> century. However, inspection of the joint between the two builds shows a well made corner to the barn and it appears that the farmhouse butts up to the northern wall of the former barn, therefore it would be later than the barn (Plate 21). This area is confused as the brickwork of the farmhouse has been repointed and the joint between the two mortared in. The explanation seems to be that the farmhouse is, indeed earliest and has been tied into the *inner* skin of the barn gable end, suggesting that the barn only has a single skin wall at this end and that the western elevation ends slightly overlapping the western elevation of the farmhouse wall.

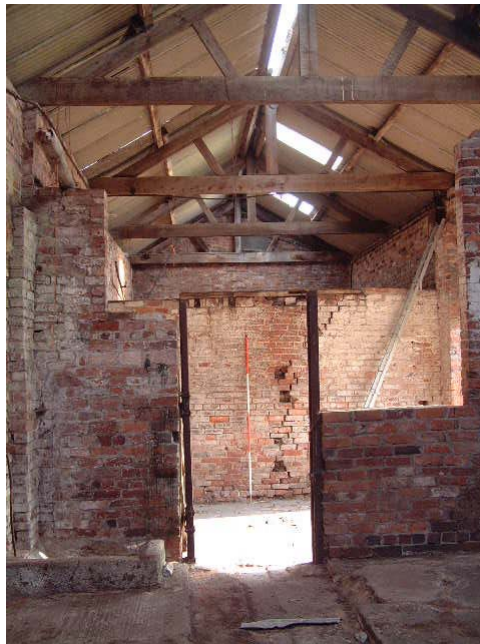
## Plate 22

*King-post trusses in Building 3, looking north (scale 2 metres)*

It is often argued that the style of roof truss can indicate a date range for a building, however, where a series of buildings have a narrow period of construction between them, this is of little use, especially where timbers may have been re-used. The roof trusses at Farley Farm vary, with mass-produced king-post trusses to Building 1, 3 and 4 (Plates 22 & 25) and a combination of queen-strut (Plate 23) and queen-post half truss (Plate 24) in Building 1. The central trusses in Building 1 appear to be re-used items and are likely to be 18<sup>th</sup> century, whereas the remainder may all be dated to the 19<sup>th</sup> century.

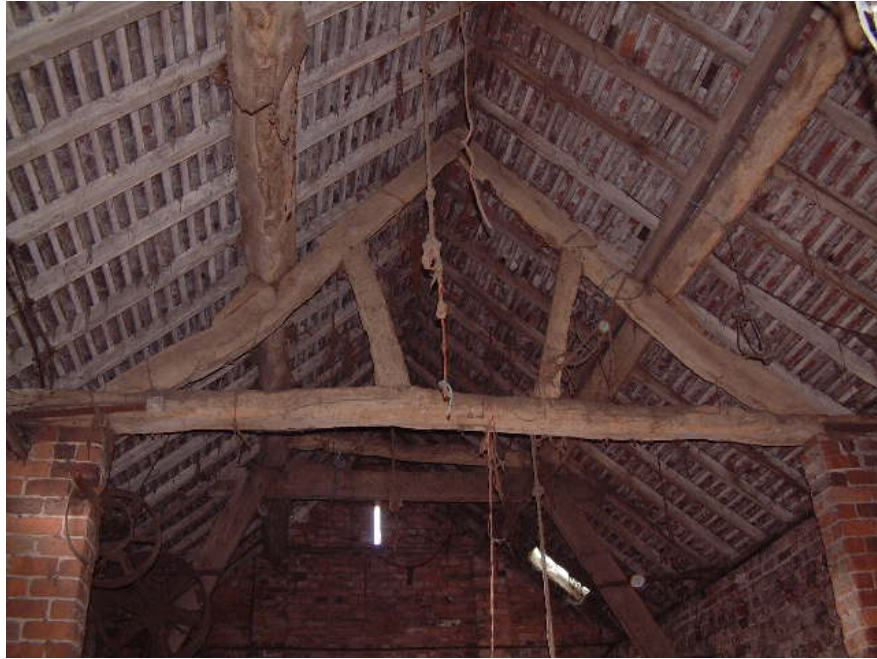
## Plate 23

*Queen strut trusses in Building 2*

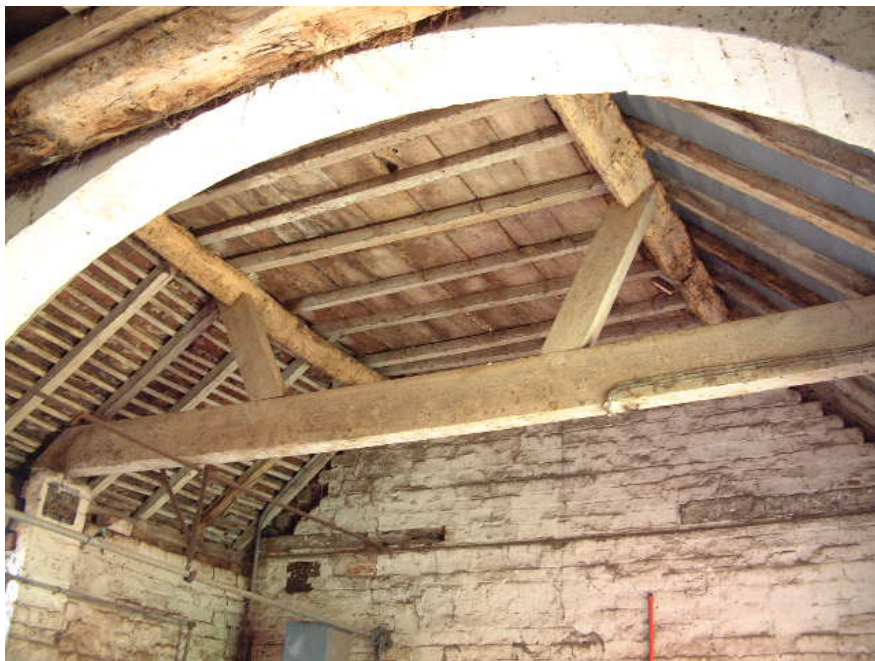
## Plate 24

*Queen-post half truss in projection at northern end of Building 2*

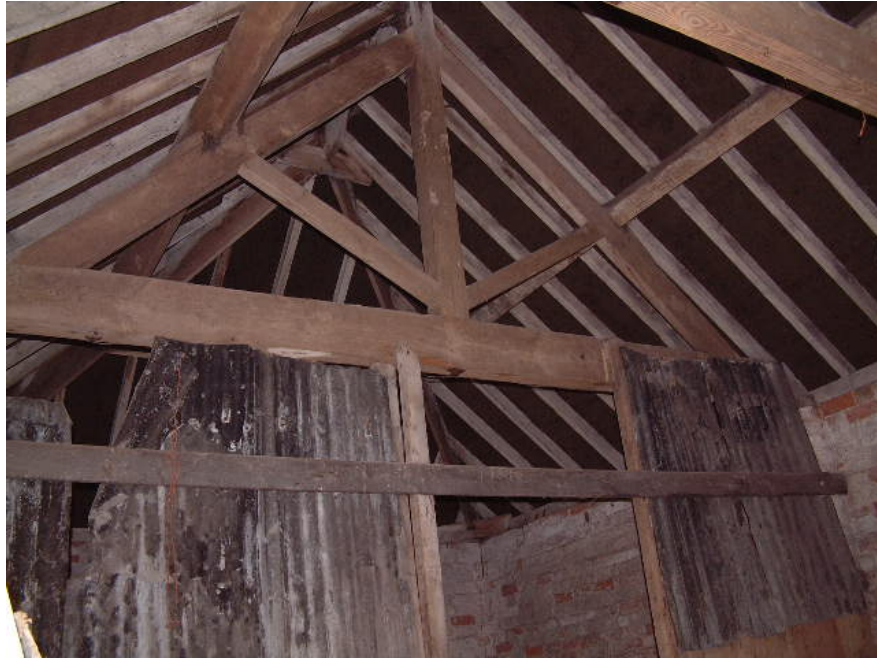
## Plate 25

*King post truss in Building 1*

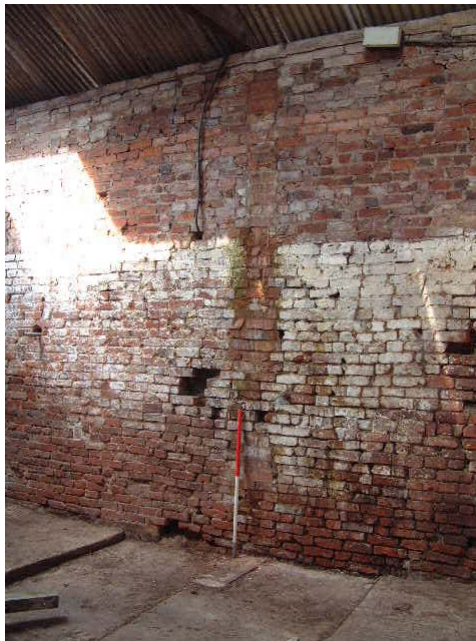
## Plate 26

*Rough construction of the extension at the northern end of Building 3*
