*Historic Building Recording and Watching Brief
at
Grafton Farm, Bockleton, Worcestershire*

A report for Mr and Mrs Thomas

May 2005

**WSM 34219 &
WSM 34220**

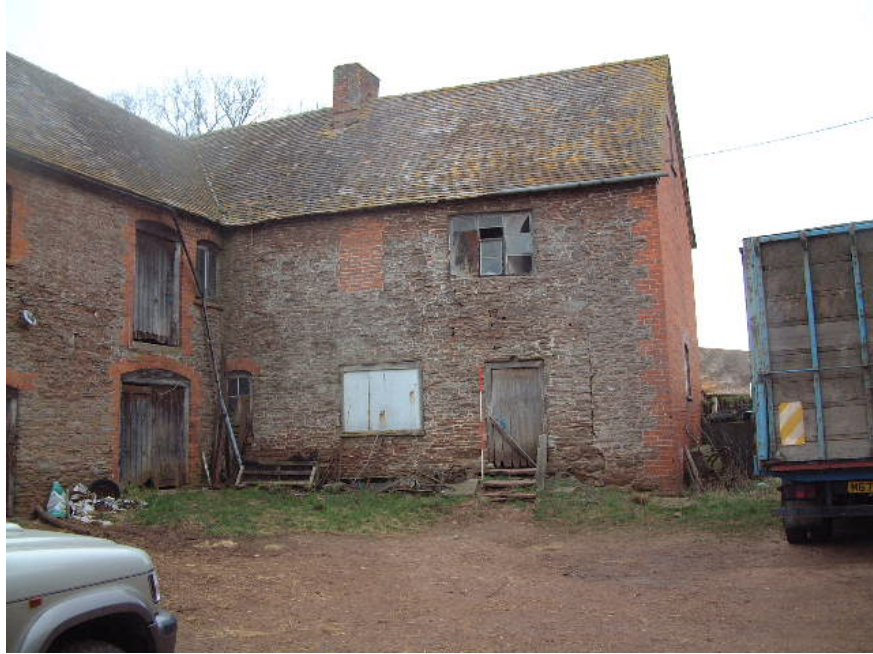
Plate 1

The former farmhouse looking north-east (scale 2 metres)

The remains of the original farmhouse stand on the eastern side of the complex (Plates 1- 4). The building is of two storeys plus attic, rough coursed stone construction with later alteration in brick. The roof cover is now of handmade clay tiles, but the steep pitch of the roof suggests that the cover may formerly been of thatch. With the exception of a first storey slit window to the eastern elevation, all the windows appear to have been inserted into the earlier fabric, rough segmental brick arched lintels being used above some windows and indications that the stonework has been disturbed above other windows that rely on the frame to support the wall

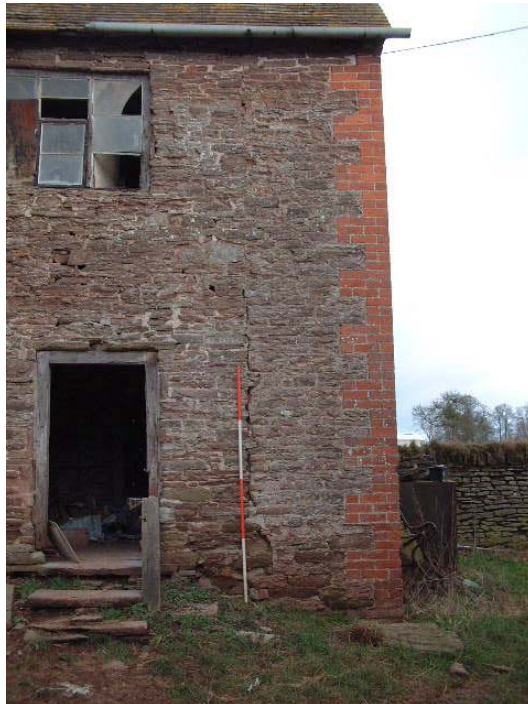
Plate 2

Rebuilt stonework tied into the newer brick southern elevation

above. It is not clear if the opposing doors, on the east and west elevations are original, but this seems likely. The northern elevation has been rebuilt in orange-red handmade brick and a limey mortar. The bricks measured 2 ¾" x 9" and are laid in an unusual quarter lap bond, with one row of alternate headers and stretchers over a row of stretchers. There are windows to the ground and second floors beneath polychrome segmental brick arched lintels. Part of the stonework of the western elevation was rebuilt at the same time that the new brick gable wall was built (Plates 2 and 3).

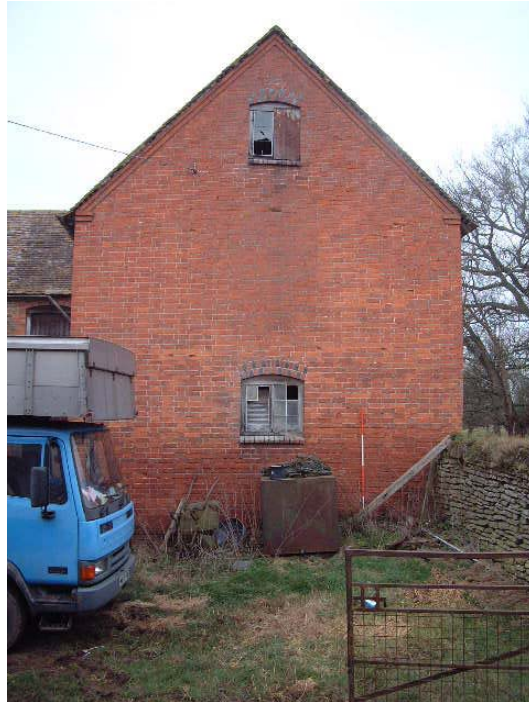
Plate 3

*Gable end at south of farmhouse
(scale 2 metres)*

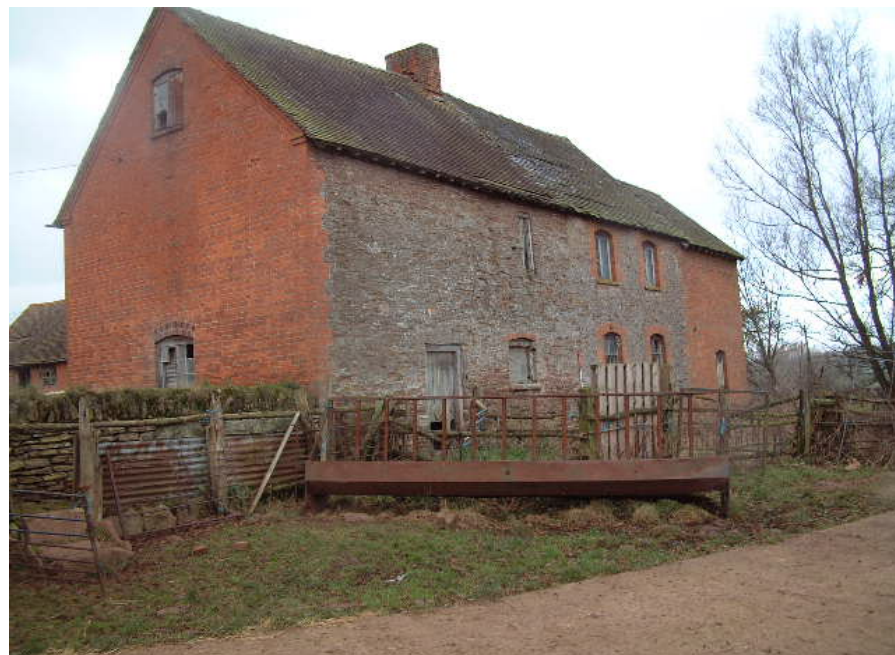
Plate 4

The farmhouse (left) extended into Building A (right of chimney, looking north-west)

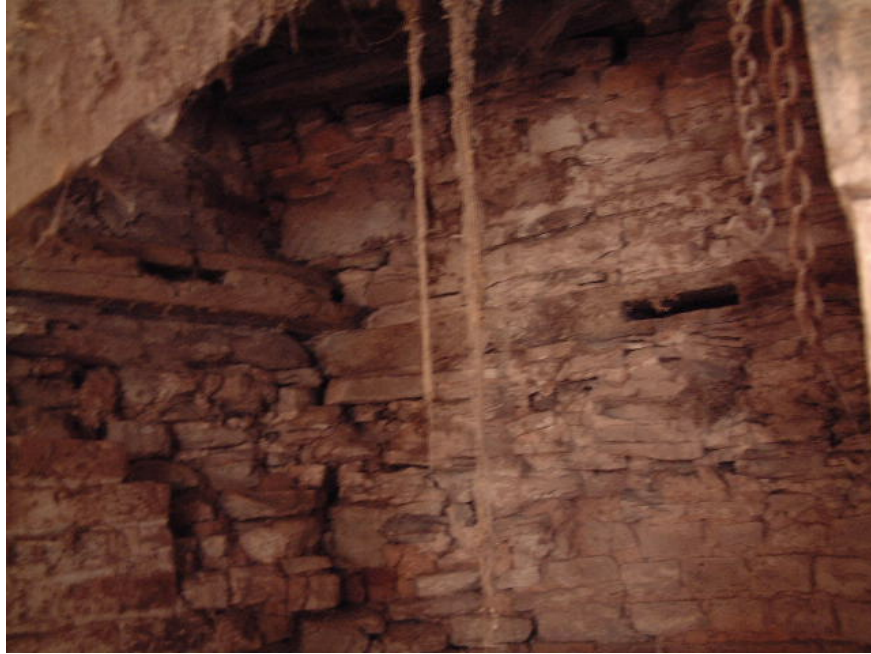
Plate 5

Bread oven in the north-west corner of the lower floor of the former farmhouse

Inside the structure, a brick hearth, bread-oven and chimneybreast have been inserted into the northern end of the lower room. The chimneybreast is built over a heavy timber mantel beam (Plates 5 and 6). Some ironwork still remains in the hearth; with a spit, hook and chains surviving in the accumulated debris at this end of the structure. The bread oven was in a dilapidated condition. A brick partition had been extended into the room from the hearth, forming a storage area, this was lately used as the control area for electrical systems around the farm. A set of timber steps had been added over the bread oven to give access to the (later) adjoining building (Structure A in Figure 5). A staircase once rose up to the first floor in the opposite (southern) corner and then dog legged up to the attic from the first floor; the lower level of the timber constructed staircase is missing and access to the first floor is now via the steps on the opposite side, referred to above. It is unsure if the staircase is an original feature. Elsewhere within the original fabric, it was noted that timbers from earlier building(s) had been used within the stone built construction (Plate 7), it would have been good economics to re-use building material, in this case timbers, inside the wall fabric and many may have been strategically placed so that nails could be driven in to fix internal fittings.

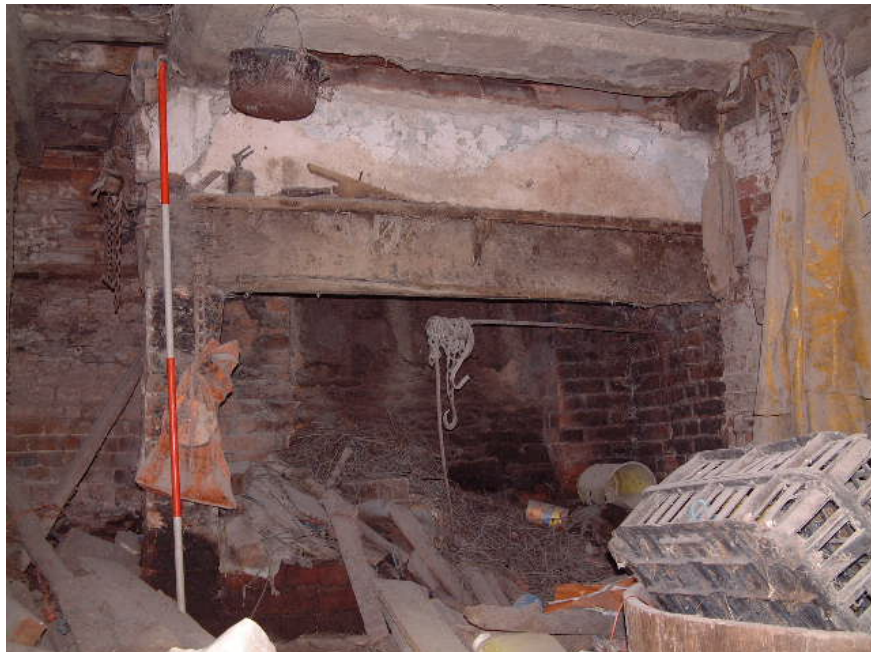
Plate 6

Hearth with iron spit below mantel beam, probably 19th century (scale 2 metres)

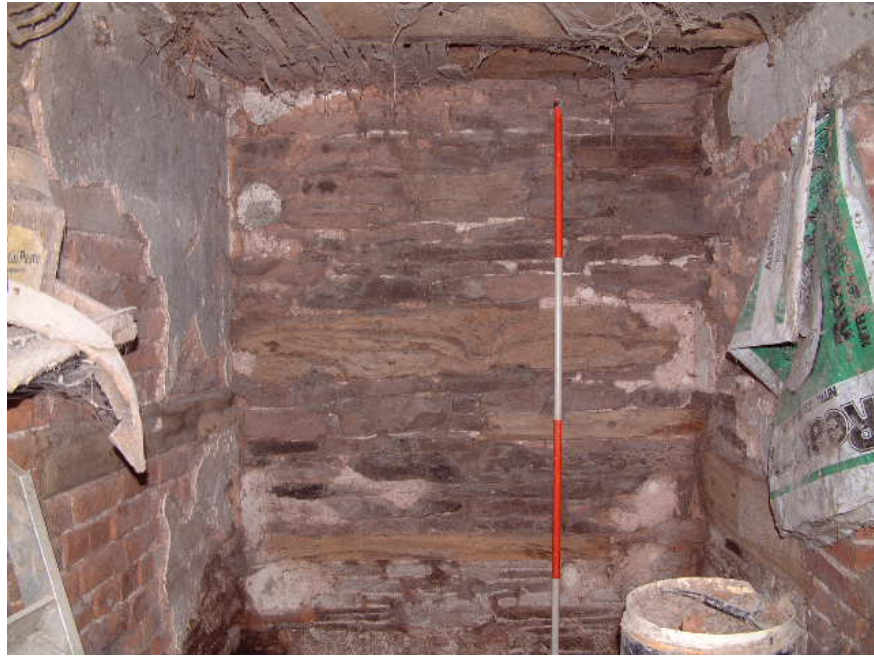
Plate 7

Re-used timbers in the stone wall fabric of the former farmhouse (scale 2 metres)

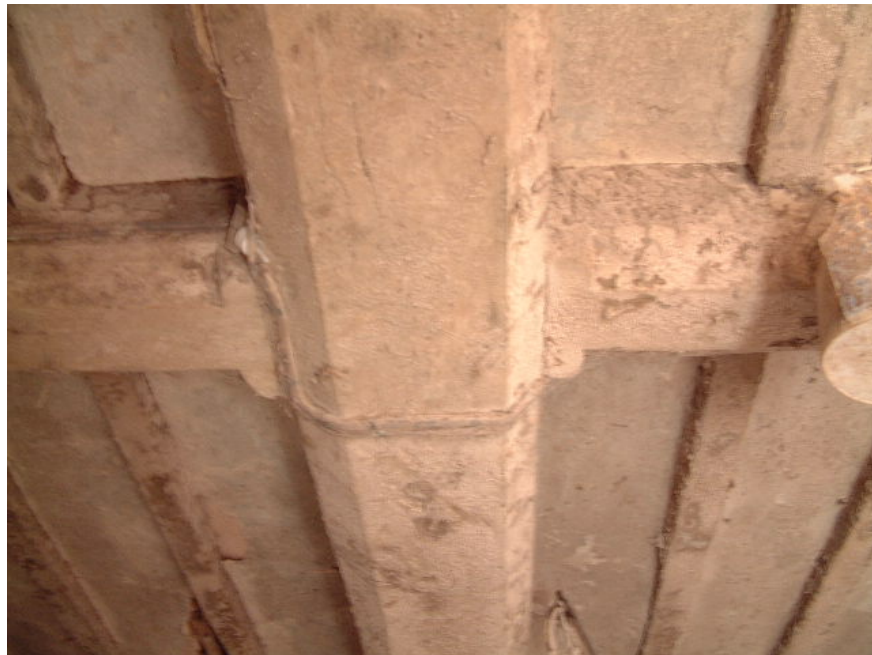
Plate 8

Chamfered axial and bridging beams at first floor level in the former farmhouse

The first floor joists were carpented into chamfered bridging axial beams, which with the bridging beams were carved with straight cut stops (Plates 8 and 9). The ceiling was lath and plaster between the joists. The internal space was lately used for milling grain and some associated infrastructure for the milling process was still in place (Plate 10).

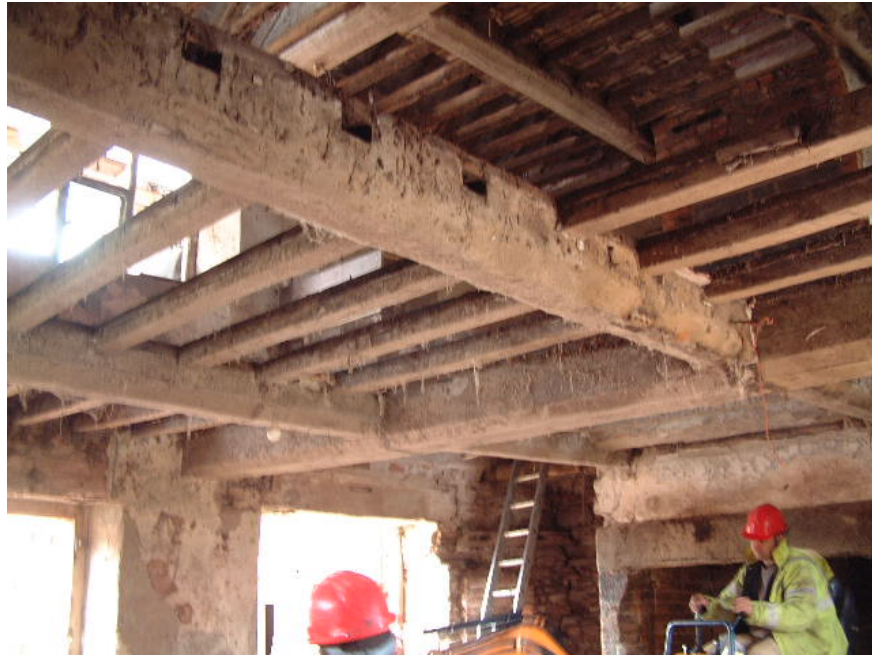
Plate 9

The construction of the first floor in the former farmhouse seen during the watching brief

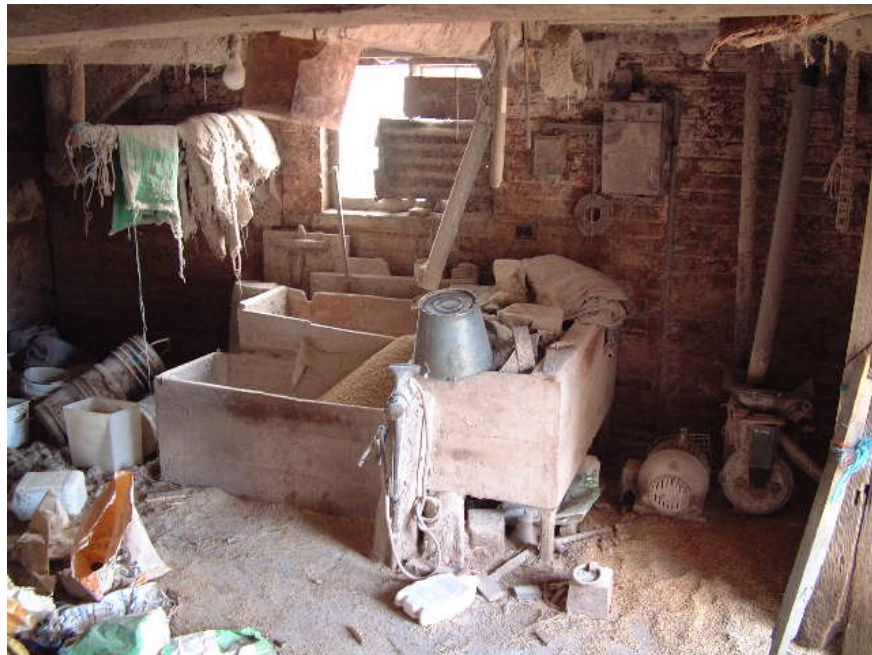
Plate 10

The lower floor of the former farmhouse has lately been used for milling grain

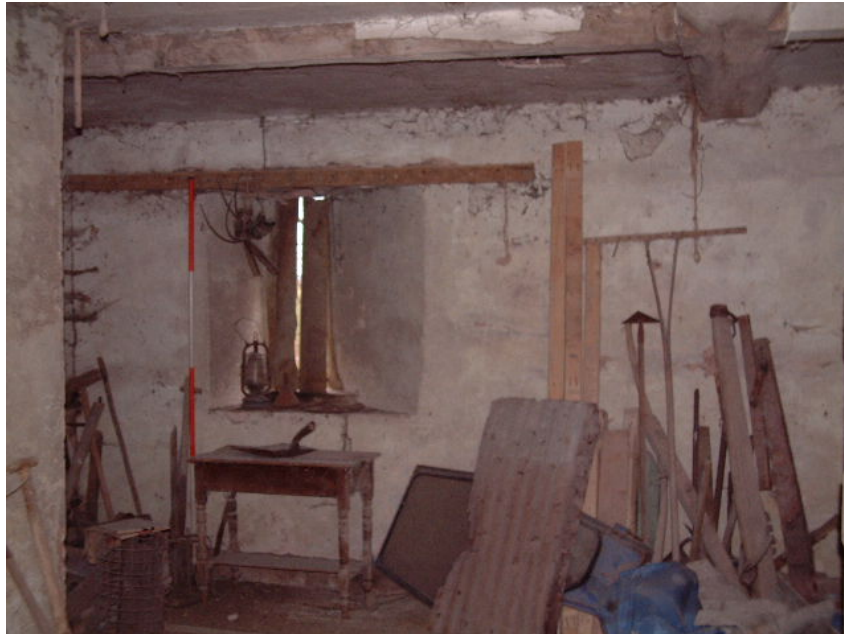
Plate 11

Original splayed window to the upper eastern elevation of the former farmhouse. Note the greater splayed reveal (right) into the room (scale 2 metres)

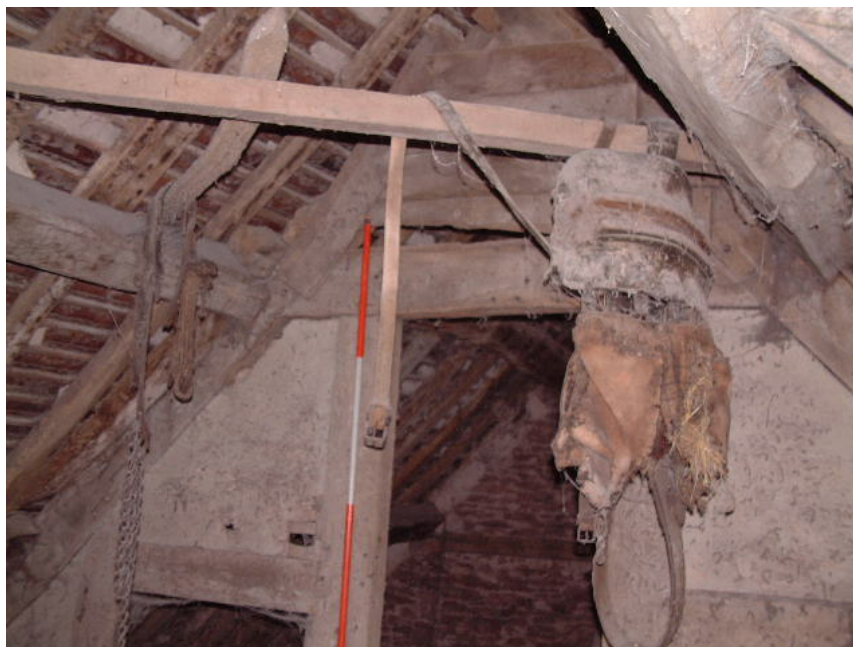
Plate 12

Truss in attic of former farmhouse with central access through, looking north (scale 2 metres)

The attic space was divided into two by a heavy central timber truss. The truss was of twin queen-struts pegged into the collar between the principals, with rails and studs forming panels (Plates 12 and 13), the rafters were supported on trenched purlins. The space between the struts formed access from one space into the next and the partition was formed by infilled panels of riven oak wattles and staves between the timbers and covered with a lime plaster including horsehair (Plate 14). There were empty mortises and peg-holes in the collar and queen-struts, this and the fact that the collar and strut joints were undisturbed, indicates that these were re-used timbers rather than due to modification of the truss. Empty peg holes in the purlins show that originally the rafters were spaced further apart (Plate 15). Chiselled carpenters' marks were noted on the rails forming the bottom of the infill panels. There was also evidence to show that at least two purlins were made from re-used timber (Plate 16). The space appears to have been used lately to store saddlery and riding tack.

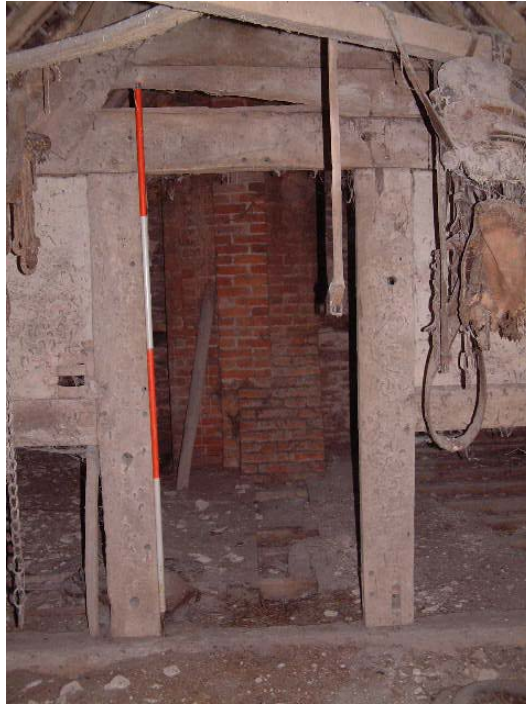
Plate 13

Central access through attic truss in former farmhouse looking north (scale 2 metres)

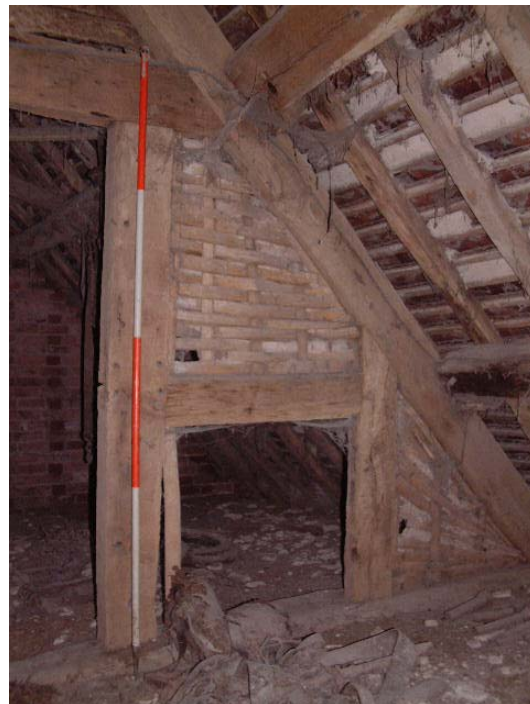
Plate 14

Wattle and daub panelling surviving in the truss (scale 2 metres)

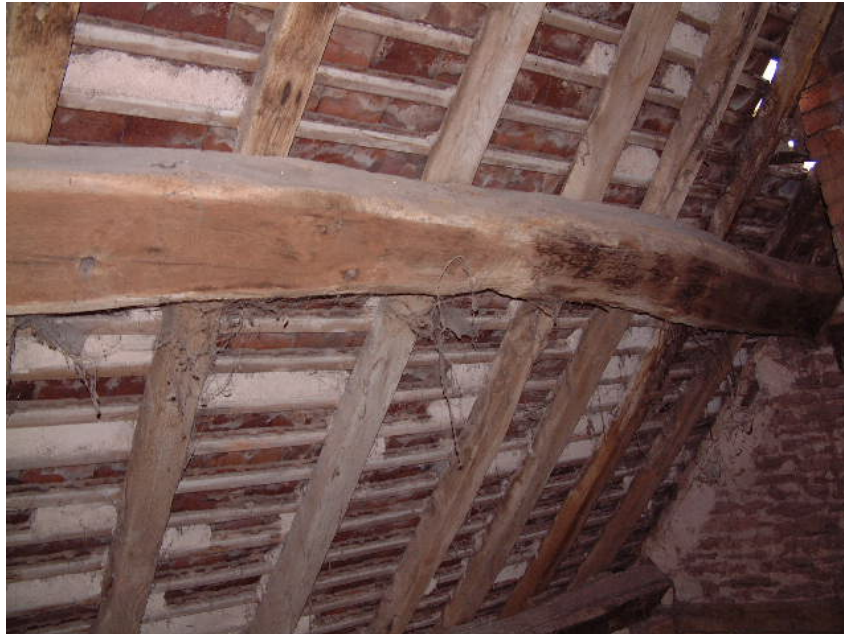
Plate 15

Peg-holes in an attic purlin, showing the rafters are not original to the purlin

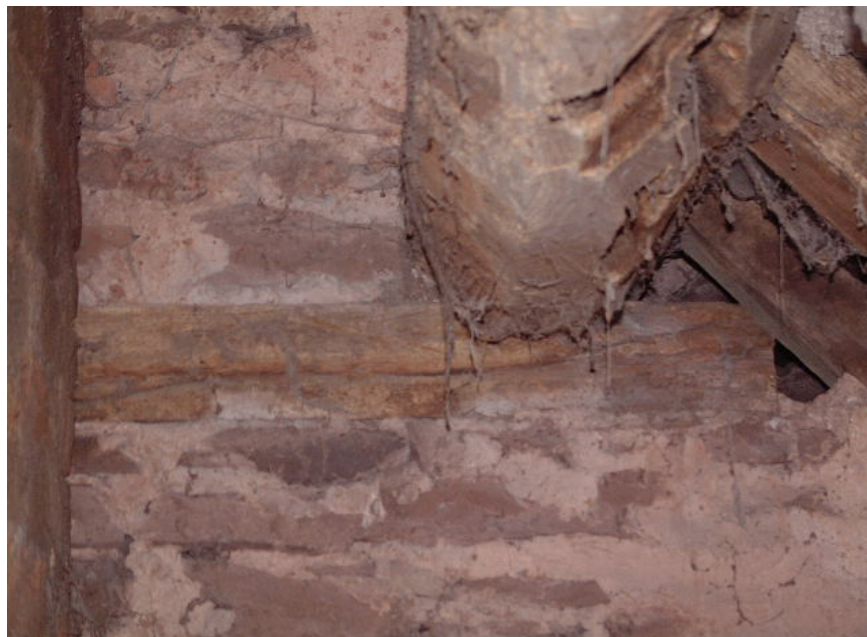
Plate 16

Attic purlin with cut mortises showing the timber is re-used. Also note a re-used rail in the end gable (north) with groove to take the bottoms of staves of a wattle and daub panel

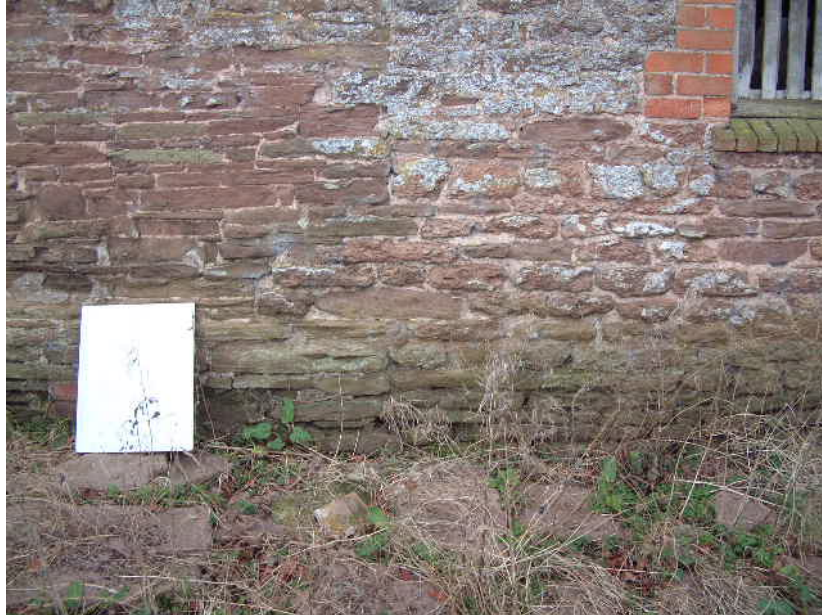
Plate 17

The stonework at the base of the build continues past the north eastern corner of the gable of the farmhouse, the extension (right) is built onto it (see text)

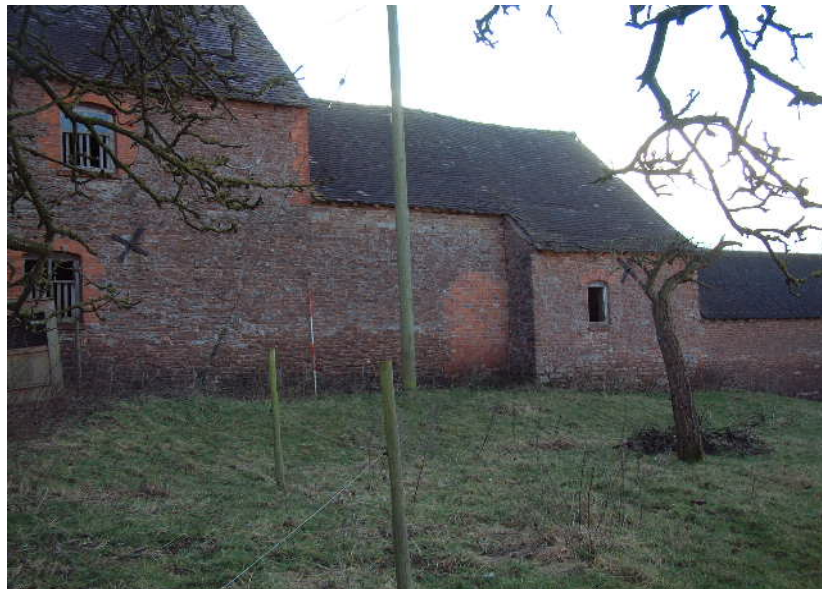
Plate 18

Northern elevation of space A (with windows), space B (with bricked up door) and attached stable at western end. Note the drop in roofline, although the wall is of a single build up to the end section.

Externally the two-storey structure butts onto the farmhouse (Plates 18 and 19). There are four windows to the eastern elevation with red brick segmental arched heads and quoins, a style followed through along the remainder of the western range (Plate 20). The northern gable end is now obscured by the adjoining brick built hop-kilns (Plate 21). The corner unit (A) has an upper floor that is carried across and above (B) although separate at ground floor level. This space was created at the time that the hop kilns were added, in order to create a processing space or 'oast-house'. Space (C) also has two stories, although the upper floor was not accessible as it was stacked to the rafters with bales-of-hay. From the front (southern side), this structure appears to be two structures, with the timber frame section having a different roofline and construction (Plate 22), however, the stone rear wall (northern elevation) demonstrates that it is of a single build and only the frontage of the timber-framed stable block is of a different phase.

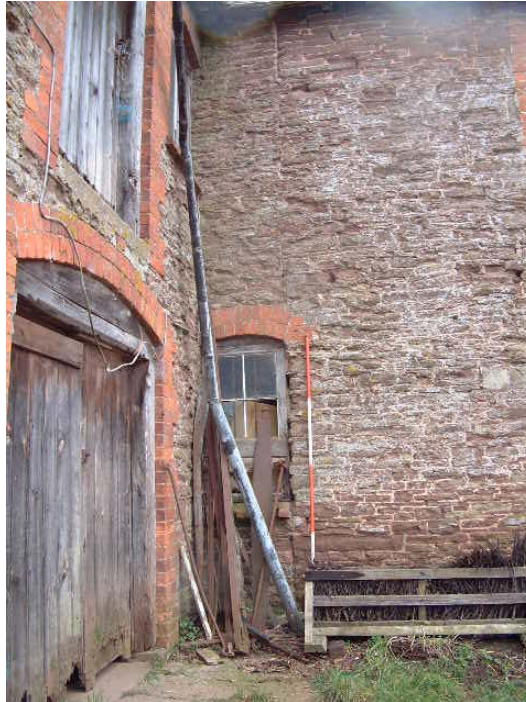
Plate 19

The butt joint between the former farmhouse (right) and Structure A (left) with the return range running to the west (scale 2 metres)

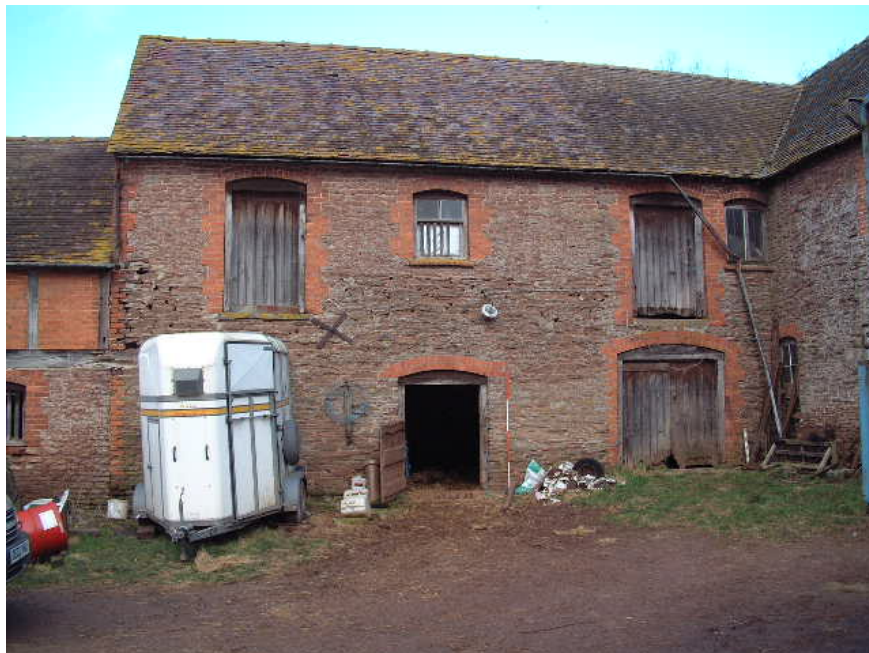
Plate 20

Southern elevation of the range of farm buildings showing A (right) and B (left)

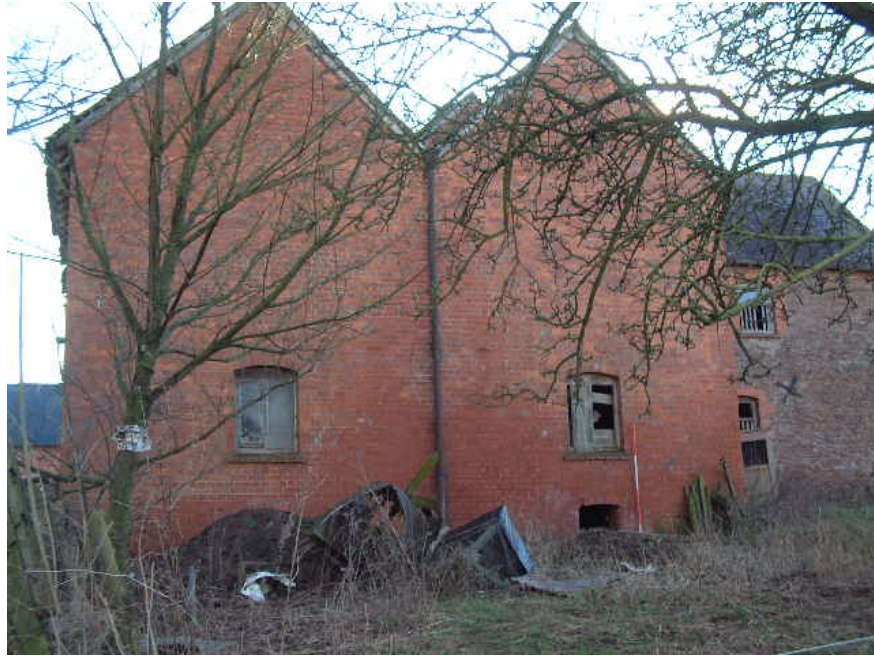
Plate 21

The hop kilns on the northern side of the complex (scale 2 metres)

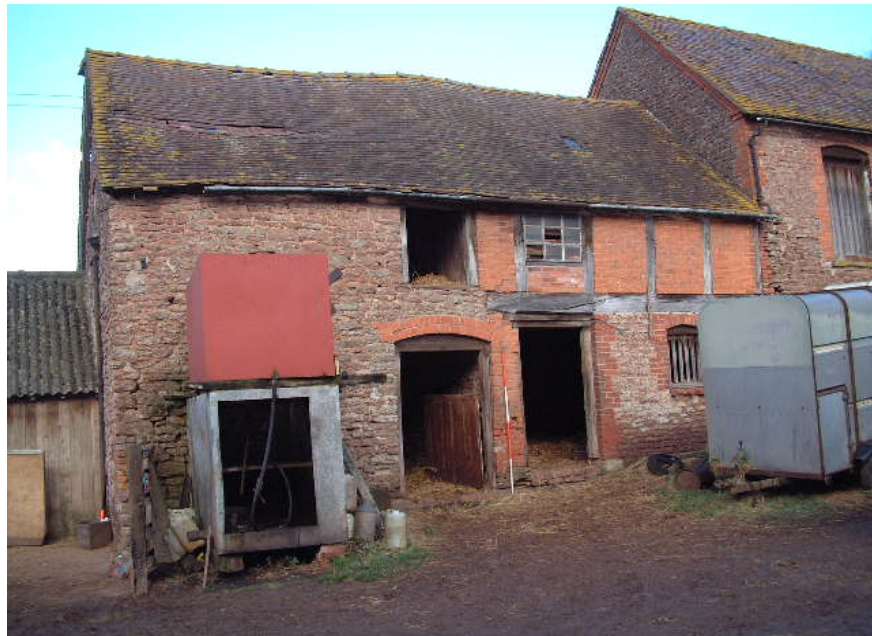
Plate 22

Southern elevation of the remnant timber-framed building (C) and the stone stable attached on the west (right)

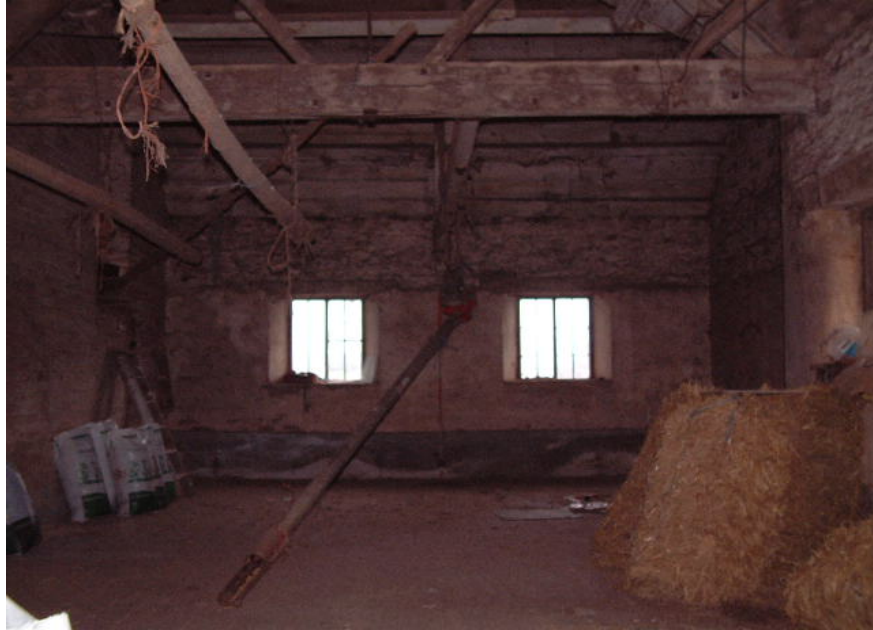
Plate 23

The oasthouse looking east, note the entrance to a kiln drying floor in the wall (top right by step ladder)

(Plate 25). A doorway in the northern elevation of the stone element of the build has been bricked up (Plate 23).

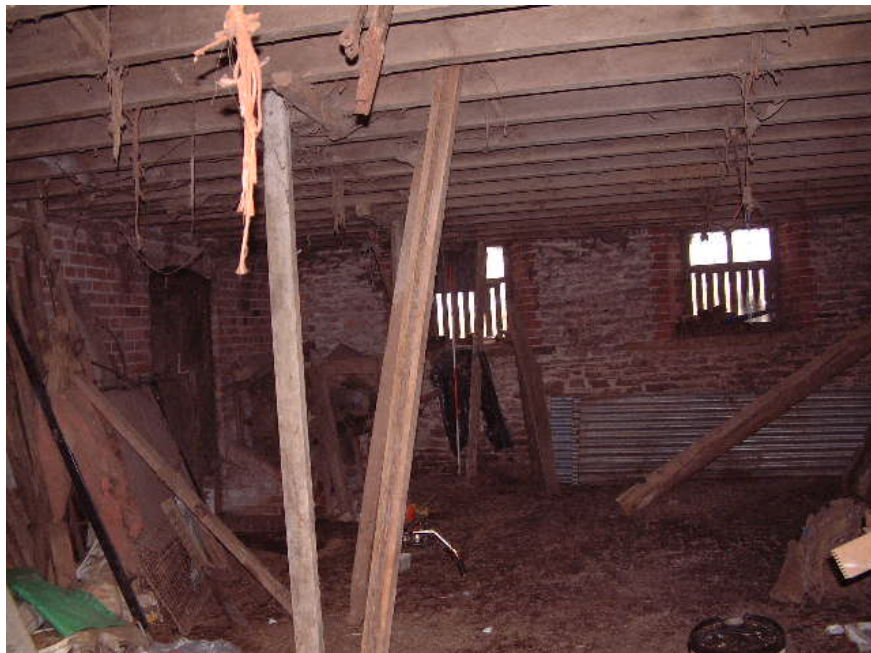
Plate 24

Space A: looking north-east, note the entrance to the northernmost kiln in the wall (left)

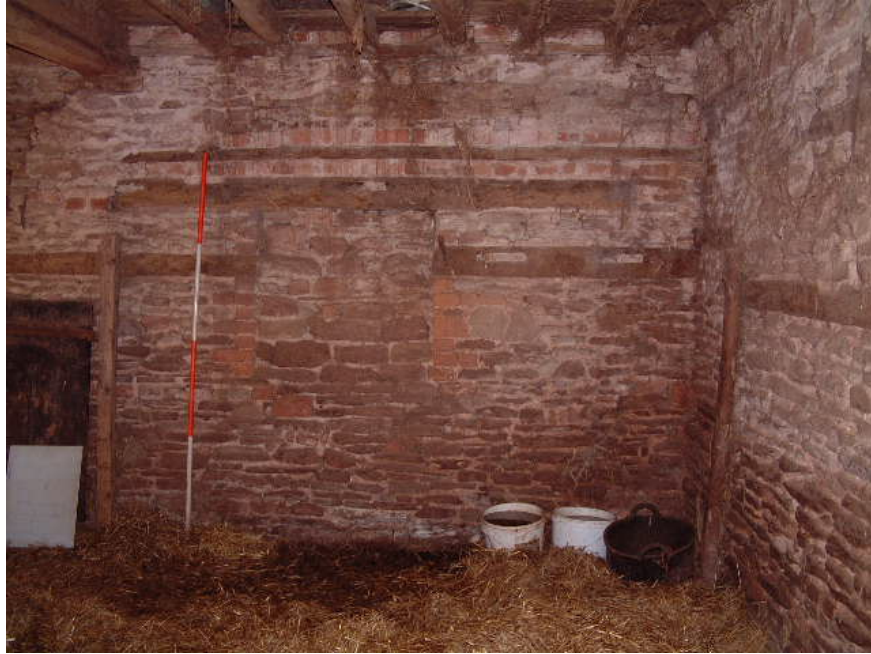
Plate 25

Space B (stables) looking north. Note extensive re-use of carpented timbers in the walls

The timber-framed element (C) is now a stable with a hayloft above. The timber studs only survive at first floor level and close inspection indicates that the framing originally extended to the east and west and has been under-built. The panel infills are now of brick, but these almost certainly would originally been of wattle and daub. Internally, the newer stone walls of this space (C) and space (B) have many sections of former timber-framed building within the fabric. These include sections with empty mortises, peg holes, and stave holes and grooves

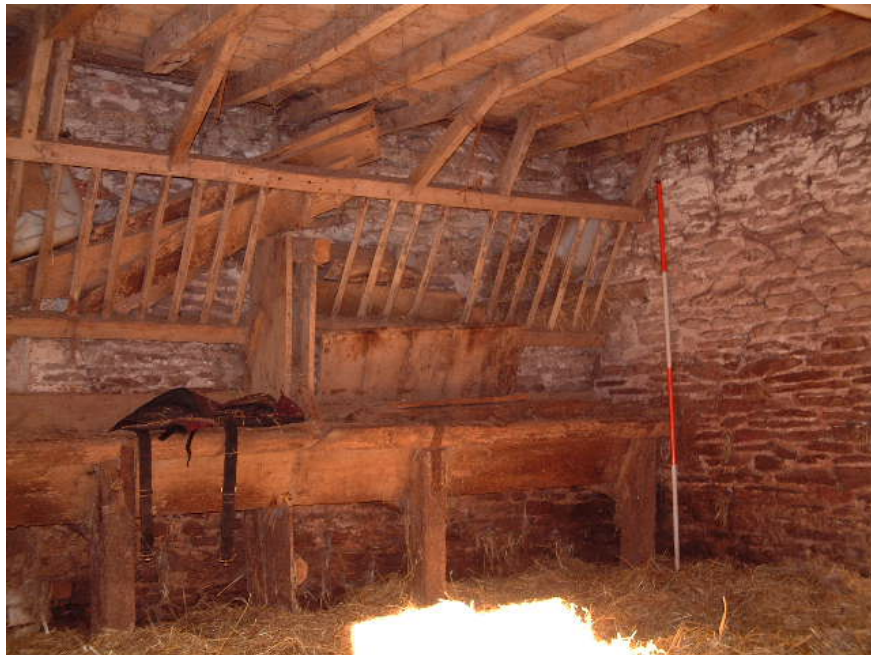
Plate 26

Space C (stables) looking north-east (scale 2 metres)

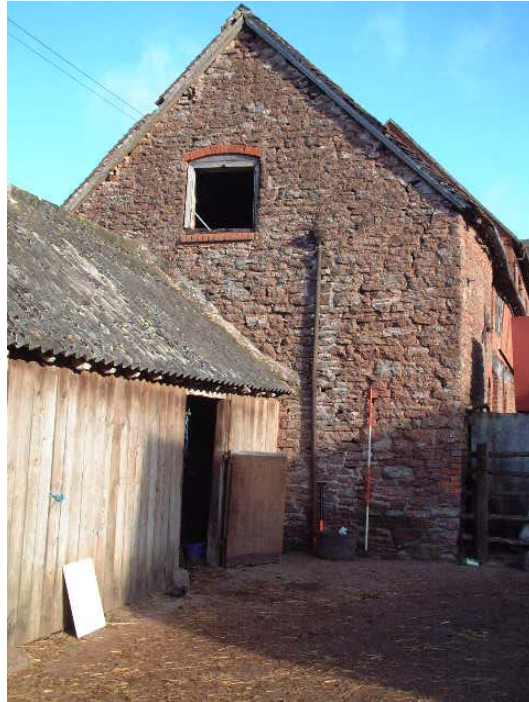
Plate 27

The stone stable block with hayloft above, added to the western end of the range (scale 2 metres)

At the western end of the range of farm buildings described above is a further stone built stable with hayloft above. This has been butted onto and shares a roofline with the gable end of the partially timber-framed section (C). There are pitching eyes with decorative orange brick lintels and sills in the west, north and southern elevation and above the stable door (Plate 27).

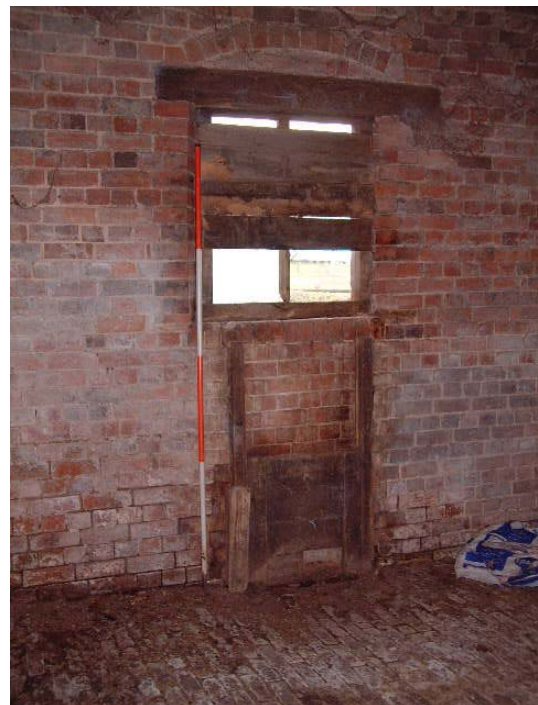
Plate 28

The vent in the northern elevation of one of the hop kilns (scale 2 metres)

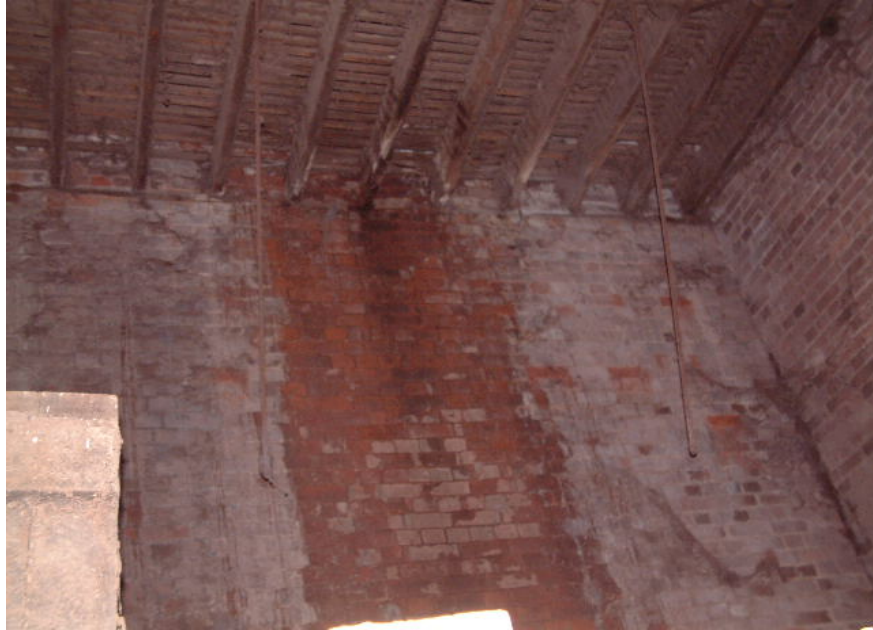
Plate 29

The laths of the drying floor in one of the hop kilns
