*Archaeological Project at The Boathouse,
Green Hill, Suckley, Worcestershire*

*An Archaeological Project at The
Boathouse, Suckley, Worcestershire*

A report for Marnie Caine

May 2005

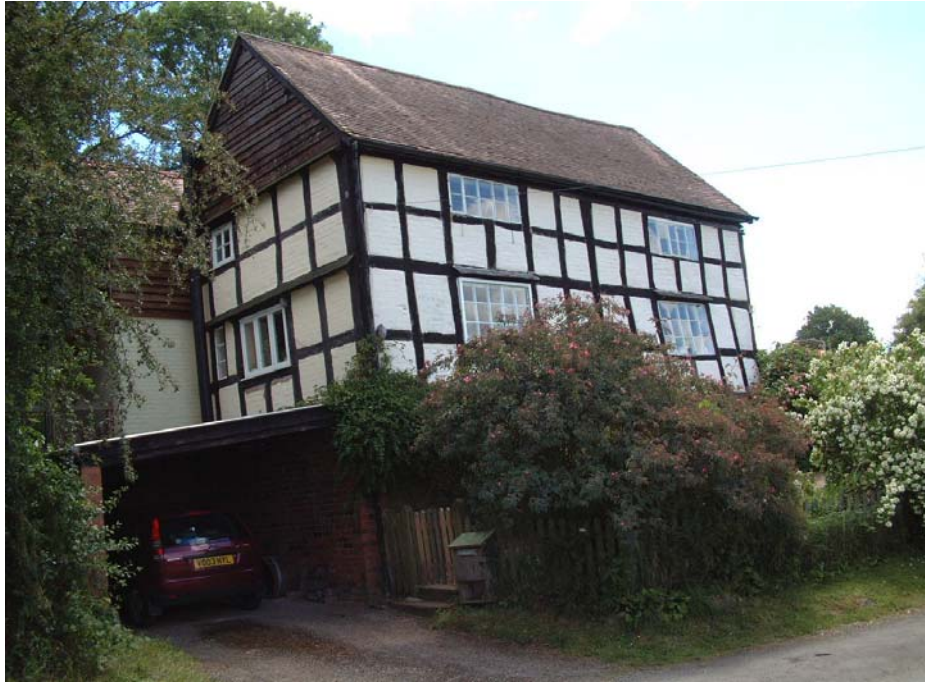
Plate 1

The Boathouse looking east

The Boathouse is a timber-framed cottage with square panelling in a style that suggests it dates from the 17th century (Plate 1). In the garden of the property, there are the remains of a small square rough stone construction, which was at the time of the project, to be combined into a new patio area at the cottage. Mercian Archaeology were requested to carry out a small-scale excavation around the remnant building to attempt to identify its former function and ascribe a date to it.

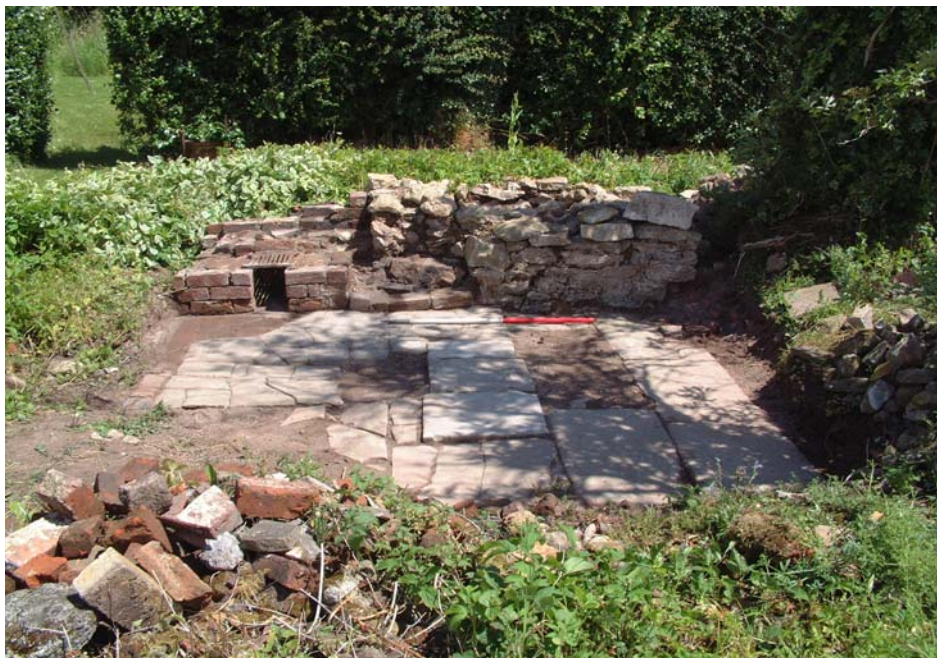
Plate 2

The square structure looking east, with the flagged floor (front) and brick pigswill hearth on the right (scale 1 metre)

The association between the stone structure, the surrounding flagged area and the remains of the brick building may be the key to interpretation. The brick structure is later than the stone structure, as it was noted to have been cut into and bonded to the north-western corner (Plate2). It is known that there was a piggery standing on the site into the 20th century (Marnie Caine pers comm.) and the northern and southern brick walls are still evident. The hearth with iron grate and lower levels of a fireback must have been used to prepare pigswill, which would have then been tipped into adjacent troughs. It seems that the stone floor was the floor of the piggery, being bounded and enclosed by the brick walls. The worn step of the entrance on the northern side was noted, with a stone flag on the external side of the entrance. The laying of the flag floor appears to be contemporary with the brick build of the piggery (based on the 19th century finds from below the floor and the use of brick typical of 19th century constructions[101]). It therefore seems clear that the flags were intended for this use at this time and do not represent the floor of an earlier domestic building on this site.

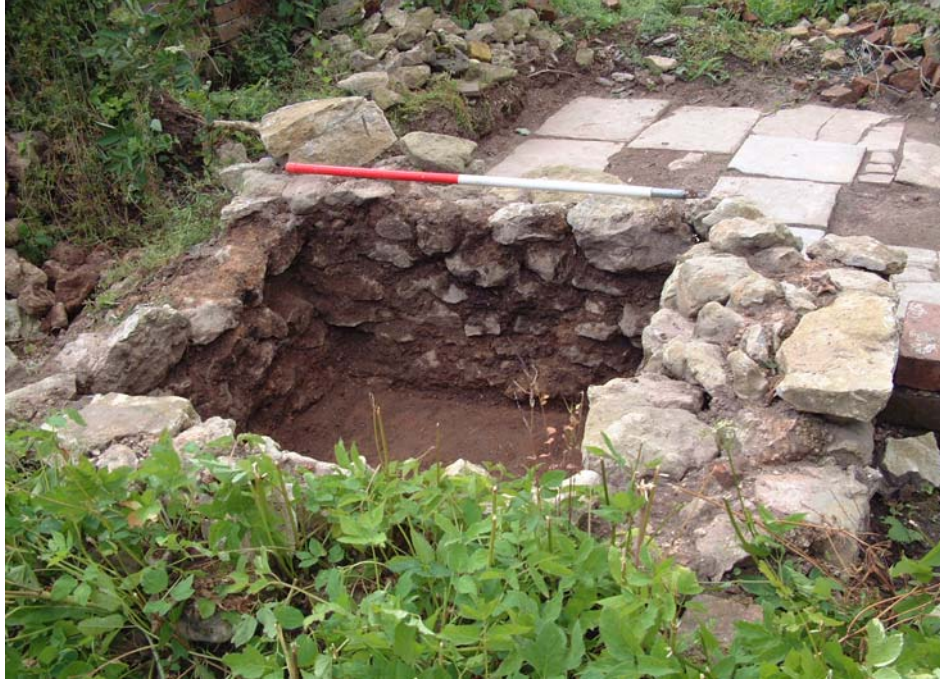
Plate 3

View to the west (scale 1 metre)

In an attempt to understand the square stone structure, the central area (inside the structure) was first cleared of tumbled stones and built-up debris [104](Plate 3). A test-pit (Test-Pit A) was then excavated into the enclosed central part. This revealed that the structure was of a single phase. The structure was buried to 0.40 metres below the present ground level and there was no visible foundation cut, which suggests that either it was constructed from inside to ground level height, within a square cut into the red clay-marl natural [105], or that the strip foundations were cut and the structure built as a tight fit into them. The evidence is unclear, but it seems likely that the square foundation hypothesis is more likely on two counts, firstly because the finds within the red silty-clay [102] over the natural [105] within the central void, were un-abraded and in good condition, suggesting they were deposited and sealed within a short period of time and secondly, that the backfill [102] was slightly less compact than the subsoil layer [101] outside the structure, this [101] was also noticeably graded, with more silt at the top and clayier at the bottom, whereas backfill [102] was well mixed with no noticeable grading of particles.
