***Historic Building Recording at  
Bank House Farm, Stanford  
Bridge, Worcestershire***

*A report for Iain and Milly Patton*

**Project: PJ 224**

**WSM 40523**

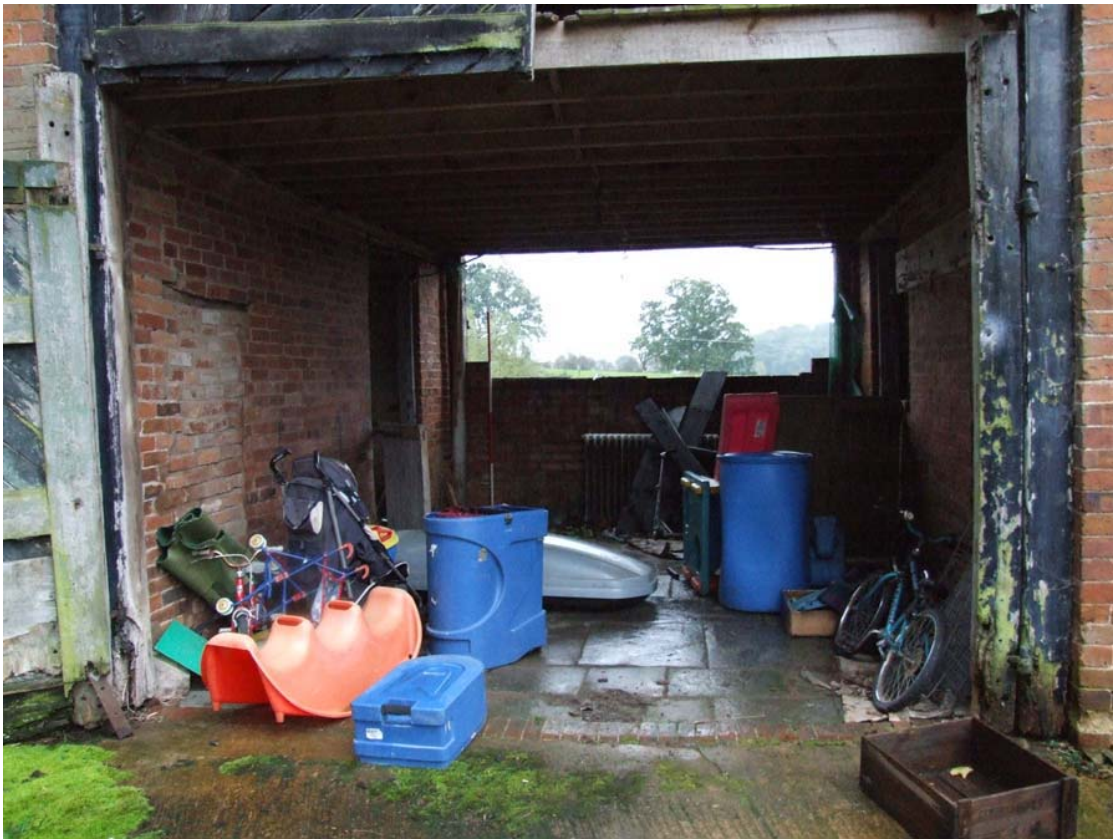
Plate 6: Threshing bay (A3) scale 2 metres

- A. The main focus of the barn is the 5 bay central section, which originally incorporated a central cart bay (A3) with stone threshing floor (Plate 6) and two storage bays to either side (A1, A2, A4 & A5). This area has been modified, with the southern cart doors removed and the opening blocked up and A1 and A2 converted to loose boxes (Plate 7). Brick partitions have been inserted at each bay division and doorways formed between, some of which were later blocked (Plate 12). Bay A4 has been converted to form a further loose box (Plate 8) and bay A5 has been opened out on the northern side, creating a cart bay (Plate 10); this is further described below. Originally, this area would have been open to the rafters and an upper floor has since been inserted to provide a hay / feed loft above the animal pens; the inserted brick partition walls can also be seen at upper floor level.

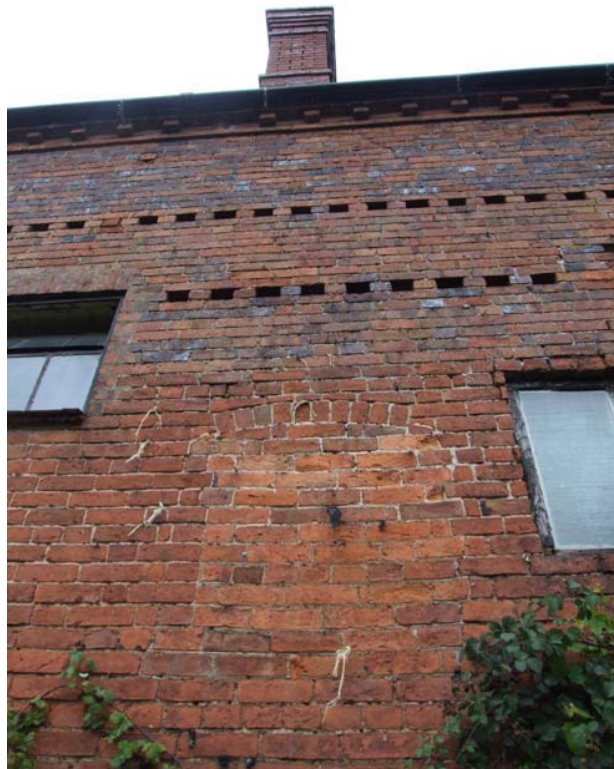
Plate 11: Blocked window with inserted chimney behind, northern side of D3

- D. Space D appears to originally have been a stable and cartshed, probably housing the carthorses, which would also have incorporated space E. This end of the range has been much modified and the upper levels of the walls rebuilt. At some stage, D3 was converted from its original use as a stable to form either a groom's accommodation, or perhaps an overseers office (Plate 9); a chimneystack and ground floor fireplace were incorporated into the space. The evidence to indicate that the chimneystack is a later

insertion is that it is built behind a former upper floor window, which has been bricked up (Plate 11). The space was converted again, probably sometime during the early 20<sup>th</sup> century, when a pair of cart doors were inserted in the northern wall rendering the fireplace obsolete. The space appears to have been lately used as a garage workshop, with an inspection pit sunk into the floor (Plate 14).

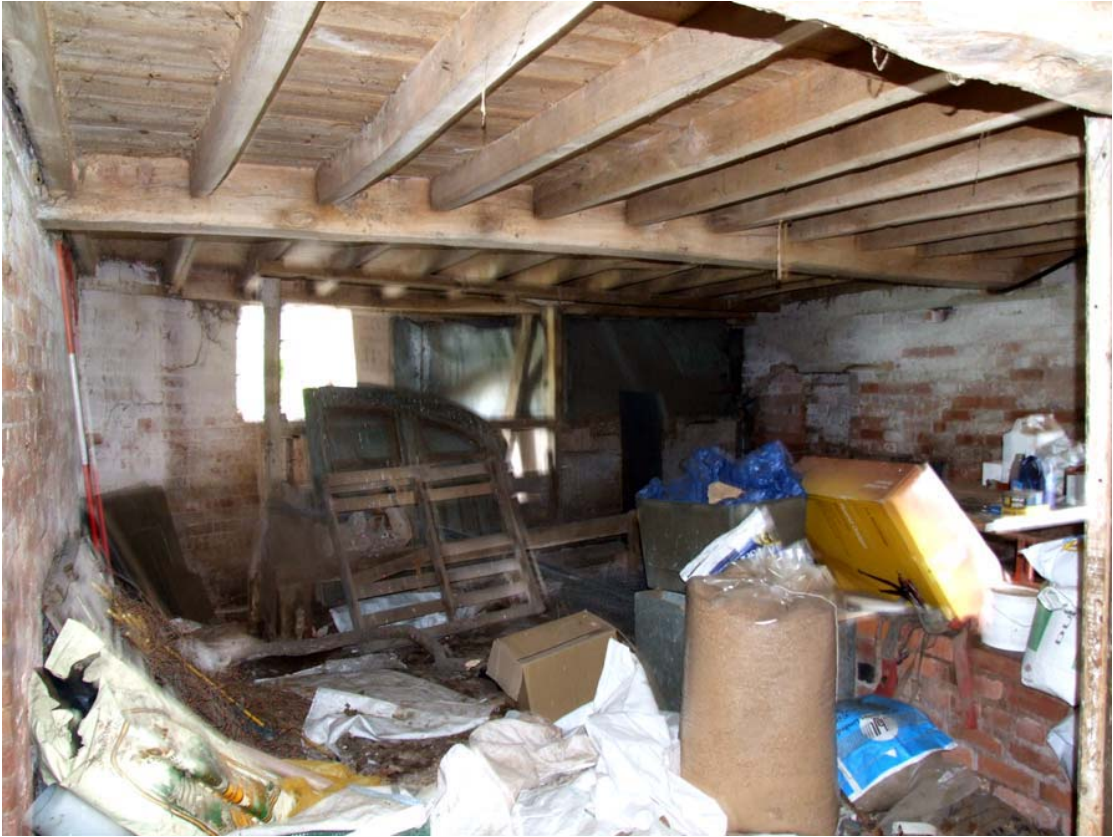
Plate 13: Space C looking north-east

- B. A cross passage gives access from both south and north into space C at the eastern end of the structure.
- C. Space C is distinctly separate from space A, with an original dividing wall at ground floor level and a doorway cut through at upper level to give access to the loft above. It was originally thought that the cross passage (B) may have been a phase division, with space C and the formed cross passage between A and C later than the original barn (A). The evidence is somewhat confused by brickwork repairs to the structure and there is a distinct 'floor to eaves brick infill' to the northern elevation at the juncture of B and C, though this does not appear on the southern elevation. The balance of evidence suggests that A, B and C are all of the same phase. Space C has a part brick and part cobbled floor within a loosebox area and was probably a calf house (Plate 13). The entrance to the upper floor, which would originally have been a hayloft, is via a door in the eastern gable end of the range.

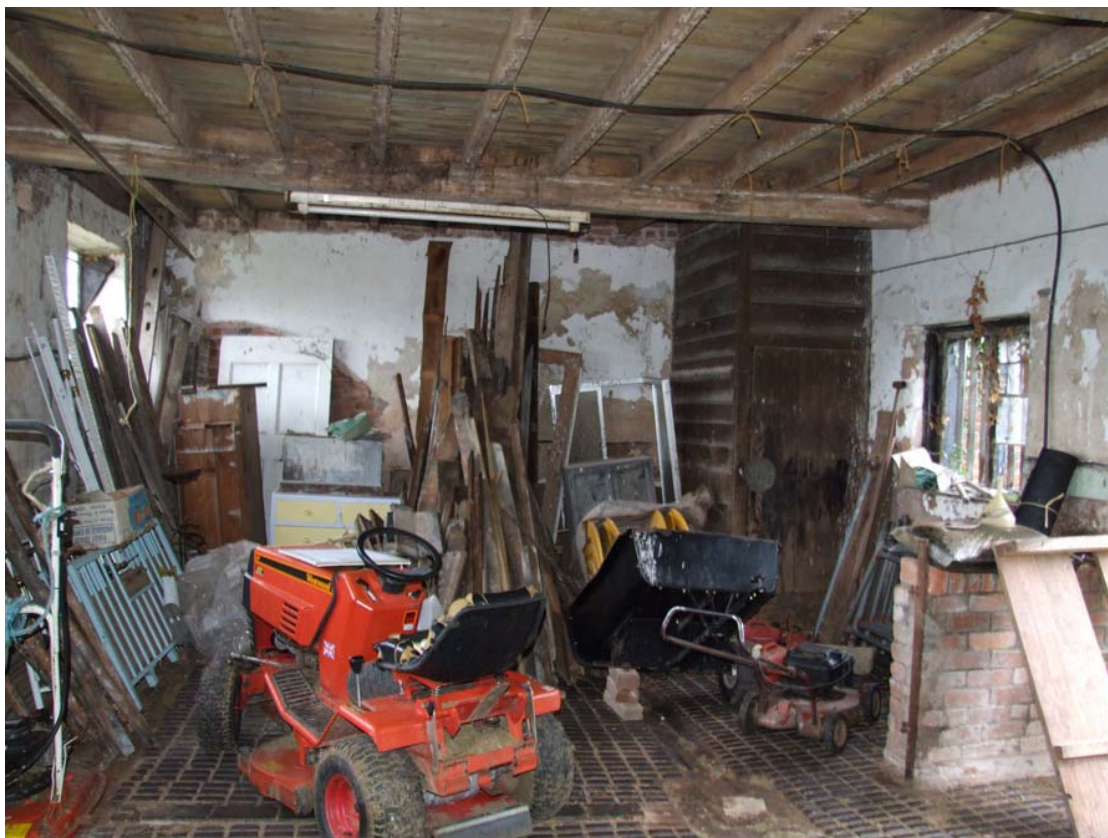
Plate 15: Space E looking west

- E. Space E was originally part of the Space D stable block; the space has been opened out, with any stalling removed and has lately been used as a storage area (Plate 15).

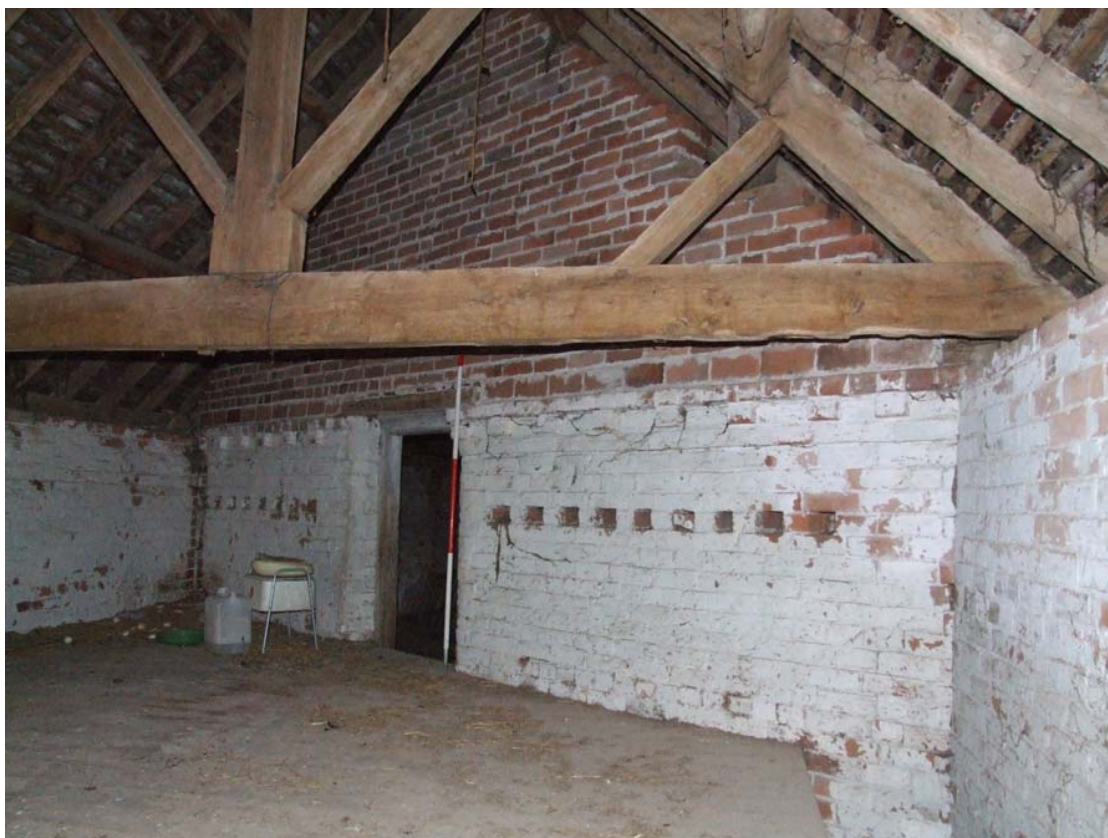
Plate 16: Dentil cornice and pierced vents carried through inside phase 2. View from upper C, looking south-west

- F. Space F is a second phase build, which butts against the main range and projects off at an obtuse angle. The evidence that indicates that space F is later than A-E is that the dentil course at the eaves of the southern elevation of the main range, and the vent piecings, carry through to the gable end and are now hidden by the fabric of the second phase build (Plate 16). The outer skin of the south-eastern gable end has been rebuilt at some stage and is not of the same quality as the remainder of the construction. This space originally comprised animal stalls, though a cart door has been inserted at a later date.

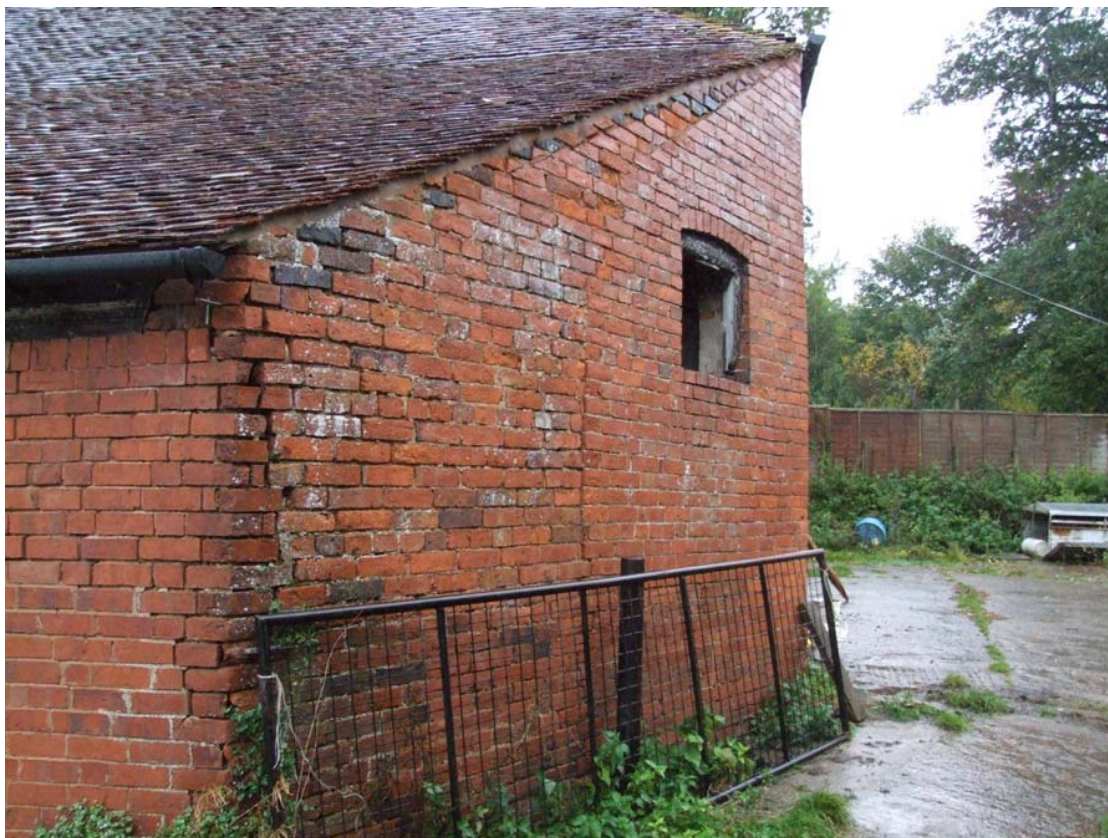
Plate 17: Scar of former roofline and front wall of second phase piggery

- G. Space G butts the rear (south-western) wall of space F. This is of a third phase and the evidence for this is that a butt joint can be seen against the brickwork of space F. Space G has also been modified and a scar of a former roofline and lowering of the original front wall profile suggests that the structure was originally a series of piggeries (Plate 17), possibly below a fowl house, with open pens to the front. The later build springs off the wall for the pens with a slightly raised roofline above. The renewed use was as a stable block.

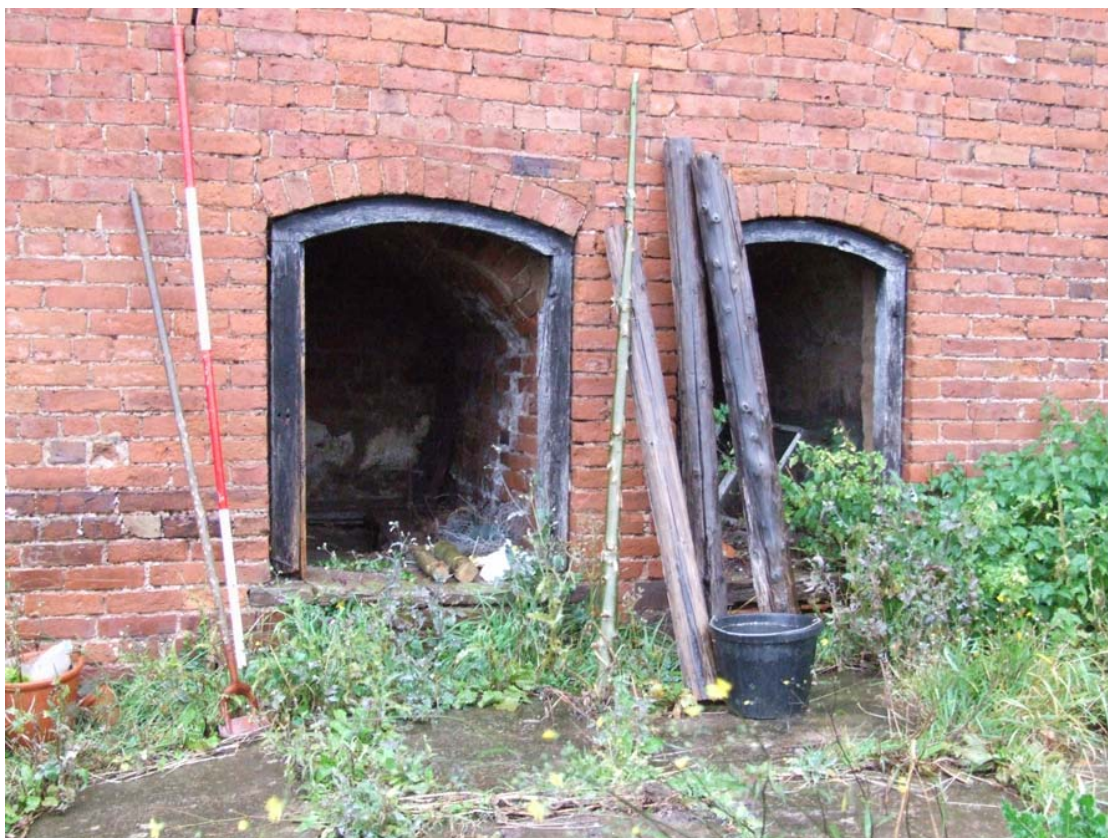
Plate 18: Dog kennels at west end of south elevation

- H. Space H is located at the western end below the floor of the main range; this comprises a pair of former dog kennels, which are accessed via the southern elevation, where the wall slopes down into the bank upon which the structure is set (Plate 18).

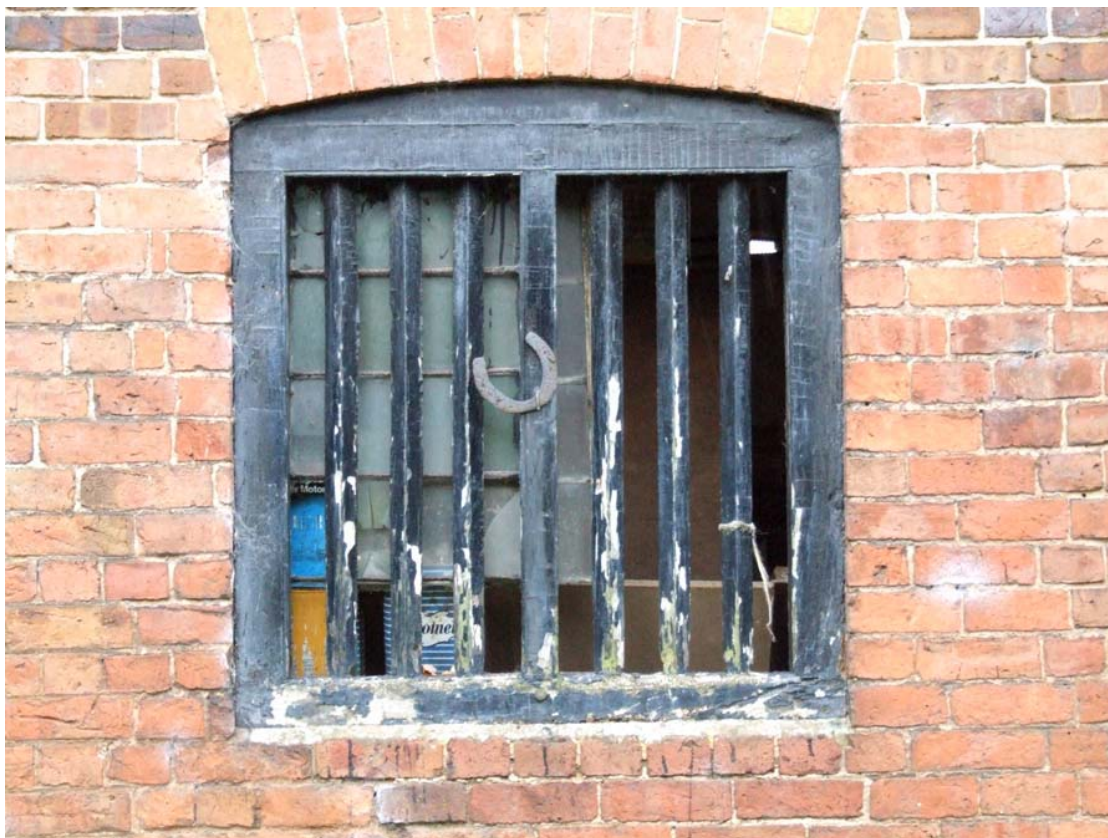
Plate 19: Slatted vent windows

Ventilation is provided to the upper floor level by rows of piercings, some of which have been infilled with a single brick. Window/vent styles are varied in style, with the type of window seemingly specific to each space to which they are installed; the ground floor windows to the northern elevation all appear to be original. A pair at the southern end are traditional peg-framed slat vented units, which were common in animal houses / stables during the 19<sup>th</sup> century (Plate 19). Three units to the central area of the northern elevation (the threshing / crop storage area) are two light iron-framed items set behind pegged timber-frames, which are carpented with chamfers and run-out stops to the inner edges (Plate 20). A single six-light sliding sash window has been inserted in the north wall above space D (Plate 21), this relates to the period when either a groom or a farm overseer had accommodation within the barn; this is further evidenced by the inserted chimney and fireplace (Plate 22), with the walls boarded out and plastered at first floor level. A series of four 8-light iron window units have been set into the southern wall within the upper level of space E. These were seemingly incorporated into the build when the walls at this end were extensively rebuilt; a slightly darker coloured brick has been used. The windows are clearly designed to allow maximum light into this space, rather than ventilation, as is often seen in mill buildings, allowing a light working area for the use of machinery; there was no evidence for the use of machinery or drive shafts noted within the fabric of the building. Further light is provided at upper level by a series of roof-lights, it is not thought that these are original. Other casement style windows have clearly been inserted (Figures 7 and 8).

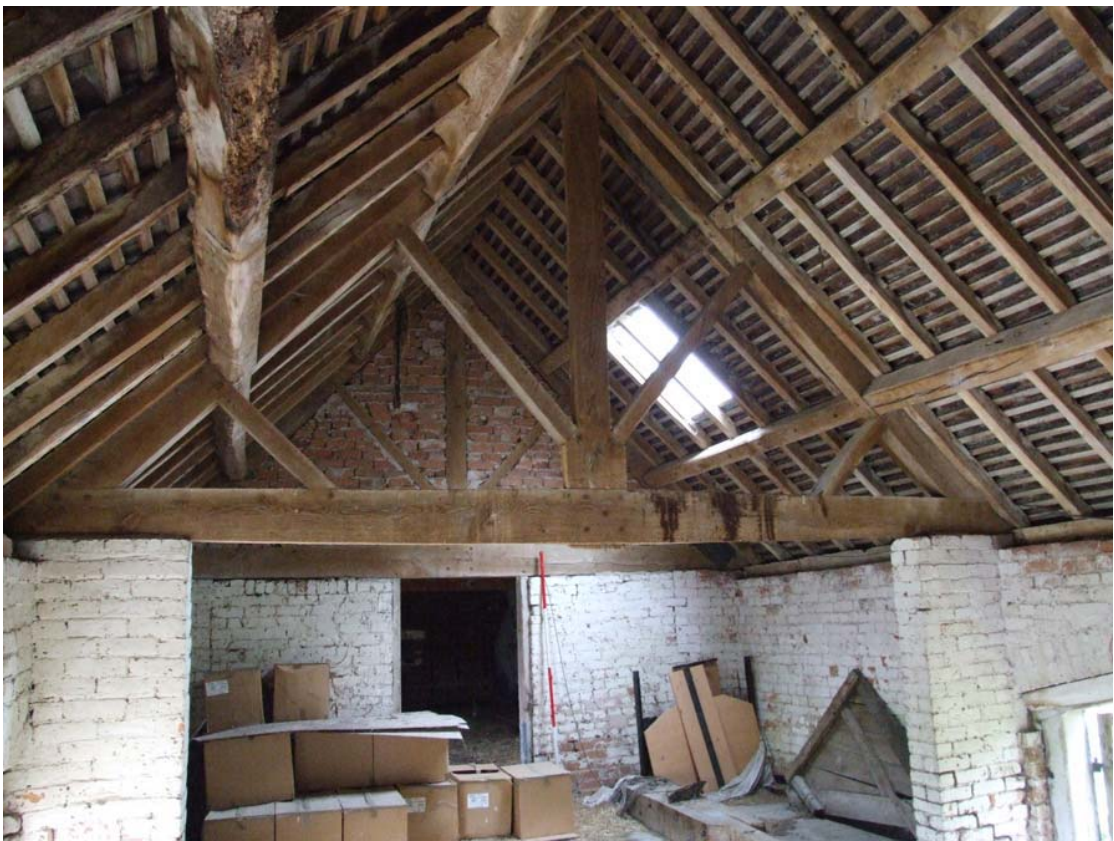
Plate 23: Typical truss

The roof structure comprises a series of king-post trusses carrying two tiers of trenched purlins and a ridgepiece. The trusses are identical in both the phase 1 and phase 2 elements of the build, indicating that the phase 2 build was added fairly soon after construction of phase 1. The trusses comprise a king post pegged into a tiebeam with either 3 or 5 pegs, a pair of principal rafters pegged to the tie and into a sloping joggle at the upper king-post, with a pair of braces pegged from sloping joggles at the foot of the post to the principal (Plates 23 and 24). One truss (T8) has been repaired and little remains of the original. Where original rafters remain, they are pegged to the purlins.
