***Historic Building Recording at
Steward's Cottage (Formerly
Brier Hill Cottage), Chaddesley
Corbett, Worcestershire***

A report for Rob & Joy Blakeway

December 2007

Project: PJ 193

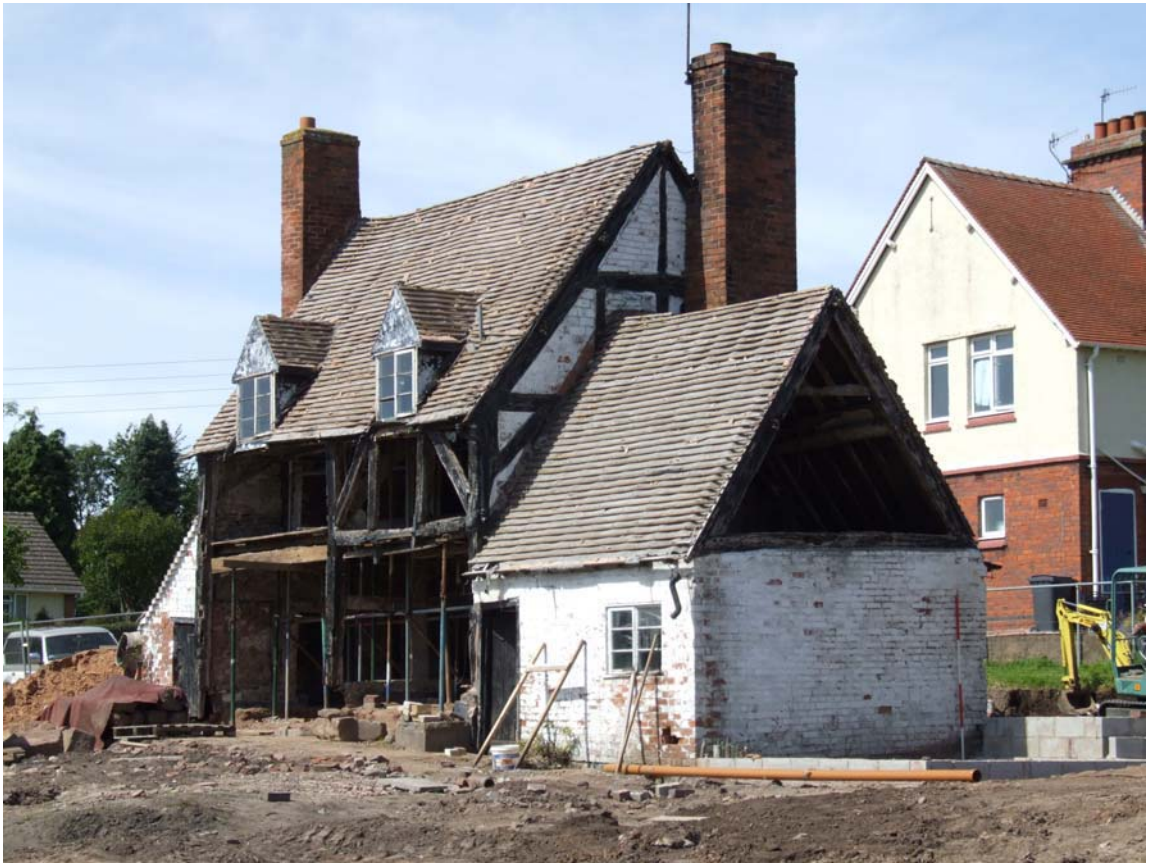
Plate 1: Cottage looking north-west (scale 2-metres)

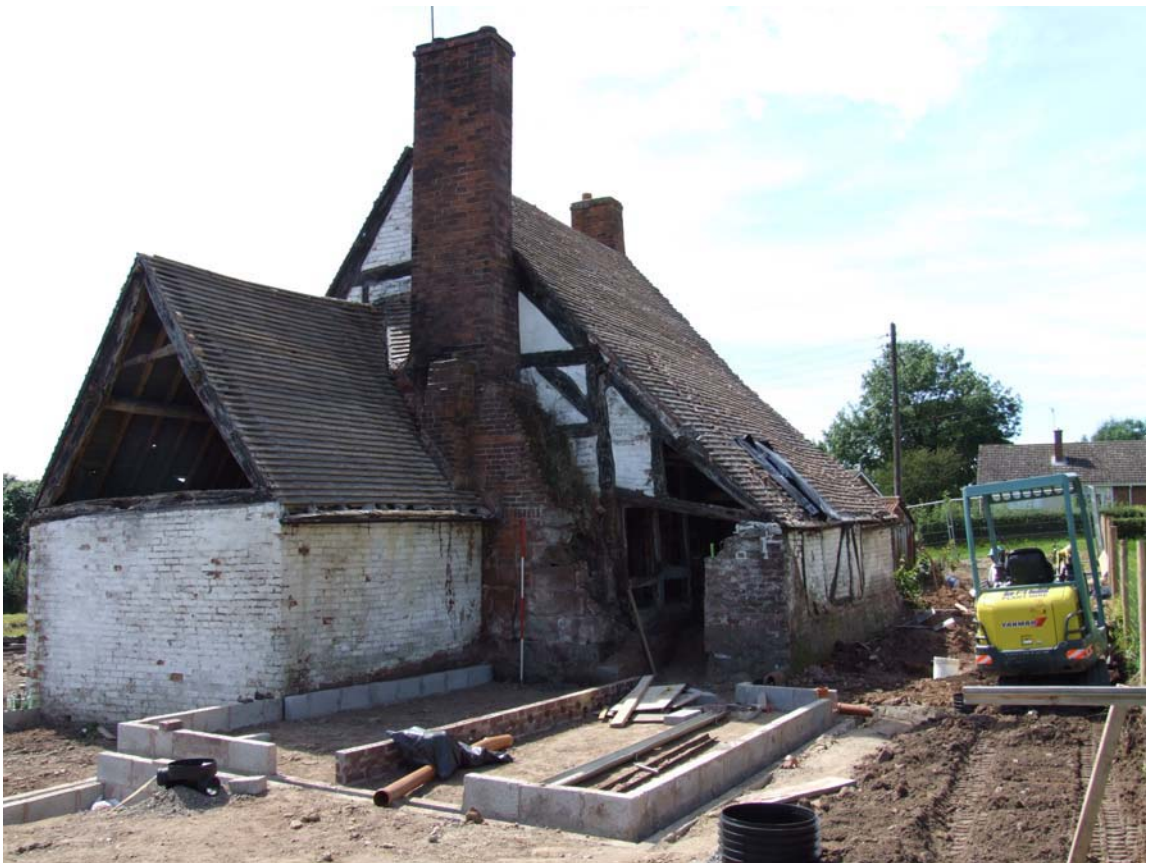
Plate 2: Cottage looking west (scale 2-metres)

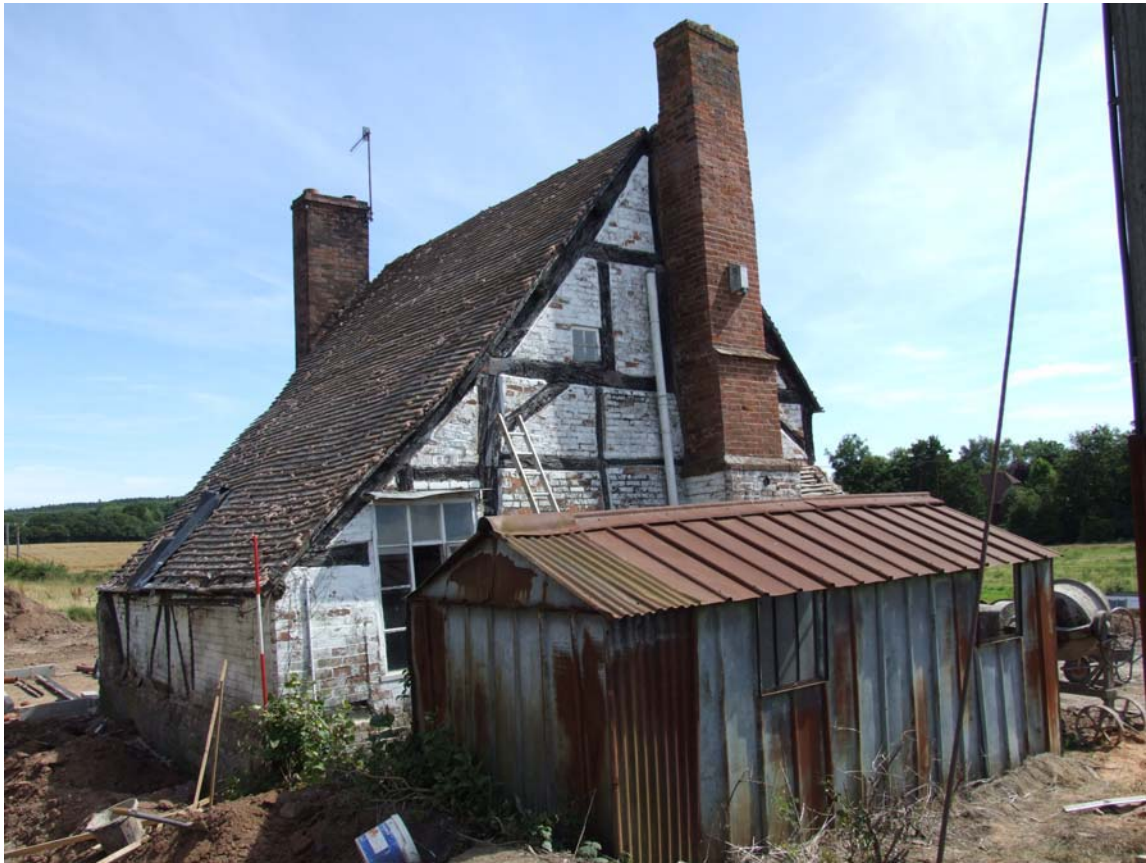
Plate 3: Cottage viewed to the south-east (scale 2-metres)

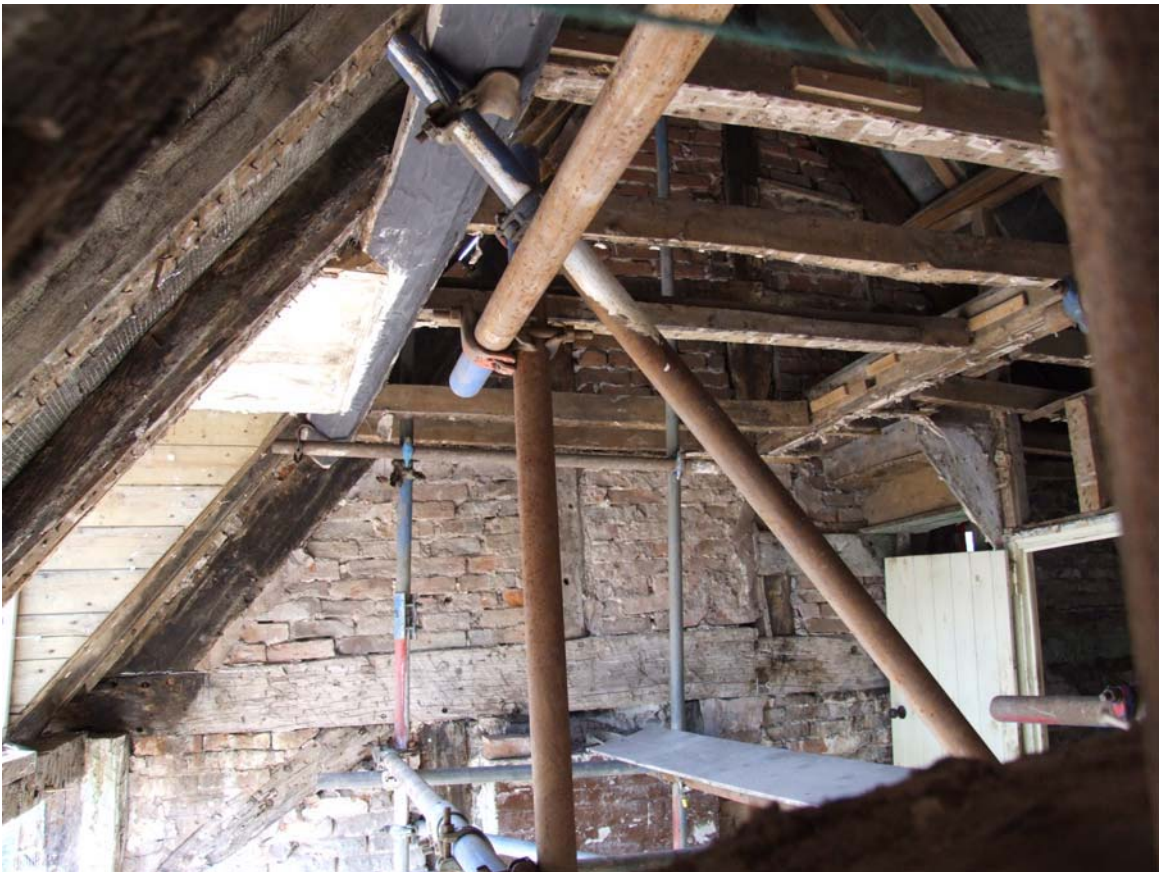
Truss T1 is formed by a pair of steeply pitched principal rafters above the tie beam, braced by a collar with three queen struts below, the present central one being an inserted replacement, and a single strut above the collar (Plate 6). The purlins are trenched into the principals, with a ridge purlin at the apex. A small window has been inserted into the gable at some time, with the strut, principal and collar notched to take the frame, this has since been removed and the aperture subsequently bricked up.

Plate 6: Truss T1 upper

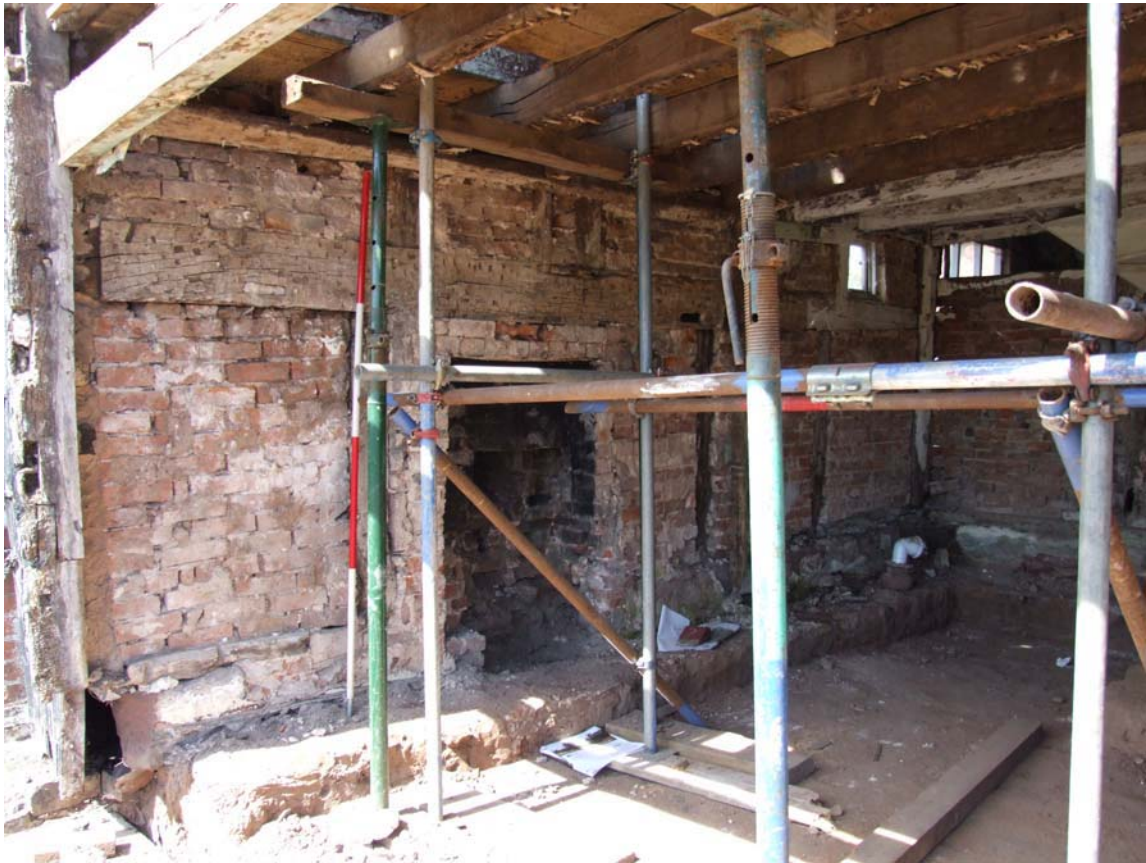
The frame below the tiebeam is much altered and the evidence suggests that many, if not all of the timbers are non-original re-used / adapted items (Plate 7). The southern post is a replacement, which has been scarfe jointed onto the stub of the original post. The pattern of peg-holes in the mid-rail indicate that this is also a later insertion and the pattern of peg-holes in the tiebeam indicate that there were originally three studs between the tiebeam and mid-rail, with a similar configuration below the mid-rail to the sole plate. It is possible that these alterations took place when the brick chimneystack was butted up to the gable end, with fireplaces being added at ground floor and first floor levels. The first floor joists are supported on a ledge pegged and nailed to this frame, indicating that the first floor above Bay 1 is also a non-original insertion.

Plate 7: Frame T1 lower (scale 2-metres)

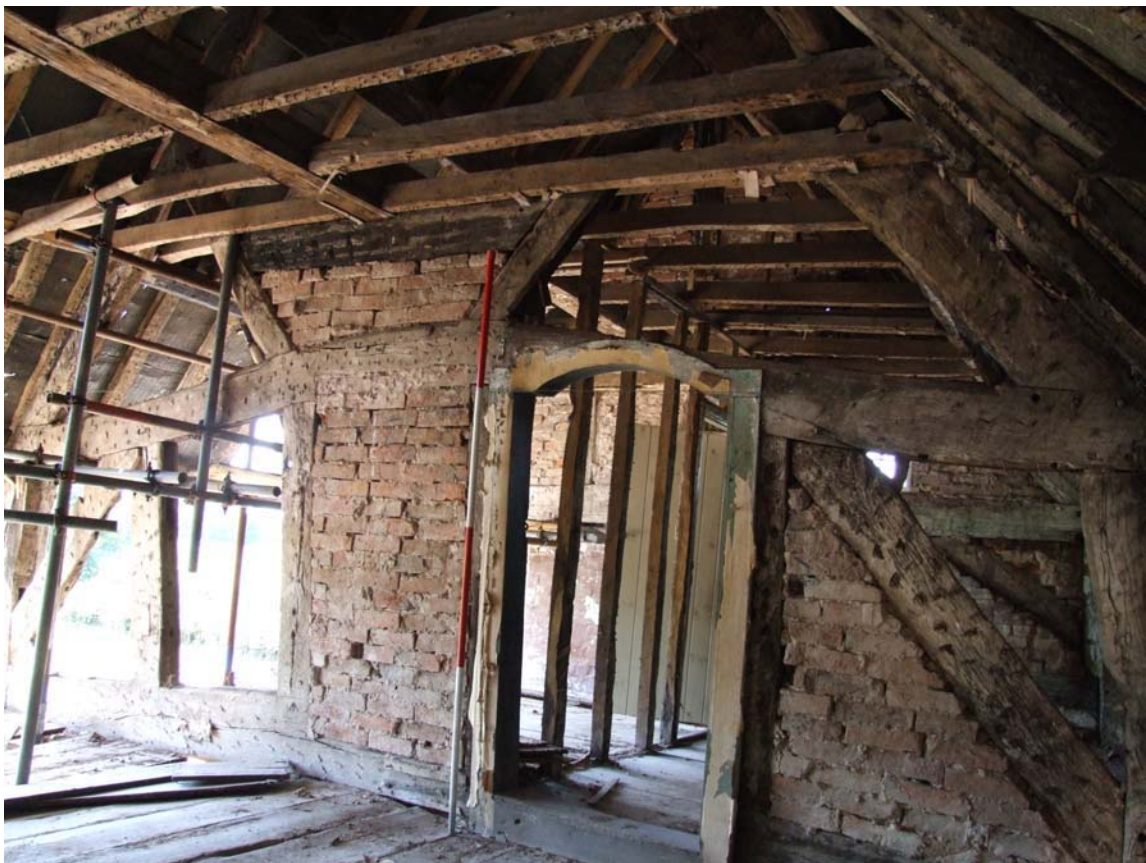
Truss and frame T2 form the central frame of the two-bay cottage. The truss is of steeply pitched principal rafters braced by a pair of raking queen struts to a cranked tie beam. Empty mortises and peg holes in the opposing faces of the principals indicate that there was originally a collar, which also braced the truss (Plate 8); this has now gone, having been removed when a loft platform was inserted into the attic space. There is evidence for former windbraces from the principals to the lower purlins, with a remaining mortise in the southern principal and a rebate to the northern timber. The principals, struts and tiebeam all have shallow chamfered and stopped edges to the eastern face, but there are none to the western face.

Plate 8: Truss T2 upper, view from Bay 2 (scale 2-metres)

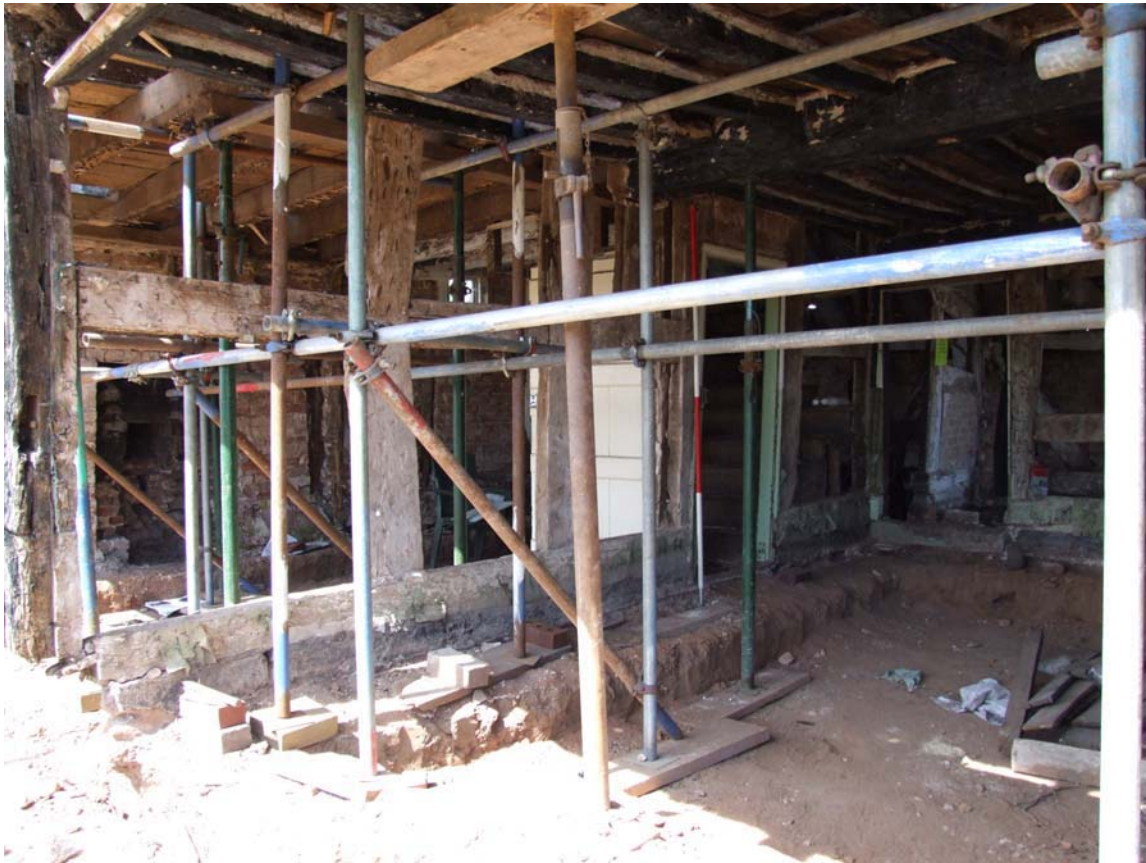
The frame below the tiebeam is wholly a later insertion, with only the northern post an original timber (Plate 9). The southern post has been scarfe jointed onto the foot of the original post, close to the sole plate. The girding beam has been slotted into the southern post aided by a long groove down the inner face, and into the northern post with the aid of a slip-tenon and further carved out groove (Plate 10). The inserted timber is re-used and was originally a tiebeam from a truss of another building; there are mortises at both ends for the original trusses principal rafters and the cut angles at the ends of the tiebeam can just be seen, there are also empty mortises, peg holes and stave holes on the lower face. Stud both below and above the girding beam also show evidence of re-use, with many empty peg holes and mortises. The insertion of this frame also indicates that the first floor is a non-original insertion, as an axial beam off a bracket nailed to the inserted timbers supports it.

Plate 9: T2 lower, from Bay 2 (scale 2-metres)

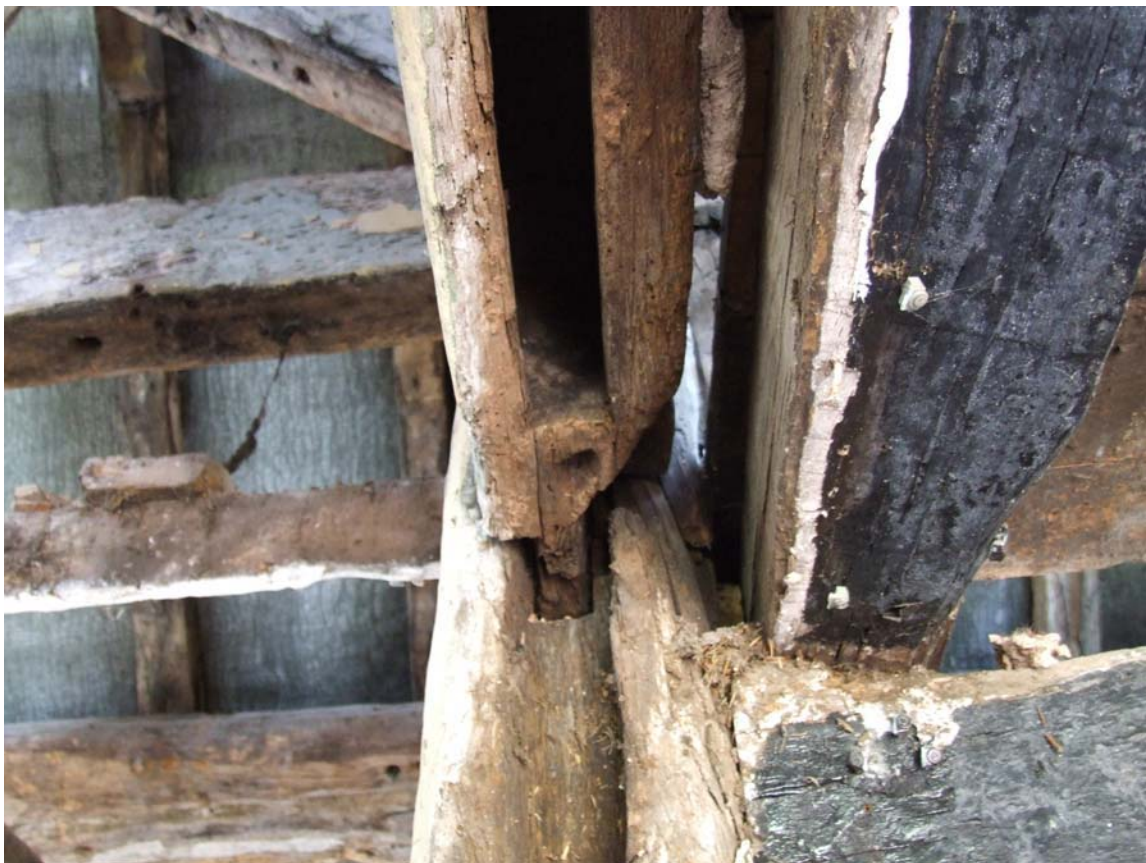
Plate 10: Slip tenon in T2, looking north

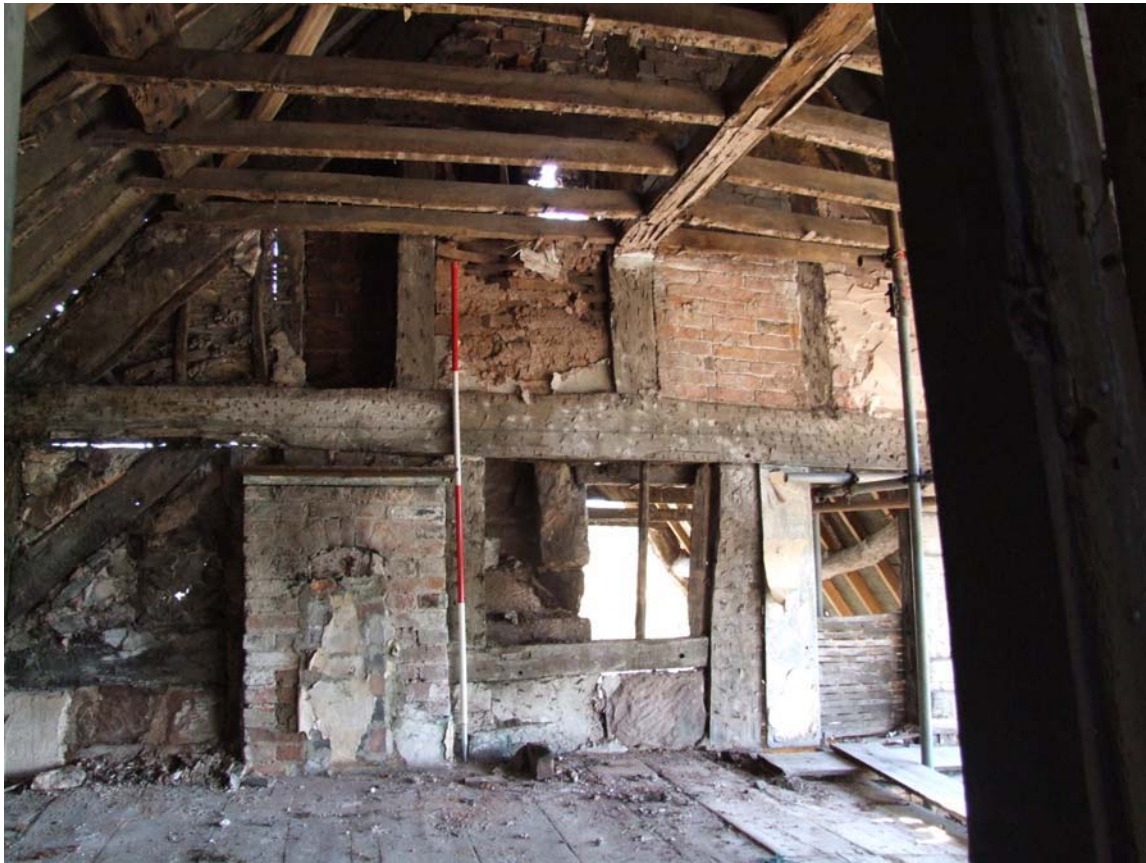
Truss and frame T3 form the eastern end gable of the timber-framed element of the cottage. The truss is almost identical to T1, with three struts below the collar and a single strut above to the apex of the principals, though the truss has a pair of curved wind braces rising to the lower

purlins. The truss still retains two wattle and daub panels, with the remainder later infilled with brick (Plate 11).

Plate 11: Truss T3 upper (scale 2-metres)

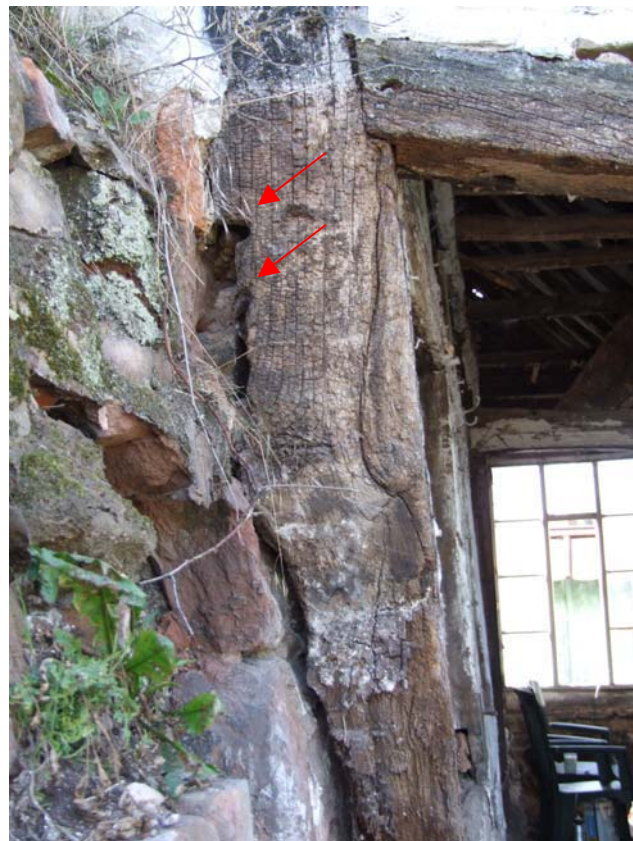
Plate 12: Empty peg-holes in north-east corner post, for rail removed when chimneystack constructed

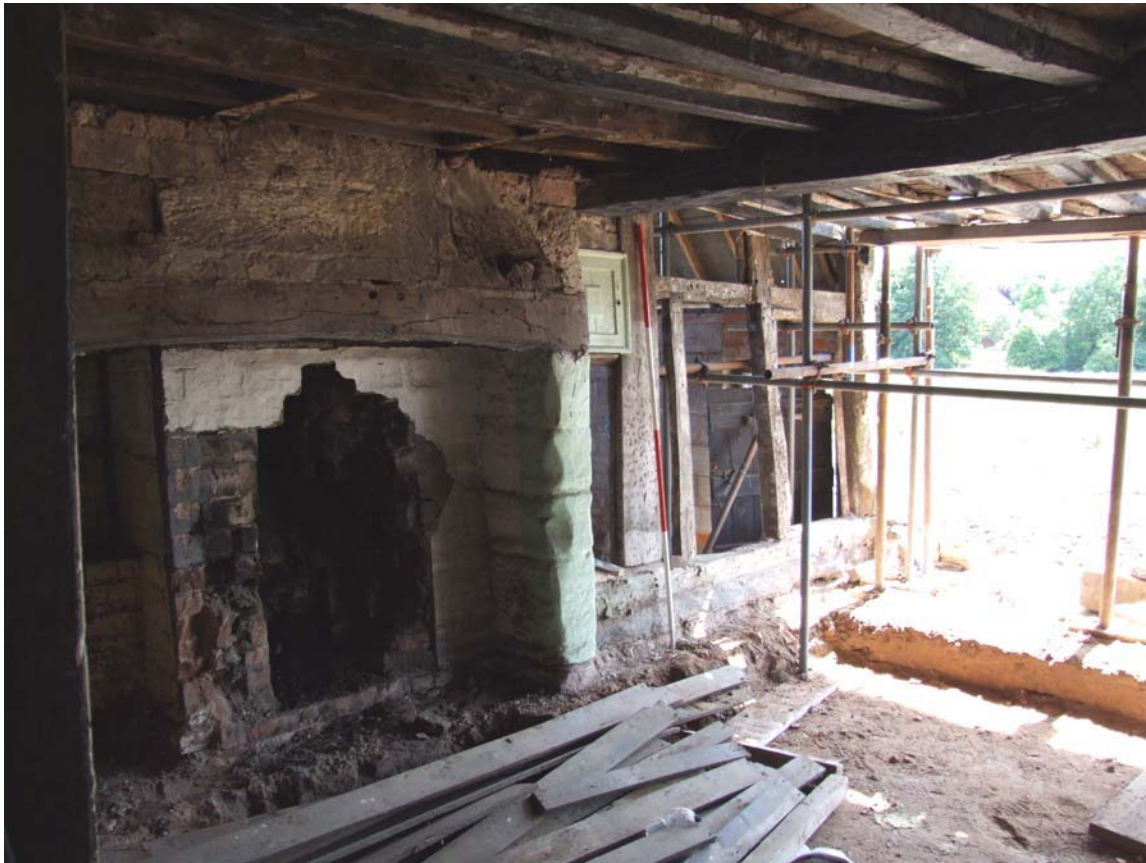
The frame below the tiebeam is much altered, with modifications to accommodate upper and lower hearths from an external sandstone chimneystack, which was butted up to the northern side of the eastern gable. The evidence that indicates that the chimneystack is later than the frame comes from an empty mortise for a lower rail, which must have been removed so that the stack could be positioned (Plate 12), with a further empty mortise (though rotted away) in the bottom of the tiebeam, which once housed a post or stud. The sole plate is also cut through to allow the stack to be placed (Plate 13). The frame doesn't appear to have had a mid-rail, but originally had tiebeam to sill posts with interceding rails. The north-east corner post has been trimmed to allow the sandstone blocks of a later bread oven to be butted against the side of the chimneystack in order that the oven could utilise the same flue (Plate 14), seemingly this was easier than cutting the sandstone blocks; this also suggests that the blocks used for the bread oven were re-used from elsewhere.

Plate 13: Frame T3 lower (scale 2-metres)

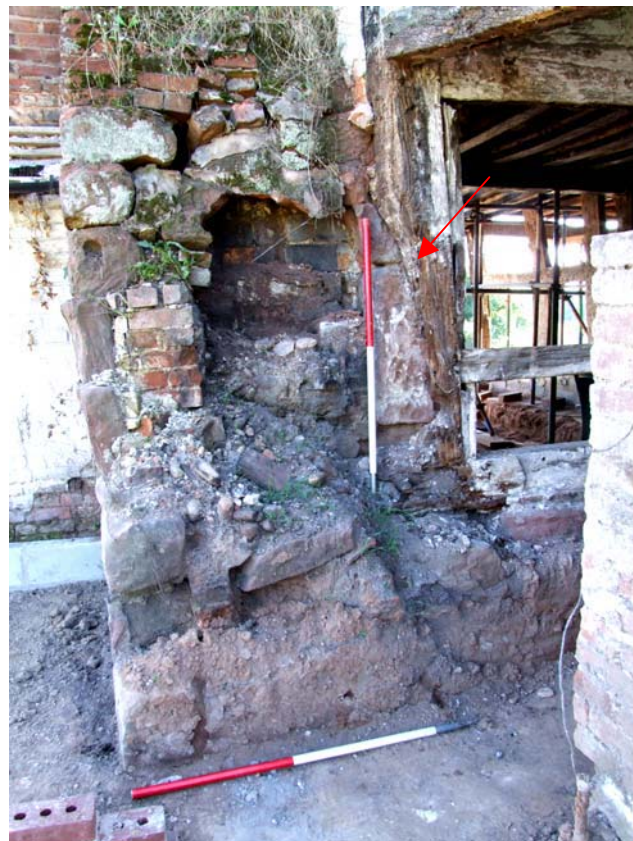
Plate 14: North-east corner post trimmed down to accept bread oven fabric (scales 1-metre)

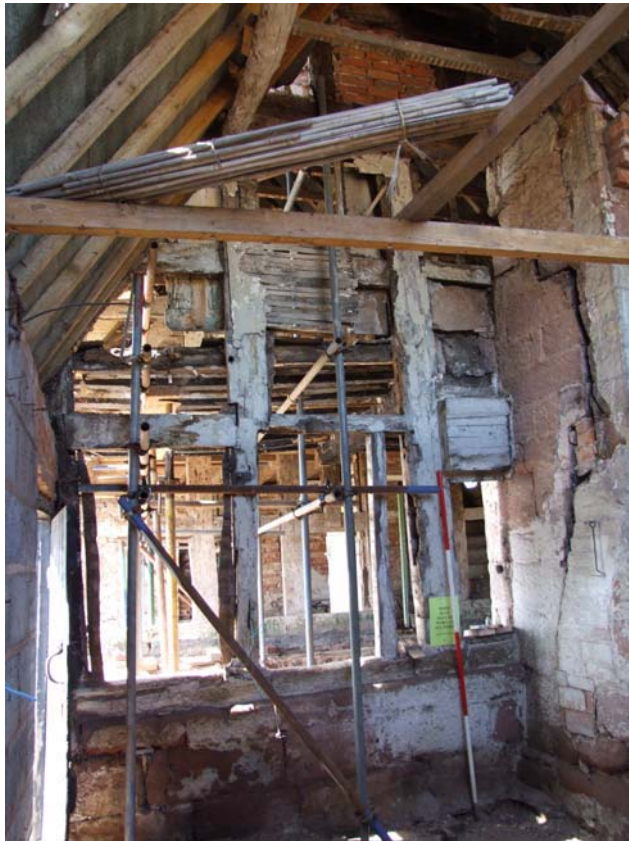
An access into the eastern lean-to extension has been created by the removal of a rail and trimming down a post to form an access; interestingly, there is a drop of around 60 centimetres inside the lean-to (Plate 15). The faces of the sole plate at the base of the aperture are well worn, suggesting that something was being constantly dragged from the lean-to into the cottage, possibly fuel for the fire, this would suggest that the created aperture was not a doorway, but a fuel hatch.

Plate 15: View of T3 from inside eastern extension (scale 2-metres)

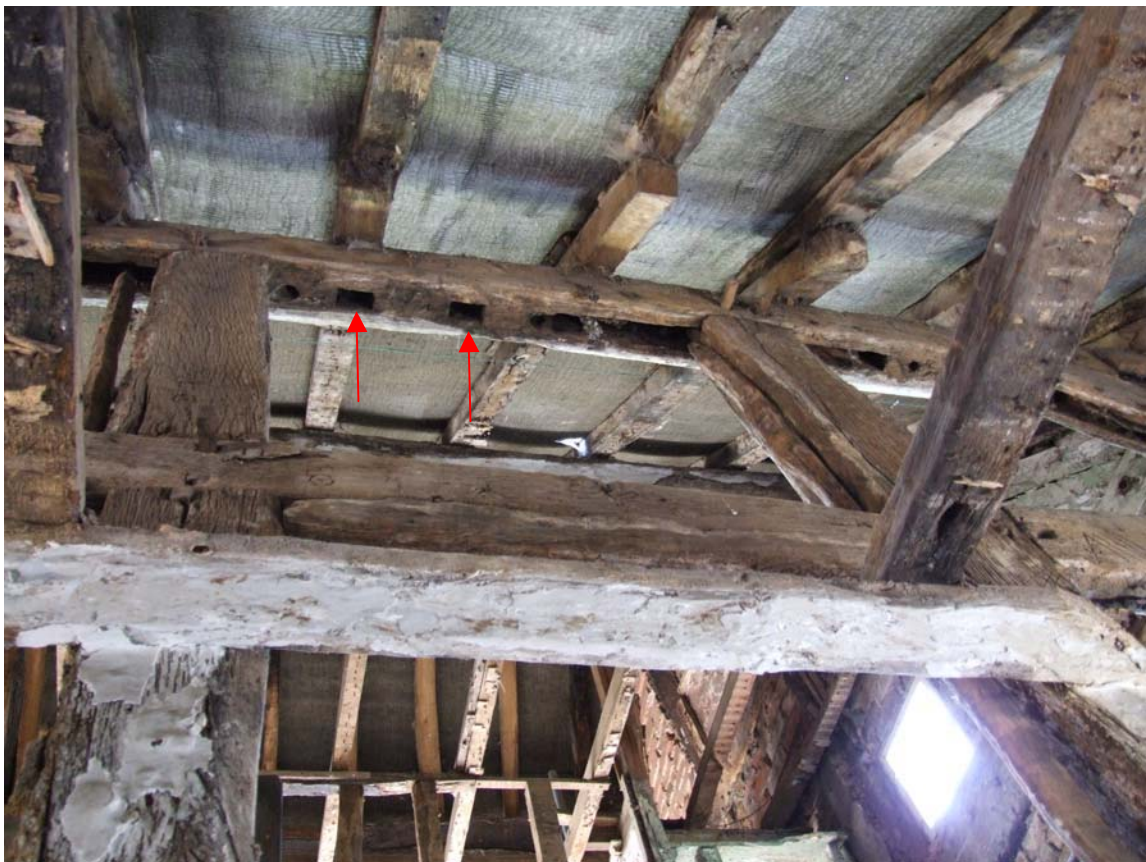
Plate 16: Mullion rebates in the wallplate of Bay 1 north-framing.

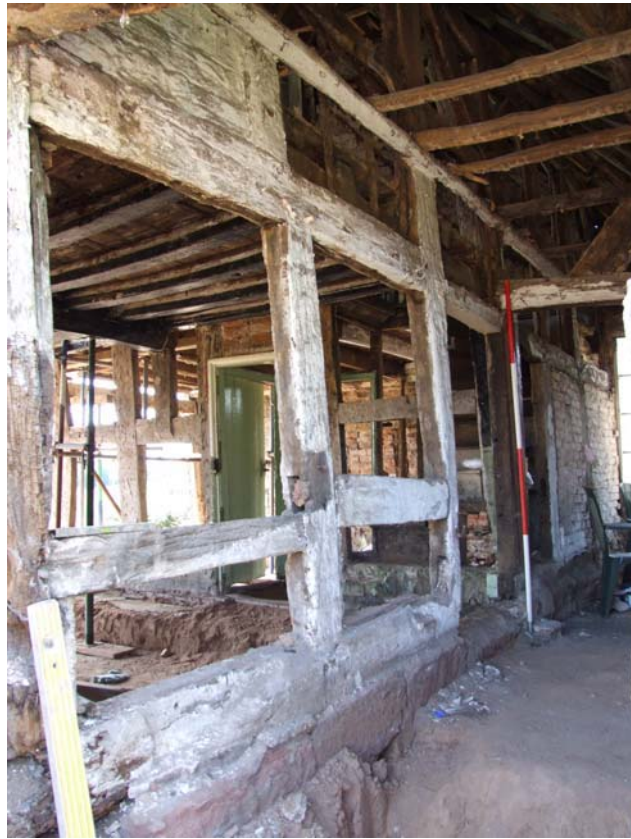
Plate 17: The north frame from inside the outshut (scale 2-metres)

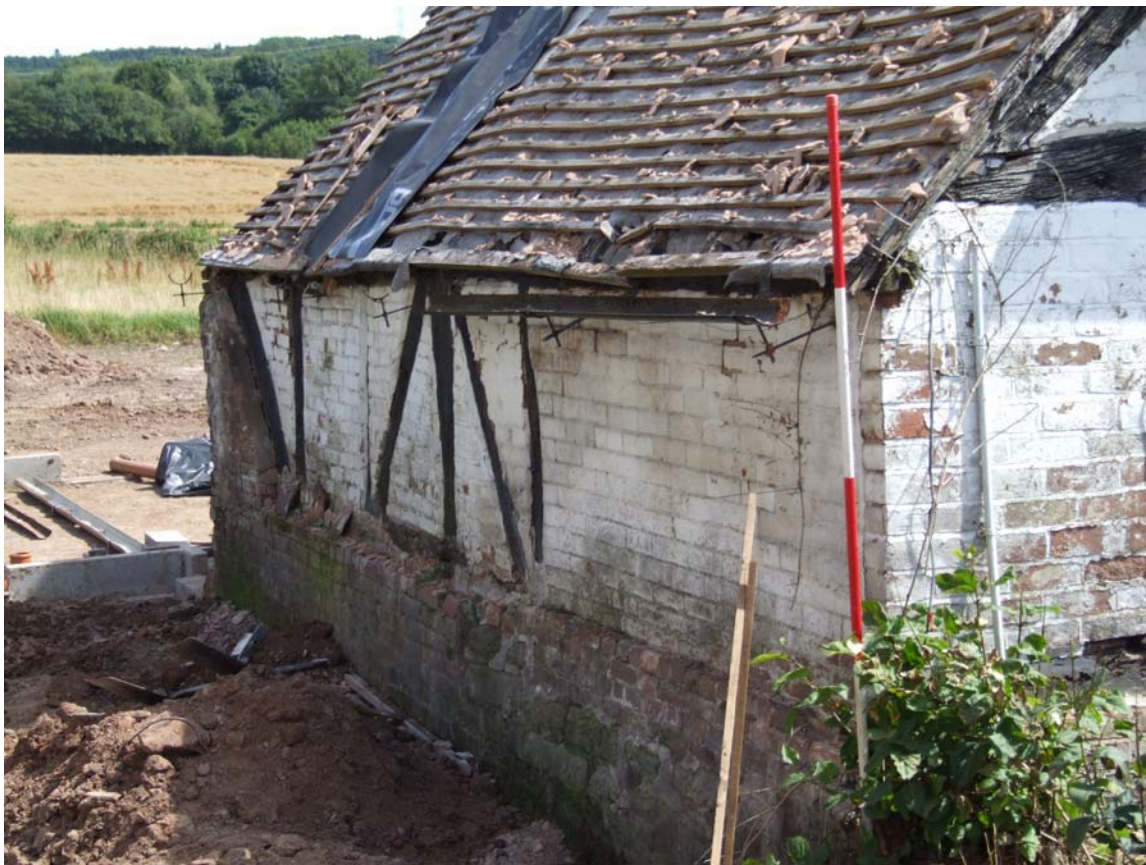
A lean-to (outshut, also 'outshot', or 'outshoot') extends along the length of the northern frame. This is timber framed on a sandstone and brick plinth, with brick panel infills. Much of the frame has rotted away, or been replaced; the pattern of original framing is hard to decipher as, similarly to the main structure, much of the timber-framing appears to be re-used, but the likely pattern is of three posts to the northern (side) elevation, with a curved down brace at each end and a pair of straight braces from the central post to the wallplate. Similarly, the framing of the western and eastern ends and the central support frame is of re-used timber. The outshut has clearly been added to the cottage, though it could not be determined if this replaced an earlier, possible original outshut.

Plate 18: North frame of outshut looking south-east (scale 2-metres)

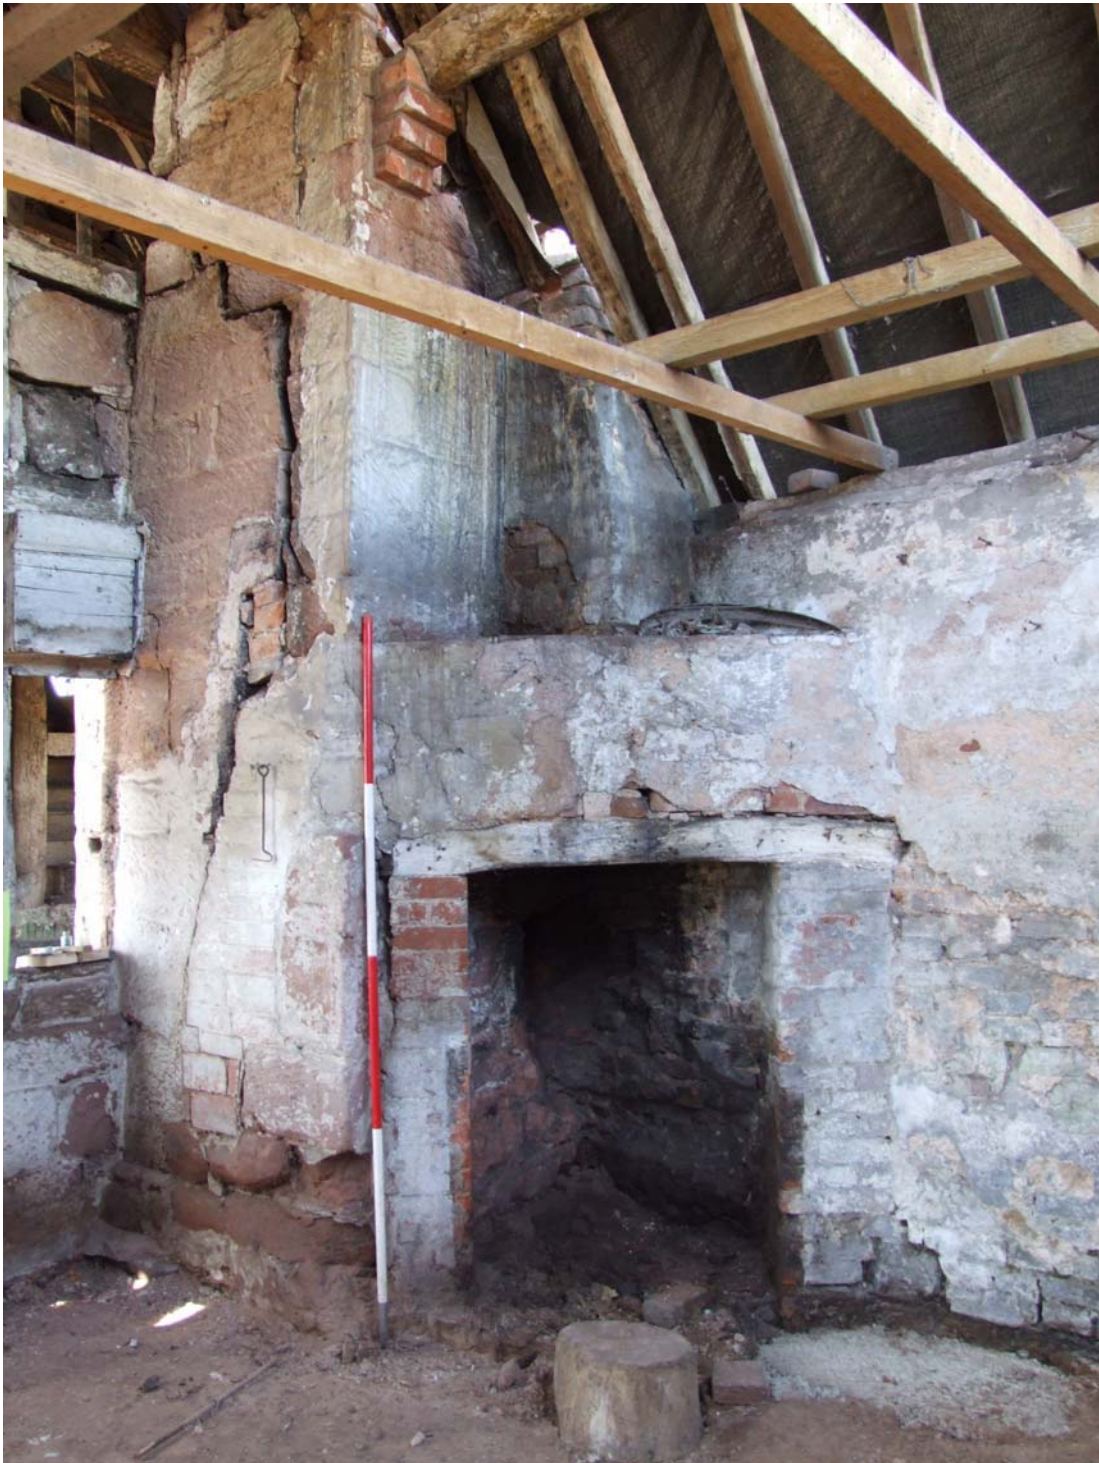
The eastern extension is a brick and mortar build, with a pitched roof-cover of plain handmade clay tiles. There is a single access door to the southern elevation and a small square six-light timber casement window allows light into the space. The floor level inside is some 60-centimetres lower than the adjacent cottage floor and as noted above (see Truss T1), fuel stored in the space was apparently dragged up into Bay 2 of the cottage through an open panel in the eastern gable end frame. The chimneystack at the eastern end of the cottage provides a flue for a hearth inside the extension, which once housed a copper boiler, which would have supplied the domestic hot water; the space appears to have been used as a washhouse and store. The flue has been inserted into the earlier sandstone block chimneystack (Plate 19).

Plate 19: Flue for the copper, inside the east extension (scale 2-metres)
