***Historic Building Recording at  
(Postal Address) Field Farm,  
Little Hereford, near Ludlow,  
Shropshire***

*A report for Mr V. Hamer*

December 2007

**Project: PJ 197**

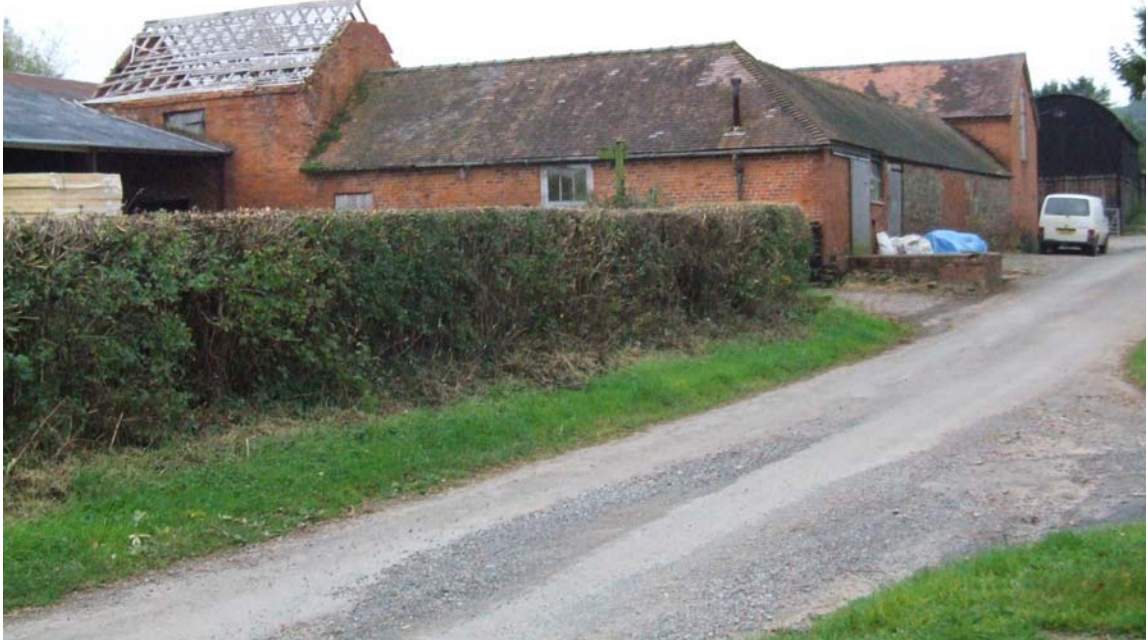
Plate 1: View of the farm buildings complex, looking south-west

The subject farm buildings comprise three ranges; the first runs parallel with the road on a south-west to north-east axis, this is referred to hereafter as the northern range; a second range returns at 90 degrees from the south-west corner, running off to the south-east (the west range) and the remaining range lies parallel with this, on the opposite side of a central yard; this is referred to in the text as the east range. The subject buildings are identified in Figure 4. The farmstead is shown in Plates 1 and 2.

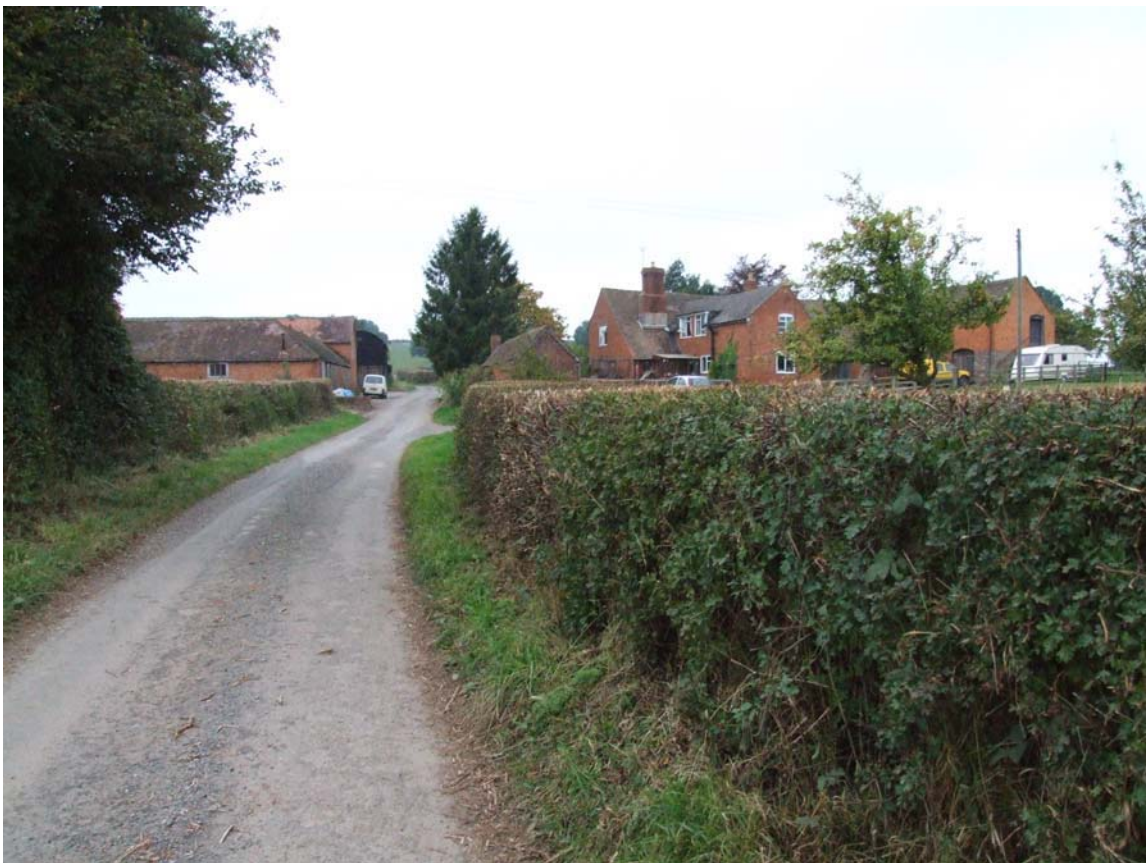
Plate 2: View to the south-west showing the road bisecting the farm

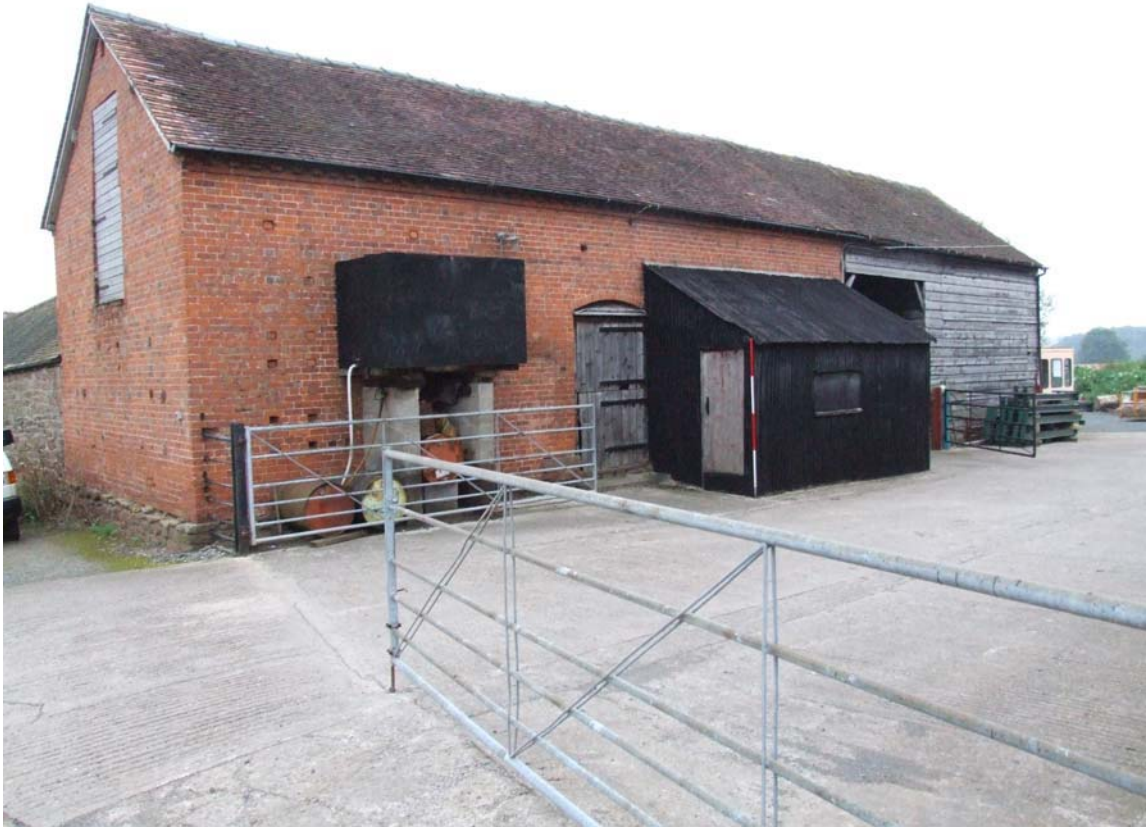
Plate 3: The western range looking south-east (scale 2-metres)

The original first phase structure is a brick and mortar construction with a pitched roof cover of plain handmade clay tiles, sitting on a low plinth of rough coursed local stone. The bricks used are hand made items measuring 9" by 2 3/4", bonded in a whitish lime mortar and coursed in a common bond (often referred to as English garden wall bond), with a row of headers between each 3 rows of stretchers. The brickwork to Bay 1 and Bay 3 is pierced, which would have provided ventilation to the internal spaces (Plates 3 and 4).

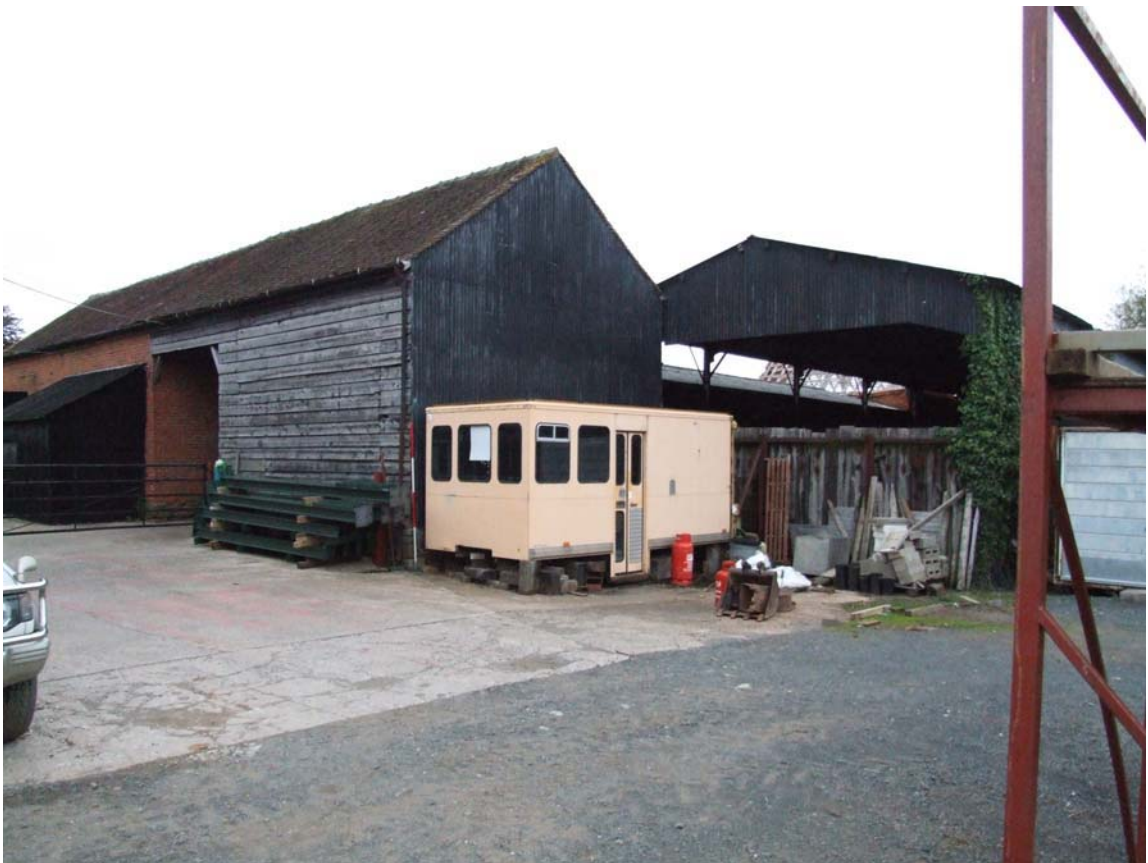
Plate 4: Western range looking north, showing modern units covering the central foldyard (scale 2-metres)

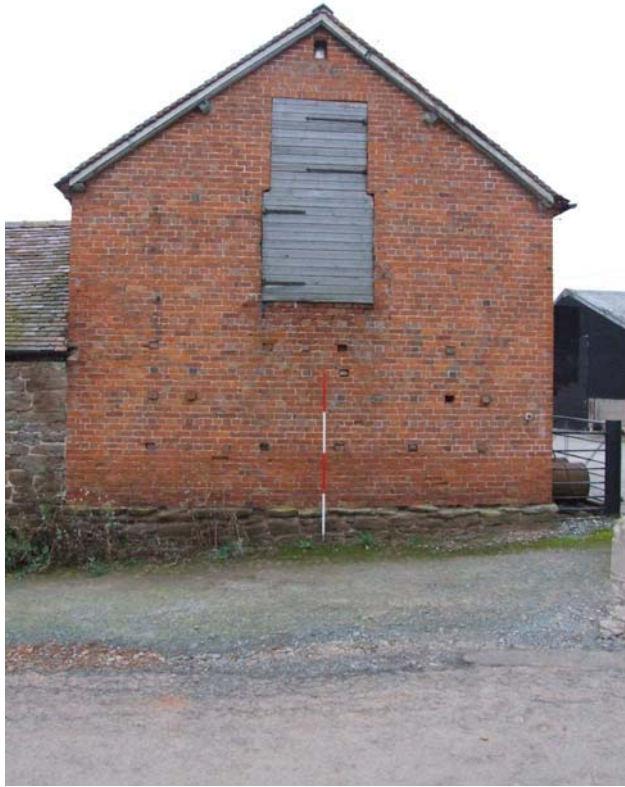
Plate 5: Western range, northern elevation (scale 2-metres)

The northern gable end has a pitching door, which has been elongated from the original pitching eye at the upper level of the elevation (Plate 5). Above the door, there is an owl hole; owls were encouraged into farm buildings to help keep down the vermin inside. There is a similar pitching door / eye configuration in the opposite southern gable and a further eye at a lower level.

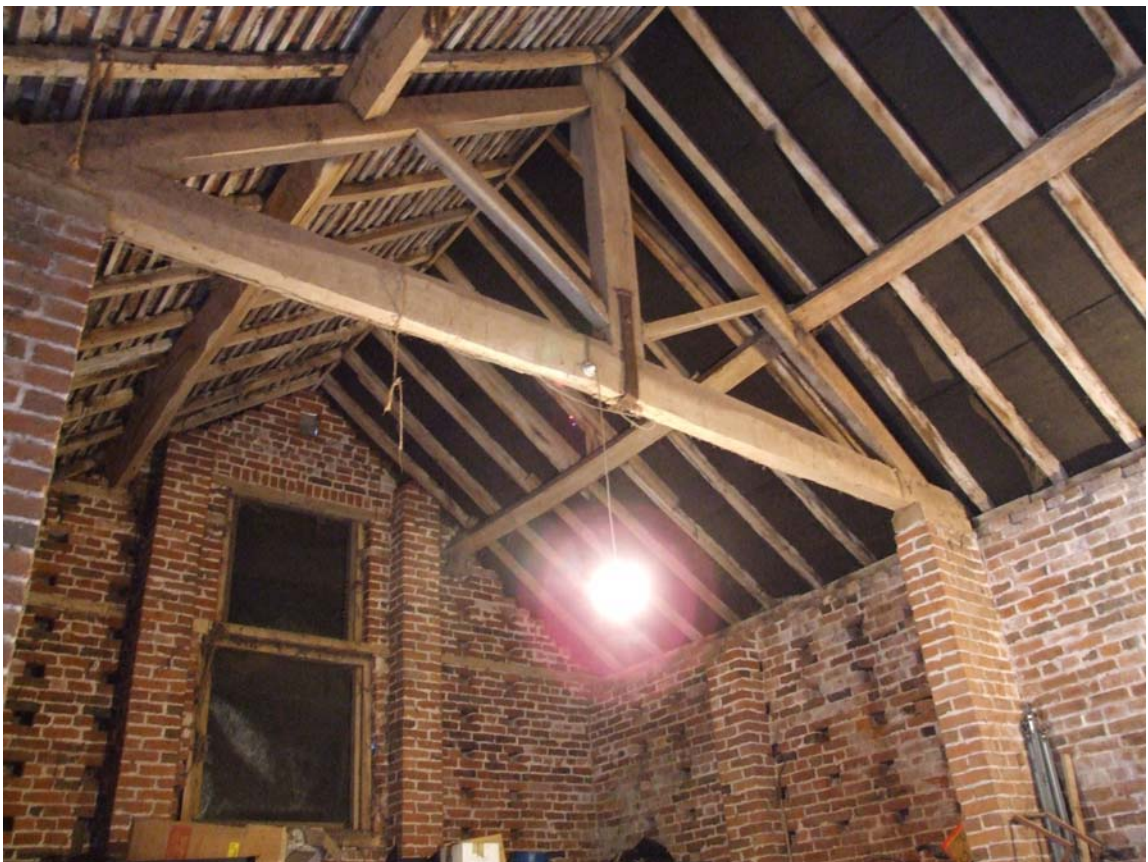
Plate 6: King-post truss in the western range (scale 2-metres)

Internally, the roof structure comprises a pair of king-post trusses, which divide the building into 3-bays, with a ridge piece and single purlins to either side. The trusses consist of a central king-post attached to the tiebeam with iron stirrup straps, with a pair of principal rafters double pegged to the tiebeam and at the shoulder of the post (Plate 6). There is a pair of struts to the northern truss, but one is missing from the other unit; the struts are connected with stump tenon joints.

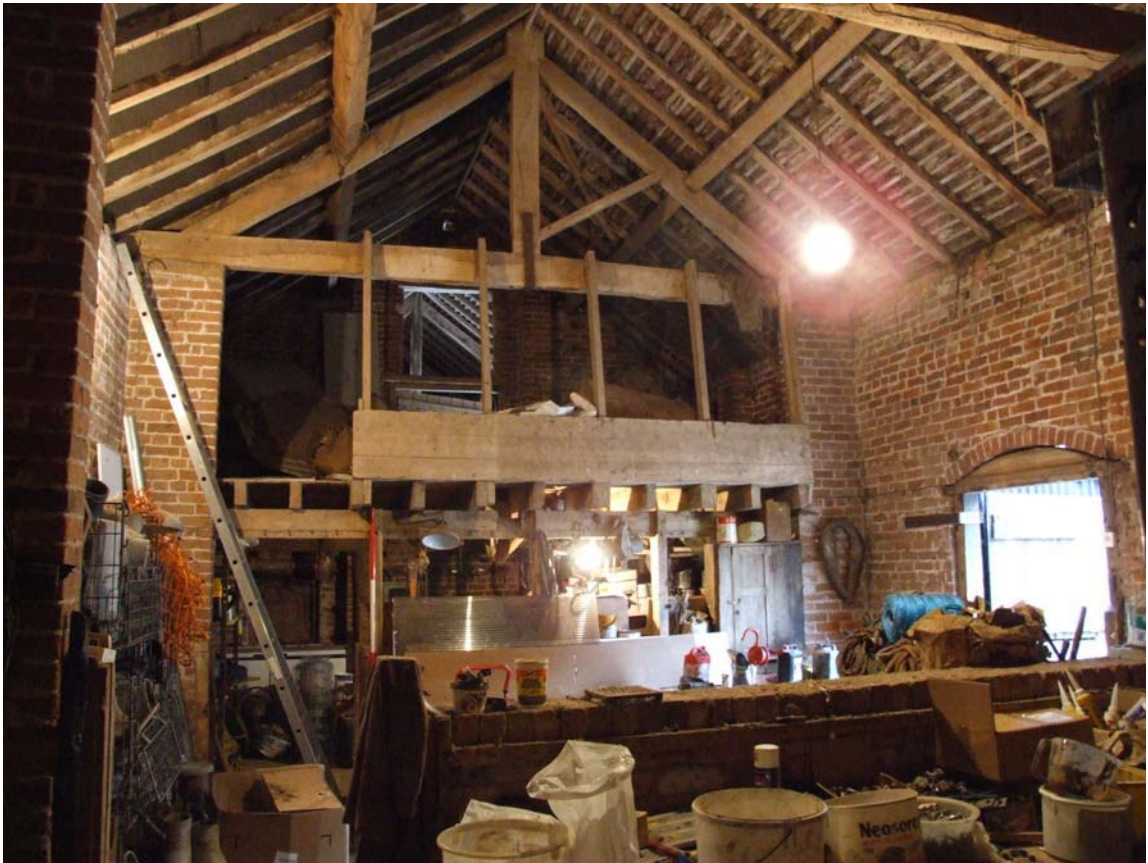
Plate 7: Inside the western range, looking south

Bay 3 has a loft at first floor level; this appears to be a later insertion, supported on posts and ledges rather than built into the brickwork, though it cannot be ascertained if this is a replacement for an earlier loft (Plate 7). The opposite end is without an upper platform, which suggests that, the pitching eye / door arrangement could only be used when the bay was full to this level. The central bay has a stone flagged floor, but bays 1 and 3 have concrete floors.

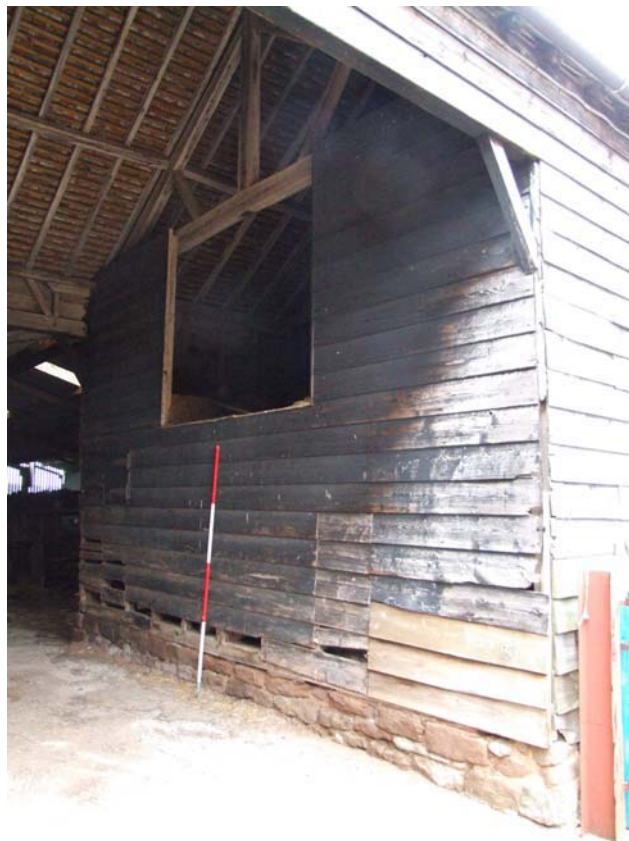
Plate 8: Timber clad extension at the southern end of the western range (scale 2-metres)

The three-bay west range was later extended, with the roof carried over an open access / cart bay from the west into the central yard, and two further bays within a timber clad unit at the southern end (Plate 8). The structure sits on a stone plinth and is timber framed, with timber weatherboard cladding. The frame is of machine sawn timber studding from wallplate to sole plate with a mid-rail, which supports the floor of a hayloft over the whole area. Corrugated iron cladding is used at the southern end.

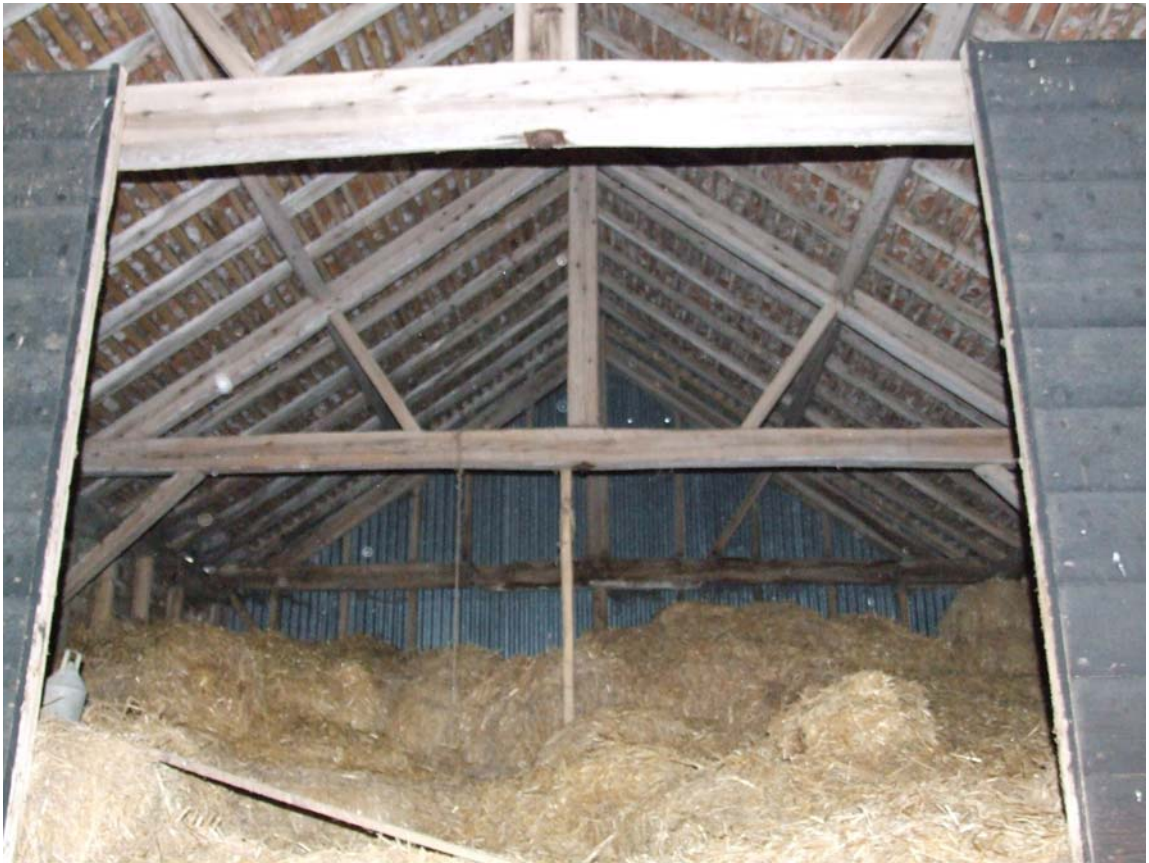
Plate 9: Truss in the timber clad extension

The king-post trusses differ from those used in the original build, with the post bolted to the tiebeam from below and slender raking queen posts from the tiebeam to the principals at the juncture below each purlin; small single pegs are used to fix the frame and there is bracing from a pair of straight knee-braces at either end (Plate 9).

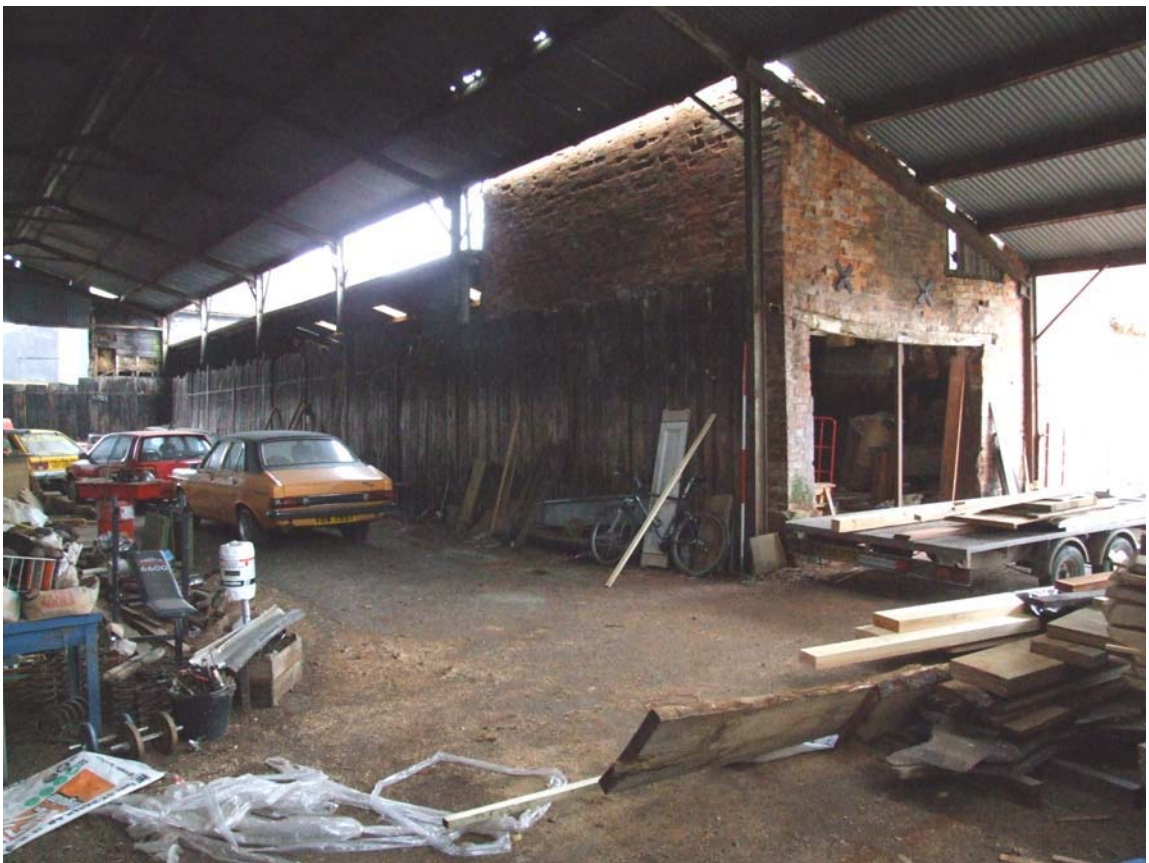
Plate 10: The eastern range from the central yard, looking north (scale 2-metres)

The east range comprises a single storey four-bay unit, with a two-storey two bay structure, which is a later addition at the southern end (Plates 10-18).

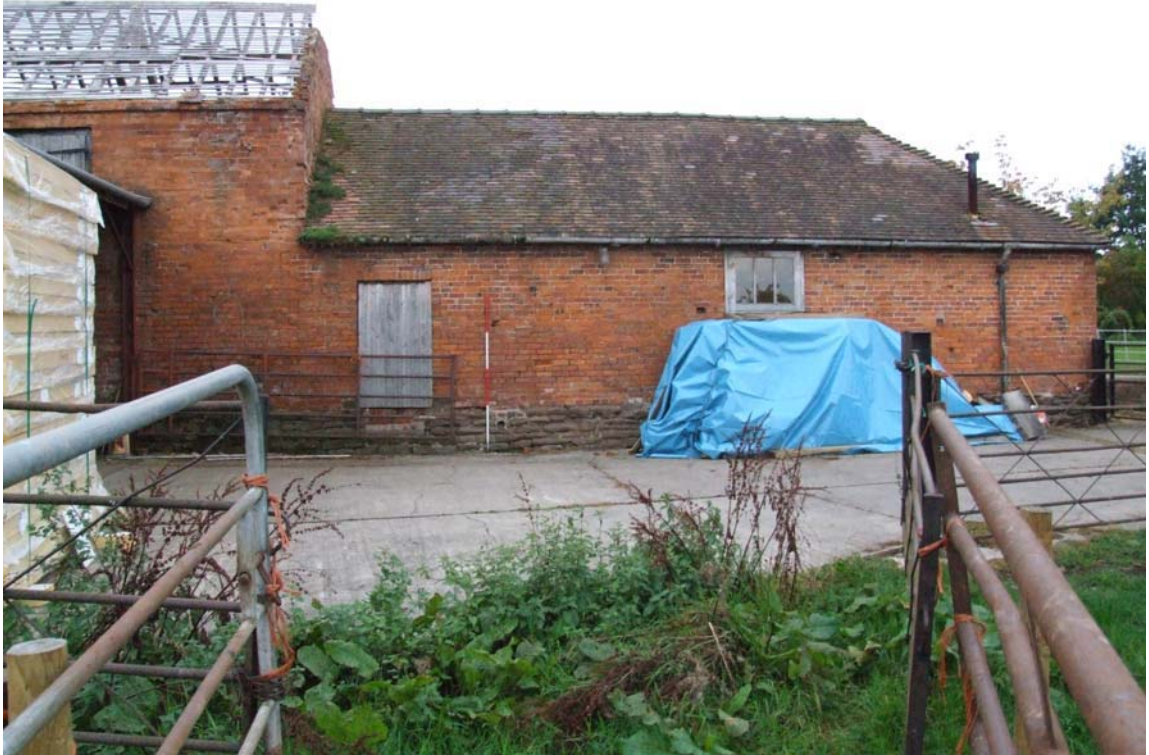
Plate 11: Single storey element of the eastern range (scale 2-metres)

The single-storey unit is constructed in 9" by 2 ¾" handmade brick and whitish lime mortar (Plate 11). The brickwork utilises a common bond with a single Flemish header at every fourth course. The roof is pitched, with a hipped gable at the north end, covered in plain handmade clay tiles. The structure sits on a low plinth of rough coursed local stone. There are access doorways to the north, south and eastern elevations, with windows to the northern gable and eastern side, it could not be determined if these are all original units. The corrugated iron wall of a modern agricultural building, which now covers the extent of the former open central foldyard, obscures the western elevation.

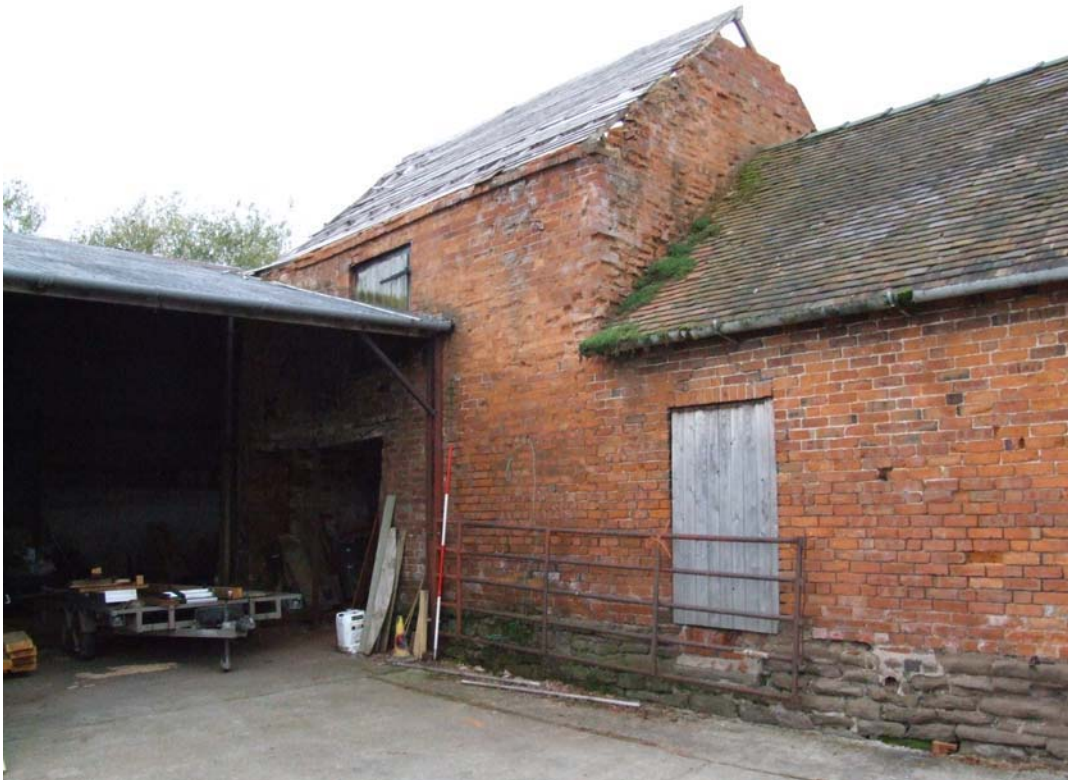
Plate 12: The two-storey element of the eastern range (scale 2-metres)

A two storey brick built extension has been added to the southern end of the eastern range; this is now in a dilapidated condition, with the roof cover missing and spored and damaged brickwork (Plate 12). The construction joint with the single-storied element (eastern elevation) of the range can be seen at plinth level, where a straight butt joint is used, and in the brickwork above, where the courses have been tied in, but the joint is 'slightly noticeable (Plate 13). There is a double door sized opening to the eastern elevation with a pitching eye and door above, at first floor level, and there is a similar double opening to the western elevation, with an access door into the single storey element of the range. There is evidence to suggest that the structure, at least to single storey height, extended to the west; there are the stub remains of the demolished outer walls from the western elevation (Plate 16); the evidence for this southern range is confirmed on the early mapping.

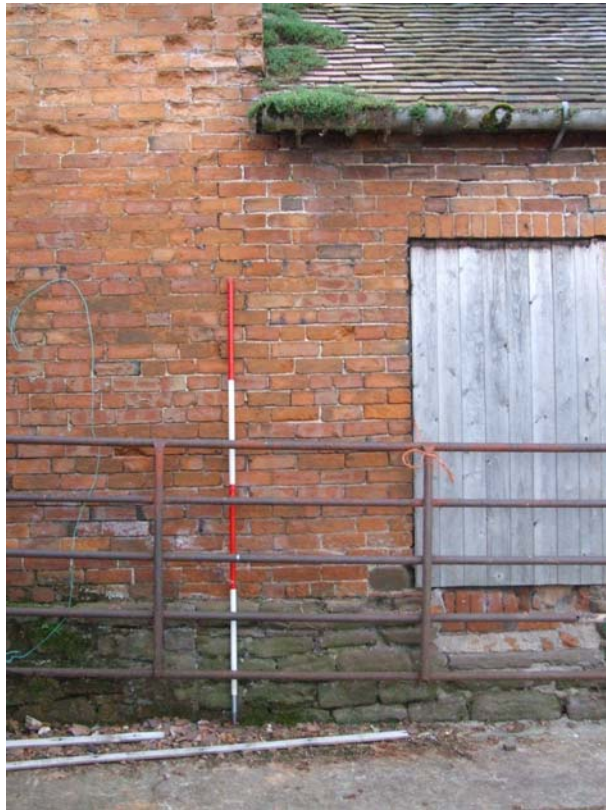
Plate 13: The joint between the original single-storey build of the eastern range and the later two-storey extension (scale 2-metres)

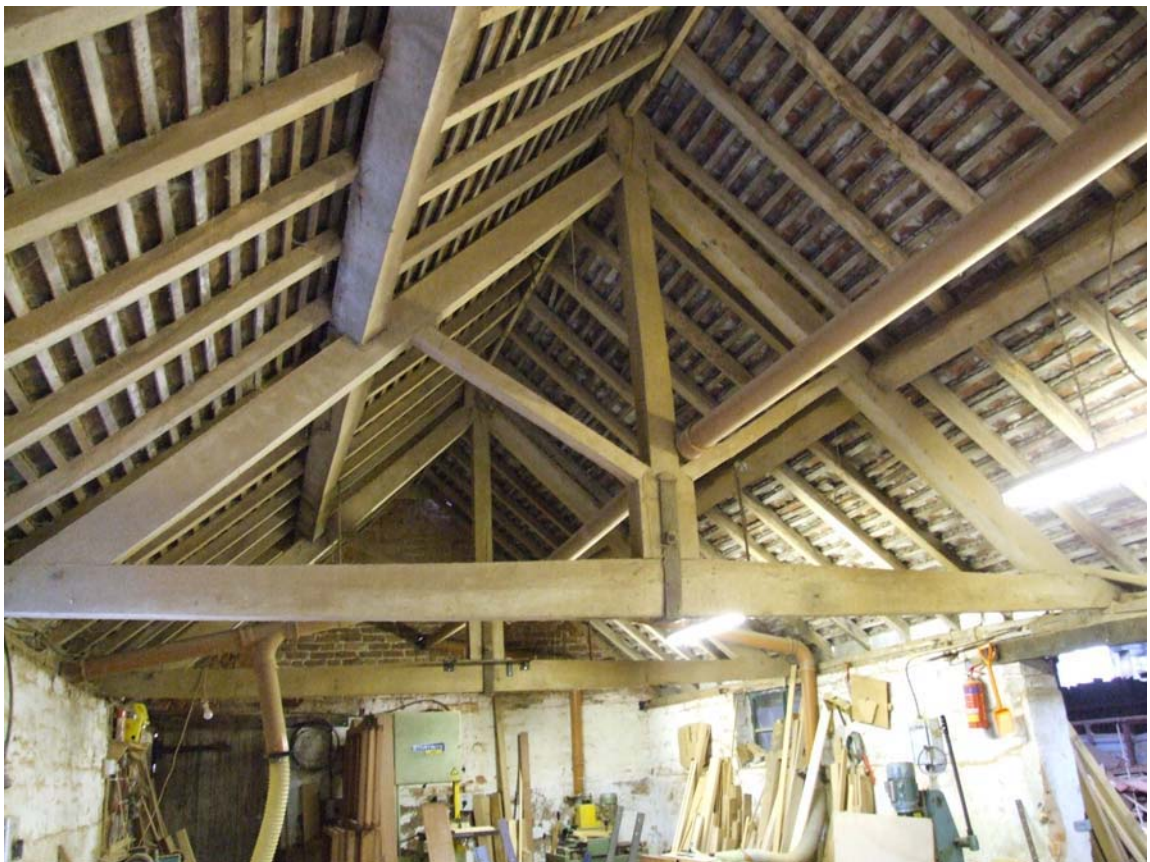
Plate 14: King-post truss in the single storied eastern range

There are three king-post trusses dividing the space into 4-bays, with a hipped gable to the north end. The trusses are slightly different in construction to those in the original part of the western range, and those in the western range extension (see above). The crucial differences are that both the struts spring from a straining sill (shoulder) towards the base of the post and single pegs are used to secure the frame (Plate 14).

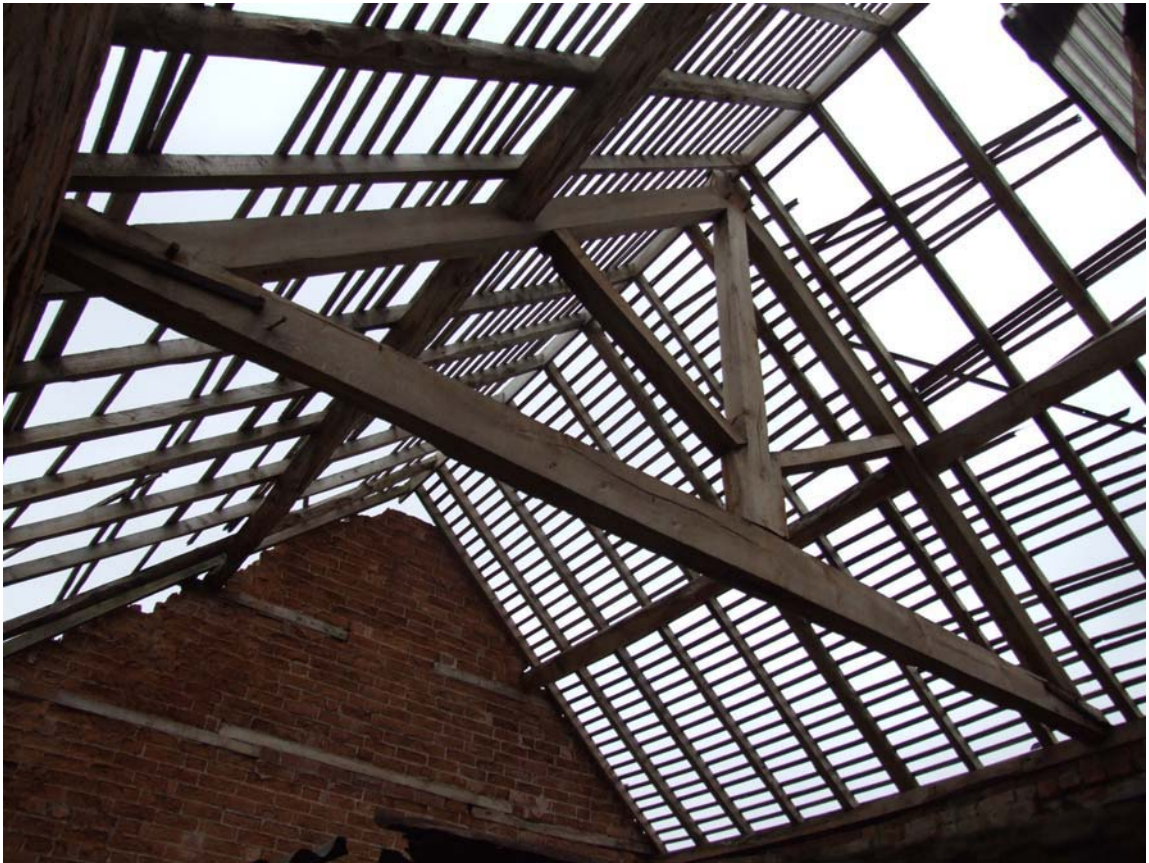
Plate 15: Truss of the two-story eastern extension

The upper floor is derelict and not accessible, but the central truss could be seen from the ground floor (Plate 15). The king-post truss is similar to those used in the single-storey unit, but the post is simply stub tenoned into the tiebeam, without any iron bracketing; though there are iron straps at the tiebeam to principal joints. Some of the timbers used in the upper floor construction are re-used; Plate 17 shows part of a former hayrack within the build.

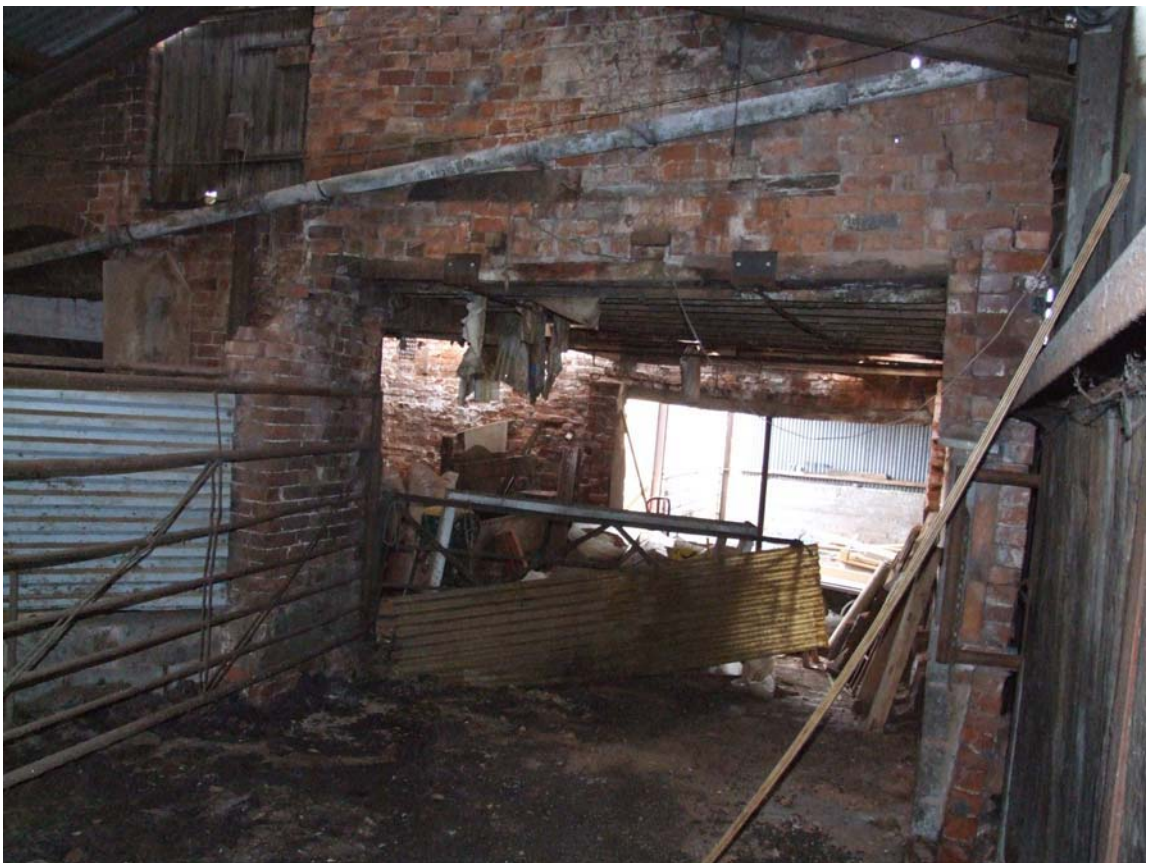
Plate 16: Stub walls of former south range (now demolished) at their juncture with the eastern range

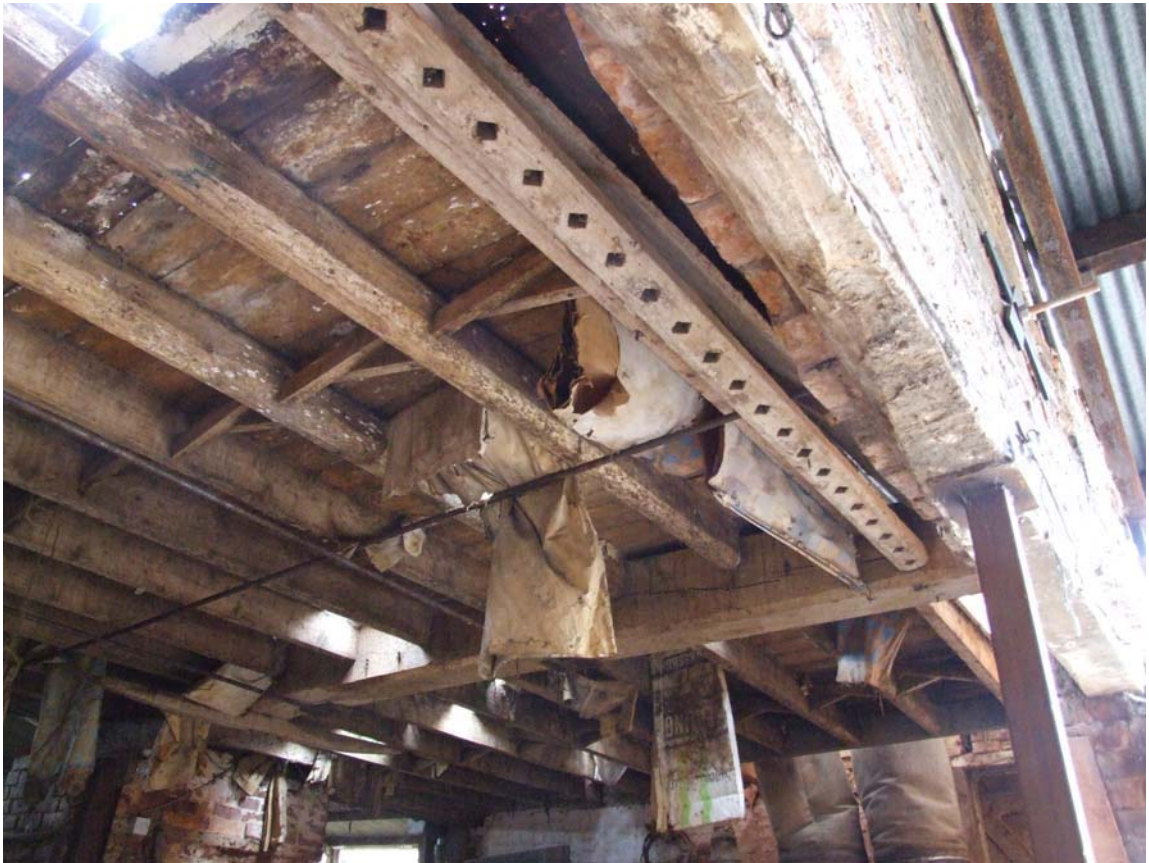
Plate 17: Part of a former hayrack used in the upper floor of the eastern range extension

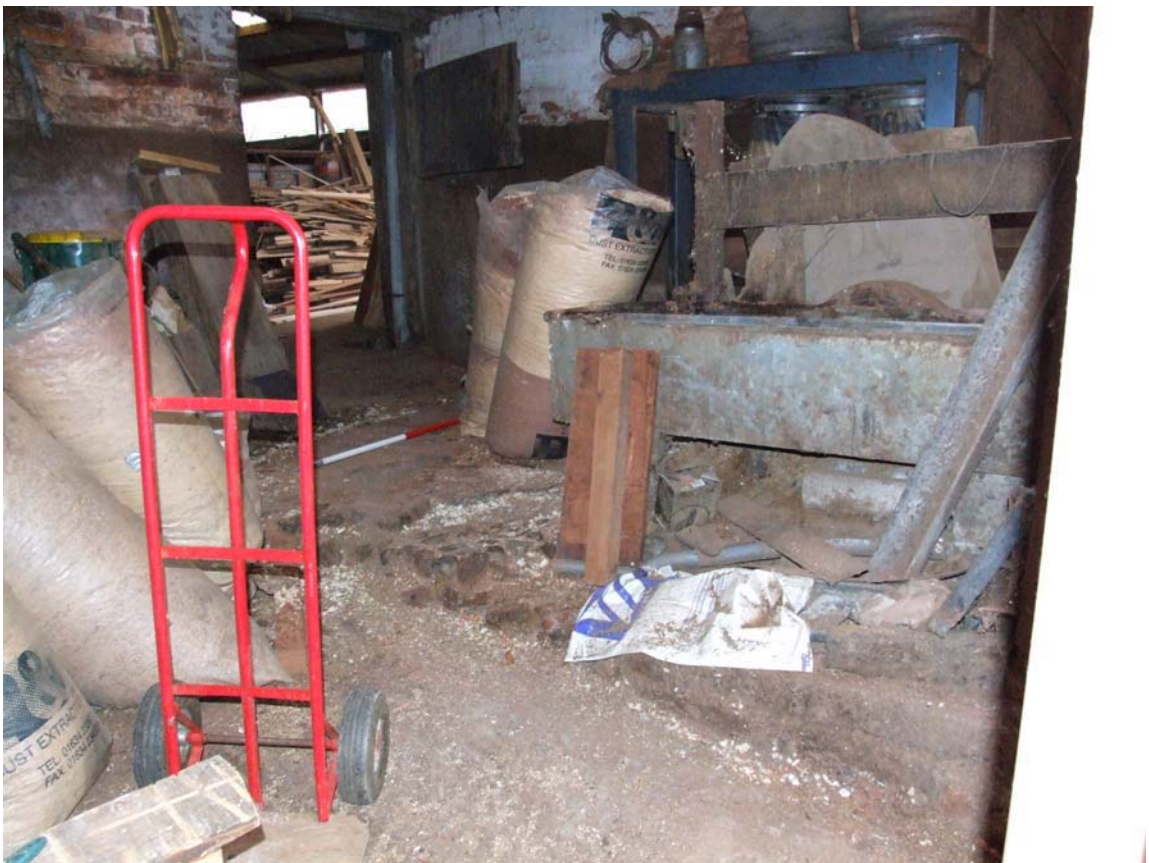
Plate 18: Former cobbled floor can be seen above the later concrete ramp

The floor of the unit is cut through by a later concrete ramp into the central covered yard area, though areas of the original cobbled floor remain beneath the modern extraction units within the space (Plate 18).

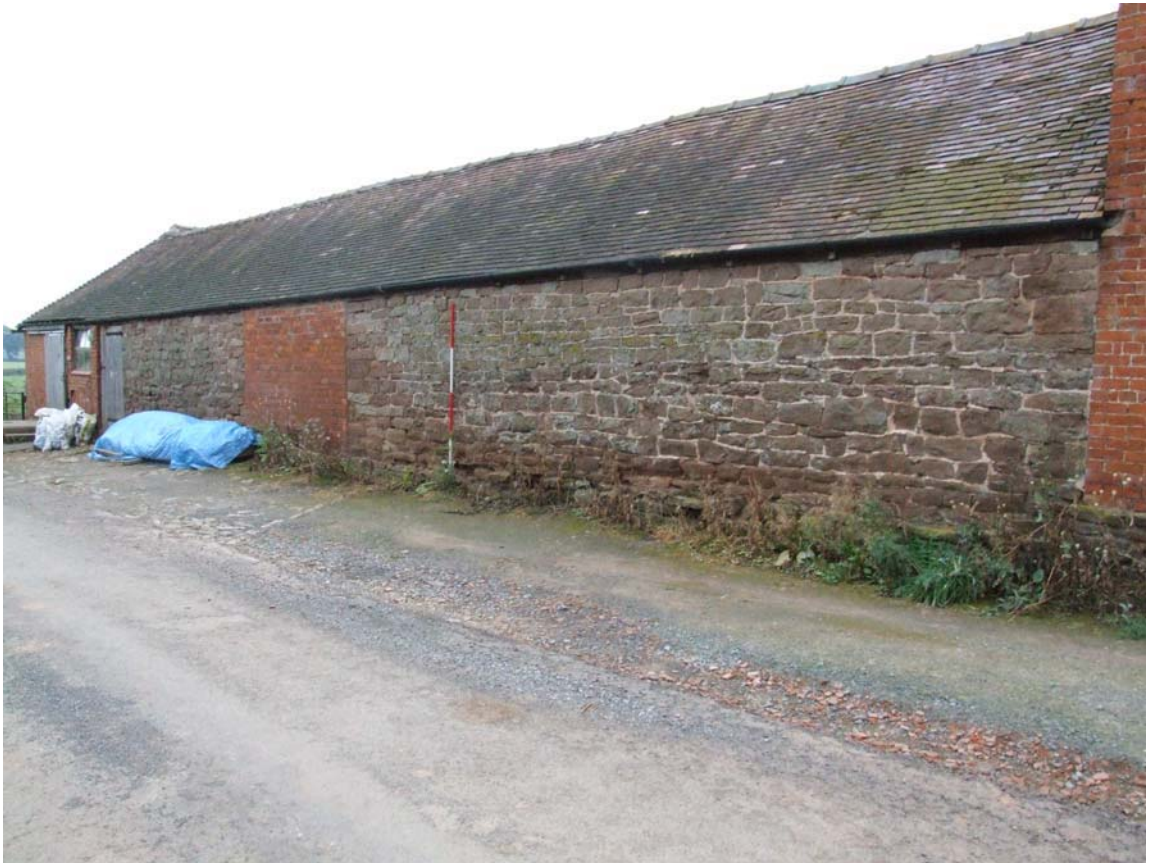
Plate 19: The northern range from the road, looking north-east

The northern range butts the western and eastern ranges, adjacent to the road (Figure 4). The structure is random coursed local stone to the northern elevation and open into the yard to the south. There was once a central entranceway from the road, but this has been bricked up (Plate 19).

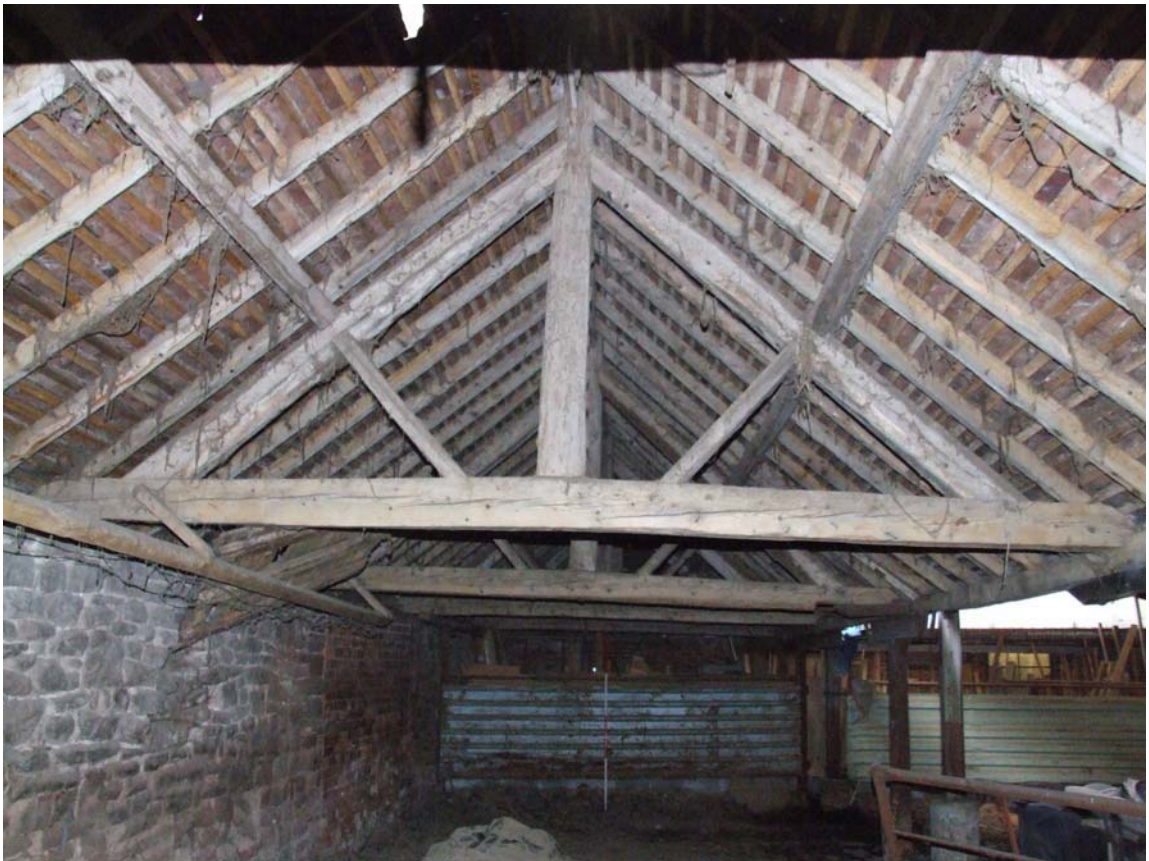
Plate 20: Truss of the northern range

The pitched roof cover of hand-made clay tile is supported on a series of king-post trusses, which are similar to those used in the western range extension (Plate 20). The roof is supported along the front on a series of posts from the wallplate; one original post survives,

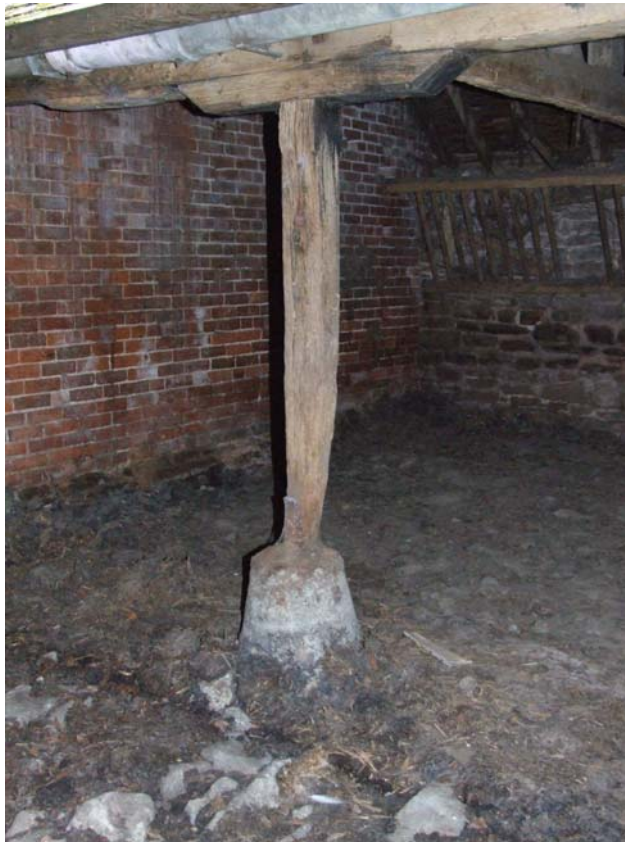
Plate 21: Original support post and cobbled floor of the northern range

this sits on a stone pad and its upper end is located in a carved bracket below the wallplate (Plate 21); a former pad now lies redundant against the outer wall of the eastern range (Plate 22).

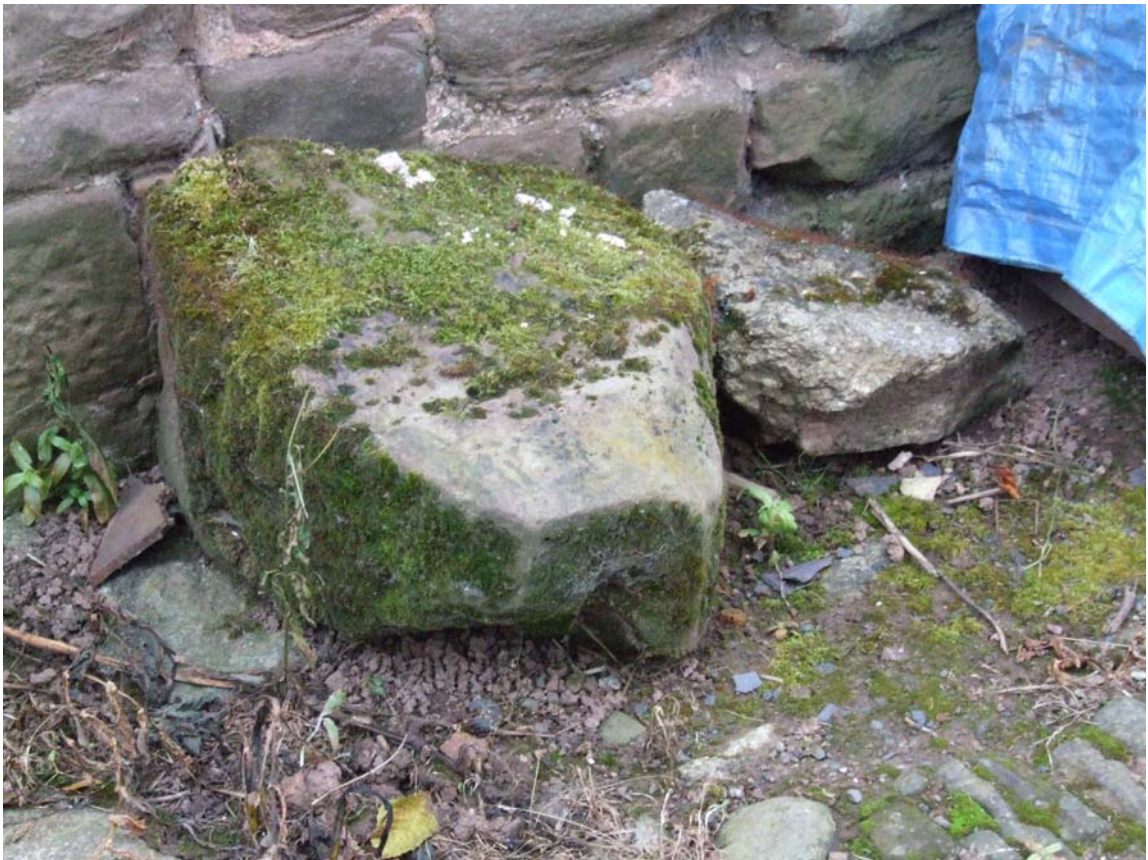
Plate 22: Former post pad, most likely from the northern range southern elevation

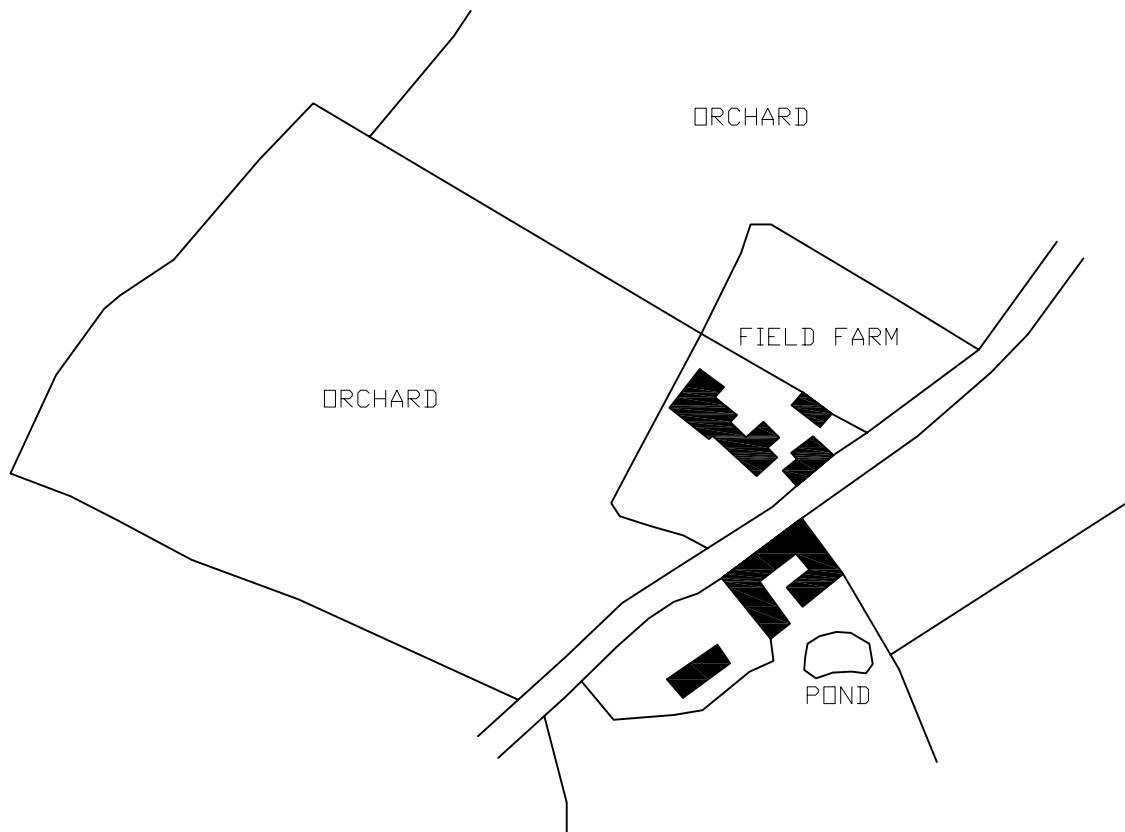
Figure 3: Sketch Drawing of the 1885-87 1st Edition Ordnance Survey Map  
(Based on Landmark Mapping 15 SO5566-15 SO5567)

The 1st edition Ordnance Survey 25” map of the area was not available at Worcester Records Office, but the 6” to 1 mile version of the map, which dates from 1885-87, which was supplied as part of the commissioned Historic Environment Record search (HER), shows the buildings on the site to now almost surround the central yard, with a gap only to the south-east corner. The map could not be reproduced in this report due to copyright issues, though a sketched-drawing of the relevant part of the map has been made and is included in Figure 3. Later Ordnance Survey maps of the area were also unavailable at Worcester Records Office.

***Building shown on the map (Figure 3) in the field to the west*** – Hay barn
