***Historic Building Recording at  
(Postal Address) Field Farm,  
Little Hereford, near Ludlow,  
Shropshire***

*A report for Mr V. Hamer*

December 2007

**Project: PJ 197**

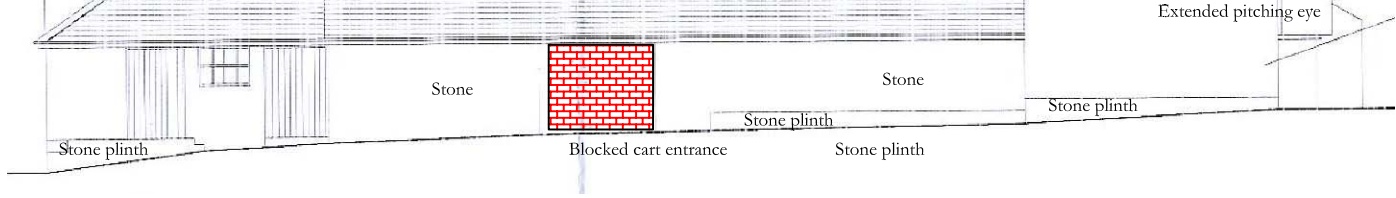
North Range, Southern Elevation

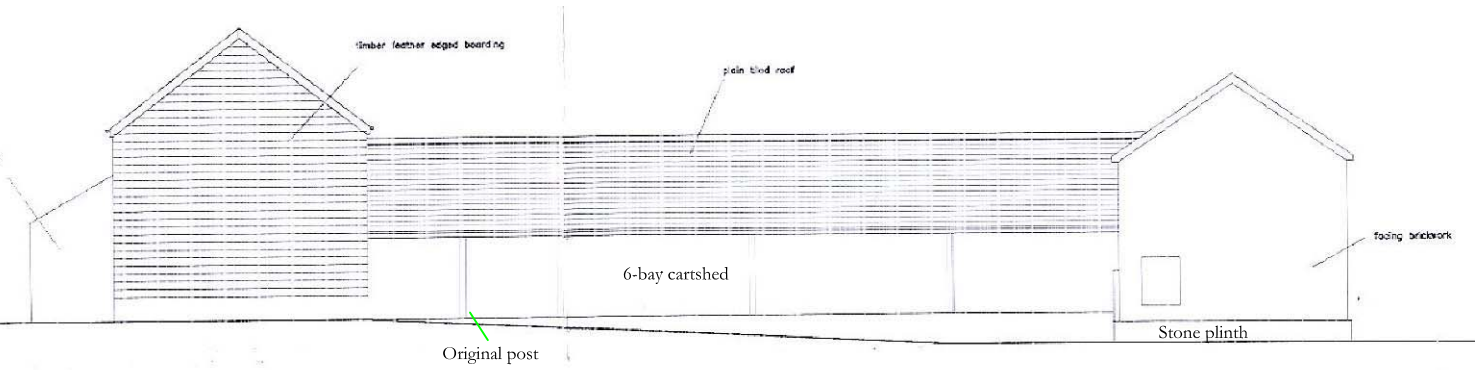
Eastern Range, Eastern Elevation
