*An Archaeological Watching Brief on  
the Site of Compensation Reedbeds at  
Salwarpe, Worcestershire*

*A Report for Halcrow UK on behalf of British Waterways*

**Project: PJ 198**

**WSM 38296**

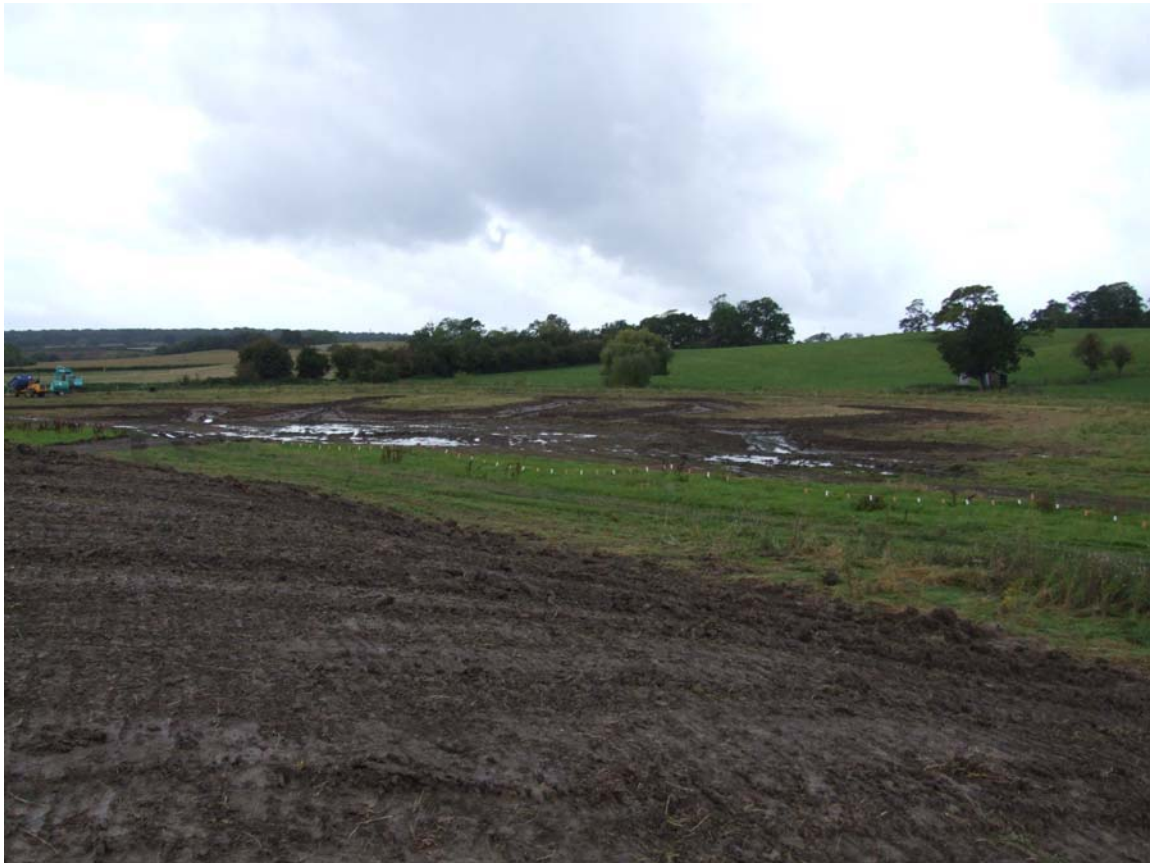
Plate 1: The new reedbeds area under construction, view to the north-west

The excavation comprised a series of long narrow curved ‘fingers’ radiating from a central amorphous shaped pond area; differences in depth of excavation was used to create steps within the area, which were designed to allow wildlife species ingress and access to the finished waterlogged area. The excavated area is shown in Figure 2 and plates 1-4.

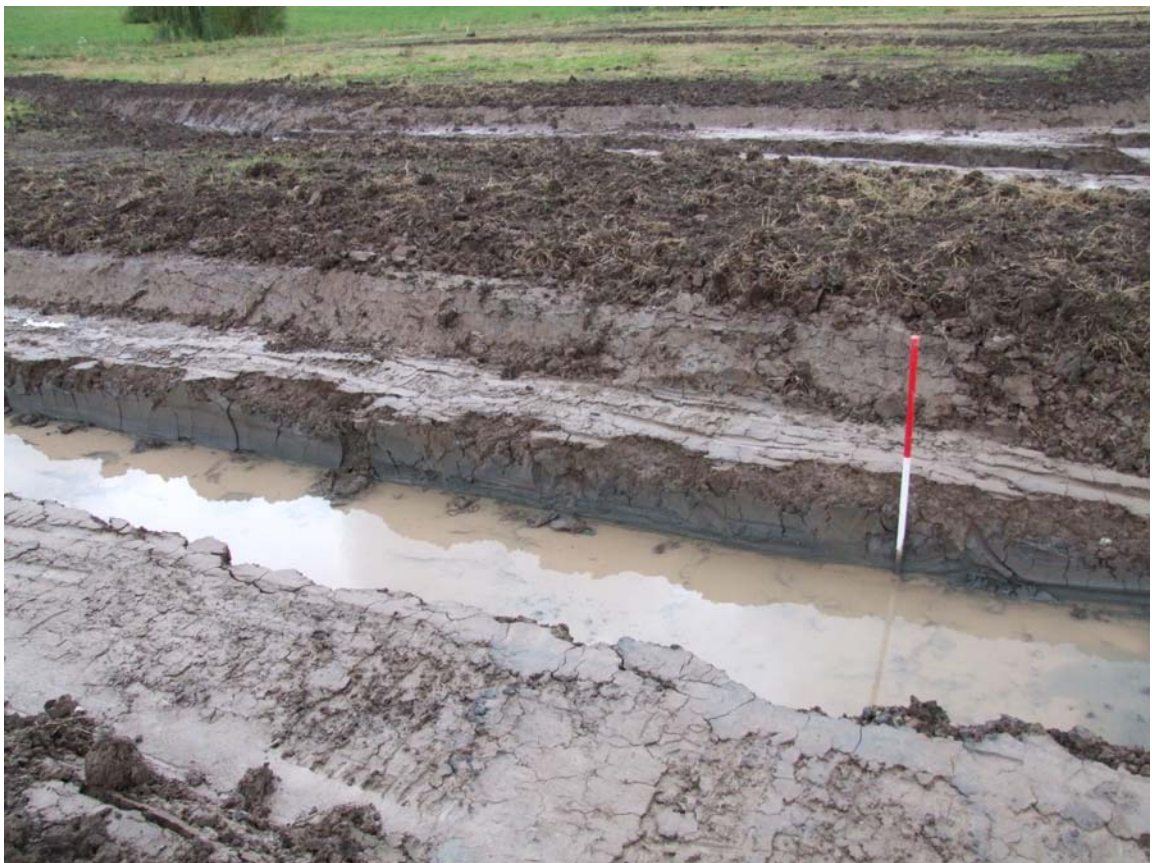
Plate 2: The general soil profile (scale 1-metre)

Excavation revealed a topsoil [100] of around 30-centimetres thick; this was a mid to dark brown blocky silty-clay containing rare round and sub-round stones. Occasional brick fragments and charcoal deposits were also noted.

A 30 to 40-centimetre layer of subsoil was identified below [101]. This was derived from alluvium, but had probably been modified by ploughing during the past. The soil was a light-brown silty clay with rare charcoal flecks, some fine roots, rare small rounded stones and occasional inclusion of brick and broken land drain fragments. This layer had been cut through by an extensive pattern of land drains of two types; orange hand made ceramic pipes and drain fills of gravel. Both types are likely to date from the past century or so.

Sealed below the subsoil was a thick layer of sterile grey silty alluvial clay [102]. The clay was generally sterile, with only a rare small round stone within the matrix.

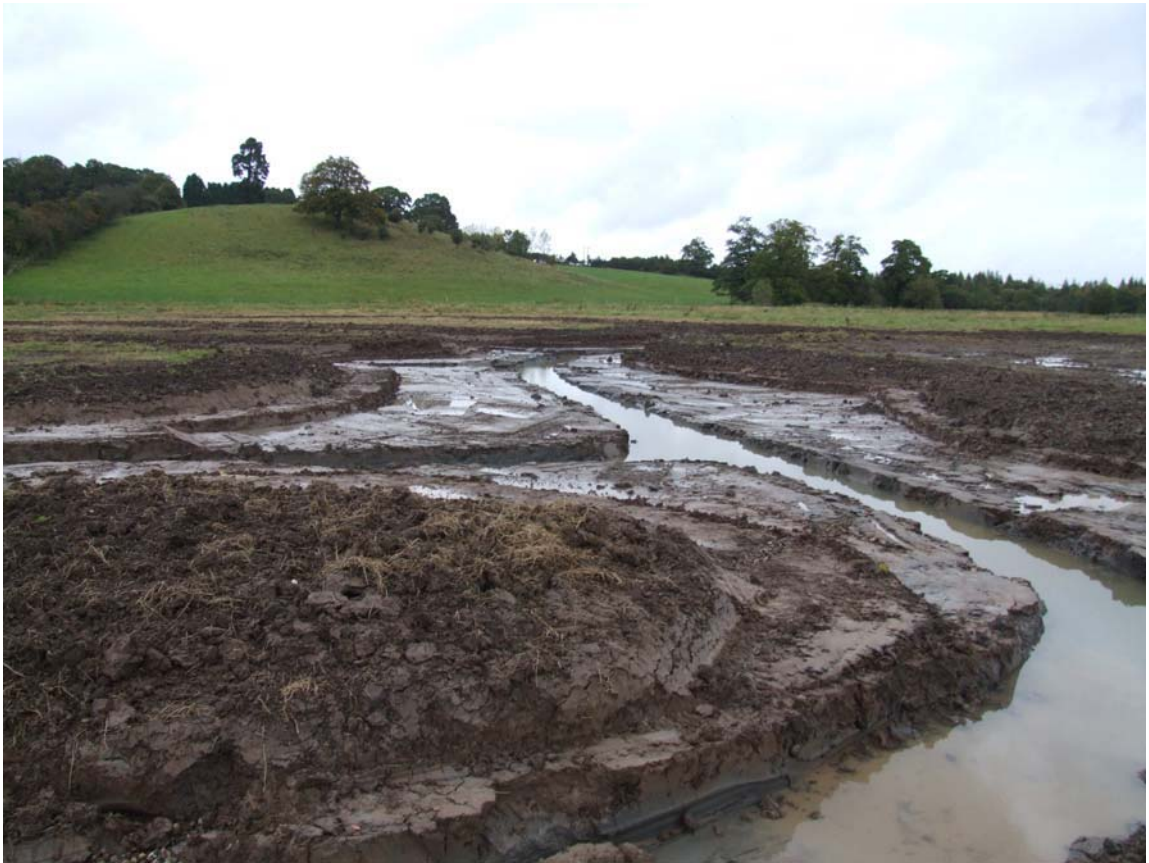
Plate 3: Waterlogged nature of the site

The weather conditions during the period of the watching brief were adverse, with torrential rain quickly flooding the excavated areas; visibility was often poor too, with mist lying over the river valley for long periods. However, the methodology adopted with the cooperation of the groundworks contractors, meant that the aims and objectives of the brief could be met and the fieldwork was successfully concluded.

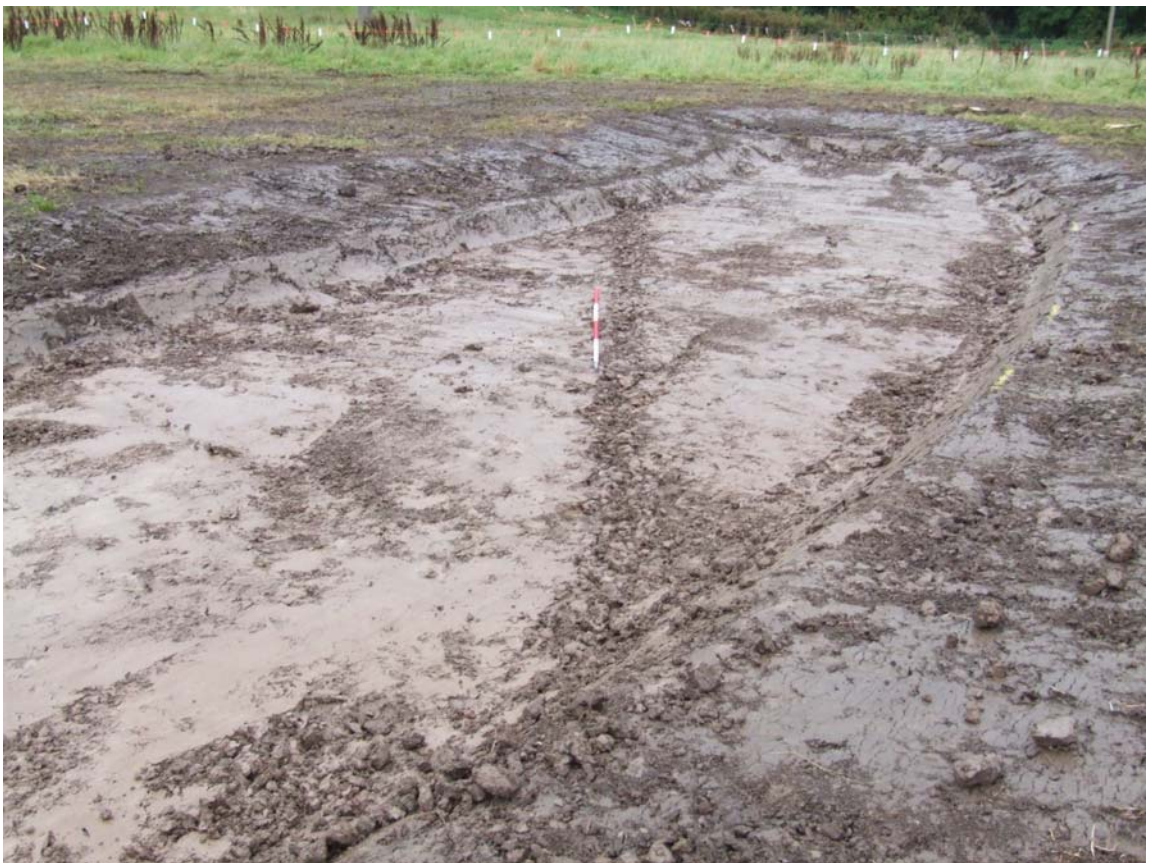
Plate 4: Stone rubble land drain (scale 2-metres)
