*Historic Building Recording at Dorhall Farm,  
Chaddesley Corbett, Worcestershire*

*A report for Mr and Mrs Palmer*

**Project: PJ 142**

**WSM 34487**

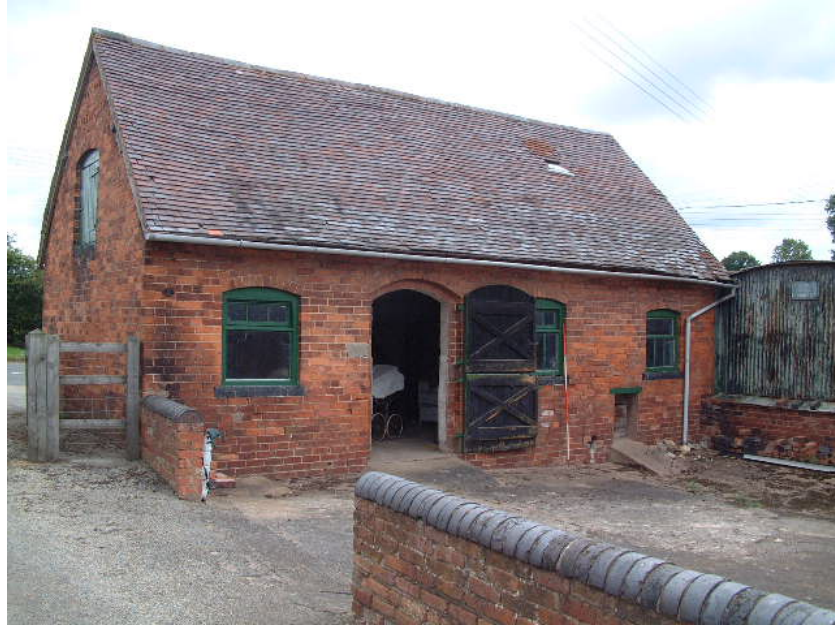
## Plate 1

*The stable block (Building 1) looking east (scale 2 metres)*

Building Number 1 is a rectangular stable and tack-room block with hayloft above, standing on the eastern side of the site adjacent to the road (Plates 1 and 2). It is constructed of brick and mortar, with a pitched roof covered in hand-made clay tiles. Ventilation to the upper floor hayloft is via a pattern of quarter-brick holes in the gable ends. There is an owl hole in the southern gable (owls were encouraged in farm buildings to keep the vermin population down) and a pitching door at the opposite end, where hay would be offloaded from a cart into the loft. The western elevation has three windows and a stable door set below rough segmental arched

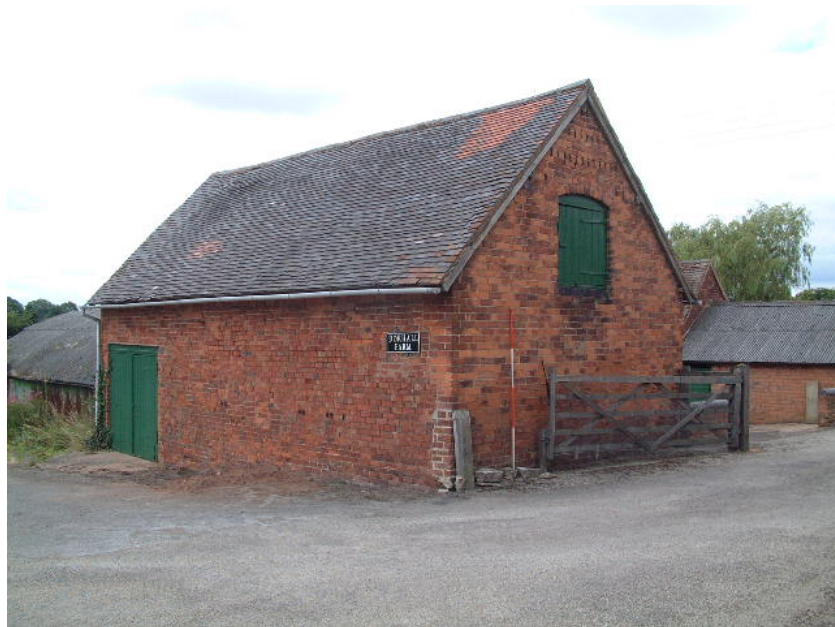
## Plate 2

*The stable block (Building 1) looking west (scale 2 metres)*

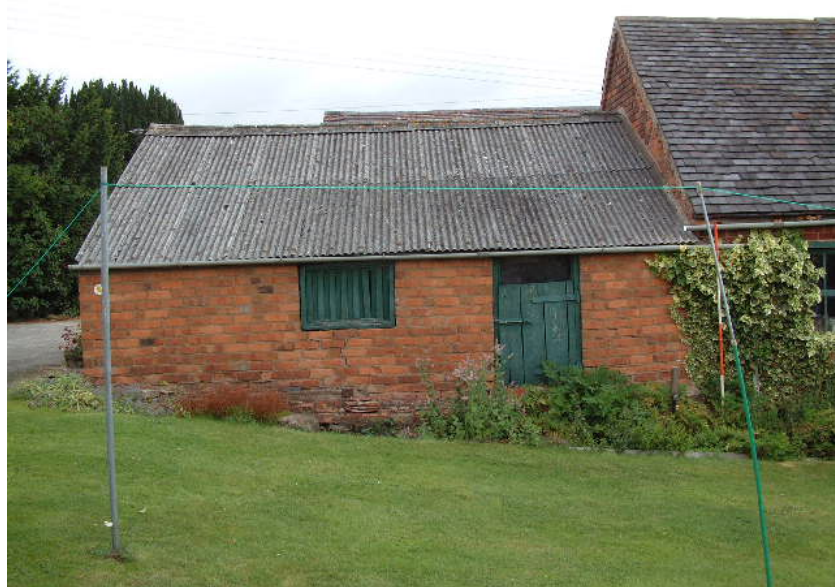
## Plate 3

*Building 2 view to the east (scale 2 metres)*

Building Number 2 lies at the northern end of the on the western range (the main subject building; Plate 3). The building is single storied of 2 ¾" orange brick bonded in a sandy-cement mortar with a corrugated asbestos roof. The brickwork is constructed in a common bond with Flemish header course every fifth course. It sits mainly on the footprint of an earlier brick structure, of which the base of the western elevation can be seen at ground level and the shadow outline of the southern end gable can be seen on the gable end of Building 3 (Plate 4). The building has been recently used as a workshop/store, but a small entrance and vented window in the western elevation indicate this may have formerly been a calving shed. Further evidence is in the form of internal partitioning for stalls (Plate 5). Early map evidence shows possible external pens at this end of the range and it is likely that the earlier building was a piggery. The structure as it stands appears to be mid 20<sup>th</sup> century, and is probably a widened version of the earlier build, the eastern elevation now in-line with the remainder of the range.

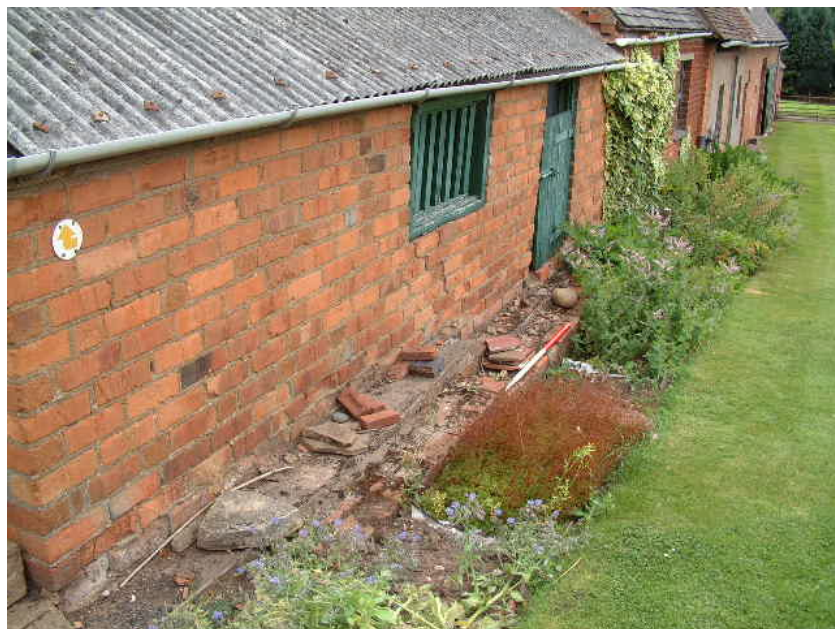
## Plate 4

*Building 2 viewed to the south-east showing earlier wall (scale 1 metre)*

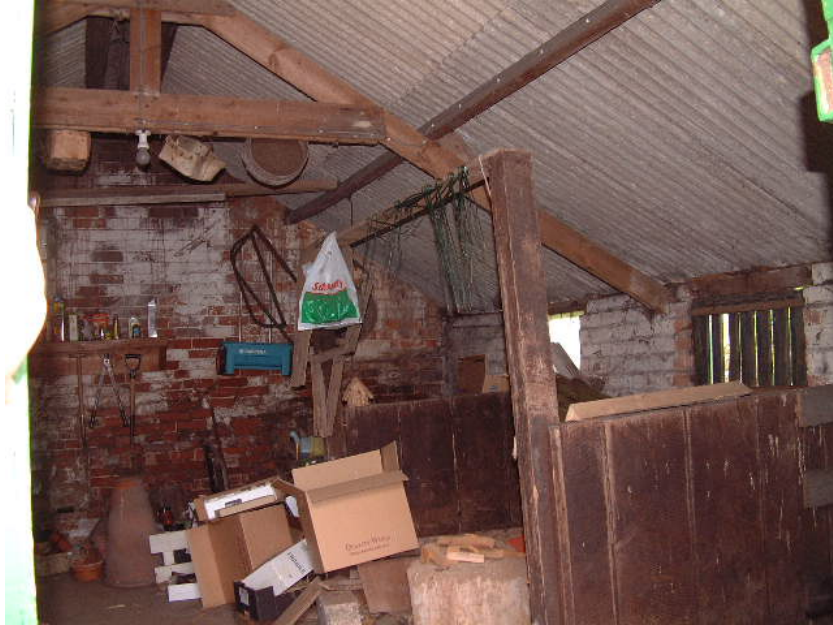
## Plate 5

*Interior of Building 2 showing stalling*

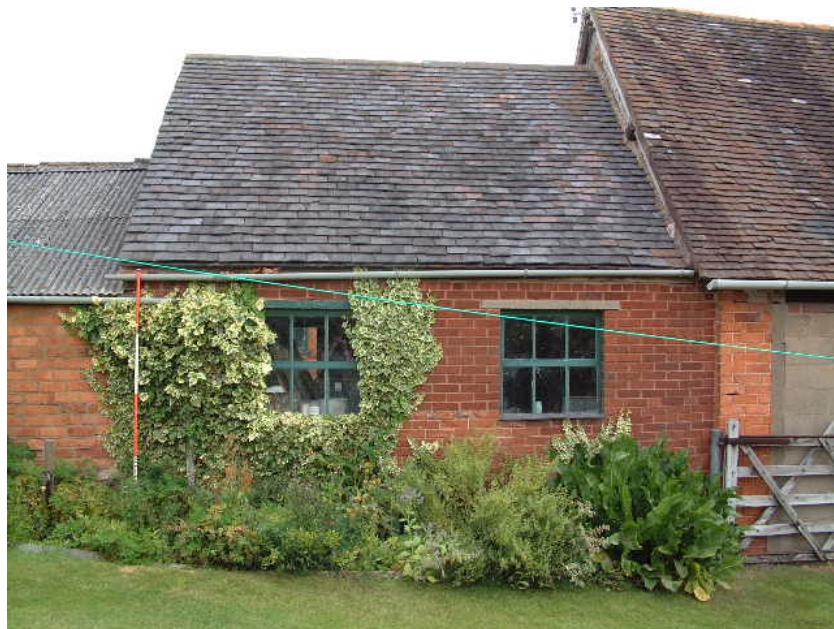
## Plate 6

*Building 3 viewed to the east (scale 2 metres)*

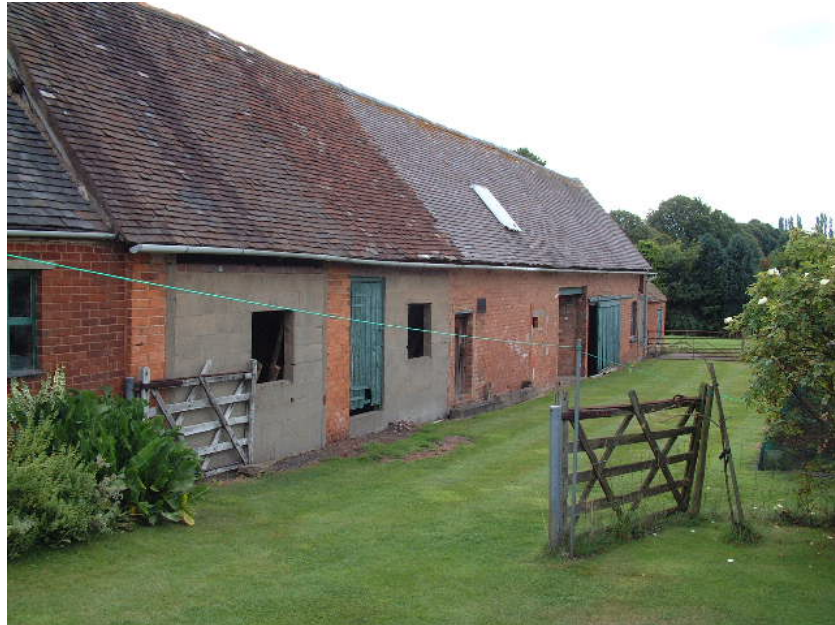
## Plate 7

*Building 4 view to the south-east (scale 2 metres)*

Essentially Building 4 encompasses Spaces A-C (Figure 5) and is all one structure (Plates 7 and 8), however, it is not all of one phase and there are internal divisions that need some explanation.

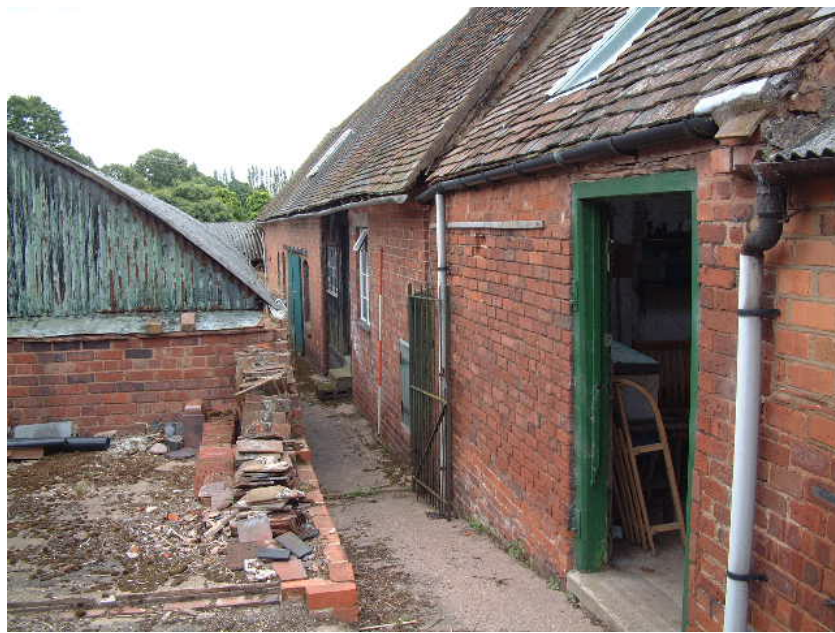
## Plate 8

*Building 4 (after gate) viewed to the south-west (scale 2 metres)*

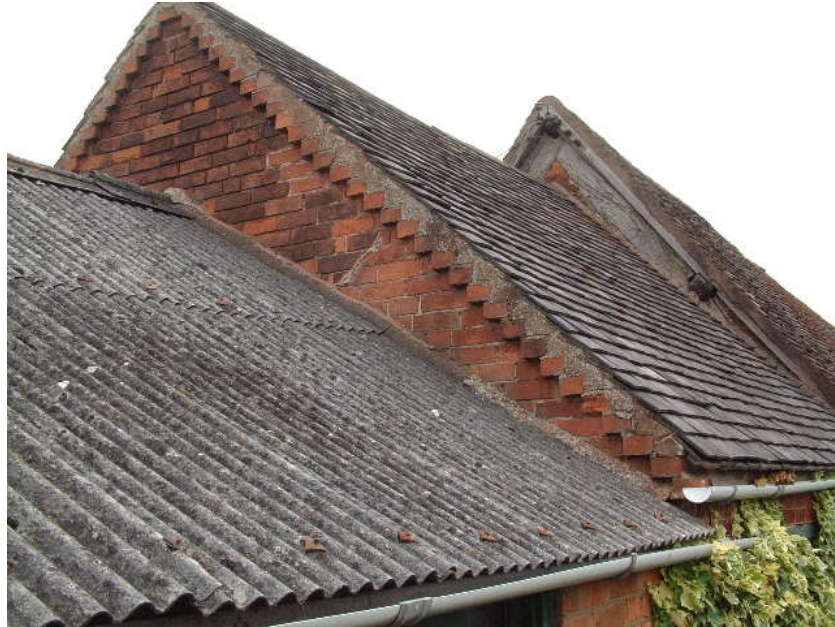
## Plate 9

*Principal rafters in gable end of Building 4 (far), also note shadow of former roofline on gable of Building 3*

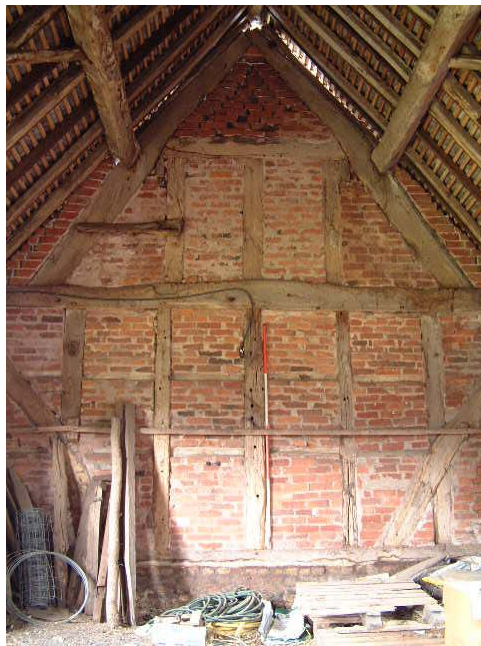
## Plate 10

*Timber-frame of northern gable end of Building 4, Space A (scale 2 metres)*

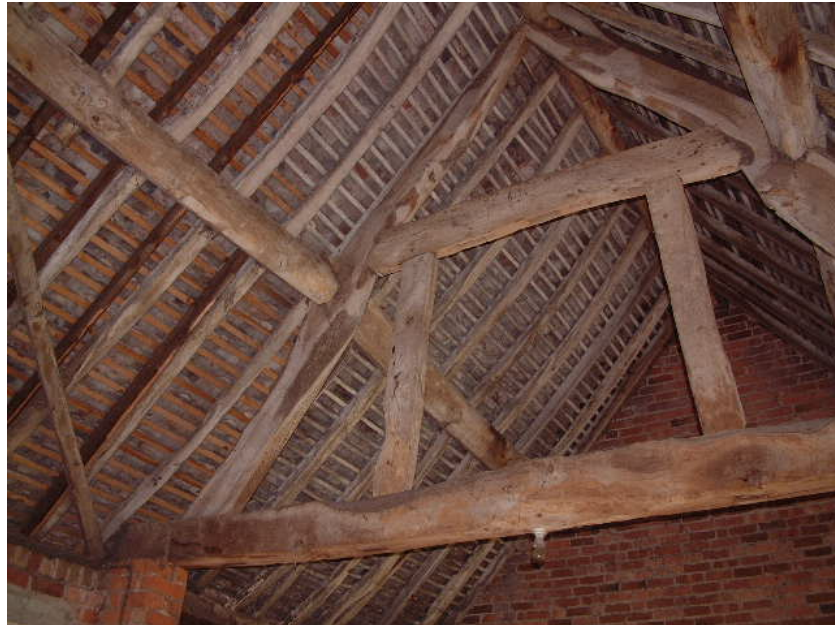
## Plate 11

*Truss T2 in Space A of Building 4*

Internal inspection of Building 4 indicates that remnants of an earlier timber-frame structure have been incorporated into the build. Timbers can be seen externally in the north-eastern corner, where a post can be seen protruding from the brickwork and at eaves level in the northern gable end (Plate 9). The steeply pitched roof is also indicative of a former timber-frame. The remaining timbers are likely to have been part of a threshing barn of three or more bays, standing on the same alignment as the present brick structure. The northern gable end frame survives intact (Plate 10) and the adjacent roof truss survives, now supported by brick piers incorporated into the superseding structure (Plate 11).

Truss T2 is now supported on brick piers. It is similar in form to the gable end truss in that the principals are again mirrored on each side, the result of splitting one timber longitudinally. The collar and queen struts are re-used from another timber-framed structure, The struts have grooves in both inner faces, suggesting they were originally studs with lath and plaster infill panels between, or possibly part of a former plank and muntion partition. The collar timber has in fact been re-used twice. It originally appears to have been an upper rail with holes for the staves of a wattle and daub infill panel on the underside. This was then re-used (or modified / altered) and mortises were cut in to take studs. The timber was then used again in the present position, with new mortises for to take struts, one overlapping an earlier mortise rebate. The tiebeam also shows evidence of likely re-use, although the empty mortises and peg holes may be associated with transverse bracing or a partition from the (proposed) threshing bay, which would have been adjacent on the southern side. Partitions were often an element of barn construction and timber-framing here would also serve to brace the structure and strengthen the points where the massive barn doors would pivot.

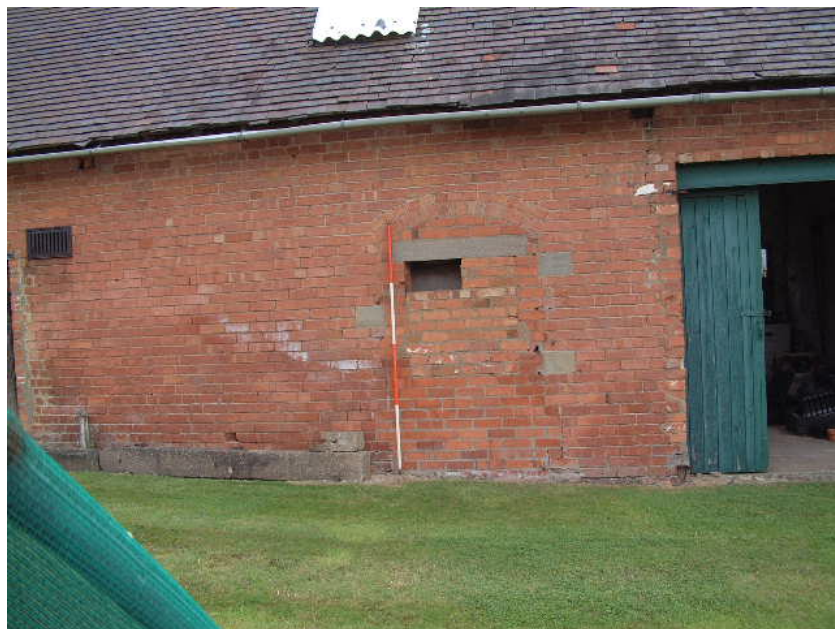
## Plate 12

*Blocked stable door in Space B of Building 4 (scale 2 metres)*

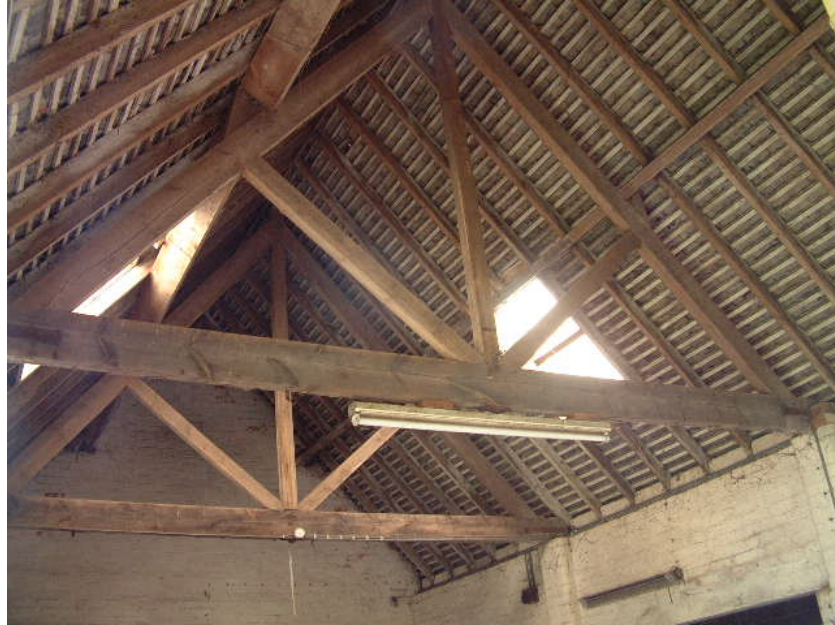
## Plate 13

*Trusses in Space B of Building 4*

Space B is a three bay area within structure 4, which appears originally to have been a stable with a pair of slat vented windows to the eastern elevation below rough segmental arched heads, with contrasting sills in Staffordshire blue plinth bricks (Plate 12). There were probably 3 windows to this elevation, but a 20<sup>th</sup> century double width sliding door has been inserted into the build below an RSJ on brick piers, which has removed evidence of former features and detail. On the opposite western elevation there is a blocked-up access doorway beneath a rough segmental arched head and with hinge and bolt fix points picked out in a white sandstone, a feature noted on the other original door apertures. There is a further inserted sliding door and an inserted personnel door at the opposite northern end. There is a blocked access way into Space C to the south. The floor is concrete and the pair of roof trusses in this section are typical mass produced 19<sup>th</sup> century king post trusses (Plate 13).

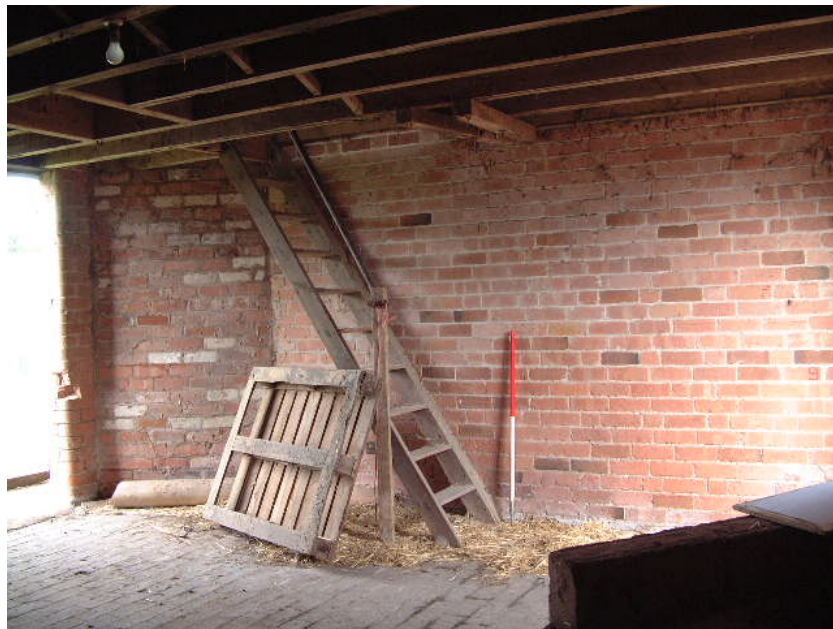
## Plate 14

*Space C, former cart-shed with granary above (scale 1 metre)*

Space C appears originally to have been a cart-shed and a separate process room (probably fodder) with a granary above (Plates 14 and 15). Physically, this part of the building was two-spaces with a dividing wall. However, the only original access to the processing area was internal and so for the purposes of this report, the area is regarded as a single 'space'. A 20<sup>th</sup> century sliding door now obscures the original open cart-door aperture, which is below a rough brick arched lintel in the western elevation (visible above the sliding door). There is a six light window with arched head and Staffordshire blue brick plinth brick sill in the western elevation of the process shed and the only access between the spaces was via an internal door. A single external doorway has been inserted into the south-west corner, below the open aperture of a pitching eye to the floor above, this is also likely to be an insertion, probably as the granary was also used as a hayloft in the 20<sup>th</sup> century. There is a window in the southern gable end bringing light into the granary. The process room has a stone flag and brick floor and the cart-shed is brick floored. The granary roof is supported on king post trusses with raised tie-beams and steel tie-rods giving extra head height in this area (Plate 16). More recently the lower floor space has also been used for produce storage and processing. There is a partially sunken turnip bin within the former cart-shed and late-20<sup>th</sup> century three phase electric processing plant still remains in the form of a 'Markham Mixer', the hopper of which, would have been supplied through a hatch in the granary floor.

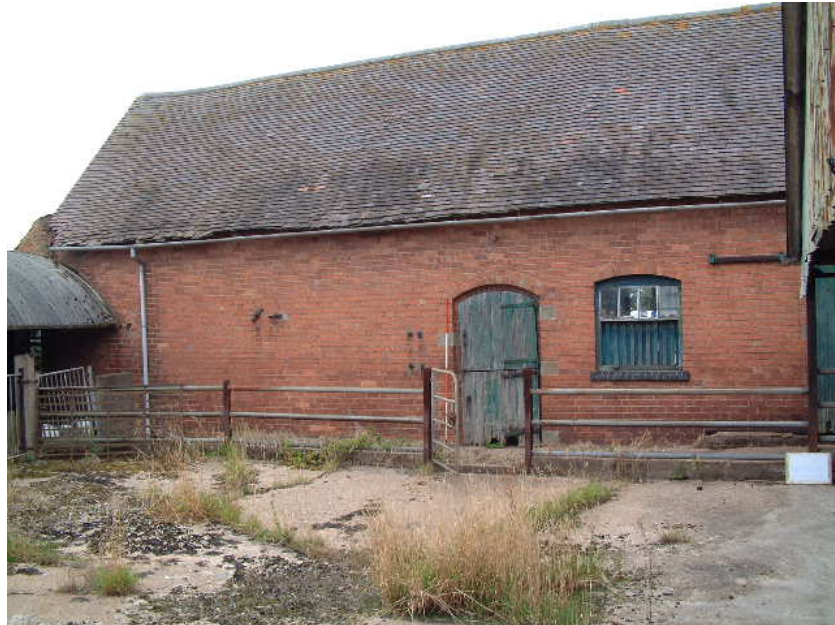
## Plate 15

*Space C of Building 4, the window is within Space B (scale 2 metres)*

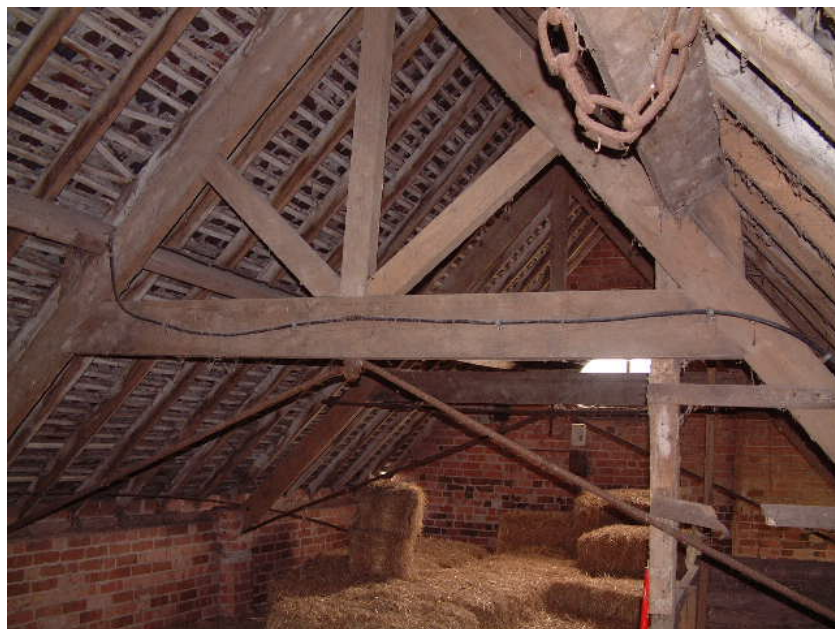
## Plate 16

*Trusses in Space C of Building 4*

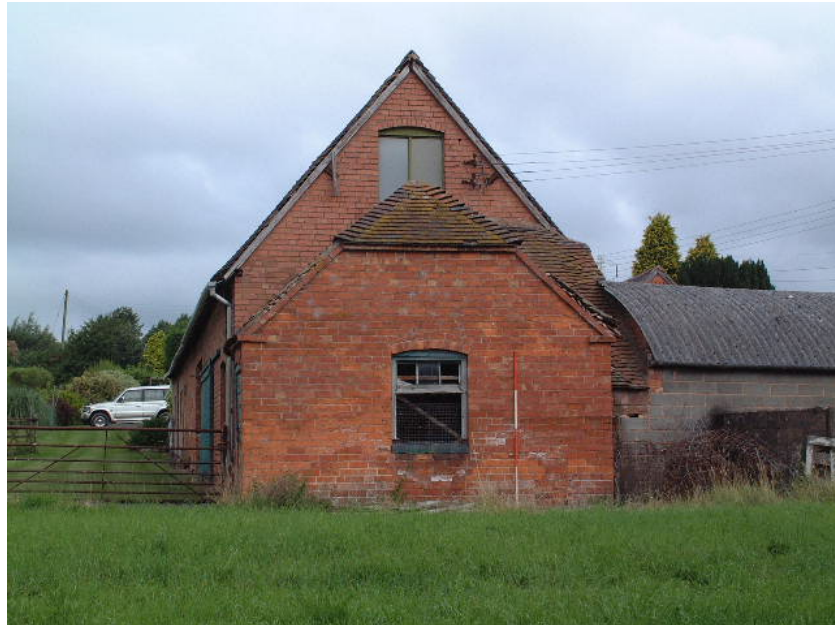
## Plate 17

*Building 5 at the southern end of Building 4 (scale 2 metres)*

Building five is a single storey brick structure at the far southern end of the range, below a hipped roof (Plate 17). The phasing evidence here is difficult to accurately interpret and various theories can be put forward, but also refuted due to anomalies within the evidence. On the face of it the building is later than Building 4, onto which it butts and earlier than Building 6, on the eastern side. However, the eastern elevation of Building 4 extends through and forms

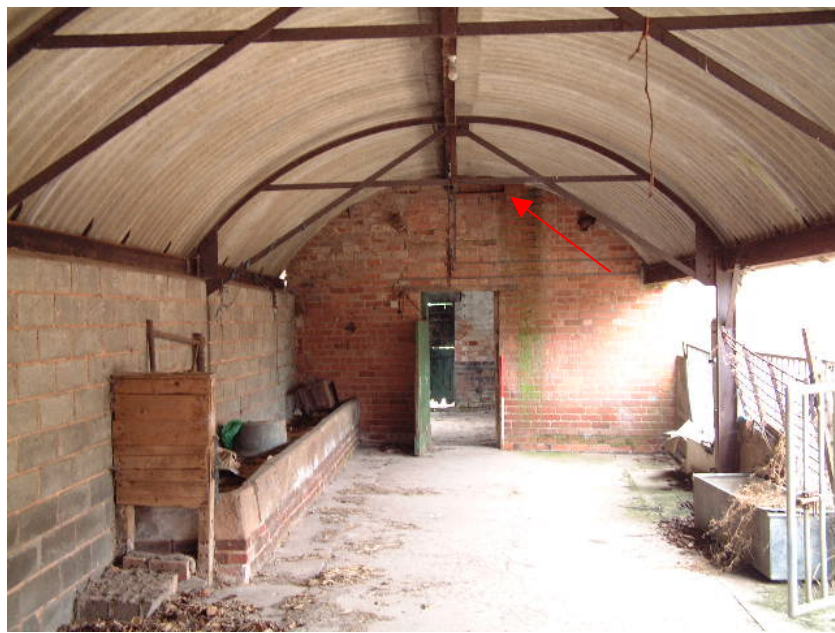
## Plate 18

*Eastern elevation of Building 4 where Building 6 butts it, note the blocked aperture (arrowed)  
(scale 1 metre)*

the rear wall of Building 5. There is a bricked in aperture to this elevation, which can just be seen below the roofline of the adjoining Building 6 (Plate 18). The logical explanation for a bricked in aperture at upper level is that the building was two-storied. However, there is no evidence that Building 5 was ever more than one story. In fact, the evidence suggests otherwise; there is a window at upper level in the gable end of building 4, which therefore must have been an external face. The alternative is that at some stage Building 6 was a two-story structure and the aperture was an upper window in the precursor to the current Building 6, although there is no physical evidence to suggest this is correct either. So the most likely scenario is that the blocked in window ‘aperture’ is actually another form of feature or a poor repair to the wall?

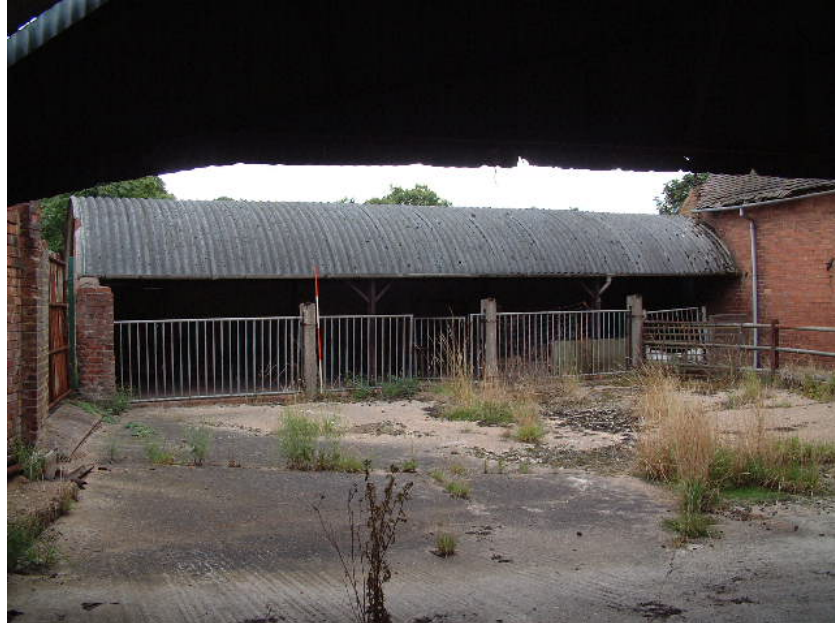
## Plate 19

*Building 6 at the southern end of the yard (scale 2 metres)*

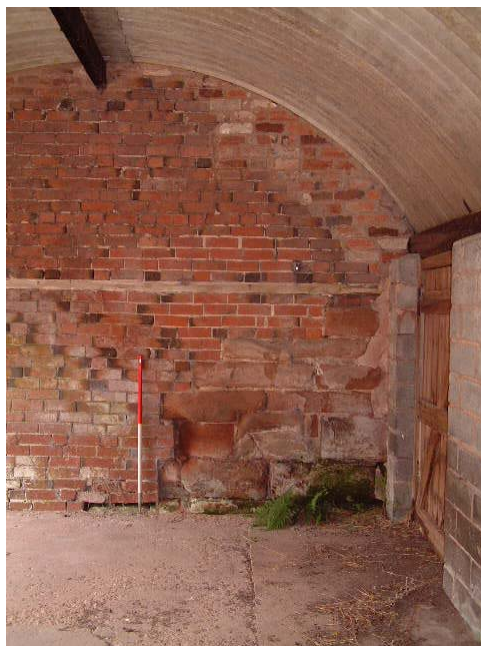
## Plate 20

*Eastern elevation of Building 6, note the sandstone and the line of a former pitched roof  
(scale 1 metre)*

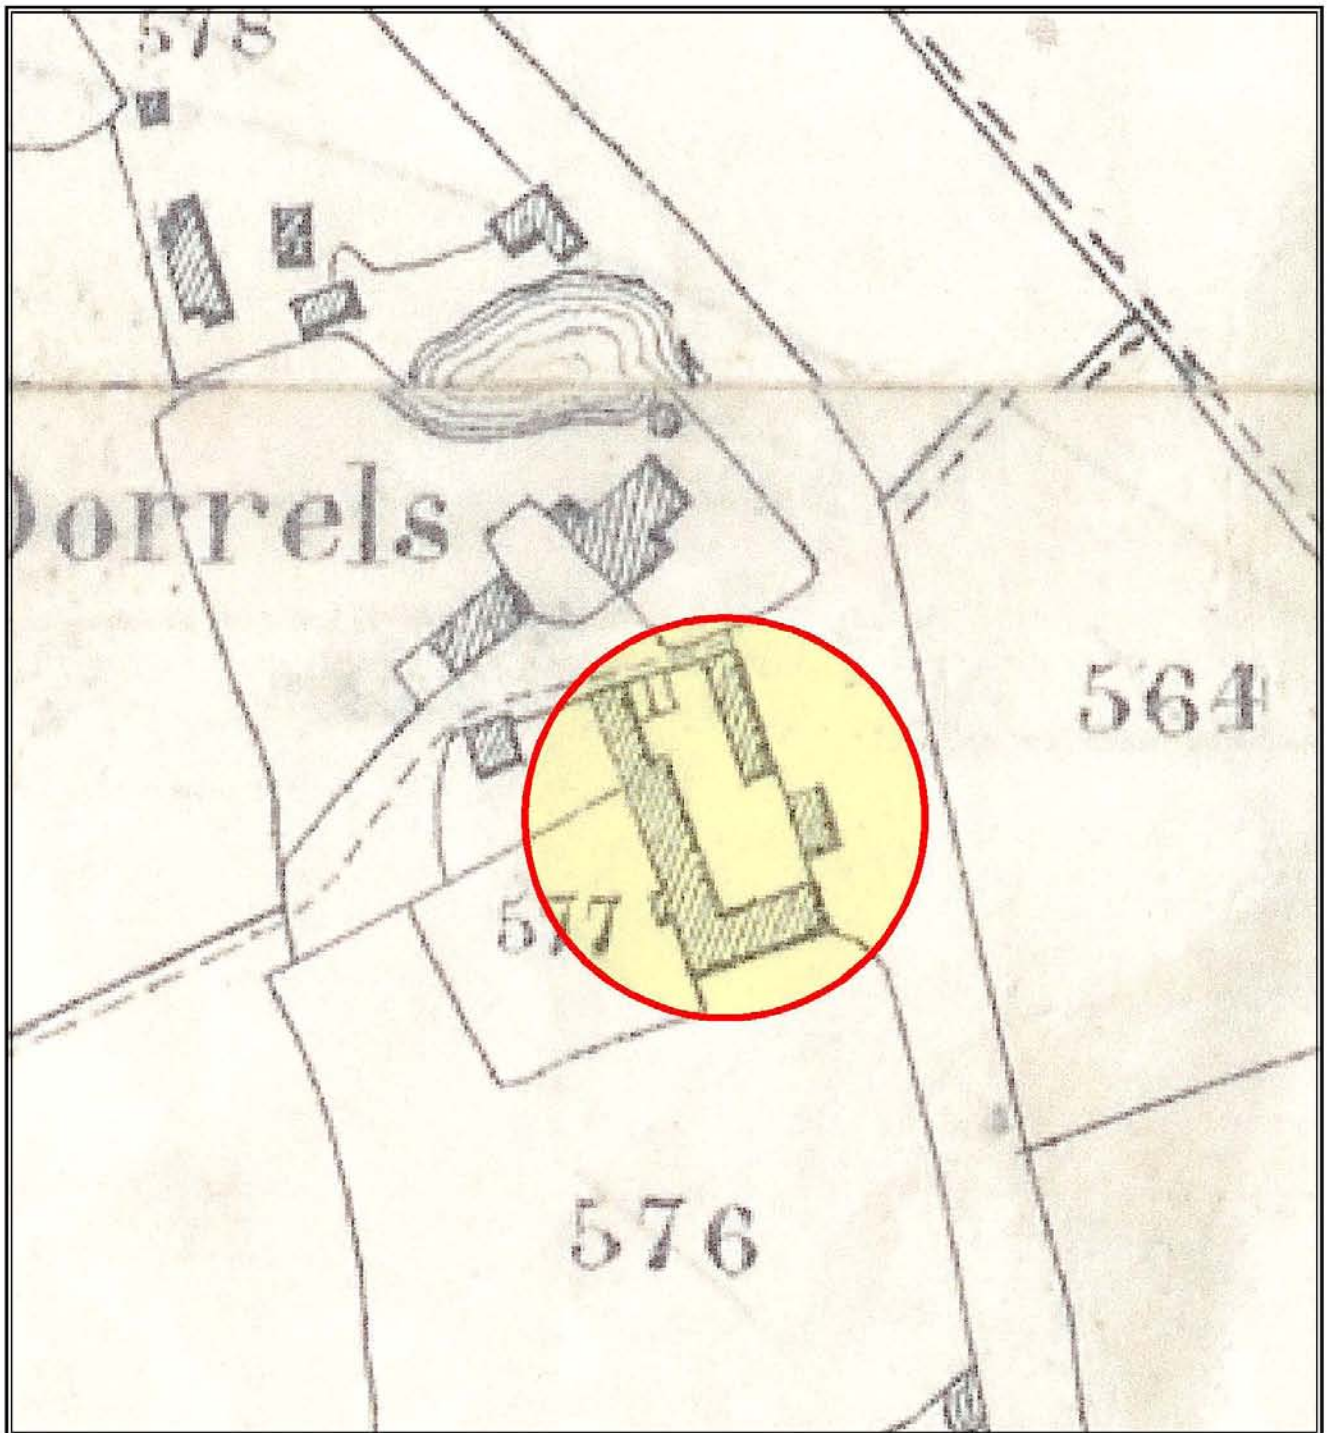
Figure 3: Extract from the Tithe Map of Chaddesley Corbett (1838)

The Tithe Map of 1838 shows the outline plan of buildings at Dorhall Farm, then known as Dorrells. The development site is highlighted

The feature shown on the tithe map (Figure 3), which suggests that the buildings depicted are precursors of the current buildings rather than the buildings we see today, is the porch or outshot shown on the western side of the plan. There is no indication on the ground that such a structure stood against, or was incorporated within the standing buildings, indicating that they are not the same buildings. It is likely that the timber-framed barn was part of a larger timber framed (and possibly sandstone) range on this side.

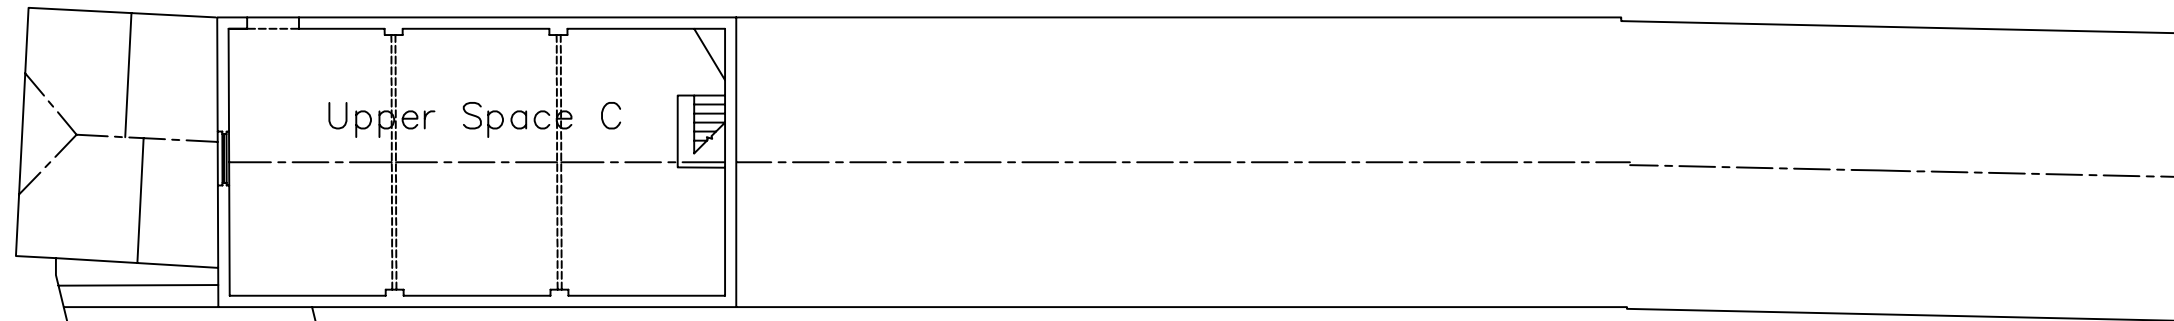
Figure 5: Phase Plan of Buildings 2-6

- Late 16th –17th century
- pre 1838 (at base)
- circa 1840–50
- circa 1860–70
- circa late 19th–early 20th C
- circa late 19th–early 20th
- 20th C

The subject buildings have been divided into individual spaces for ease of description, although the spaces do not necessarily denote each is a separate building (see text below). The numbered spaces and buildings referred to are shown in Figure 5.

Based on the evidence collected we are able to suggest the phases and dates for the buildings at Dorhall Farm as shown in Figure 5.
