*Historic Building Recording at  
Stone House, Stone,  
Worcestershire*

*A report for Mr John Broadhurst*

July 2008

**Project: PJ 215**

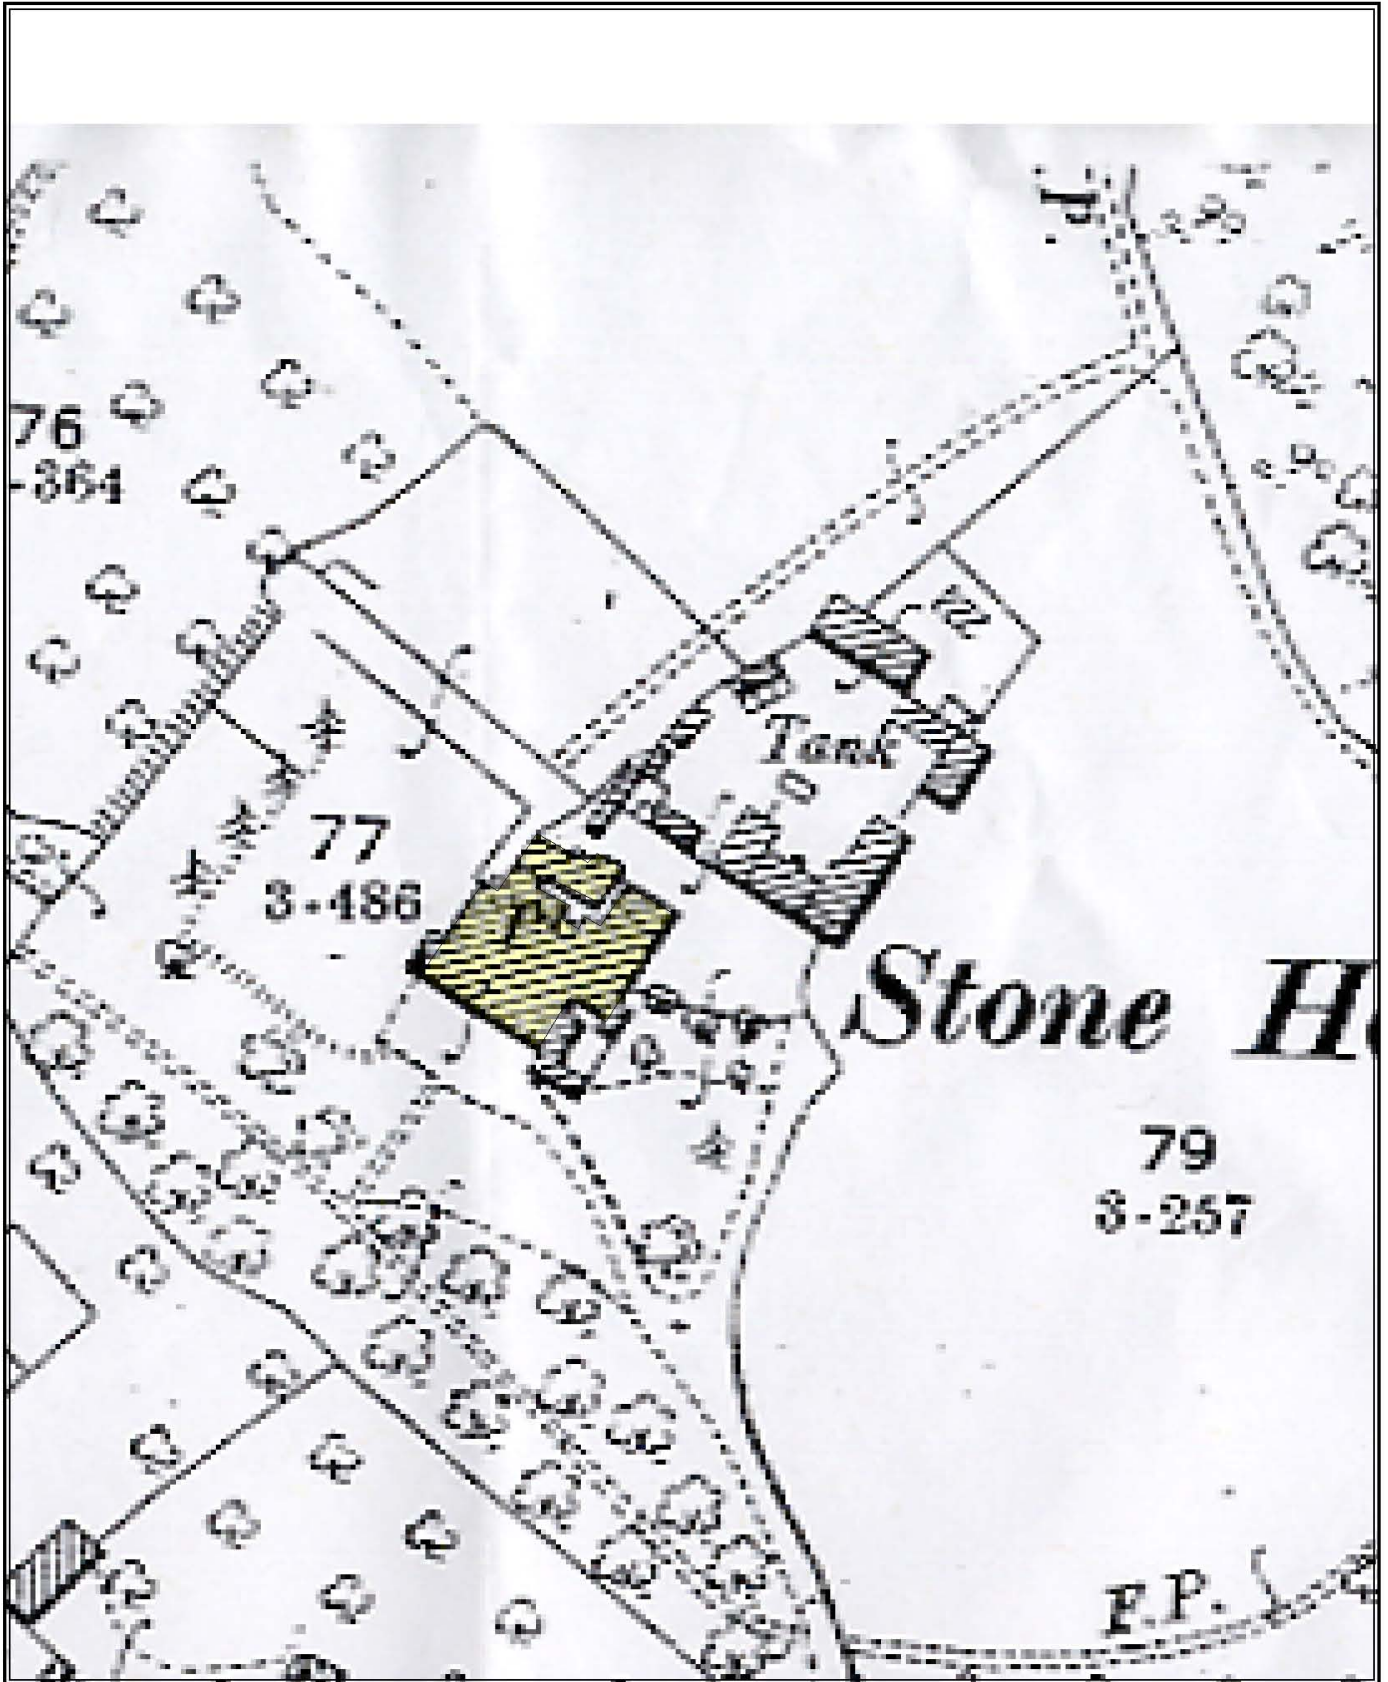
Figure 4: Ordnance Survey 2nd Edition (1902)

The 1902 Ordnance Survey map showing Stone House (main building highlighted) and the stable block to the rear

The development of the site between 1884 and 1903, when the 2<sup>nd</sup> edition Ordnance Survey map was produced, is difficult to accurately determine, as the map does not differentiate between different elements of the build such as the main house and external lean-to structures and attached non-domestic buildings. However, it is clear that the building had been extended in the north-western corner, with the detached service block remodelled and now incorporated into a new rear service wing, with servants quarters above (Plate 15). It seems likely that at the same time the two-storey element at the north-western corner was raised to three stories and incorporated into a remodelled continuous western fenestration, with replaced windows and stringcourse to match the frontage; the present French windows at ground floor level are likely to be 1920's replacements. At this time the present kitchen was constructed between the service block and the rear of the building (Plates 16 and 17), infilling part of the former courtyard. The kitchen is reached via a lobby reached by steps down from the courtyard, which also contains the access to the main cellars. A corridor and paired doorways also lead from the corridor at the rear of the hall to the kitchen and service block. The rear corridor also appears to have been 'fashionably updated' at this time, with a series of ionic columns inserted along its length.
