***Watching Brief at
St Mary Magdalene's Church,
Himbleton, Worcestershire***

A report for Himbleton Parochial Church Council

May 2008

Project: PJ 211

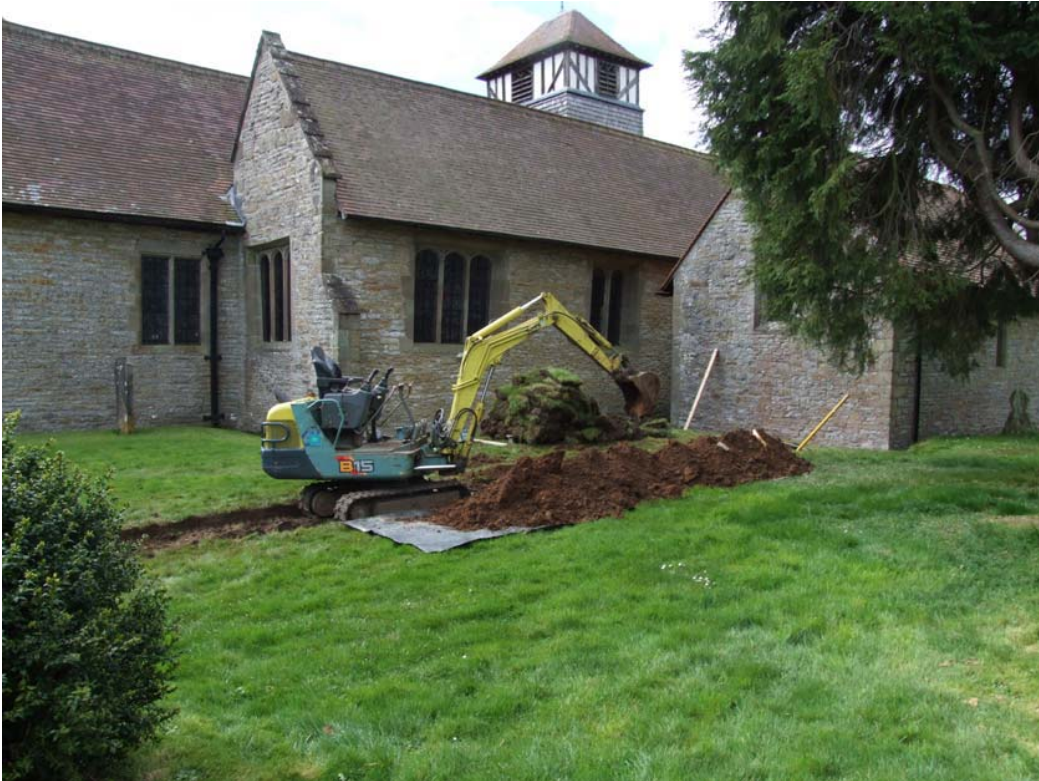
Plate 1: Work in progress, view to the south-west

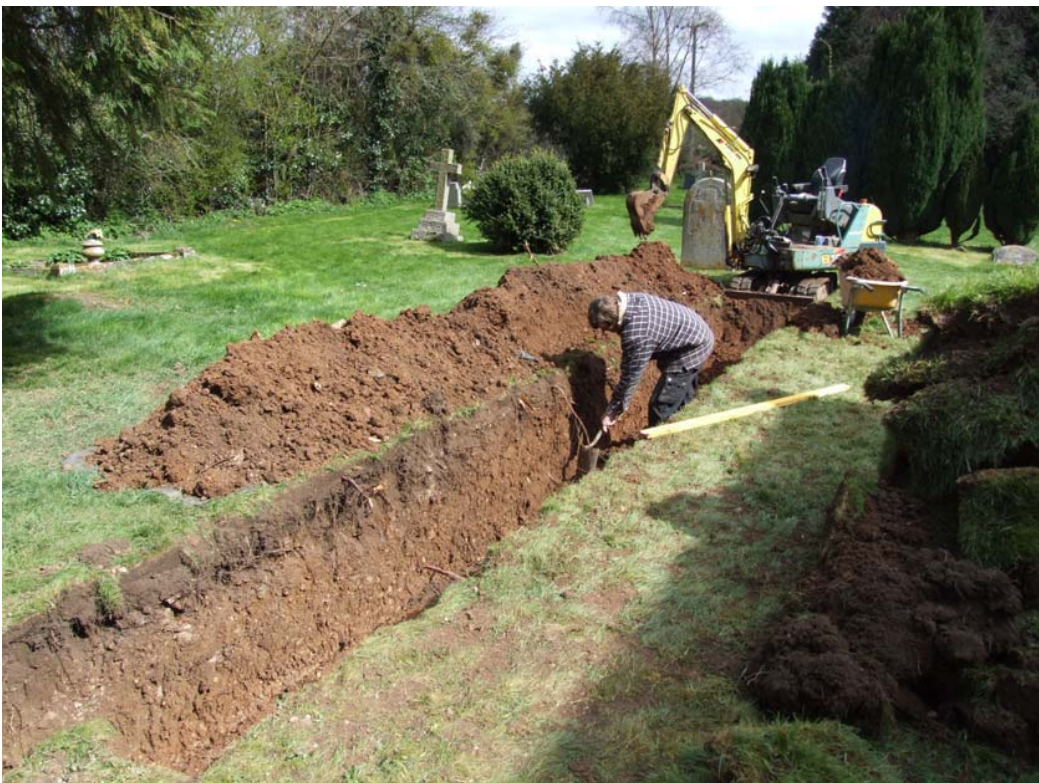
Outside the vestry, a trench arch drainage system was utilised to carry away foul drainage from the new WC. The trench for the system measured 10 metres long by just over a metre wide, with a maximum depth of 80-centimetres. The top 28-centimetres comprised turf and greyish-brown silty-clay topsoil, which contained a small percentage of small to medium sized round and sub-round stones [100]. The topsoil sealed a 50-centimetre thick homogenous layer of medium brown silty-clay, again containing roundish stones [101]. The undisturbed glacial deposits of orange and grey clay-marl and gravel [102] were observed below this level.

Plate 2: The trench during excavation, view to the north-east

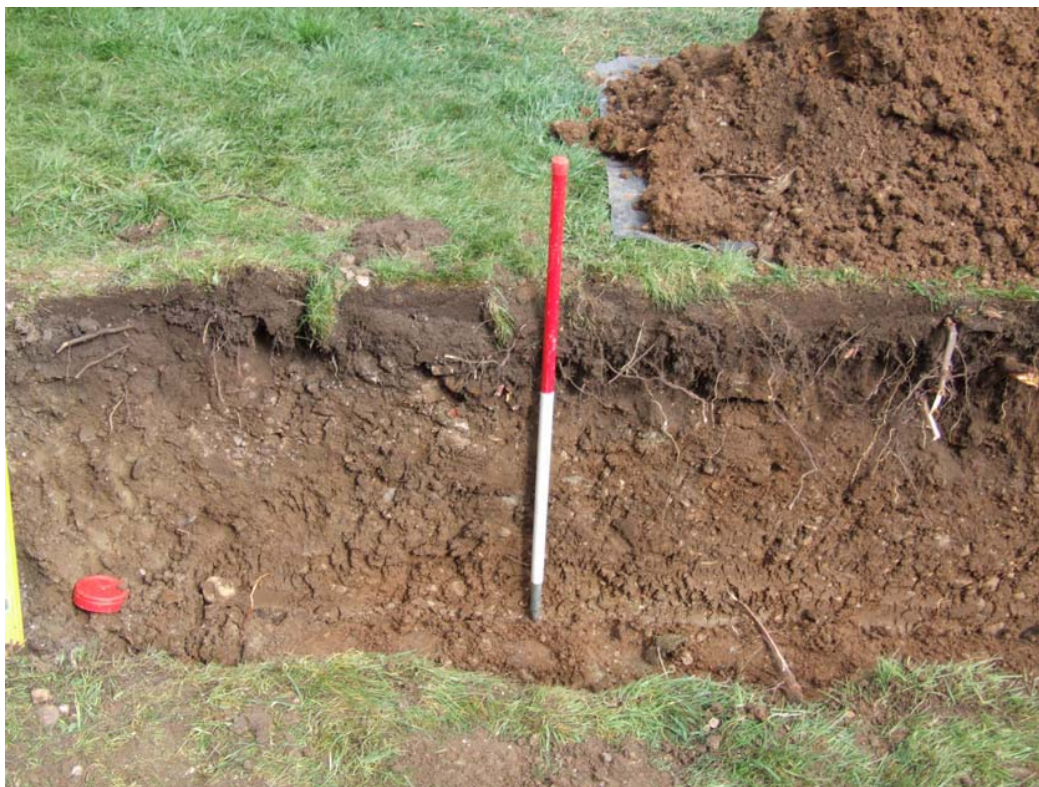
The sub-soil [101] did not appear disturbed, or well mixed and unusually for a graveyard soil, contained little redeposited human bone; one fragment of very degraded skull was identified towards the eastern end of the trench, together with a small patch of very degraded unrecognisable bone. There was no visible grave cut associated with this material, which was located around 60-centimetres below the surface, and it is assumed that the bone was from a previously disturbed burial.

Plate 3: the soil profile (Scale 1-metre)

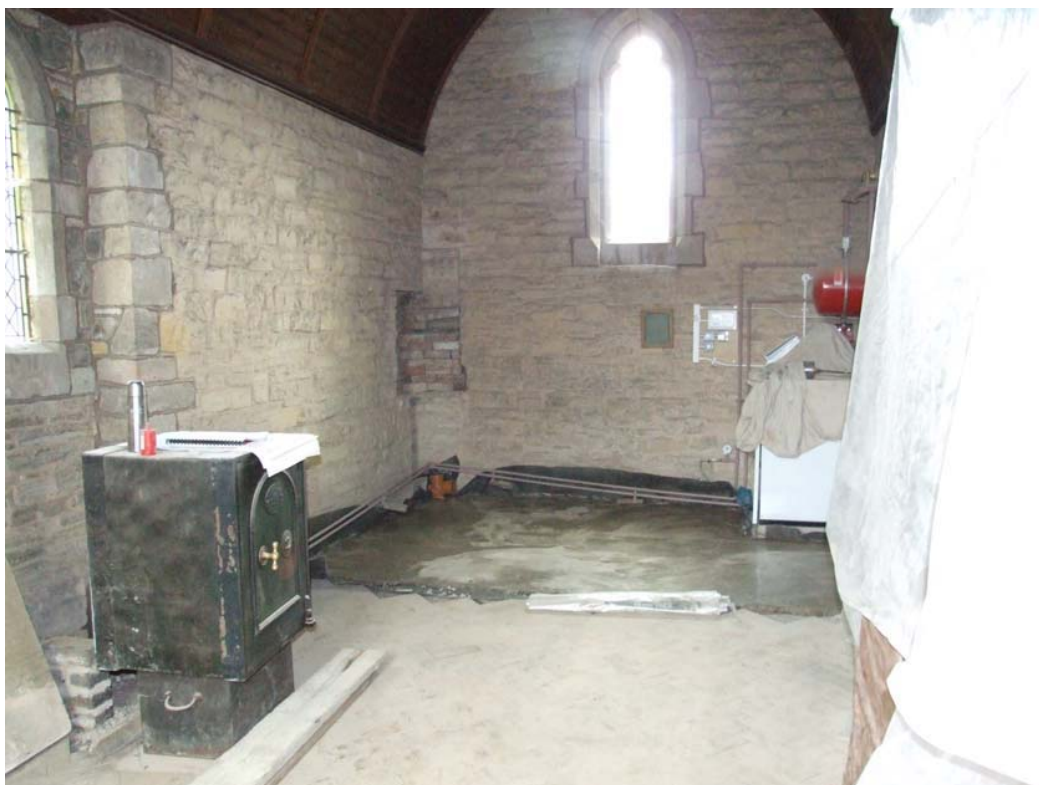
The wooden parquet floor inside the vestry was partially removed in order to accommodate the termination of the new service trench inside the building. The floor appeared to be original to the build and, therefore, dated from 1906. The block floor was set onto a concrete raft, which extended to around 16-centimetres below the floor level; only this layer was disturbed during the works and no archaeological features or deposits were observed.

Plate 4: Interior of the vestry following reinstatement of concrete floor raft
