*Historic Building Recording at
The Button Factory, Willow Road, Bromsgrove
Worcestershire*

A Historic Building Recording at The Button Factory, Willow Road, Bromsgrove, Worcestershire

A report for David Payne Homes Ltd

October 2003

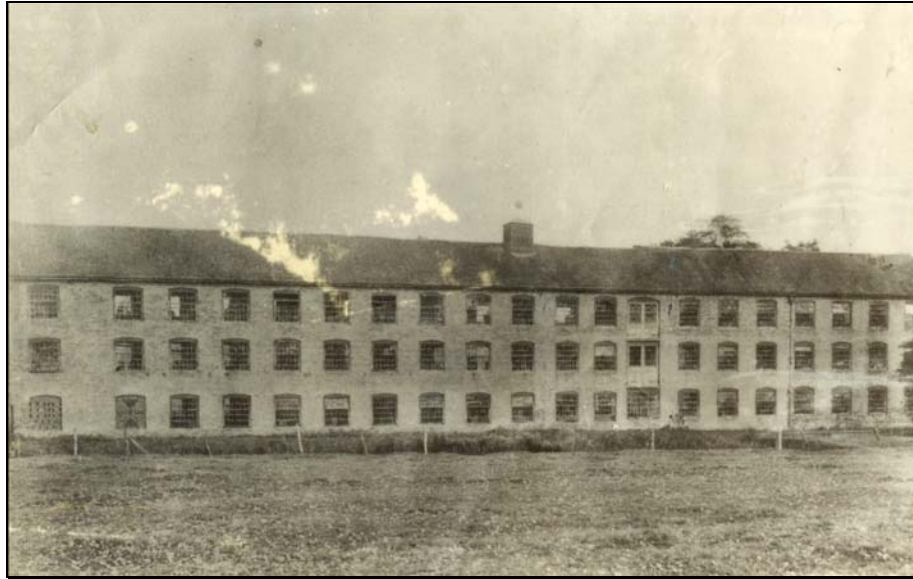
Plate 1

*Photograph of The Button Factory taken at the end of the 19th century
(Supplied by Mr E.Waldron)*

The mill was apparently extended in 1829 and by the 1830's employed around 300 people (Richards 1984, 99). The Tithe Apportionment Map of 1840 showed that by this time Benjamin Sanders owned a house and garden and factory on the site (Figure 2). The map shows a detached building just to the north, which may have been Sanders' house. He also owned much of the land surrounding the manufactory. A photograph dating from around 1890 shows the extent of the three-storey building by this date (Plate 1).

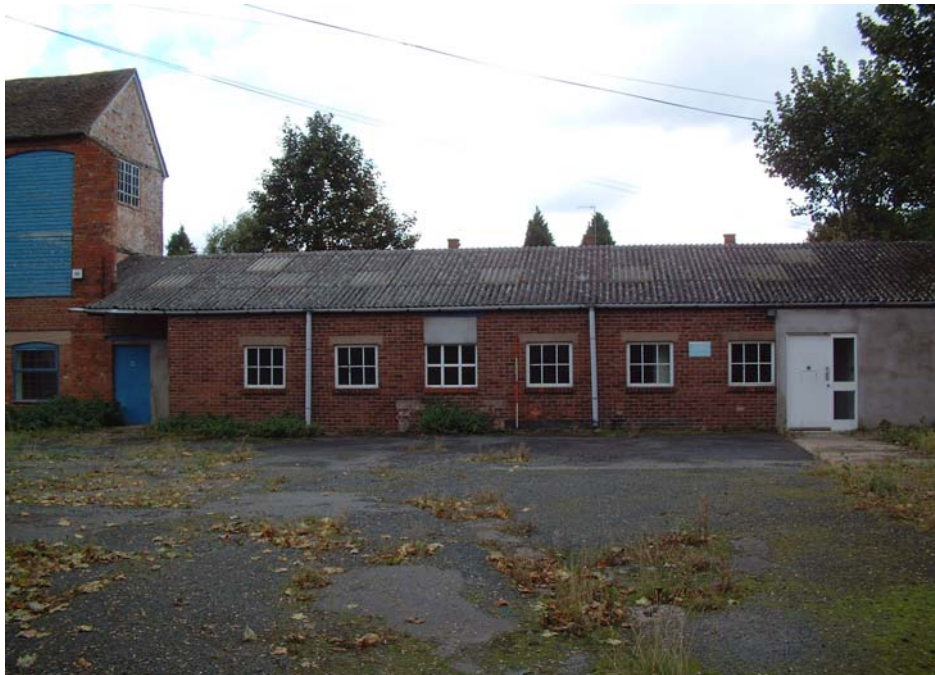
Plate 2

*The southern extension built in 1958 to replace the end of the building
destroyed by fire (Scale 2 metres)*

The building at the southern end of the complex was built in 1958 (Figure 7). It is a single storey construction of 9" brick walls with an asbestos apex roof. Stud partitioning divides the internal space. The building is generally in good condition (Plate 2).

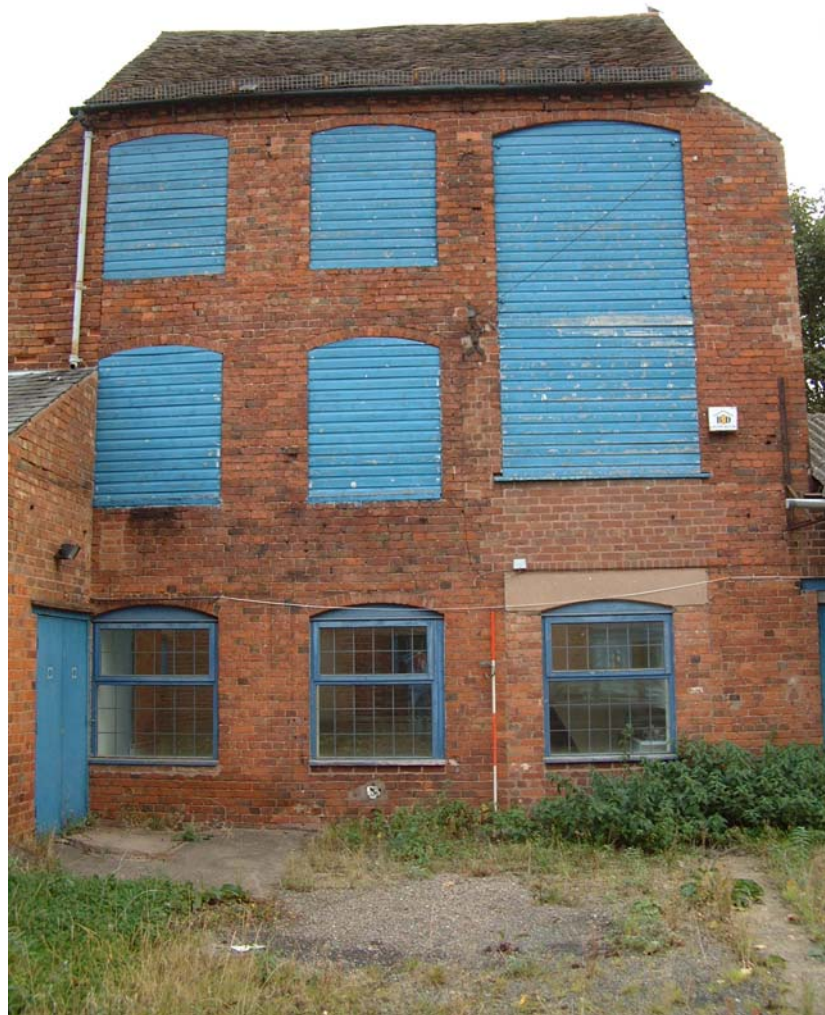
Plate 3

Western elevation of the former three-storey mill building (Scale 2 metres)

The three-storied central section of the complex (Figure 7) represents a single bay of the original 18th century mill building, the rest having been destroyed in two separate fires. All that remains of the original build are the western elevation, which apart from minor alterations to the loading bay section remains generally intact; the opposite eastern side was significantly altered at ground floor level when a lean-to extension was added in the late 19th century (although much 20th century alteration has obscured the evidence); the former bay partition walls at the north and south also remain, their upper access apertures are now bricked up and a second floor window inserted at the southern end; the buttresses at the north and south ends were part of the original sidewalls, but have been strengthened by extra brick courses (Plate 3).

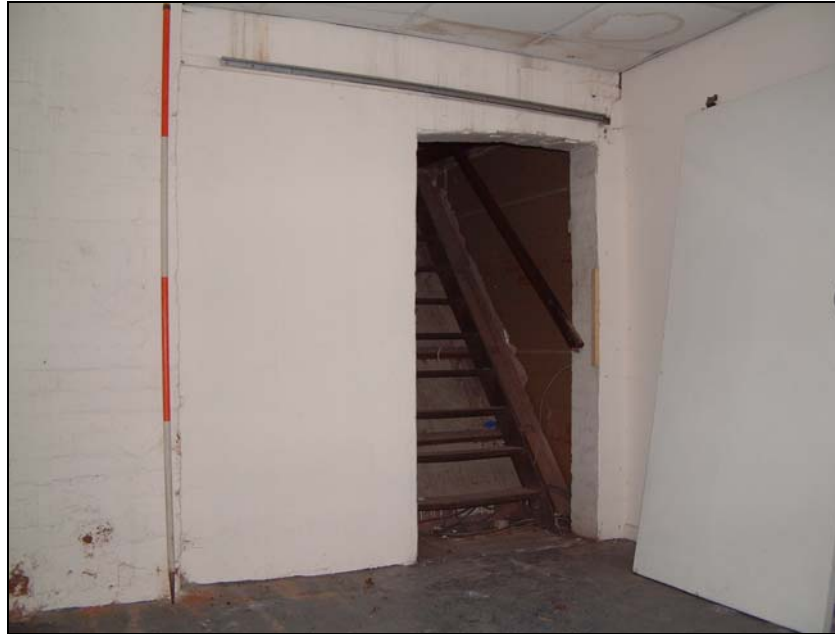
Plate 4

Staircase to first floor of the three-storey mill building. Note the central dividing wall has cut the arched lintel. This was originally an opening from one bay to another (Scale 2 metres)

The earliest windows are 30 light cast iron rectangular units below segmental arched heads. Most, however, have been replaced with wooden frames. At first and second floor levels on the western elevation there are pairs of loading doors, which are now boarded over. These would originally have opened to allow raw materials to be winched up from the ground below. There is a 12 light rectangular window on the upper floor eastern elevation indicating the possible position of a stairwell or landing. The building has been altered in this area and evidence of the original form is obscure. The existing staircase rises from an access through the original southern partition wall; the enclosing wall has cut the segmental arch above the access to the staircase (Plate 4).

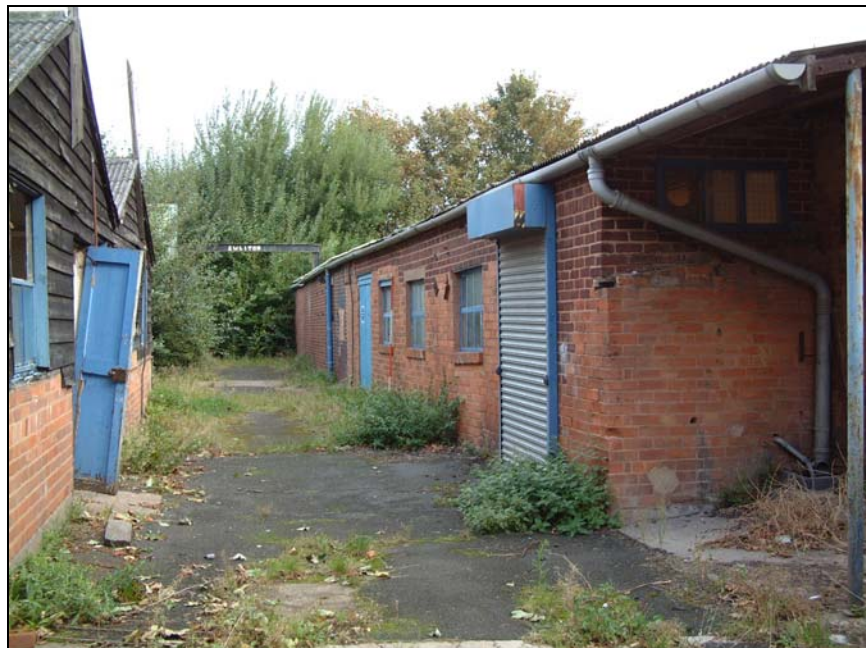
Plate 5

Lean-to building's obscuring the 1958 extension at the northern end

A single storey extension was added at the northern end to replace the parts of the mill building that collapsed after the fire of 1915 (Plates 5 and 8). The building is a rectangular brick structure with prefabricated steel roof trusses. The remaining original windows are large 24 light cast iron units with arched heads and there is a circular light in the apex at the northern gable end (Plate 9). Some window apertures have been bricked up. There are some remains of the power train bolted to the western wall (Plate 10).

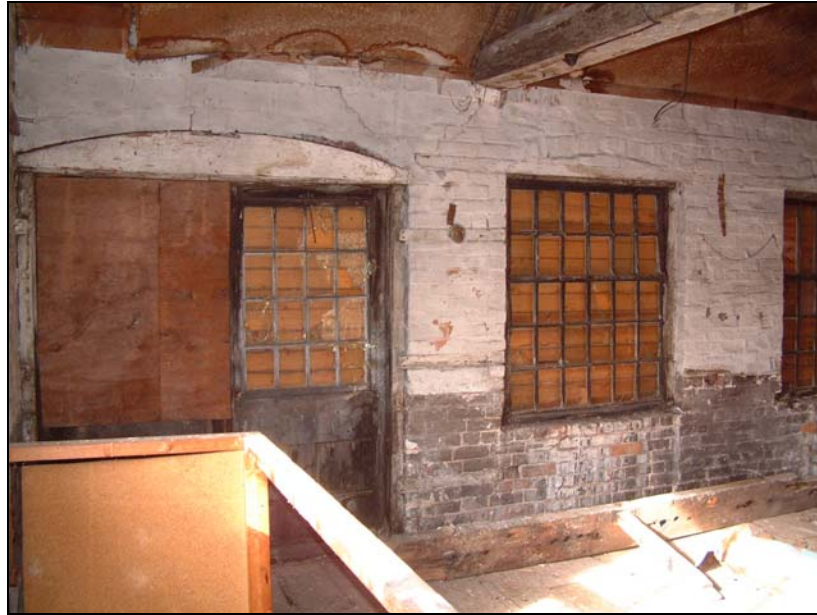
Plate 6

Upper floor of the three-storey build showing the loading doors

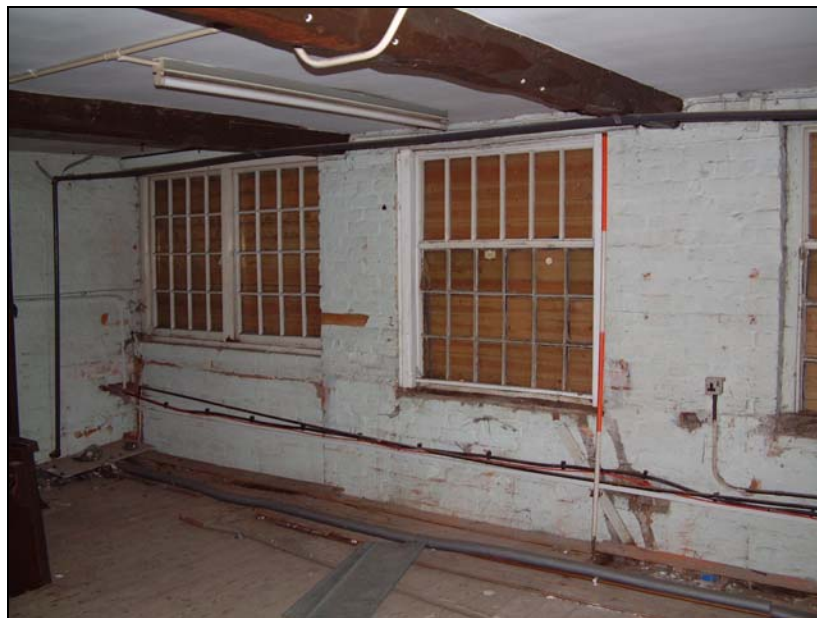
Plate 7

First floor of the three-storey section showing the former location of loading doors on the right, replaced by a later window (Scale 2 metres)

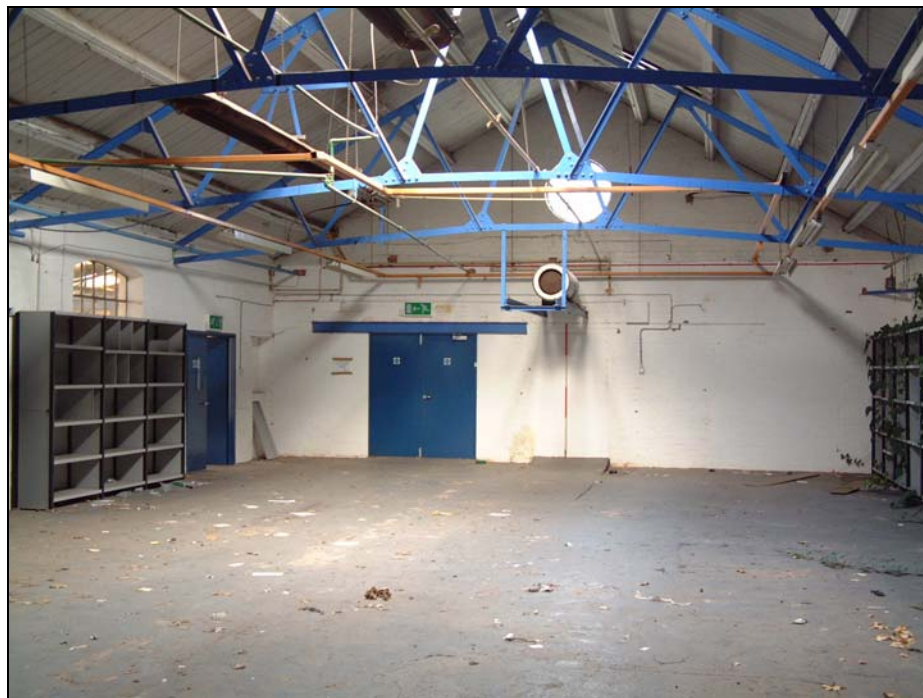
Plate 9

Replacement building erected after the 1915 fire (Scale 2 metres)

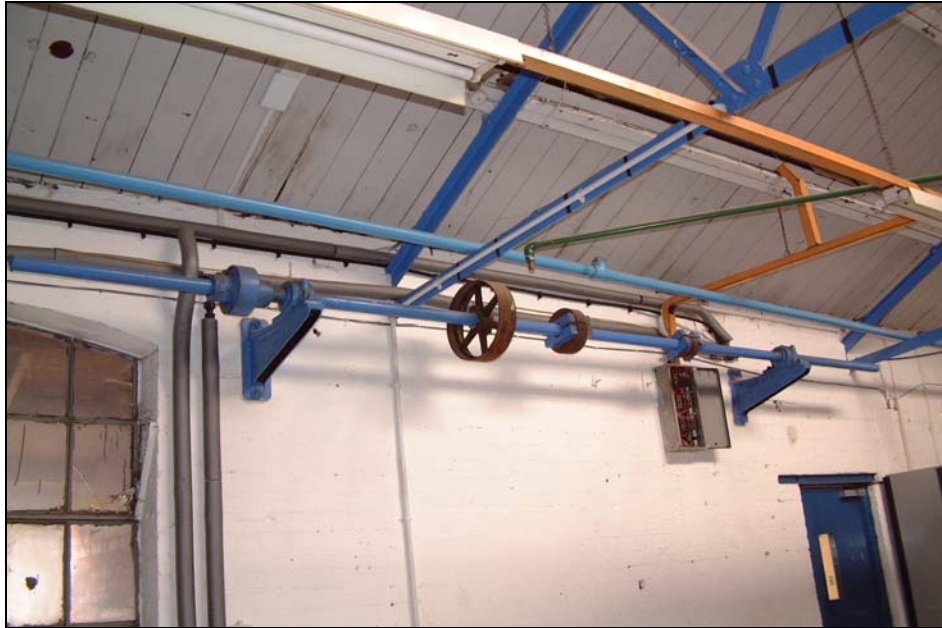
Plate 10

Flywheels and shaft of part of the factory power train in the northern building.

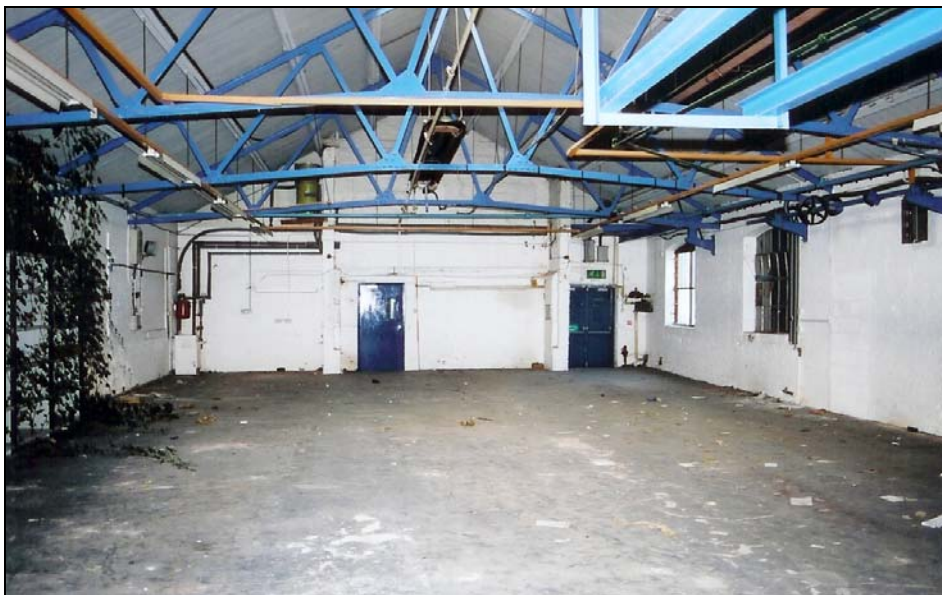
Plate 11

The northern end of the three-storey build where it is butted by the 1915 extension. The side walls of the original mill building project forward, adjacent to the blue doors

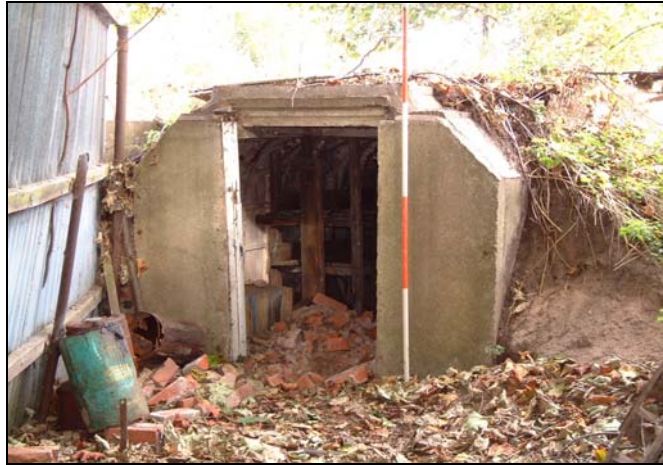
Plate 12

Entrance to air raid shelter (Scale 2 metres)

The air raid shelter stands in the north-west corner of the site (Plates 12 and 13). The floor of the shelter was not visible at the time of the survey, as there was a layer of heavy brick rubble inside, although the height of the structure is around 2 metres (Figure 9). The shelter is semi-sunk into the ground and still partly covered in earth, which would have been piled on immediately after construction in order to hide the shelter and to add a second dimension of protection against fall out from bomb damage.
