A Report for the Punch Pub Company

Project: PJ 123

WSM 33945

# 1. Project Background

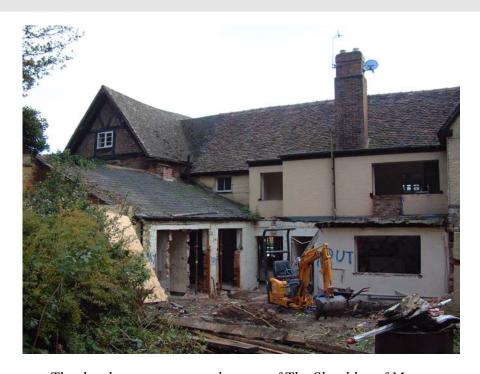
The watching brief was carried out at the rear of The Shoulder of Mutton following the progress of the ground workers.

The flagged patio area was lifted and hardcore and debris cleared prior to the foundation trenches being excavated.

The development area at the rear of The Shoulder of Mutton

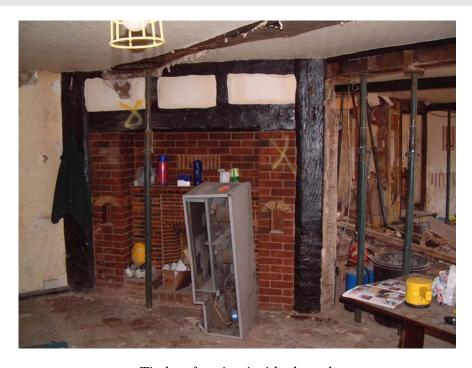
The present building is not listed, probably as the outside has been altered so much that it was missed during the listing processes. However, the structure contains much 17<sup>th</sup> century timber-framing and remains of early sandstone walls (Plate 3).

Timber-framing inside the pub

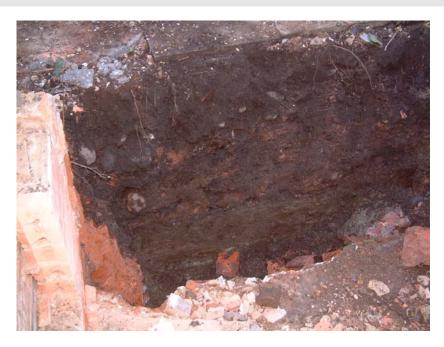
The foundation trenches were excavated by mini-digger to a maximum depth of around 1.50 metres below the flagged yard (ground level). The exposed profiles revealed a humic garden soil to a depth of around 0.30 metres [101]. This contained several large cobbles that are likely to have once formed part of a cobbled yard, probably for the stable yard at the rear of the former coaching inn. These would have been disturbed and moved during previous development on the site.

The garden soil sealed a buried soil layer, again very humic and dark brown in colour [104]; there were no cobbles in this layer. This deposit was around 0.35 metres thick and lay over a

disturbed layer [105] containing pockets of redeposited natural (parent material). The natural undisturbed and sterile parent material [106] was encountered at around 1.20 metres below the flagged patio surface. This was of a light to mid-grey clay-marl. The foundation trenches for the new extension cut into this material.

North-west facing section in the foundation trench for the new build See Figure 5)

The watching brief determined that there were no significant archaeological features within the area of trenching for the proposed development. The deposits however show evidence of two periods of heavy disturbance, although due to the lack of finds it is not possible to date these events. Layer [105] contained pockets of disturbed natural parent material indicating that there had been digging into the natural at sometime. There were no dateable finds to date the layer of disturbance, but it seems likely that this deposit dates from the 17<sup>th</sup> century when The Shoulder of Mutton was first built.

This was overlain by a layer of humic soil [104], typical of a garden plot soil. Again there were no dateable finds, but this layer was cut through during the mid 20<sup>th</sup> century extension work at the pub, indicating it was pre mid-20<sup>th</sup> century. The topsoil [101] and backfill of the mid-20<sup>th</sup> century foundation cut [102] contained large cobbles that must have originally been part of a cobbled yard. It is likely that these were part of the yard surface of the stable area at the rear of the pub and probably date from the original 17<sup>th</sup> century build. These may have been disturbed during the mid-20<sup>th</sup> century work at the pub, or possibly during much earlier works.

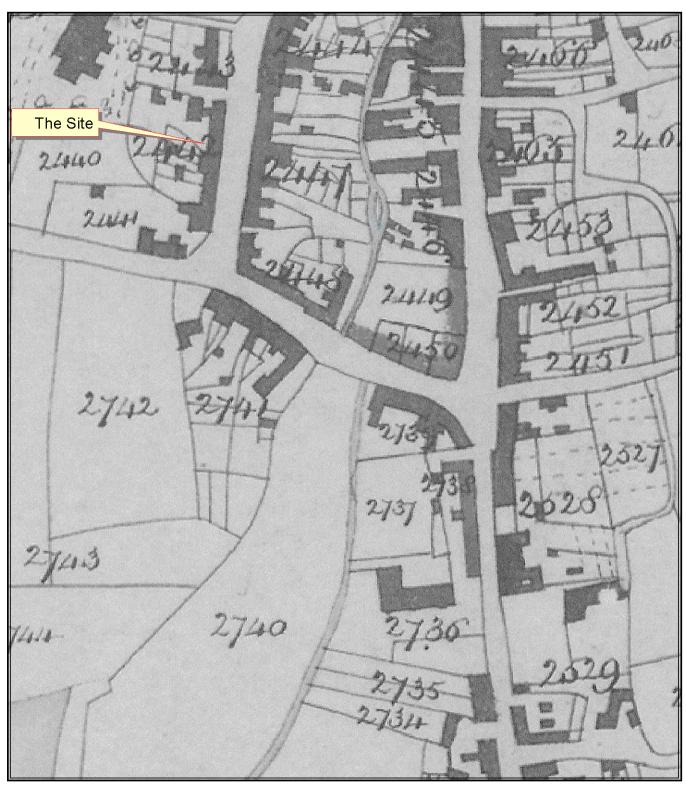
Figure 2: Extract from the Bromsgrove Tithe Map (1840)

The mid-19th century Tithe Apportionment Map for the Parish of Bromsgrove shows the development site to be within plot 2442 (see text).

The earliest available map of the area was the 1840 Tithe Apportionment Map of Bromsgrove WRO: x760/46. The map shows the St John Street frontage built up with the rear property boundaries bordering the churchyard of St John the Baptist (Figure 2). The tithe apportionment makes no reference to The Shoulder of Mutton or a public house within this block, instead the buildings within the whole block are listed as 'houses and yards owned by the proprietors of the houses of the town of Bromsgrove' (WRO: BA 1572, f760/45).

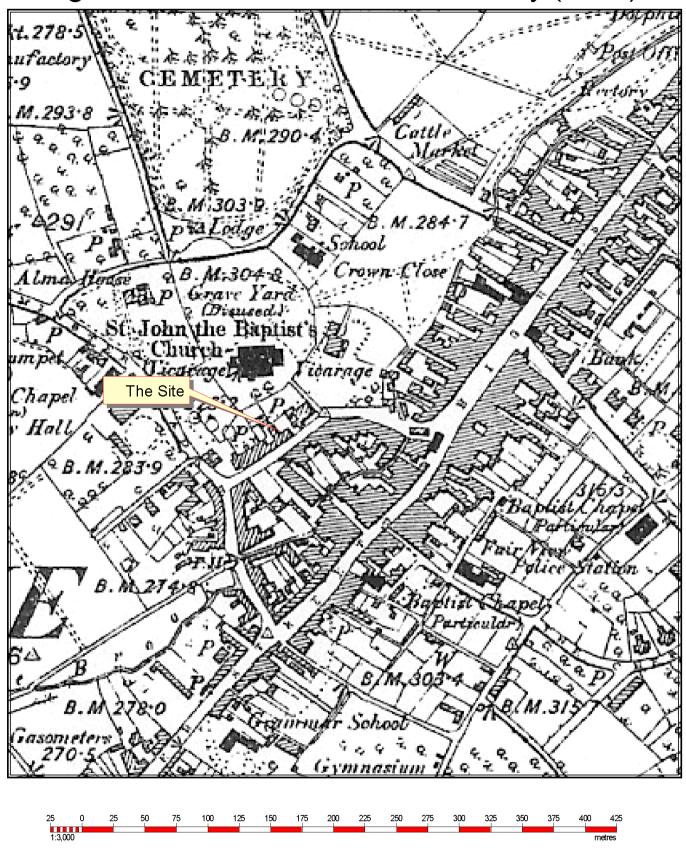
Figure 3: 1st edition Ordnance Survey (1883)

The first edition Ordnance Survey map shows the area on the north-western side of St John Street in similaruform as today.

Only the small-scale 6" to 1 mile 1<sup>st</sup> edition Ordnance Survey map of 1883 was available at the Worcester Records Office. This was limited in detail and of little use (Figure 3).

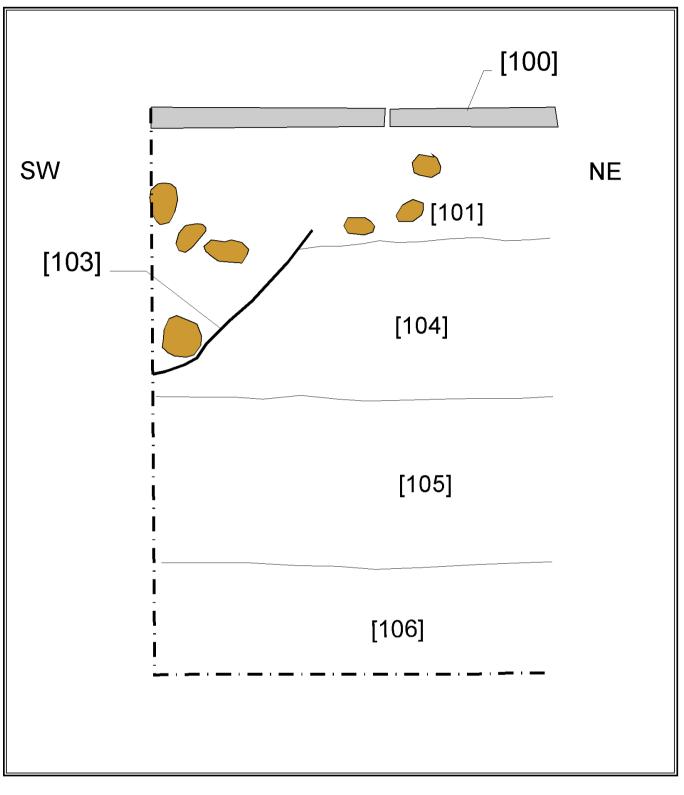
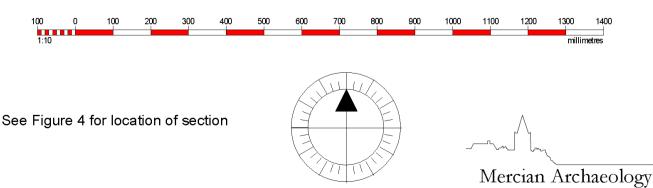
Figure 5: NW Facing Section in Foundation Trench

The garden soil had been cut through by the foundations of the 1960's-70's rear extension [103] to the pub, the backfill of the foundation trench [102] being indeterminable from the topsoil.
