*Historic Building Recording at Lower Bank Farm,  
Eastham, Worcestershire*

*Historic Building Recording of a  
Barn at Lower Bank Farm,  
Eastham, Worcestershire*

**Project: PJ 190**

**WSM 37309**

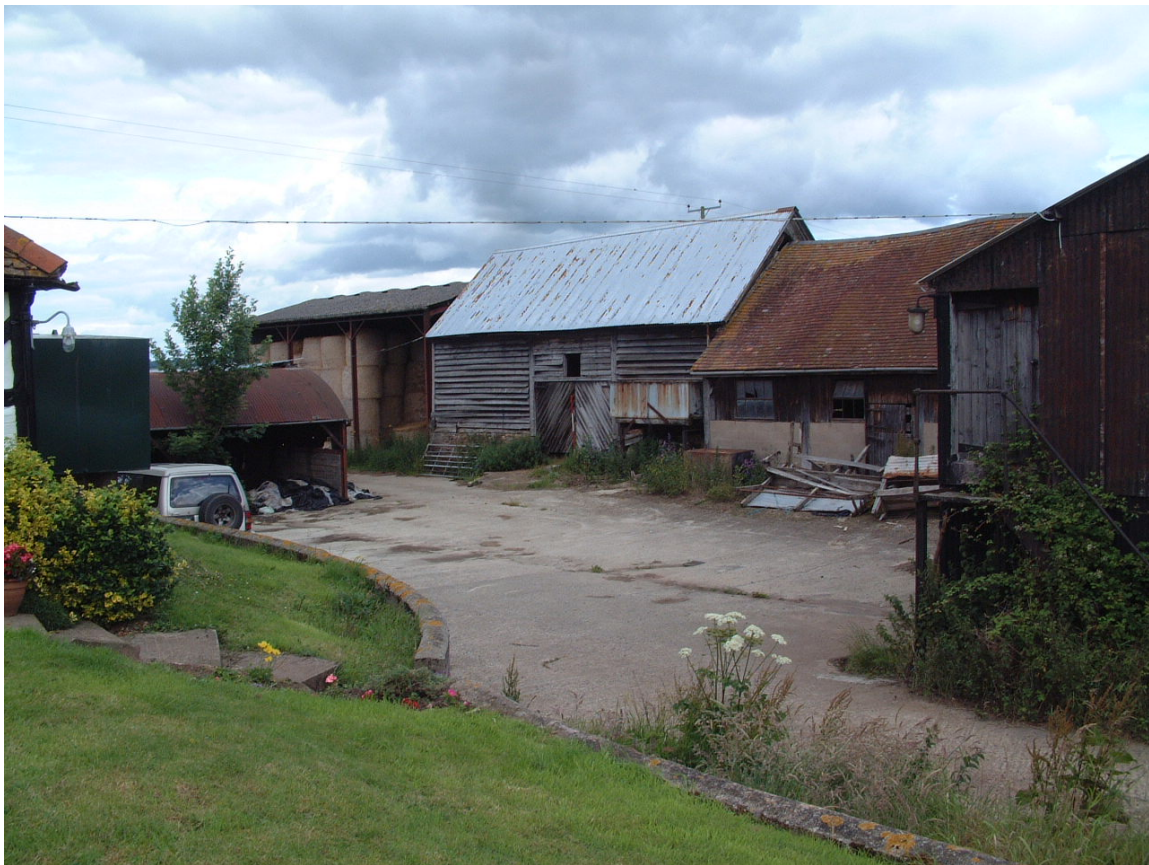
**Plate 1:** *Barn (centre) and shelter shed (right) looking north-west*

The barn is built on level land at the brow of a hill (glacial drumlin) with a slope to the south and west. There is a noticeable *holloway* running parallel with, and adjacent to the road on the east of the site. As it stands, the barn is a three bay timber-framed post and truss construction below a corrugated iron roof covering, with storage bays either side of a central cart bay, with full height cart doors to the field side to the north. The structure is clad externally in weatherboard. Generally, the barn is in good condition (Plates 1 -3).

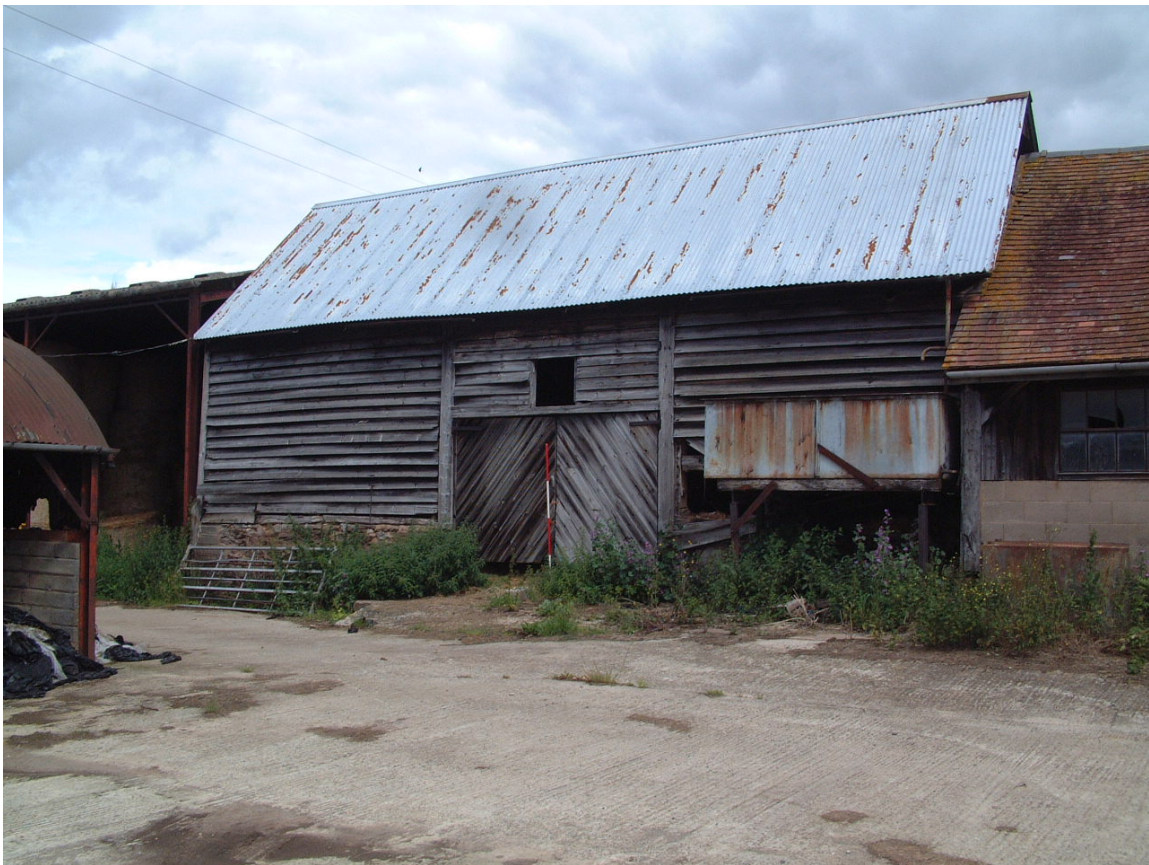
**Plate 3:** *The barn looking north-west (scale 2-metres)*

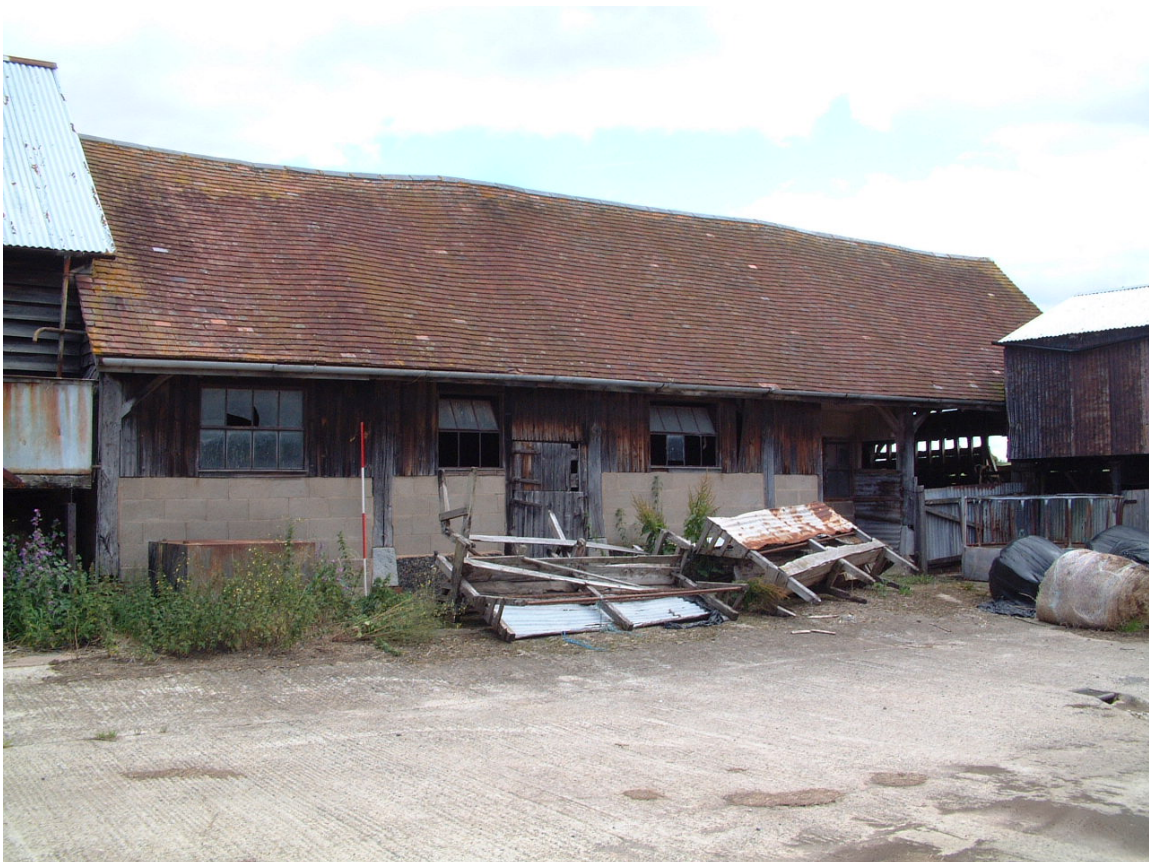
**Plate 4:** *The shelter shed looking north-east (scale 2-metres)*

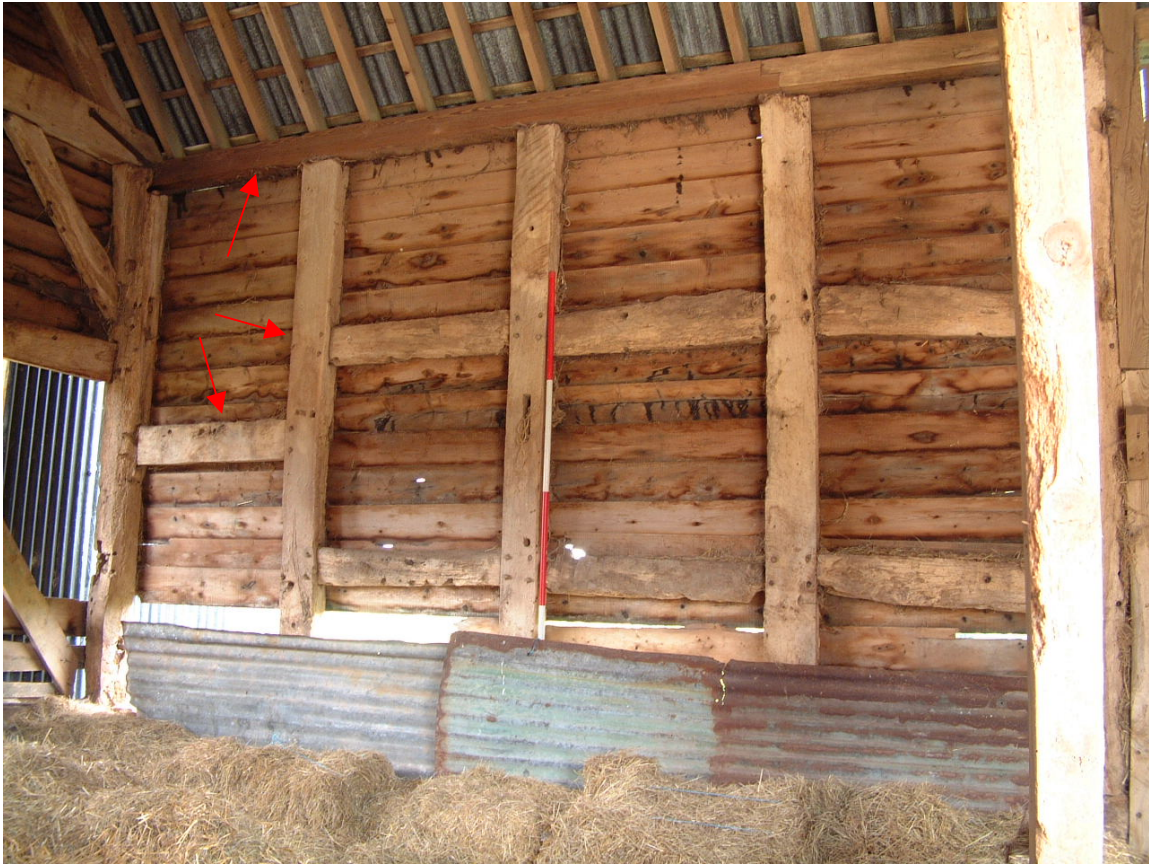
**Plate 5:** *General pattern of framing as viewed in bay 1 northern side. Timbers arrowed are later insertions, see Plate 6 (scale 2-metres)*

The barn framing employs three sill to wall-plate intermediate posts between each bay post, with rails between forming three rows of rectangular panels (Plate 5). The evidence suggests that this is the original pattern of framing. The majority of the timbers are original, which is unusual for an agricultural structure of such antiquity. However, there are inserted timbers (Plate 6) and evidence for alteration, which is further discussed below.

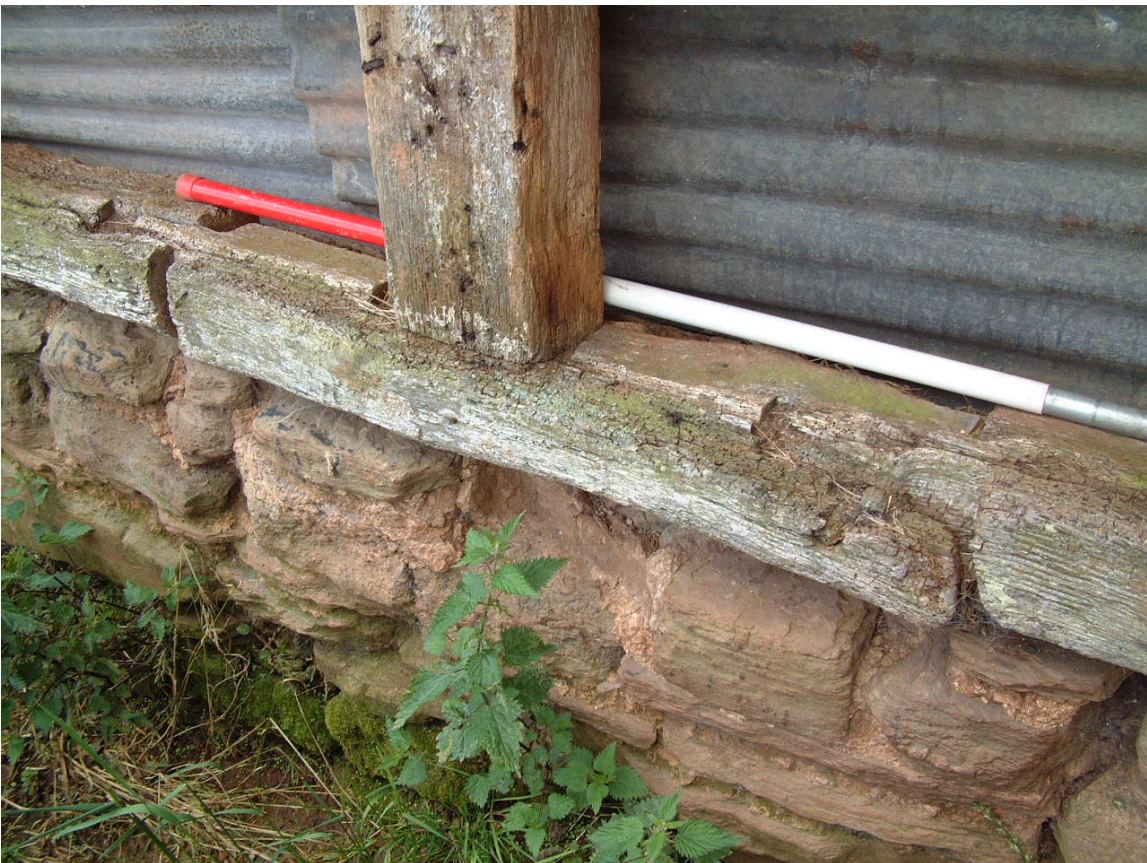
**Plate 6:** *Scarfed in sill section and inserted post; reverse side of Plate 5 (scale 1-metre)*

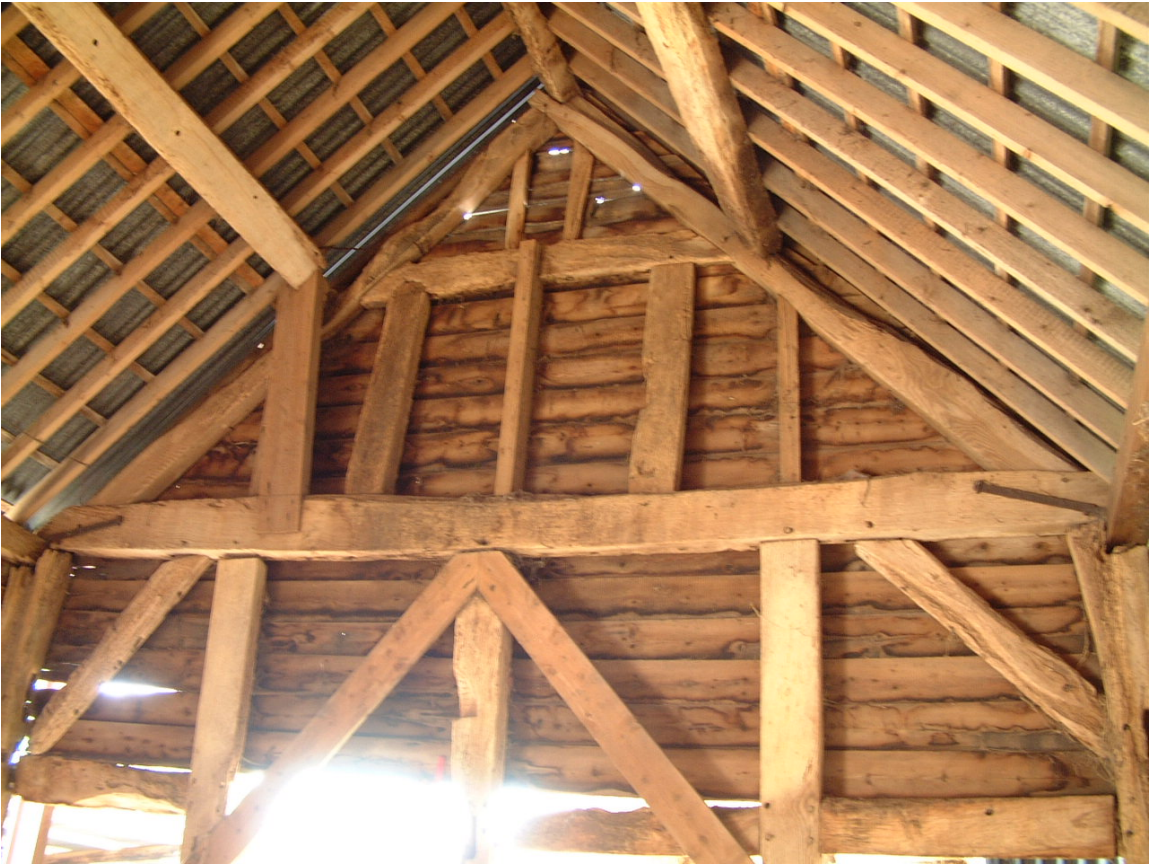
**Plate 7:** *Truss and frame T1 looking west*

The end frames (T1 and T4) have original trusses of tiebeam, twin queen-struts, collar and principal rafters, with each post braced to the tiebeam by short knee-brace (Plate 7). Empty mortises in the inner faces of the posts indicate that they were originally also braced to the wall plates. Long diagonal braces used to strengthen T1 are not original and probably date to Phase 2 alterations (see below). Trusses T2 and T3 both utilise a pair of raking queen-posts instead of the queen-struts as used in T1 and T4 (Plate 8). Though this combination is not unusual, there are indications to suggest that T2 and T3 maybe later modifications (see below). The timber-frame sits on a local stone rubble plinth wall. Cross frames at the cart bay (T2 and T3) are supported on plinth walls of 9” x 3” mass-produced brick and the sills and braces are not original to the build.

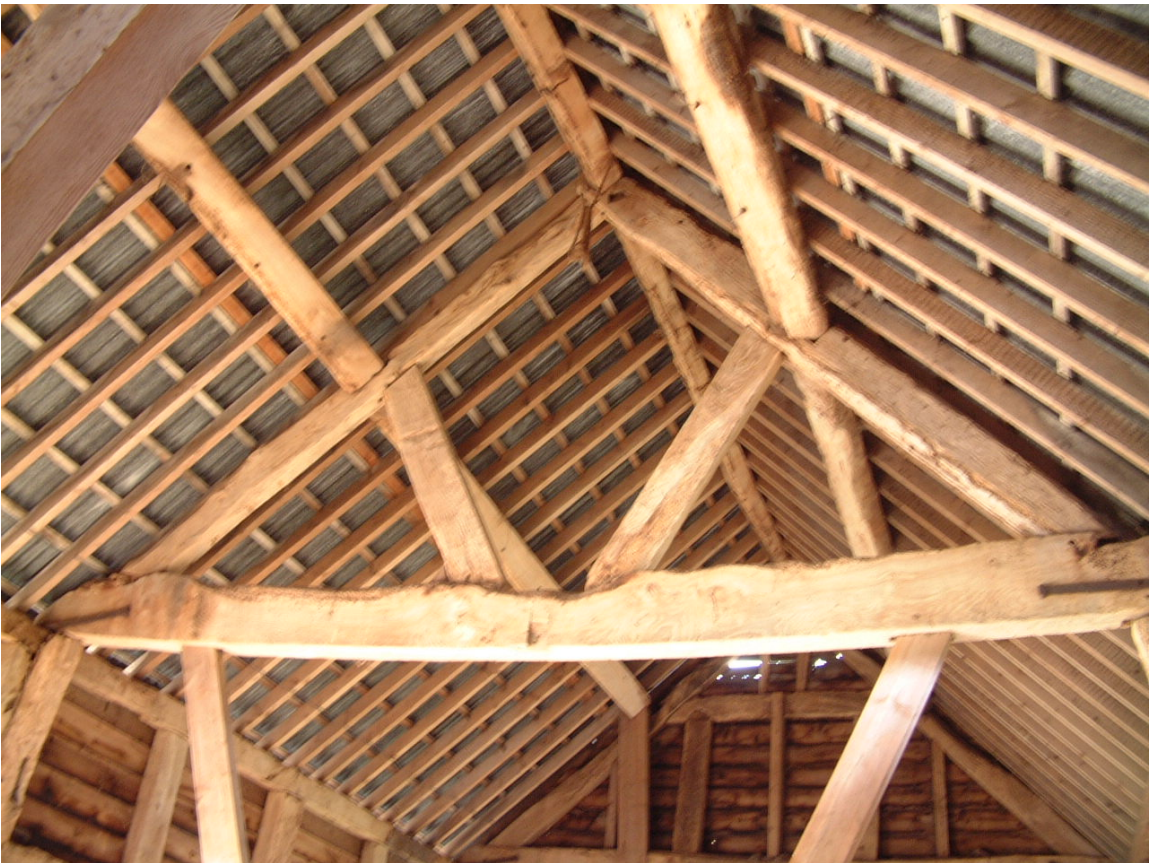
**Plate 8:** *Truss T2 looking west*

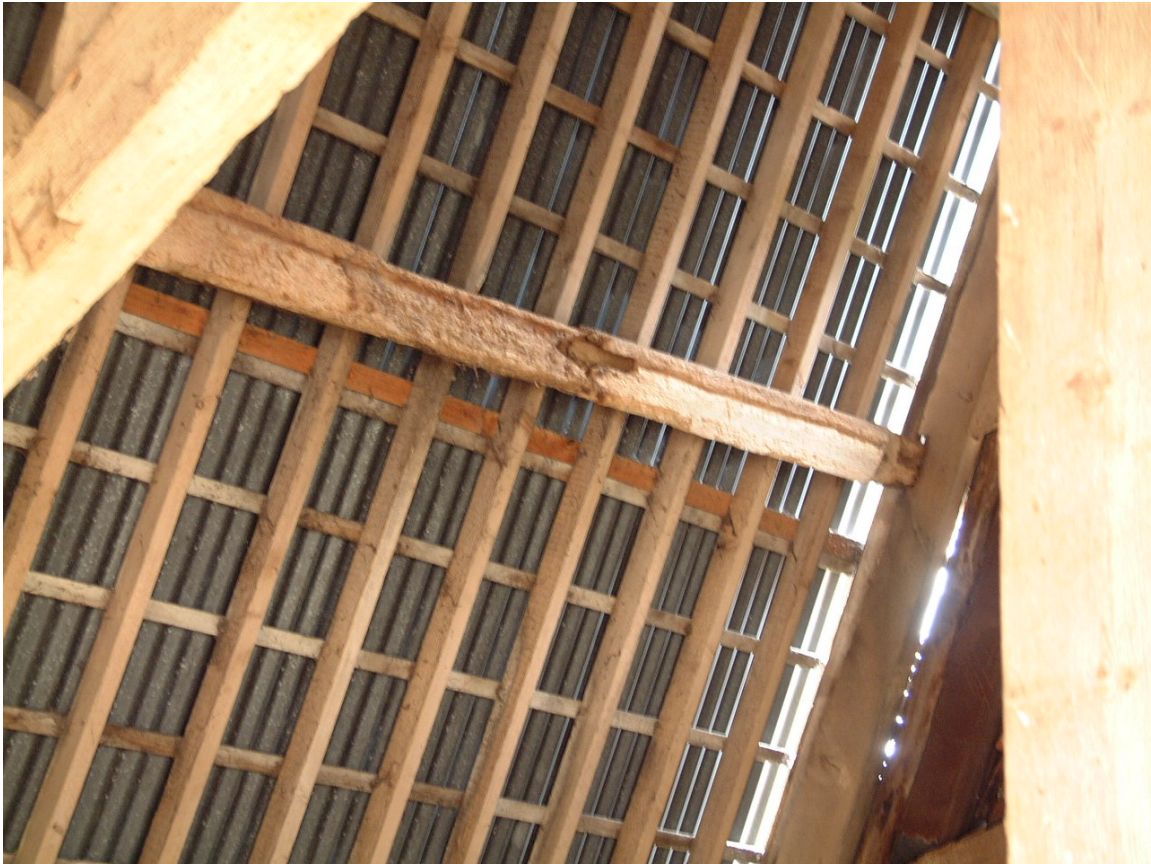
**Plate 9:** *North purlin in bay 3 showing evidence of reuse*

possible to say for definite if any of the purlins were original. The northern frame purlin of Bay 3 was clearly re-used, with an empty mortise and a groove to take the bottoms of staves for a wattle and daub panel (Plate 9), three other purlins had rafter peg holes and were possibly original (Plate 10).

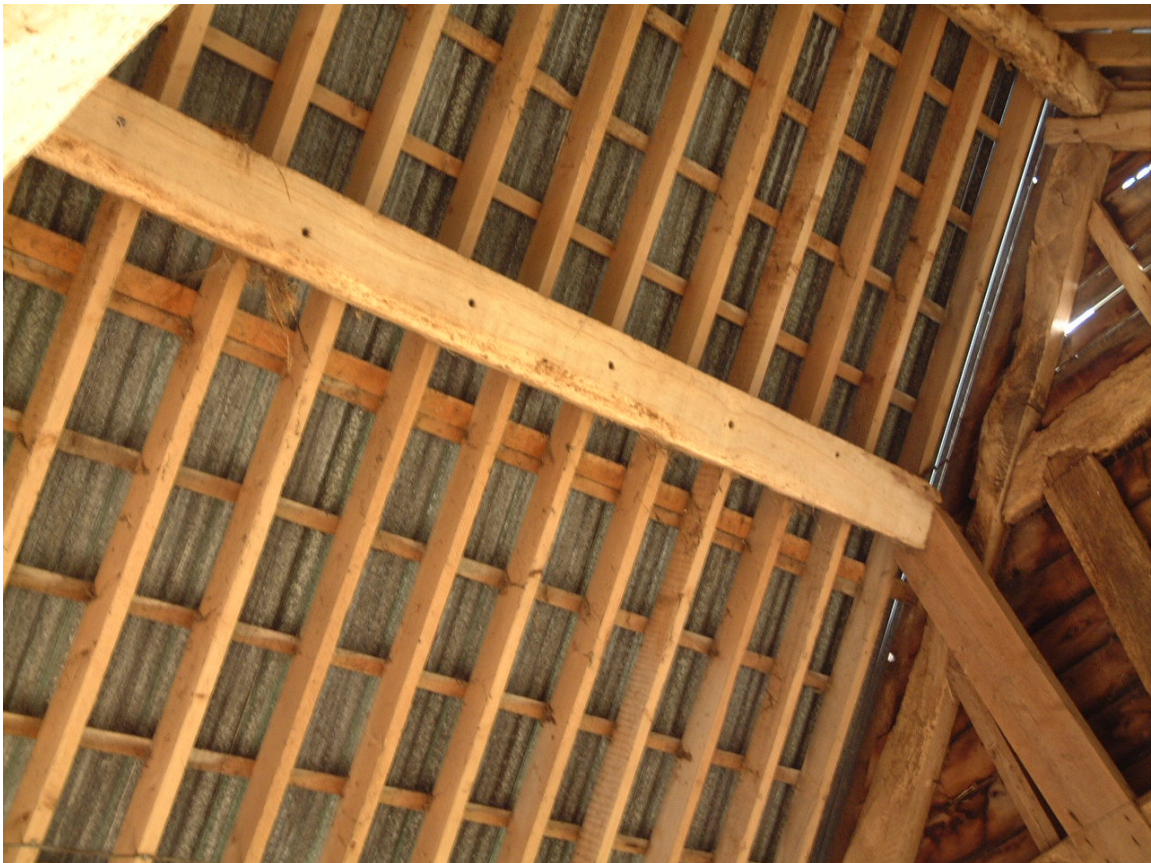
**Plate 10:** *Purlin in bay 1 south roof frame with empty rafter peg holes*

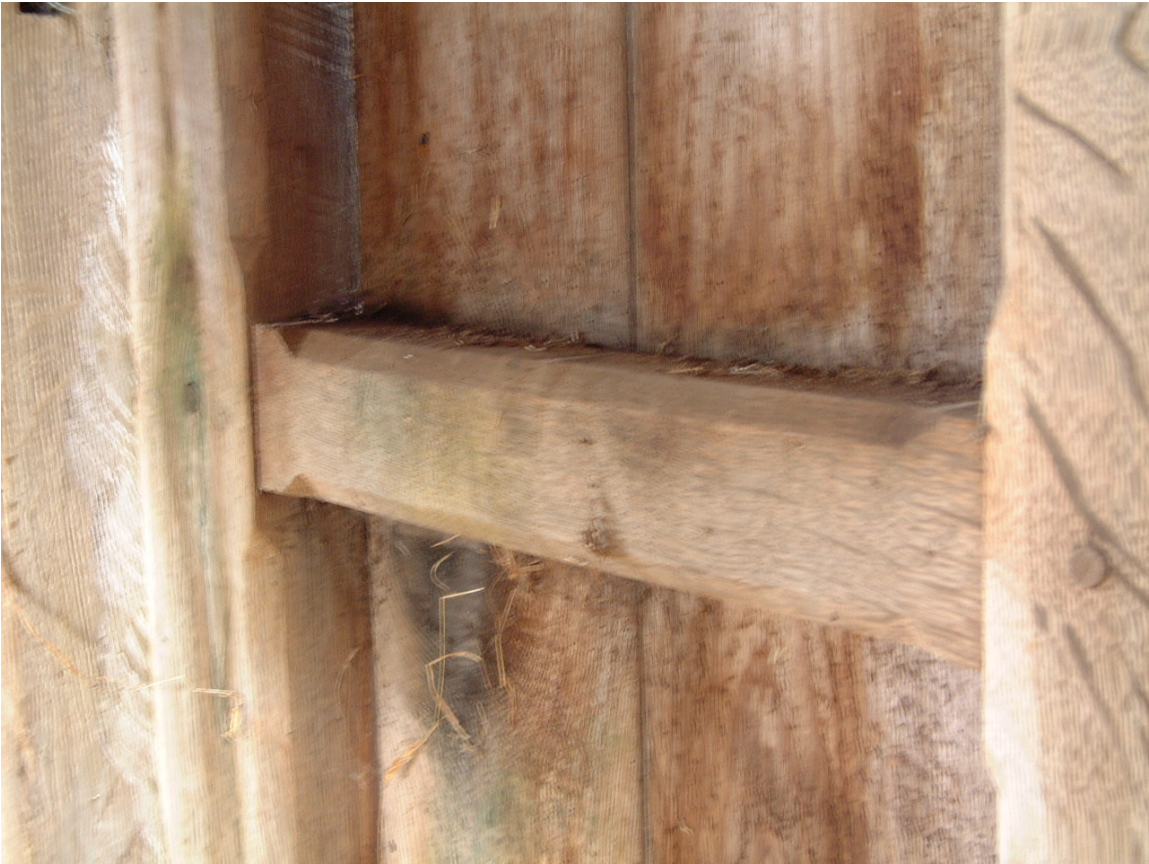
**Plate 11:** Northern cart door framing; style is similar to that used in shelter shed framing (see Plate 13)

The barn doors were clearly not original. The southern doors were set on posts fastened to the inner faces of the central frame posts and were fabricated from modern softwood. One of the northern doors was more interesting; its hardwood frame peg jointed, with chamfered and stopped braces in a similar style to the main timber members of the adjoining shelter shed (see below and Plate 11).

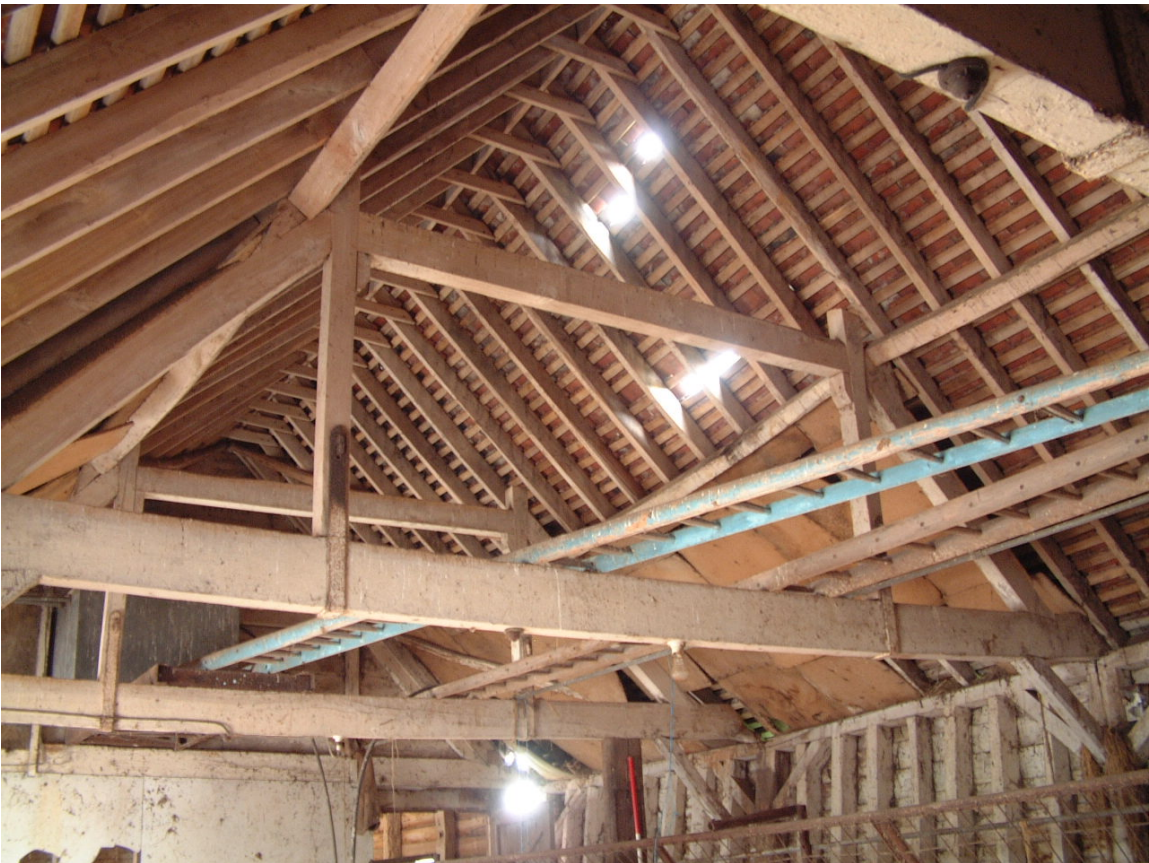
**Plate 12:** Truss style in shelter shed

The shelter shed abuts the eastern gable end of the barn, with a doorway between the two entering into a feeding passage along the rear of the shelter shed. The structure is wider than the barn, but has a lower pitched clay tile roof, which is supported above a series of mass-produced / machine-cut queen post roof trusses (Plate 12). These each comprised a pair of queen posts tenoned into the tie beam and tied with iron stirrup straps; the tops of the posts are angle cut around the purlins, which rest on cleats on the principals; the trusses are tied with straining beams at the top (collars).

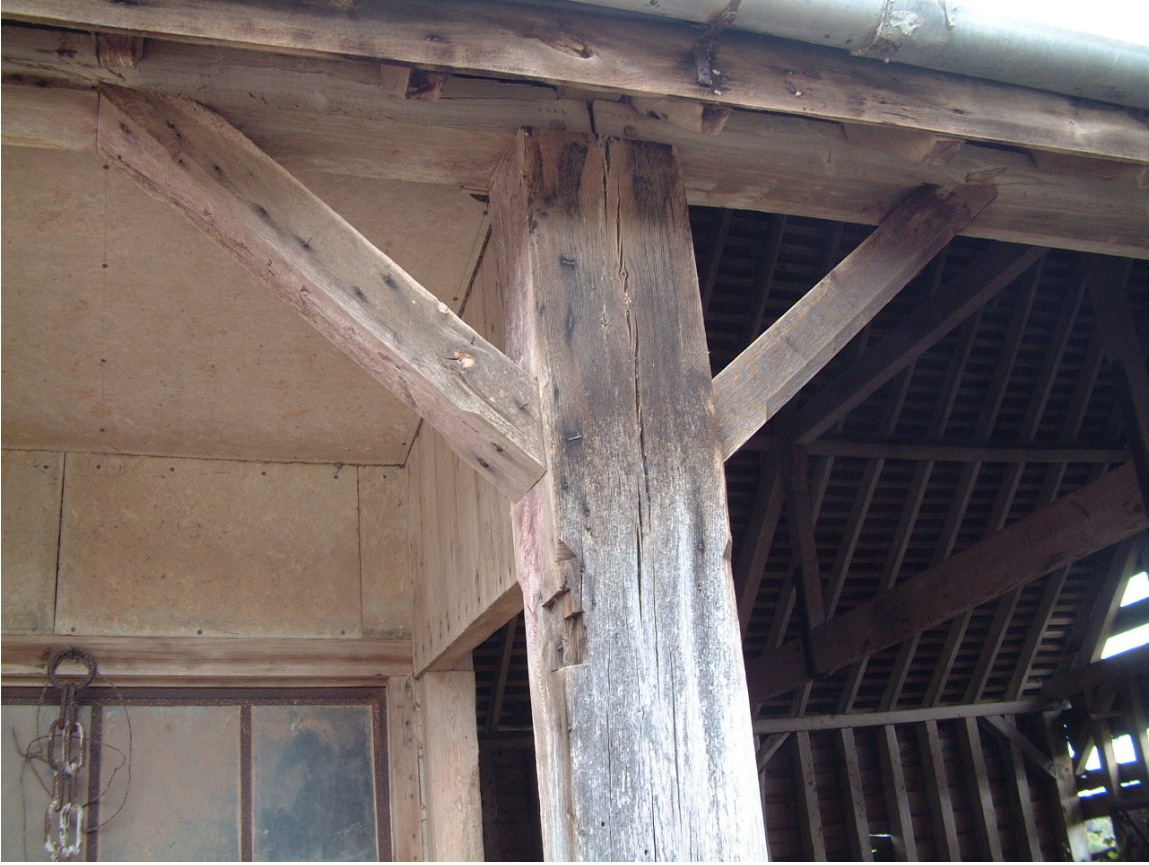
**Plate 13:** *Chamfered and stopped braces and post of the shelter shed*

The trusses are supported on a series of posts, which are braced to the tie beams and wallplates with short knee braces. These have all been chamfered and stopped (Plate 13), as have the posts. Nails are used to fix the braces in position, whilst the posts are pegged to the wall plates. The structure sits on a low brick plinth, with the front posts of the open side, set onto stone post pads. Close studding nailed between the posts and weatherboard cladding completes the structure (Plate 14).

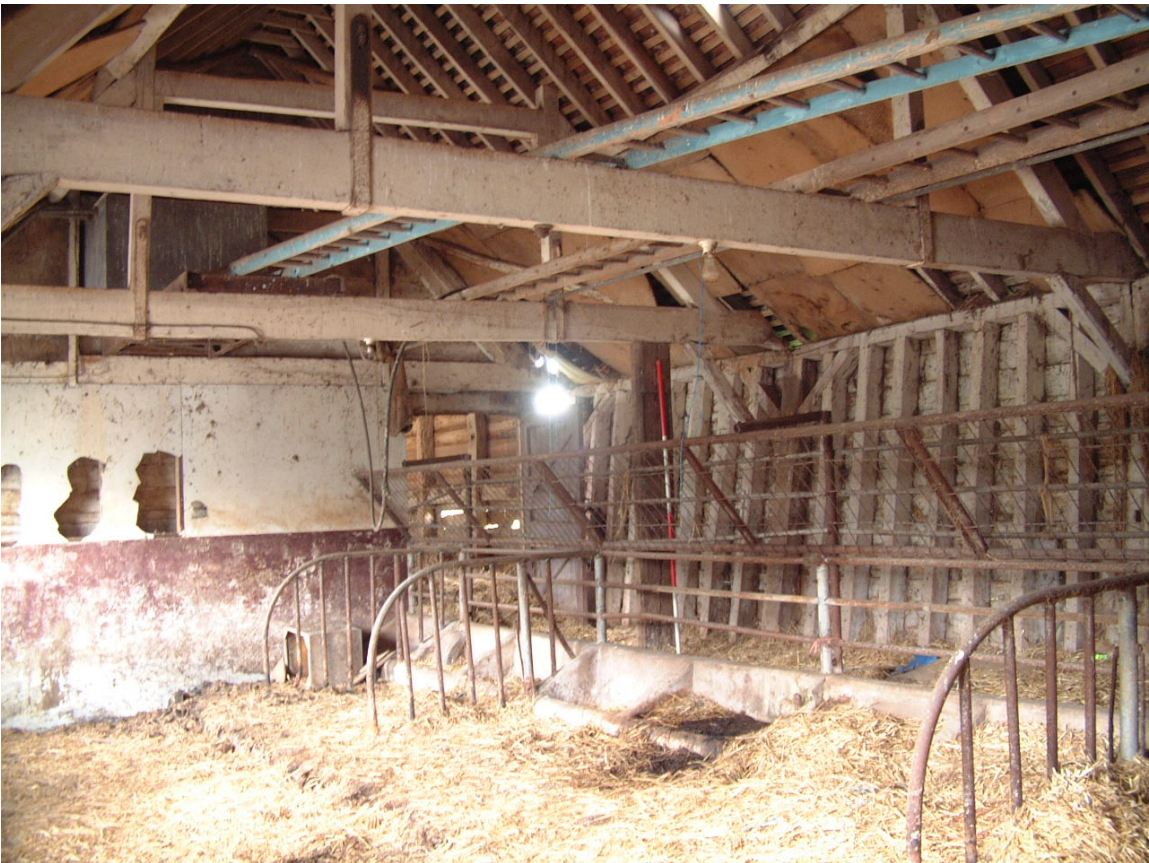
**Plate 14:** *Inside the shelter shed looking north-west (scale 2-metres)*

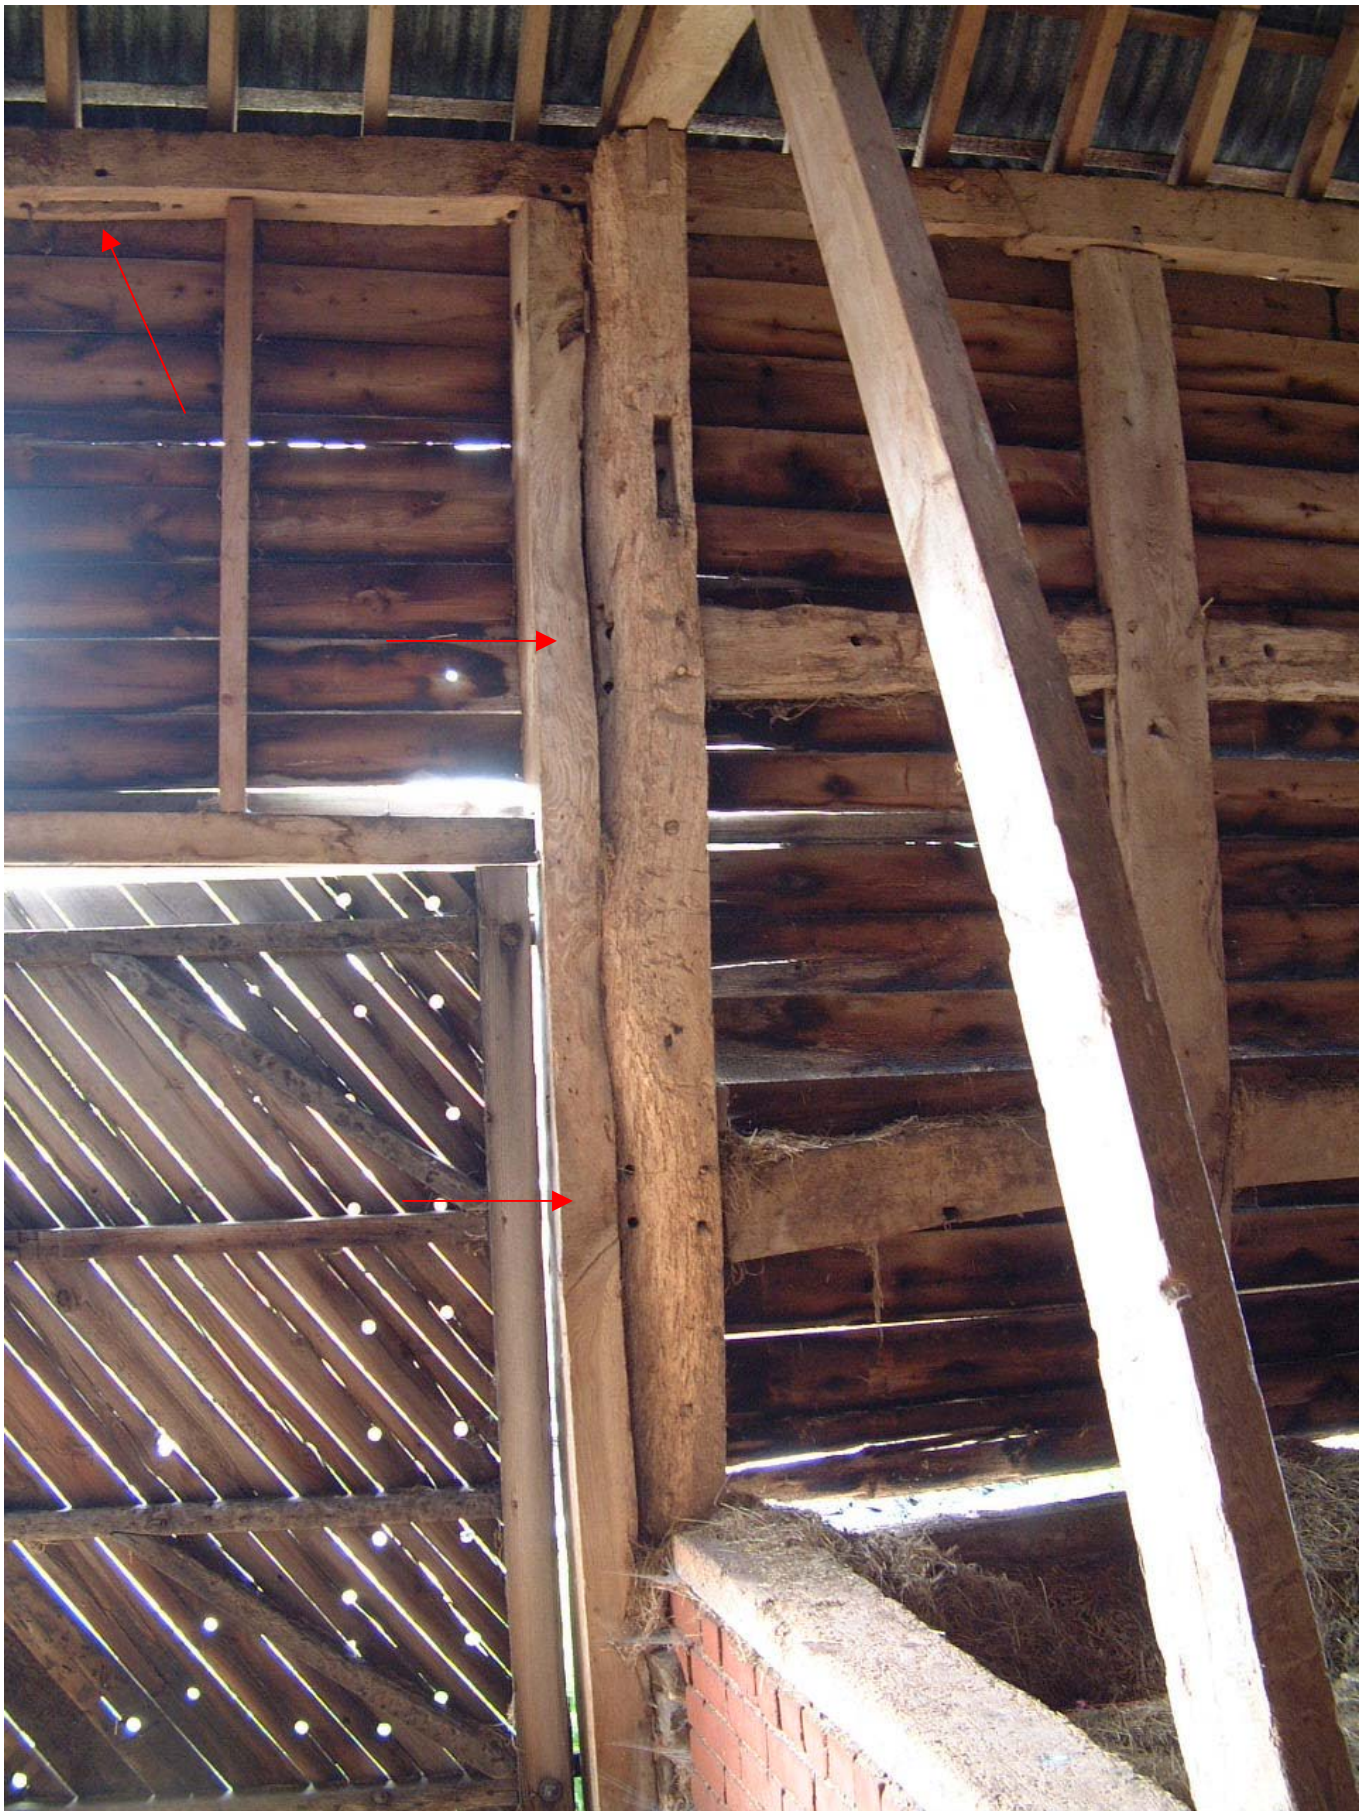
**Plate 15:** *Empty mortises and peg holes in T2 south side and wall plate (arrowed) indicating framing extended across the present cart bay.*

- ❑ Empty mortises and peg-holes in the posts of T2 indicate that originally the side framing extended across what is now the cart bay (Plate 15). There are, however, no corresponding mortises on the posts of T3, indicating that these are not in their original position.

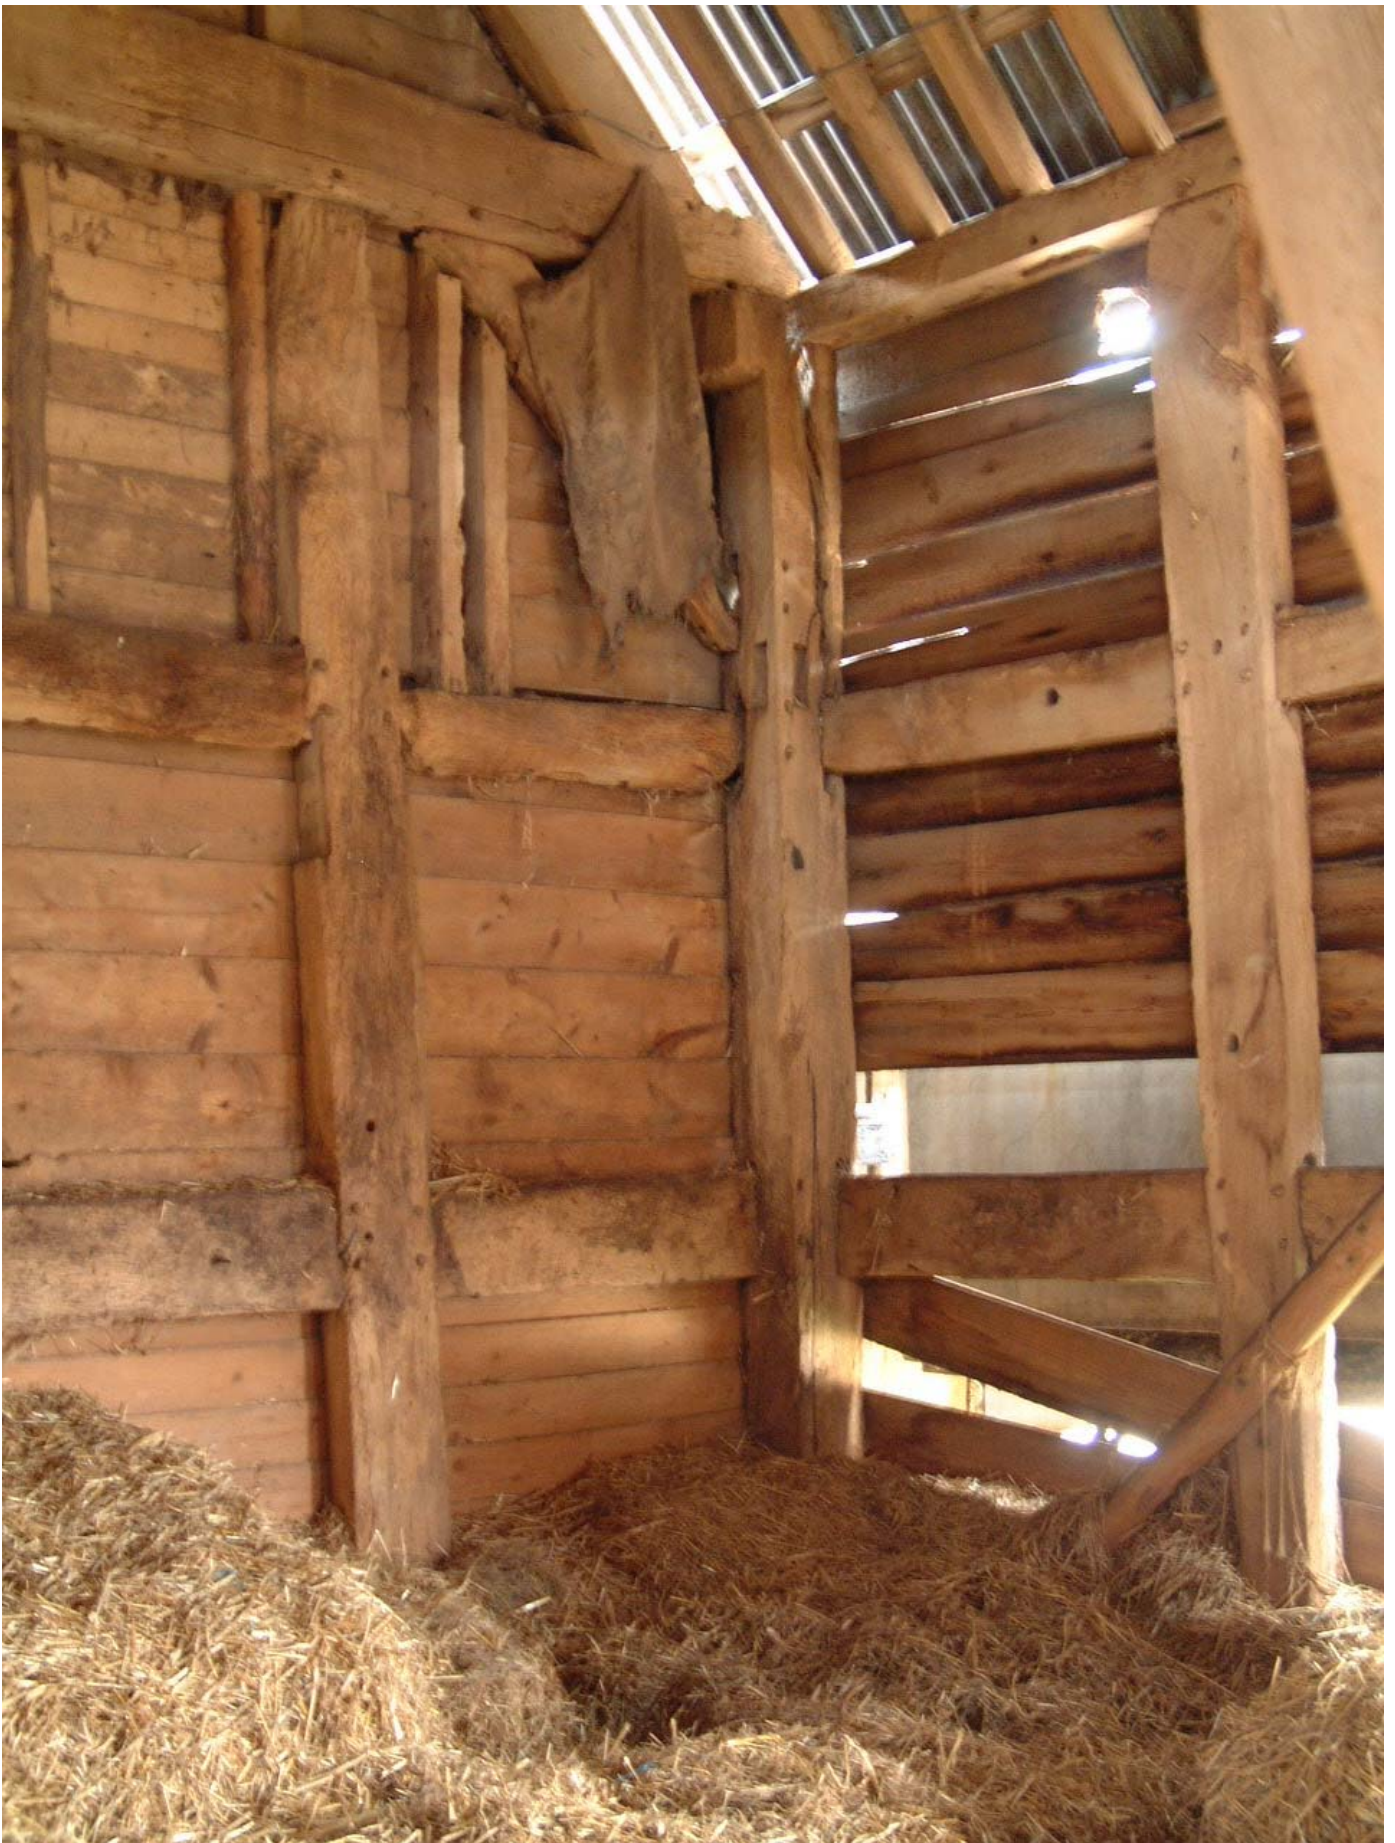
**Plate 16:** *South-east corner post showing 'modified' head and empty mortises for bracing*

- ❑ The cross bracing for the cart bay is clearly later than the original, having less degraded, more slender and machine cut timbers.
- ❑ Jowelled heads were used in the original main posts, but gunstock jowels (Plate 16) are used in those that appear to be of second phase, though some heads may have been altered / damaged.
