*An Archaeological Watching Brief at  
Castle Farm, Greenway, Rock,  
Worcestershire*

*A report for Mr & Mrs Greenhalgh*

April 2005

**Project: PJ 134**

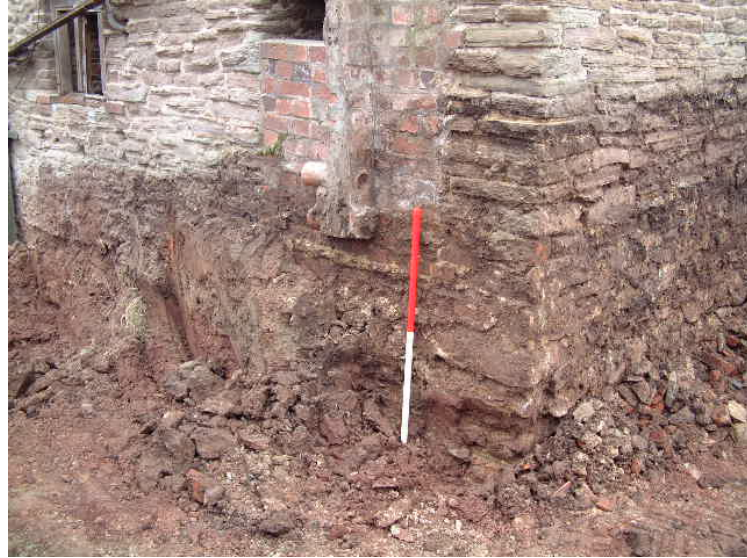
## Plate 1

*The level of build up against the building, note the bricked up window (scale 1 metre)*

The external work involved removal of over 1 metre of accumulated soil from around the southern and western sides of the building. It became clear how much accumulation or build up was around the building as two ground floor windows buried by the material build up were uncovered (Plate 1).

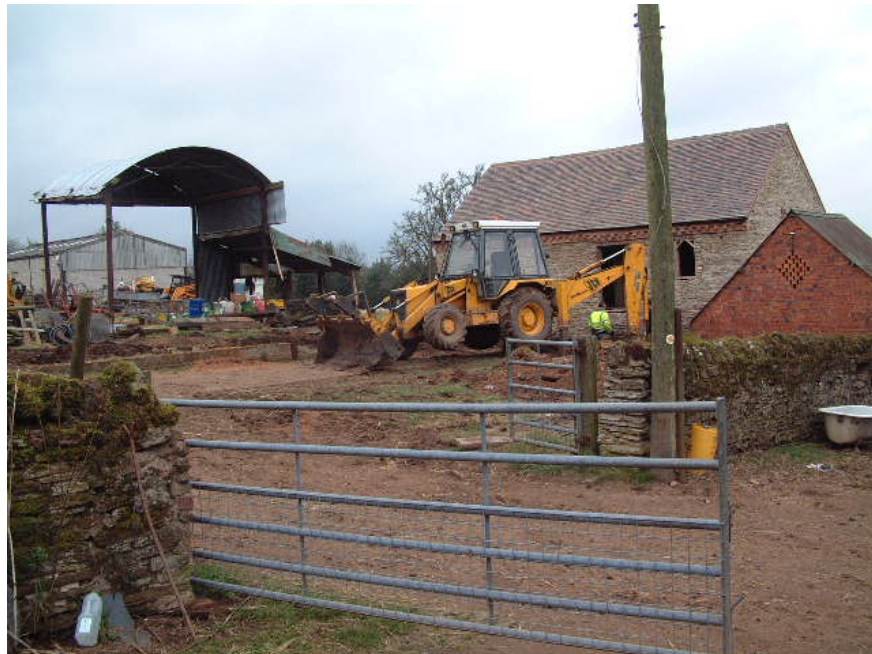
## Plate 2

*Work in progress. Note the Dutch barn (left). It is proposed that the dumped material was to facilitate a level platform for its construction*

The foundations of the building were of crushed and broken stone rubble in a shallow cut into the natural clay-marl. . Over the natural was a thick deposit of red clay containing a few fragments of 20th century clay roof tile and un-dateable brick. The deposit also contained some broken window glass, broken ceramic field-drain, coal fragments and some degraded timber. The western section of the excavated area demonstrated that this deposit had been purposely placed in order to level the area, which naturally sloped up to the south. This was also apparent, as a Dutch barn had been constructed on the flat platform created by the levelling

(Plate 2), probably during the early to mid-20<sup>th</sup> century (although the levelling may have been a little earlier).

The watching brief determined that there were no significant archaeological features or deposits within the development area. There were no significant finds within the material excavated from around or within the subject building and the evidence suggests that the majority of the built-up earth at the rear (south) of the subject building, had been purposely deposited. It seems logical to suggest that the material had been used to level the natural slope to the north in order to create a level platform for the construction of the adjacent mid to late 20th century Dutch barn.

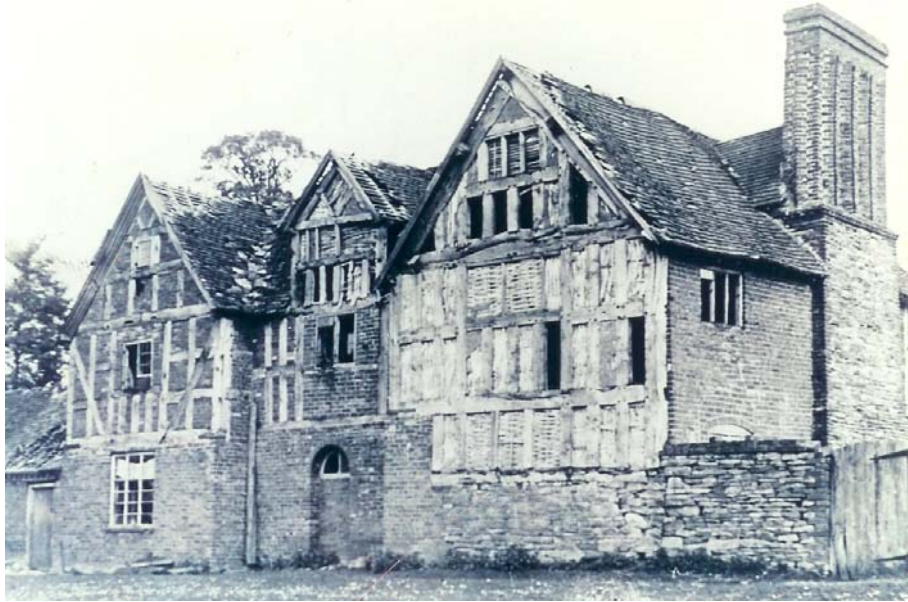
## Plate 3

*The former Castle Farm house, taken around 1900 before its demolition (kindly supplied by Mrs Greenhalgh)*

A further archaeological mystery was presented by Mrs Greenhalgh of Castle Farm. Plate 3 shows a photograph of the previous Castle Farm around the start of the 20<sup>th</sup> century just before it was demolished. The site of the farmhouse is unclear and it was hoped the results of the watching brief might shed some light on the former location of this building.

Although the watching brief returned only negative results, the background work was able to locate the site of the original farmhouse. The image of the former farmhouse shows it to be a three storey double pile timber-framed structure with close studding and wattle and daub panels. The structure is likely to date from the late 15<sup>th</sup> to 16<sup>th</sup> century with 17<sup>th</sup> century additions and later alteration with partial underbuild in stone and brick and an external brick chimneystack (Plate 3). The cowshed in the north-eastern corner of the farmyard complex now sits in this position and it is possible, although not inspected, that the cowshed contains some stonework within its fabric from the underbuild of the former farmhouse.

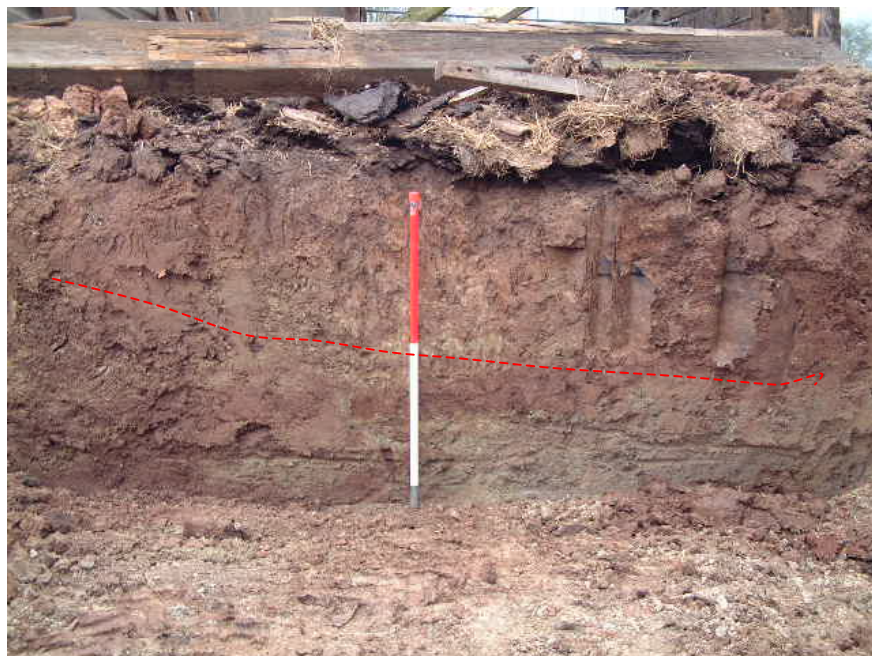
## Plate 4

*Dumped material over the natural slope (shown by line) (scale 1 metre)*
