An Archaeological Watching Brief at The Button Factory, Willow Road, Bromsgrove, Worcestershire

A report for David Payne Homes Ltd

April 2005

Project: PJ 131

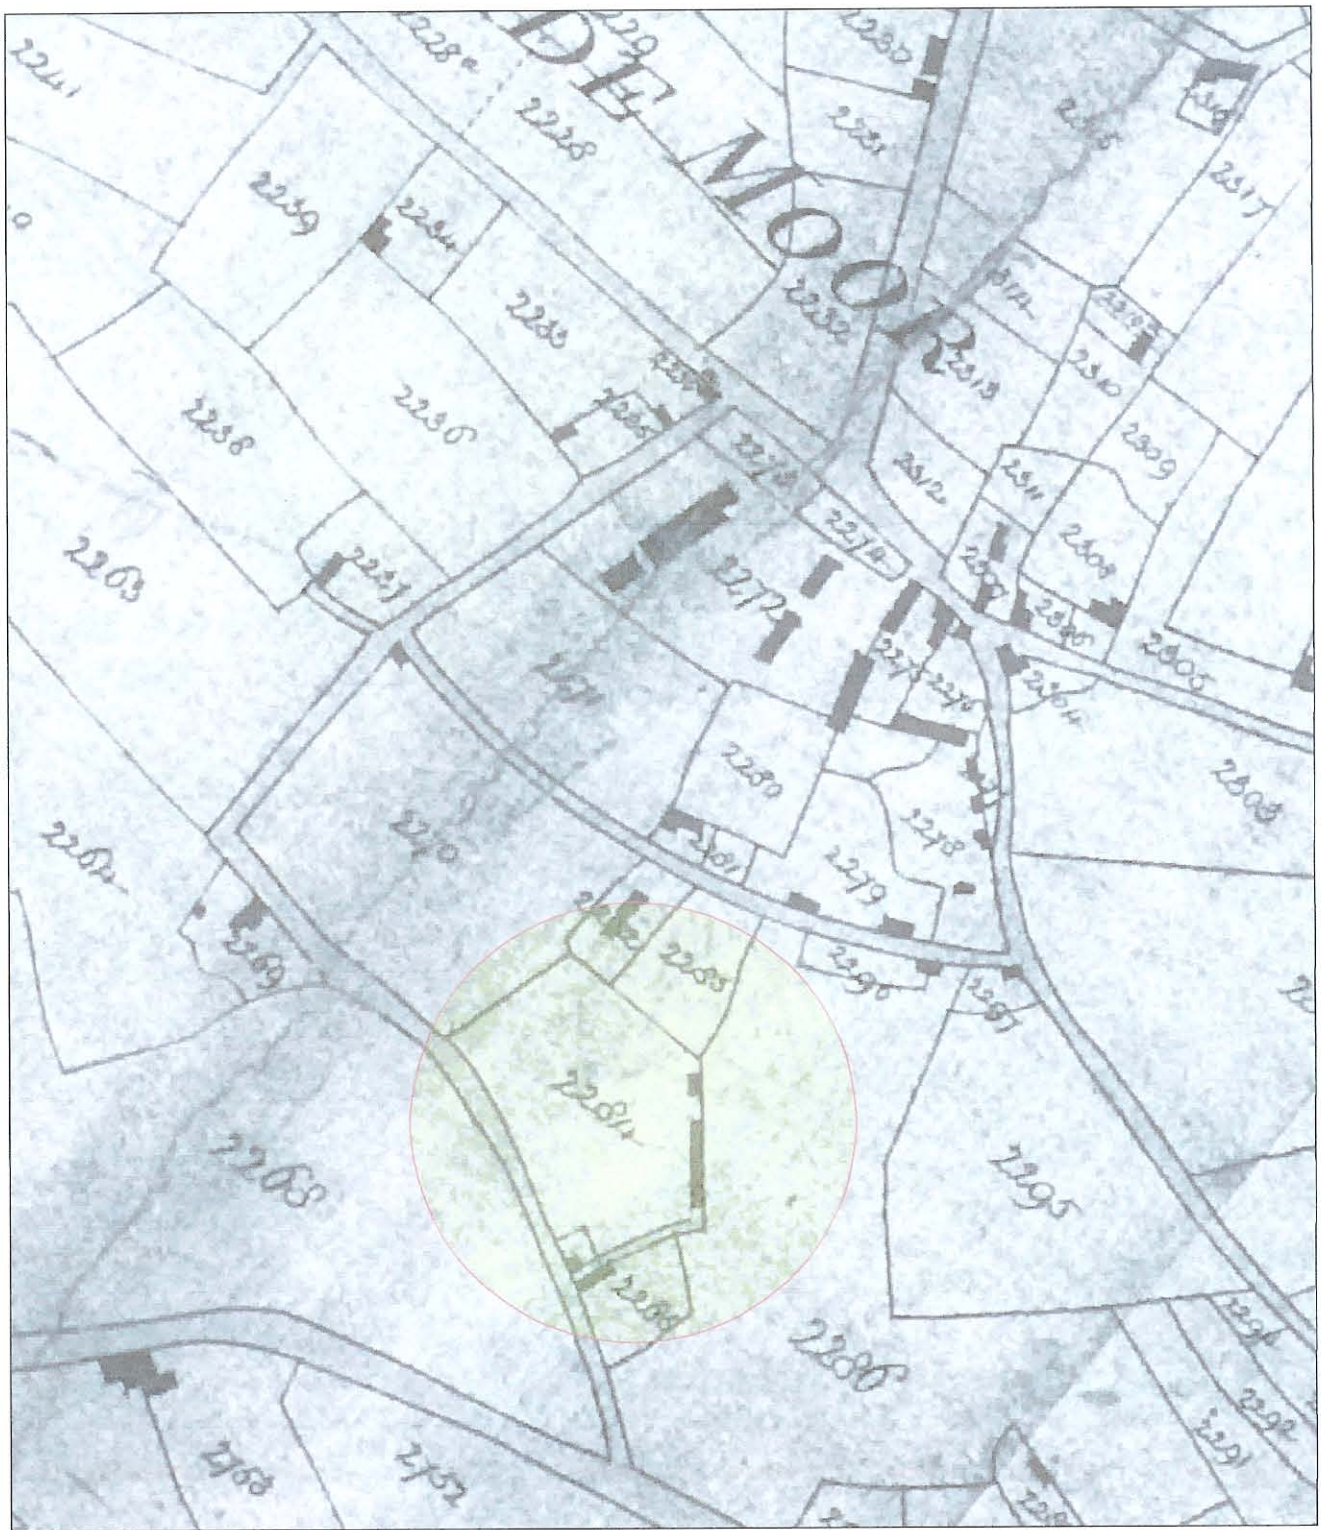
Figure 2. Extract from Bromsgrove Tithe Apportionment Map (1840)

Tithe Apportionment of Bromsgrove (1840) with location of site highlighted. Not to scale. The overlay shows a detached building to the north of the mill, this was possibly the factory owners house as referred to in the tithe apportionment.

The mill was apparently extended soon after being purchased by Sanders and by the 1830's it employed around 300 people (Richards 1984, 99). The Tithe Apportionment Map of 1840 showed that by this time Benjamin Sanders owned a house and garden and factory on the site (Figure 2). The map shows a detached building just to the north, which may have been Sanders' house. He also owned much of the land surrounding the manufactory. A photograph dating from around 1890 shows the extent of the three-storey building by this date (Plate 1).

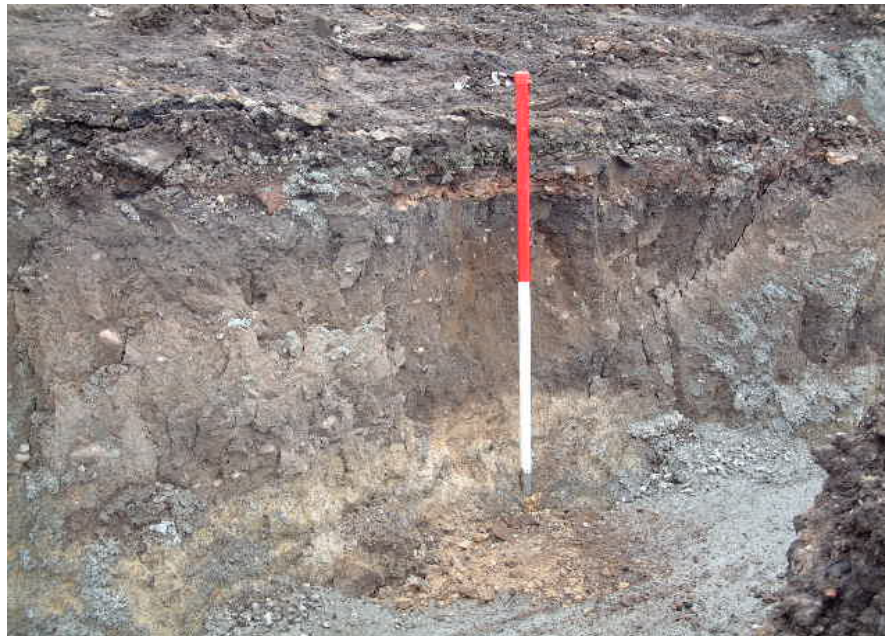
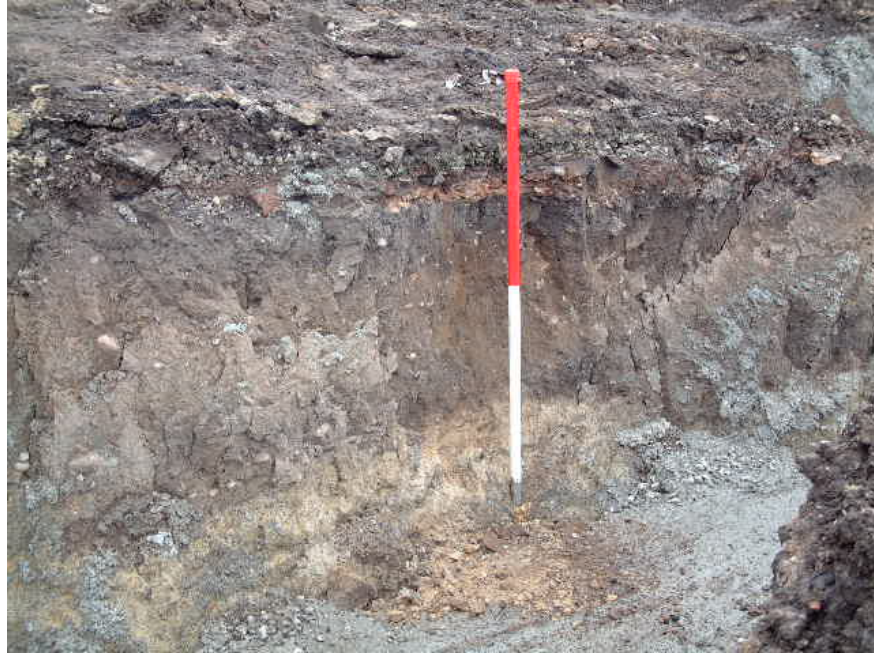
Plate 4

A layer of greyish sandy-silt subsoil remained to a maximum of 0.35 metres over the natural (Plate 4), although this had been heavily truncated by later development relating to The Button Factory. This layer appears to have slowly built up, rather than been the result of ploughing, suggesting that the area was subject to waterlogging and is likely to have been used as rough grazing prior to the 18th century. Waterlogging was in evidence in the bottom of the excavations on the eastern side of the site (Plate 5).

Silty subsoil over natural yellowish sand, below demolition layer (scale 1 metre)

Silty subsoil over natural yellowish sand

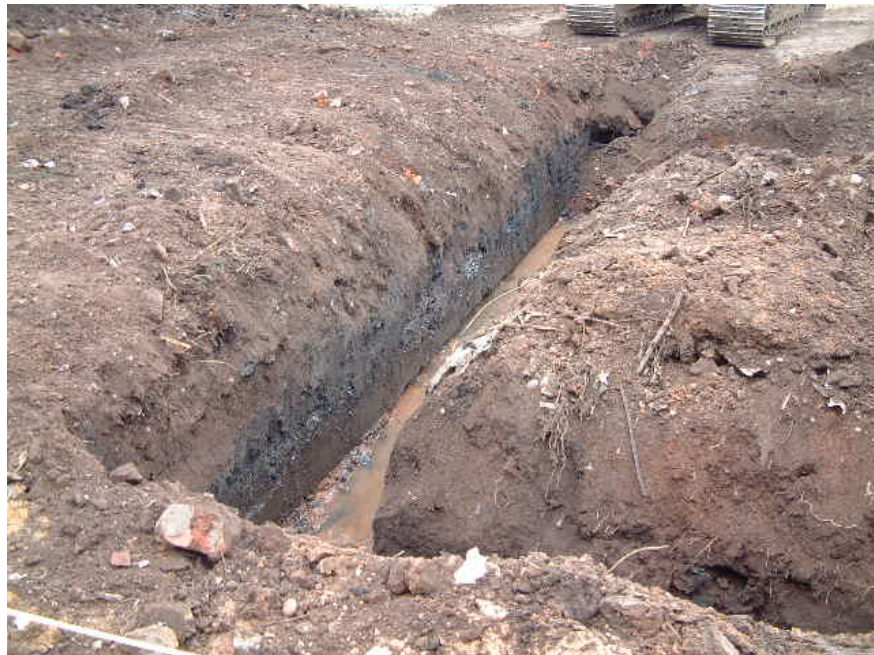
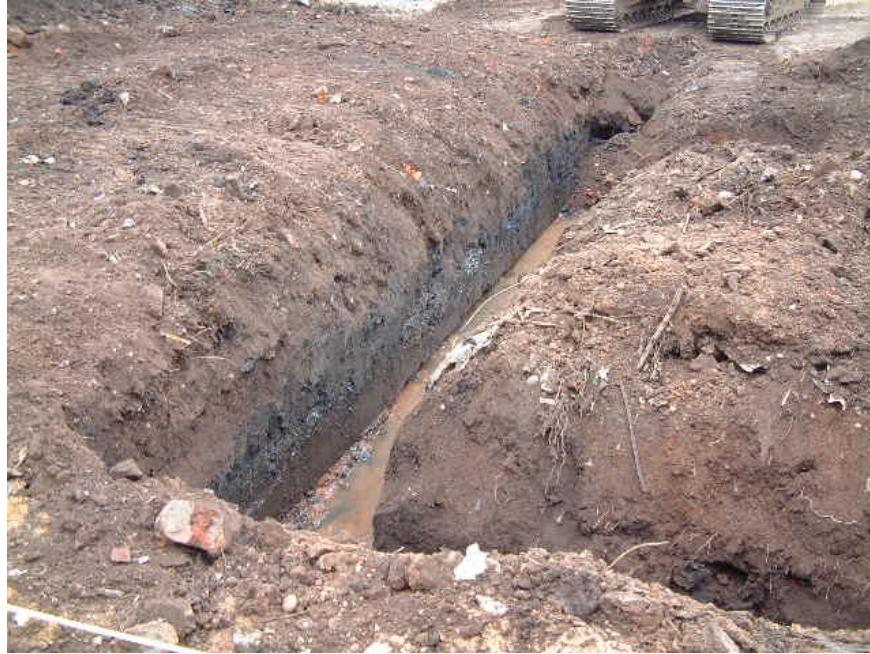
Plate 5

Waterlogging on the eastern side of the site

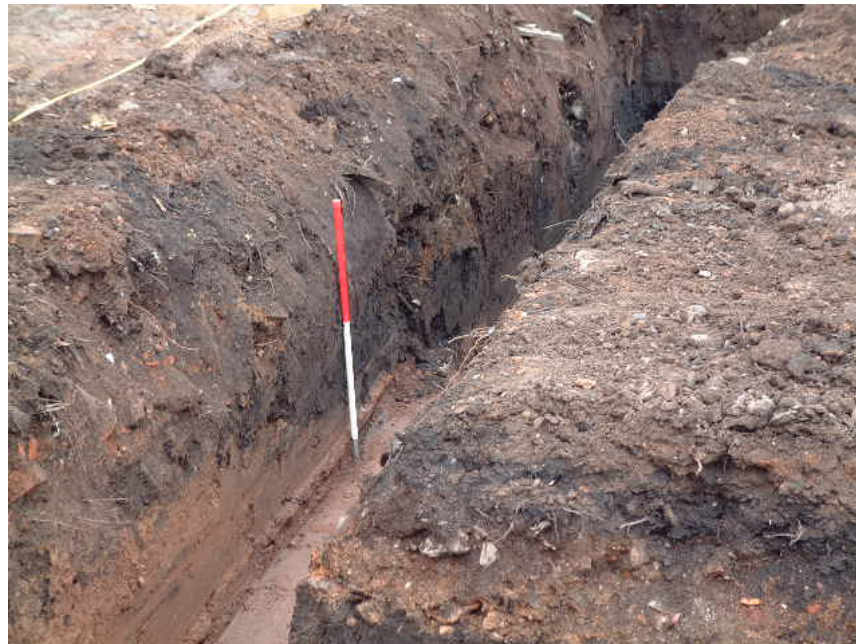
Plate 6

The western side of the pond shown on the early Ordnance Survey maps (Figures 3-6) was seen in east-west sections of the foundation trenches on the north-western side of the site (Plate 6). The pond had been excavated with 45 degree edges into the sandy-silt subsoil and had gradually silted up with a very wet dark humic silt, which contained occasional brick fragments, some degraded timber and the base of a Victorian green glass bottle. The pond was

The line of the pond on the west of the site indicated by the dark fill; view to the north-east (scale 1 metre)

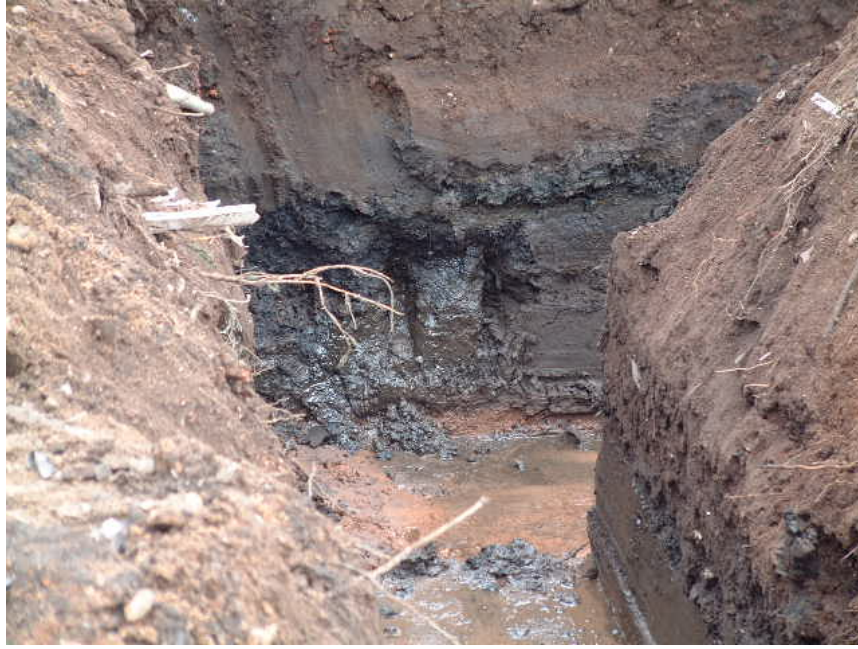
Plate 7

not lined, but simply cut into the natural sand, which contained a percentage of clay / marl in this area. The thick black fill of the former pond was also noted on the eastern side of the site (Plate 7), where the ground was at its wettest. This fill had been cut into and levelled with a layer of crushed brick, before the buildings at the north-eastern end of the site were constructed. The top 50 centimetres of the site had been heavily disturbed, both during the construction works of the 1920's and also during the recent demolition of the buildings.

Waterlogging within the backfill of the pond at its eastern side

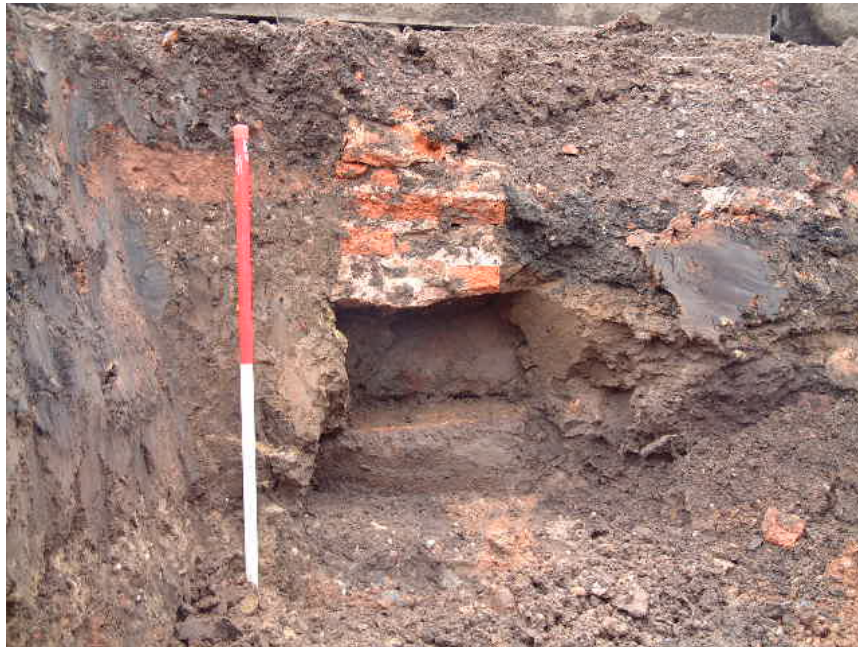
Plate 8

The foundations to the original late 18th century building were seen in several places. These were of large ashlar blocks of sandstone laid on cobbles at the top of the natural sand, with the construction of orange brick and mortar above (Plate 8). An arched brick drain was also seen running roughly north to south across the site (Plate 9). It appears that this was still in use at the end of the life of The Button Factory, as it ran directly into a manhole at the southern end of the site.

Much of the foundation of The Button Factory was of substantial ashlar sandstone blocks. Close inspection of these indicated that they were purpose cut rather than re-used items. The size of the blocks suggests that the builders of the factory understood the potential of waterlogging at the site, which is testament to the remnant part of The Button Factory standing for over 200 years without evident subsidence.

Sandstone foundations of The Button factory (scale 1 metre)

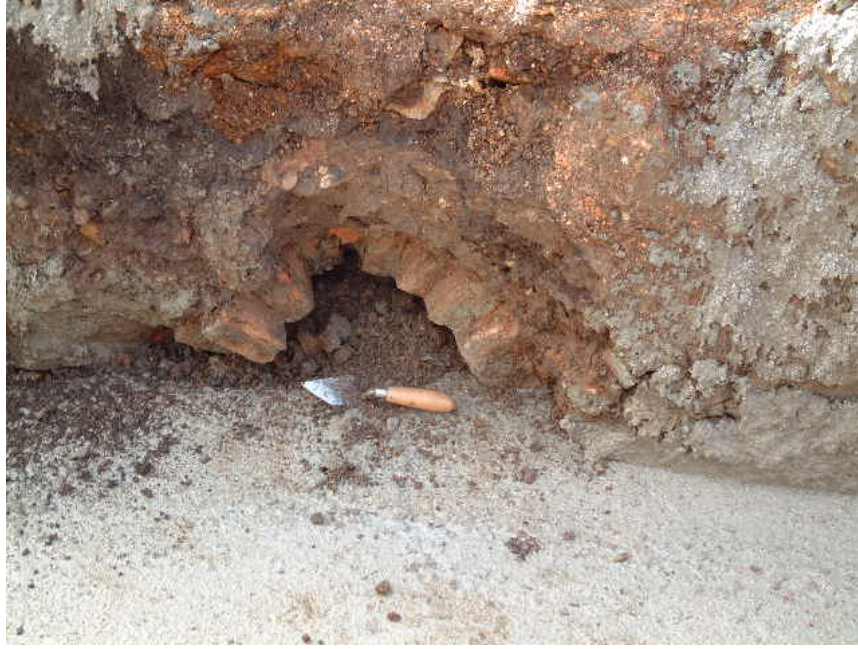
Plate 9

North-south brick arch drain seen at the southern end of the site

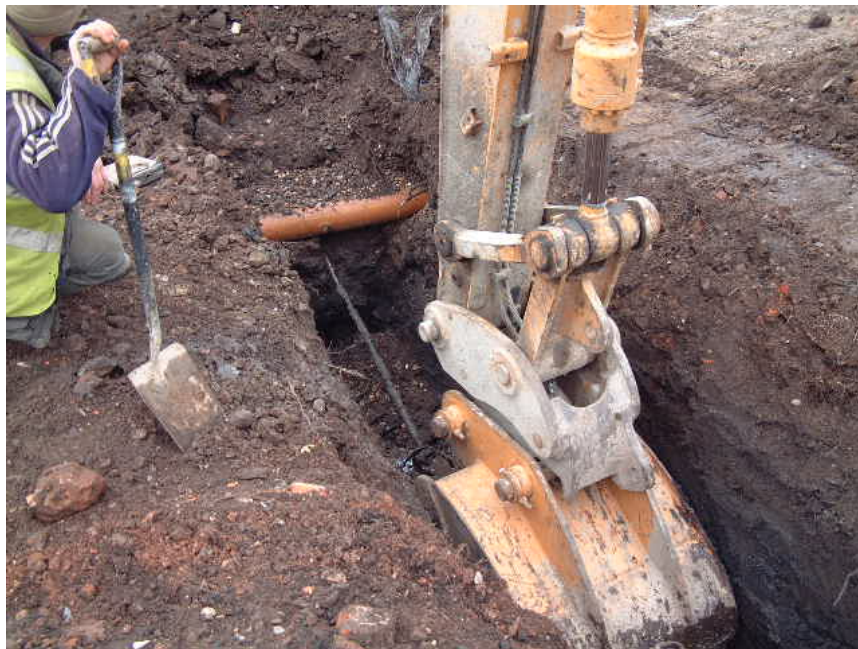
Plate 10

The site was noticeably devoid of pottery, even for a non-domestic industrial site. One unstratified sherd of ripple rim moulded slipware dating from the late 18th to early 19th century was identified on site. An impellor shaft from a 20th century pump was unearthed from within the backfill of the pond (Plate 10).

Part of an impellor pump found within the fill of the pond
