ARCHAEOLOGICAL RECORDING OF A
“PILL-BOX” AT THE FORMER
ARMY MEDALS OFFICE SITE,
WORCESTER RD, DROITWICH,
WORCESTERSHIRE

WSM 38552

Archaeological recording of a “pill-box” at the former Army Medals Office site, Worcester Road, Droitwich, Worcestershire WSM38552.

February 2008

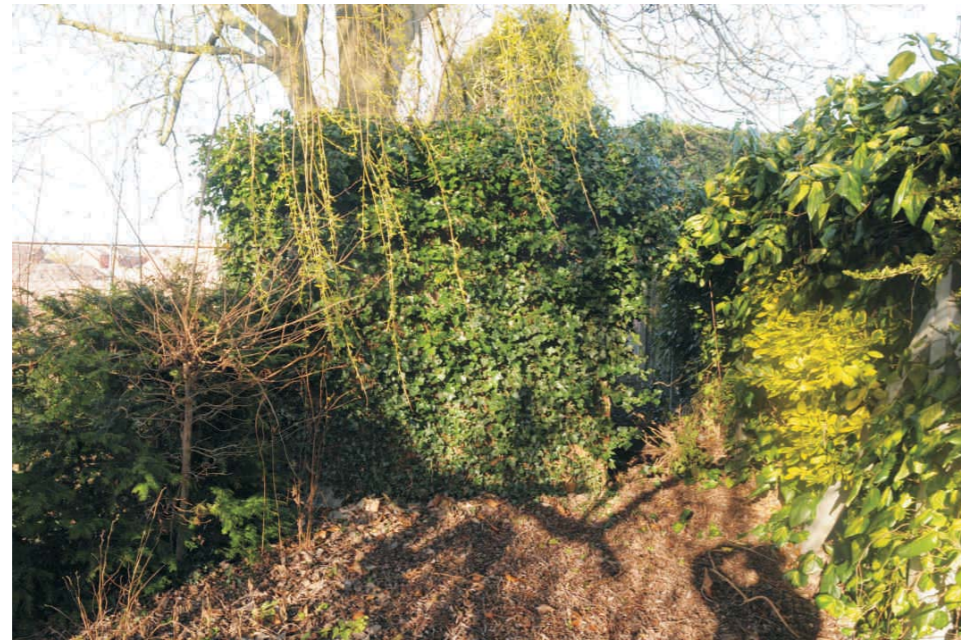
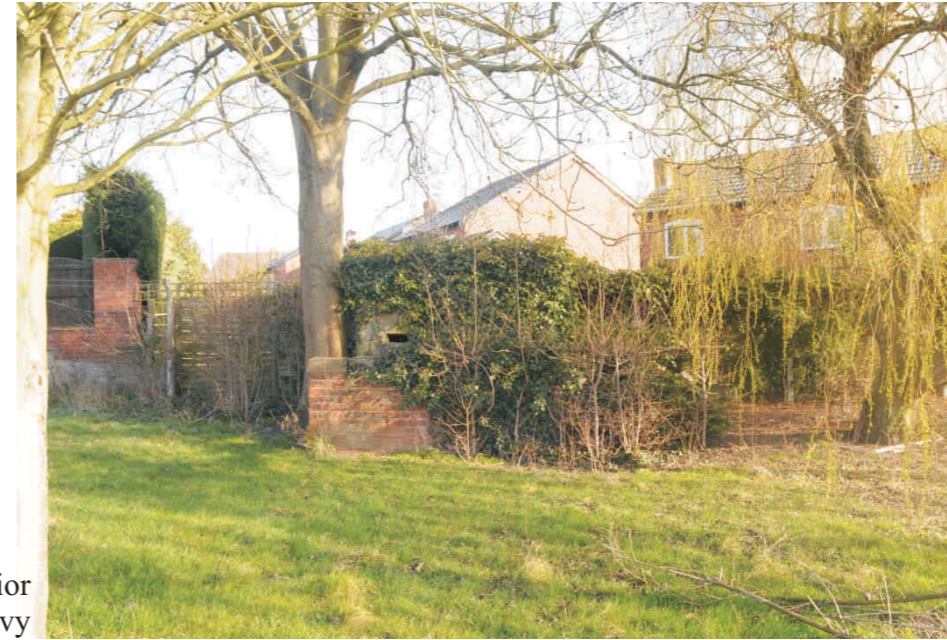
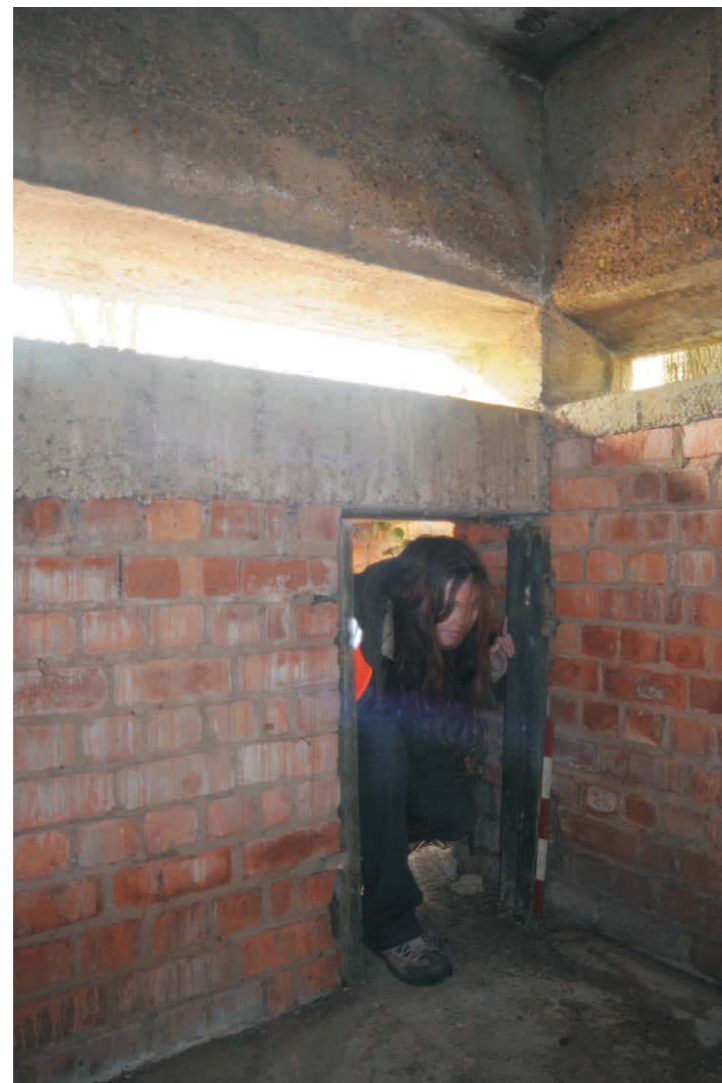
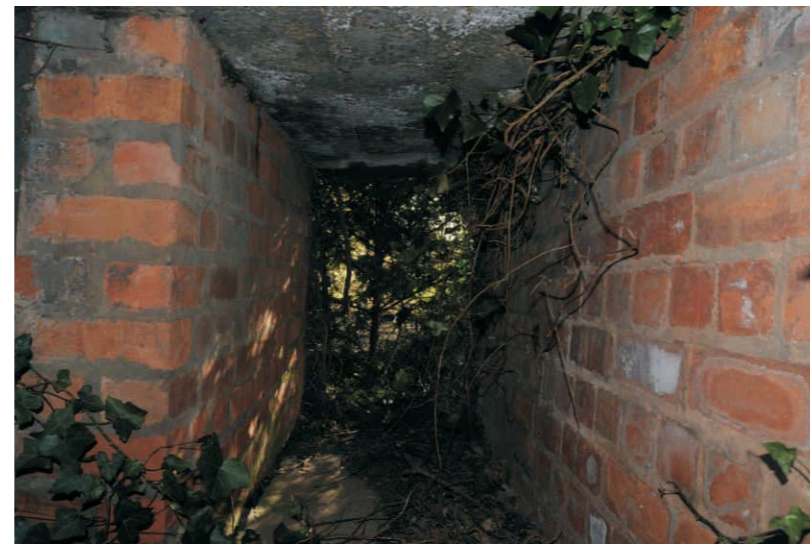
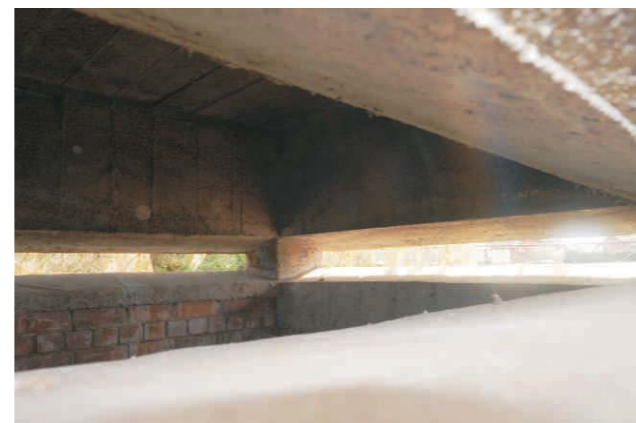
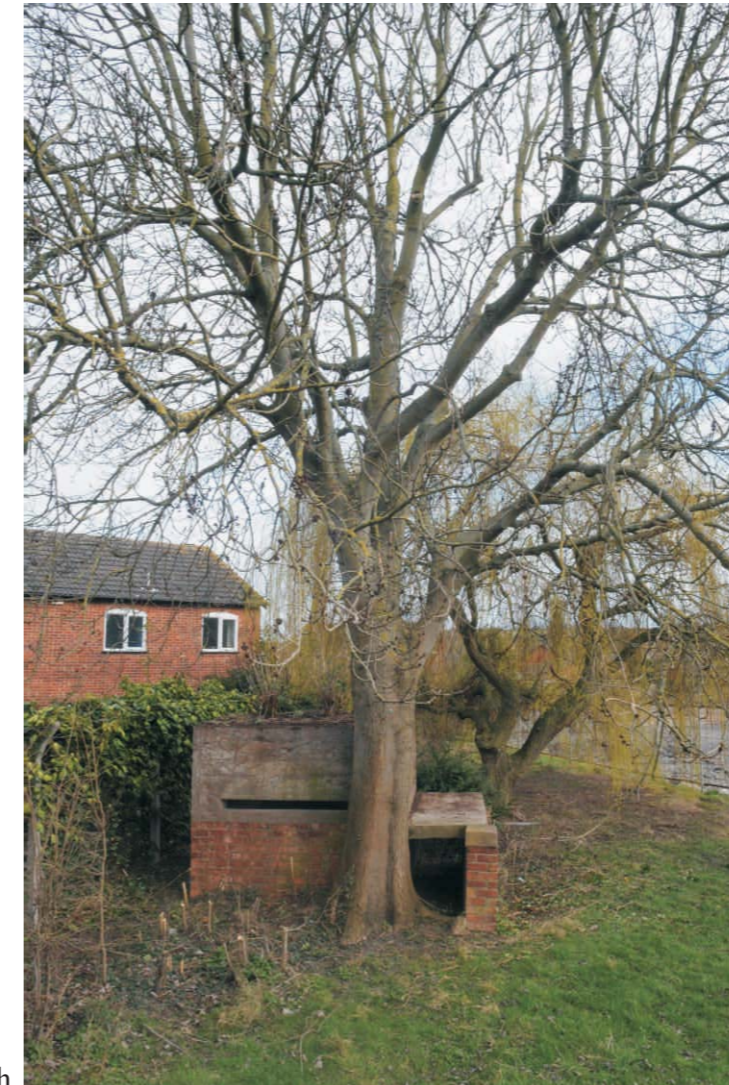
Figure 11: General photographs

- 4.1 Searches were made at the Worcestershire County HER, Worcester Family History Centre, Worcestershire Record Office for documentary sources, published sources, cartographic sources and aerial photographs. Little material directly relevant to the present site was identified, but cartographic sources including the Tithe Awards plan and the Ordnance Survey (Figs 1-5) indicate that the development area was agricultural land until circa 1940, and that the area has suffered extensive residential development in the post-war years. The records of the Defence of Britain project were consulted for examples of similar structures elsewhere.
- 4.2 On inspection of the site it was found that the structure was heavily overgrown with ivy and brambles (Fig 11) and was nearly totally obscured by vegetation, that also

extended within the building, filling the embrasures. Substantial effort was required to clear the structure of growth so that it could be recorded. On removal of the ivy etc, the building was found to be in good condition, excepting some movement caused by the roots of an adjacent tree.

East elevation prior to removal of ivy and undergrowth

South elevation prior to clearance of ivy

Internal view of doorway

Entrance crawlway prior to clearance

View through embrasure

Tree growth

- 7.7 The tree (Tag No: Green Lowther 00382) represents the only substantial threat to the long-term future of the building - it may however be possible to restrict further tree growth by crown pruning or similar tree surgery. Retention of the tree would have landscape benefits, and also has the merit of helping to protect the structure from weathering. The restriction of tree growth would however require regular appropriate management and annual monitoring. The alternative, (which is felling), raises a substantial immediate risk of damage to the building plus a long term issue of potential settlement as the tree-bole rots out.

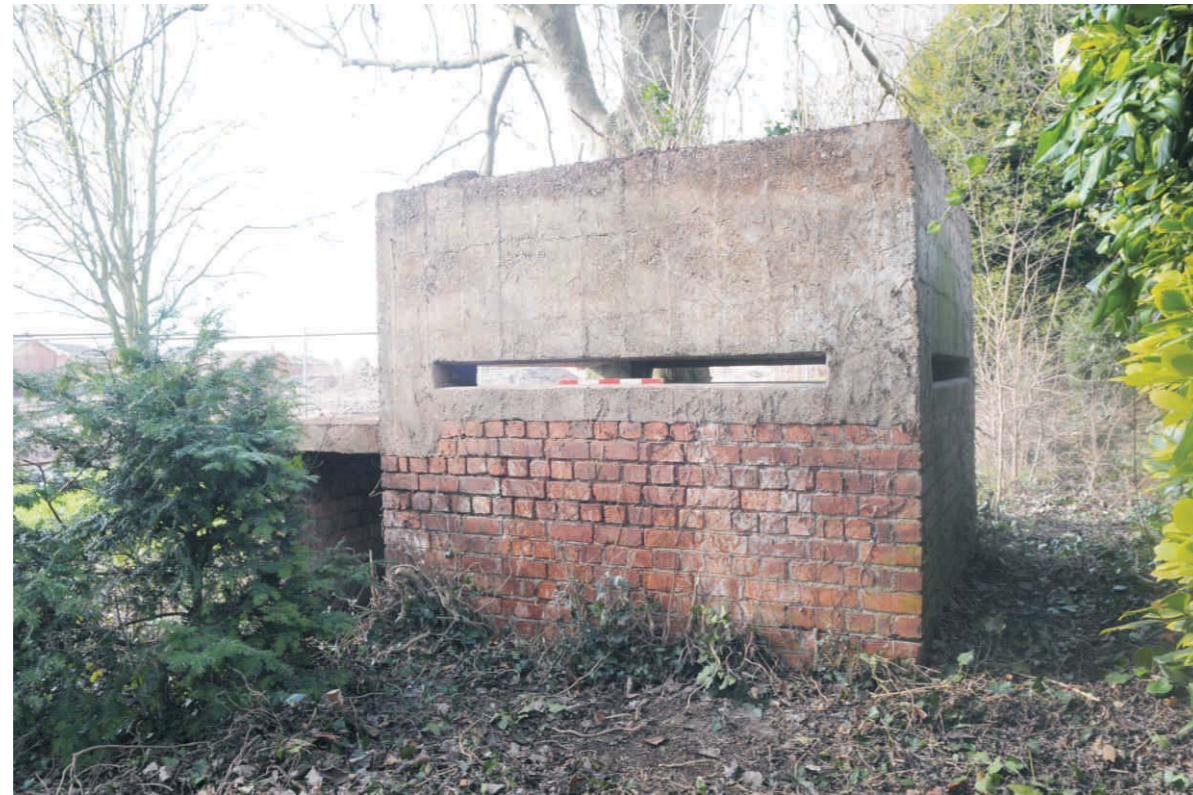
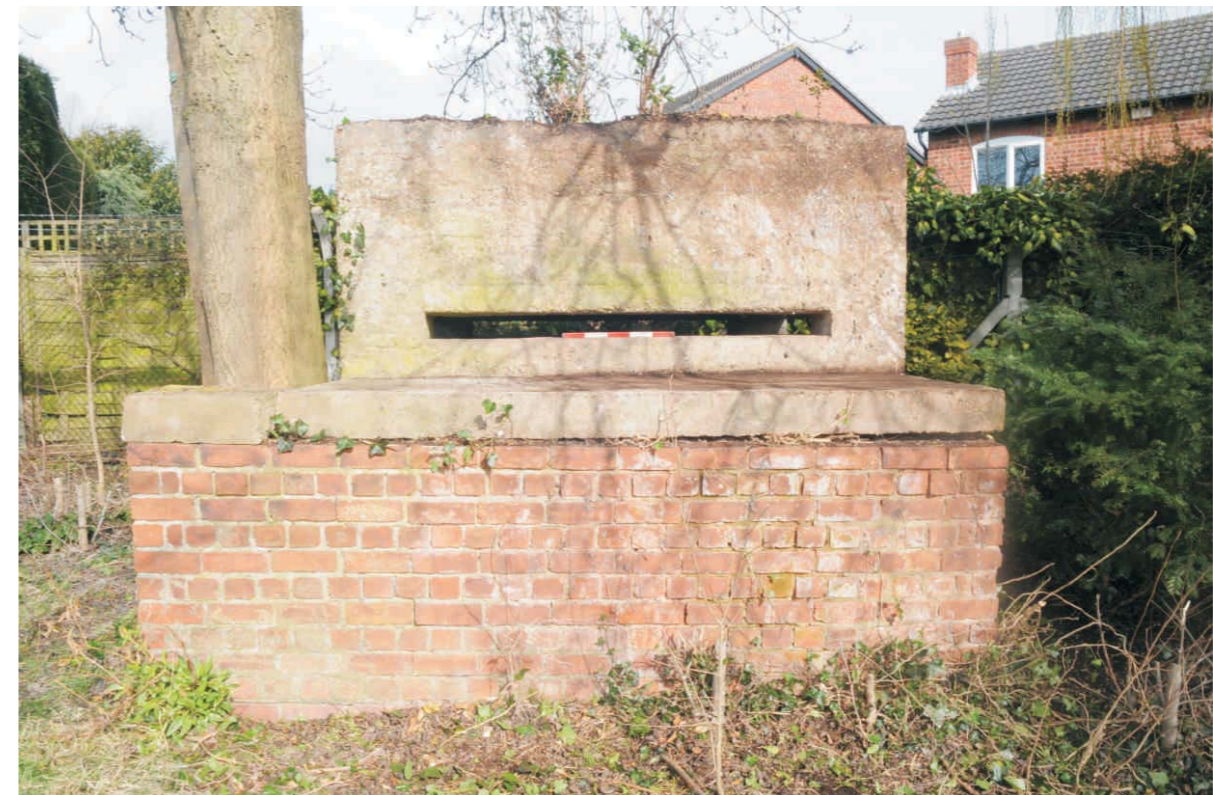
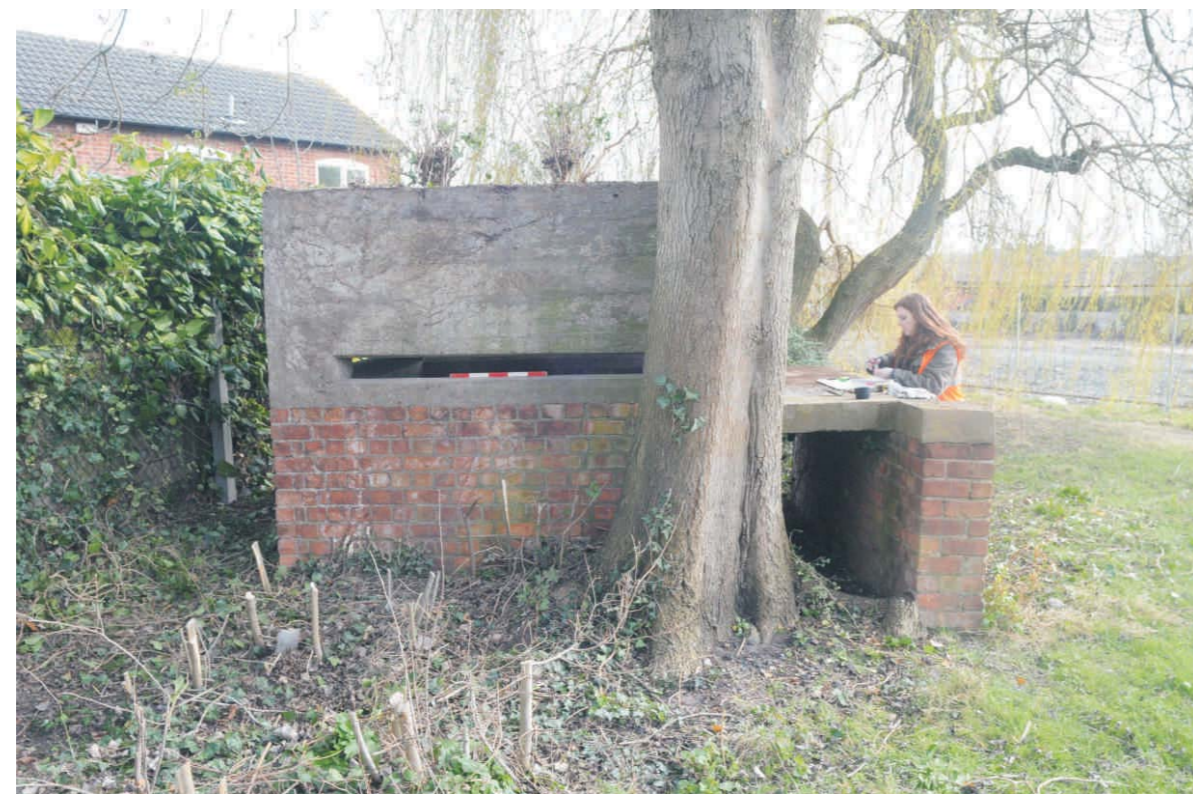
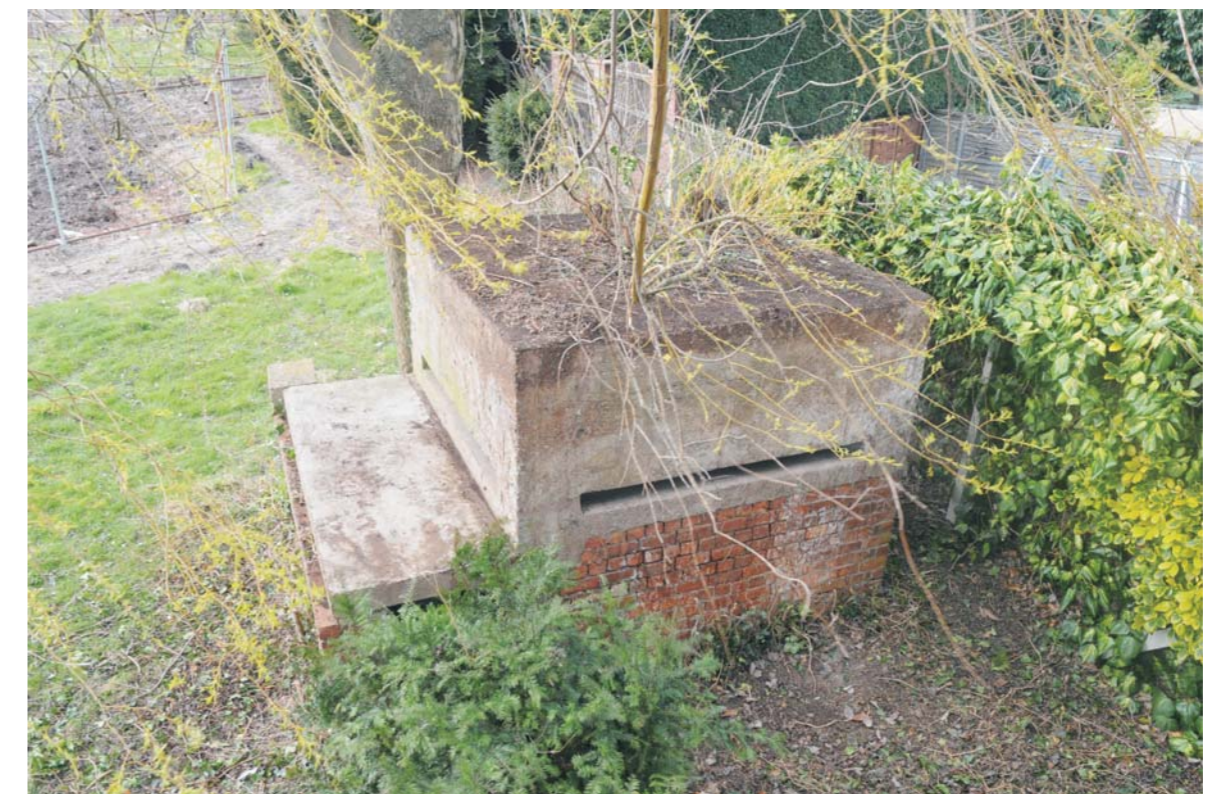
Figure 6: External views

- 7.6 The condition of the building is good (Figs 6, and 11) - its location in a securely guarded compound has prevented the usual depredations of vandals, and the only damage it has suffered has been moderate external weathering and some structural movement of the floor slab and blast wall as the result of tree-root action. The tree

roots do not seem to presently threaten the structural stability, though there has been lateral movement of the blast-wall amounting to around 85mm. The blast wall does now lean slightly, but still provides adequate support to the concrete roof of the crawlway. Cracking and lifting of the internal floor slab has occurred, particularly close to the base of the tree at the south-western corner. It is however almost entirely restricted to the area of the crawl-way.

Eastern elevation (Scale 0.5m long)

Southern elevation

Western elevation

Overhead view from south-east

- 8.1 The maintainence works presently required on the structure to secure its long term protection are as follows:
- 8.1.1 Removal of remaining vegetation and pointing of the brickwork (with an appropriate lime-based very weak cement mortar to ensure porosity and flexibility).

- 8.1.3 Securing of the entry points against illicit use (bricking up of both ends of the crawl-way) with walls of 9" engineering brick is strongly recommended as it will additionally support the crawl-way roof. The blockings should be recessed at least 200mm within the openings, and of dark blue brick to reduce the visual impact. The blocking walls should be secured with stainless screw-in ties rather than toothed into original brickwork.

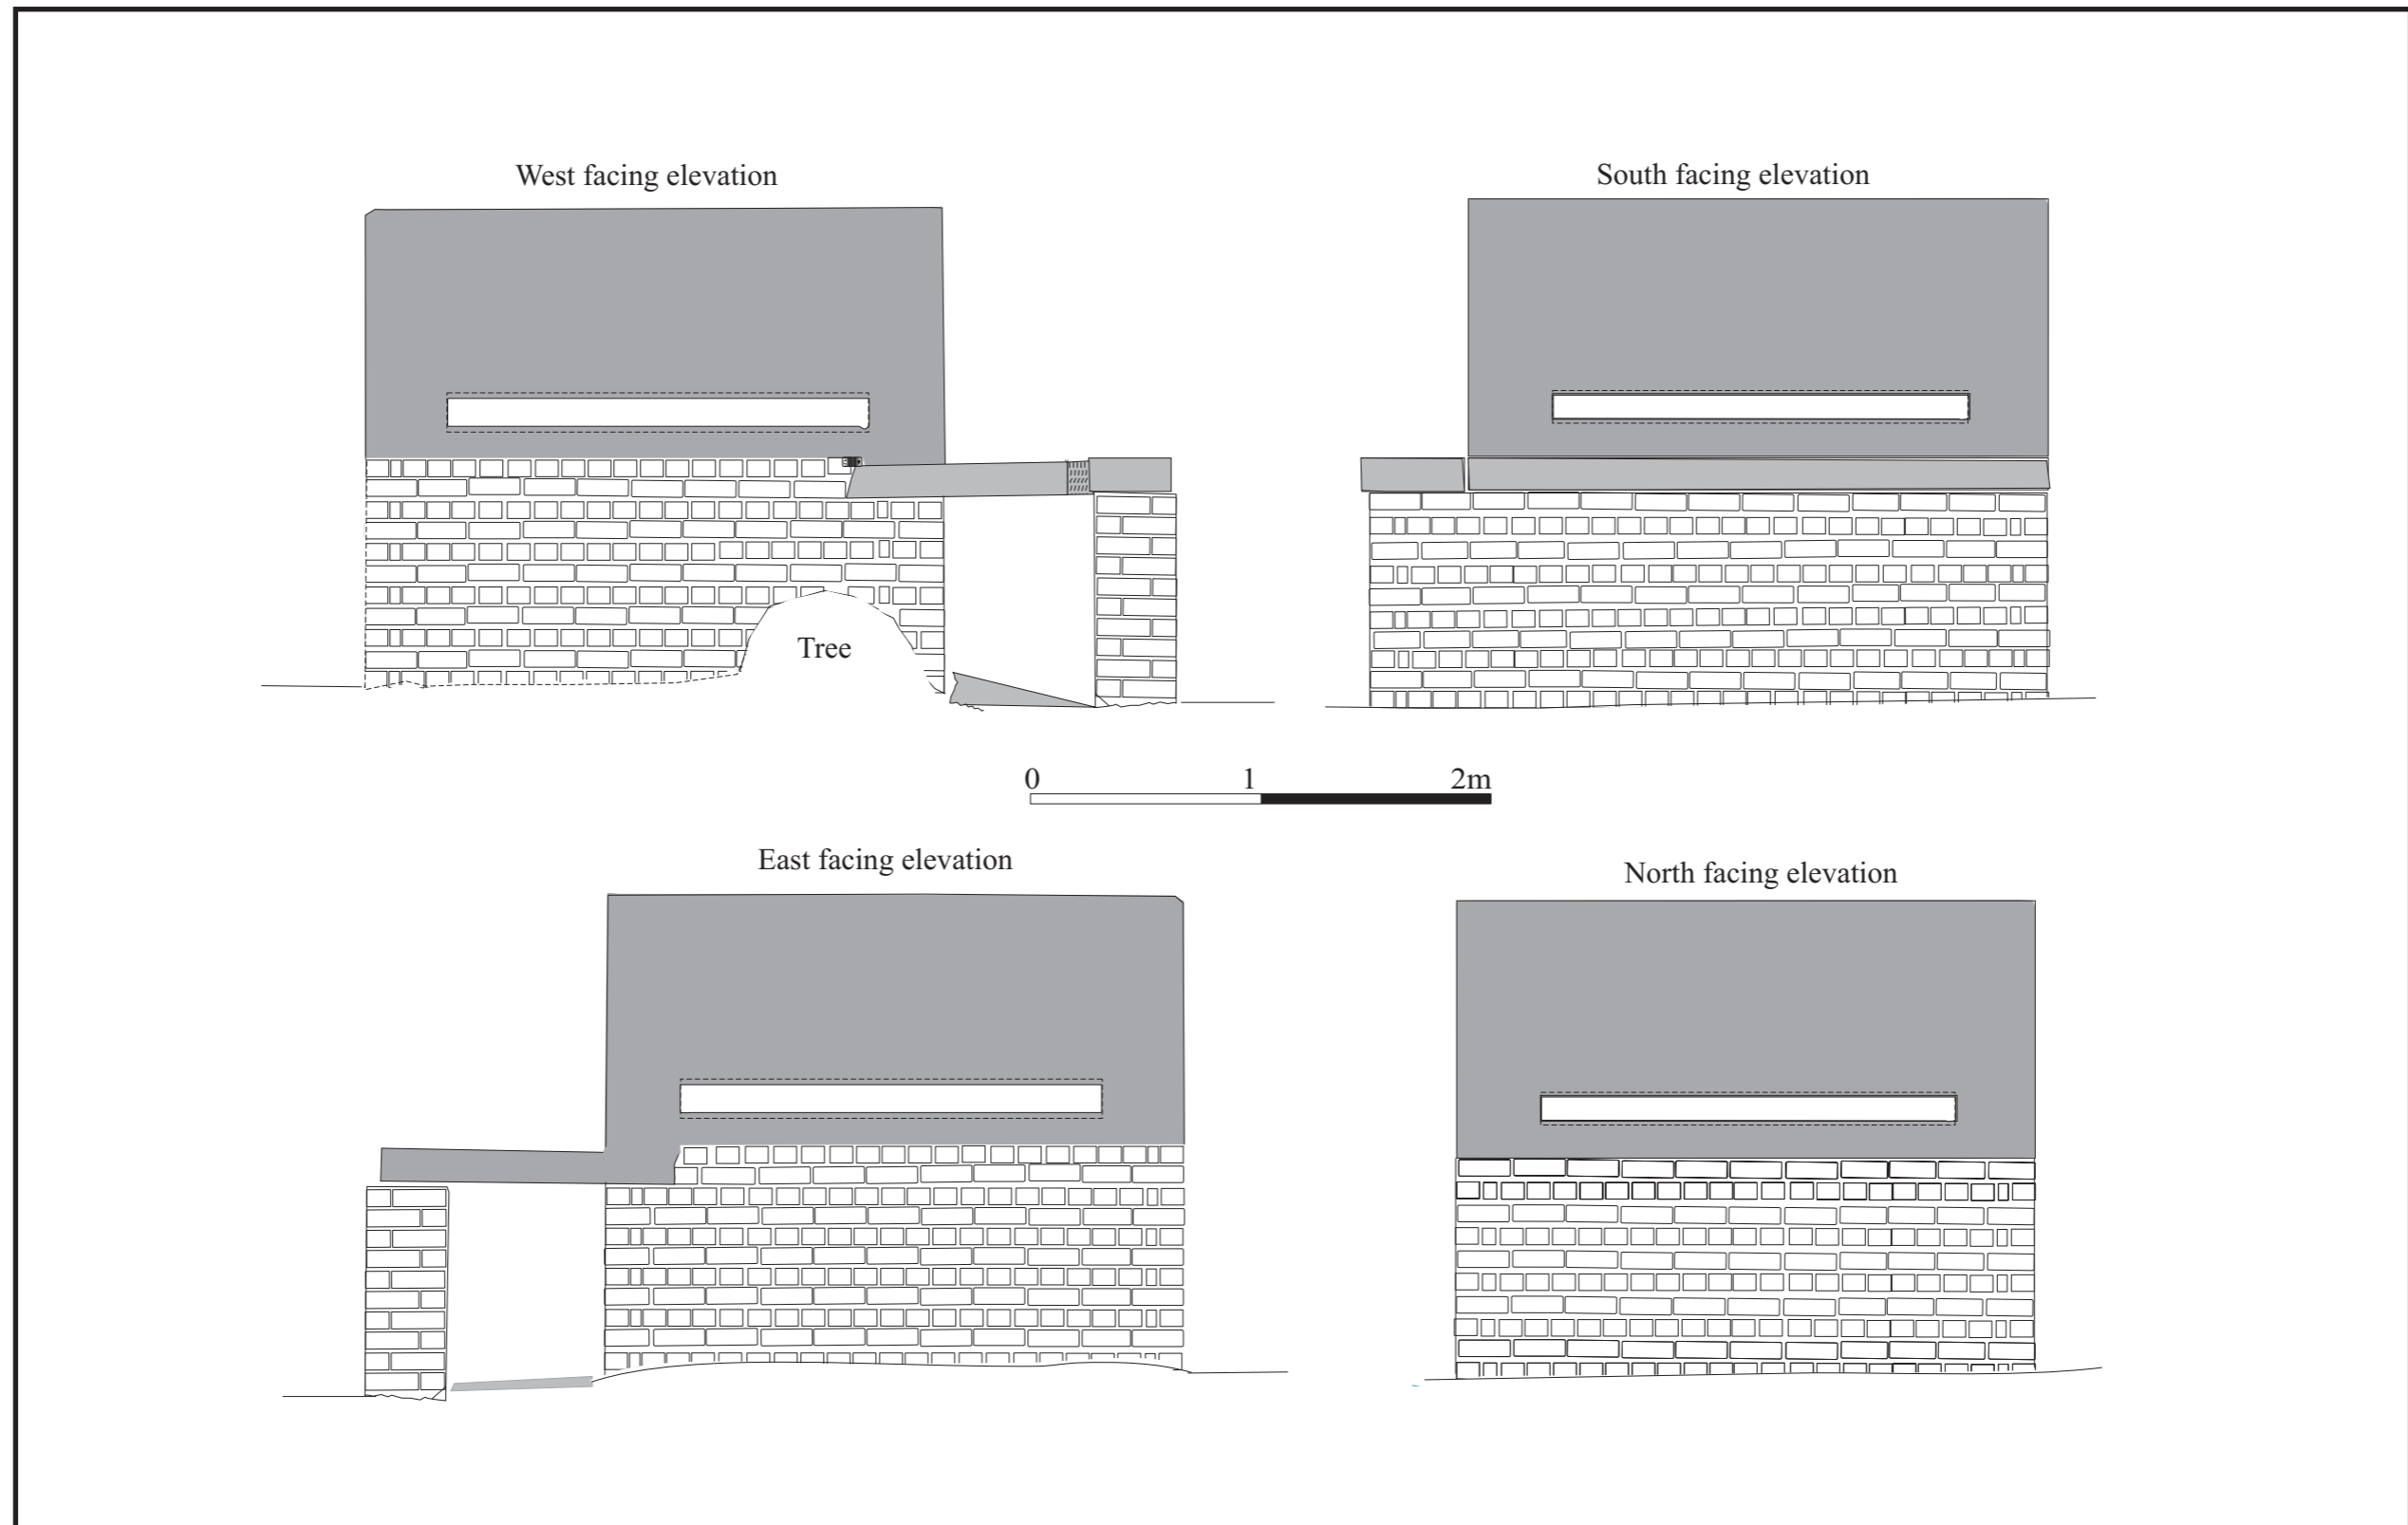
Figure 7: External elevations

- 4.3 All elevations of the building were drawn, together with roof and floor plans at a common scale of 1:20. Most of the elevations are reproduced in the present report, with the exception of the west facing internal elevation, which was very similar to the other internal elevations (Figs 7-9). The drawn record was augmented by a thorough photographic survey, consisting of 263 digital photographs presented on the enclosed CD ROM.

- 7.2 The building is constructed primarily of 12" brickwork with a cast reinforced concrete superstructure and roof. The concrete was cast in situ and the shuttering planks can still be seen in outline. The internal shuttering was of vertical planks 6-8" wide and 2" thick and the external shuttering was horizontal planking of similar dimensions. The embrasures were also cast around planks, the rough casting being later smoothed off with cement based mortar. The roofs and floor have a floated finish. Brickwork is in an adaption of English bond, with a lime and cement based mortar. The roof thicknesses are between 5" and 6" The extent of reinforcing in the concrete is unknown, only part of one rod (1/4" section) being visible. The floor is of 4" concrete, apparently un-reinforced and cast within the brick walls. Depth of the brick foundations is unknown.

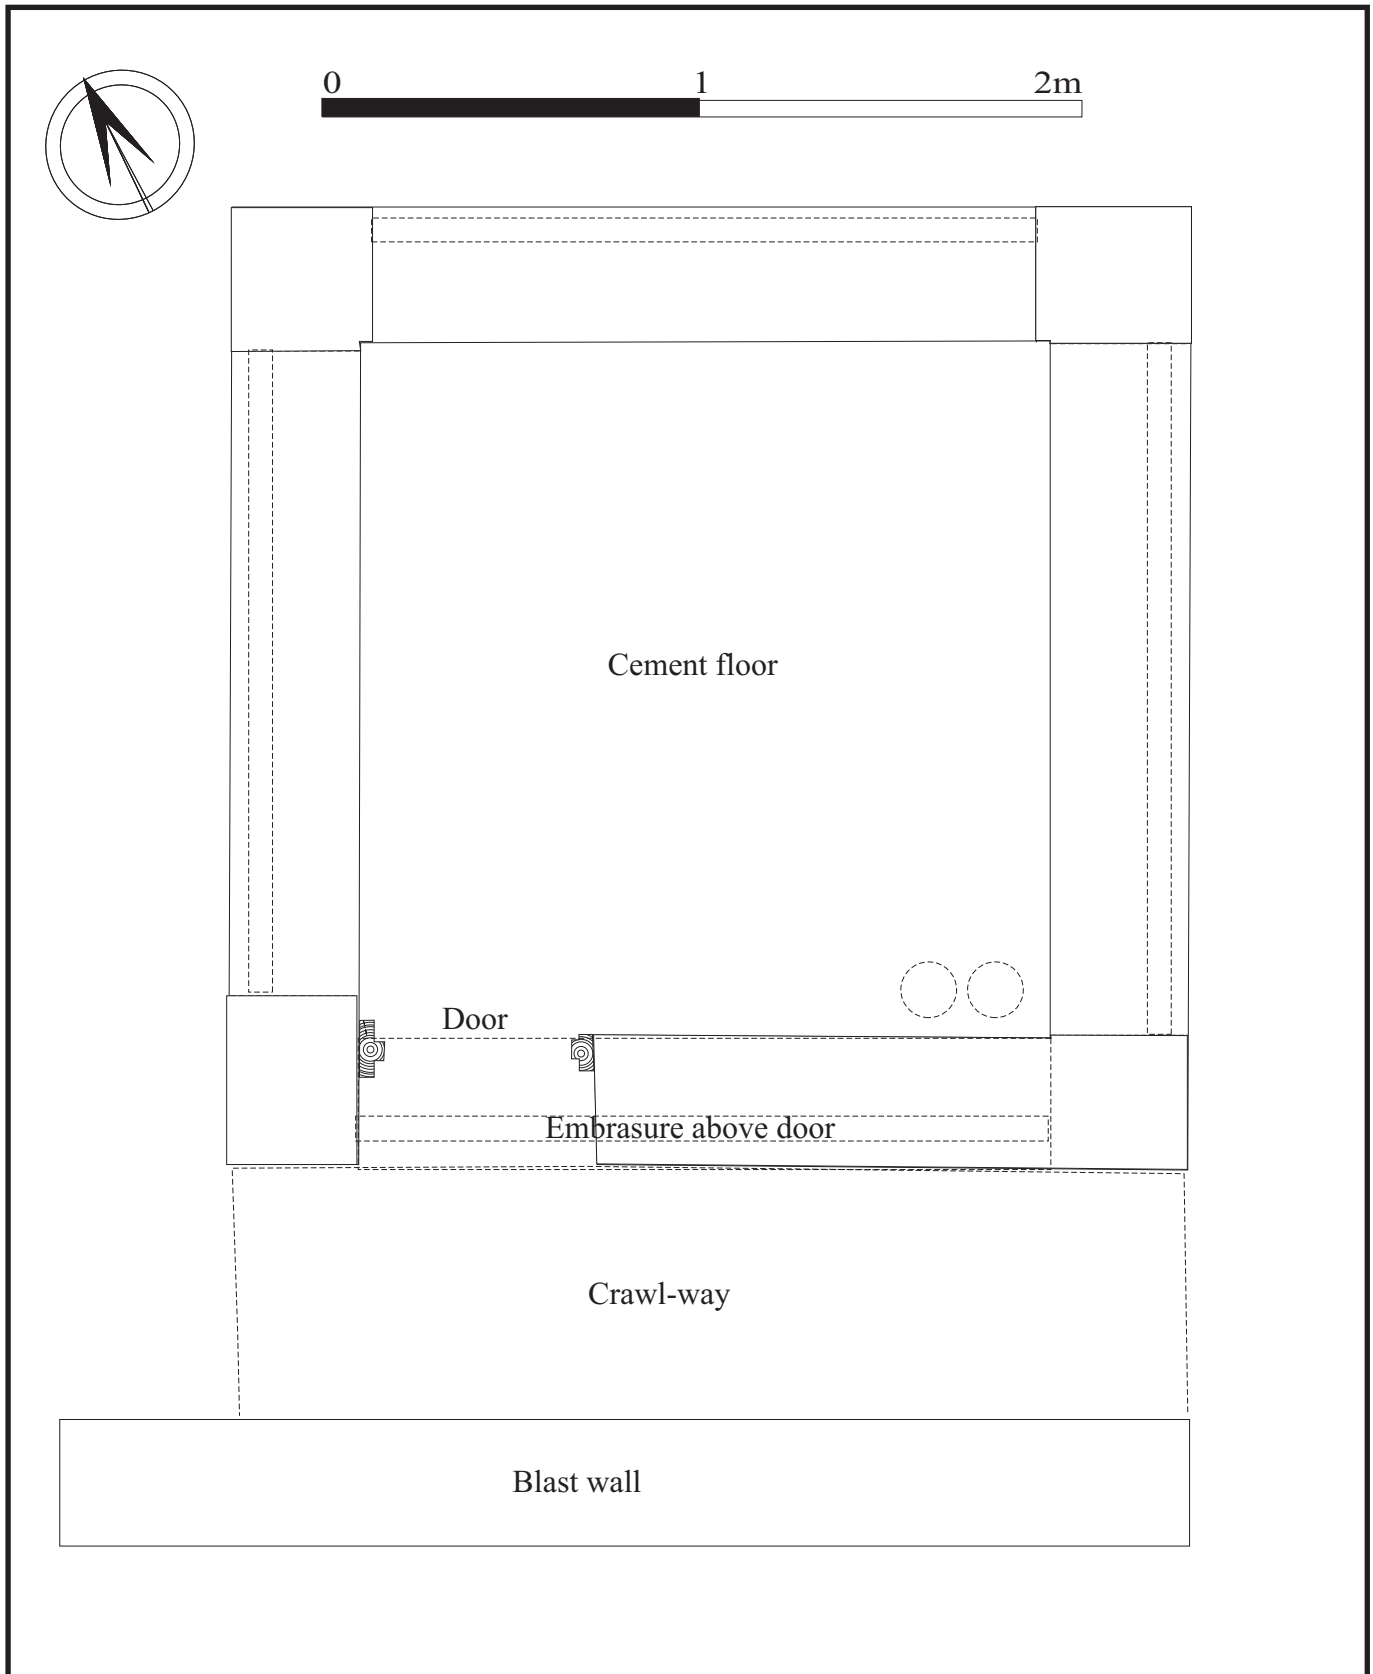
Figure 9: Ground plan

- 7.1 The structure recorded lies on the northern edge of the development site, close against the fence of the former MOD site (Fig 1). The building is square in plan (the main block being 2.53mx2.54m or 8'4" square), with a covered crawl-way on the southern side providing access to a small doorway in the south western corner (see Figs 8, 9 and 11). Subsequent development has obscured the original outlook, but the pill-box is sited to cover lower ground to the south and east. Interestingly most of its view in this direction would have been obscured by the temporary office buildings it was presumably intended to protect. It is too far from the Worcester Road to give any effective fire on an enemy approaching along the road line.
