BUILDING RECORDING AT
ROMERS FARM, BOCKLETON
WORCESTERSHIRE

WSM 41771

**Building recording at Romers Farm,
Bockleton
Worcestershire
WSM 41771**

**Mike Napthan MIFA
10th January 2010**

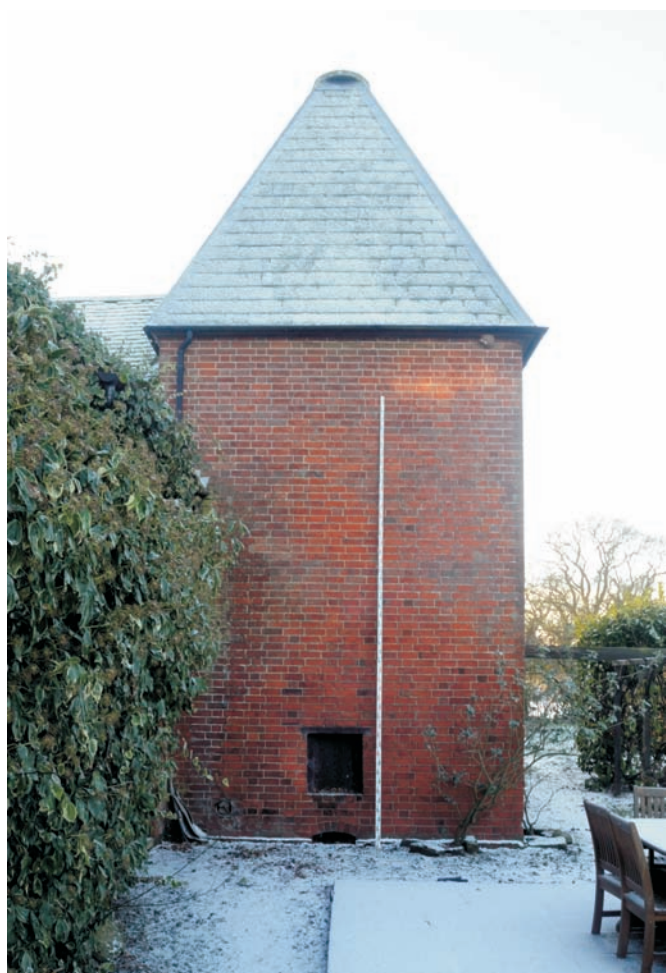
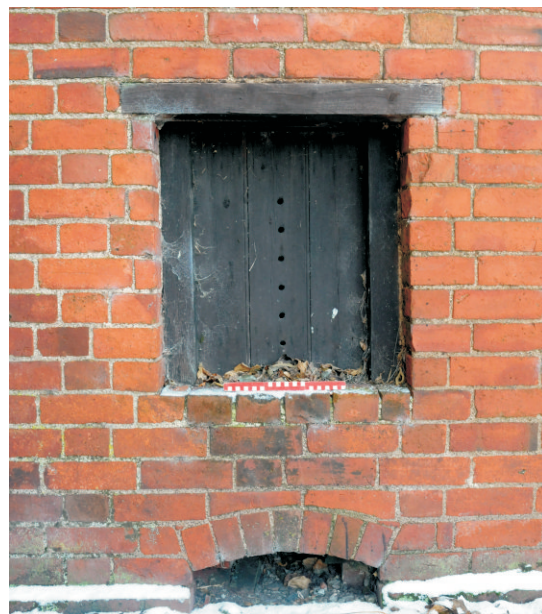
Northern elevation of hop kiln with detail of vent and flue (above)

- 6.8.2 The ground floor western window or loading door has been converted to a full height doorway with louvre above (Figs 9 and 16). The remainder of the external fabric is largely as built, with the exception of two inserted and subsequently blocked large diameter metal pipes on the northern elevation. These pipes were possibly part of a secondary forced air drying system. The kiln floor has been eroded and patched in places, and the flues are choked with debris. It is unclear how the under floor flues were operated, but it is likely that the flues served as a form of draught for the kiln, or possibly a “hypocaust” arrangement providing gentle heat. The small size of the oast reflects the small acreage dedicated to hop-growing on the farm and the kiln would only have been in use for a short period each year, as hops needed to be dried within a few days of picking (Cook and Bretherton, 1998).

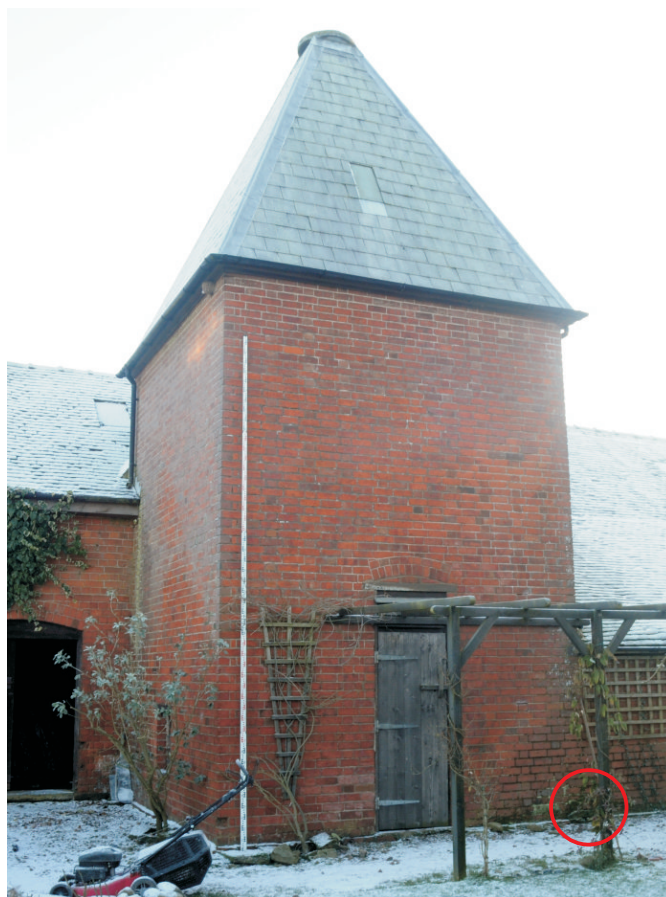
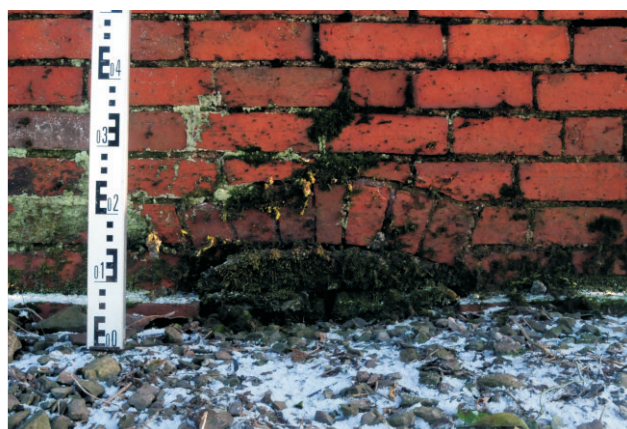
Western elevation with detail of blocked flue (ringed on main image)

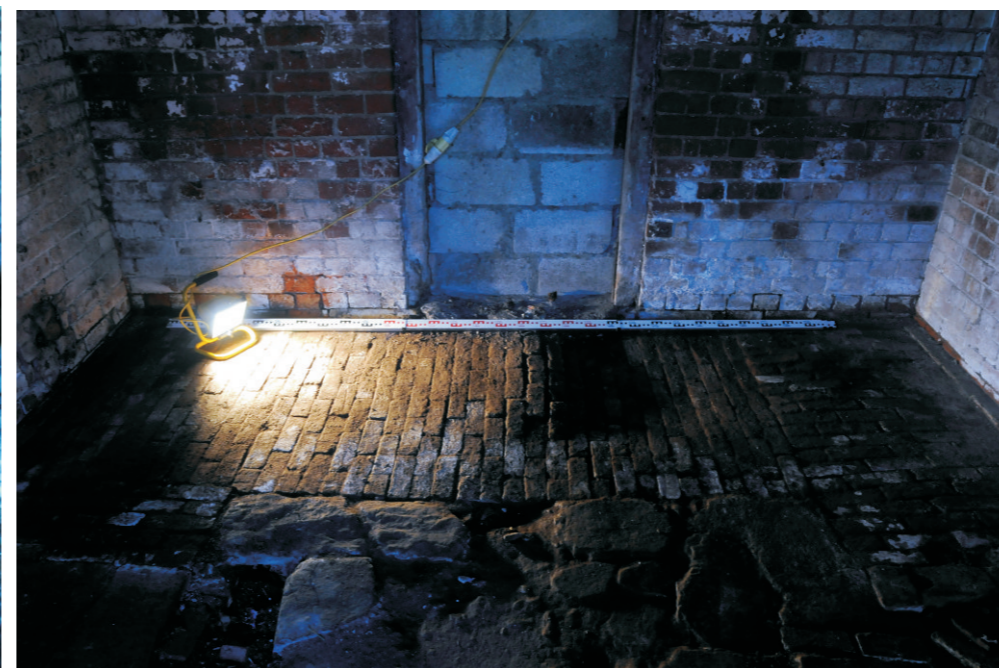
Kiln floor facing east, showing subsidence in front of doorway, probably over a flue

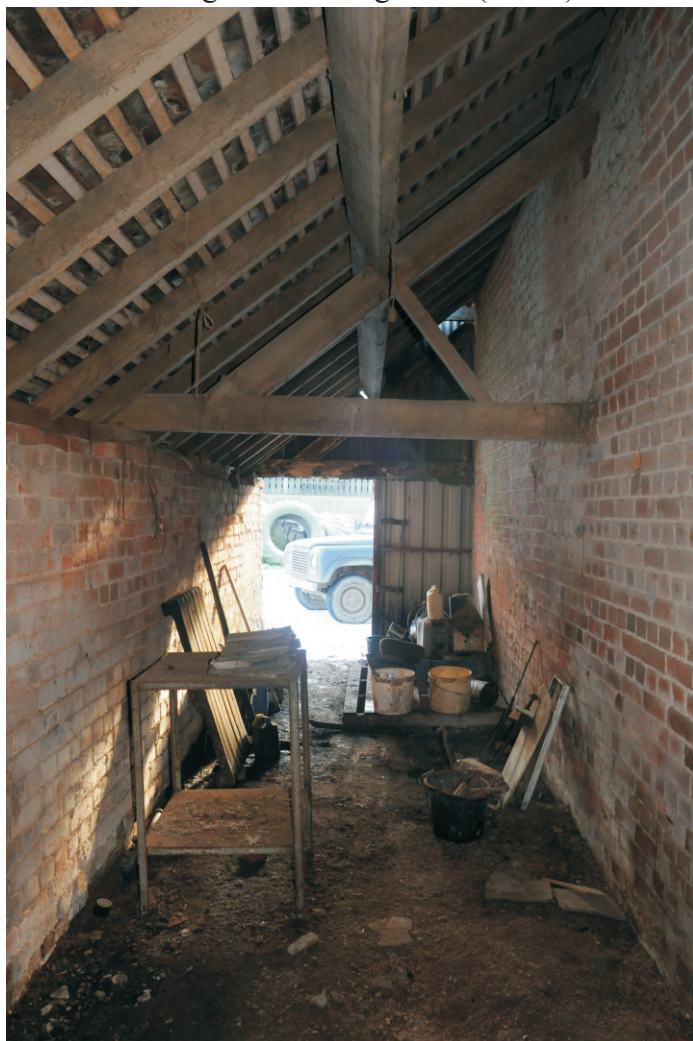
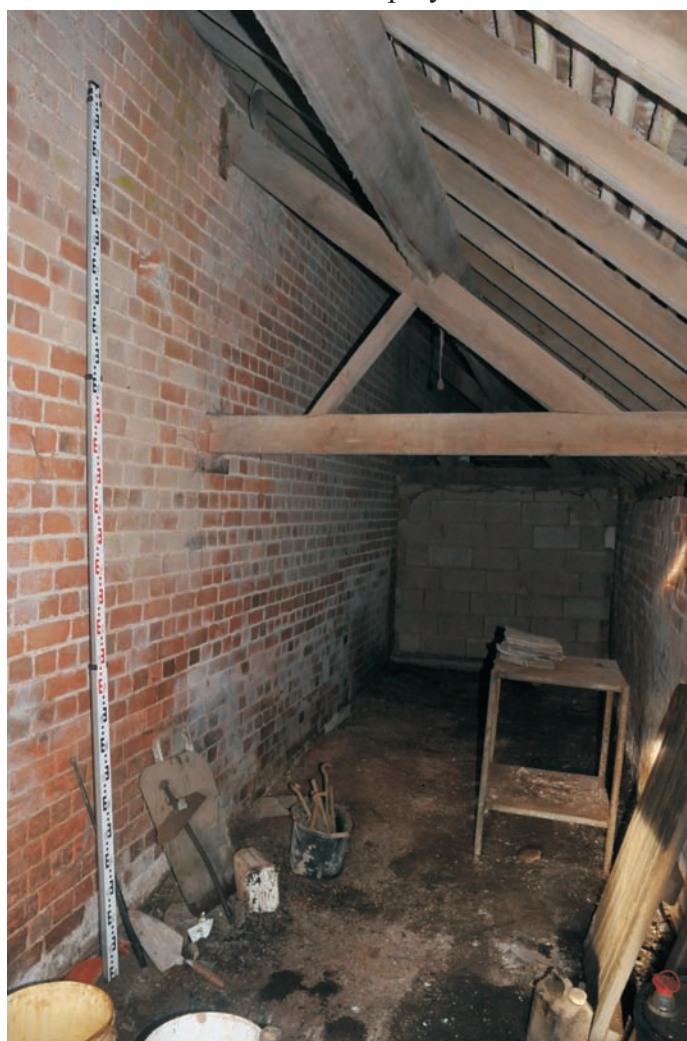
Interior of “long store” facing south (below) and north - note inserted block wall of spray/chemical store

- 6.4 *Spray/chemical store* – this room lies in the centre of the eastern elevation. The door, door frame, southern wall and floor are all recent insertions, but it appeared possible that the doorway (which extends to the eaves plate) might be an original opening. The door is of secure metal construction in a sturdy timber frame. The floor is of cast concrete, and the southern blockwork wall has been constructed on this slab. The interior of the room was largely occupied by stored chemicals, but it appeared that there were no surviving interior features of any historical interest. The block-work wall had been constructed beneath an original softwood roof truss of simple form (Figs 11 and 17).

- 6.5 *Long store room* – this room (Figs 4, 11 and 18) is accessed only from its southern end, which is entirely open other than modern cladding added to the timber gable end truss. Prior to the insertion of the spray store the present space was 13.25m long and 2.16m wide, with an effective entry height of around 1.88m beneath the eaves. This is an impractical shape for most agricultural purposes, and indicative that it probably served a specialized storage function. The 1905 sale particulars include a “horse box” adjacent to the wain-house, and it is possible that one end served this purpose. The eastern wall is of 9” brickwork (bricks being 234x112x80mm), without any original openings. A number of empty mortices in the brickwork of the western wall may relate to built in racks or fittings now lost. The floor of the room is of earth.

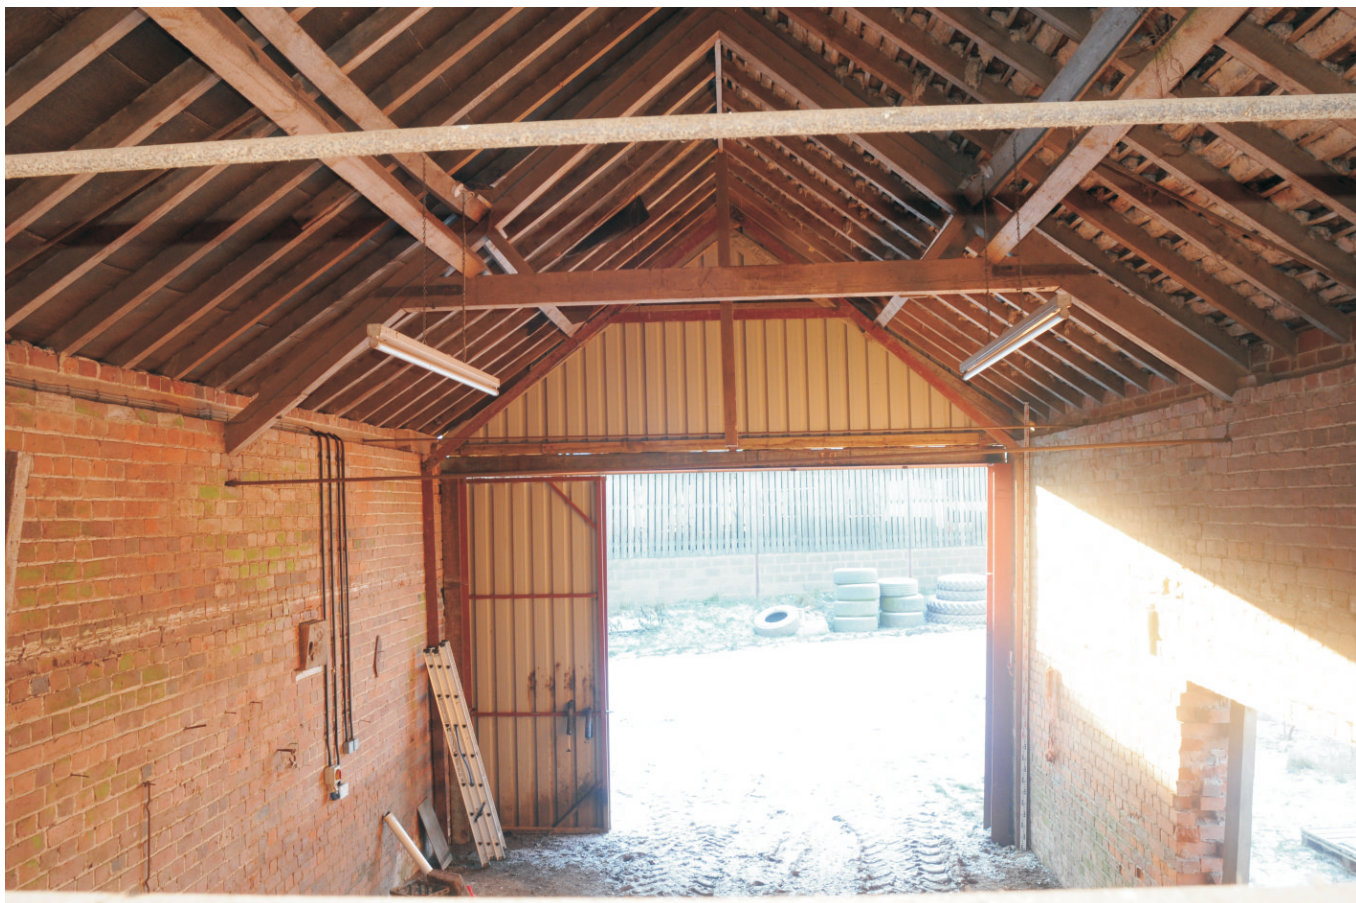
“Granary” facing south - note white line marking former upper floor level

- 6.6.3 The majority of the upper or granary floor had been removed, and only the northernmost bay and the sawn off stubs of the other bridging beams remained. The present wooden steps and balustrading to the remaining fragment of floor are recent (?1970s) insertions. If there were originally internal steps they were not at this position. The upper part of the southern gable end has also been removed, and replaced with a secondary truss and a more recent sliding metal door. A further large opening of unknown purpose has been crudely inserted in the western elevation, and this has been temporarily propped with planks. There are smaller crude openings broken into the

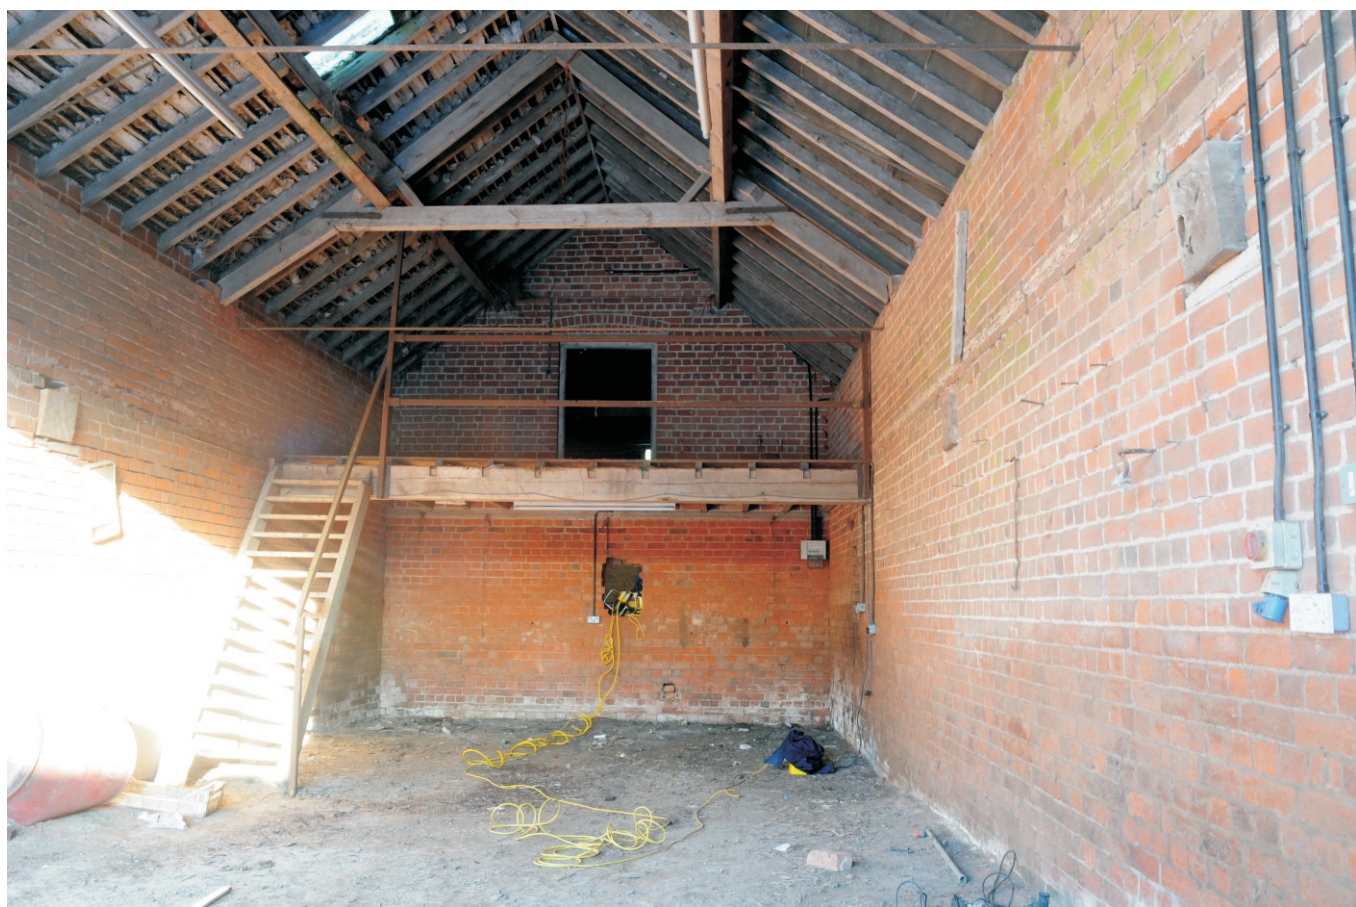
“Granary” facing north - note truncated former upper floor bridging beams

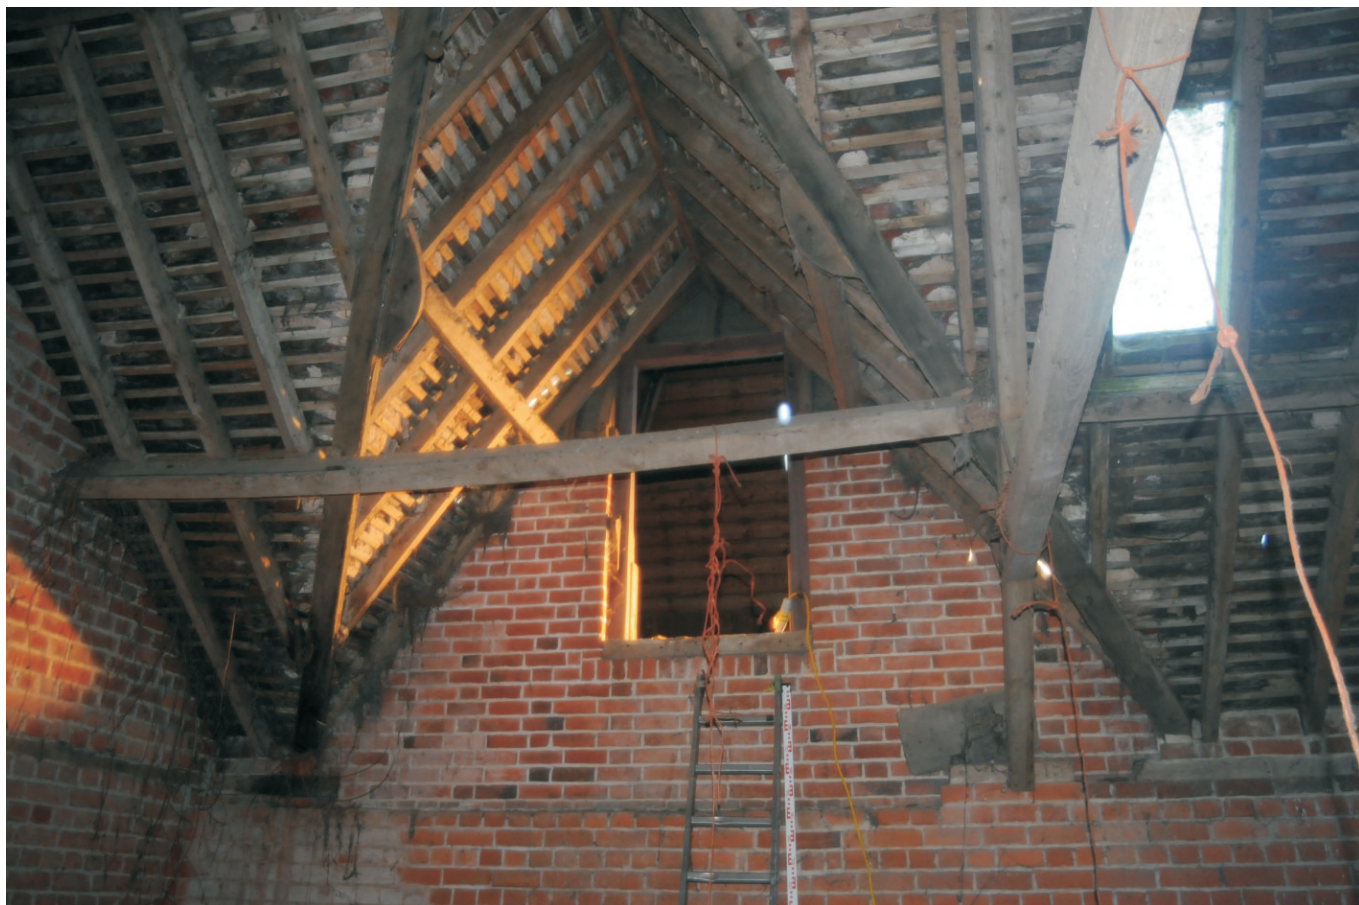
Entrance to Hop Kiln drying floor from upper floor of "Root House"

- 6.7.3 When the hop kiln was added to the western elevation (some time after the 1885 survey) the roof of the root house was partially rebuilt to facilitate provision of a doorway from the upper floor to the drying floor of the hop kiln. As usual the drying floor of the kiln was placed higher than the packing floor, and presumably accessed by steps now lost. The upper floor of the root house has been partially removed, but the majority of the joists remain, and these show no sign of the openings usually found in hop-packing floors (known as “presses”) used for filling hop-pockets, which were hung from the underside of the presses and filled from above by a labourer pressing the hops in with his feet, or in some cases by screw presses.

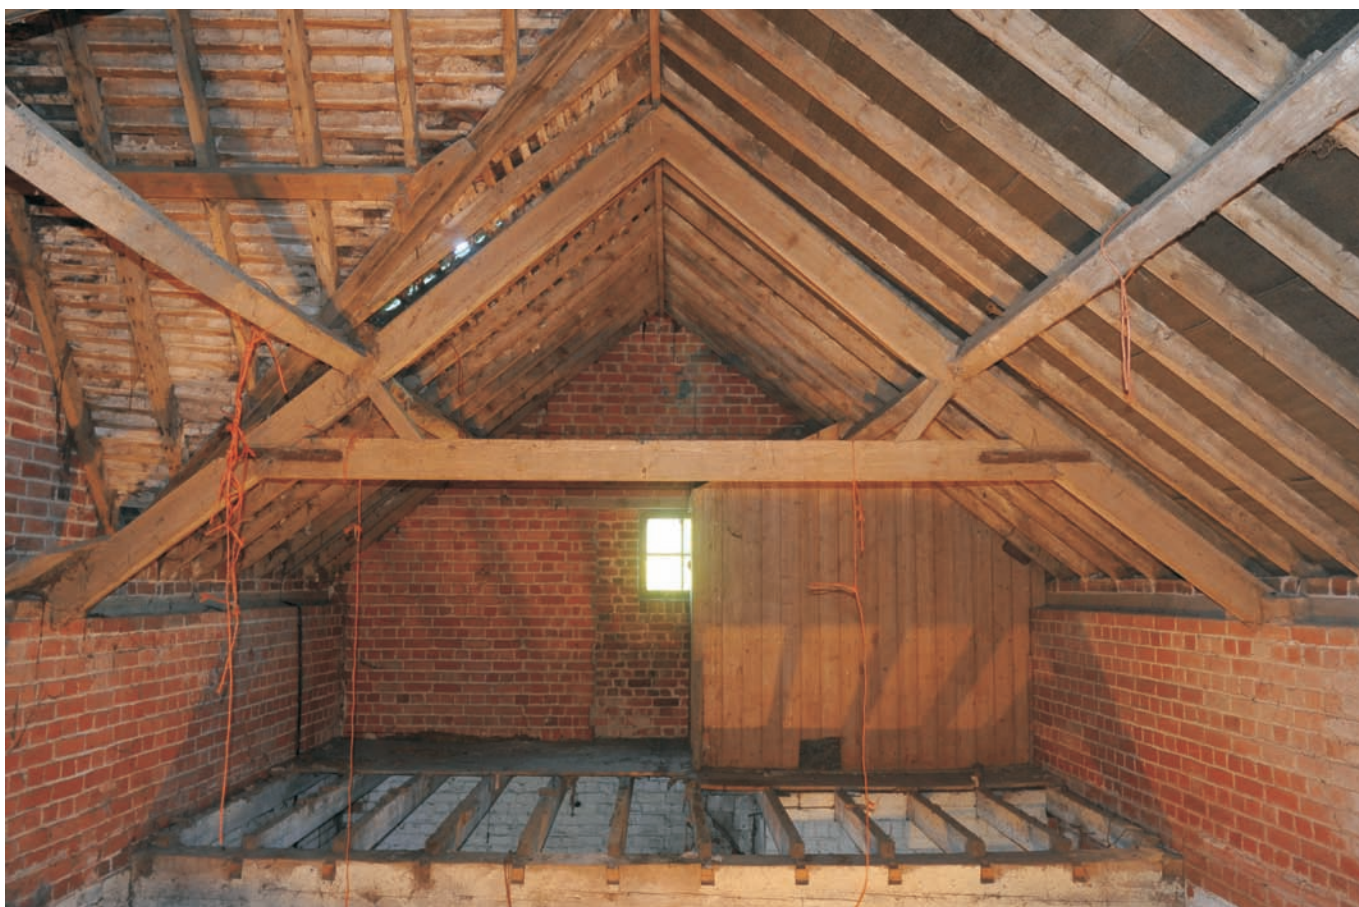
Northern end of upper floor of "Root House, showing matchboarded enclosure of inserted staircase"

Twentieth century alterations to the fabric included the removal of the external covered staircase at the north end of the building, and its replacement with an internal stair. This occurred in the early years of the century. The small northern window was also inserted at this time. Around the mid 20th C the workshop door was crudely widened and the hearth and chimney removed to facilitate use as a car garage. In the latter part of the 20th Century the wain-house was also adapted for modern vehicles by removing the majority of the granary floor and the upper part of the southern gable end. A large opening was also crudely made in the western wall. Within the probable root house the joists were removed from the central bay of the first floor. A steel-framed sliding steel door and metal cladding have been added to the southern gable end in recent years.
