CHESTER HOUSE  
17 NEW STREET, STOURPORT-ON-SEVERN  
WORCESTERSHIRE

# Chester House 17 New Street, Stourport-on-Severn, Worcestershire

Mike Napthan MCIFA

21<sup>st</sup> October, 2017

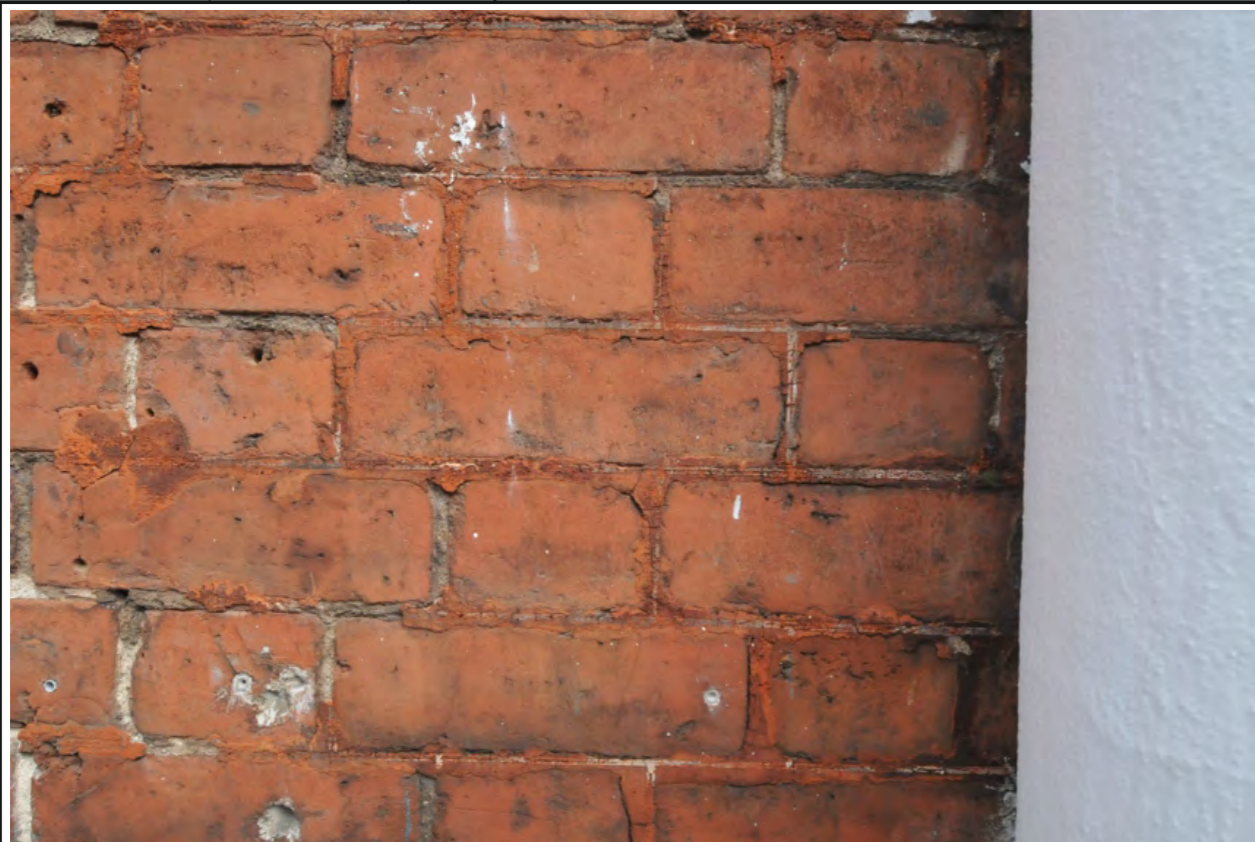
Detail of struck false jointing and brickwork colouring

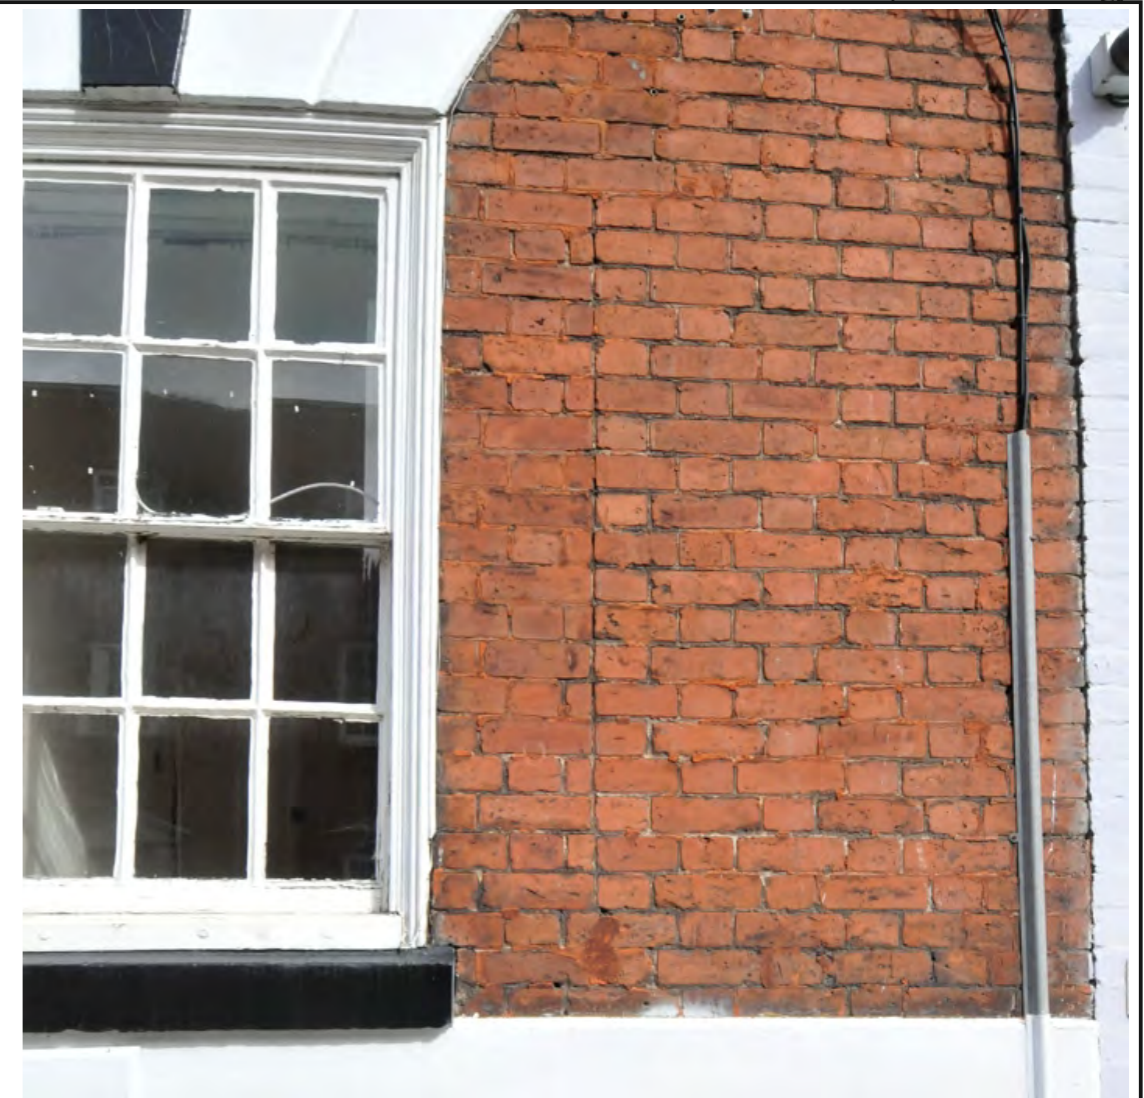
Area of brick infill of former window opening - note vertical joint

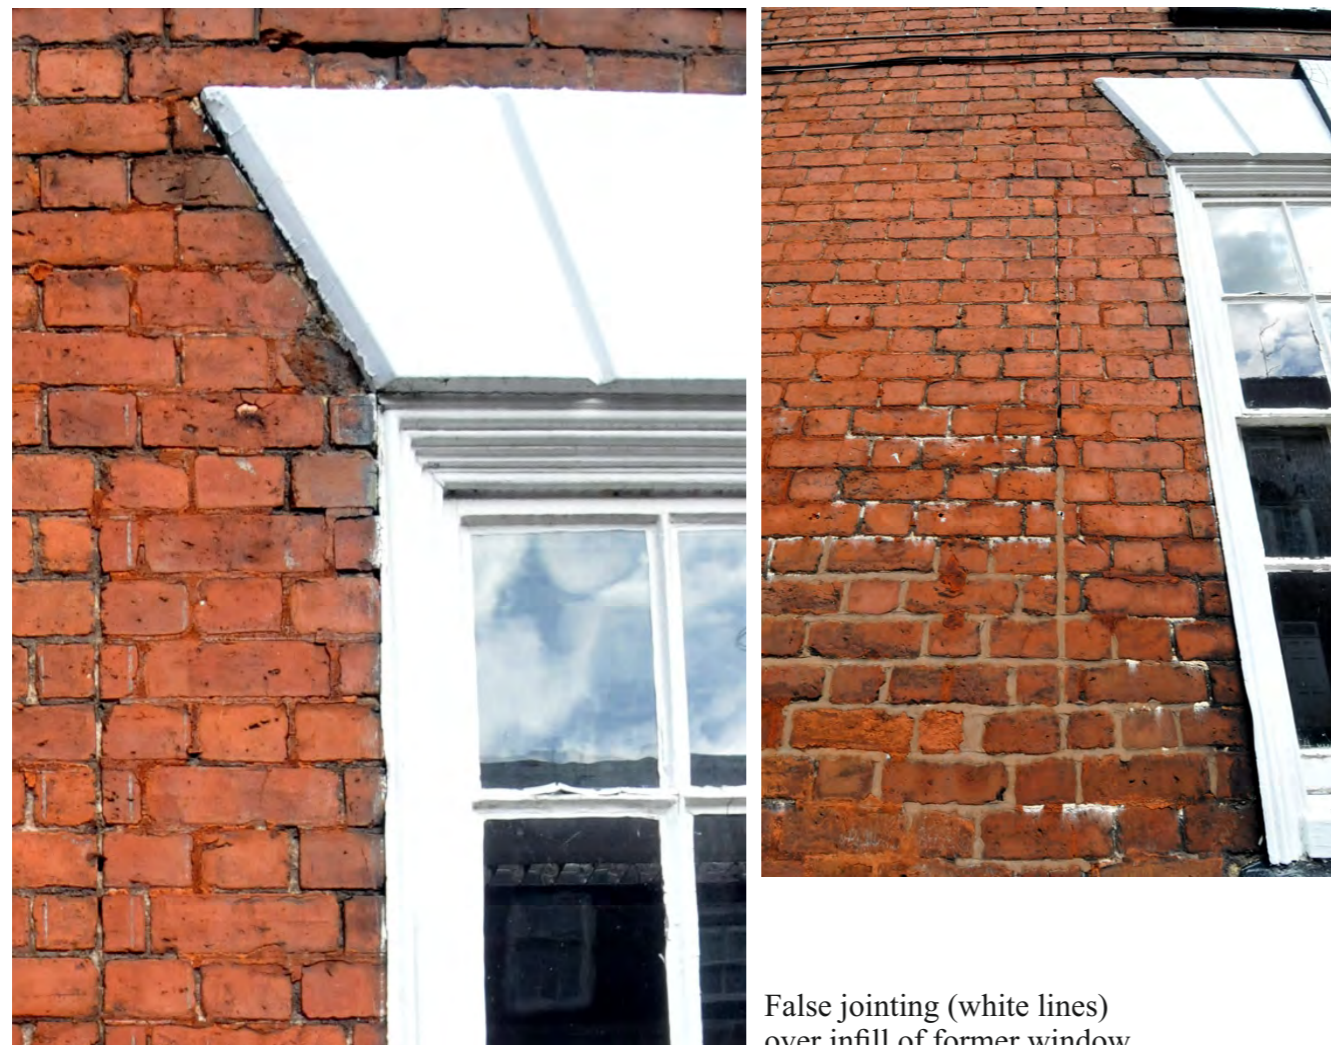
False jointing (white lines) over infill of former window

Area of brick infill corresponding to former window position

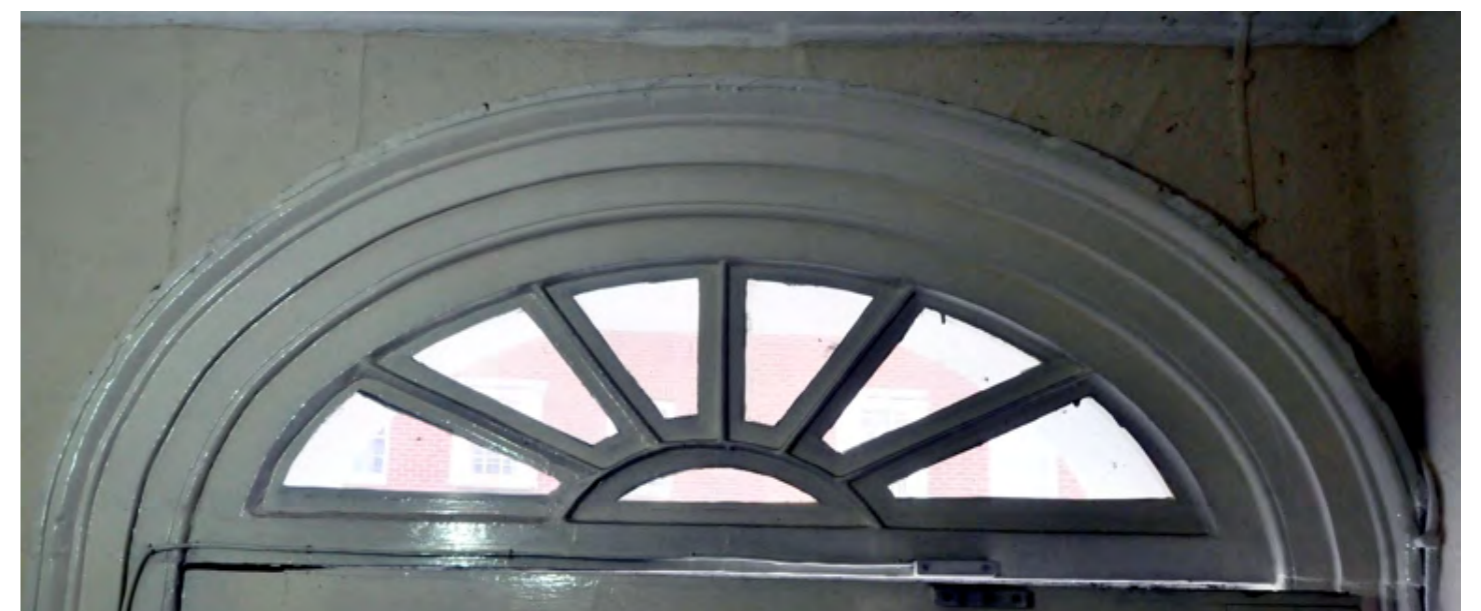
Figure 3: Elevation details

Detail of interior of cast iron fanlight glazing bars

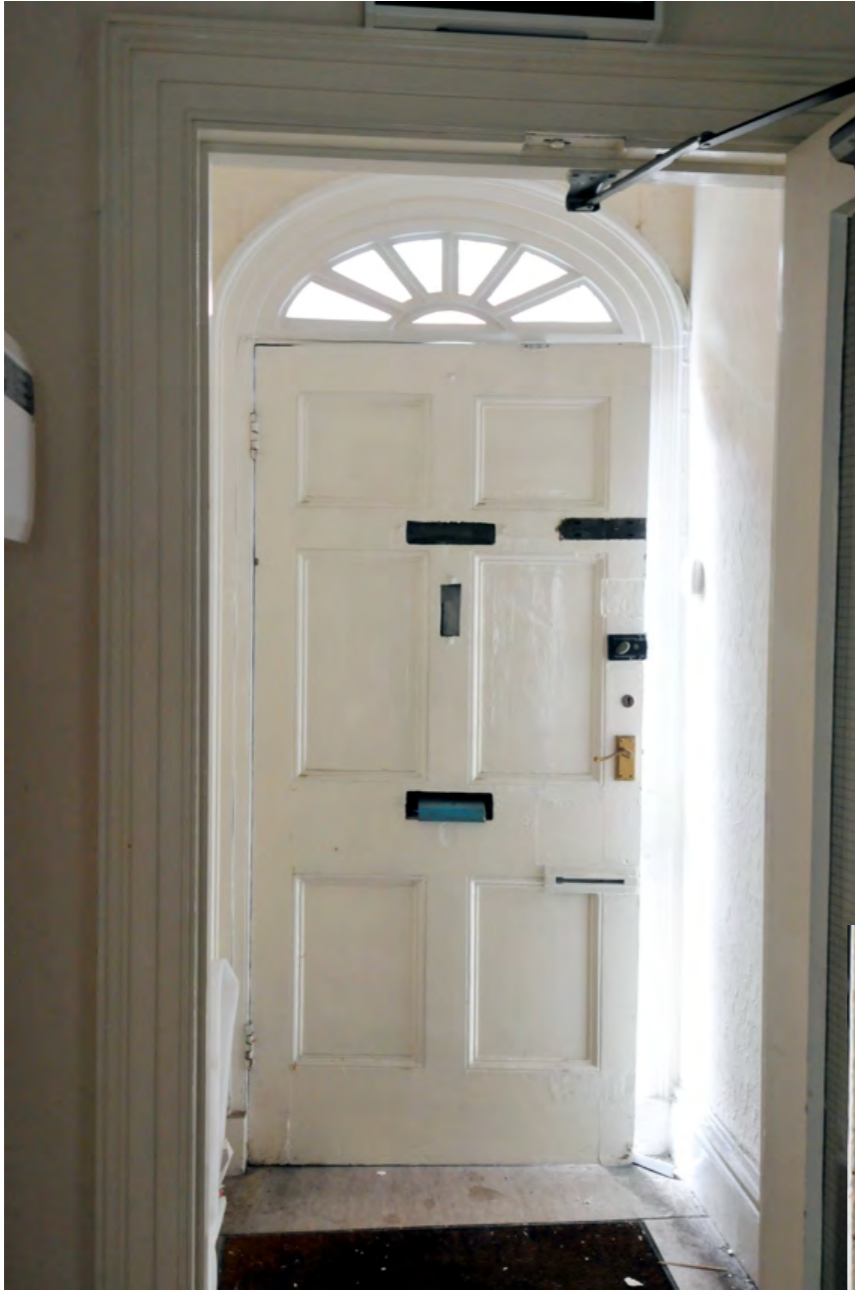
Front door

The entrance hall is approached through a small draught-lobby of early-mid 20<sup>th</sup> Century origins – the ceiling mouldings continue through to the main part of the hallway, as do the skirtings. The inner door is modern fully glazed softwood, probably replacing a half-glazed door with stained glass, typical of late 19<sup>th</sup>-early 20<sup>th</sup> C lobby arrangements. The front door itself is of 6 panel construction; typical of the early-mid 19<sup>th</sup> Century and surmounted by a half-elliptical cast iron fanlight. The door bares traces of several previous lock arrangements; all apparently of mid-19<sup>th</sup> C and later character. The hinges are butt hinges, which also suggest a date for the present door hanging of circa 1830 or later.

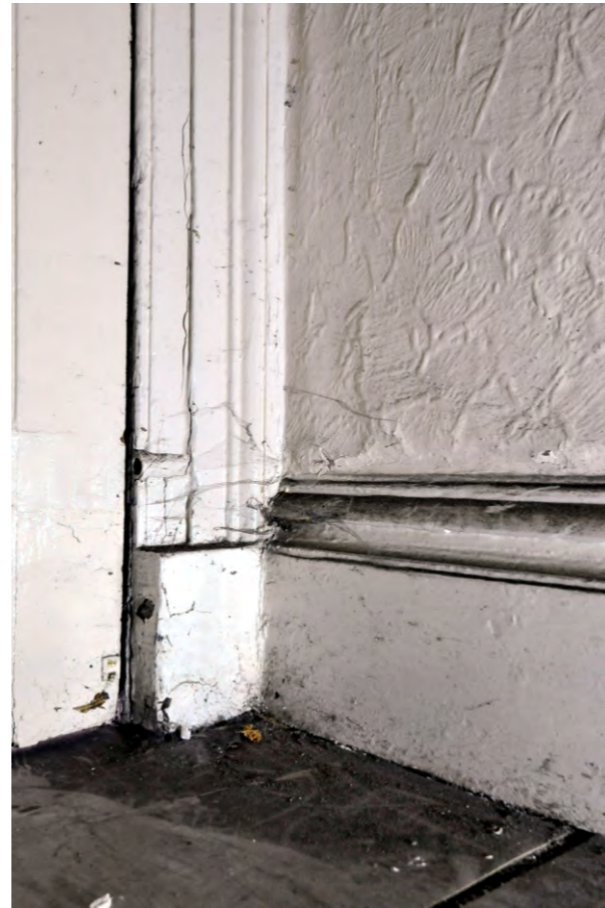
Detail of lobby skirting and doorcase

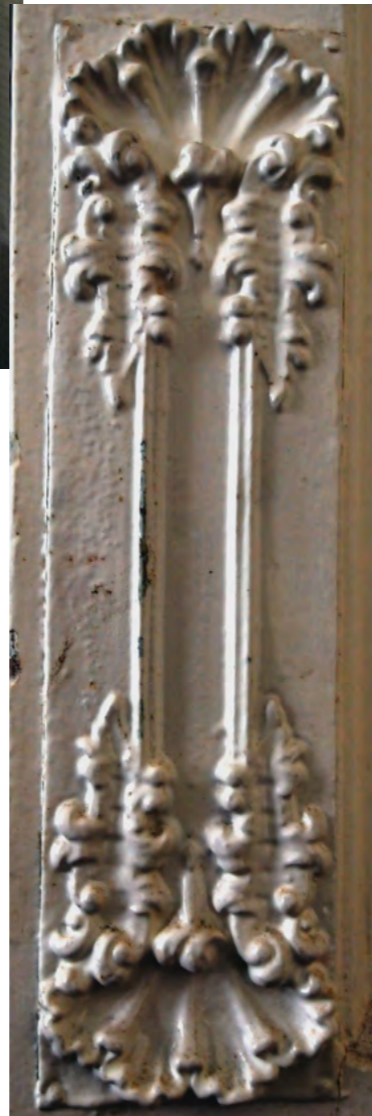
Finger-plate detail

The northern front room is lit by an 8 over 8 sash window with folding internal shutters. The shutters are of tri fold design, internally grained, the hinged wings being of three panels with applied ogee mouldings. The shutters retain original early 19<sup>th</sup> Century fittings. The window sashes also appear to be original and early 19<sup>th</sup> Century in date, but it should be noted that the windows have either been relocated or reduced in width as the brickwork opening has been infilled on the northern jamb. It is also of note that this window stands in a full height recess with a reeded window case and blank squares to the upper corners. The jambs are splayed and panelled to match the shutters. The window case is very similar to the hall door case within this room. The hall door is of six panel design and bears a particularly fine cast finger plate.

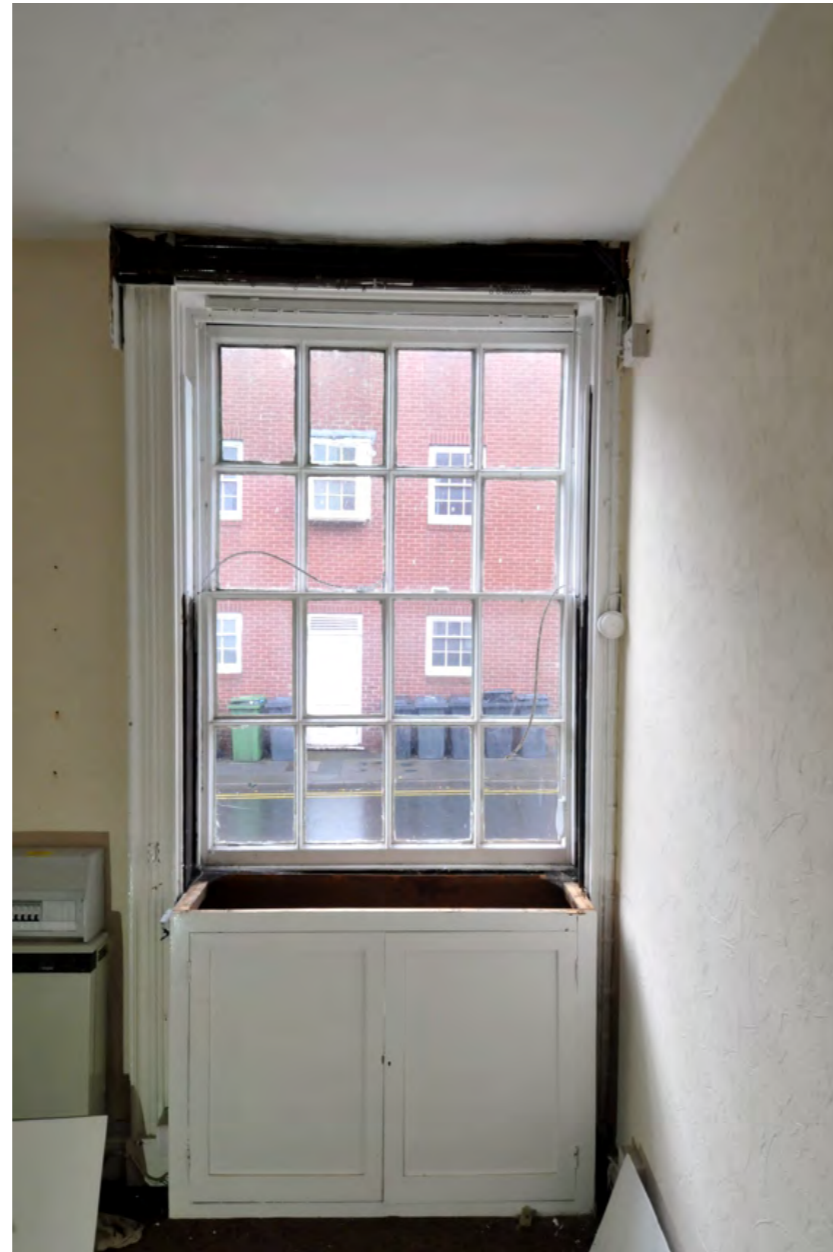
Window to front elevation - note that the window is both off-centre and partially obscured by partition wall. Cupboard is later addition replacing original vertical sliding shutter box

The southern front room is rather narrow and has a very awkwardly placed 8 over 8 vertical sliding sash window. The window was originally provided with vertically sliding internal shutters – the pulley wheels and rebates for the shutters are still visible behind the flap-doors. The shutter box, below the window, has regrettably been removed and replaced with a crude cupboard, but sufficient remains to allow accurate reproduction of the shutters if so wished. It is noteworthy that the treatment of the window shutters is different between the two front rooms, despite the window joinery appearing to be contemporary. Vertical sliding shutters possibly reflect a need for greater security in the southern room. The window case is similarly reeded with blank corner squares to that in the northern room. The upper part of the window case/architrave retains a grained finish where it was protected by a 1960s pelmet. The partition wall to the north side of the room impinges on the window architrave in a most awkward manner, and it appears very probable that this wall is a later (mid 19<sup>th</sup> Century) insertion.

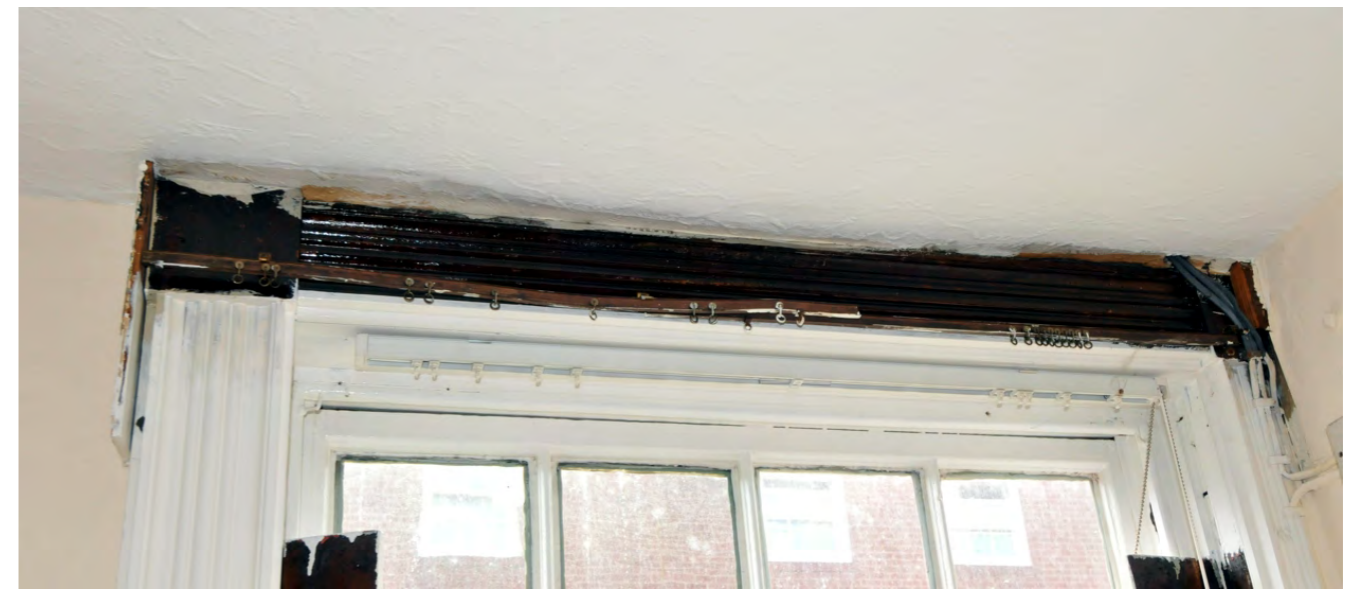
Front southern room window with evidence of former vertical sliding shutter

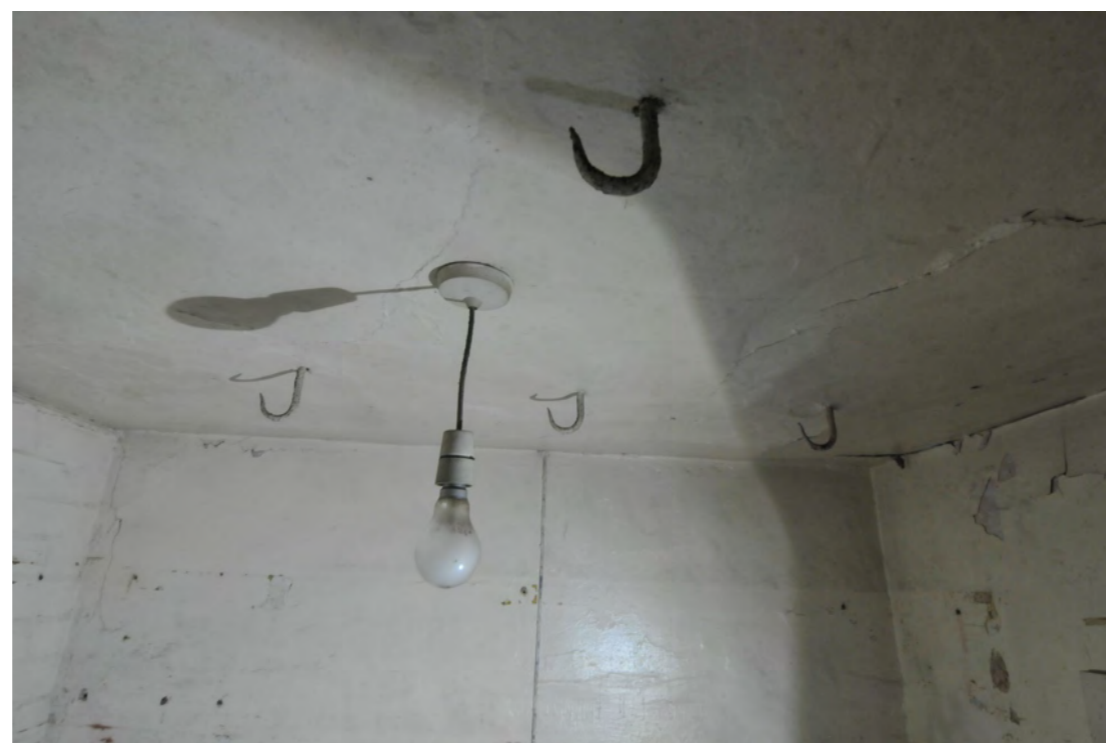
Former cold box/drying chamber (originally part of NW room, now accessible only from northern front room through inserted doorway)

To the north of the fireplace an opening has been created through the wall to access a former salting chamber/ dry storage area, originally part of the back kitchen. In recent times this square chamber was used as a storage area, but ceiling hooks and a vent to the exterior indicate the likely original use for hanging meat and other foodstuffs. The floor is of quarry tile of mid-late 19<sup>th</sup> C date. The eastern wall is of mid 20<sup>th</sup> C brick, probably contemporary with the 1950s-early 60s flat roofed rear extension.

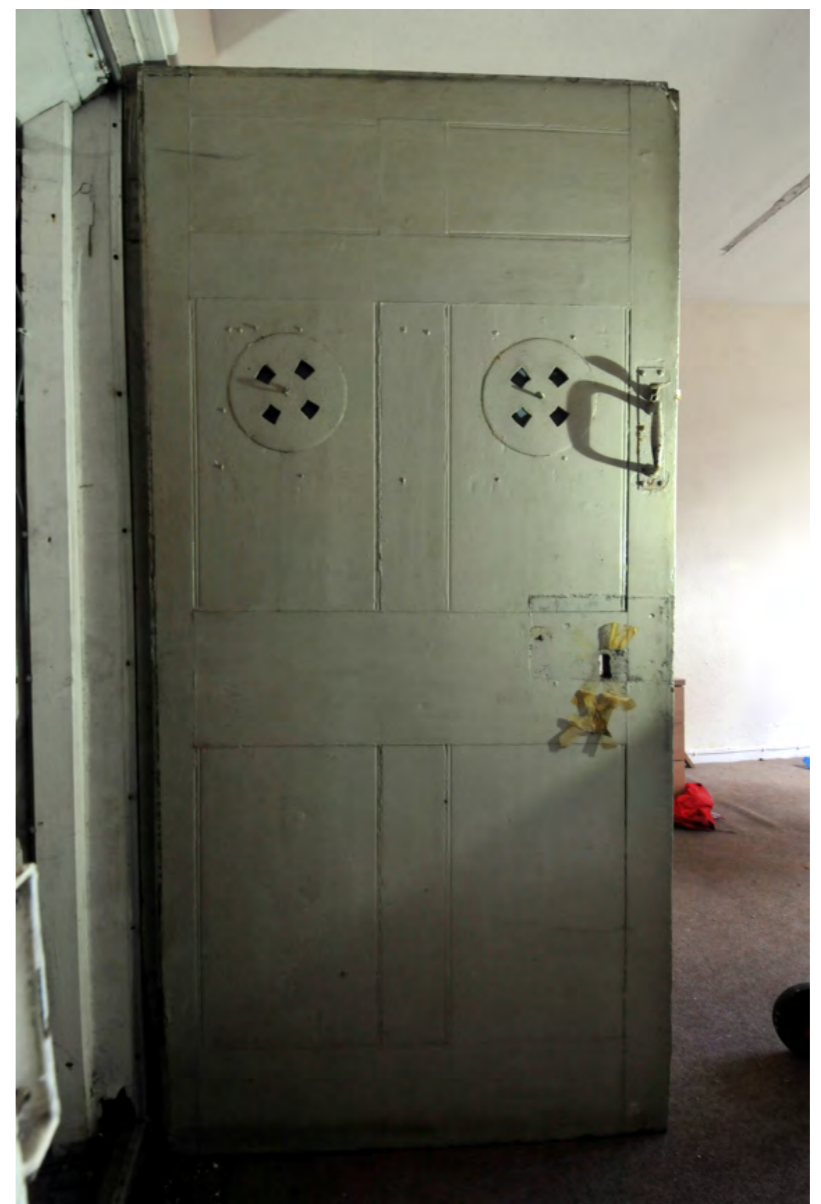
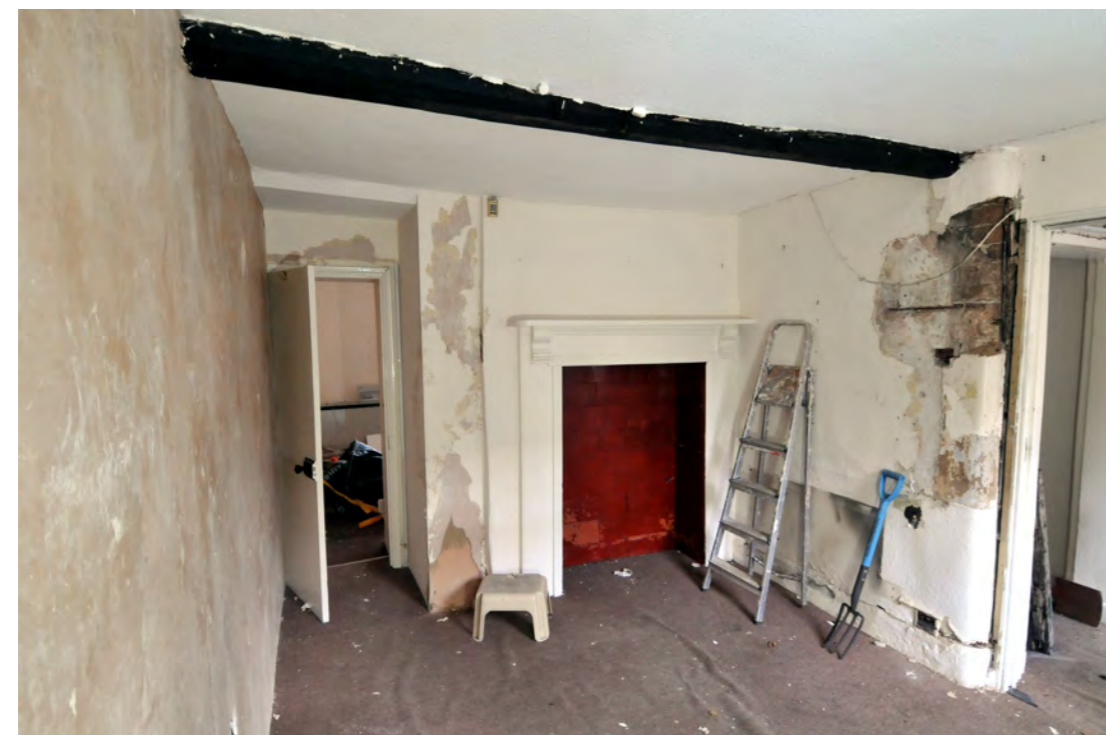
Southern rear room (inserted doorway to front room)

In the south eastern corner of the room there is a doorway through to the rear wing – this appears to be a relatively recent (early-mid 20<sup>th</sup> Century) opening.

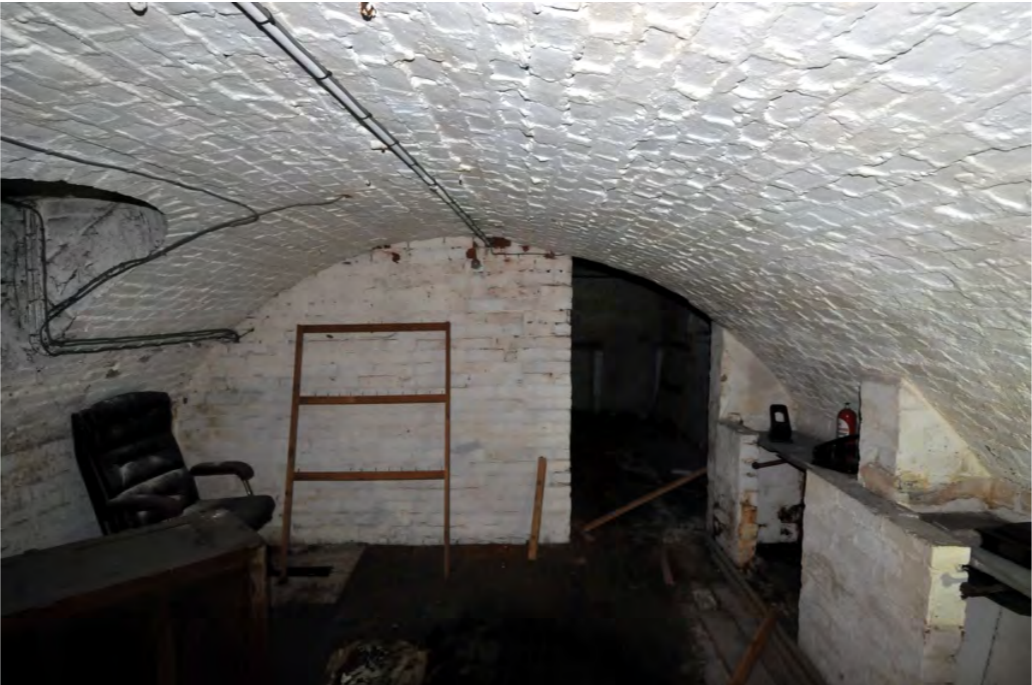
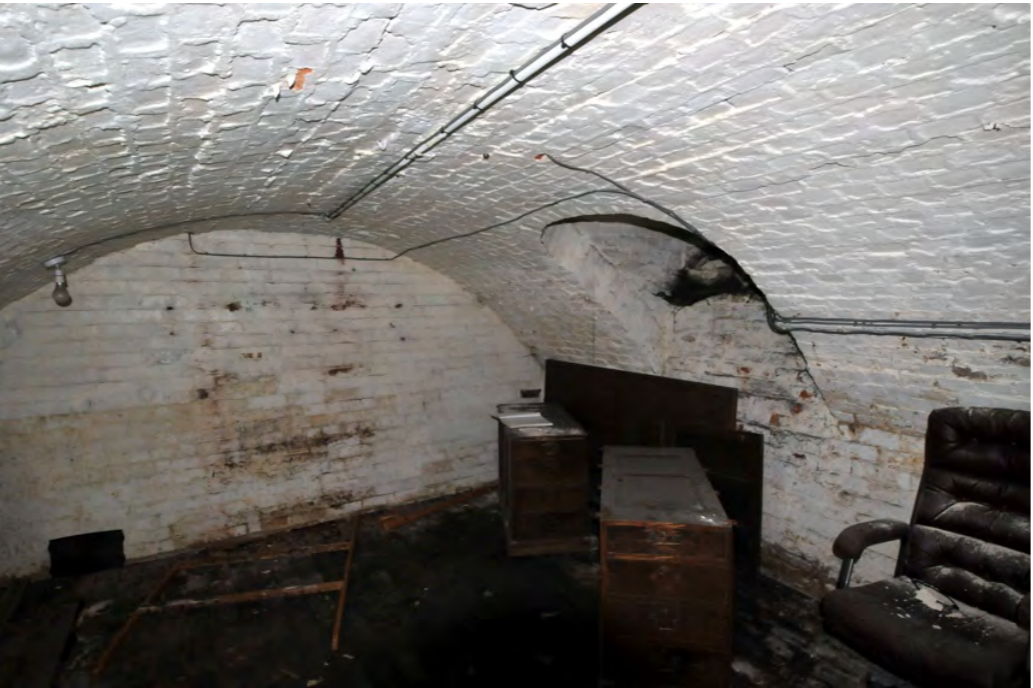
Southern cellar facing north

Southern cellar facing south

At cellar level there is a brick vaulted cellar under the southern half of the frontage, whilst a conventional cellar occupies the area beneath the northern front room. The cellars are distinctly different in character, brickwork and plan form. The sequence of cellar development is unclear, but as there is no evidence of an independent entrance to the southern cellar this vaulted area most probably was constructed after the northern cellar. There are some indications that the northern cellar entrance has been altered, but the alterations do not necessarily relate to the construction of the second cellar. The brick partition between the cellars is of similar construction to the vault it abuts. It should be noted that the northern end of the vault is self-supporting, not built over the wall. Whilst the nature and sequence of the cellarage is unusual, the cellars themselves are individually of conventional form. A bridging beam supports the ground floor over the northern cellar, and the oak floorboarding above is exposed. The cellar formerly had a lath and plaster ceiling, but this has been entirely removed. There is a substantial corbelling to support the hearth (and possibly part of the chimney-breast) of the fireplace of the northern front room. Some of the floor joists have been replaced in modern machine sawn softwood; the original joists appear to be of Baltic redwood.

In both cellars there are the remains of brick and slate shelving units, but these provided only limited storage space. There is no evidence of the cellars having been “habitable” space, despite the respectable headrooms and comparatively dry conditions. It is likely that there were originally small windows to the street frontage, but these have been infilled and provided with vents. It is notable that the cellar door was provided with circular (and apparently controllable) vents, now blocked.

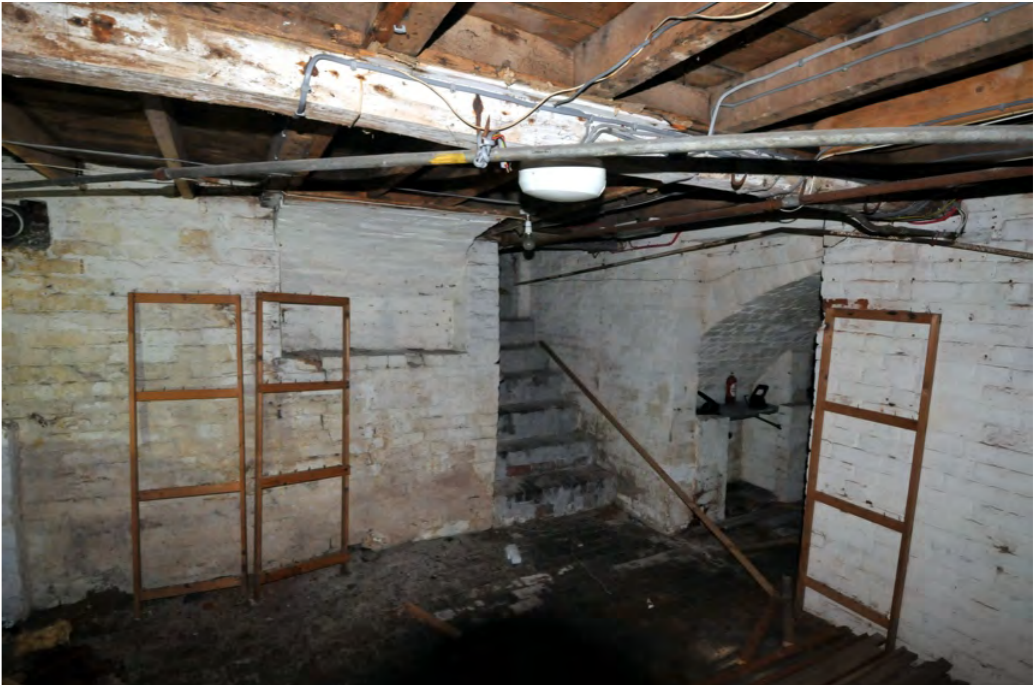
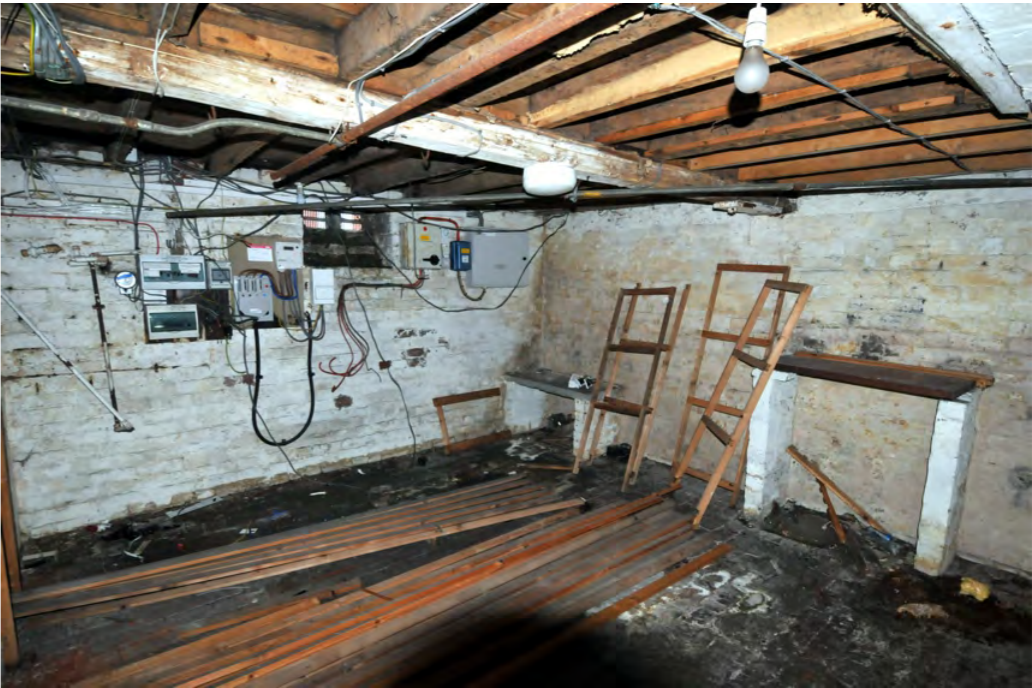
Northern cellar facing south-east

Northern cellar facing north-west

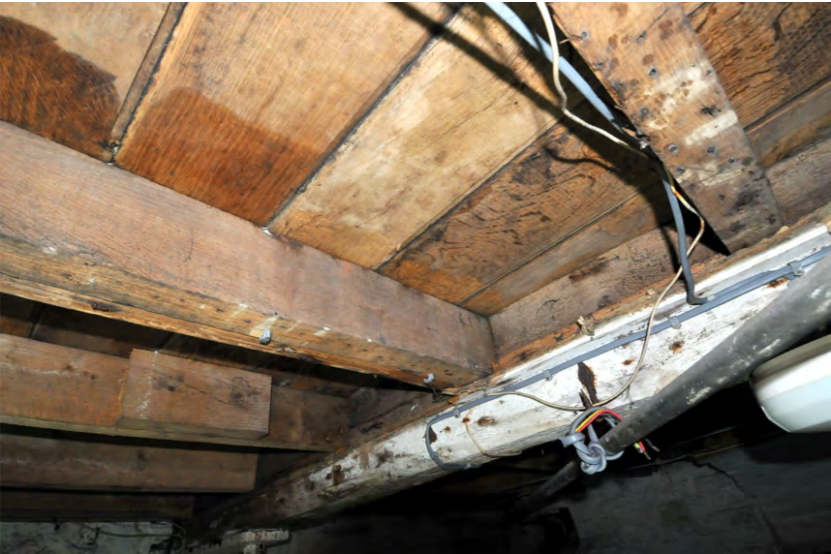
Underside of oak boarding

Whilst not presently visible, the floor of this room is of good quality oak boarding, probably of early-mid 19<sup>th</sup> C date (visible from cellar). The northern room is probably that described in 1826 as *“a good dining room in front”*.

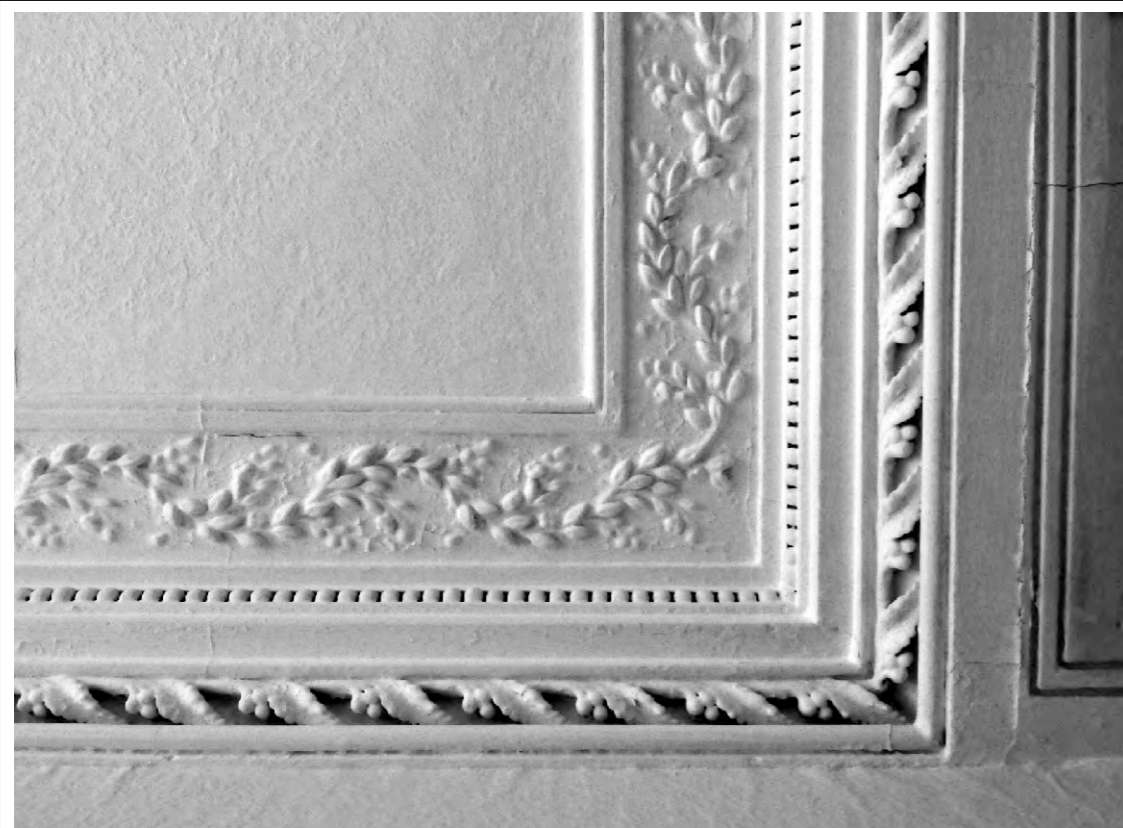
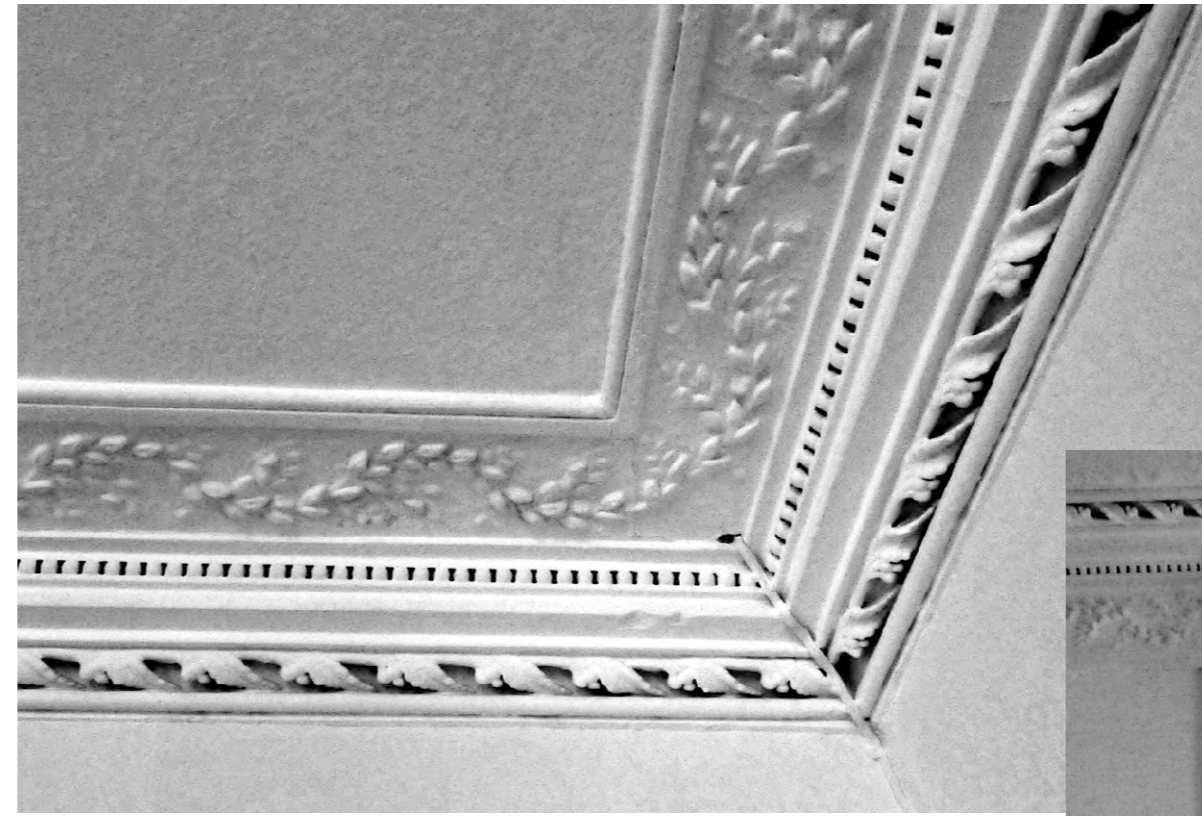
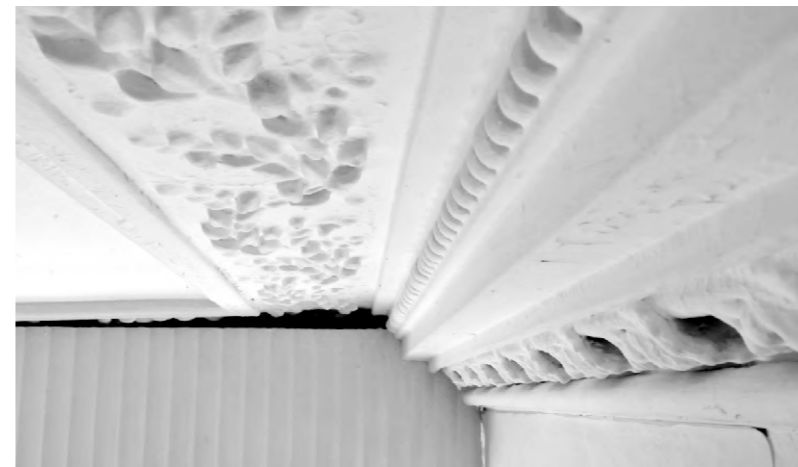
Figure 11: Detail of first floor front ceiling mouldings

Downstand soffit moulding (scars relate to removed flurescent strip lights)

The northern front room at this level is the largest and most ornate in the house – it is undoubtedly the “handsome drawing room” of the 1826 description. The ornate plasterwork appears to be a little later than 1826, however – possibly 1830s. It is unlikely that the plasterwork was installed at the time of construction of the building, but probably added during the occupancy of Mr Lewty. The room is lit by two 4 over 4 sliding sash windows in good quality full height window-cases with splayed sash-boxes and reeded architraves. The glazing, in horizontal format, is somewhat of a local peculiarity noticeable locally in Stourport and occasionaly Kidderminster, but unknown in the central and southern parts of the county. It may reflect the work of one or two local joiners. The fenestration to this room is also notably off-centre; the northern window being hard against the party-wall. The reason for the imbalance is unclear – there is no external evidence that the windows have been re-located. Externally this imbalance is less visible as the façade extends some 22-24” to the north of the window jamb – internally the jamb is cramped against the wall. It is possible that an additional brick lining has been added within the room or, possibly the “party wall” is of more than double thickness. The window sashes have, in part, been replaced with modern reproductions easily identifiable by heavier glazing bars.

The ceiling is divided lengthwise into two panels by a downstand containing a substantial bridging beam. There is surprisingly little evidence of deflection in this beam, despite the long span -this hints that it may well be flitched. The plasterwork of the beam casing is not provided with a roundel or similar for a central pendant light (which were common by the 1840s), and it appears that the room was lit by wall-lights originally. The plasterwork is of good quality, and may be broadly dated to c.1820-40 by comparison with 77 Montpellier Terrace, Cheltenham, constructed originally 1822-25 (Napthan 2017).

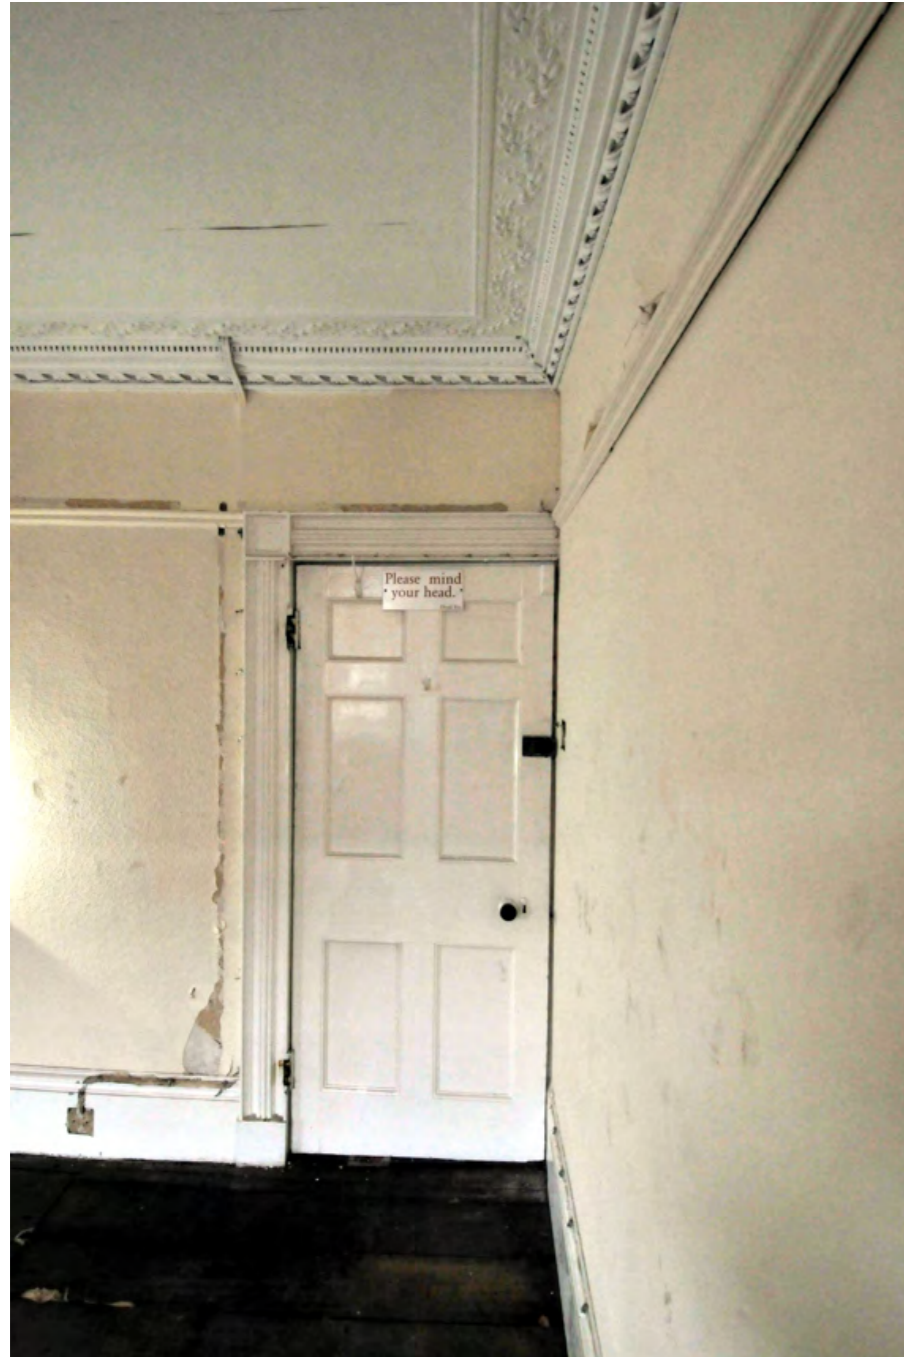
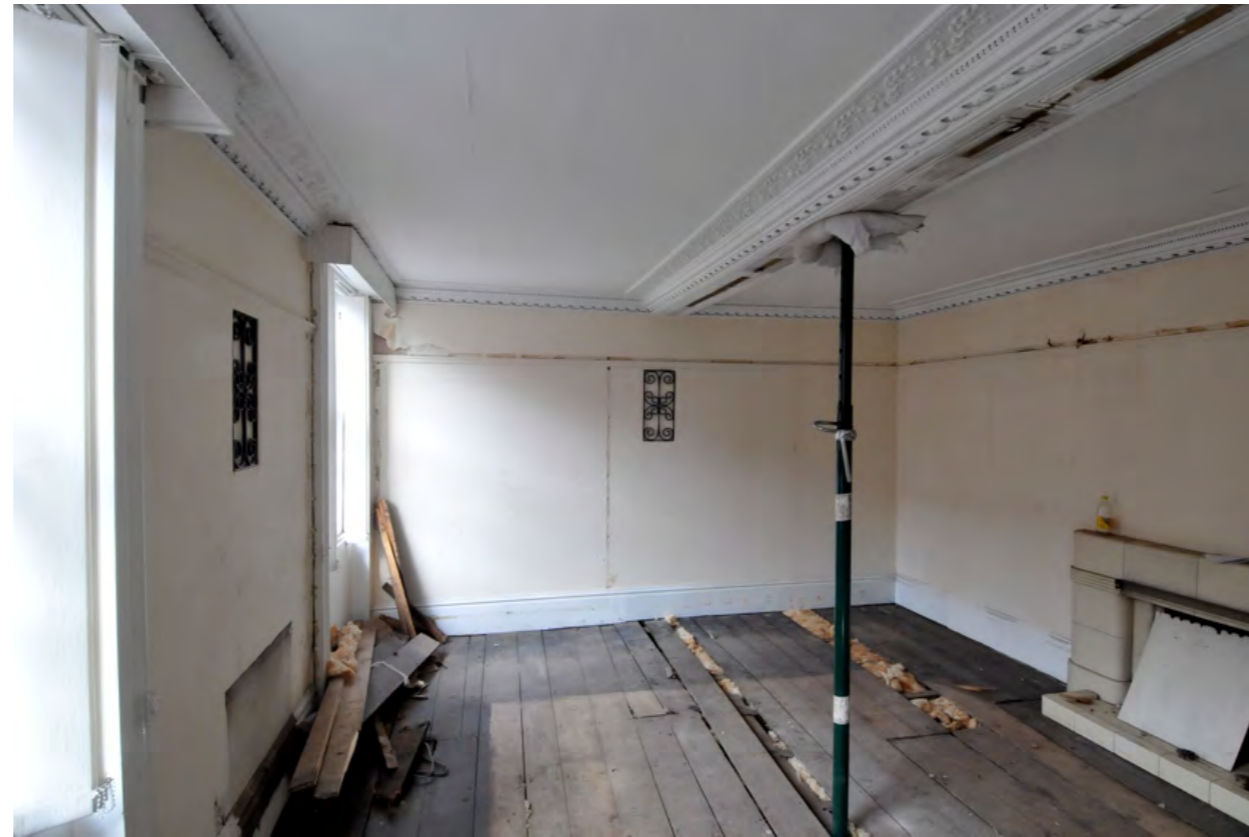
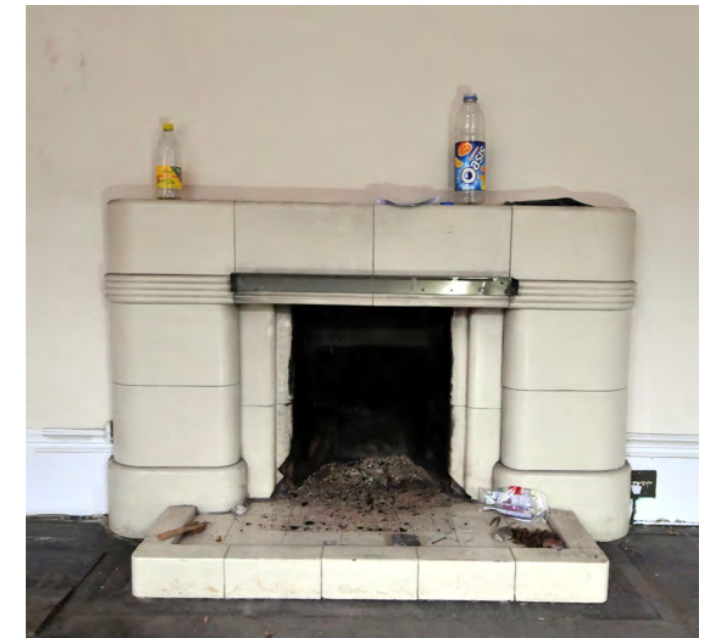
1930s ceramic fire surround

Figure 12: First floor front northern room details - nb the wrought steel panels conceal former recessed lighting

The floor of this room is of moderately wide oak boarding (recently lifted and loosely re-laid). The fire-surround is of circa 1930s “streamlined” form in beige ceramic, set over an earlier hearth. Three of the walls have inset wrought-iron grilles protecting panels of over-painted coloured glass (amber). These appear to be mid 20<sup>th</sup> Century light fittings cut into recesses created for the purpose. It is possible that they are from the pre-war period, and unlikely to be post 1950s as the wrought grilles are rivetted not welded.

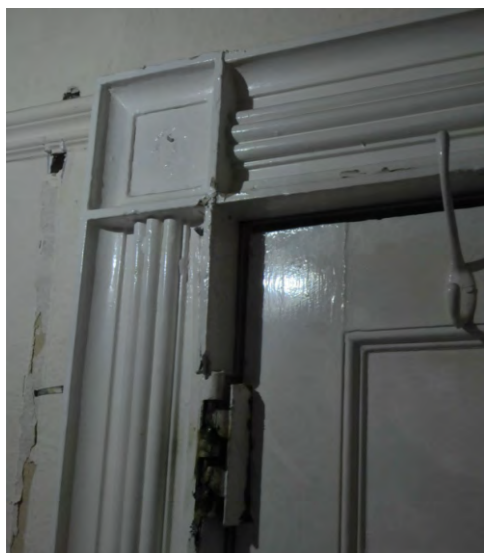
Doorcase detail  
note scar of removed  
patera

The door case within this room is similar to that in the room below, having a reeded architrave with square corner plaques. In the present case the plaque bears the scar of a removed central patera of uncertain form. The position of the doorcase, cramped against the partition wall on the lock stile is also very noticeable – the architrave being omitted during to lack of space. The door itself is of relatively common early 19<sup>th</sup> Century six-panel design, hung on very heavily worn brass rising hinges.
