CHESTER HOUSE  
17 NEW STREET, STOURPORT-ON-SEVERN  
WORCESTERSHIRE

# Chester House 17 New Street, Stourport-on-Severn, Worcestershire

Mike Napthan MCIFA

21<sup>st</sup> October, 2017

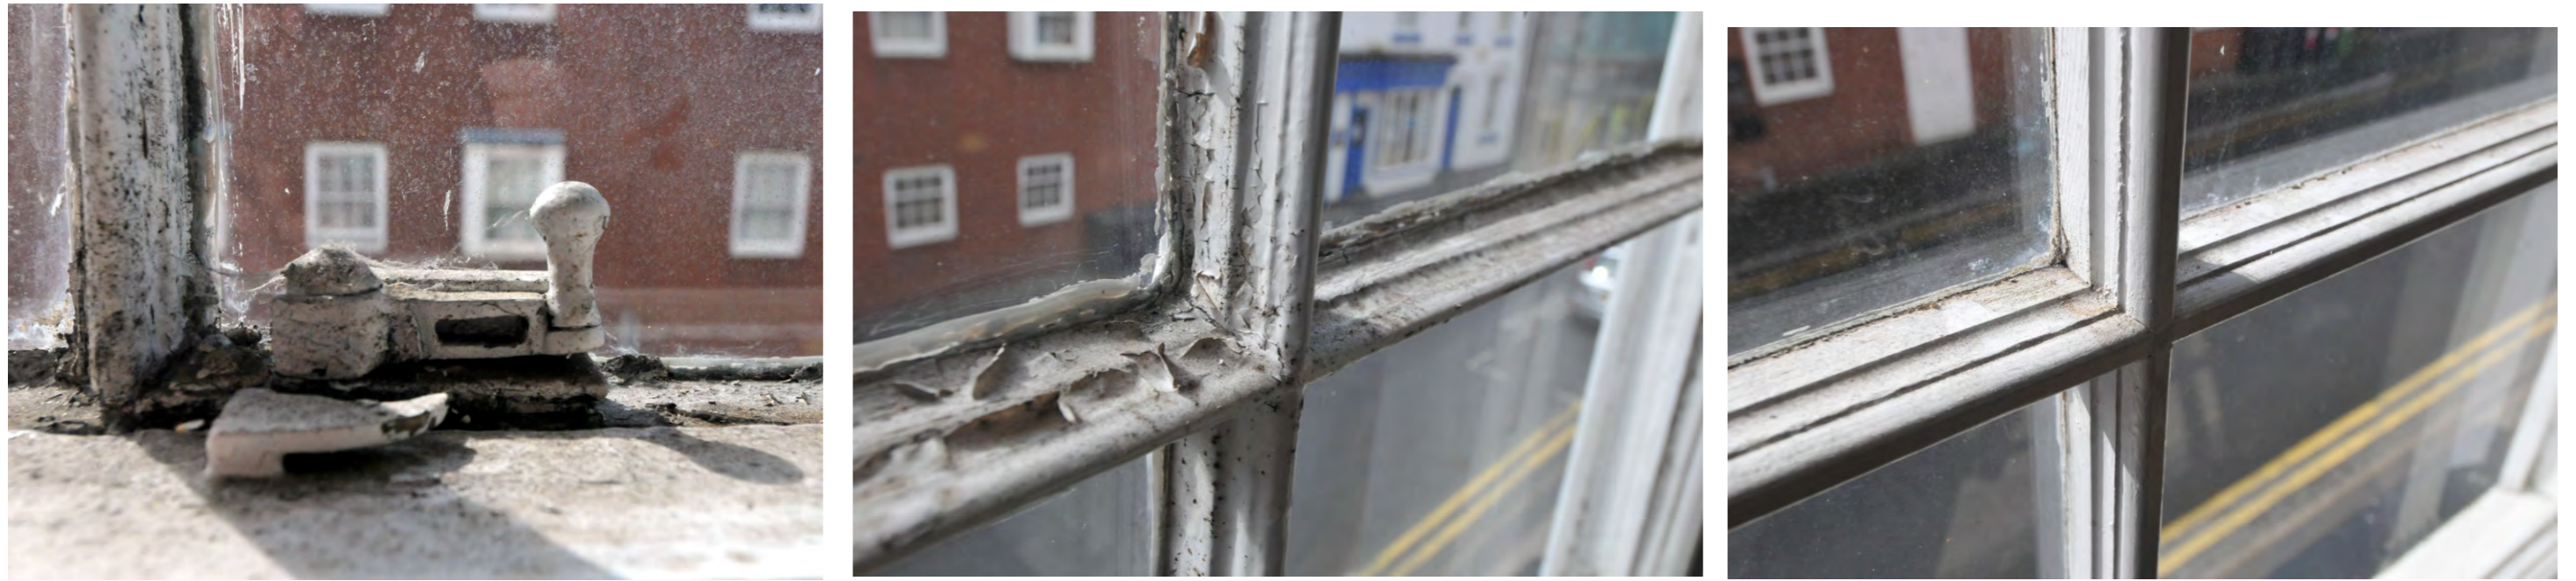
Window details front elevation 1st floor showing original glazing bar and replica profile ( above)

The northern front room at this level is the largest and most ornate in the house – it is undoubtedly the “handsome drawing room” of the 1826 description. The ornate plasterwork appears to be a little later than 1826, however – possibly 1830s. It is unlikely that the plasterwork was installed at the time of construction of the building, but probably added during the occupancy of Mr Lewty. The room is lit by two 4 over 4 sliding sash windows in good quality full height window-cases with splayed sash-boxes and reeded architraves. The glazing, in horizontal format, is somewhat of a local peculiarity noticeable locally in Stourport and occasionaly Kidderminster, but unknown in the central and southern parts of the county. It may reflect the work of one or two local joiners. The fenestration to this room is also notably off-centre; the northern window being hard against the party-wall. The reason for the imbalance is unclear – there is no external evidence that the windows have been re-located. Externally this imbalance is less visible as the façade extends some 22-24” to the north of the window jamb – internally the jamb is cramped against the wall. It is possible that an additional brick lining has been added within the room or, possibly the “party wall” is of more than double thickness. The window sashes have, in part, been replaced with modern reproductions easily identifiable by heavier glazing bars.

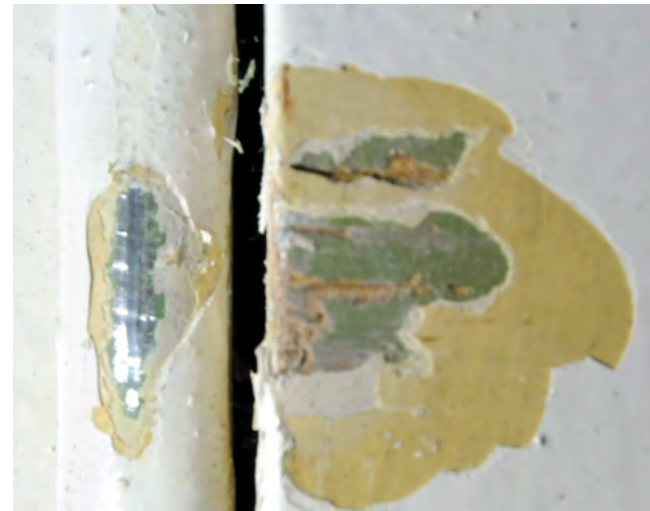
Paint scrape showing original green paint of window-case

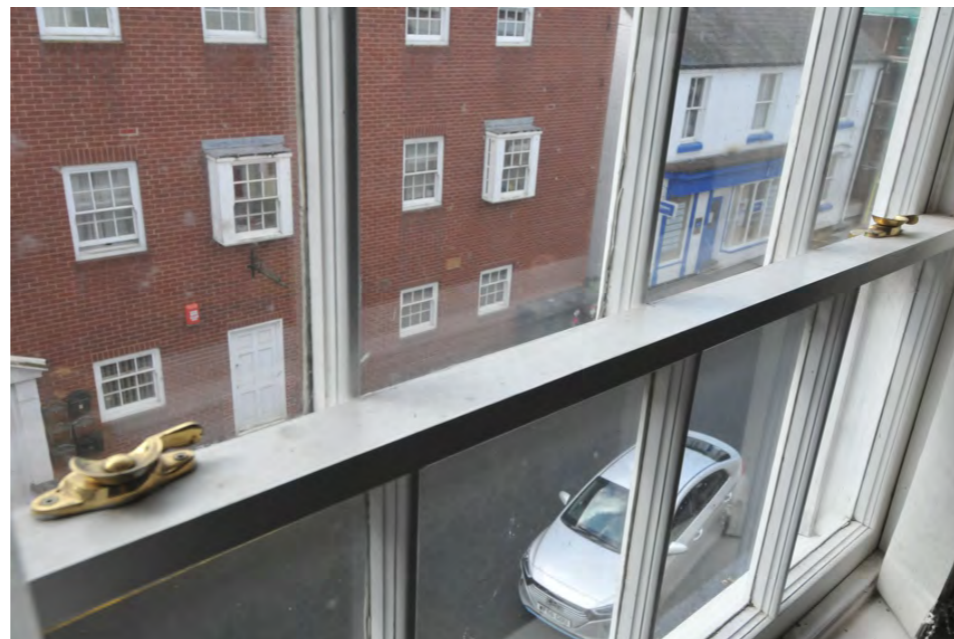
Detail of replica window second floor front

The first floor front room in the north corresponds in plan to the Drawing room beneath it, other than that the fireplace (removed 20<sup>th</sup> C surround) is set slightly further to the south. The windows are of four over four vertically sliding sashes (arranged as rows of four fairly large rectangular panes). The windows are very simply treated internally with narrow architraves around the recesses. The imbalanced arrangement of the first floor windows is repeated at this level. The middle window sashes are recent replicas.

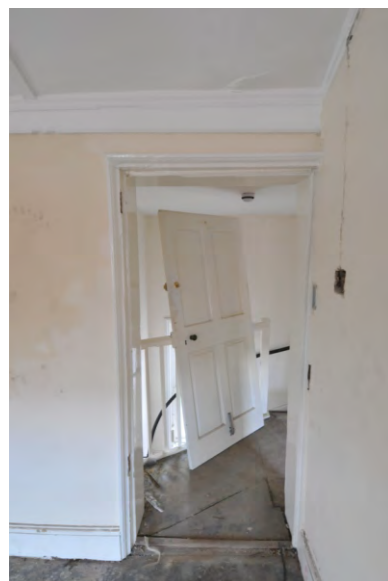
Second floor front (north) doorway and removed door

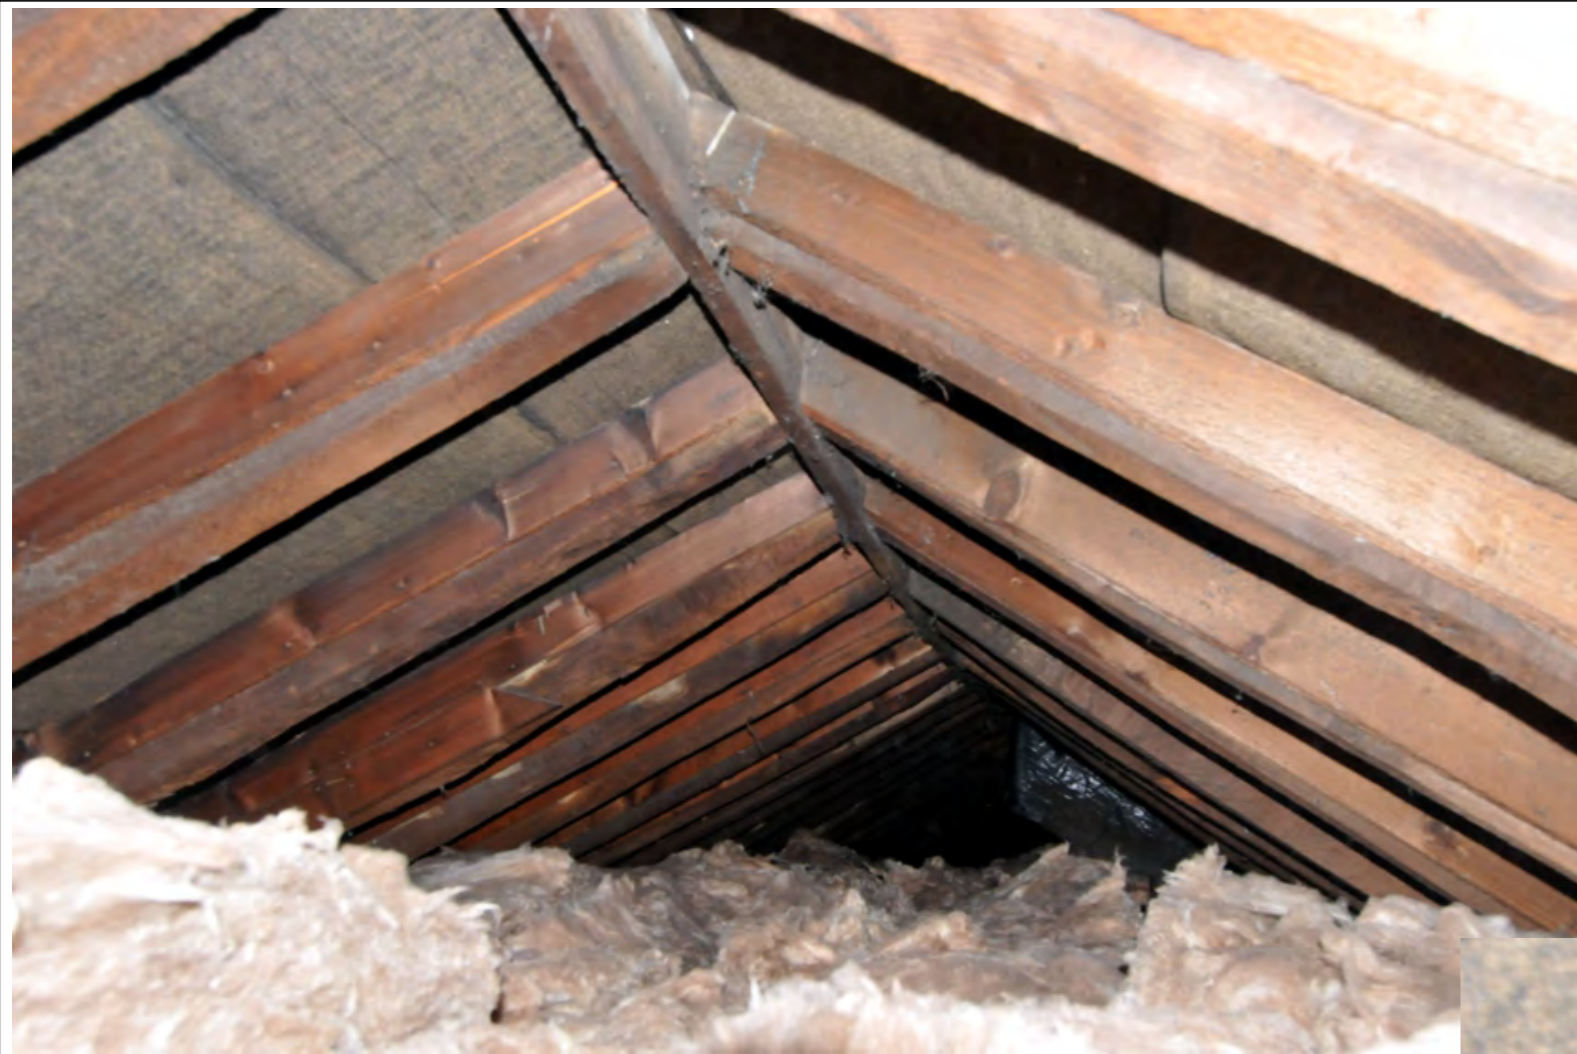
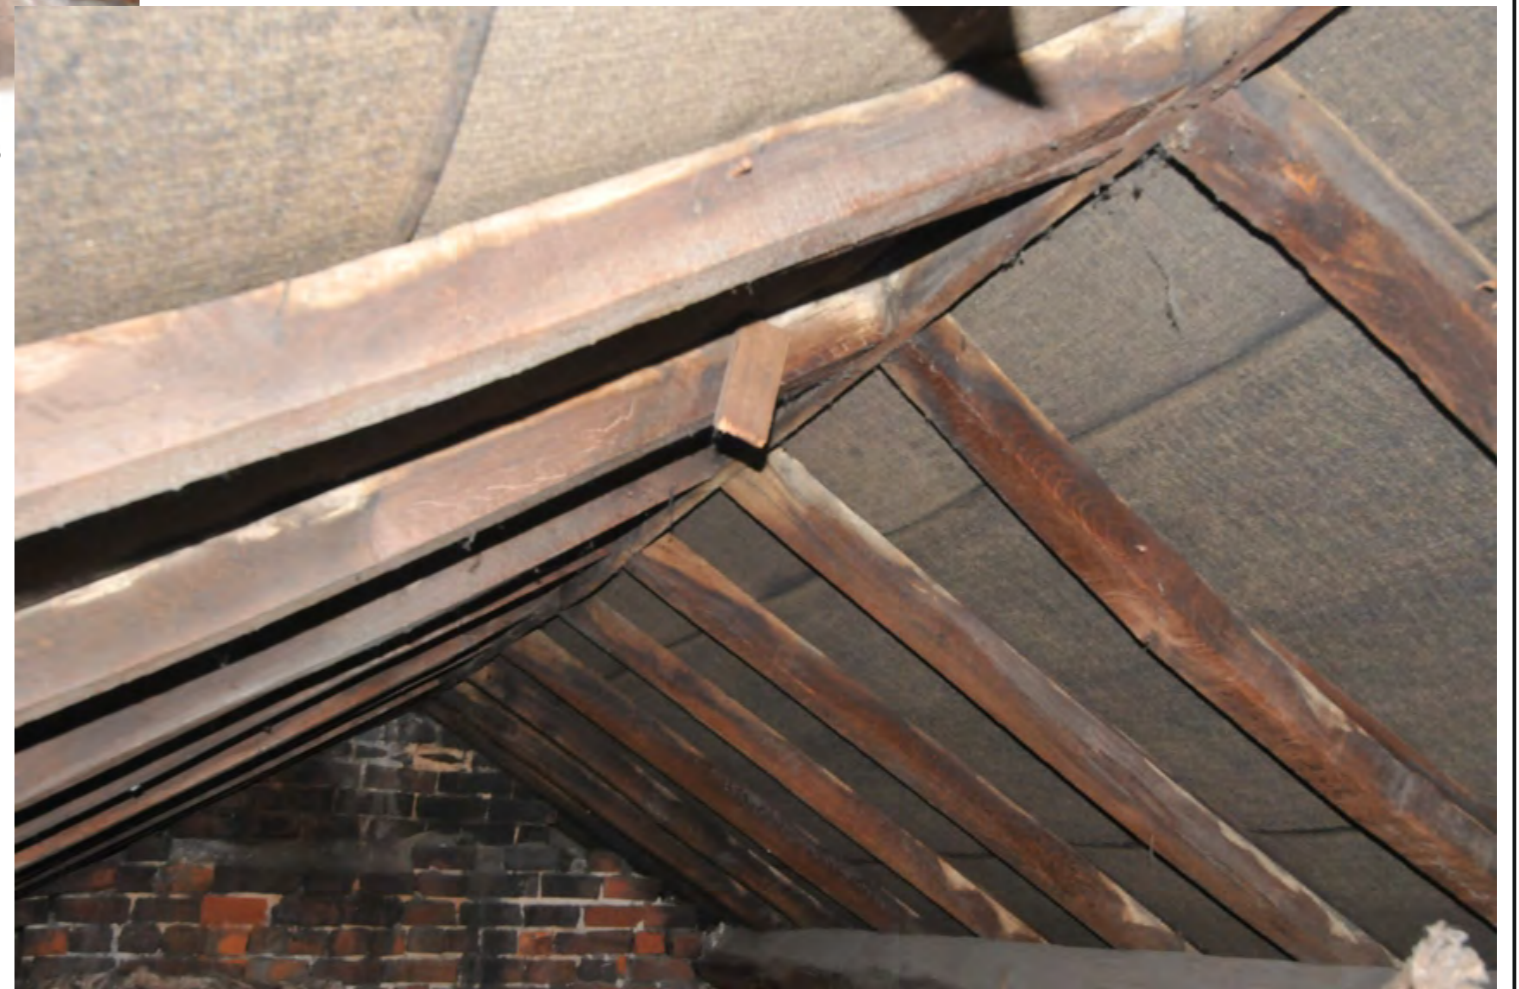
Figure 15: Roof structure

Roof structure (mill sawn paired common rafters on Baltic softwood purlins)

An access hatch gives access to the roofspace (Fig 15) – the roof has been underfelted but appears to be slate. The pitch is relatively low and the structure is entirely of common rafters of mill-sawn Baltic timber nailed to a ridge board. This form of construction was used in the last few years of the 18<sup>th</sup> Century, but is more commonly early-mid 19<sup>th</sup> Century.
