SHEFFIELD MANOR

SITE RECORDS

AREAS: XXI XXII

ROOM XXII

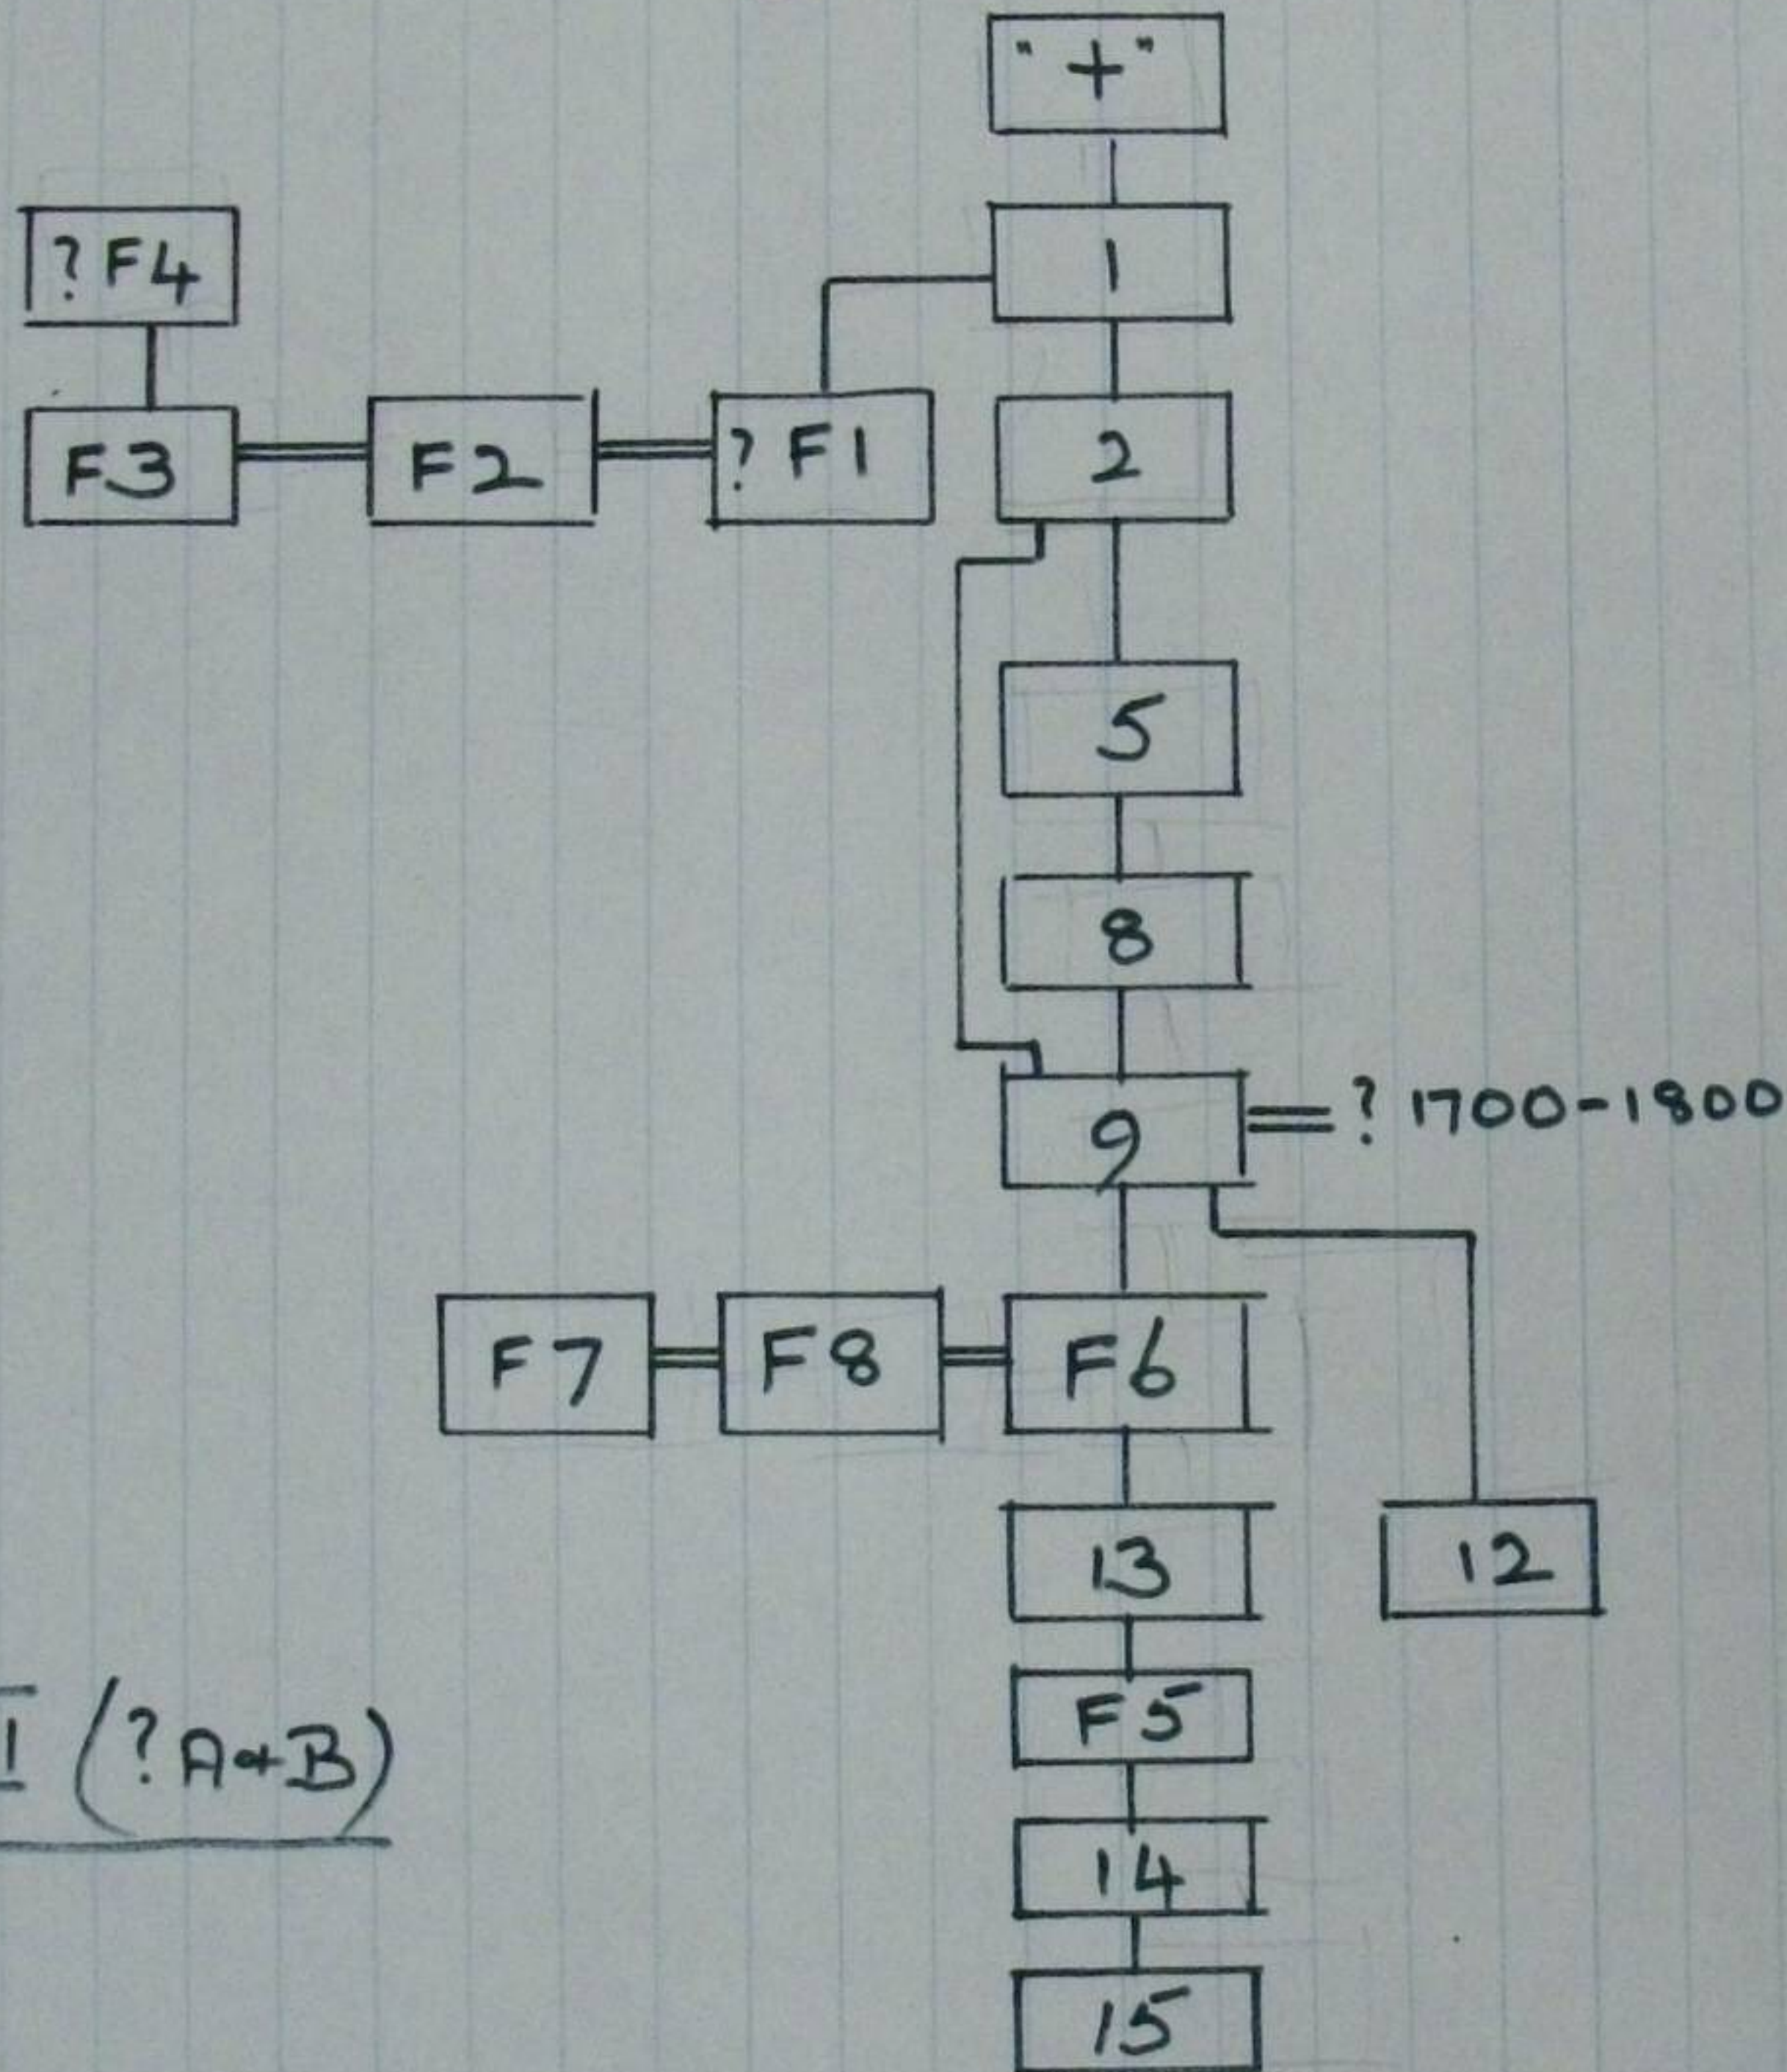
SM71 XXII (?A+B)

The room is divided into two very separate parts by the wall [F3]. To the south of [F3] the room is filled from natural to modern ground level almost entirely by brown loam (layer ⑦). This layer produced some late medieval pottery and no minor ware. [F3] and the west wall are footed on natural. See plan page 6 and separate elevation of west wall.

On North side of [F3] is an almost certain Garderobe [F8]. This is floored with large flags approx 2" thick grouted with yellow clay. This yellow clay has also been used to grout walls adjacent to garderobe. In North wall of XXII there is a drain opening for the garderobe running through the wall [F7].

Between North wall and [F3] a masonry arch [F1] spans garderobe. This arch is made from two stone lintels but jointed at centre and supported by stone hammers in E. and W. walls.

At outside edges of [F1] masonry has been added above to extend beam slot [F2]. [F2] appears to have supported a box structure no doubt provided with a least one hole.

Garderobe has two levels of flooring [F6] and [F5] with dark earth (15) under them. Level of natural was not determined but would appear to be about

18" under level of lowest floor F5.

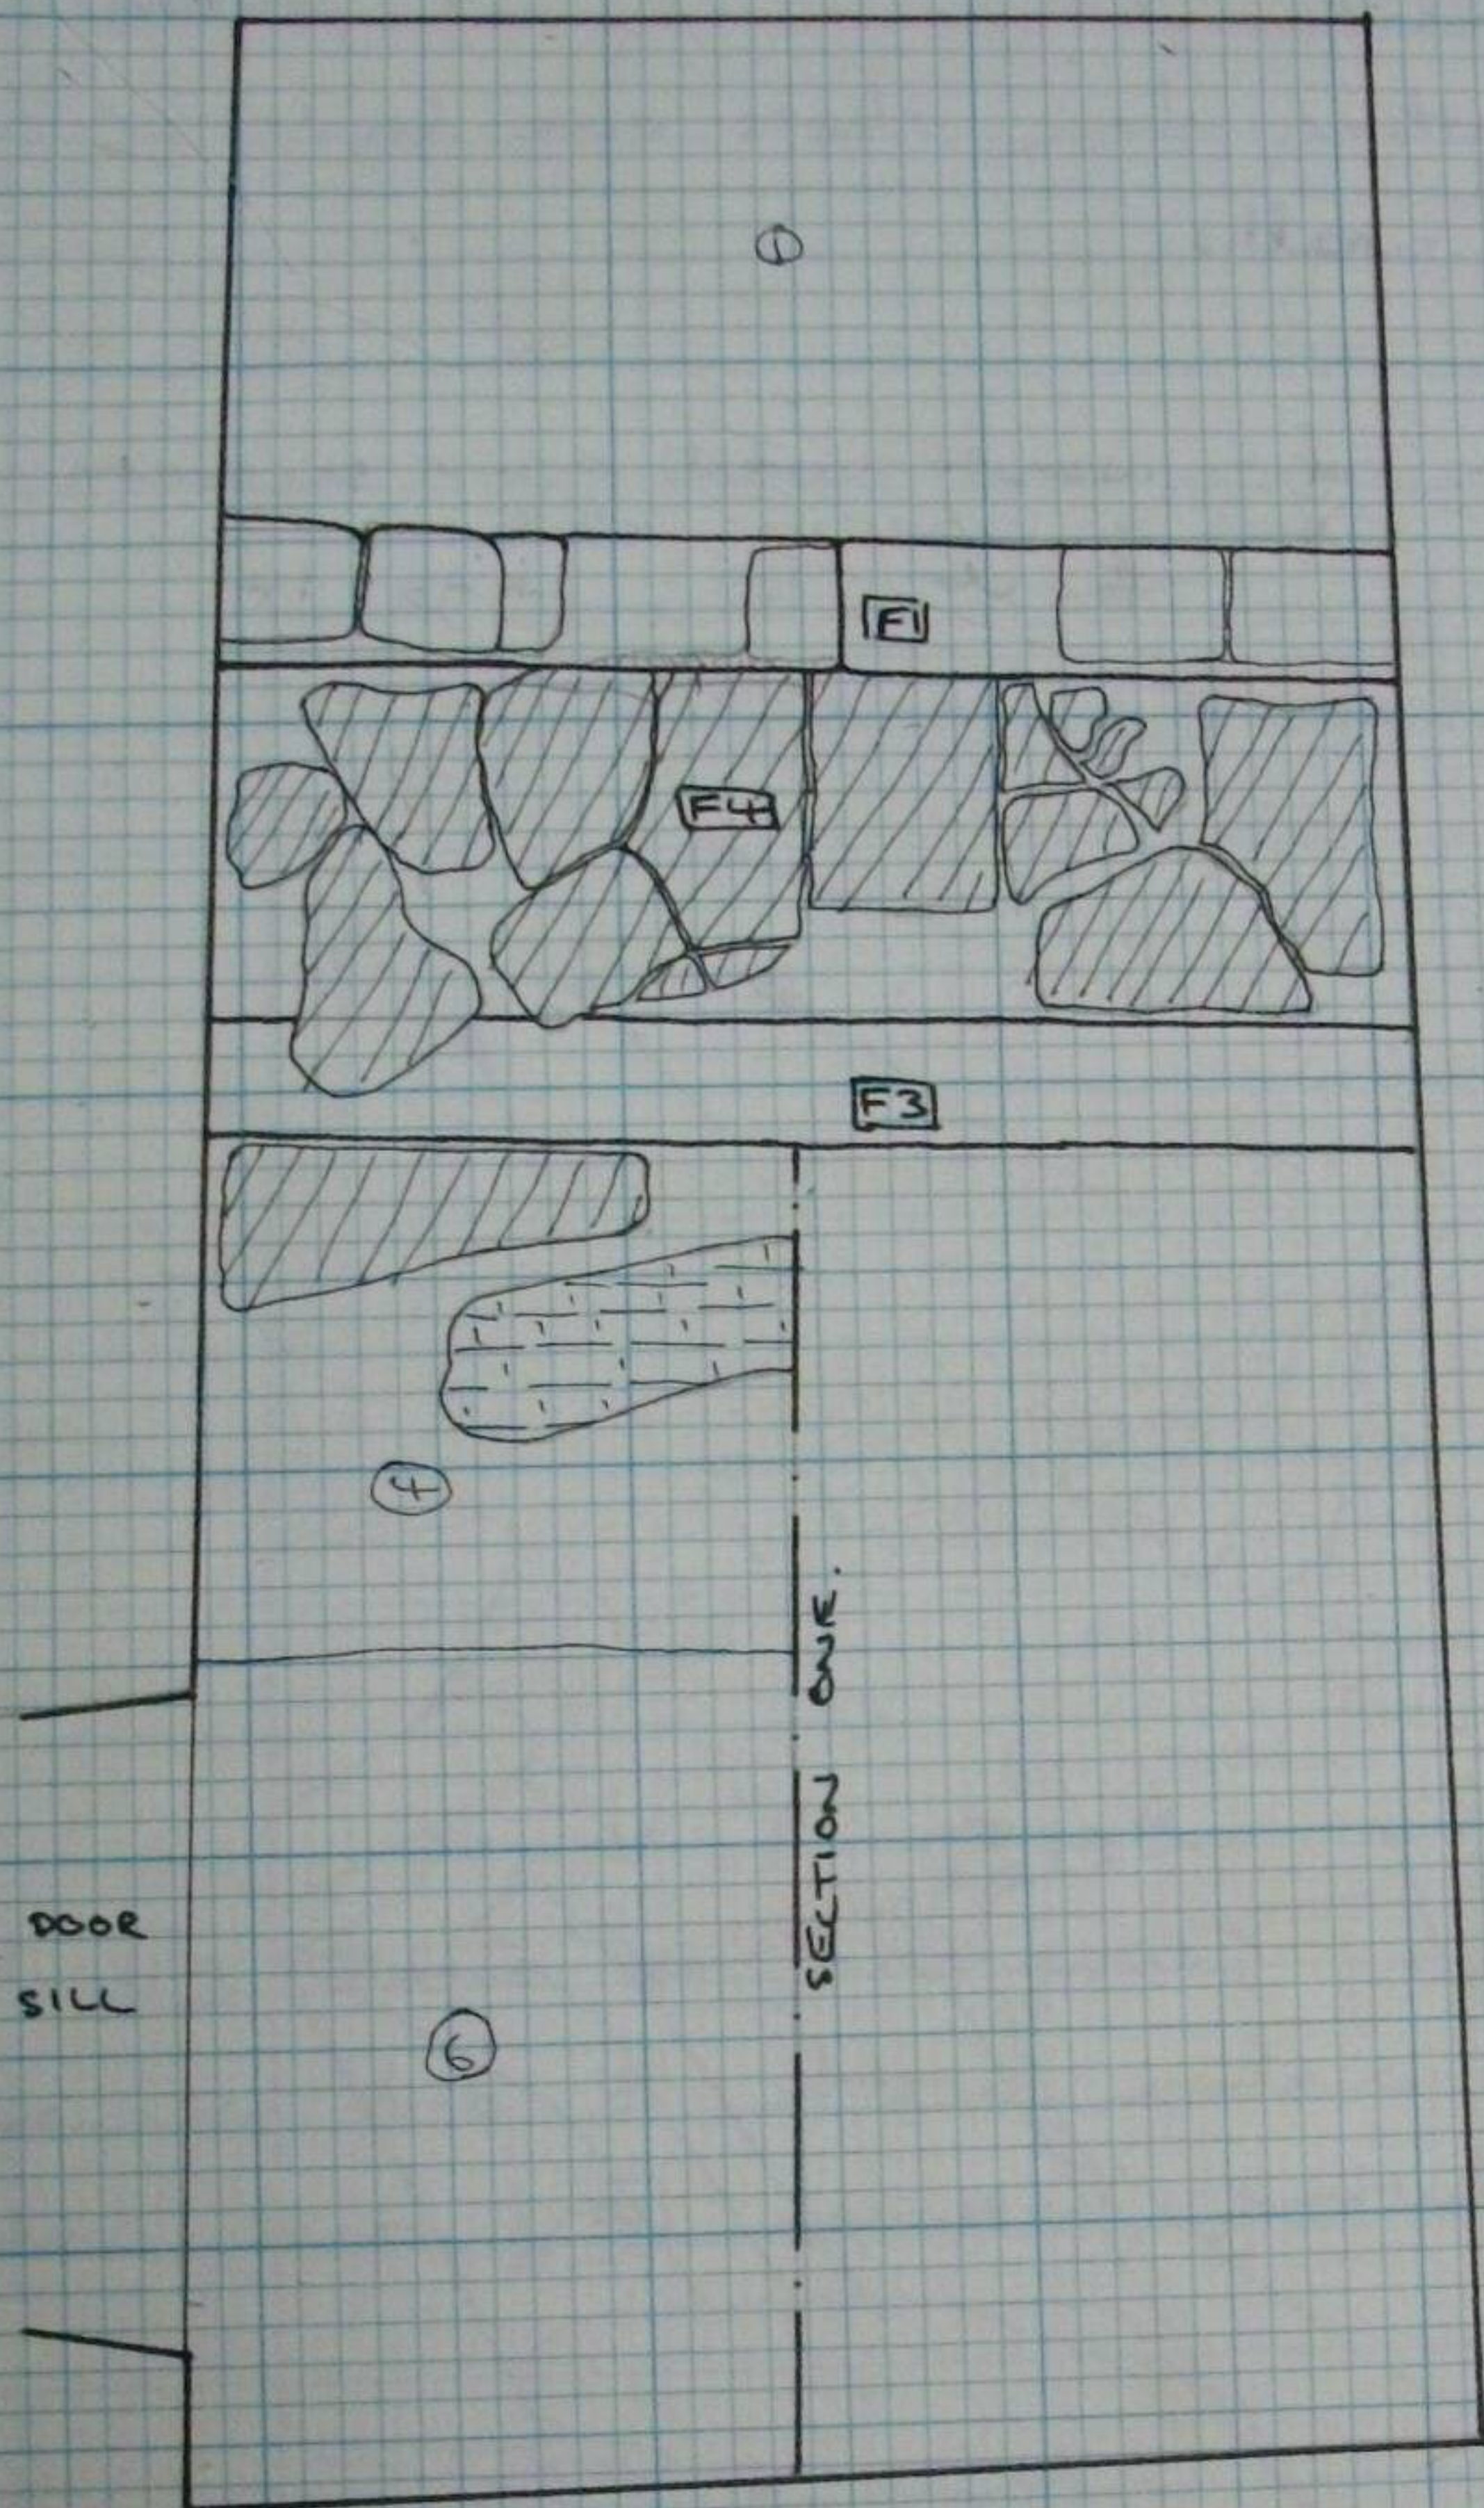
GENERAL PLAN

ROOM XXII

SCALE $\frac{1}{2}" = 1 \text{ FOOT}$.

[F2] Timber Slats. Large no. of clay pipe stem frags from yellow clay incise slab. It is not possible to say conclusively whether these slats are built or cut in East and West walls.

[F3] Wall in front of Arch. Approx 9" thick.
 Grouted with clay. Connected to arch [F1] by slats [F2]. Relationship with E. and W. wall not certain - jointing between [F3] and walls is rather poor.

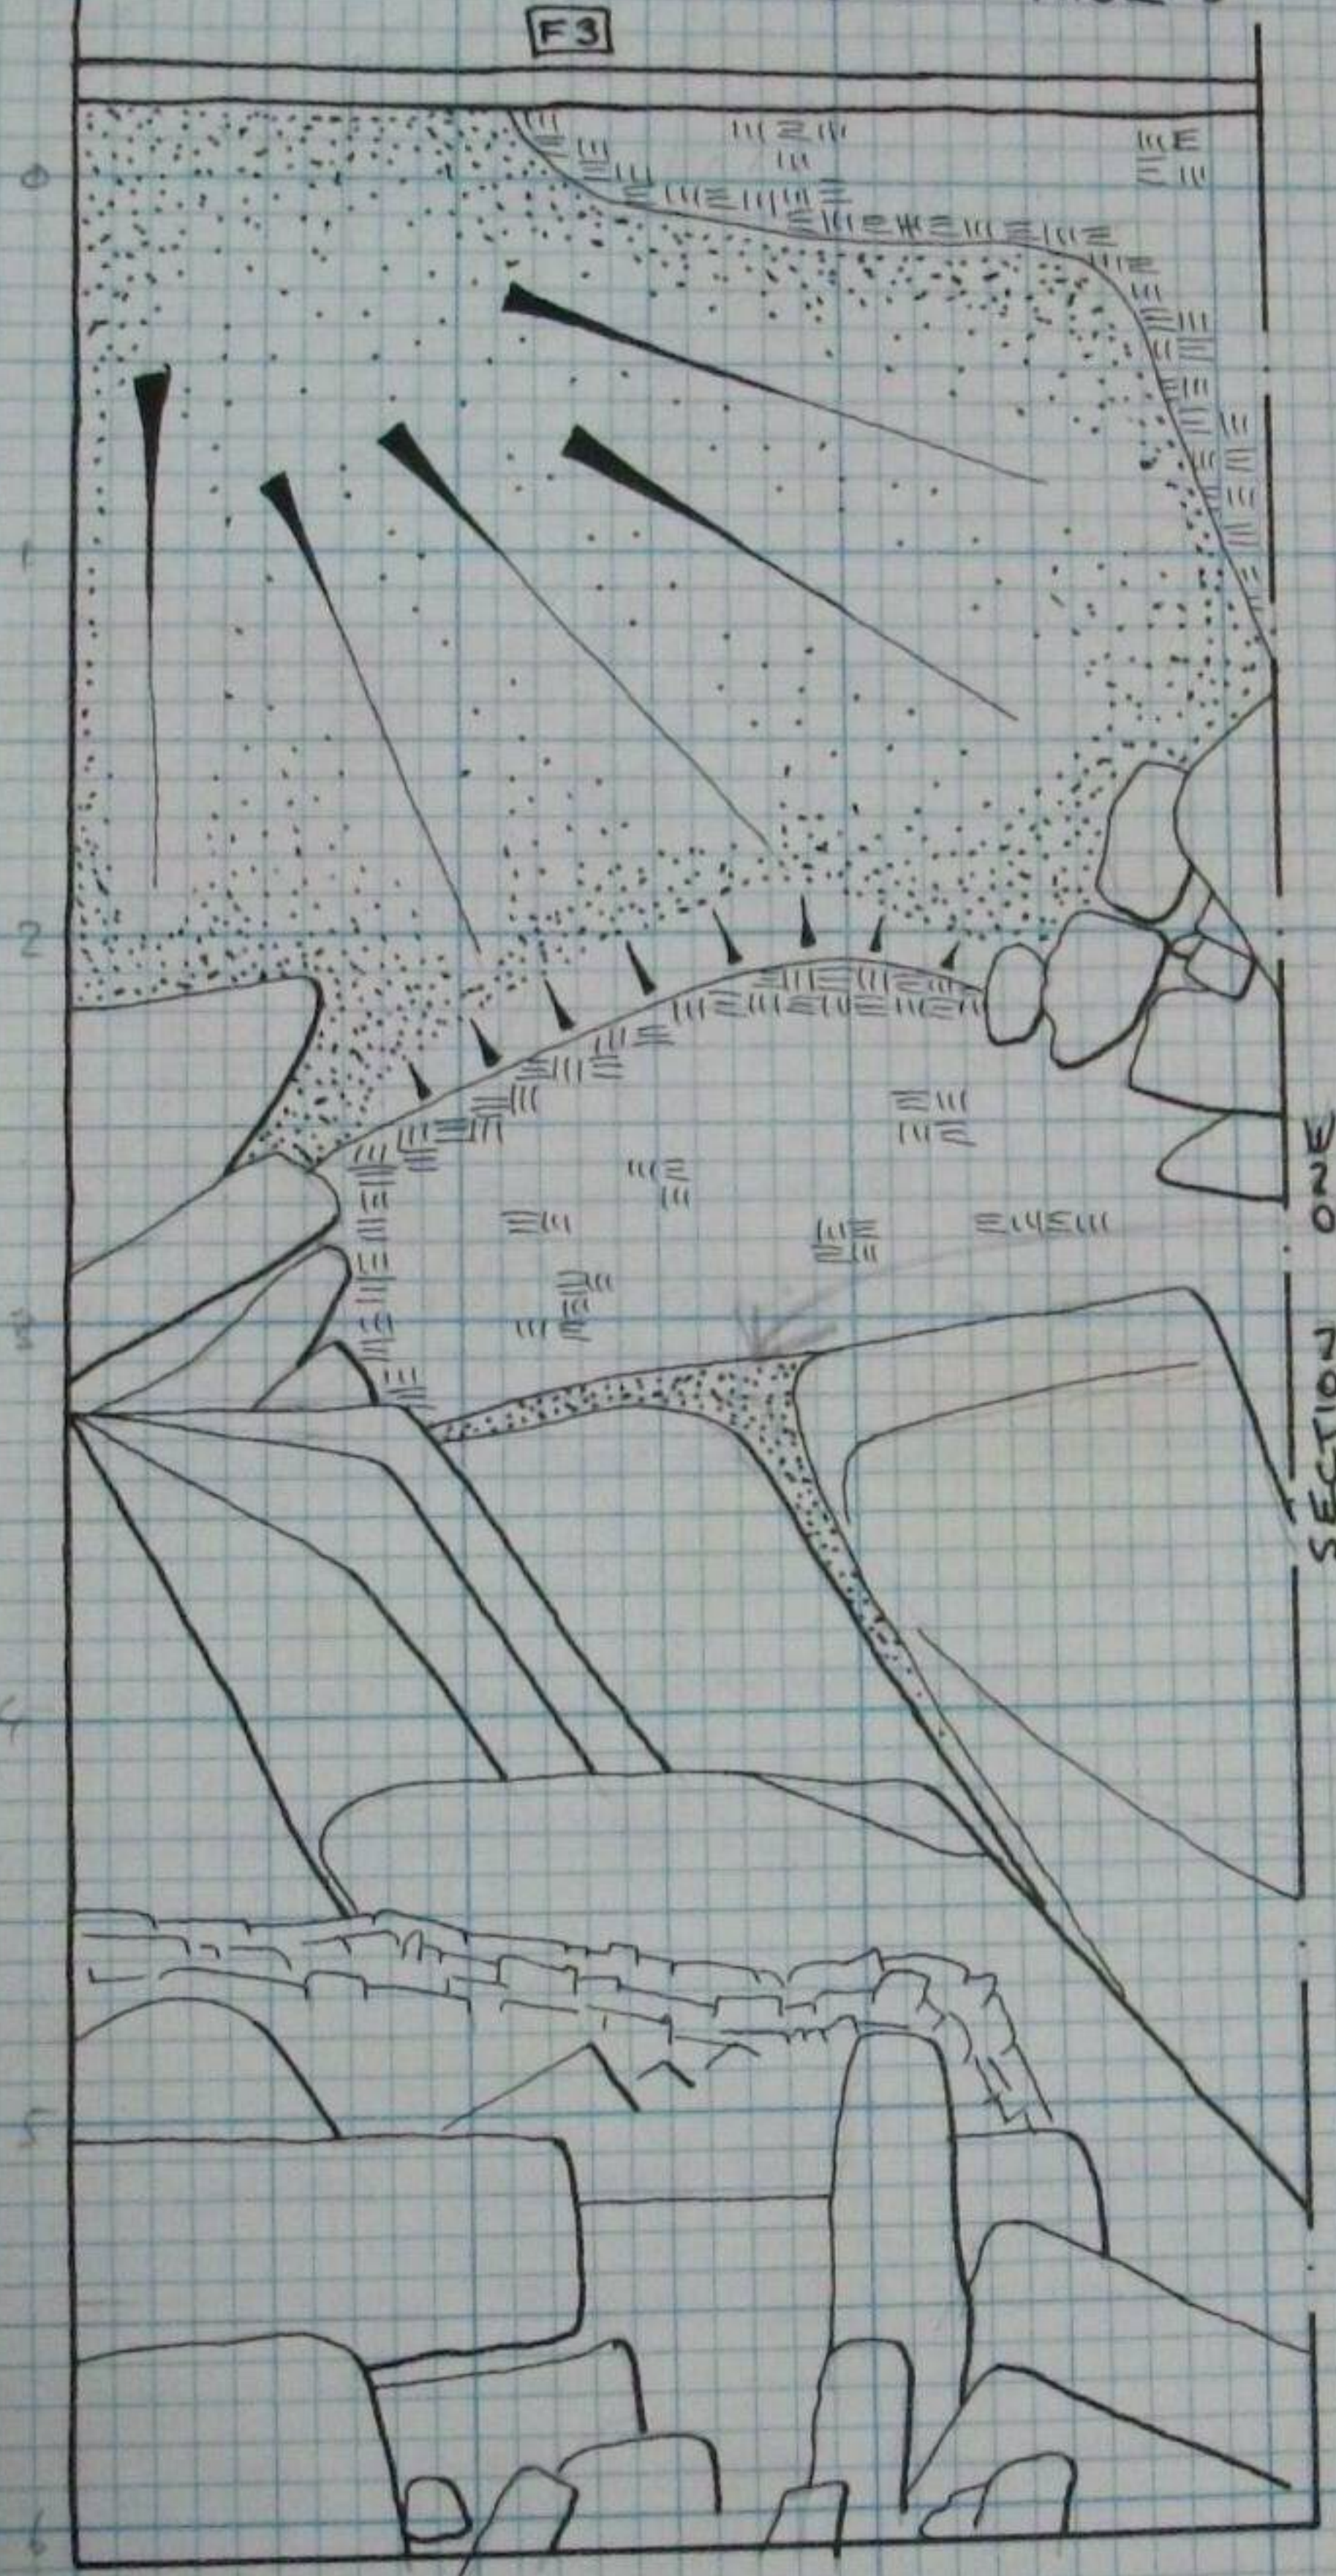
ROOM XXII TRENCH PLAN (PART ONE - SOUTH OF F3)
LOWEST LEVELS.

To S. a depression dug into natural grey clay & iron paning layers - probab. connected w. construct. of [F3]

PLAN CONTINUED ON PAGE 8
F3

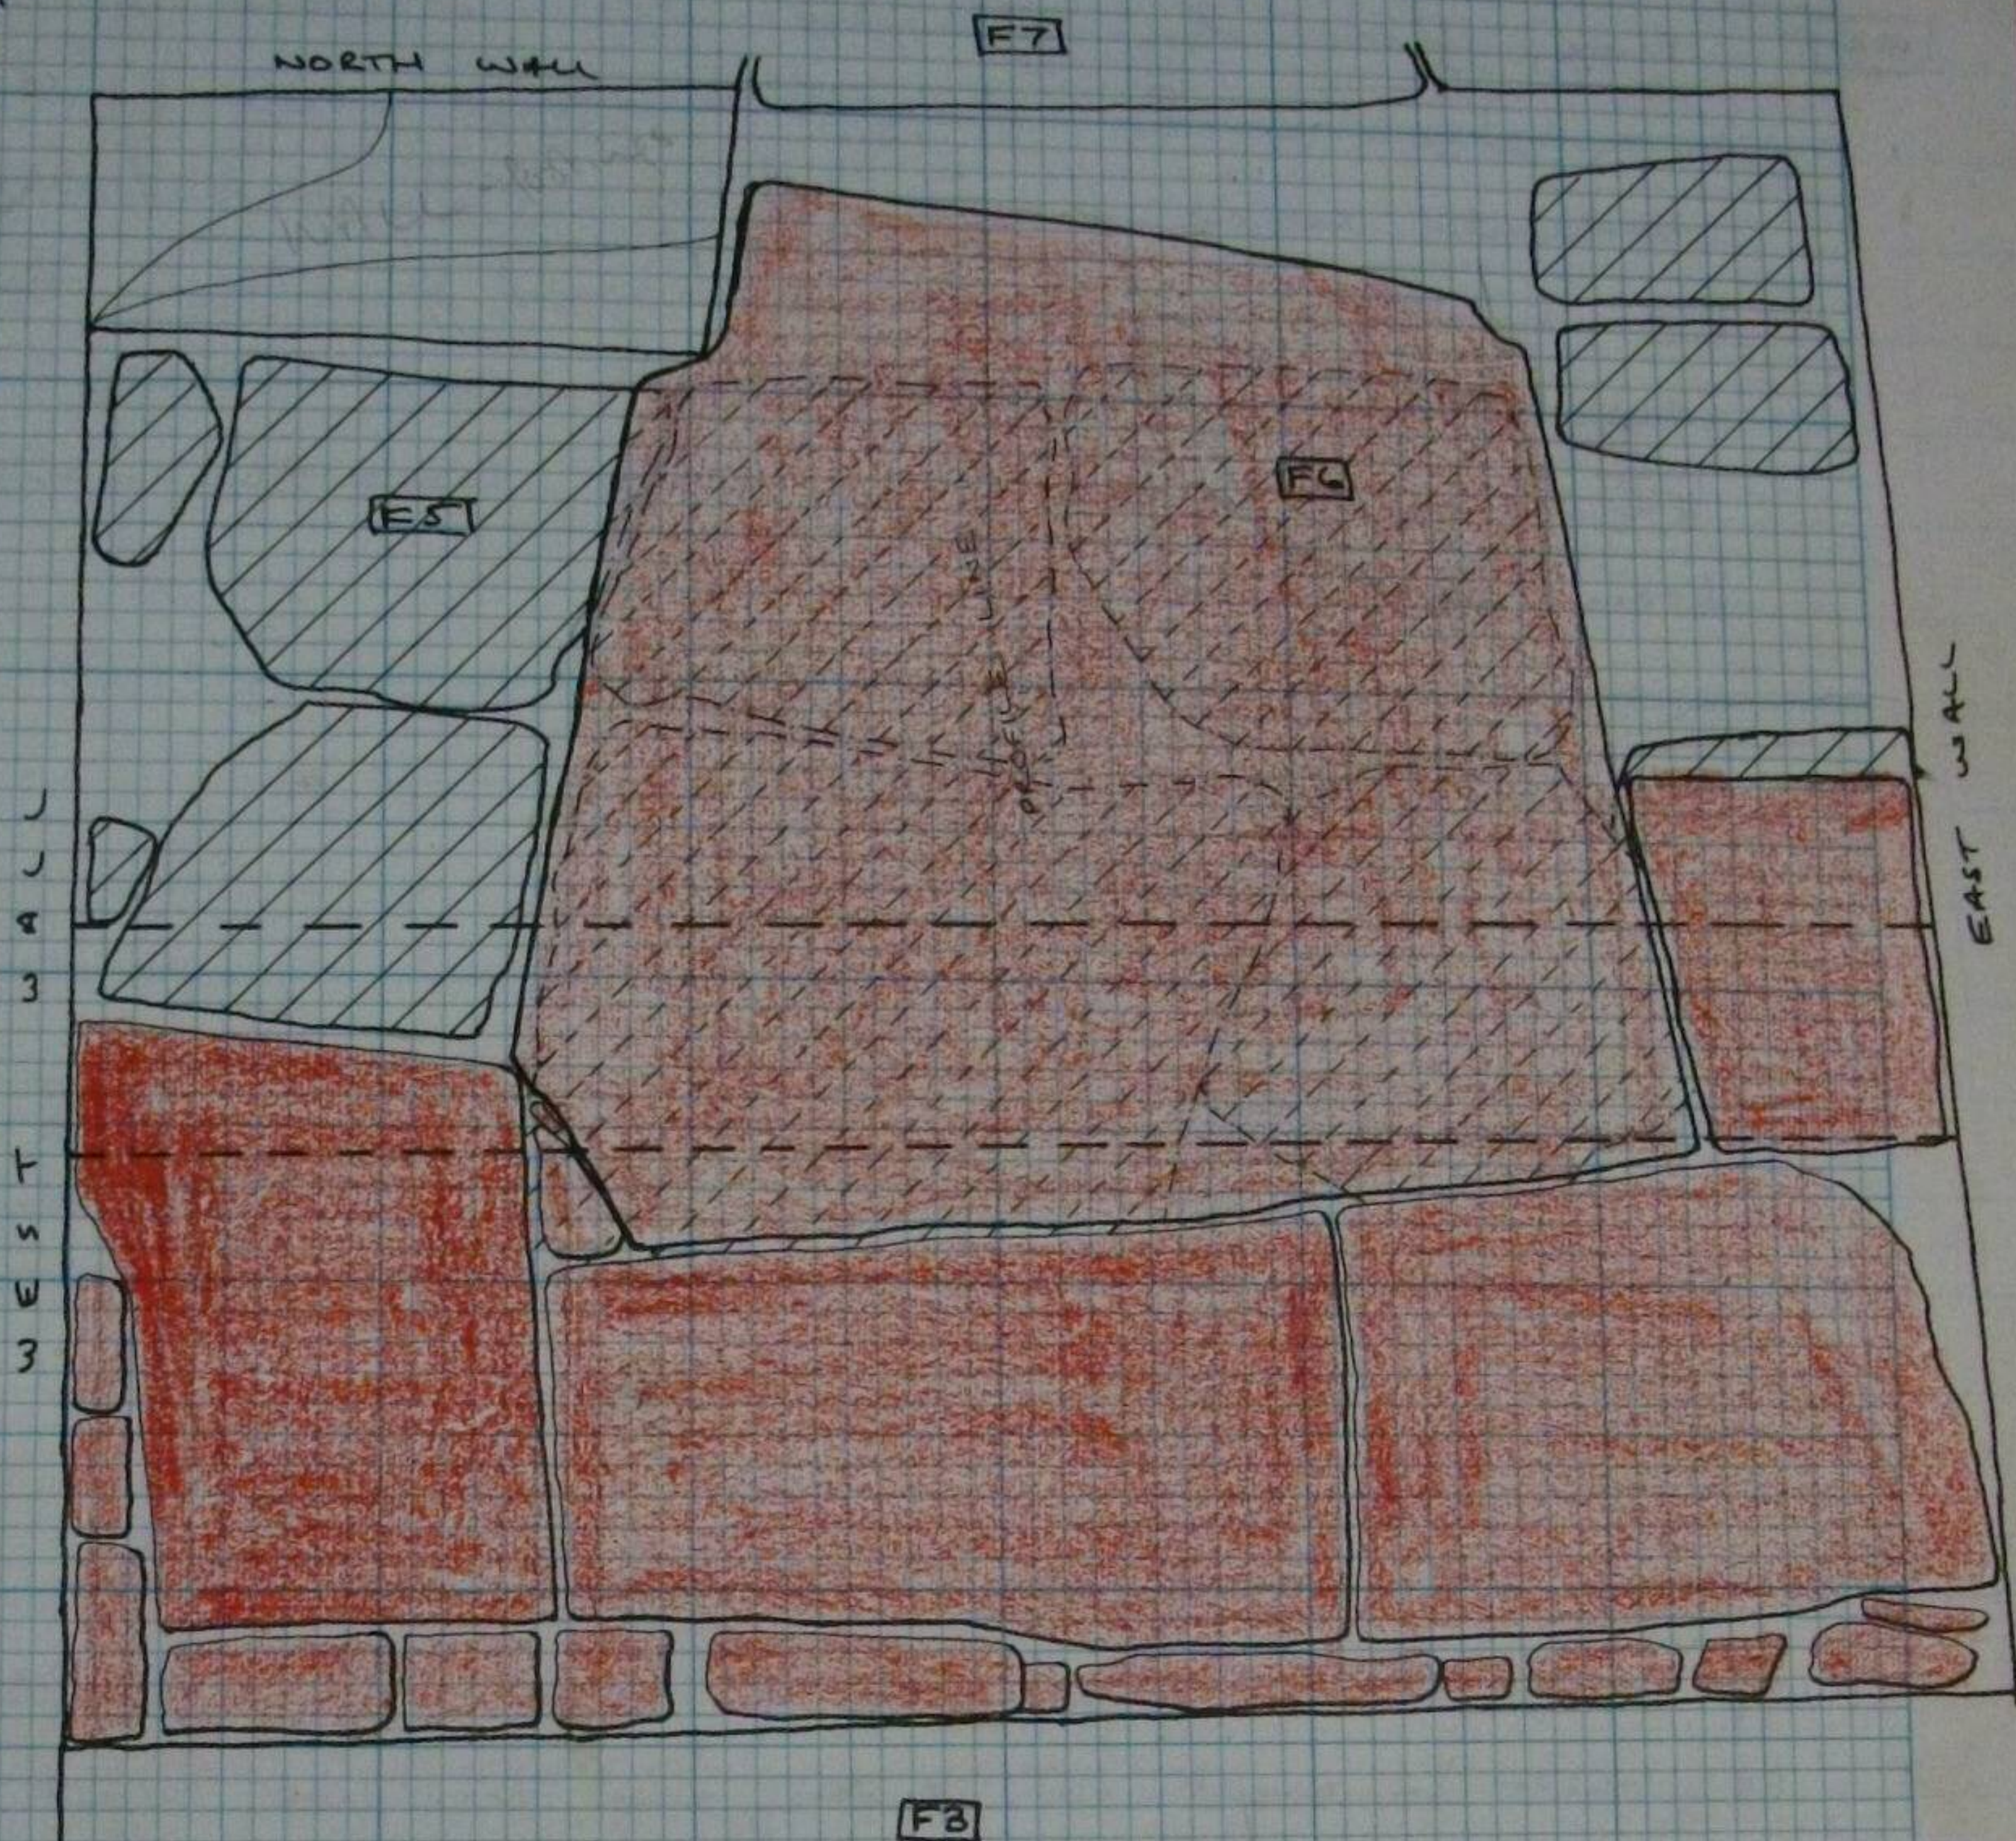
UPPER FLOOR [F6] : SHOWN ~~WHITE~~ IN RED

LOWER FLOOR [F5] : SHOWN HATCHED (AND DOTTED WHEN UNDER STONES OF [F6])

ALL FLAGS ARE SANDSTONE.

[F6] Flag floor of Gardarobe [F8] composed of one very large central flag ($42" \times 28"$) edge with more moderate sized flags. Along [F3] and south of [F1] small stones have been used to 'Edge' floor. All stones are grouted with yellow clay. [F6] slopes considerably down towards mouth of drain [F7].

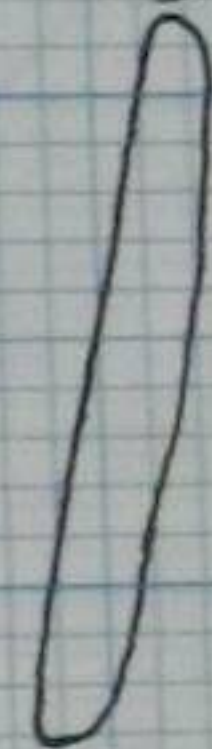
PROFILE OF GARDEROBE FLOOR.

[F7] Drain to gardarobe. Traced only through thickness of wall 36" width of mouth 31". Height of mouth 25". Is built in wall i.e. sides and top are wall fabric. Destination unknown.

NORTH WALL

F7

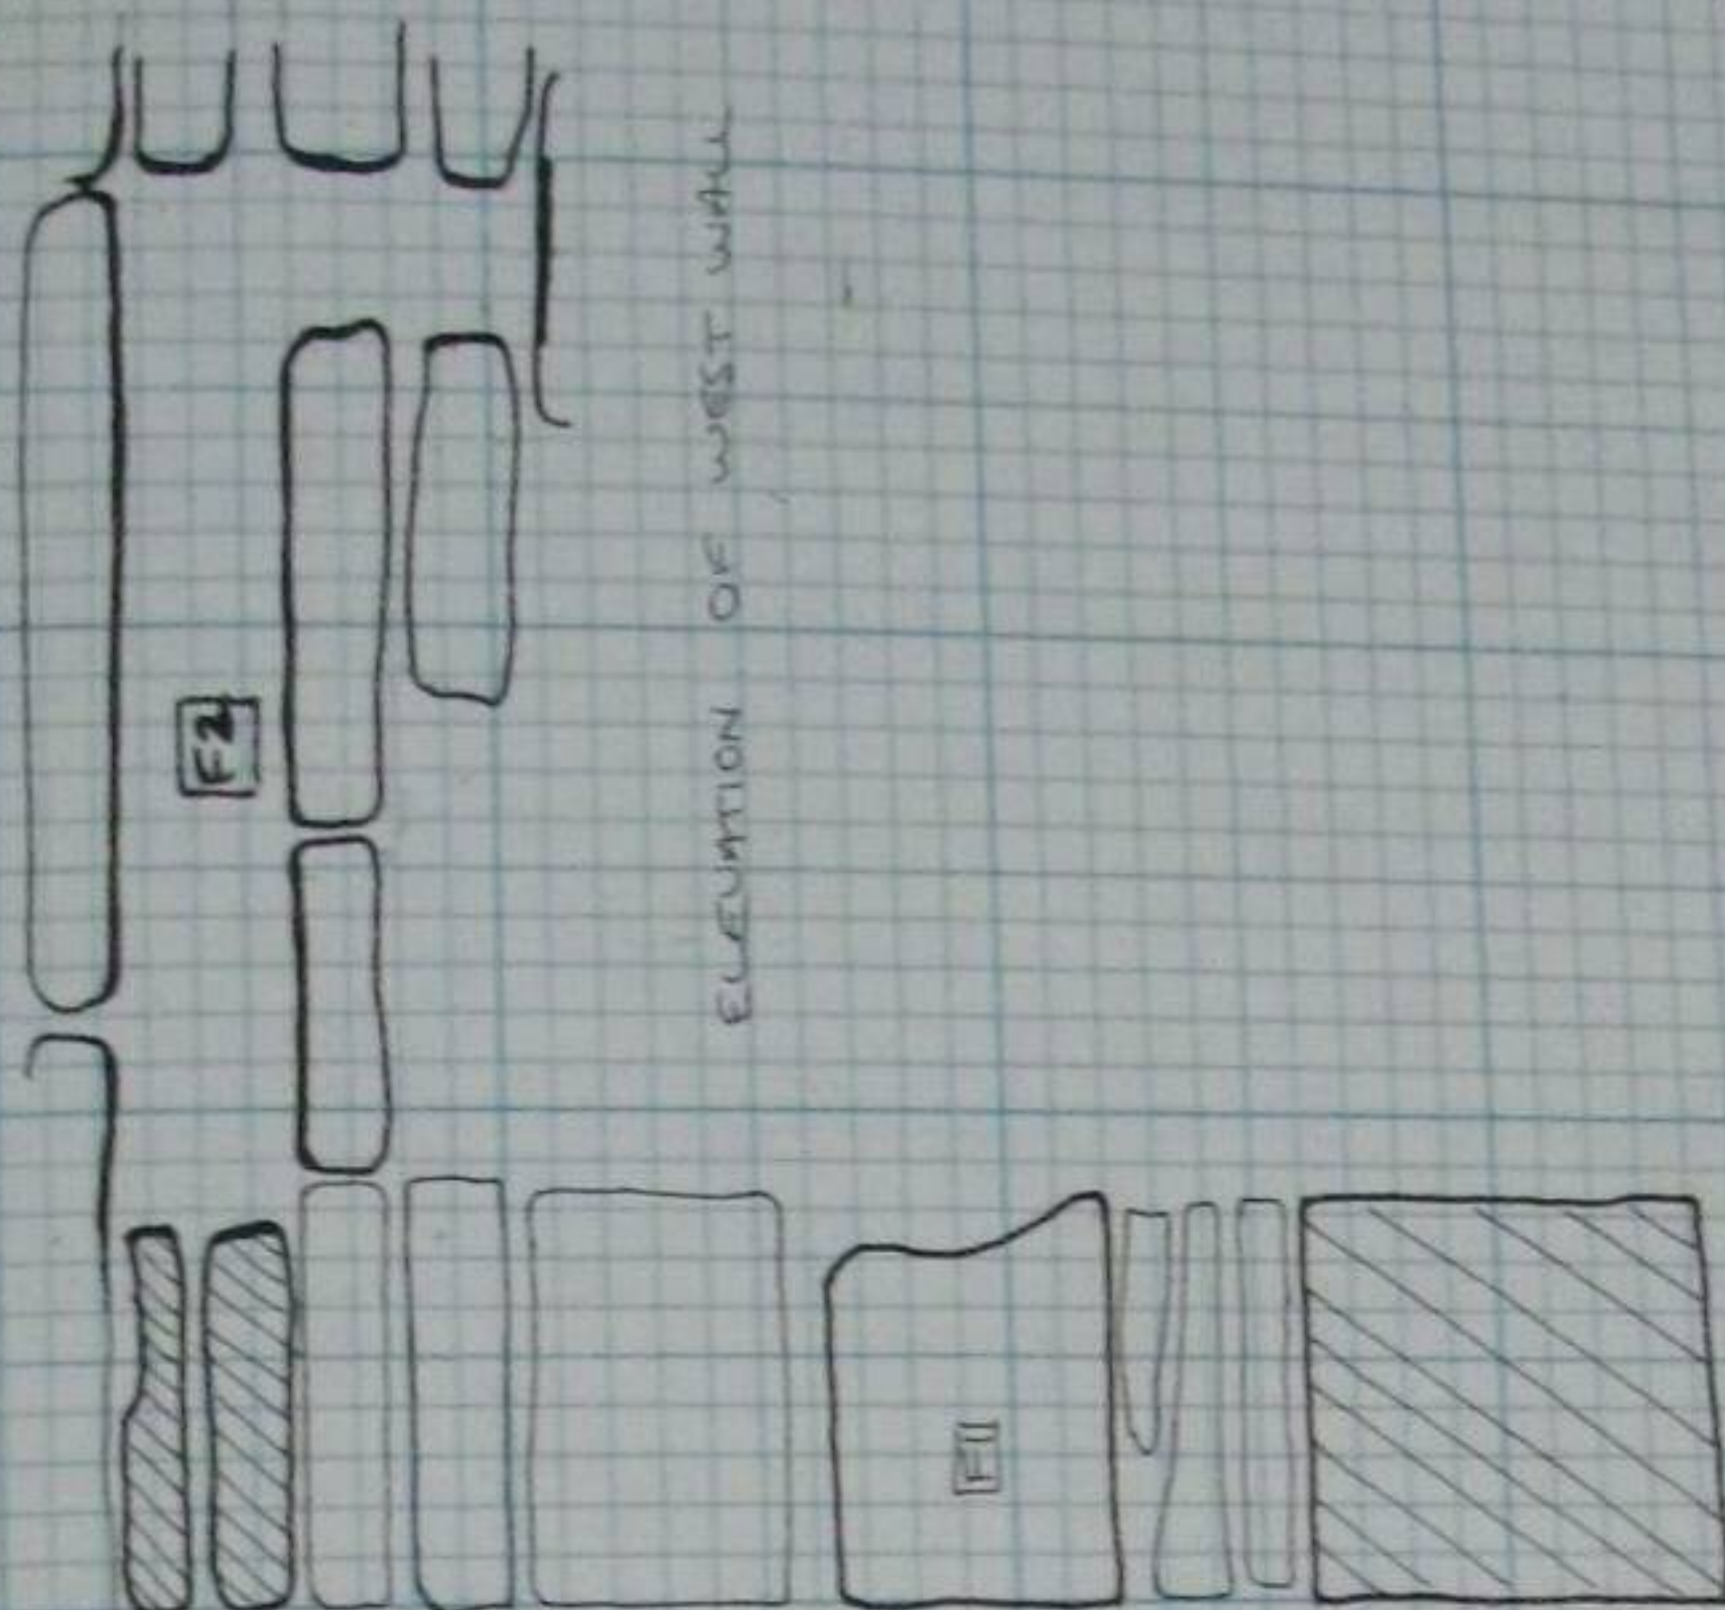
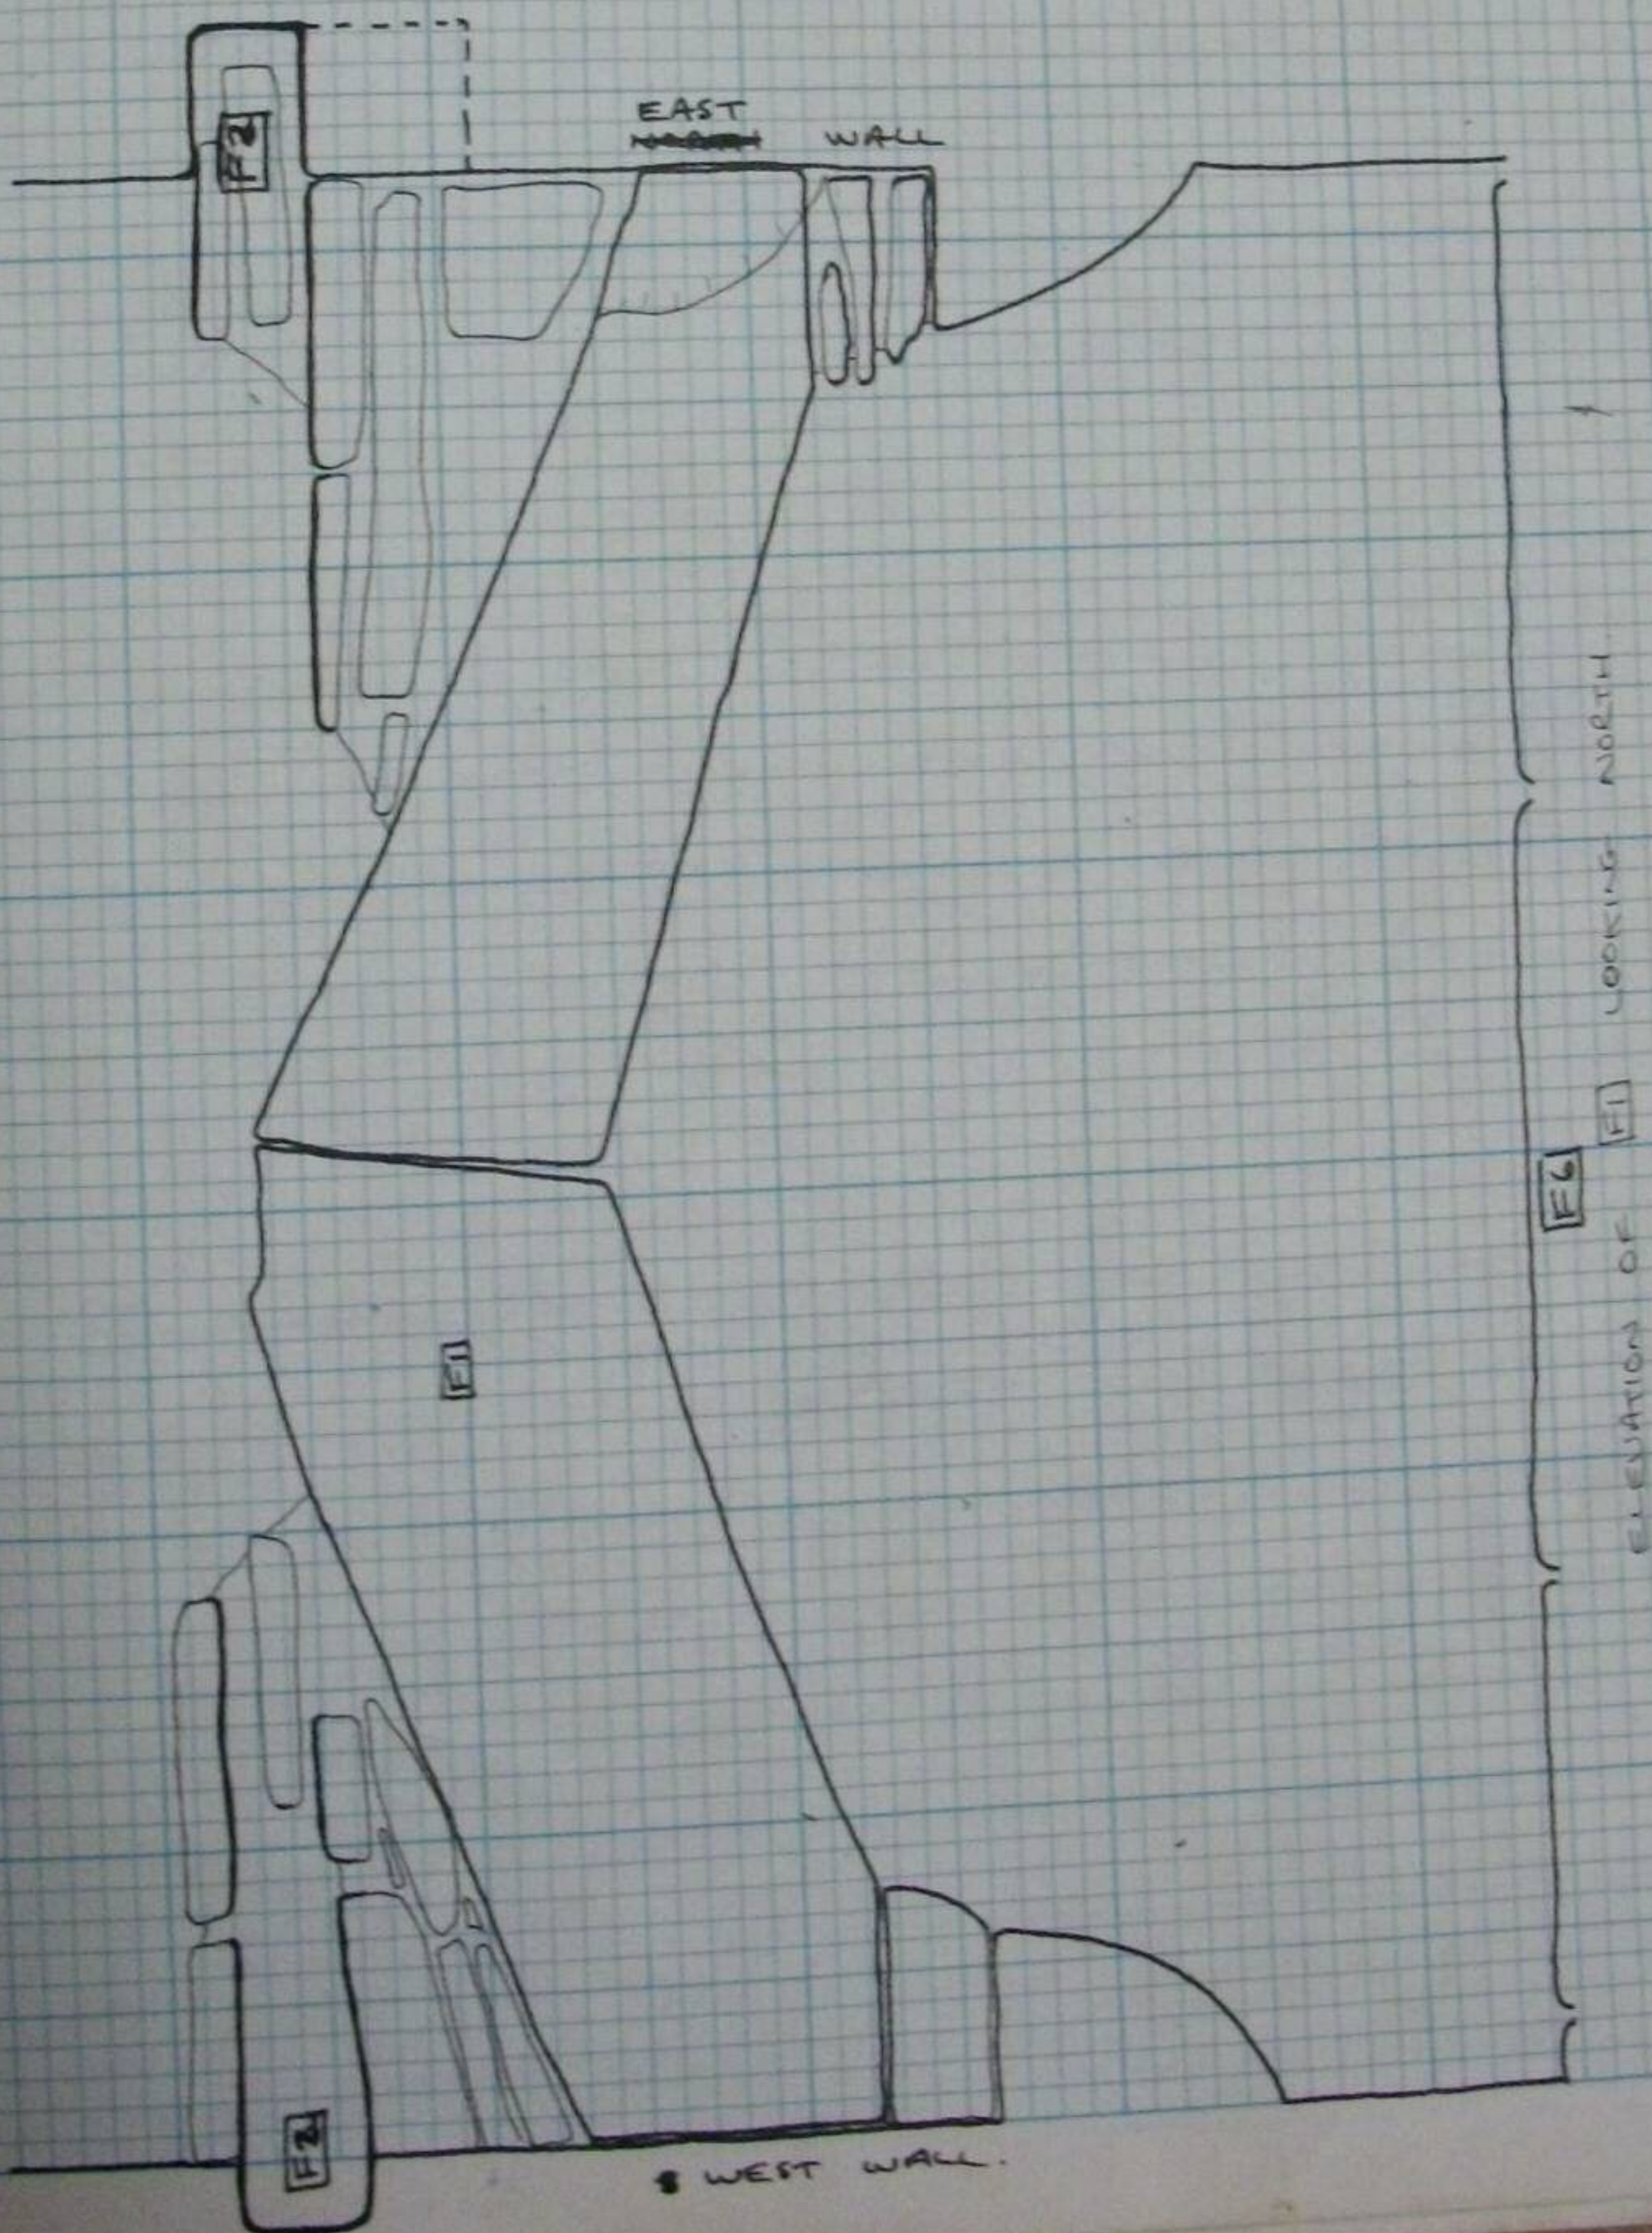
ROOM XXII ELEVATION OF F1 AND BEAM SLOT F3 IN WEST WALL.

F11 Stone Arch. Between E and W. walls.
35" south of N. wall. Two stones butt jointed
at centre. Angle between stones at centre about 140°
Little stones are rough dressed and average
12" x 9" cross section.
Supported on dressed hammer stones with
packing stones between little and hammers.
Rough masonry added to carry beam slot F2
