SHEFFIELD MANOR

SITE RECORDS

AREAS: XXI XXII

ROOM XXII

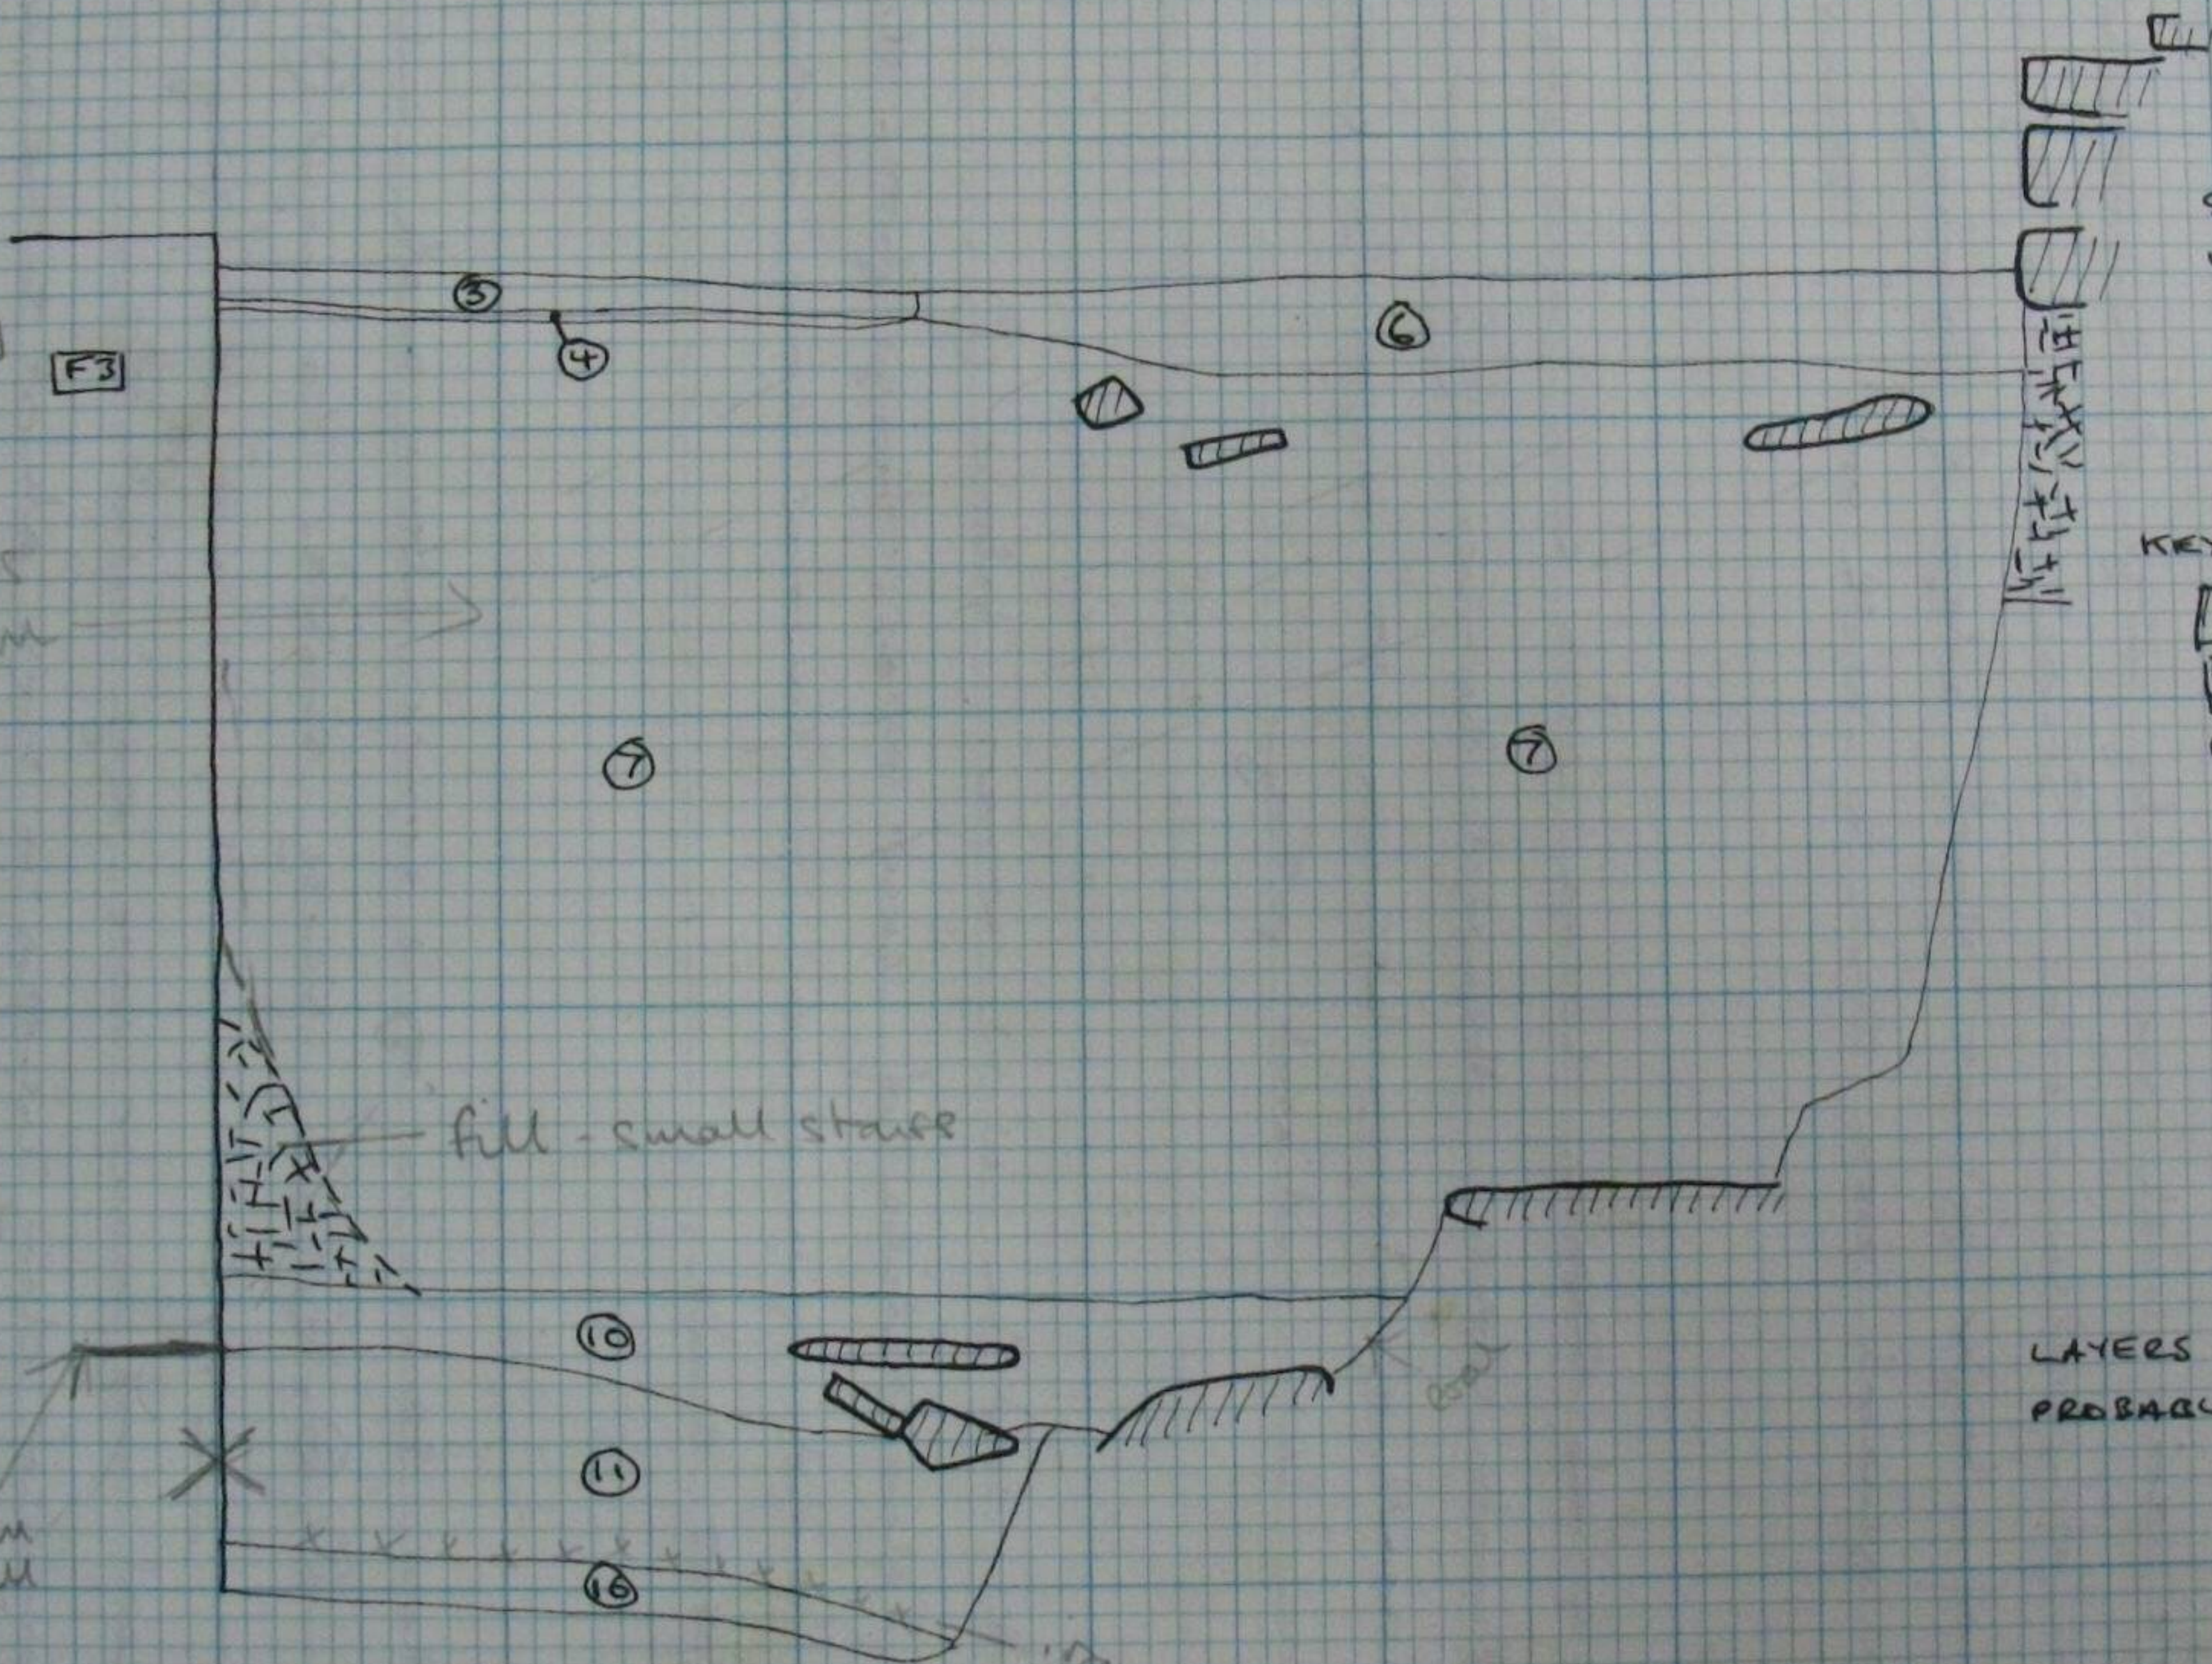
SECTION ONE

SMALL STONE RUBBLE
- ③ GREY CLAY.
- ④ YELLOW SAND.
- ⑥ DARK SOIL.
- ⑦ BROWN LOAM.
- ⑩ COMPACTED YELLOW SAND.
- ⑪ HARD GREY CLAY.
- ⑫ YELLOW CLAY

LAYERS ⑩, ⑪ and ⑫ ARE
PROBABLY NATURAL.

fill - small stave

Roman
wall

iron panning - road.

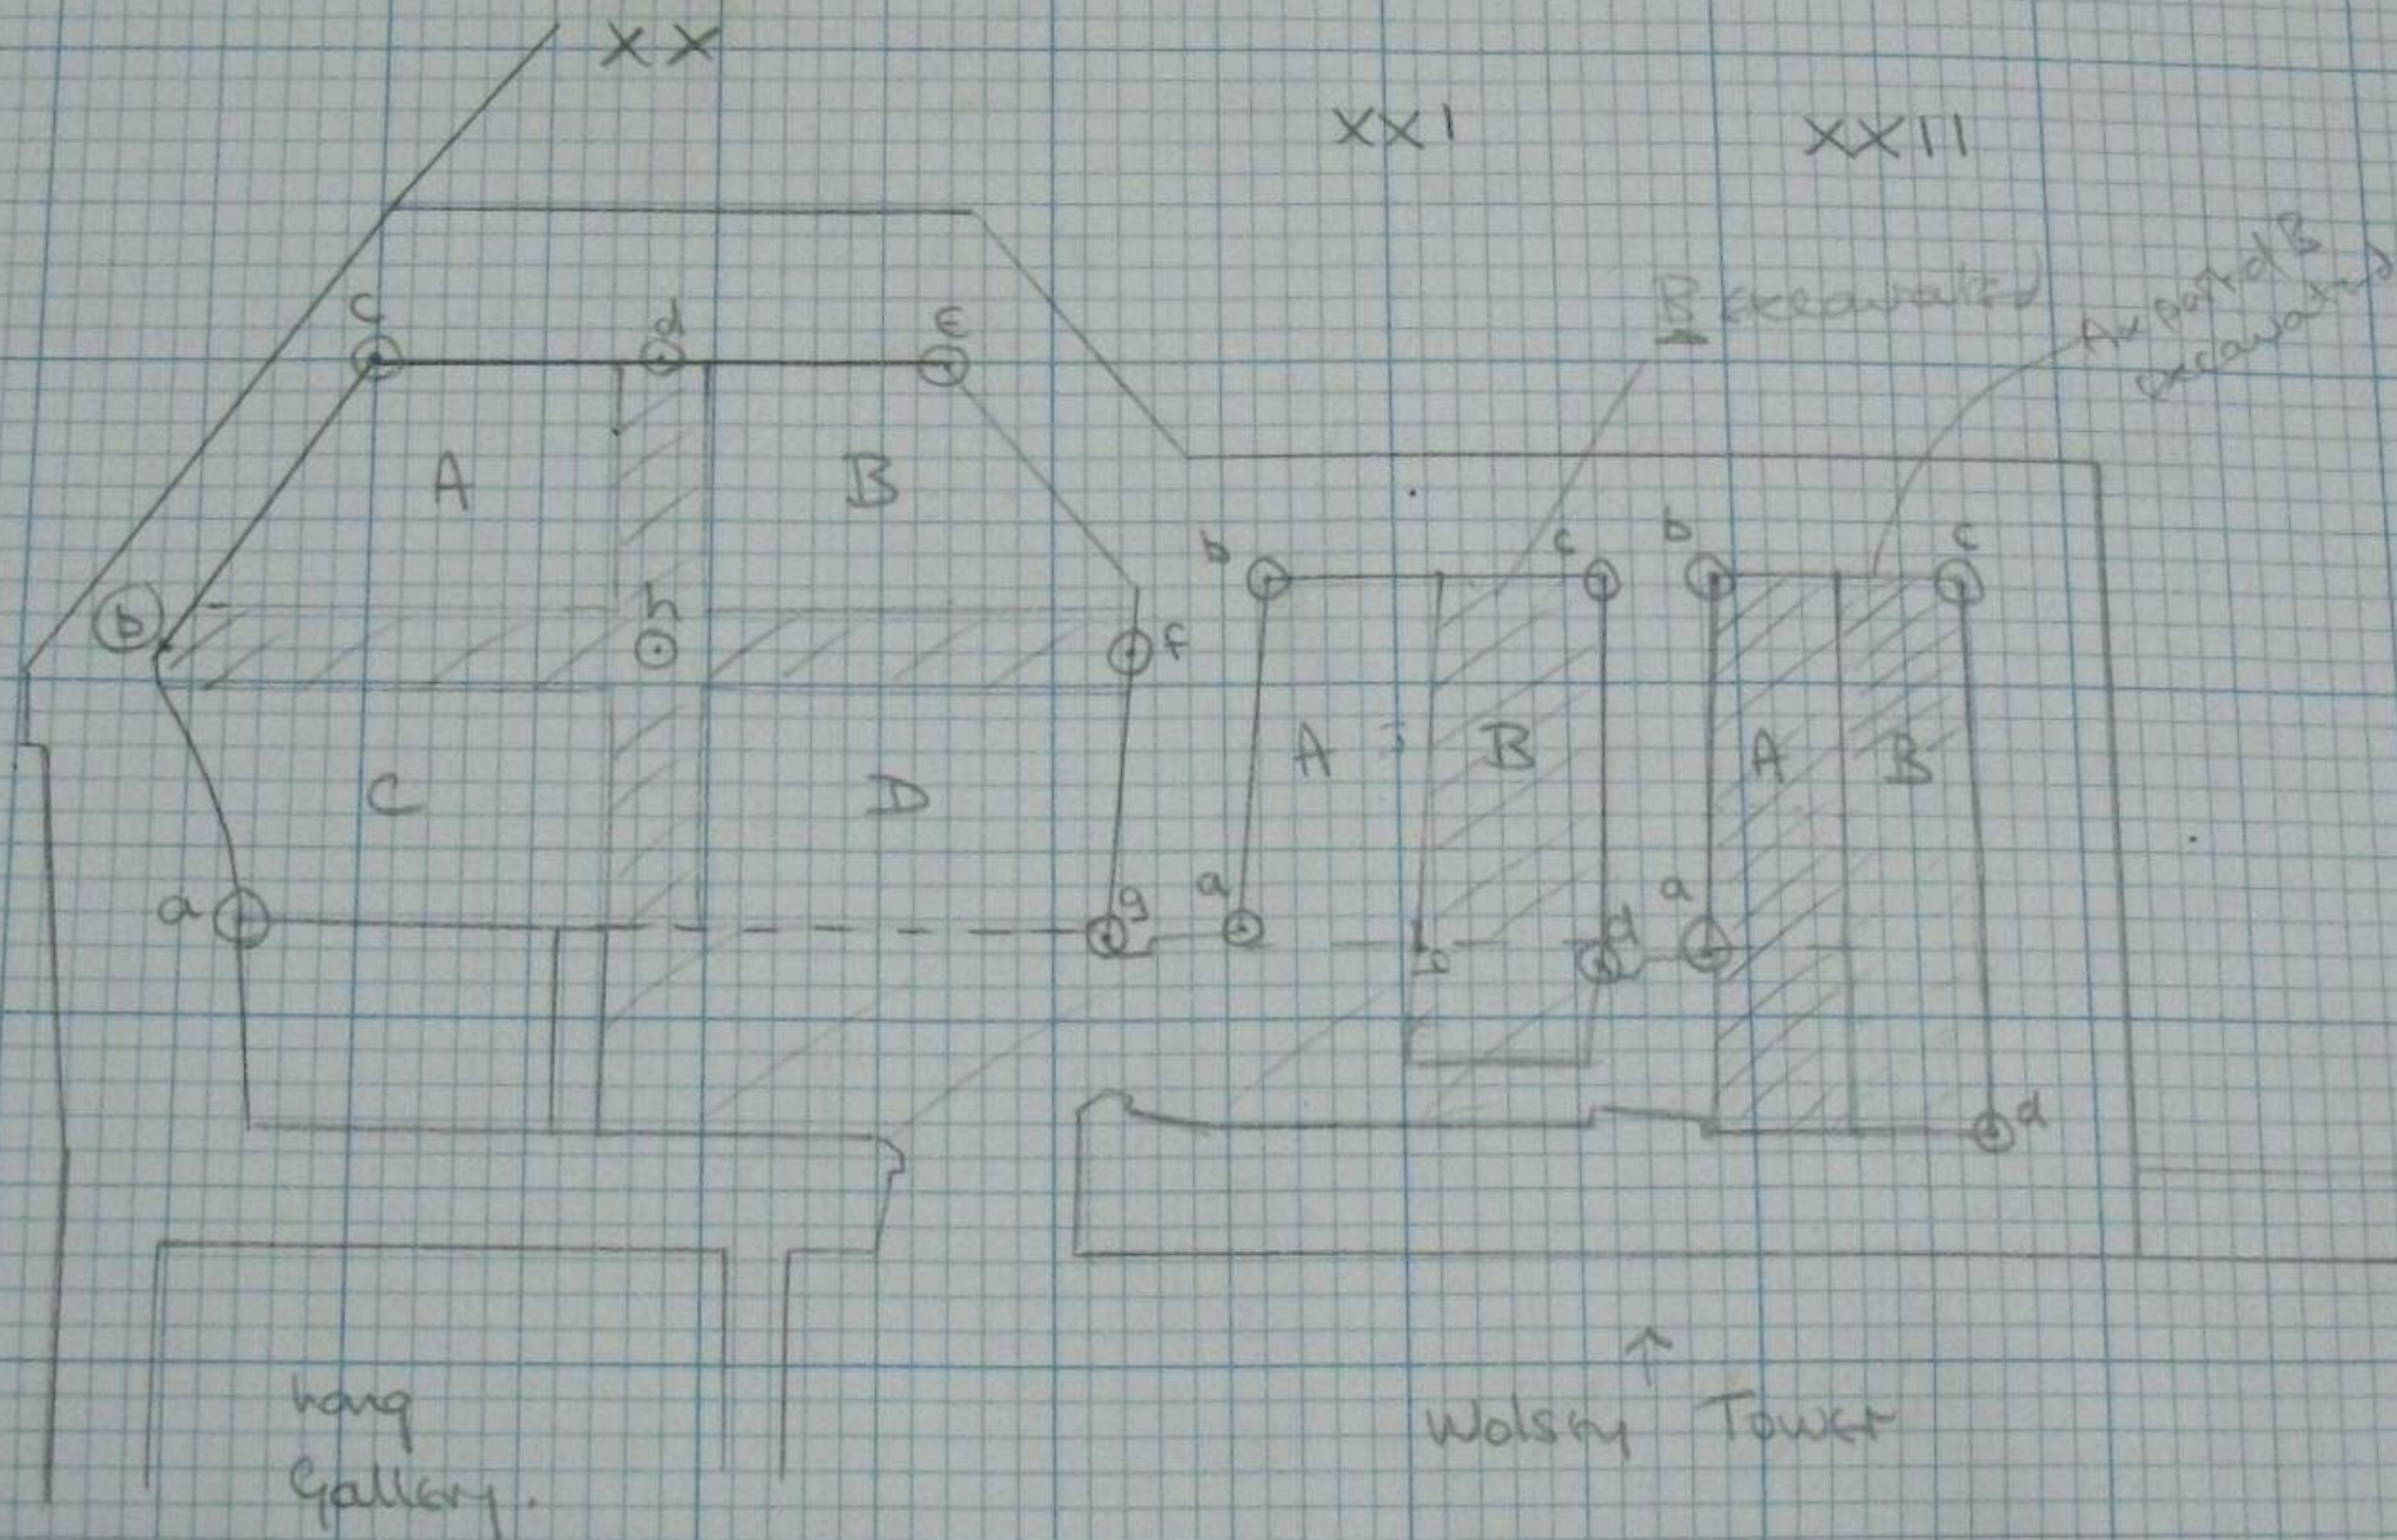
PLAN of EXCAVATION

SITES (3) XX XXI XXII

XX - Divided into 4 squares A, B, C, D.
BASE LINE c, d, e. (d mid-point along c, e.)
LEVEL - bottom of "floor joist" slot.
d-h = 7' long
Baulks - 2' wide.

XXI b-c Divided in $\frac{1}{2}$ (A & B). → 9' long section $\frac{1}{2}$ way
between E & W walls.

XXII b-c as above

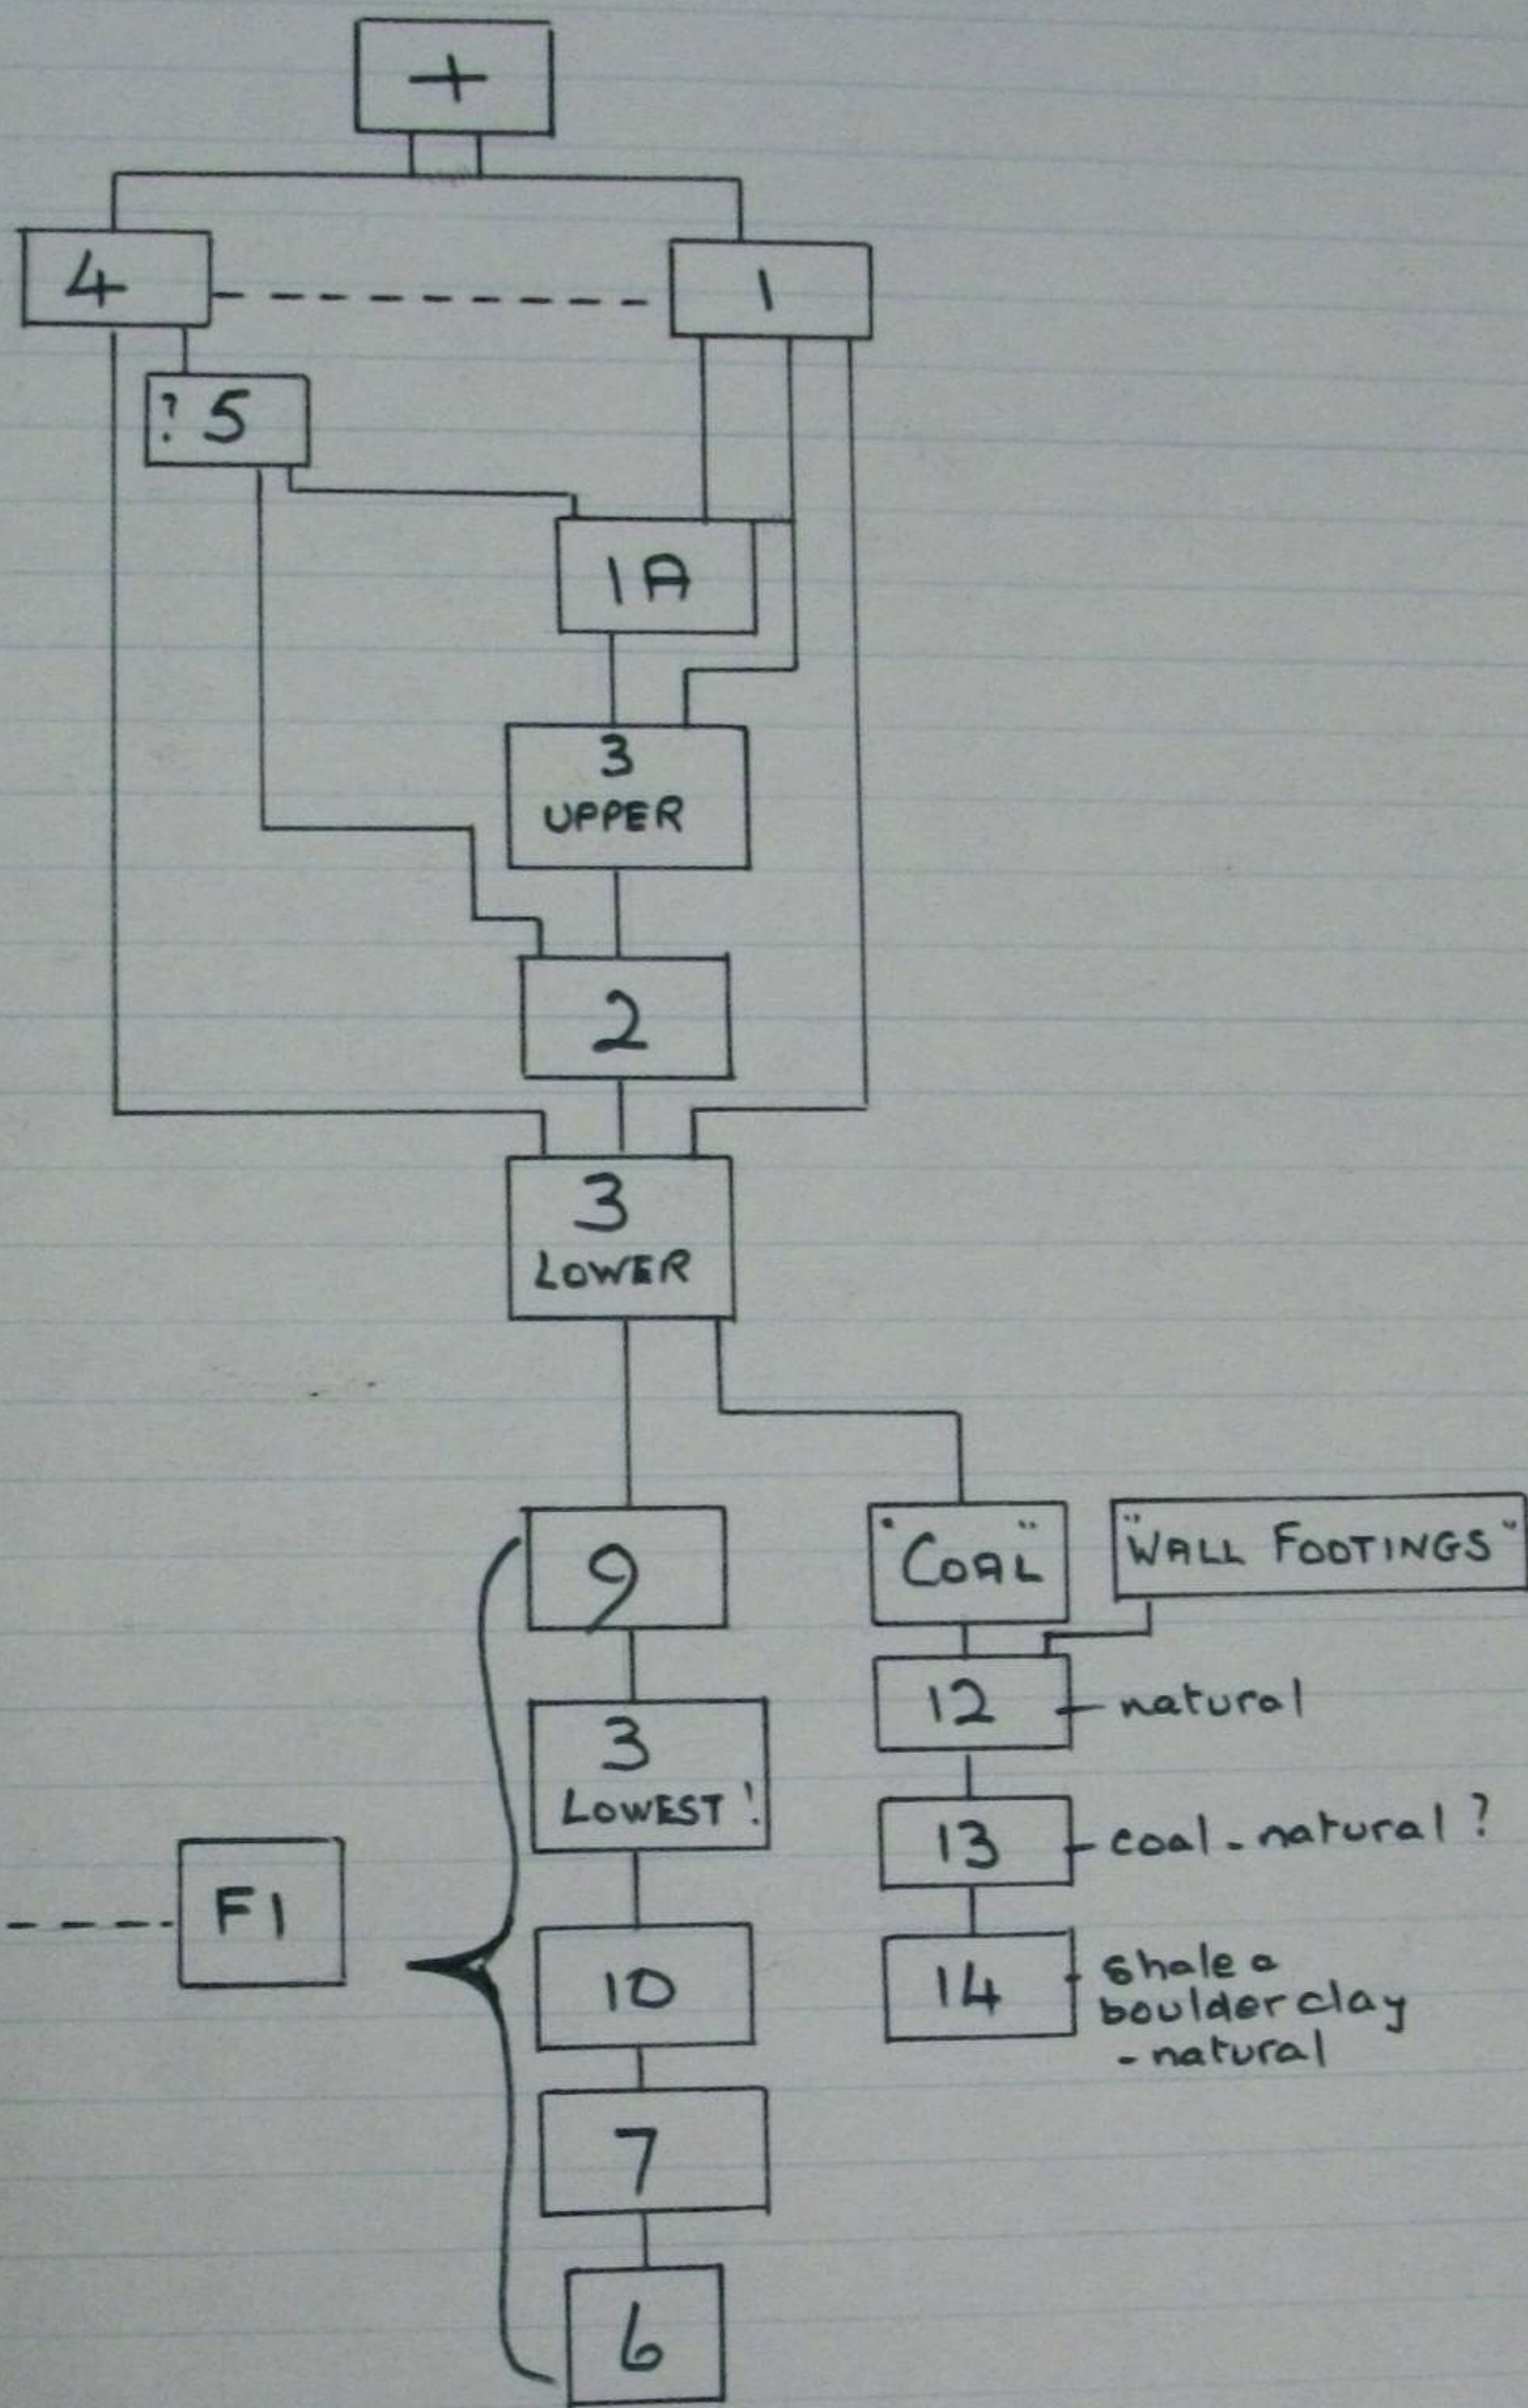
SM 71 XXI

ROOM XXI

GENERAL PLAN
AT SURFACE LEVEL.

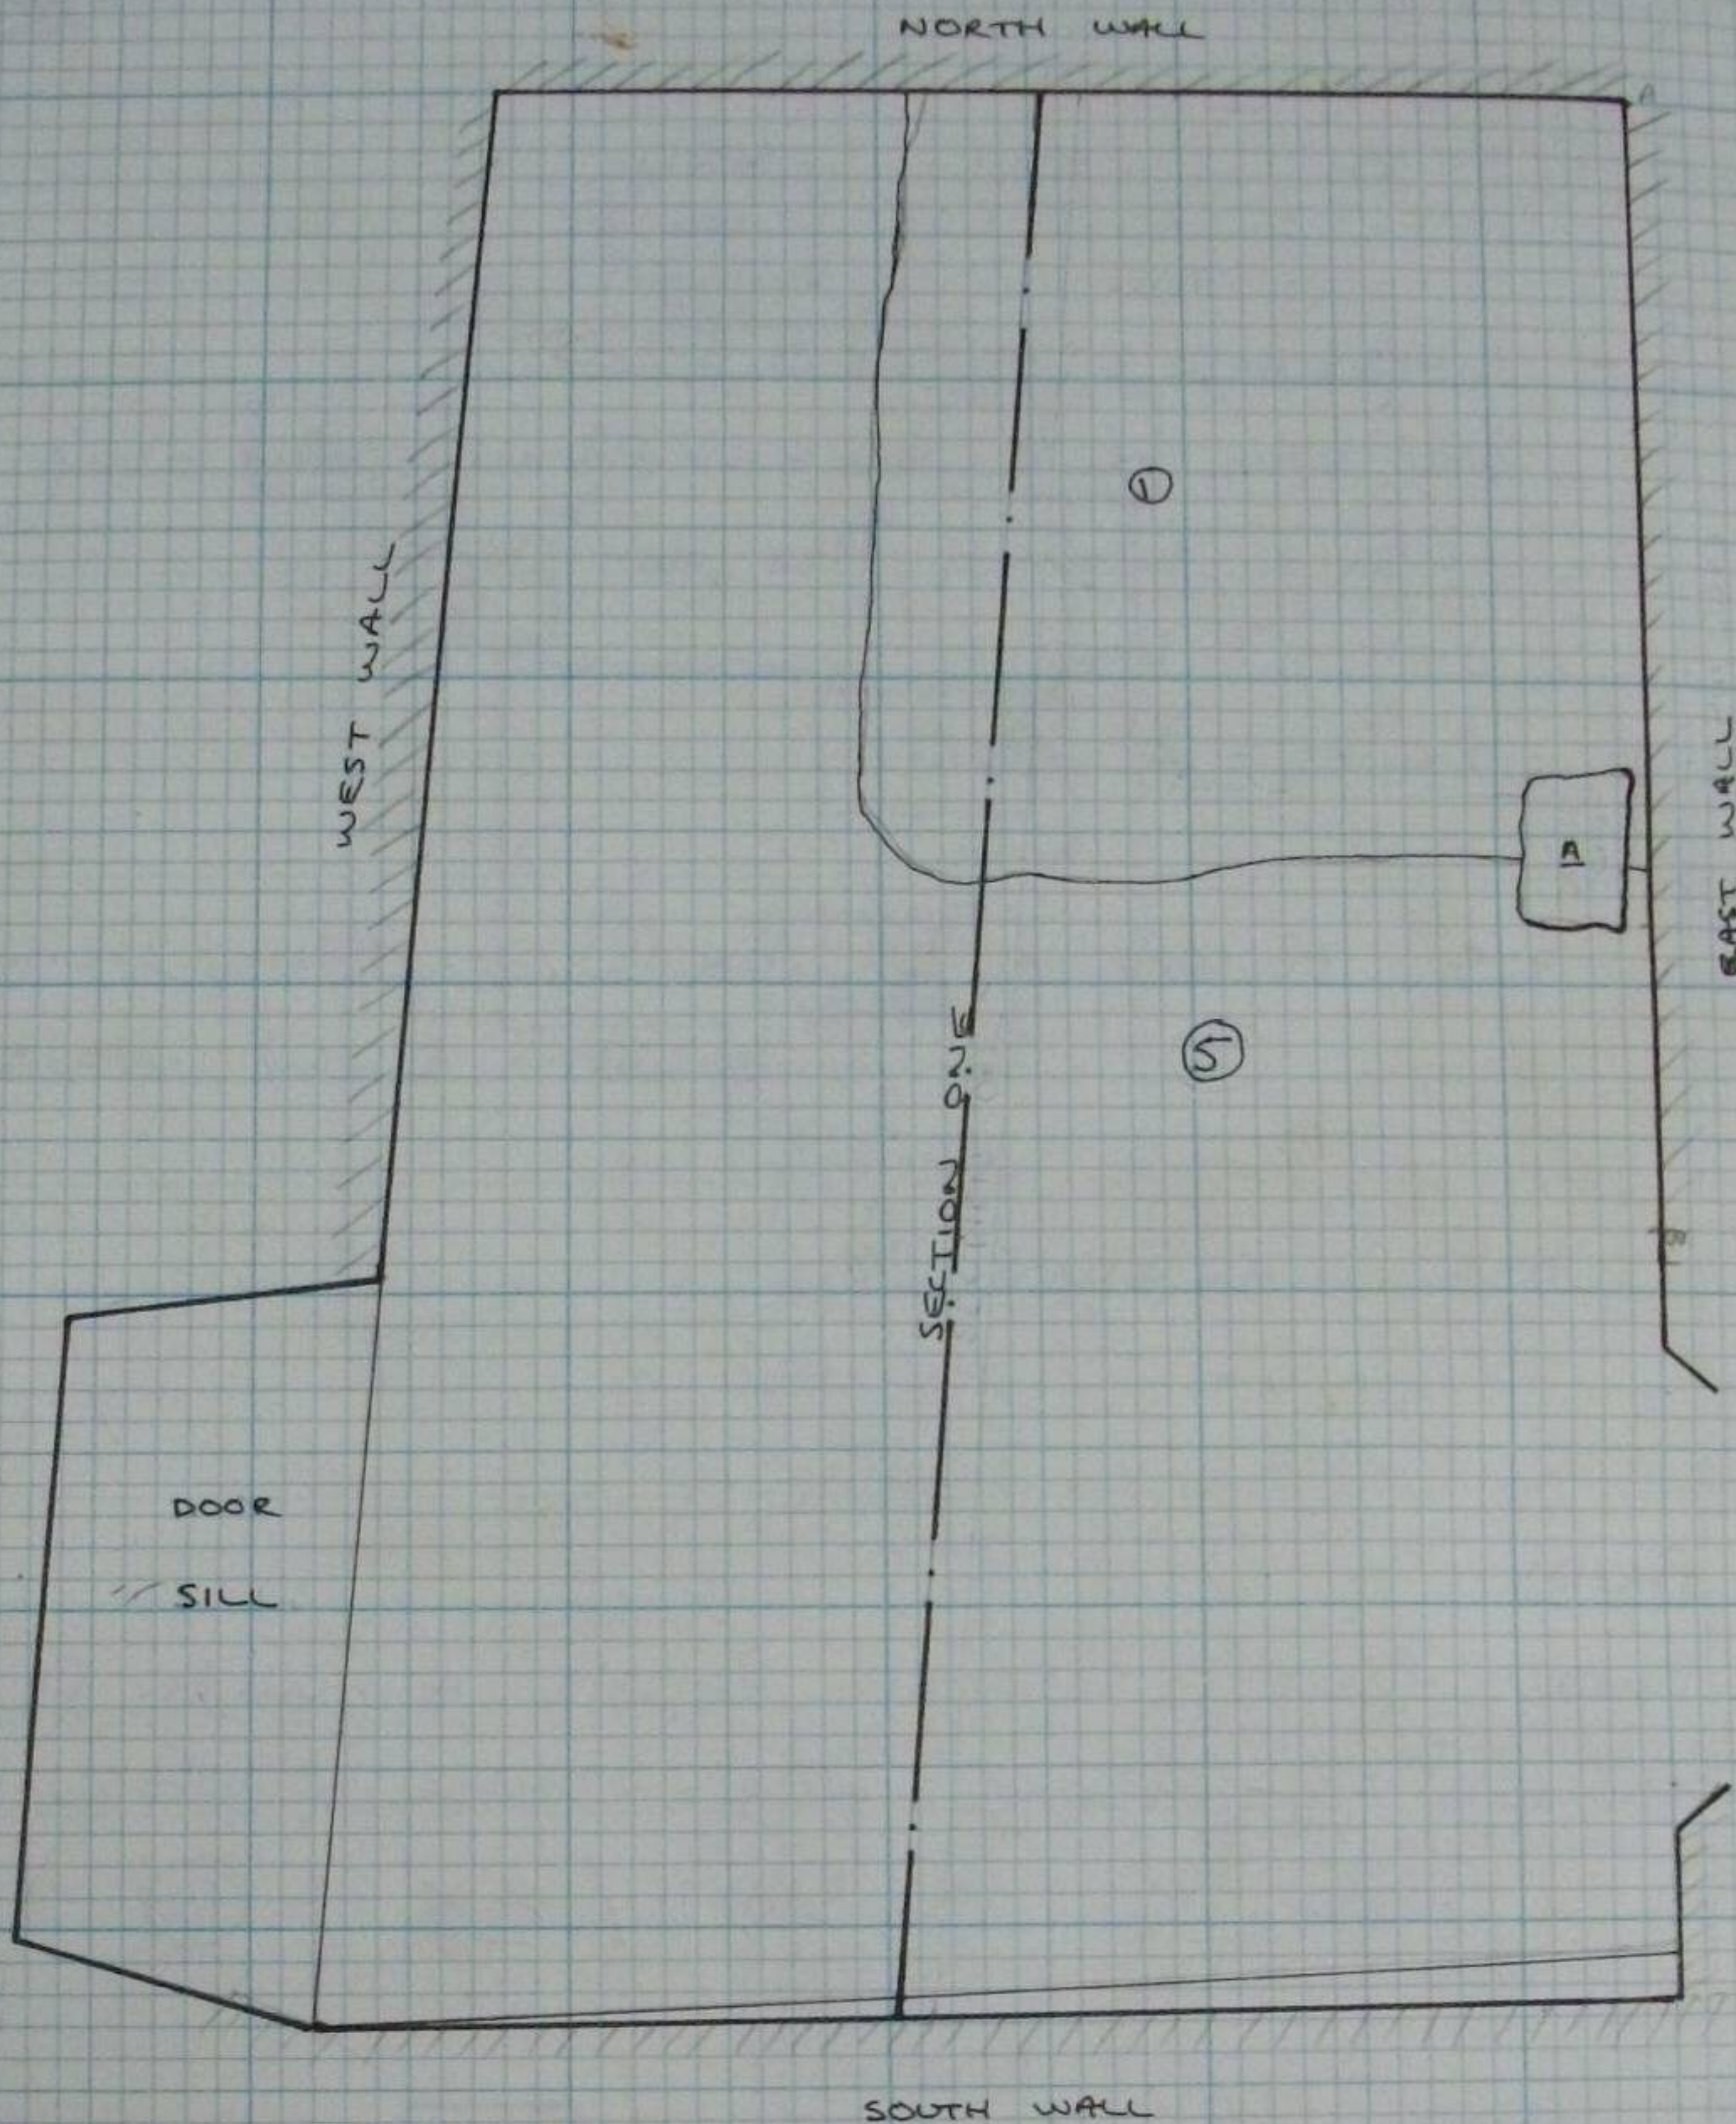
KEY:

A IS ROUGH DRESSED SANDSTONE.

① BURNED RED CLAY (SEE PAGE 13)

⑤ PURPLE ASH AND CLINKER (SEE PAGE 15).

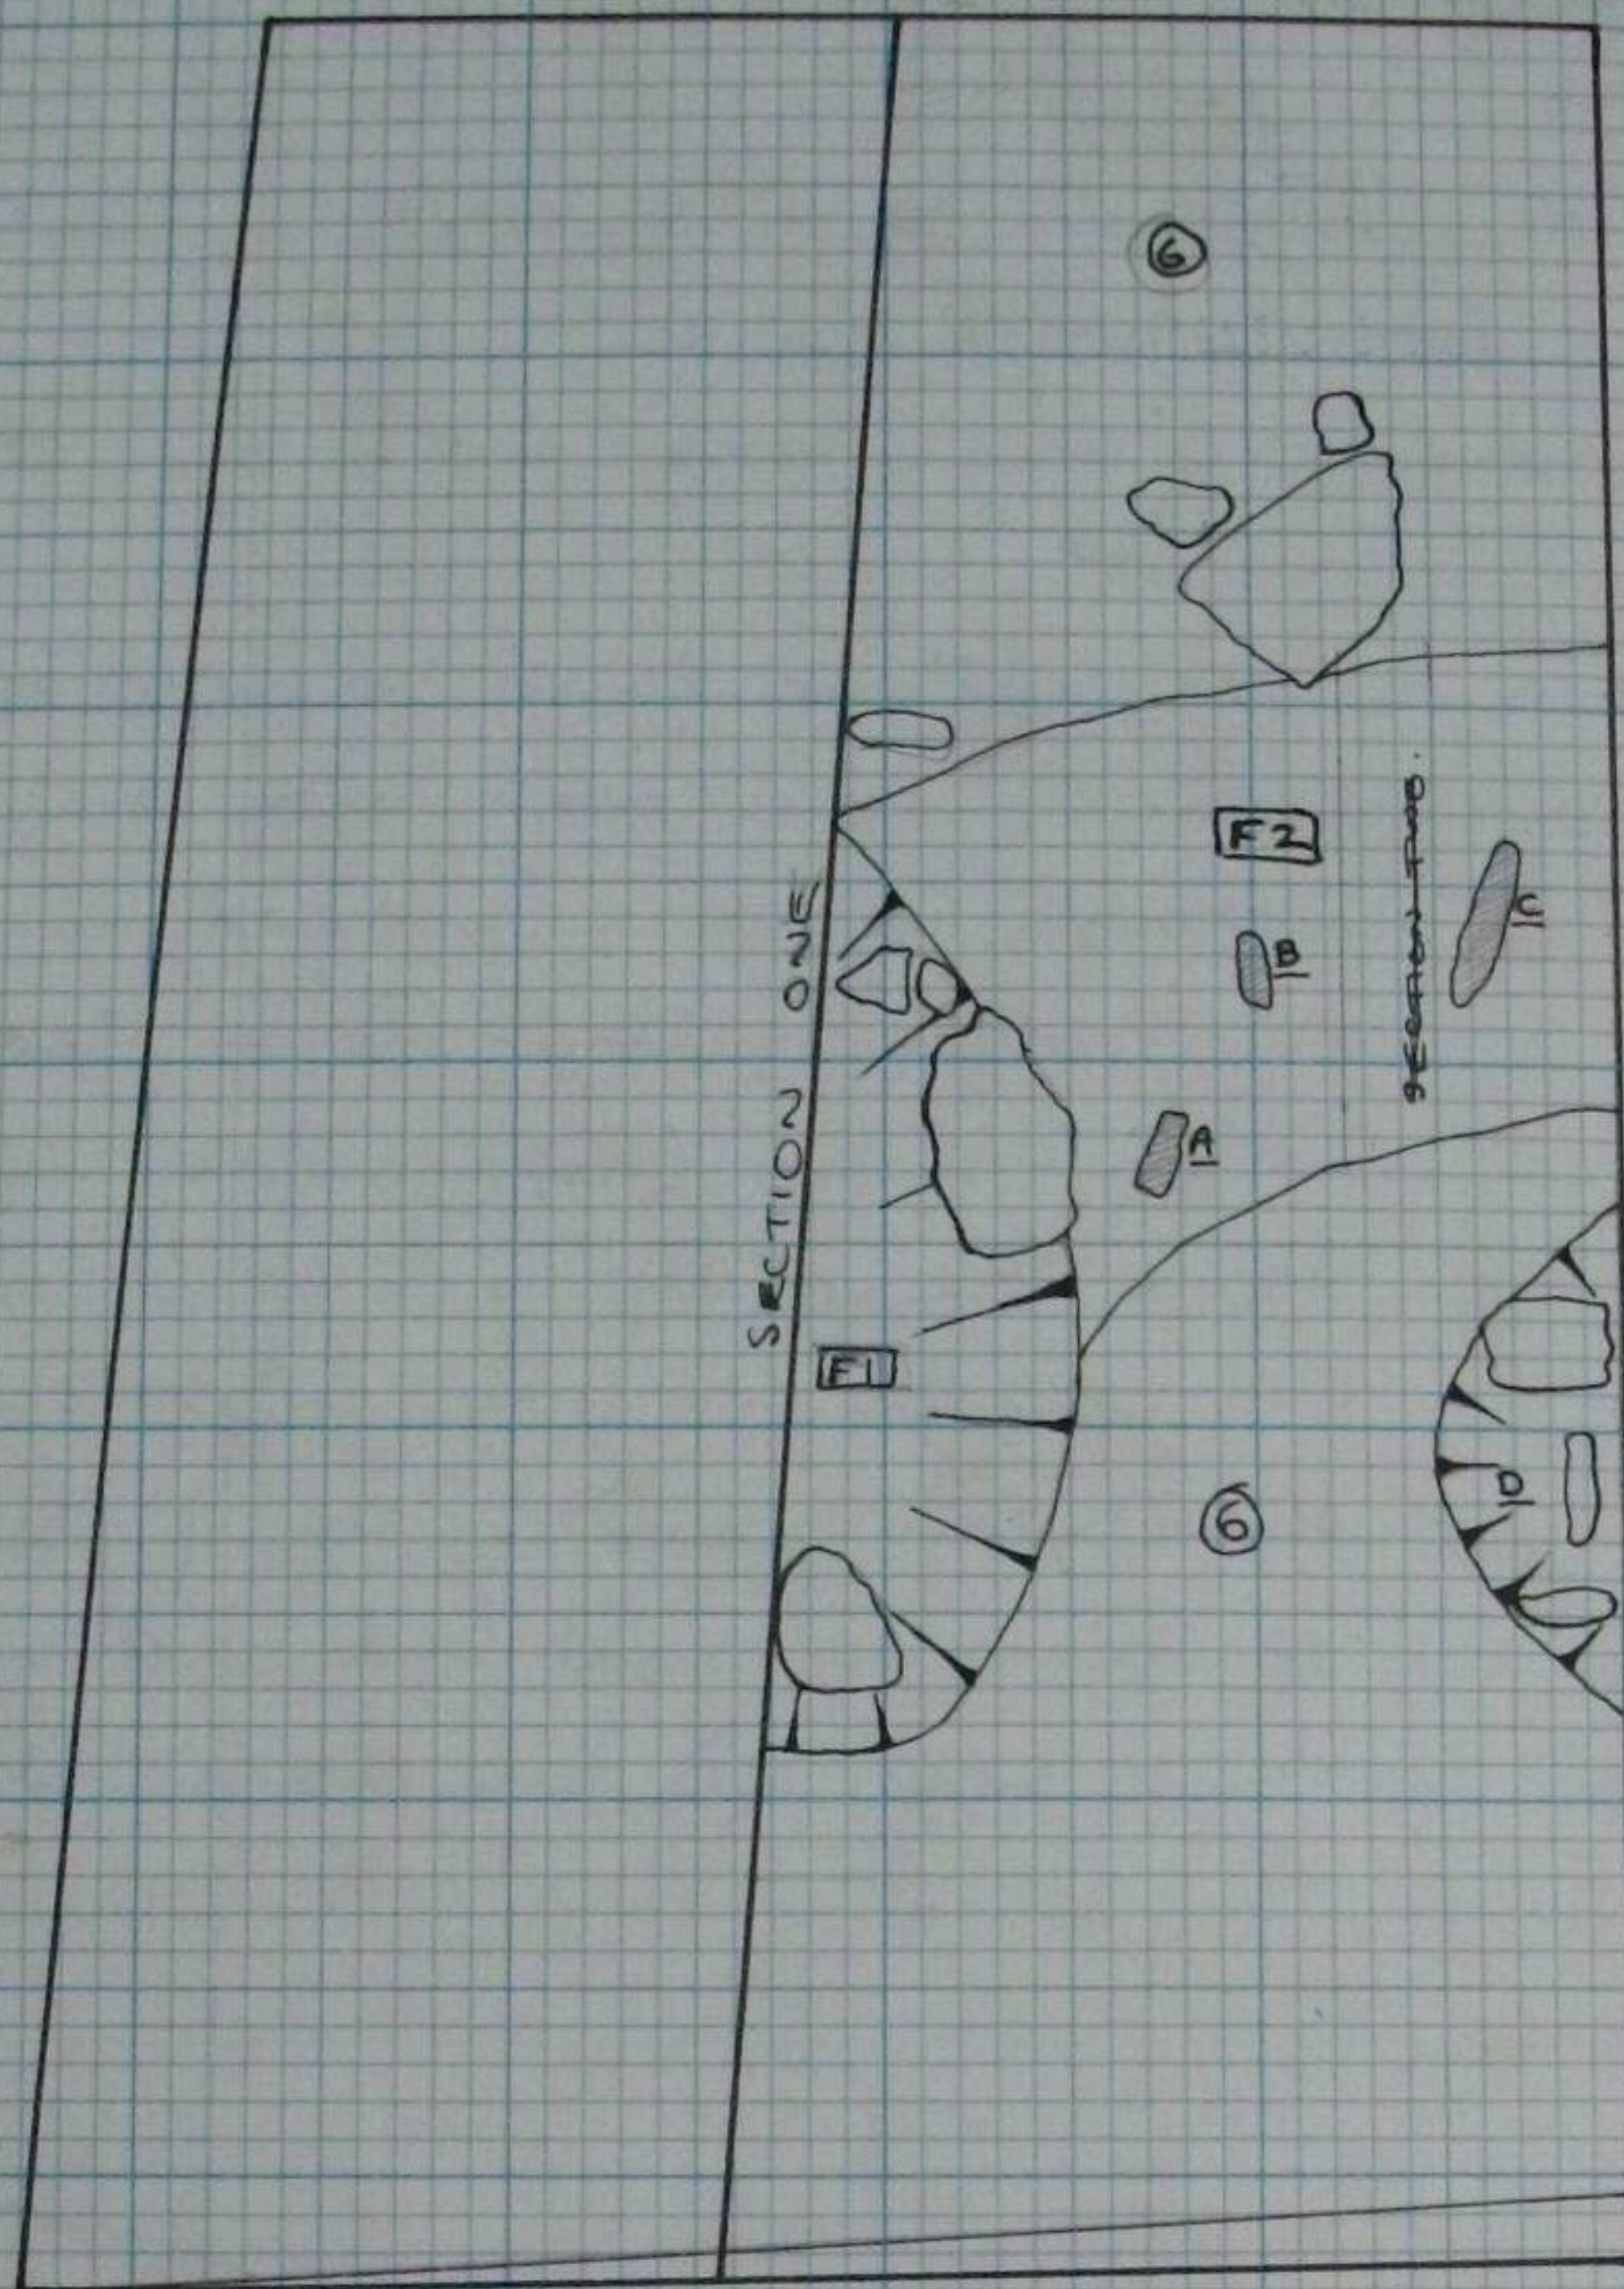
ROOM XYI TRENCH PLAN
AT LAYER ⑥

KEY:

A, B, C ARE STONES SET UPRIGHT INTO DARK LAYER. ⑧

ALL STONES ARE SANDSTONE.

D IS A SHALLOW DEPRESSION (6" DEPTH) IN LAYER ⑥

? coal seam partly dug out - [F1] remainder

[F2] ? ditch? Runs from roughly centre of East wall to side of [F1]

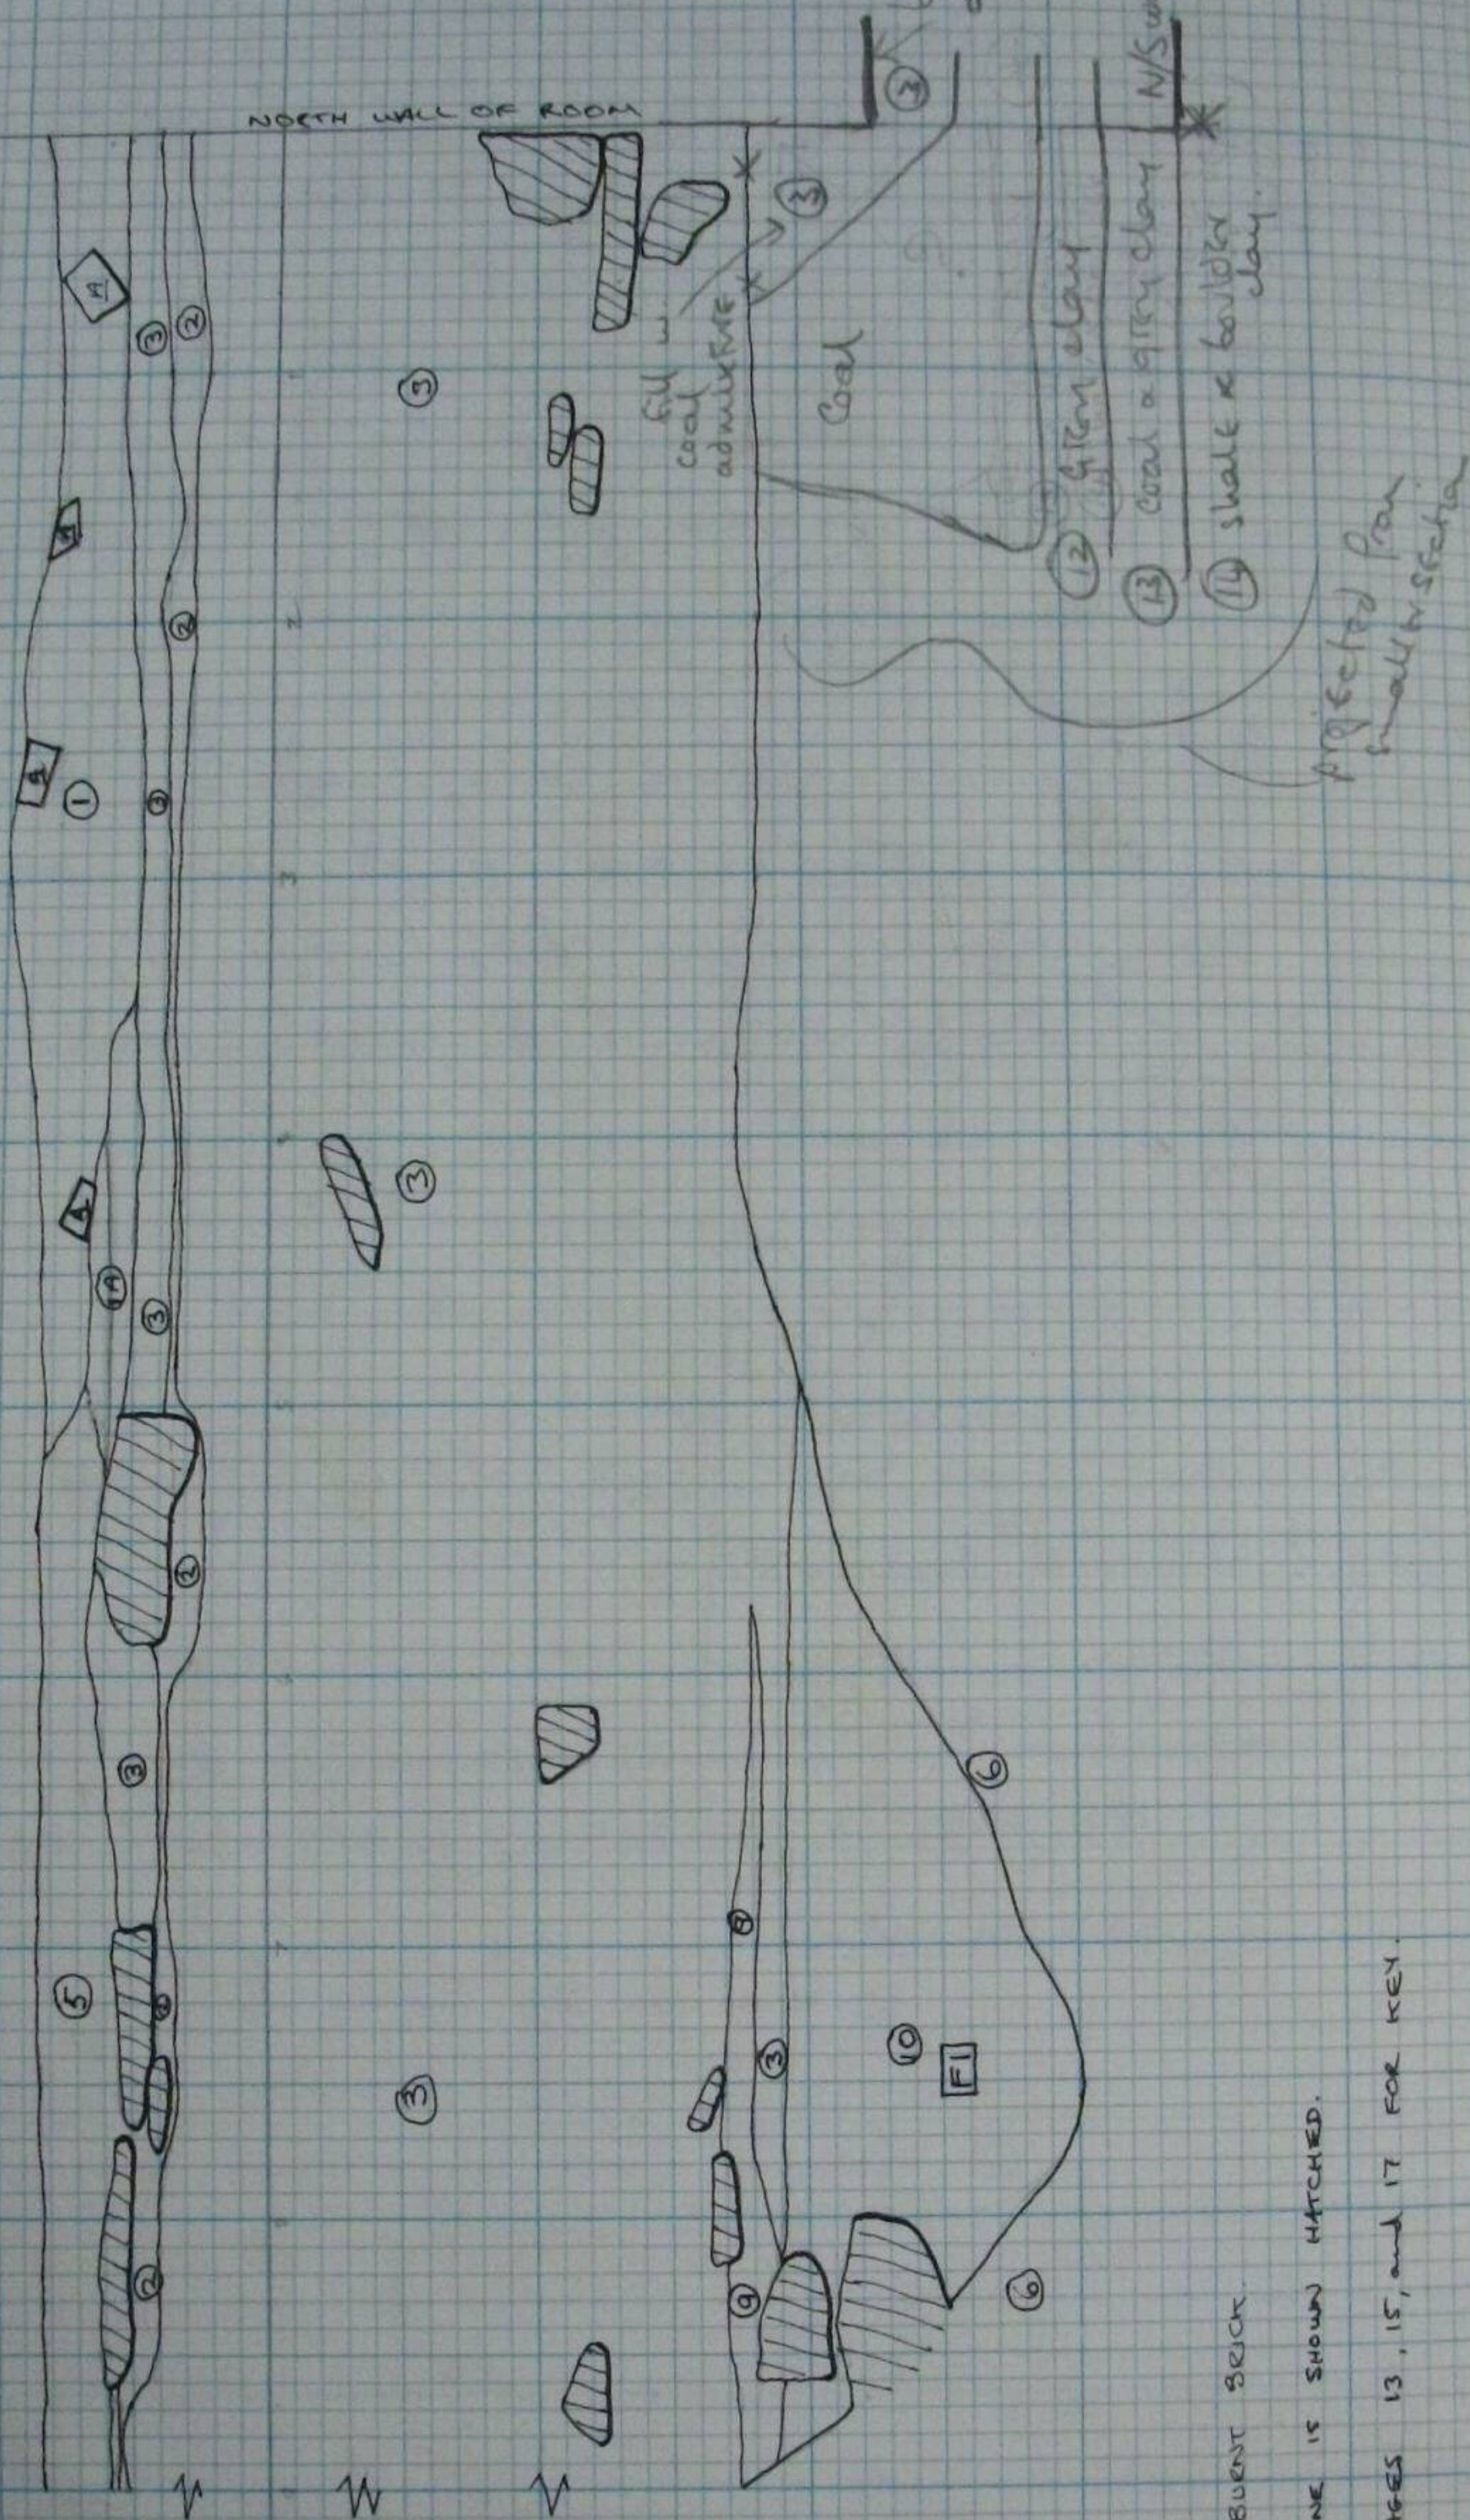
SECTION ONE

KEY:

A IS BURNED BRICK.

SANDSTONE IS SHOWN HATCHED.

SEE PAGES 13, 15, and 17 FOR KEY.

N/S CROSS WALL

F1 = PIT. Appears to be bisected by N.S. section of trench (SECTION ONE, page 8)

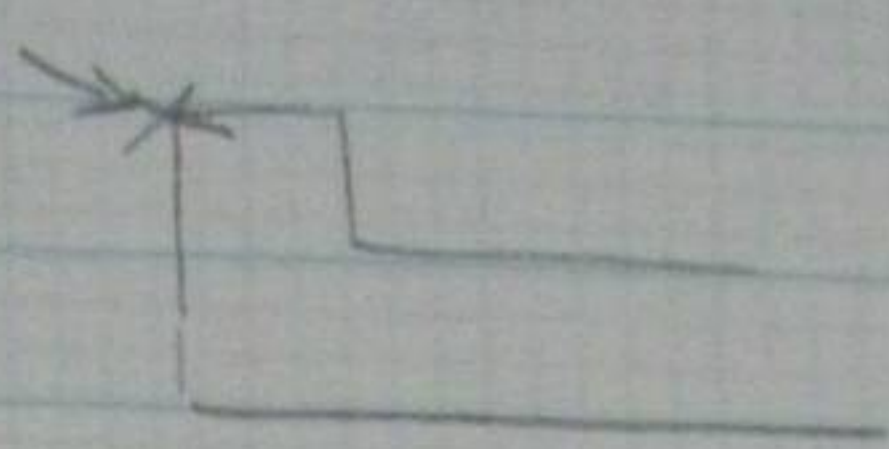
- W side * join N/S cross wall ^{deeper - by 14"} ~~same level~~ - ~~to S. the cross wall goes deeper~~ - resting in ^{60176 clay} ~~an sand~~ C. No signed foundat. trenches.
- 1) Bottom of arch beam \rightarrow 31" to bottom of wall
 - 2) 51" Top of door sill stone \rightarrow to bottom of wall.

WALL - 30" wide

E side - 46" from top of door sill to bottom of wall.
See section for full details on E side.
