JOHN
BURTON

SHEFFIELD MANOR

SITE RECORDS

AREAS XVI XVIII

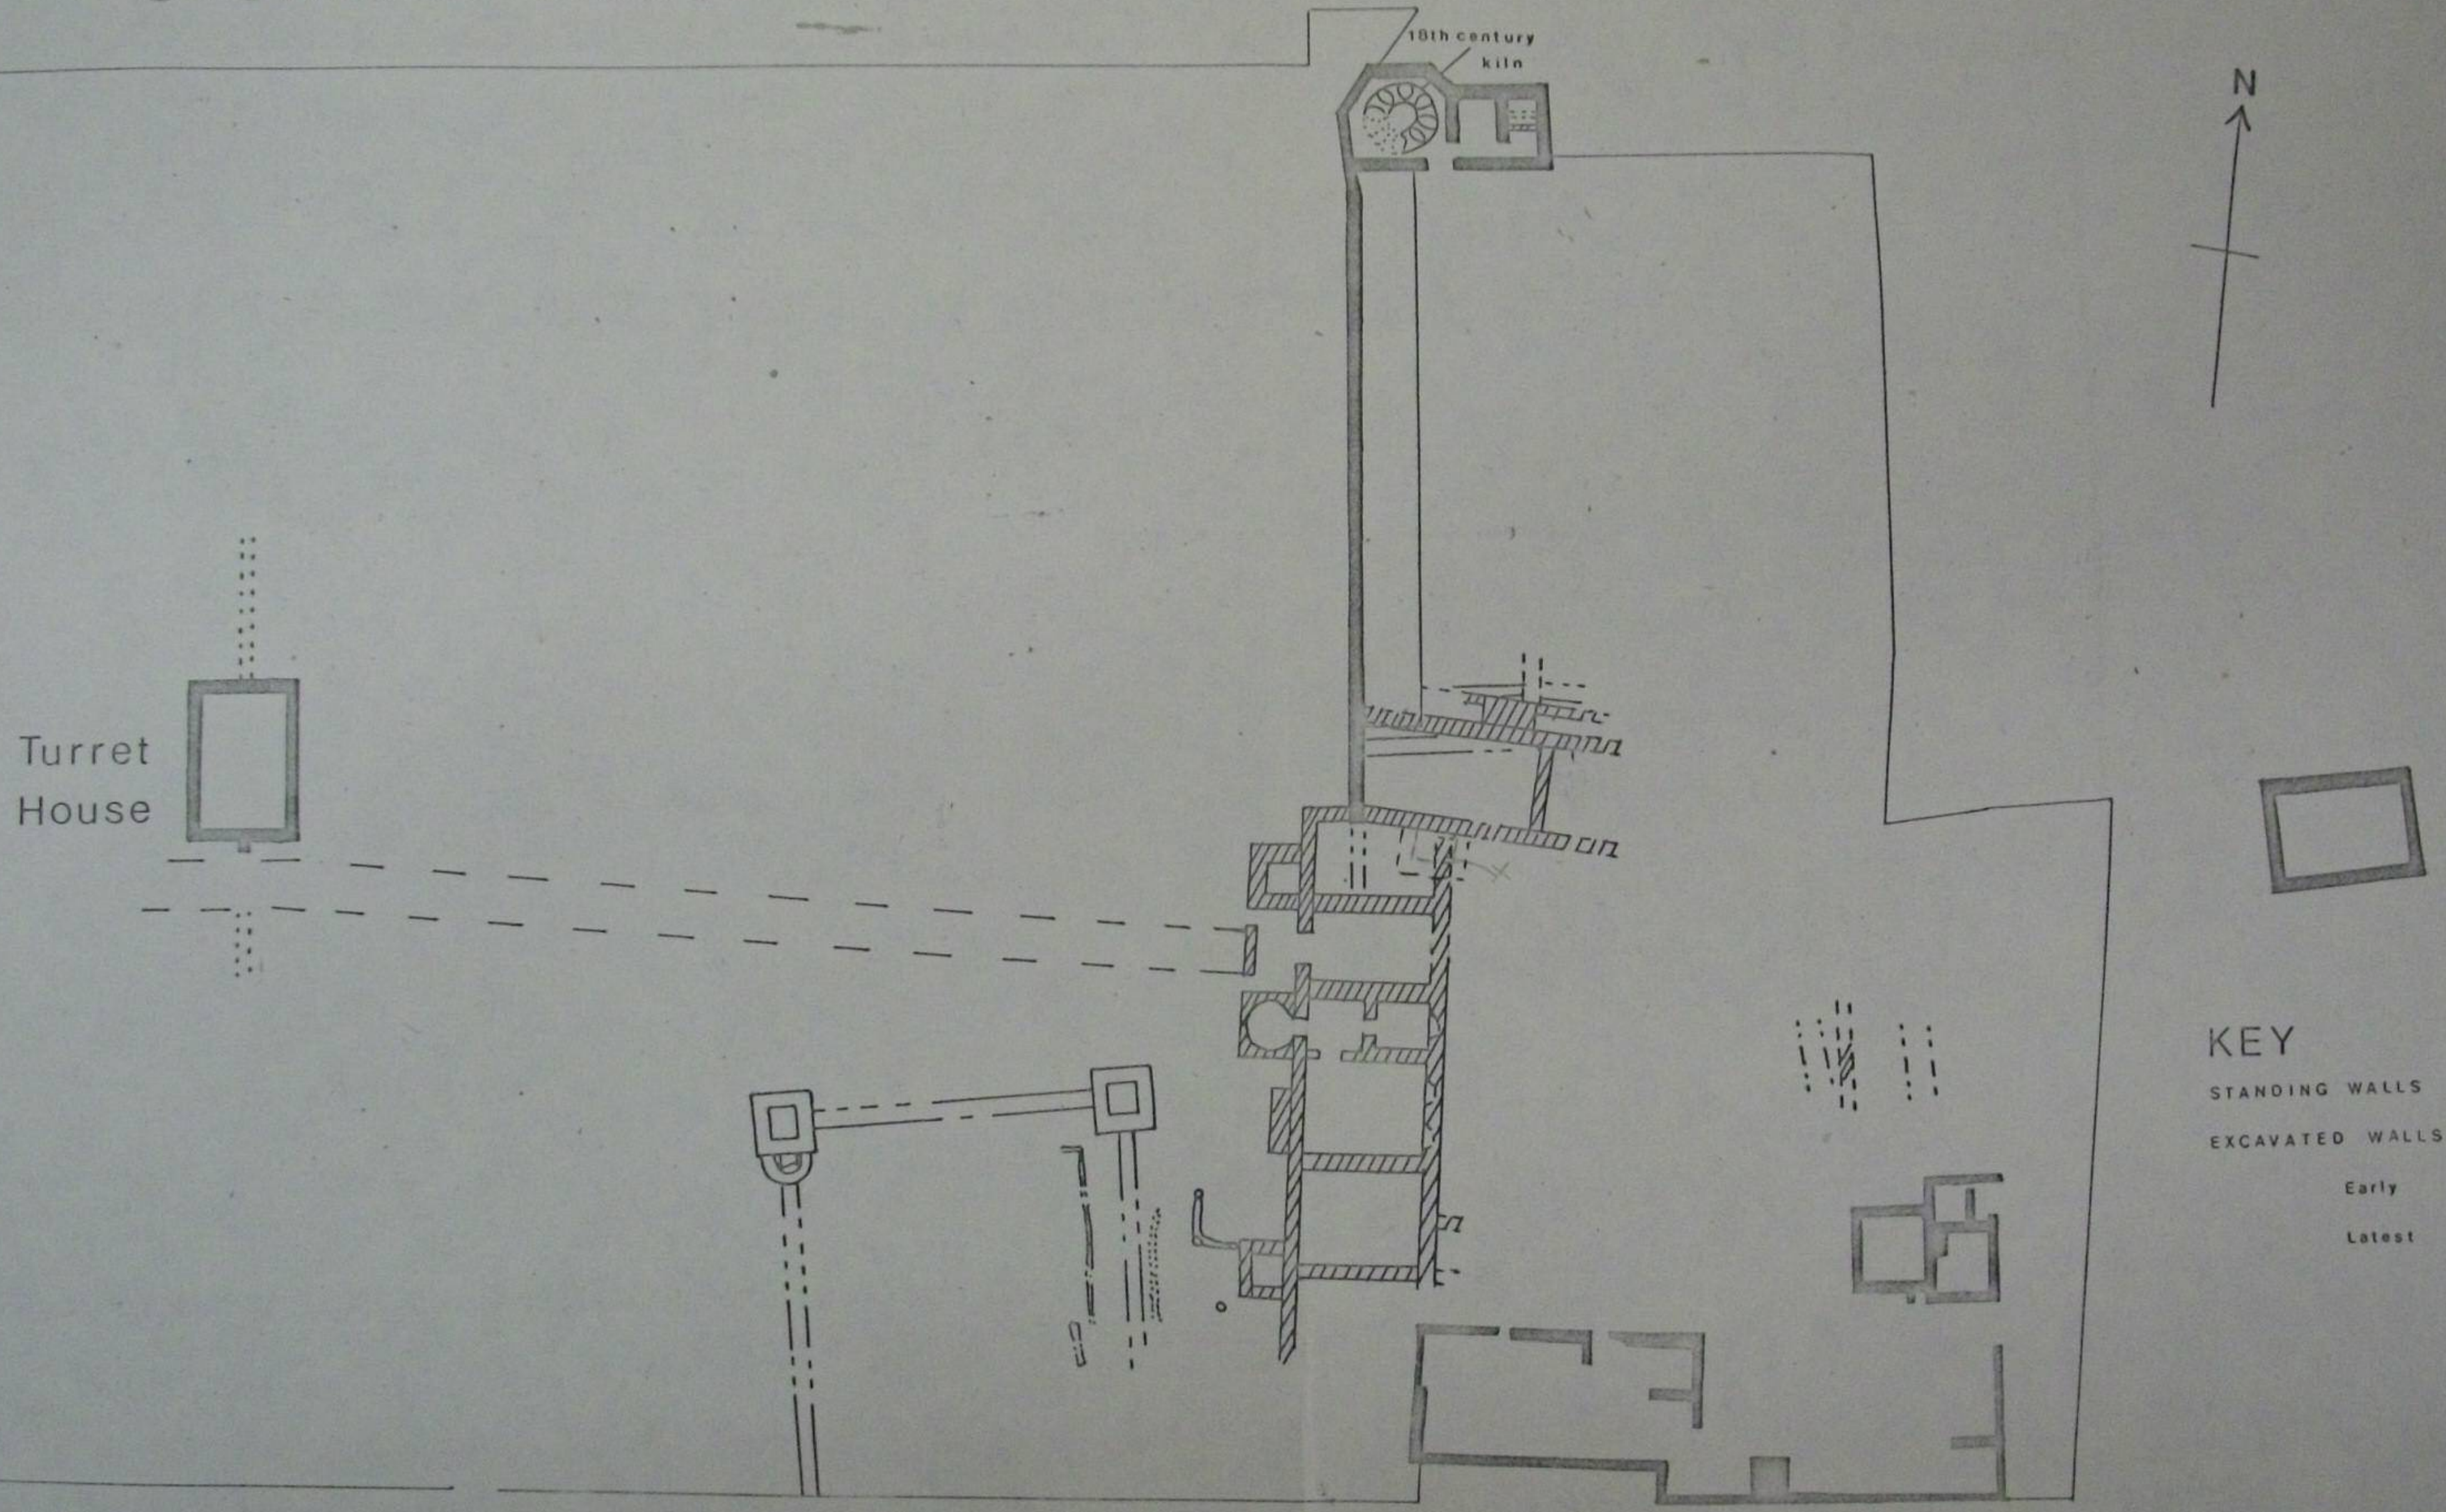
Sheffield Manor

Turret House

18th century kiln

KEY
STANDING WALLS
EXCAVATED WALLS
Early
Latest

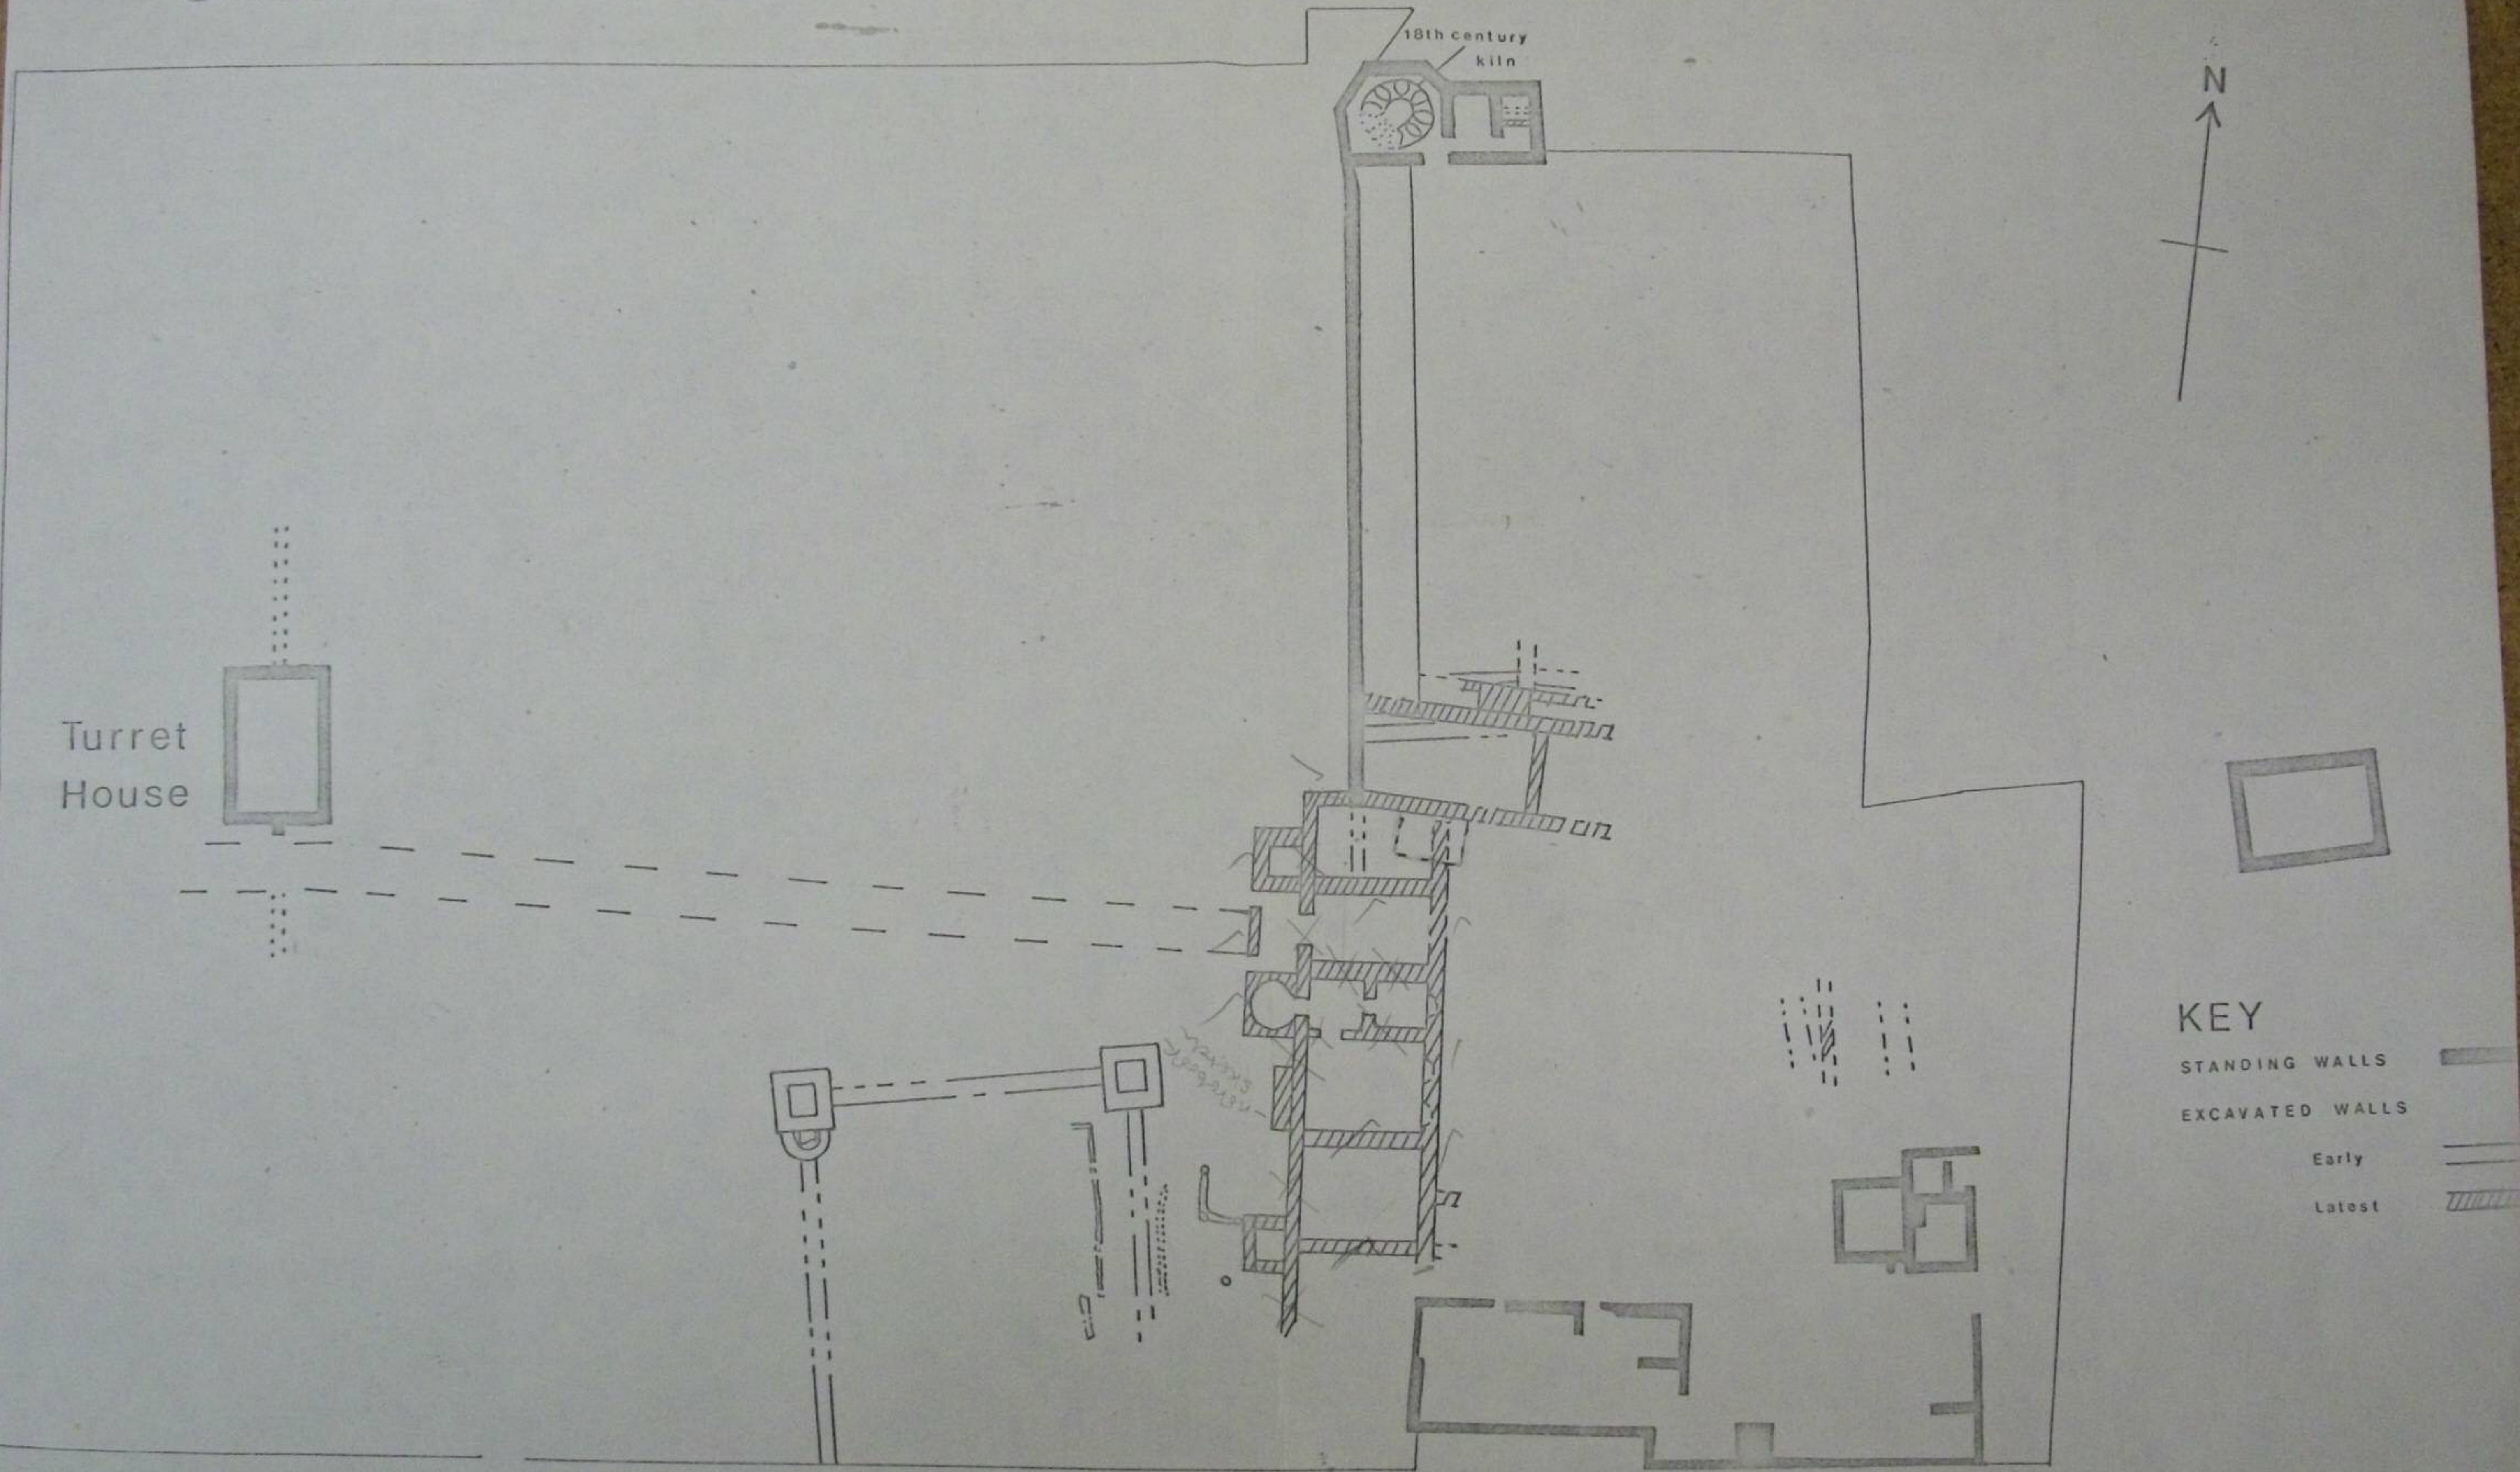
Sheffield Manor

Turret House

18th century kiln

KEY

- STANDING WALLS
- EXCAVATED WALLS
- Early
- Latest

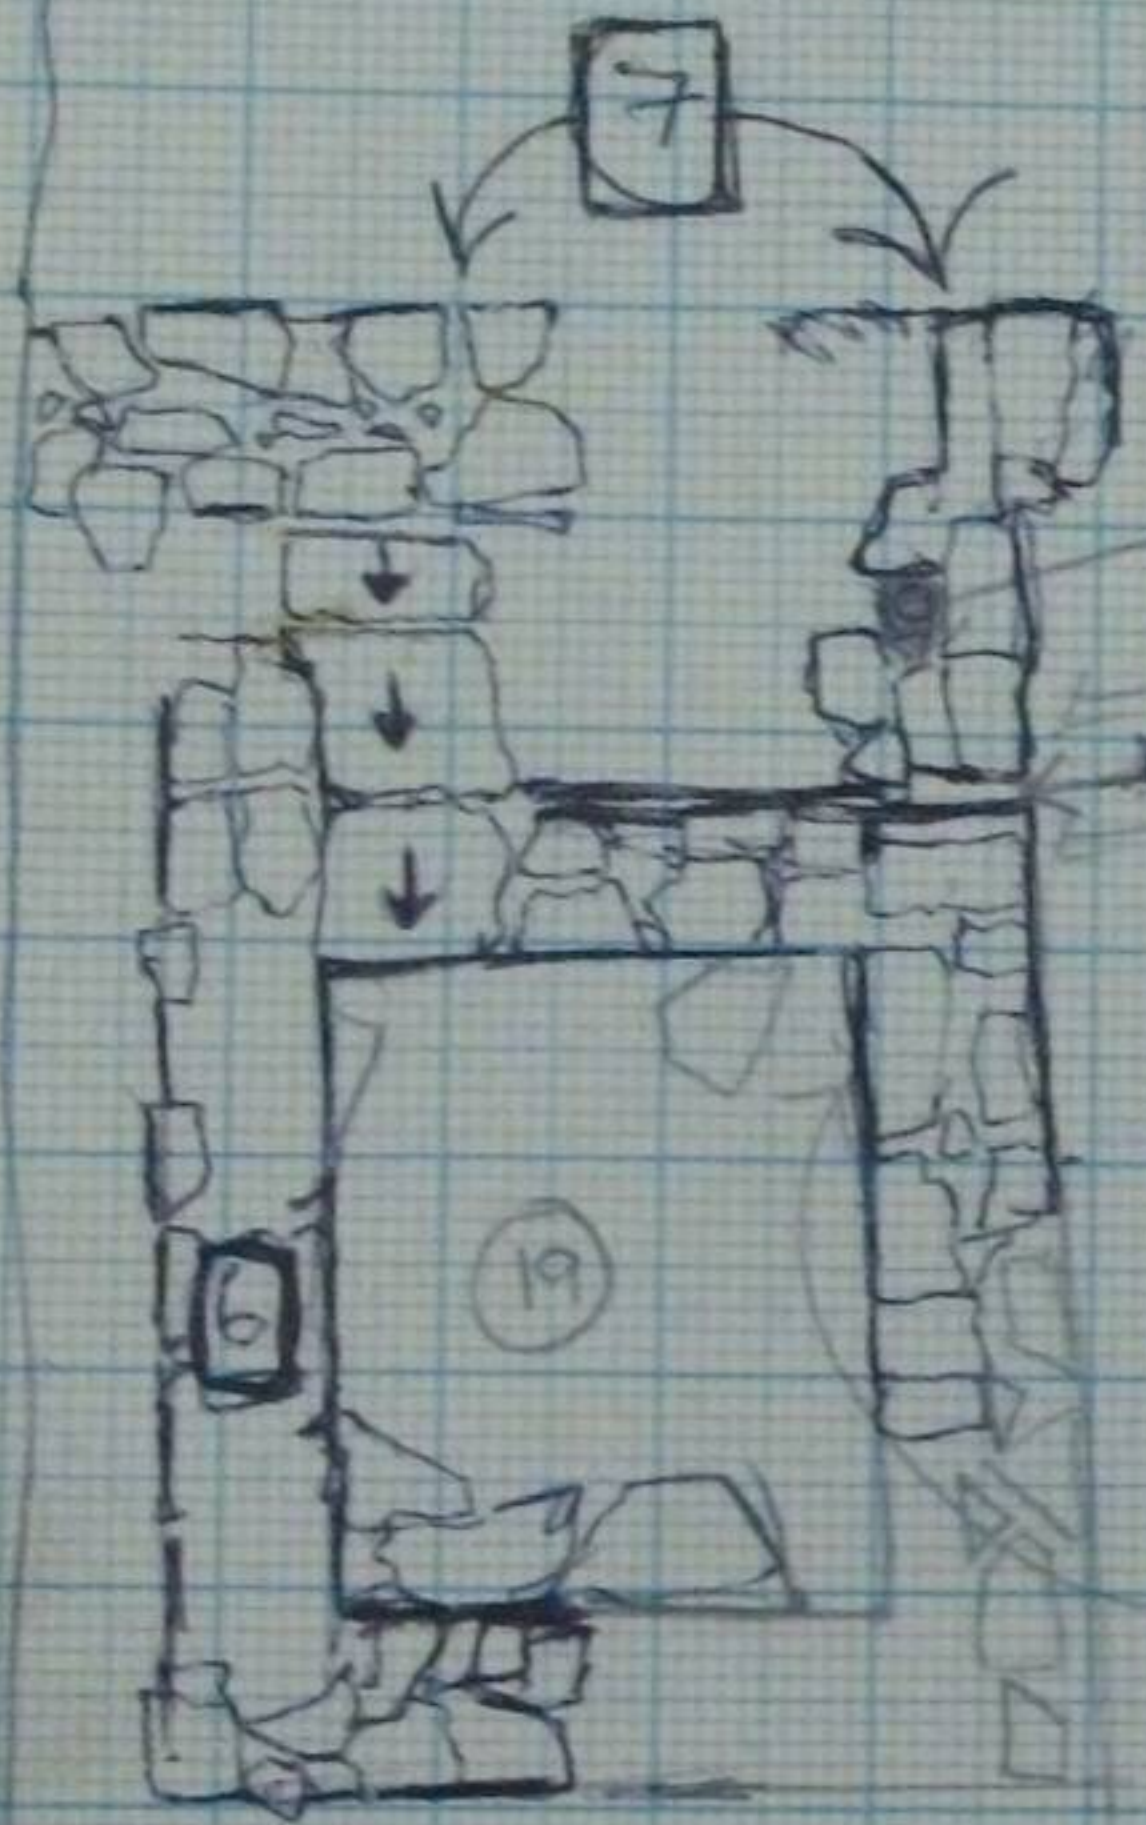
dark soil fill.

3 courses, mottled -

Base 500mm above base of top 770 cm above base of

5 courses, mottled - 400 cm high

whitish mottled.

inner surface ideal if burnt. Remains of flagged floor inside.

(Natural Bedrock)

Gray mottled wall.

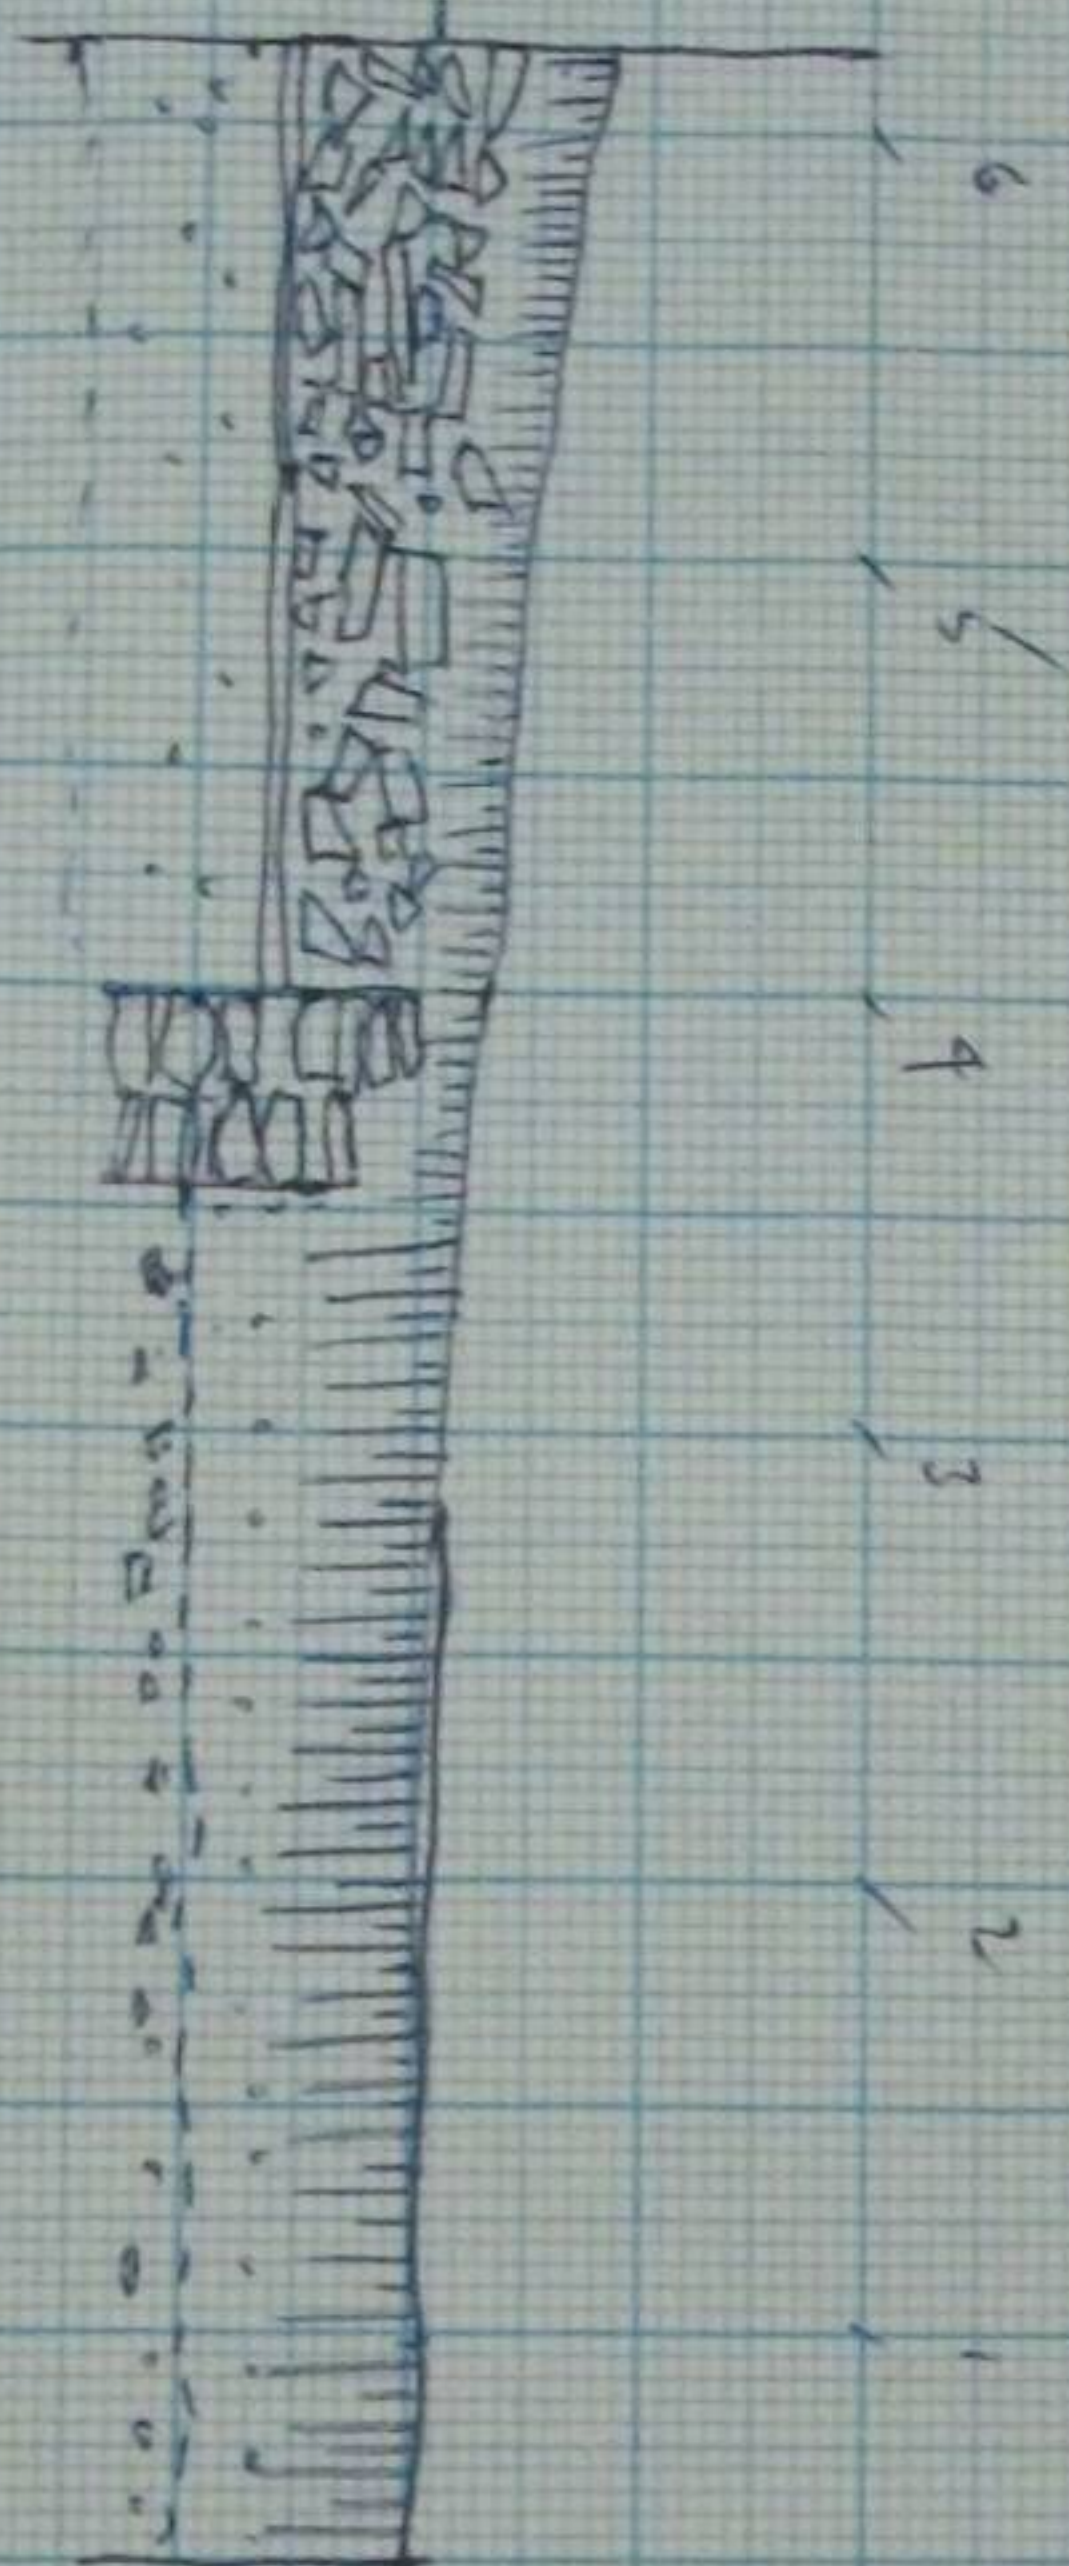
PLAN

Revised window mullion

Dressed
corner
stones.
Rest of wall
random rubble
with some brick
Some white mortar
in courses about
foundation
but partly weathered.

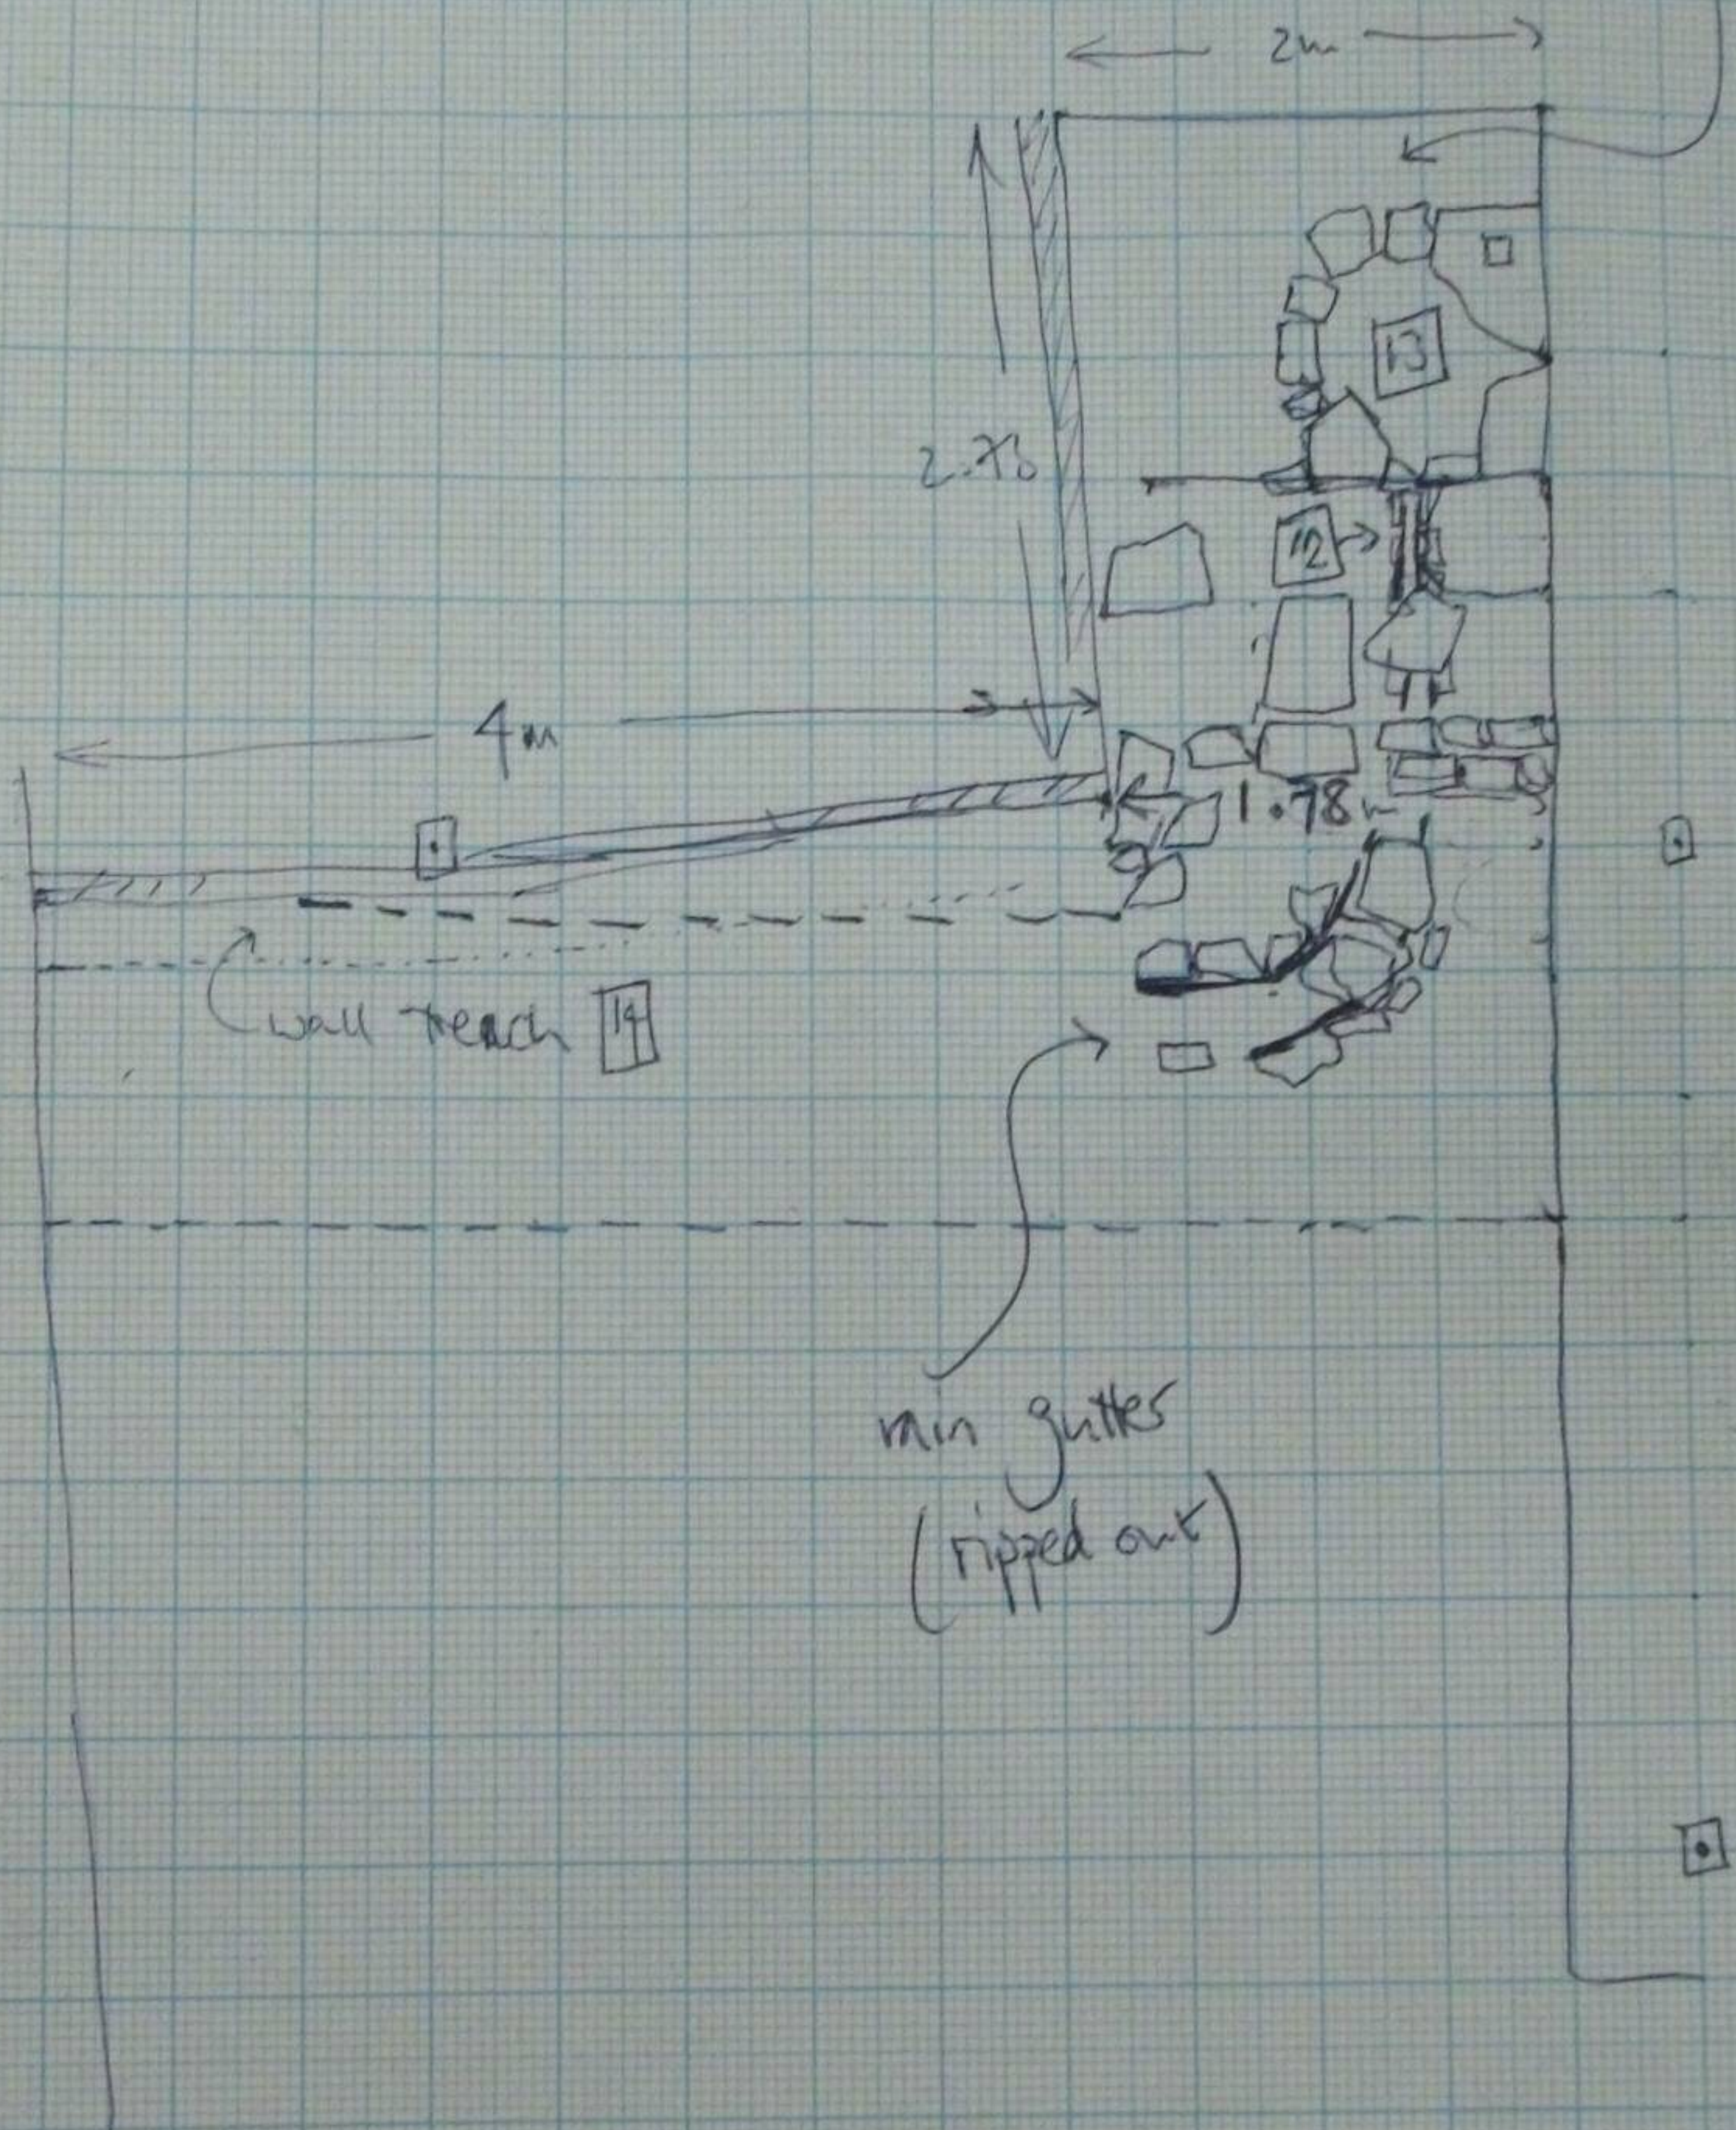
XVI northern extension

topsoil features
(ripped out)

min gutter
(ripped out)

A northern extension to the trench was opened and the northern section drawn (see page 6).

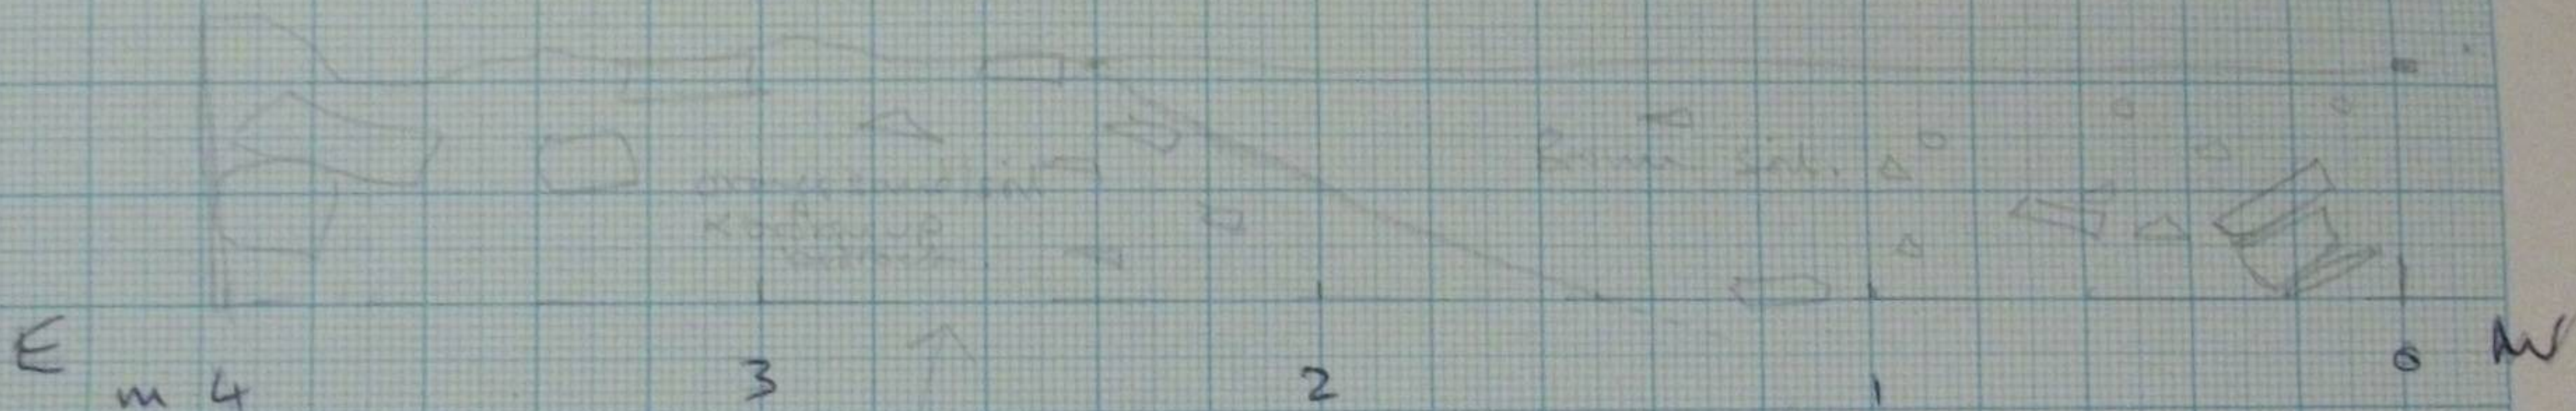
XVI
South face - cutting over earliest wall. 15

ALL NATURAL

approx. top of earliest wall

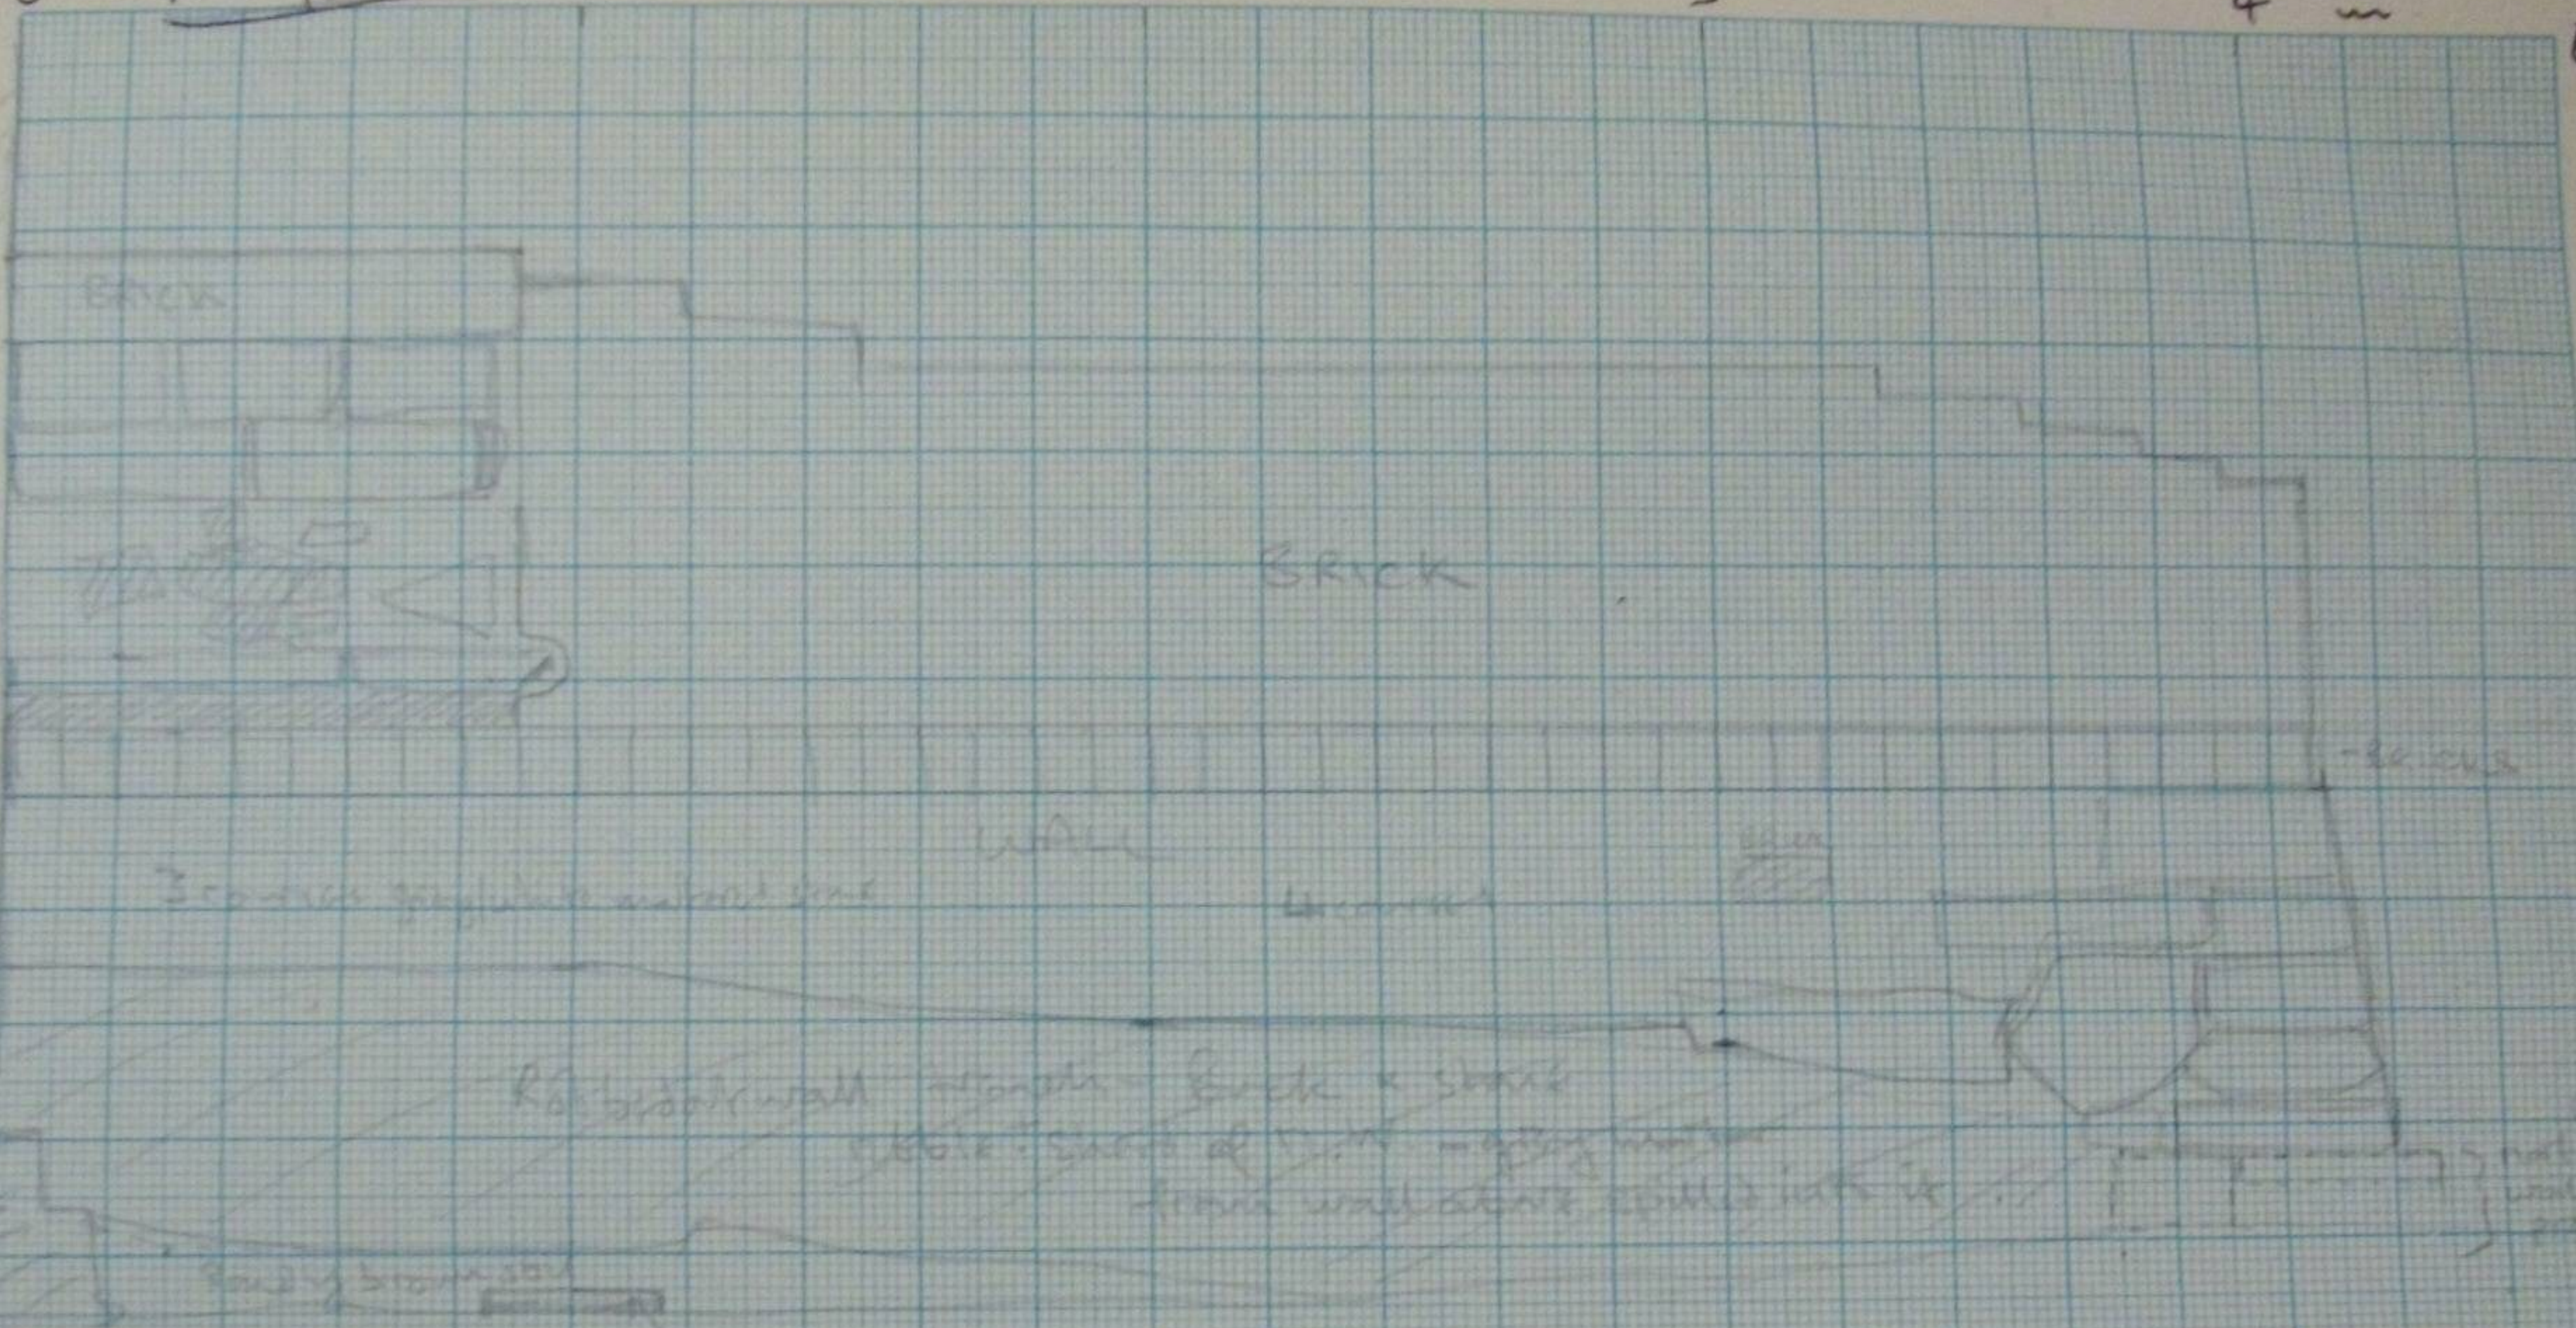
No. face XVI

W. front of range

flat slab - probably
 not natural
 ? roof of stone &
 mortar

natural
 wall
 projected
