Manor Lodge, Sheffield

Archaeological Evaluation

ARCUS report 1107.8(1)

September 2009

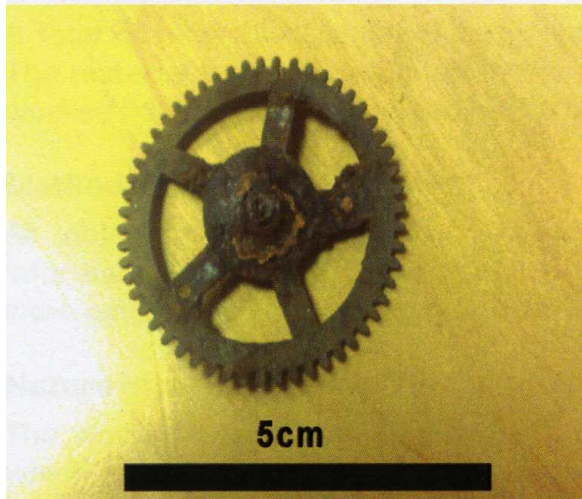
Figure One. Copper alloy cog (11/12)

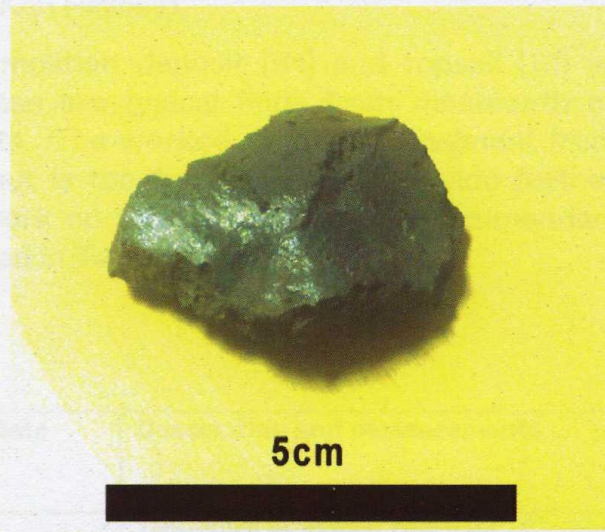
Figure Four. Vitrified ceramic sherd(71)

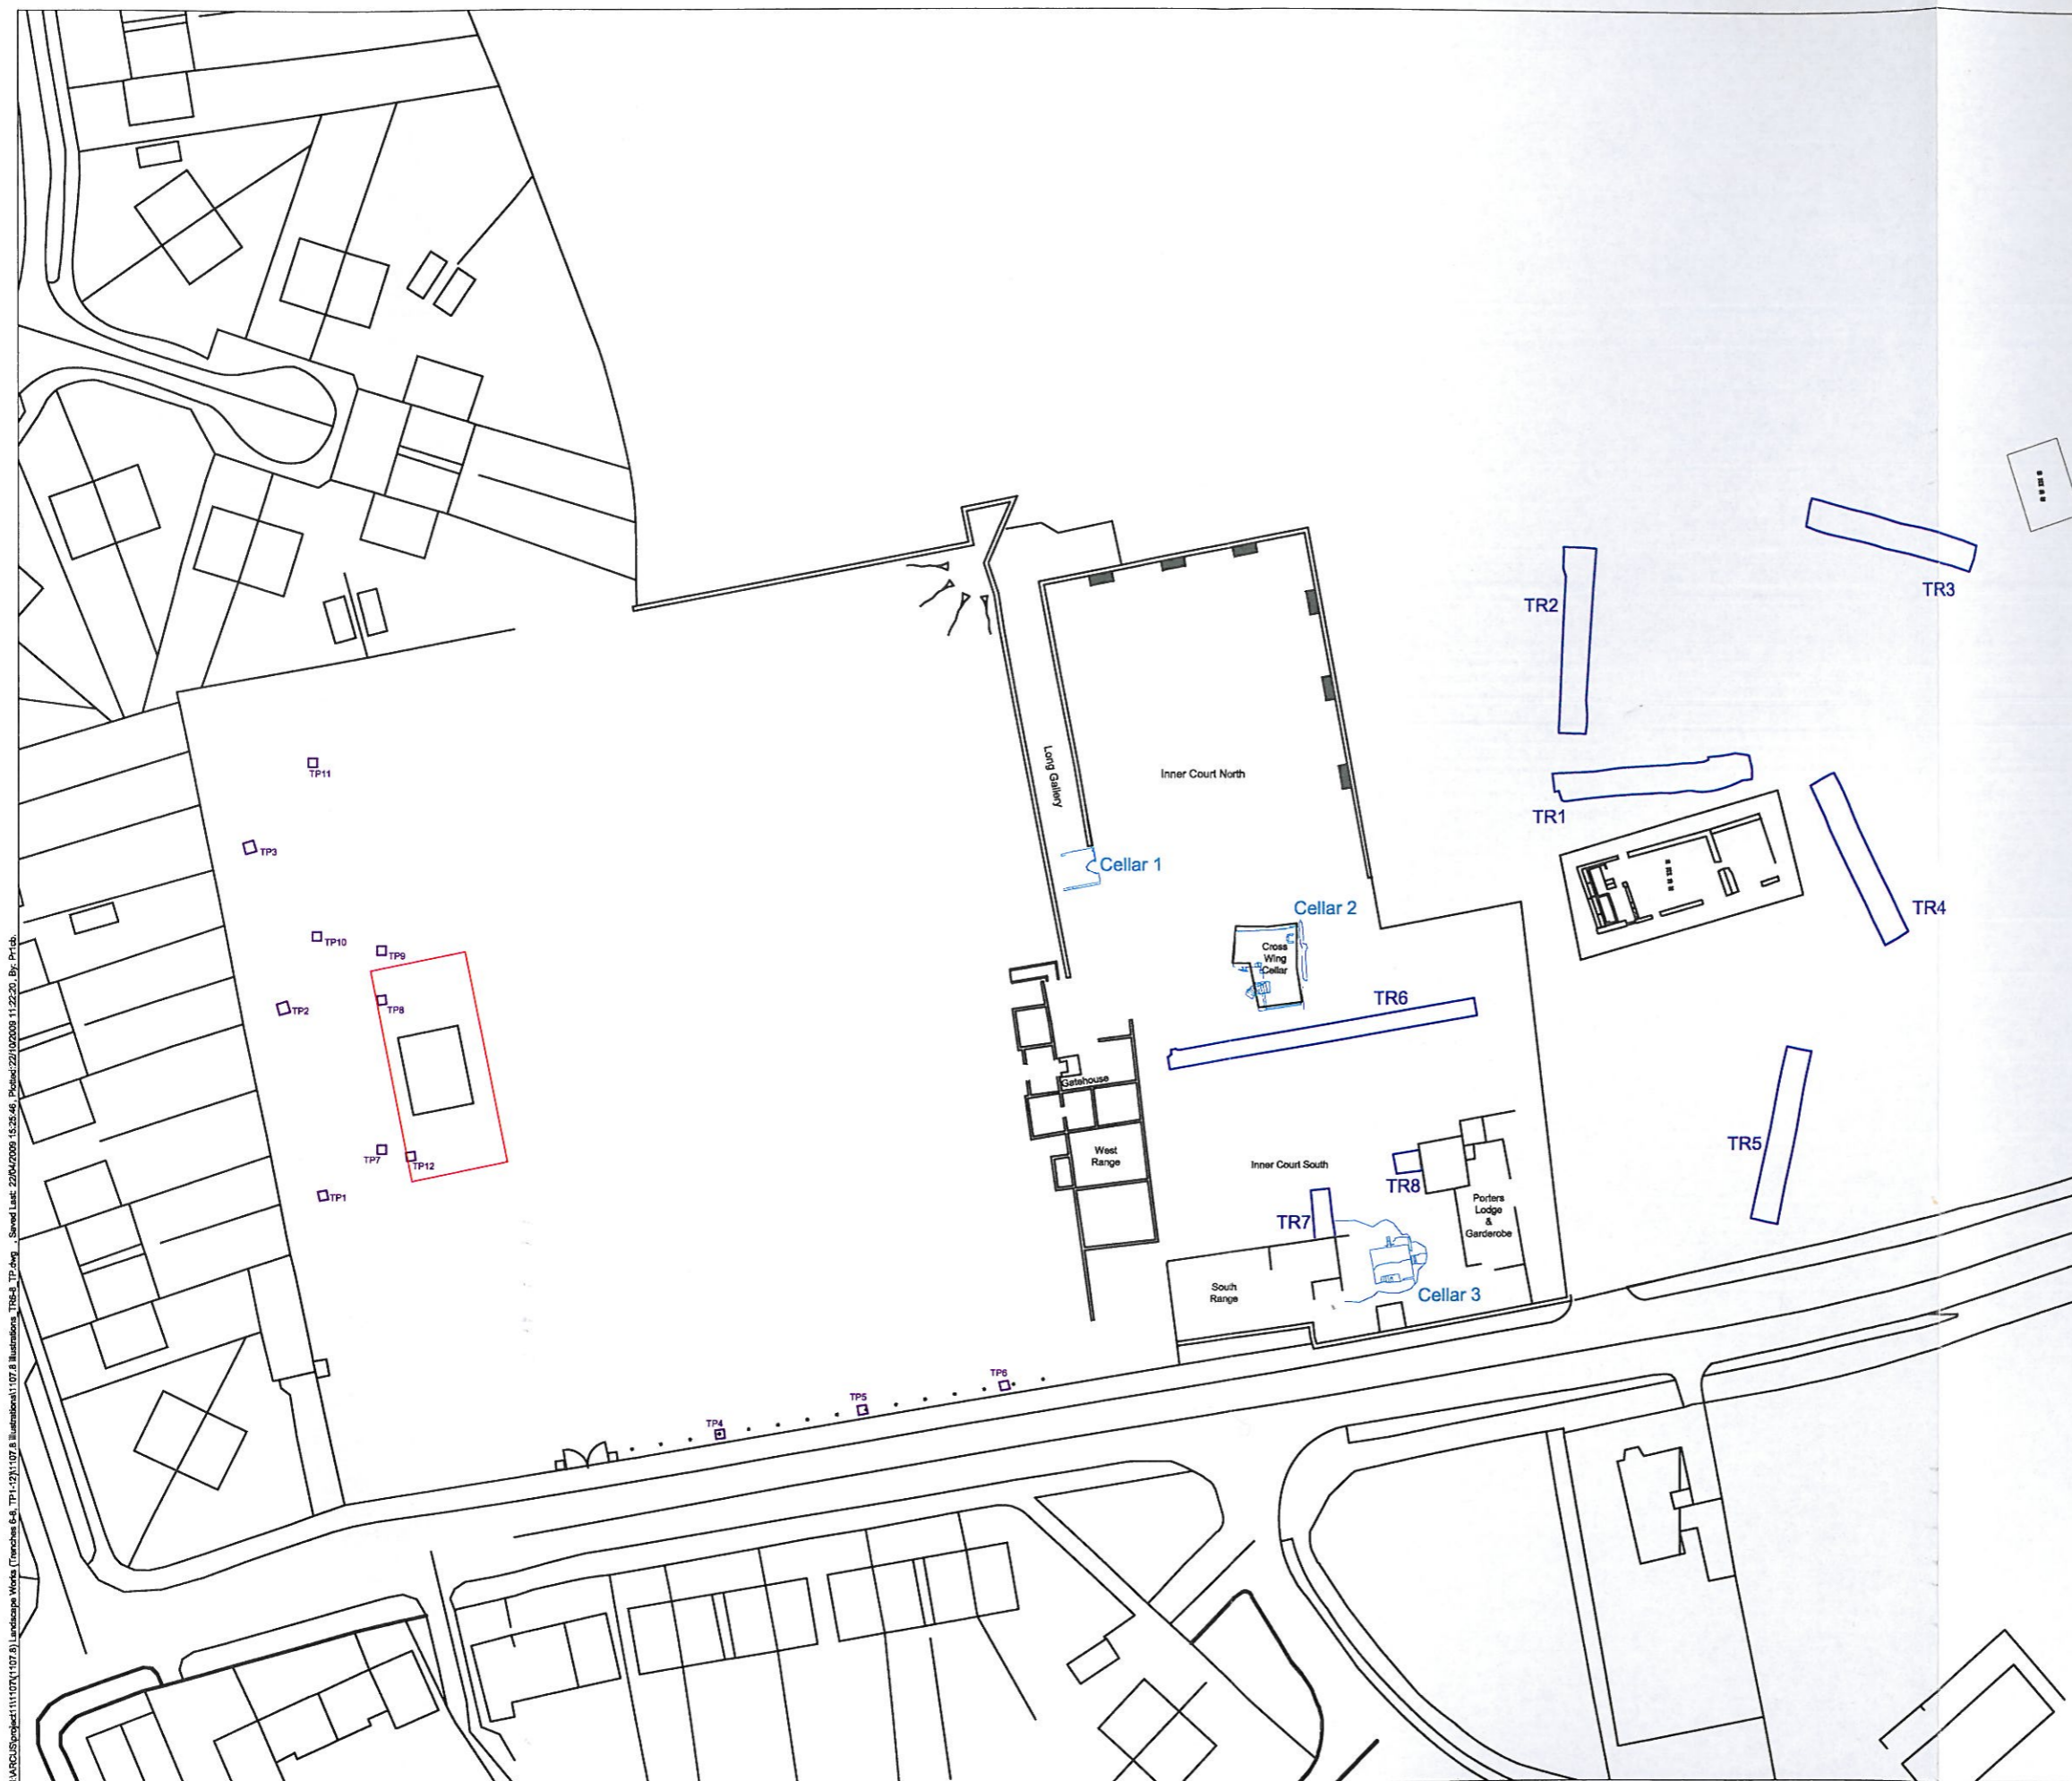
Scale 1:750	Date February 2009
NGR SK 3763 8650	Drawn CS
Project No. 1107.8(1)	Ill. No. 2

- Key: Excavation type**
- ARCUS evaluation trench
 - ARCUS test pit

Within the area designated for the shelter orchard, no archaeological structures were found within test-pits 7, 9, 10 or 11 and the majority of artefactual material was recovered from the top and subsoils. The cut features and associated deposits within test-pit 11 produced assemblages of finds comparable to the finds recovered from the top and subsoils of test-pits 7, 9, 10 and 11. The structures encountered in test-pits 8 and 12 are probably associated with the 18th to 19th-century extension and occupation of the Turret House as a farmhouse and barn. Based upon the results of test-pits 7-12, an a preservation zone immediately around the Turret House has been proposed to ensure that any remains of the 18th to 20th-century farm occupation are not impacted by the proposed landscaping (**Illustration 2**).

Shelter Orchard	Orchard planting outside of designated protection area around Turret House (see Illustration 2) / No Further Mitigation Recommended
South Boundary Hedgerow	No Amendments or Further Mitigation recommended
South Range Cut & Drop range	No Amendments (see Disabled Access Path) / Watching-Recording Brief during landscaping
Disabled Access Path	Watching-Recording Brief during landscaping and path construction / Redesign of path to follow the existing south range cut & drop (see Illustration 8)

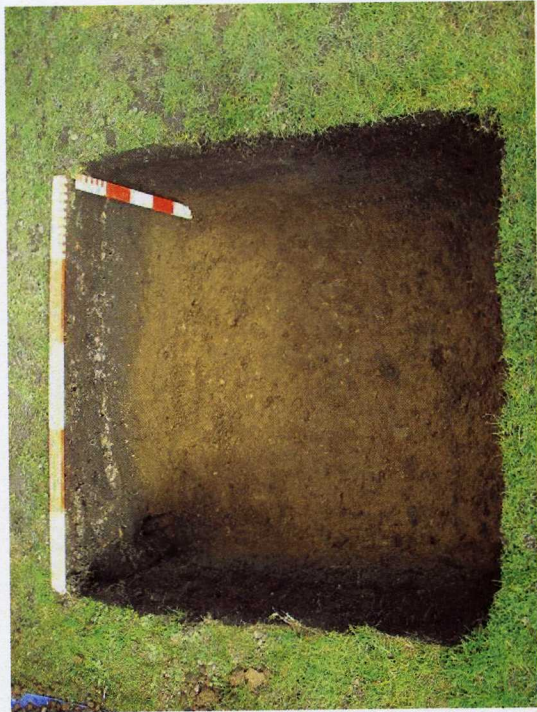
Plate 1: Test-pit 1
(viewed facing north; 1.0m and 0.5m scale)

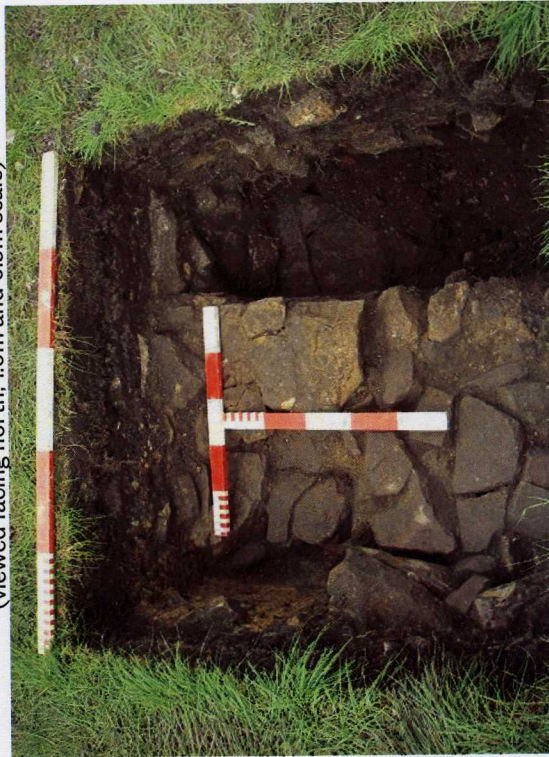
Plate 3: Test-pit 8; Wall 83
(viewed facing north; 1.0m and 0.5m scales)

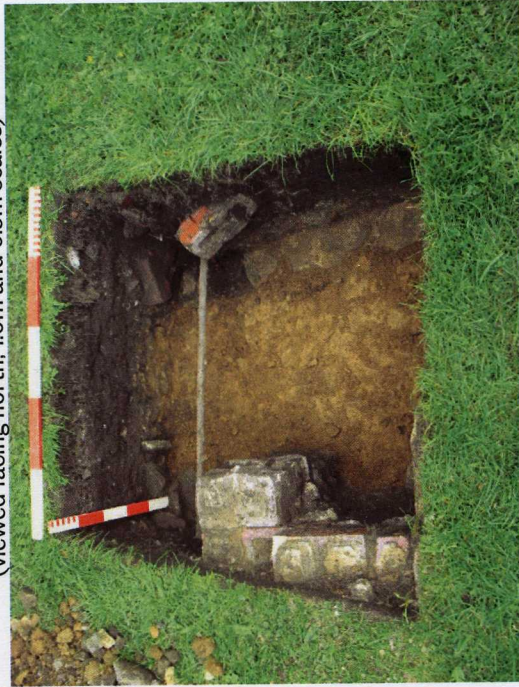
Plate 4: Test-pit 12
(viewed facing north; 1.0m and 0.5m scale)

Test-pit 12 revealed features likely associated with the 18th to 19th-century occupation and extension of the Turret House as a farmhouse with attached barns. The earliest structure within test-pit 12 was the heavily truncated foundation of a north-south sandstone wall [127] which was encountered at c.154.82m AOD under c.0.15m of demolition material (128) and c. 0.5m of topsoil and turf. The composition, location and alignment of wall 127 suggests it was likely part of the 18th to 19th-century barns attached to the south side of the Turret House. Later intrusions within test-pit 12 included a posthole [125] and wooden post [124] cut through the line of wall 127, an east-west lead pipe [123], and possible a later redbrick structure [129] (**Plate 4**). Finds from the topsoil included 10 sherds of late 19th-century ceramics.

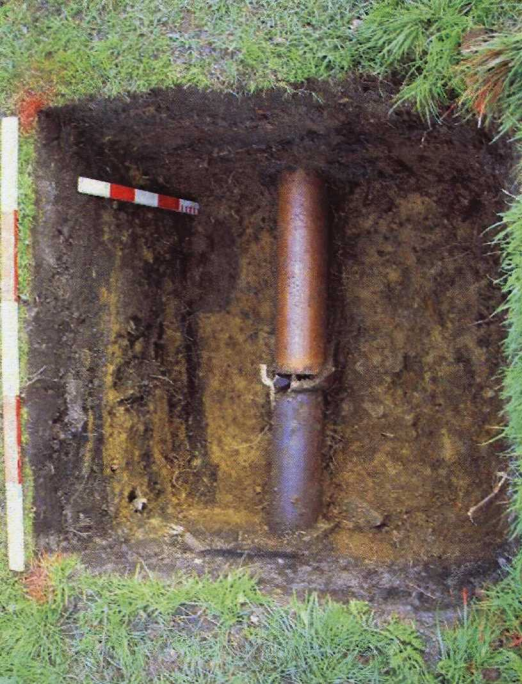
Plate 5: Test-pit 9
(viewed facing east; 1.0m and 0.5m scales)

The soil profile in test-pits 9 and 10 were similar to nearby test-pit 2 with c.0.30m of topsoil and c.0.10m of subsoil overlying degraded parent material (**Plate 5**). No archaeological features were encountered within test-pit 9, but a concentration of demolition material / made-ground in the north section may be related to small structures recorded on the 1893 OS map (**Illustration 10**). Test pit 10 had a north-south aligned ceramic land drain [102] set atop the natural and a small posthole [104] cut into the natural at the east edge of the test-pit. No finds were recovered from the fill of posthole 104, but this feature may also relate to the structures recorded on the 1893 OS map. Finds from the top/subsoil and made-ground layers included over 250

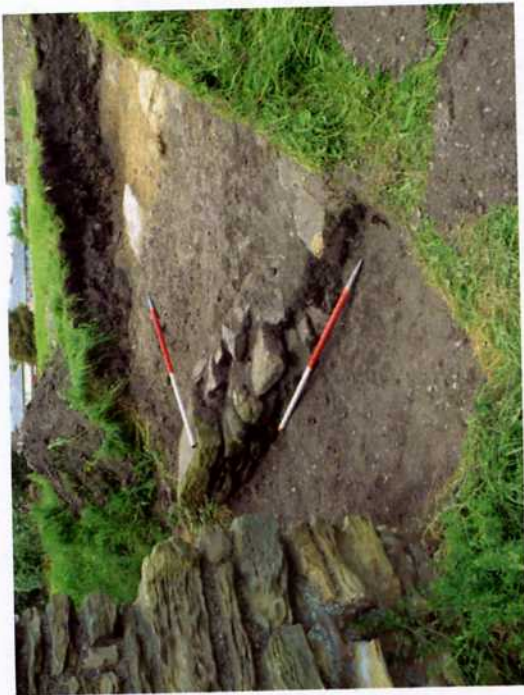
Plate 10: Trench 7; wall 7011
(viewed facing northwest; 1.0m scales)

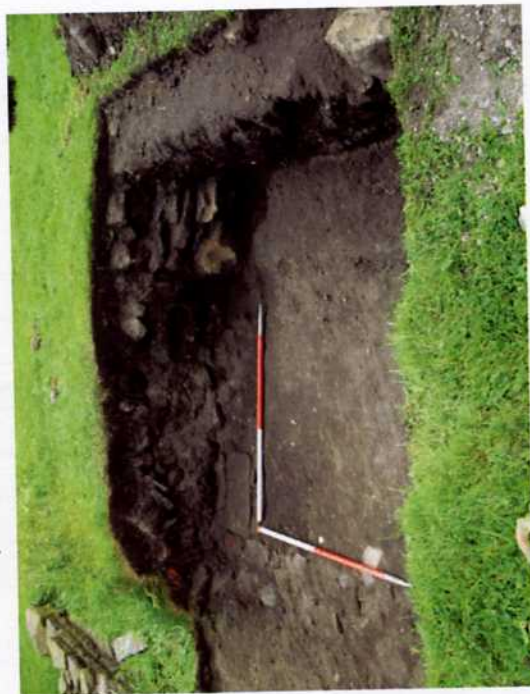
Plate 12: Trench 8
(viewed facing south; 1.0m scales)

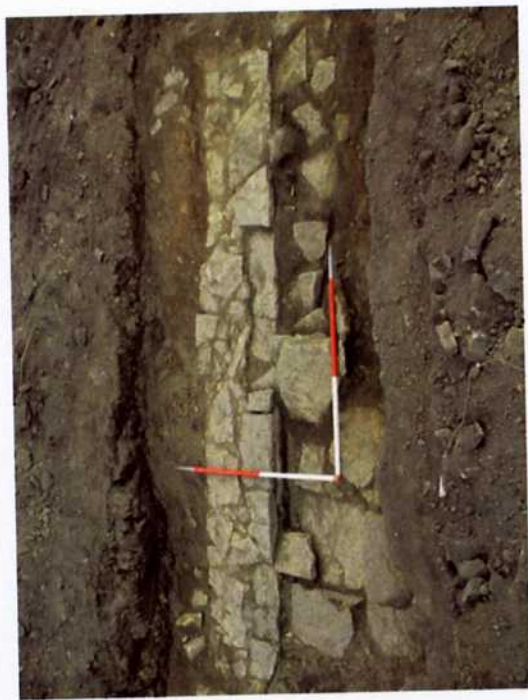
Plate 9: Trench 6; wall 6026 and surface 6031
(viewed facing north; 1.0m scales)

Immediately east of the cottage structures, the foundations of substantial east-west walls [6023 and 6026] with an associated stone surface [6031] were uncovered c.0.50-0.60m below the upper levels of the cottage structures at c.157.40m AOD (**Plates 8 and 9**). Walls 6023 and 6026 were comprised of rough/unworked sandstone bonded with a clay mortar. While only the top of the surviving course was exposed during the evaluation, walls 6023 and 6026 appeared consistent with the 16th-century wall foundations excavated during the 1968-80 Museum Sheffield excavations (Beswick, pers. comm.). Walls 6023 and 6026 lie on the same east-west alignment with a break in the line of the wall(s) defined by two short sections of north-south aligned walls [6024 and 6025]. Walls 6024 and 6025 were keyed into the east and west ends of walls 6023 and 6026 (respectively) and possibly defined a drain feature. Abutting the south face of wall 6026, a heavily disturbed deposit of sandstone potentially represents the remains of a surface associated with wall 6026.

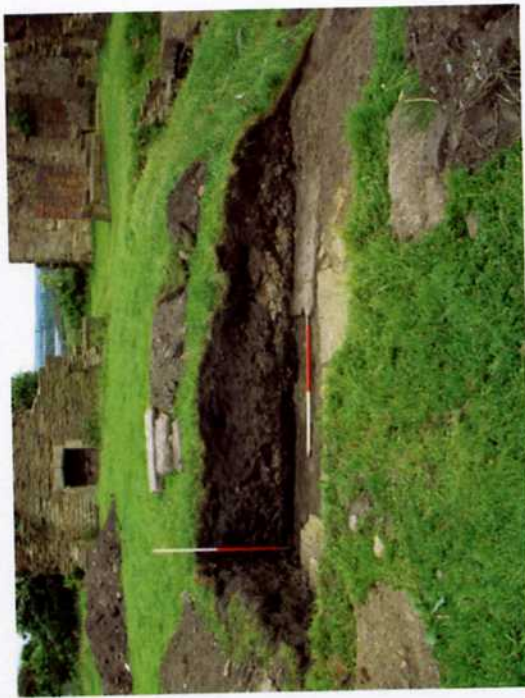
Plate 11: Trench 7
(viewed facing east; 1.0m scales)
