Interim Statement 1107.2

# Interim Statement on Archaeological Evaluation on land immediately to the east of the Manor Lodge, Manor Lane, Sheffield, South Yorkshire

June 2007

By Mike McCoy

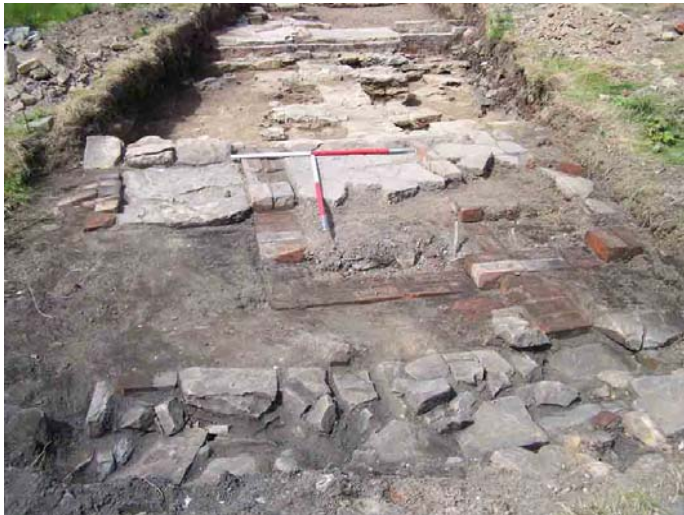
Plate 1 - Trench 1: Viewed facing west (1m scale)

In Trench 1 (**Plates 1 and 2**) structures relating to cottages located north of the Grade II-listed cruck barn were uncovered immediately beneath the modern ground level. These included sandstone wall foundations and floor surfaces, as well as red brick internal dividing walls and later external additions, related to a sequence of buildings shown on the 1893, 1923 and 1954 OS maps. Slots dug within the footprint of the cottages revealed the presence of a buried soil layer predating the earliest phase of cottage construction.

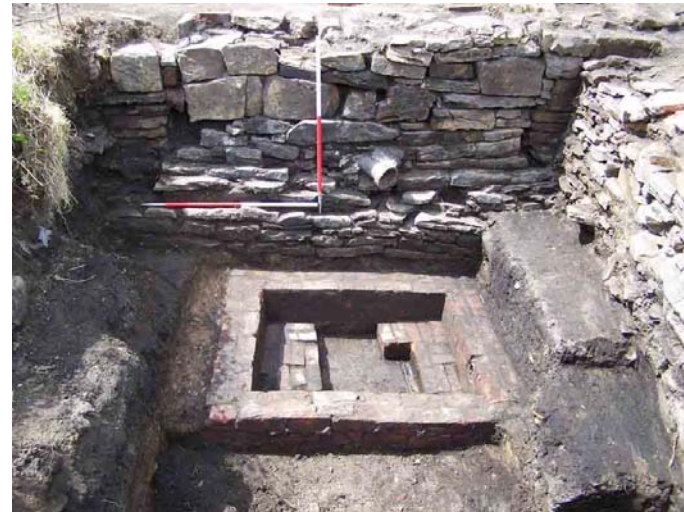
Plate 2 - Trench 1: East face of wall 1003 (1m scale)

East of the cottage footprint, a substantial north to south sandstone revetment and boundary wall [1053] was uncovered immediately beneath the modern ground level. Trench 1 was extended north along the line of the wall to determine its extent as part of the watching brief. This wall is shown on the 1893, 1923 and 1954 OS maps.

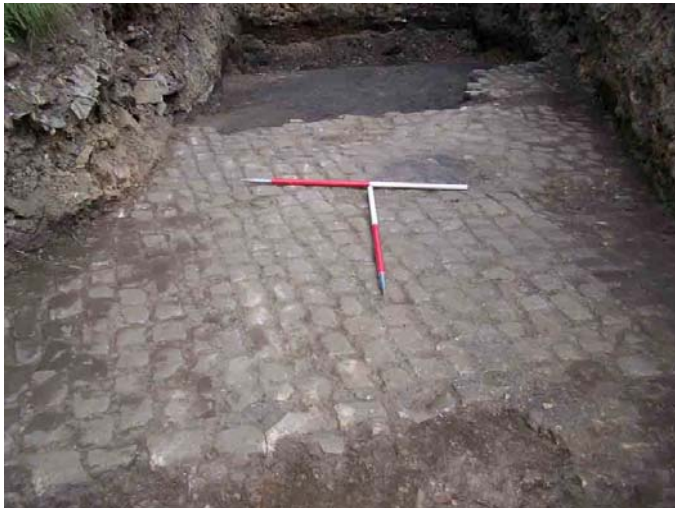
Plate 3 - Trench 2: Cobblestone road surface (1m scale)

Structures relating to the colliery and later works on the site were uncovered at varying depths within Trench 2 (**Plates 3 and 4**). These included red brick and cobblestone surfaces built directly on sandstone bedrock and buried under up to 3.00m of demolition material (north end of trench). The corner of a sandstone boundary wall forming the northwest corner of the area bounded by the revetment and boundary wall [1053] in trench 1 was also uncovered. This boundary wall is shown on the 1893, 1923 and 1954 OS maps.

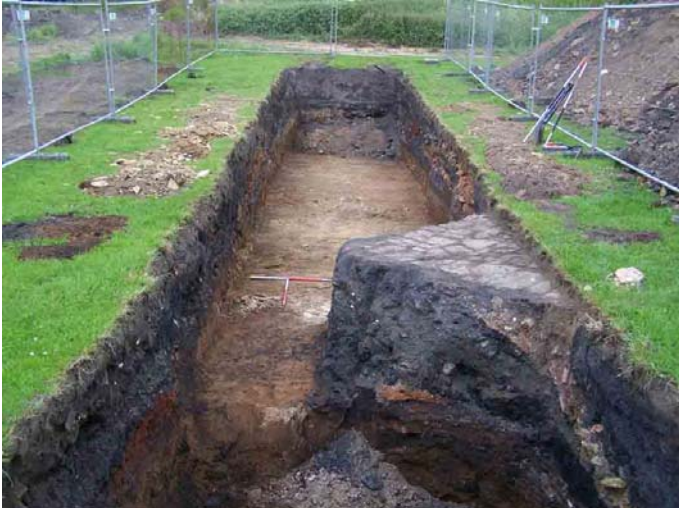
Plate 5 - Trench 3: Viewed facing west (1m scale)

Deposits of industrial dumping and made ground comprised the majority of Trench 3 (**Plates 5 and 6**). A buried subsoil layer was preserved beneath the industrial dumping throughout the majority of the trench. The only structure in trench 3, uncovered immediately beneath the modern ground level, was the corner of a sandstone surface which corresponds with a building feature appearing on the 1954 OS map.

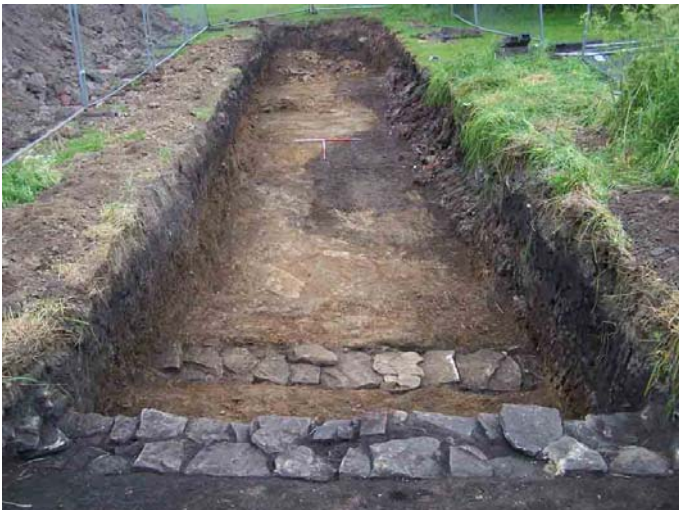
Plate 7 - Trench 4: Viewed facing south (1m scale)

In the north of Trench 4, two linear structures were encountered (**Plate 7**), an east to west sandstone boundary wall built on subsoil and an east to west sandstone drain cut into the sandstone bedrock. The boundary wall is shown on the 1893, 1923 and 1954 OS maps. Demolition material was encountered from immediately below the modern ground level down to the sandstone bedrock. Along the eastern edge this demolition layer lay between the modern topsoil and the remnants of a buried soil and subsoil layer (**Plate 8**).

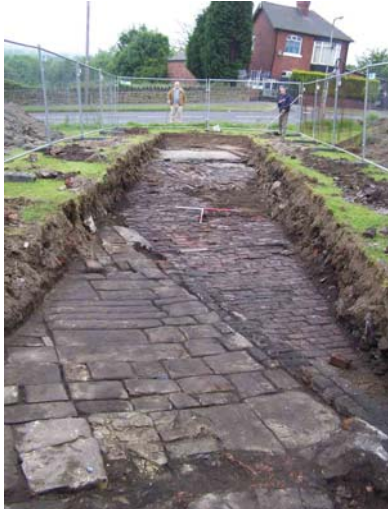
Plate 9 - Trench 5: Viewed facing south (1m scale)

Structures relating to the nineteenth- to twentieth-century cottages fronting Manor Lane were uncovered immediately beneath the modern ground level (**Plate 9**). These included sandstone wall foundations, red brick walls, sandstone floor surfaces, concrete surfaces, red brick yard surfaces and a sandstone sett surface. All the structures encountered correspond with features on the 1893, 1923 and 1954 OS maps. Slots dug through these features revealed a buried subsoil layer surviving beneath both the building and yard surfaces (**Plate 10**).
