Manor Lodge, Sheffield, South Yorkshire

The Long Gallery & Inner Court
Excavations and Building Recording

Volume 1

Report reference: 74612.01

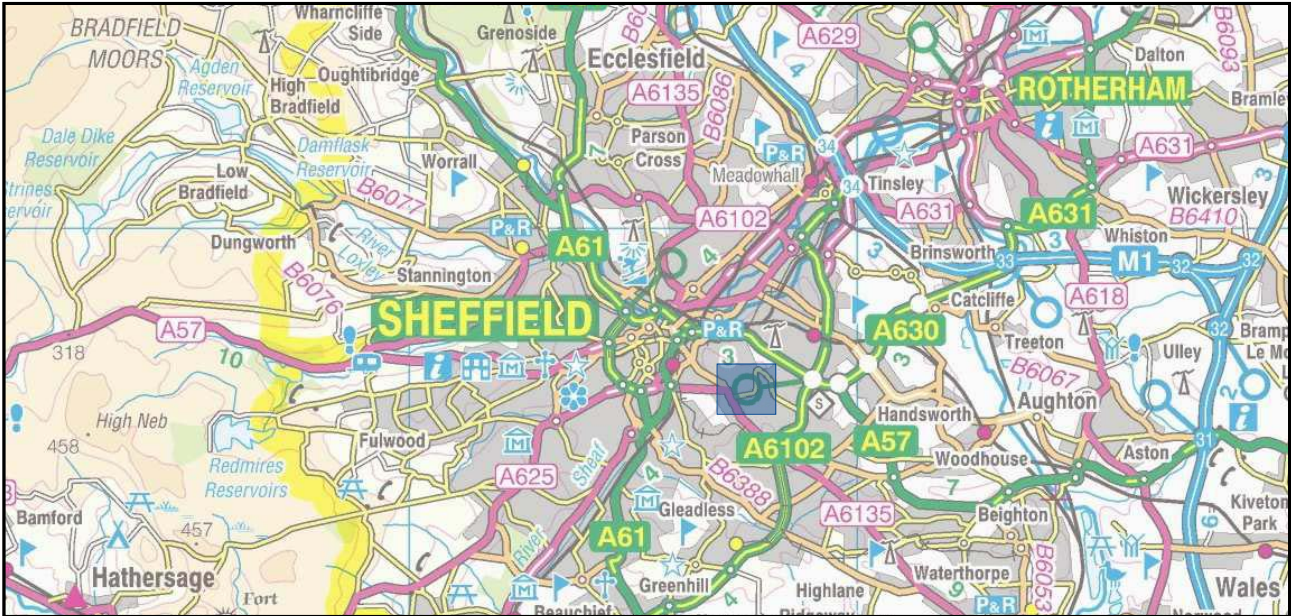
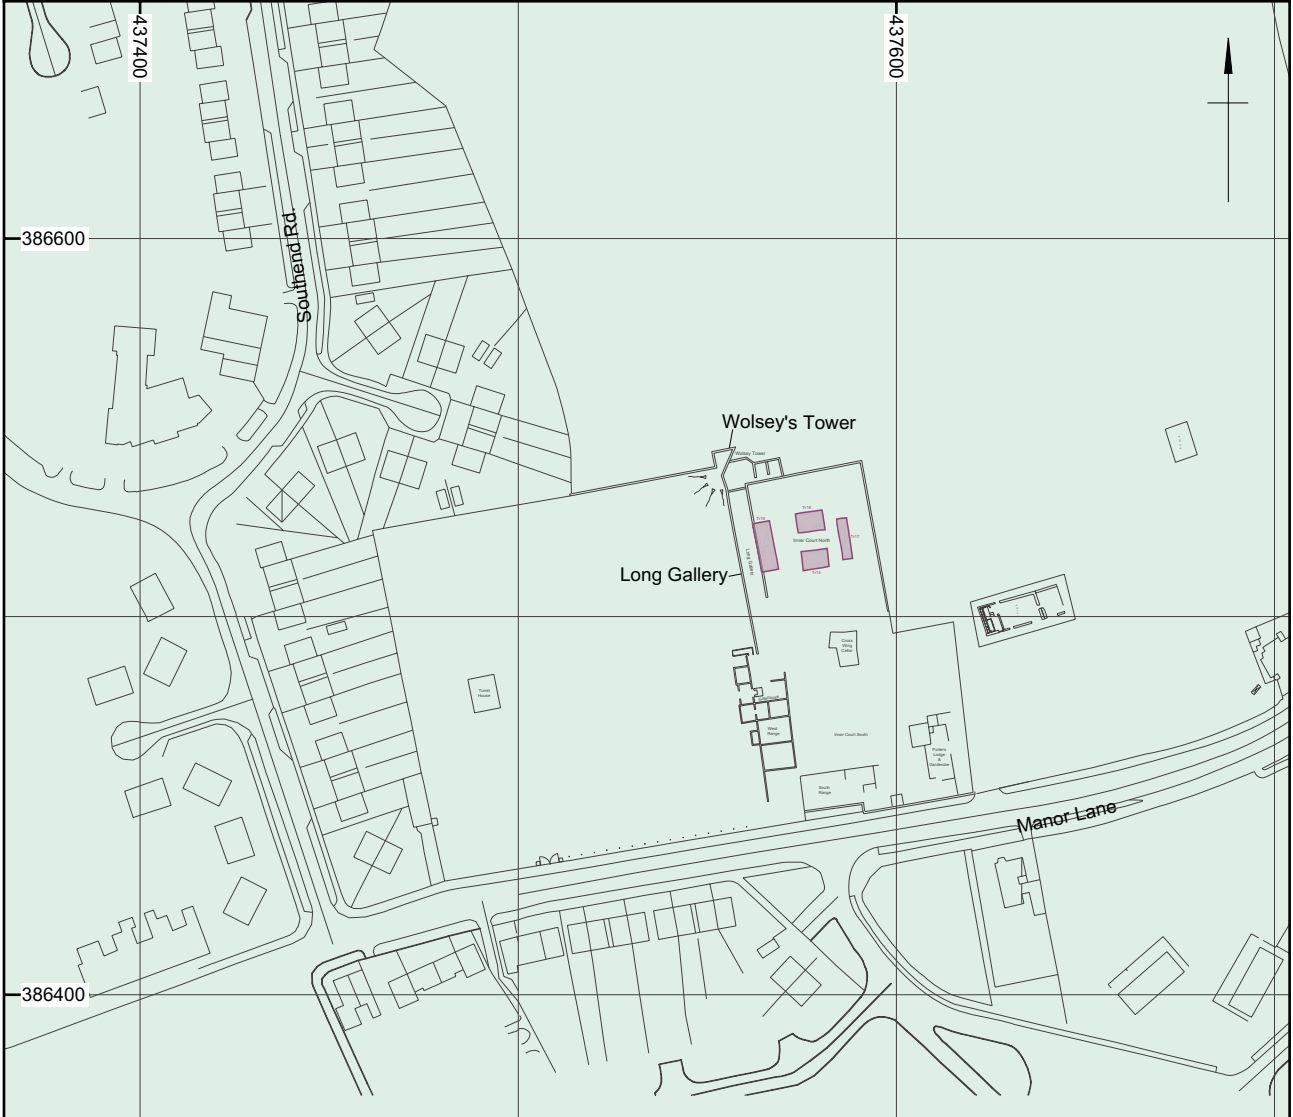
Figure 1

- Site location
- Excavation Trench

Site location

- 1.2.1 The Site is located off Manor Lane, approximately 2km south-east of Sheffield city centre at National Grid Reference (NGR) SK 376865 (**Figure 1**). The Site includes the historic buildings and below-ground remains of the Manor Lodge complex and a modern visitor centre. It is bounded by 19th-

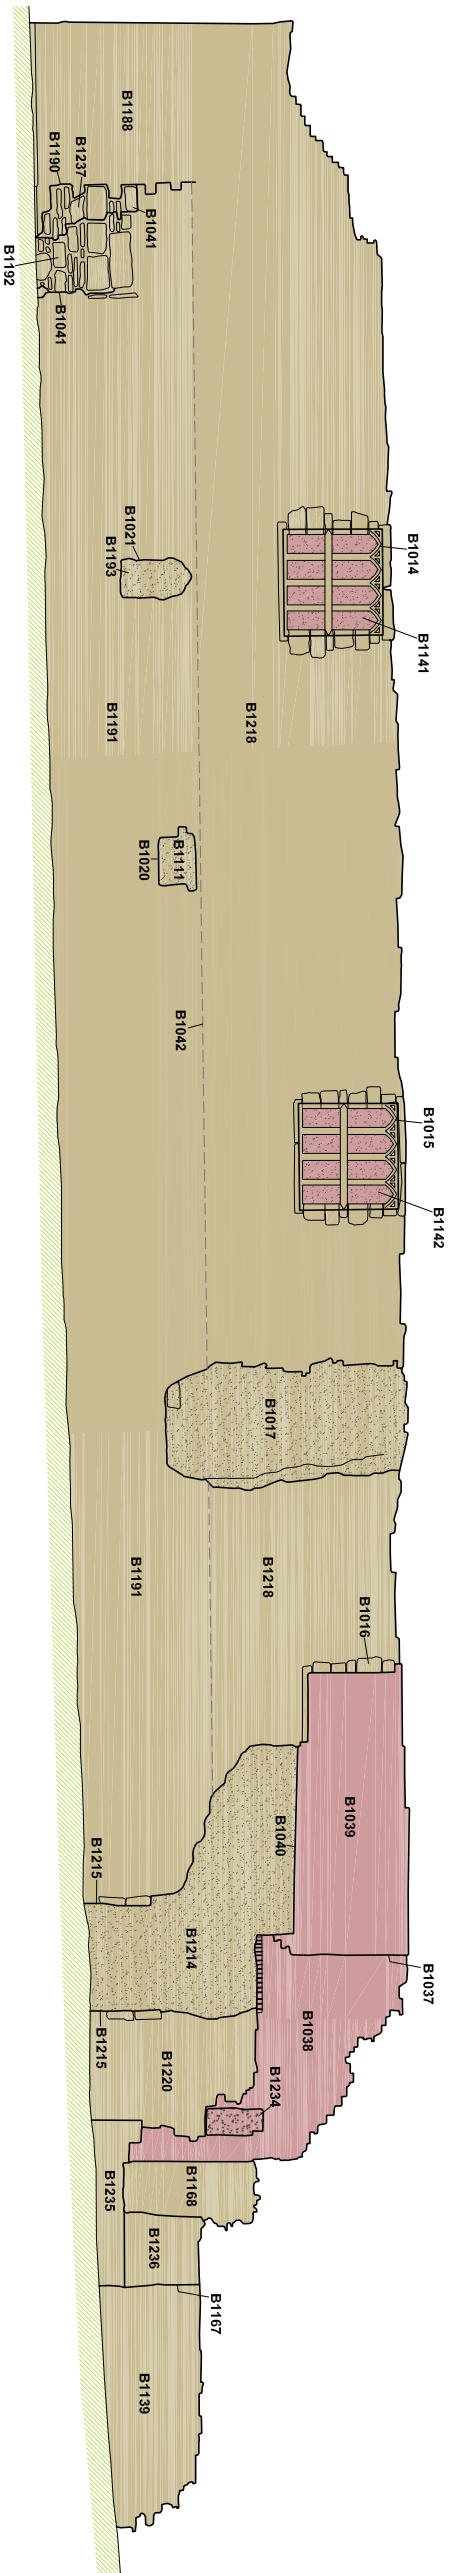
Figure 4

Extant first floor plan

- 6.5.3 The southern end of Building 03 was heavily altered in later phases when Buildings 04, 05 and 06 were constructed. This removed much of the fabric and obscured some of the original features of the structure.
- 6.5.4 The surviving elements of Building 03 comprise its two-storey west wall, a small low-level section of its north wall, and the largely buried foundations of its east wall with areas of surviving stone plinth (**Plates 1–3, Figures 3-6**). These are described separately below:

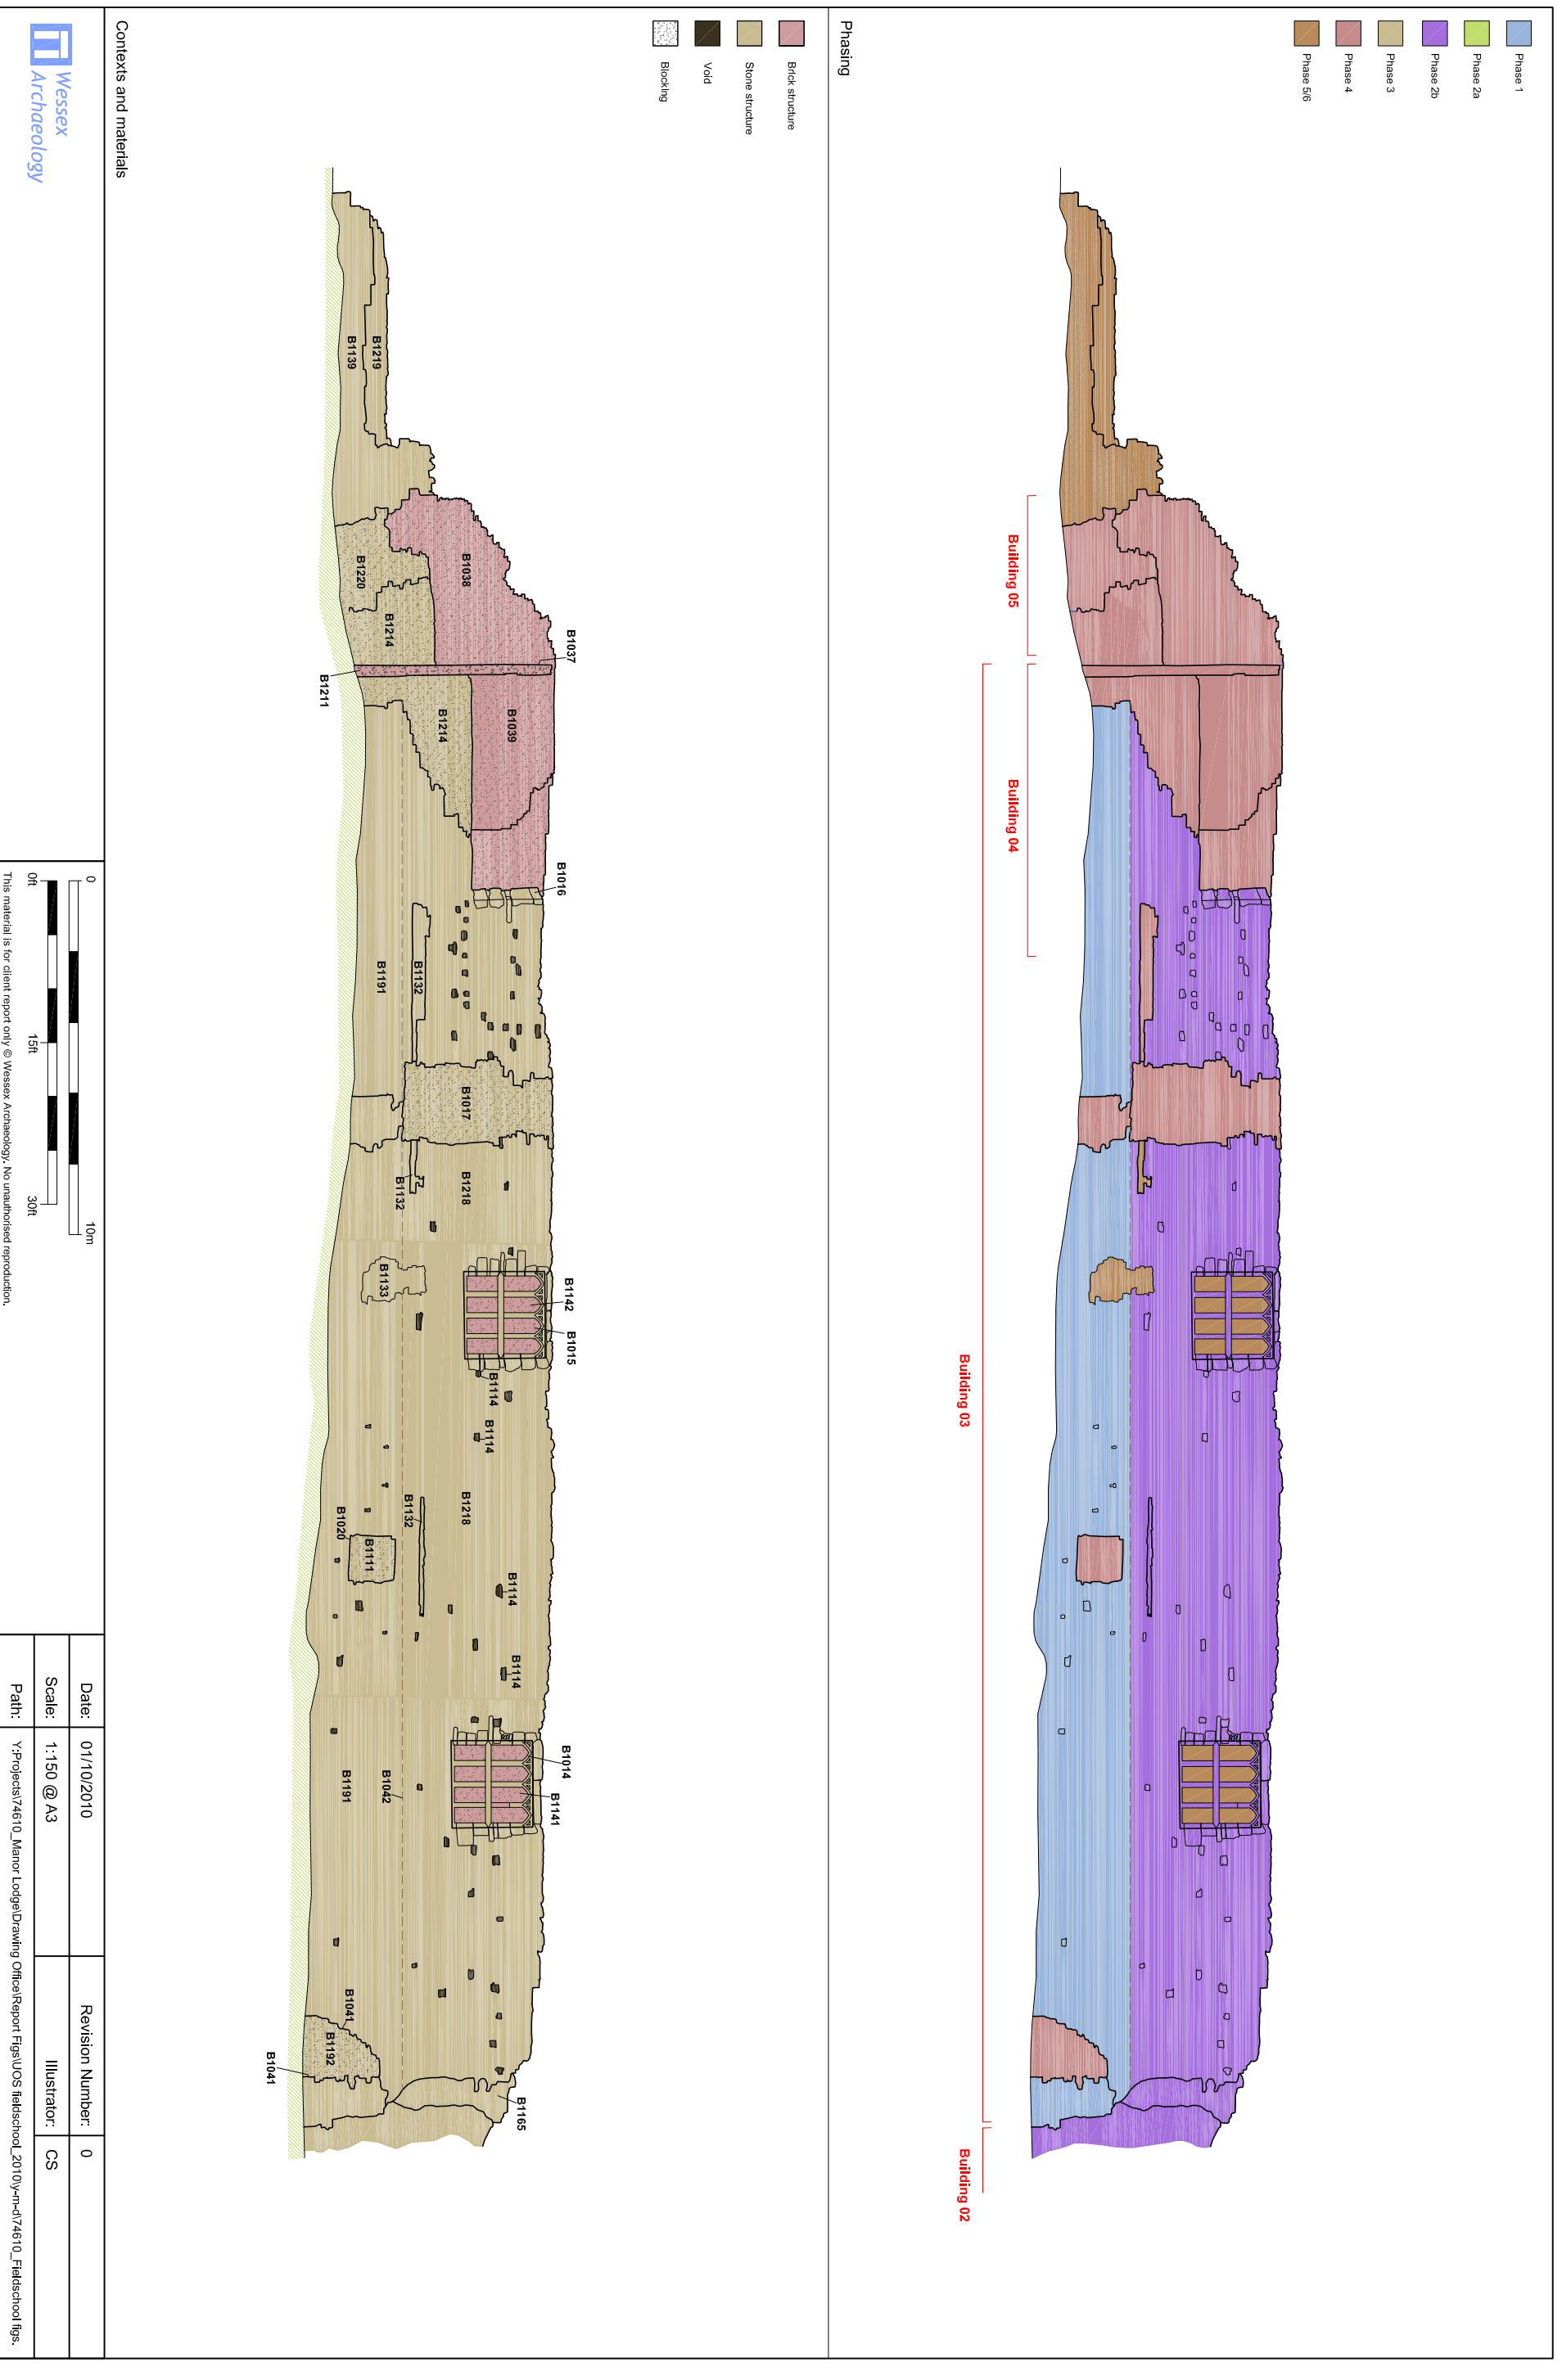
Figure 5

West-facing elevation of the west wall of the Long Gallery

Elevation 2: East facing elevation of the west wall of the Long Gallery

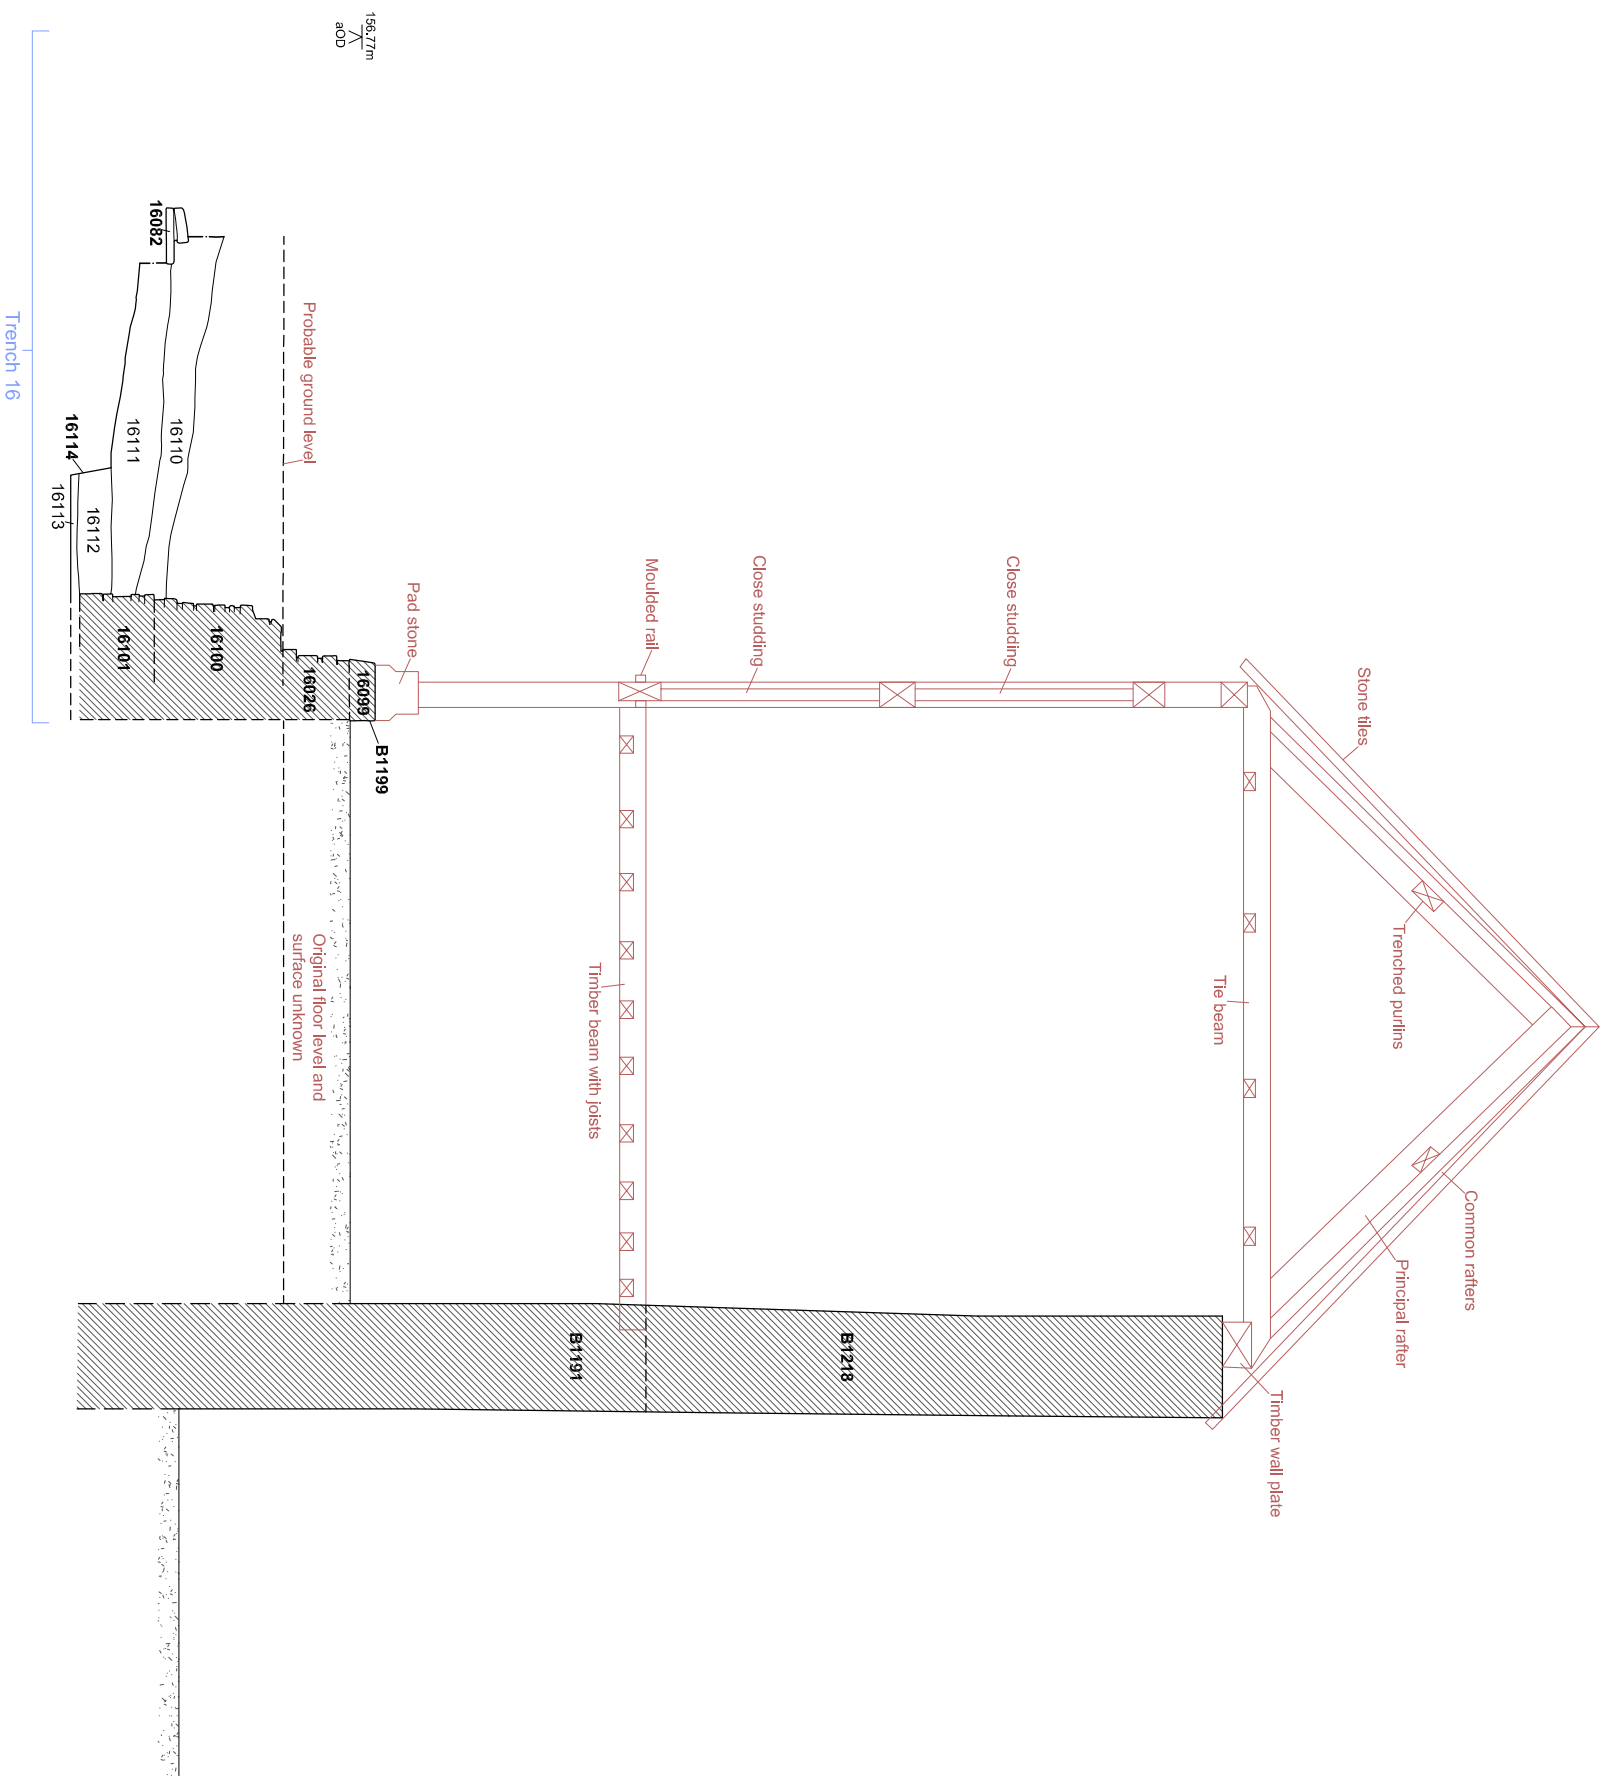
Figure 7

North-facing cross-section through Building 03 (the Long Gallery) and Trench 16, showing Phase 2 features and reconstruction

- 6.5.10 The east side of Building 03 was originally made up of a timber frame resting on stone pads, laid on a low stone wall on stone foundations (**Figure 7**). The stone foundations and parts of the low stone wall are all that remains (**Figure 3**).
- 6.5.11 The low stone wall (**B1195, B1199, B1203**) was capped with a chamfered stone plinth (**B1107**), parts of which remain *in situ*. On top of this, stone pads would have supported the timber frame. None of the timber framing has survived, although two of the original stone pads appear to have been retained elsewhere on site (**Plates 7 and 8**). The east wall has been altered along much of its length during all phases of activity.

- 8.4.2 The earliest features in Trench 16 were the foundations of the Long Gallery, which were visible only in section (**Figure 13, Plate 24**). This structure was built within a foundation trench (**16114**) that had been cut into natural clay deposits. An initial thin clay deposit (**16113**) covered the base of the cut and was followed by the insertion of masonry (**16101**). The foundation trench was then backfilled with a further clay deposit (**16112**).

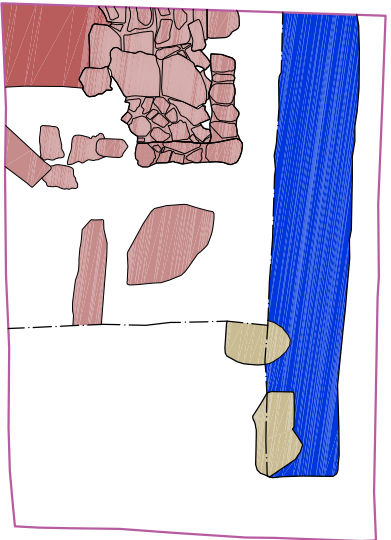
Figure 11

Plan of Trench 15

8.3.2 The earliest features in Trench 15 were two pits (**15014, 15016**) which had been cut into the surface of the natural bedrock (**Figure 11, Plate 20**). Both features proved to be too deep to be emptied safely and excavation ceased at a depth of 0.69m from the surface of the bedrock. However, excavation was sufficient to reveal that each feature was a slightly bell-shaped pit; narrow at the top and rounding outwards below. Each pit, measuring 0.25m in diameter, had been backfilled with bedrock fragments and degraded coal.

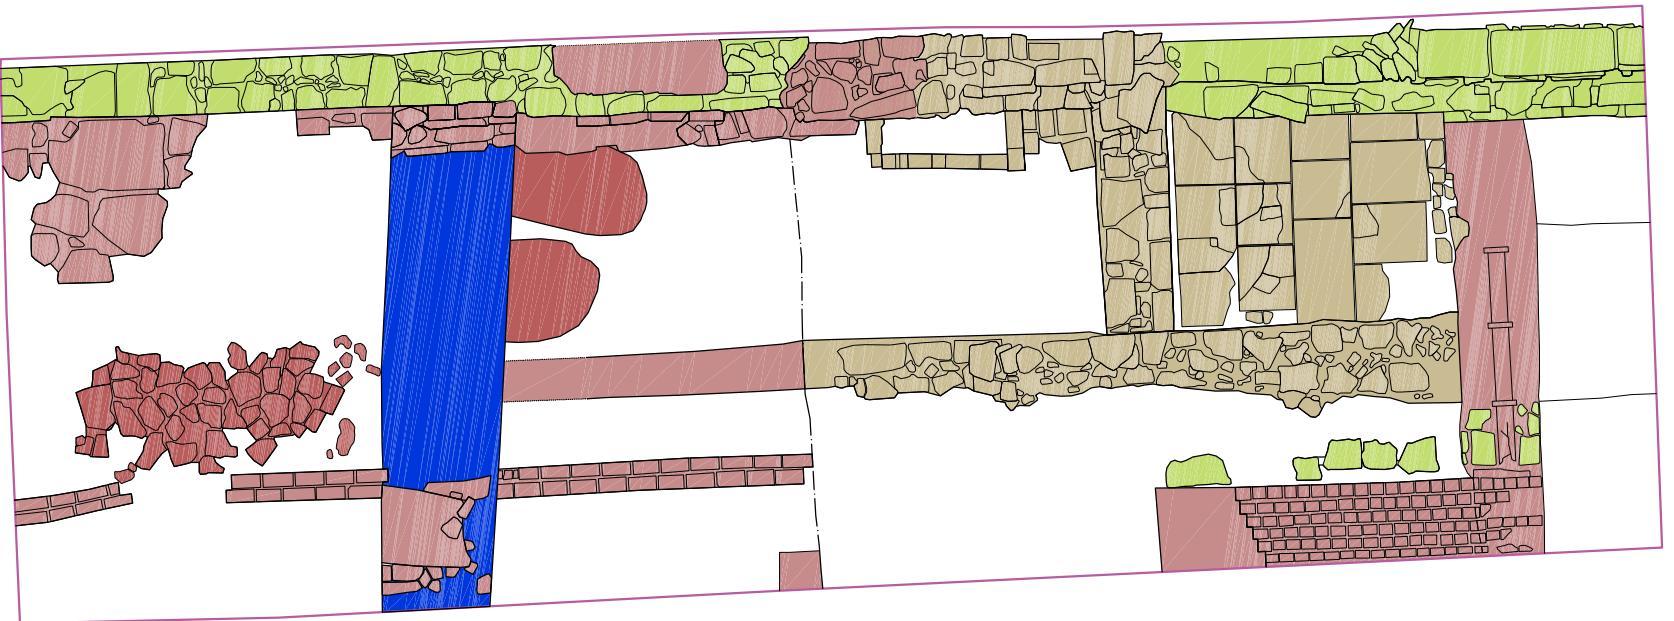
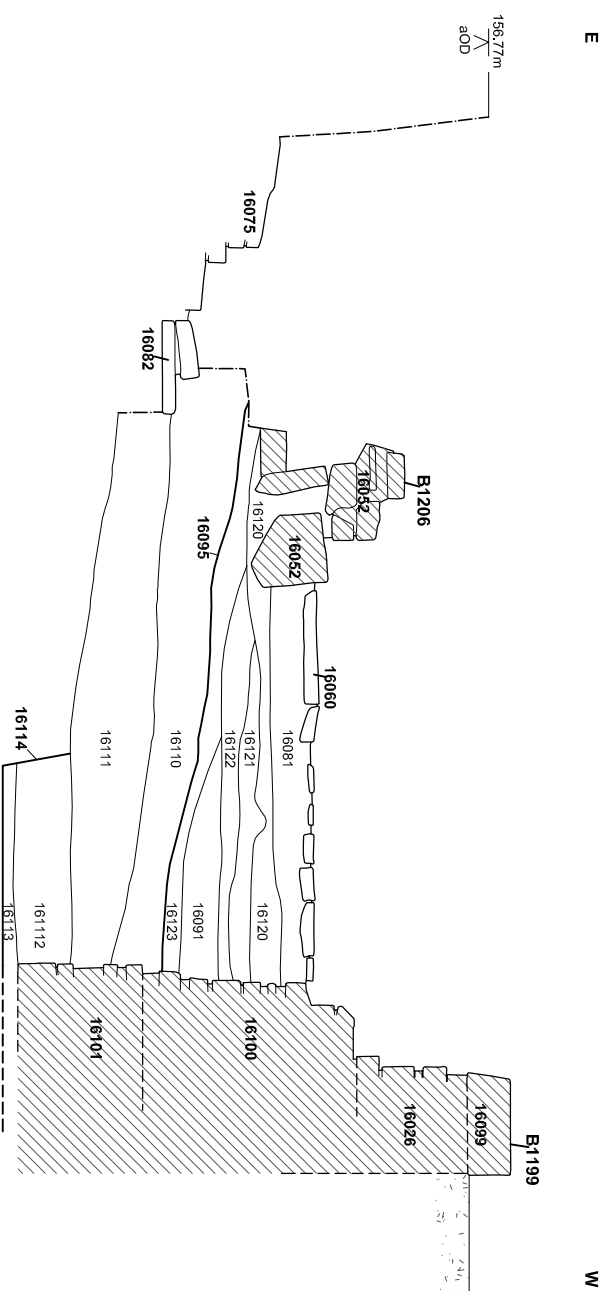
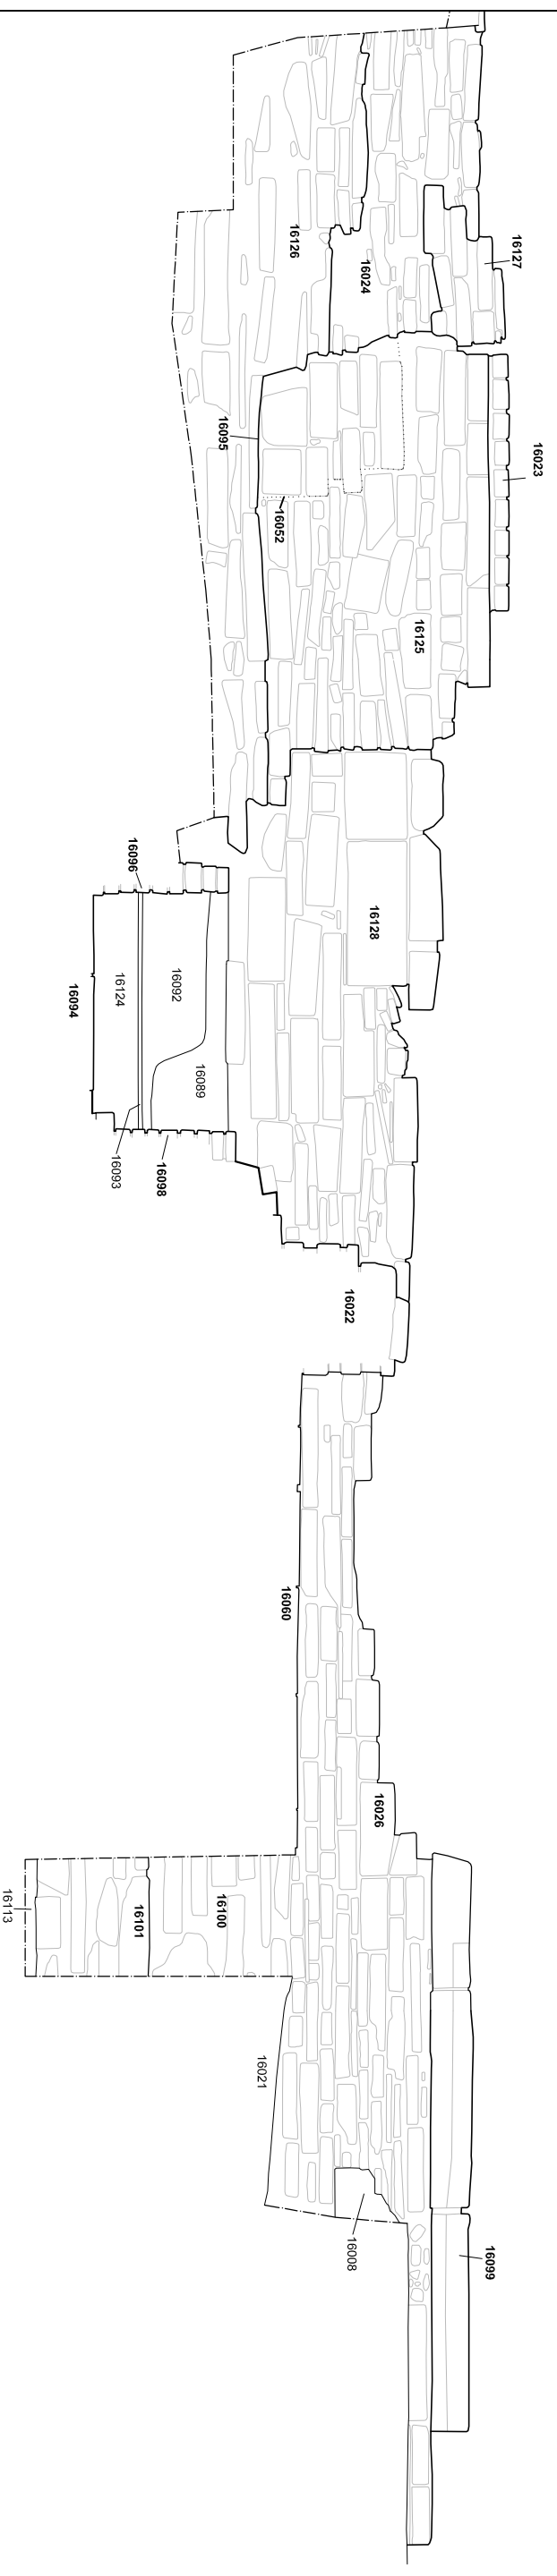
Section 1
E

Section 2
S

- 8.4.6 Evidence of the re-use of the Long Gallery as a pottery workshop was identified. Part of the construction of the workshop involved the demolition of a 4m long section of the Phase 2 Long Gallery wall and also, in places, the removal of Phase 2 deposits to expose the upper foundations of the Long Gallery. Evidence of the extent of this phase of demolition and truncation (cut **16095**) was visible in the Long Gallery wall and in deposit **16110 (Figure 13)**.

- 8.4.13 The repairs to the former Long Gallery wall comprised: the strengthening and widening of its foundations by stonework (**16029**, **16049**; **Figure 12**) and, the blocking of the previously open bays with brick walls (**16023**) built on top of the Phase 2 stonework. This phase of activity also includes two stone post-pads (**16011**, **16071**) which were positioned to the east of the Long Gallery wall and may have been used for scaffolding (**Figure 12**, **Plate 23**).

- 8.5.2 The earliest features in this trench comprised a series of intercutting pits (**17046, 17048** and **17060**) which had been cut into natural bedrock (**Figure 14, Plate 30**). These features proved to be too deep to be emptied safely and therefore excavation ceased at a maximum depth of 1.2m from the surface of the bedrock. However, excavation was sufficient to establish that these features were probably elongated pits with irregular, steep sides. The pits were closely spaced on a north to south alignment and each was backfilled with a mix of broken bedrock and degraded coal (**17049, 17052, 17057**; not illustrated).
