England

BUCKINGHAMSHIRE

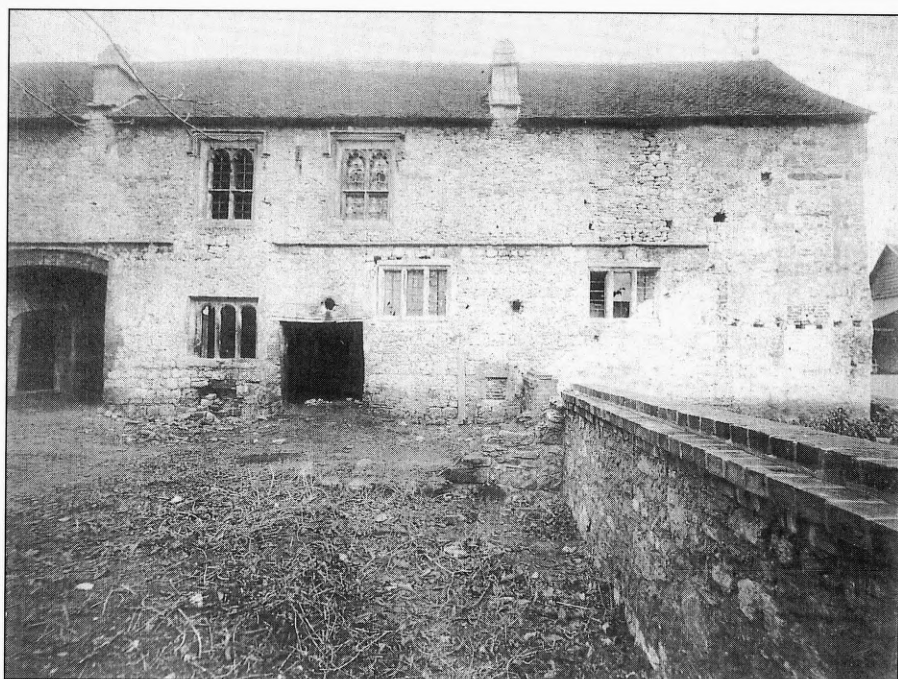
South elevation of the Long Gallery, east end, 1896

The Long Gallery is thought to have been the Abbey's guesthouse and was converted to use as a brewery in the 16th century. This industrial use, which continued until 1895, had a great impact on the earlier fabric, as seen in photographs of 1896, although most of these interventions have been repaired in a sympathetic manner. The building retains many original features, such as the upper floor windows. The photographs provided evidence for a demolished building and associated lean-to which originally
