The church of St Mary's at Linton near Ross

Stephen Yeates

Structural assessment and documentary research on the church of Saint Mary, Linton, in Herefordshire and its wider territorial context indicated that it was an important pre-Conquest mother church. This paper describes the historical perspective, the likely phasing of this complex building, the materials used and their probable source.

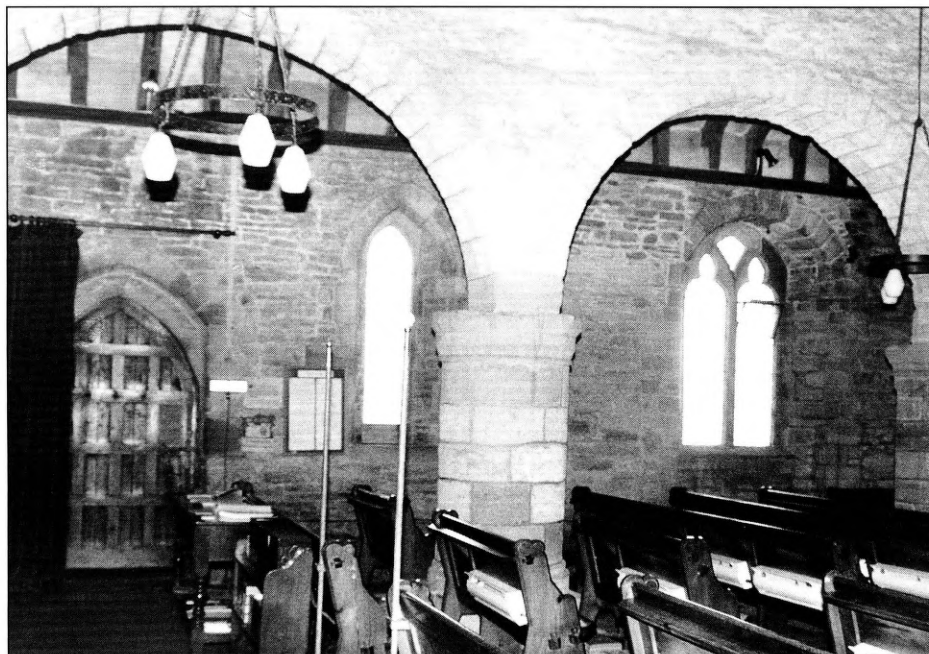
Plate 2 Arch of the north arcade with no characteristic mouldings

The arches are difficult to date as they have no characteristic mouldings (plate 2)

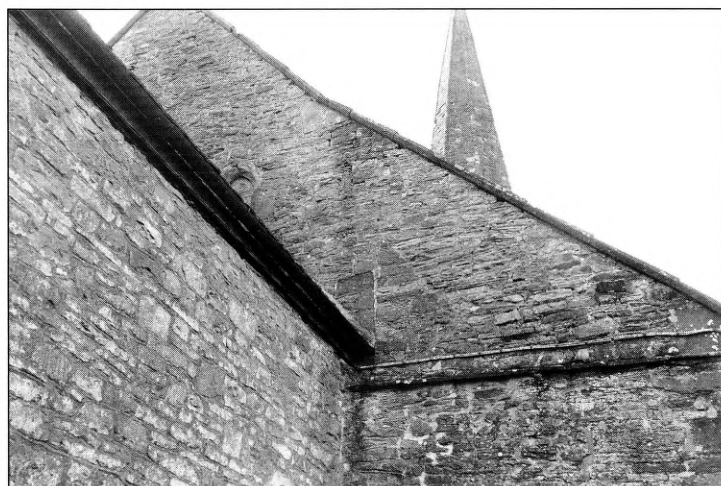
Plate 3 Roof lines on the east wall of the nave showing two or three building phases corresponding with the phasing of the north nave wall and north aisle; north side

On the east wall of the nave and in both aisles there are clear signs of at least two, and possibly three, building phases evident in roof lines, which correspond with the phasing of the north nave wall and north aisle (plates 3 and 4)
