# Rood Stairs

## - an analysis based upon a systematic sample from three English counties

*Joshua Schwieso*

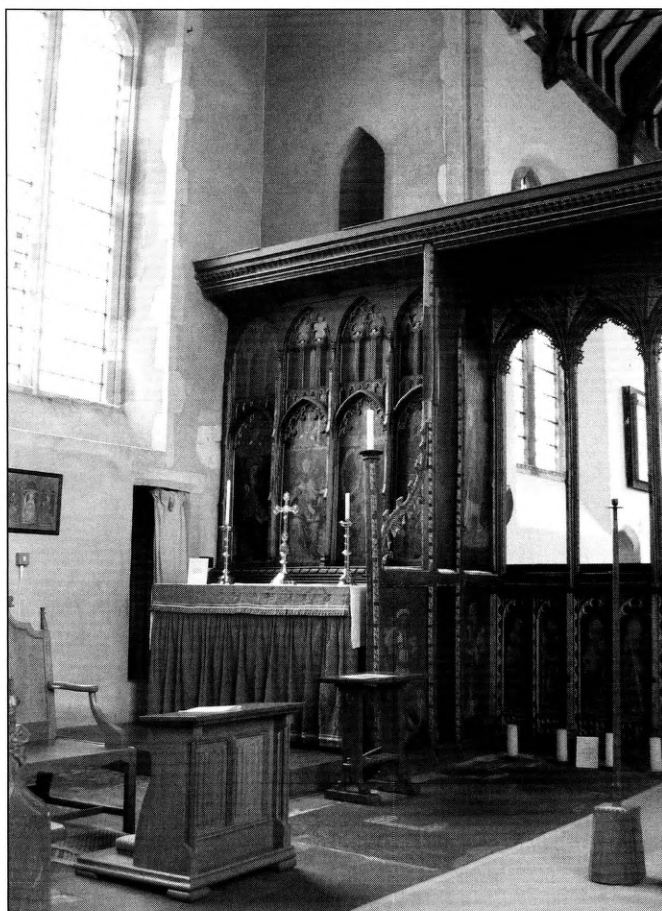
Plate 1: Ranworth, Norfolk - upper & lower doors in different walls

Rood stair locations are dictated by the position and nature of the rood screens which divided the chancel, and chancel chapels, from the parochial nave and aisles, and upon which the loft virtually always stood. In most cases the screen ran straight between the outer north and south walls of the church. Hence the stairs are normally constructed either within one of these outer walls or, very occasionally, within one of the internal piers that the screen touched as it crossed the church. In an un-aisled church with a chancel arch, the loft above the screen ran across the western side of the chancel arch but could project eastwards into the chancel as well. In such cases the lower door into the stair and the door from the stair to the loft can be in either the nave or chancel side walls, in the nave east wall, or in the chancel west wall. The lower and upper doors can be in the same or different walls as at Ranworth, Norfolk (Plate 1).

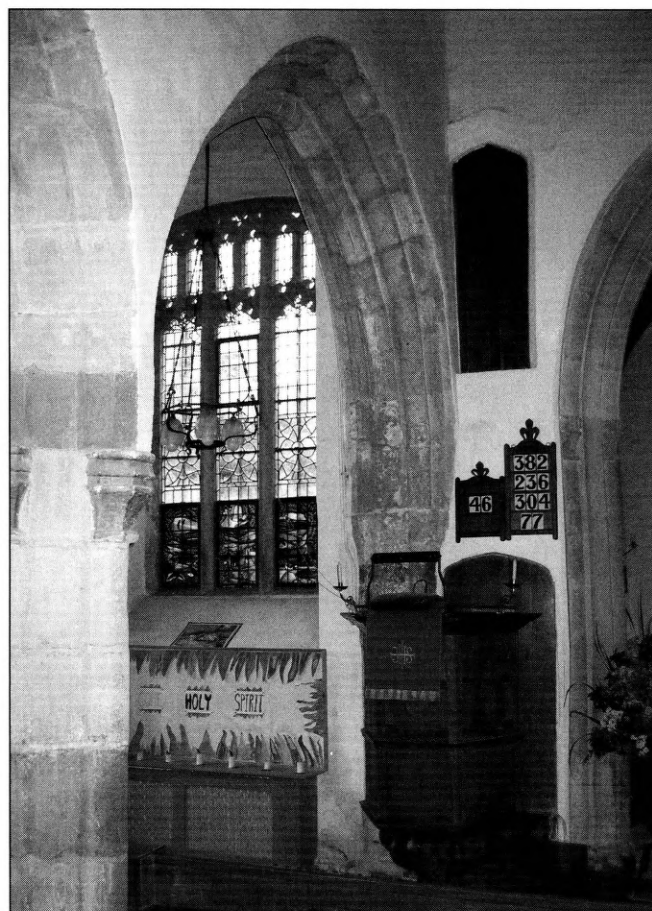
Plate 2: Winsford, Somerset - upper & lower doors in the same wall

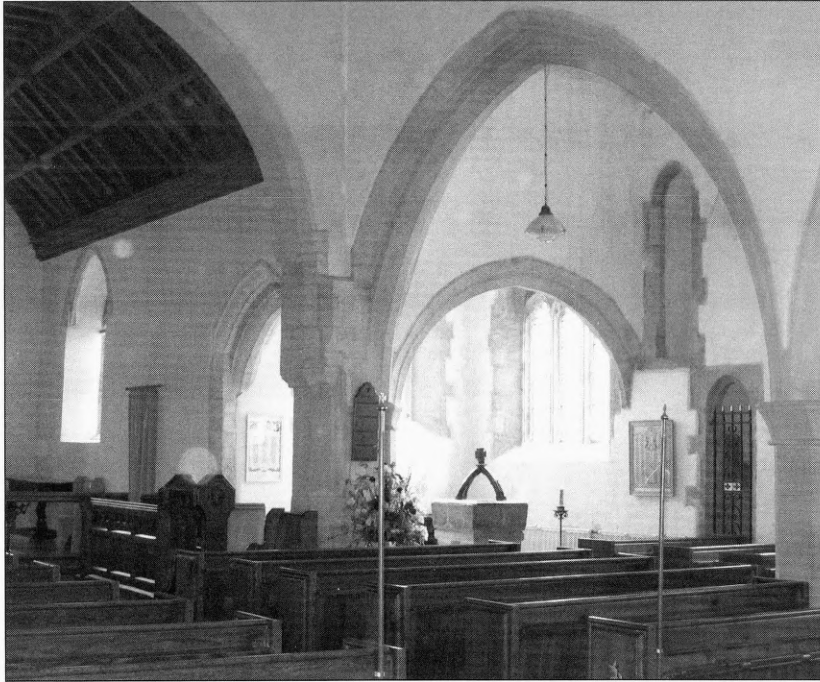
Plate 3: West Buckland, Somerset - upper & lower doors in aisle wall

Where there were aisles to the nave, but not to the chancel, it appears that the screen and loft did not continue across the east wall of the aisles - which would have had no functional purpose and would have blocked the aisle east window - since in such cases the upper door is always in the region of the chancel arch rather in the aisle walls, as at Winsford, Somerset (Plate 2). Where the church had chancel chapels as well as aisles, the screen usually ran across the aisles as well as the nave. In such cases the stair is in one of the aisle walls as at West Buckland, Somerset (Plate 3).

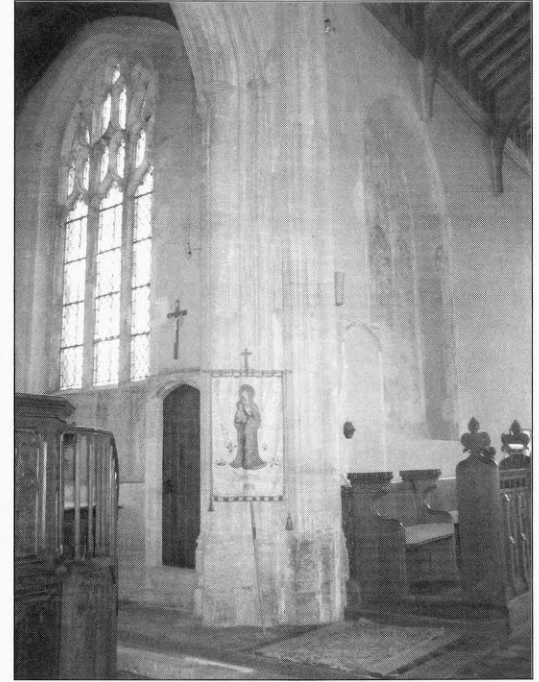
Plate 4: Wiveton, Norfolk - two lower doors giving access from aisle & chancel

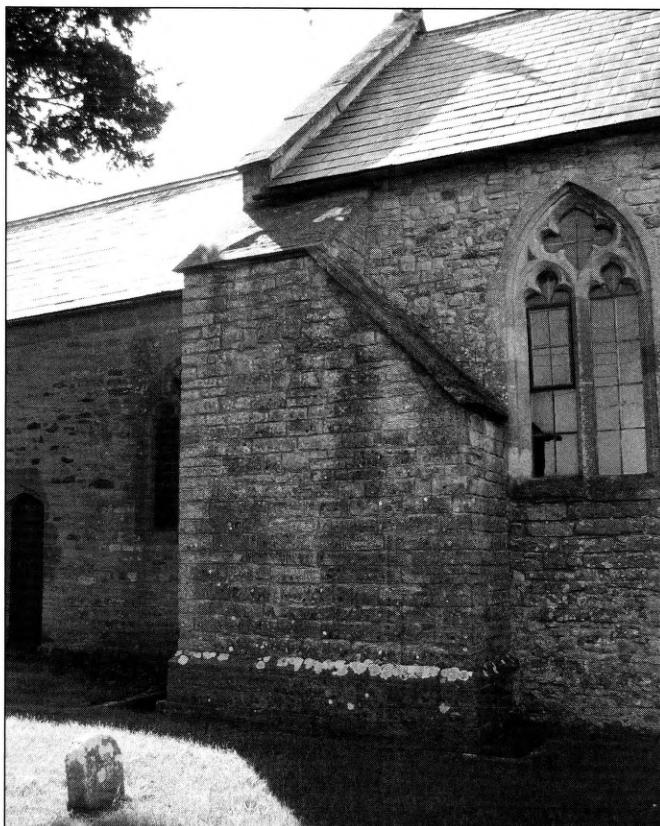
Plate 5: Lyng, Somerset - neatly finished projecting stair with sloping roof

Where the wall was not thick enough a projection was added to accommodate the outer side of the stair. In Somerset these tend to be neatly finished with angle quoins as at Lyng (Plate 5) whilst in Norfolk the projections tend to be more roughly finished as at Sparham (Plate 6) – no doubt because of the scarcity of decent freestone. Normally these projections are rectangular with a single sloping roof, often continuing that of the main nave or aisle roof. Occasionally they are more complex in form reflecting the rising stair inside, and having two or more roofs at differing angles as at Lyng (‘Sloping Projections’ in Table 3). Very occasionally the screen rises from a window bay and, or, ends up in a high window opening which also served to light the rood loft as at Porlock, Somerset. Projecting stairs comprise 20% of the total sample, being 22% of the small Cornish sample, 26% of the Somerset sample, and 11% of the Norfolk sample (Table 5).

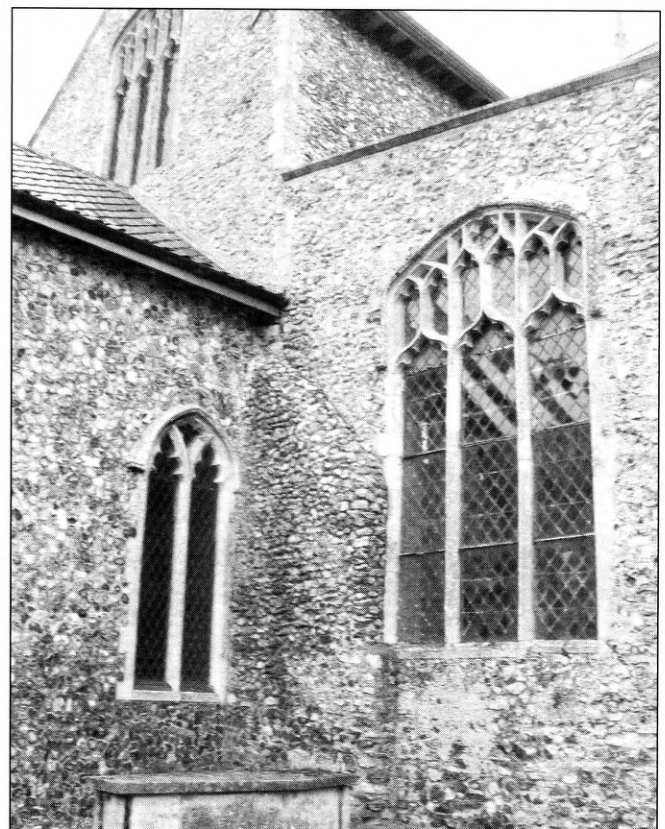
Plate 6: Sparham, Norfolk - rough projecting stair

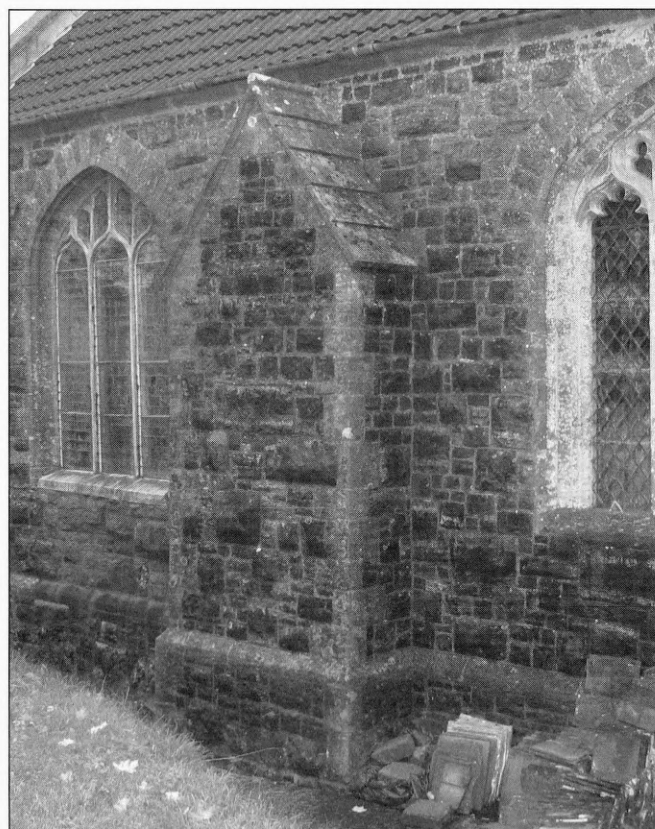
Plate 7: Ashbrittle, Somerset - gabled rectangular turret

Rectangular turrets usually have a sloping roof, though a few in Somerset have a little gabled roof such as that at Ashbrittle (Plate 7). In Norfolk there are a small number of such turrets standing at the junction of nave aisle and chancel and these, taller and more imposing than the norm, may have conical roofs like the more elaborate multi-angular versions (see following section). Rectangular turret stairs comprise 13% of the total sample, ranging from 16% of the Somerset sample, to 11% of the Norfolk sample, there being none in the small Cornish sample.

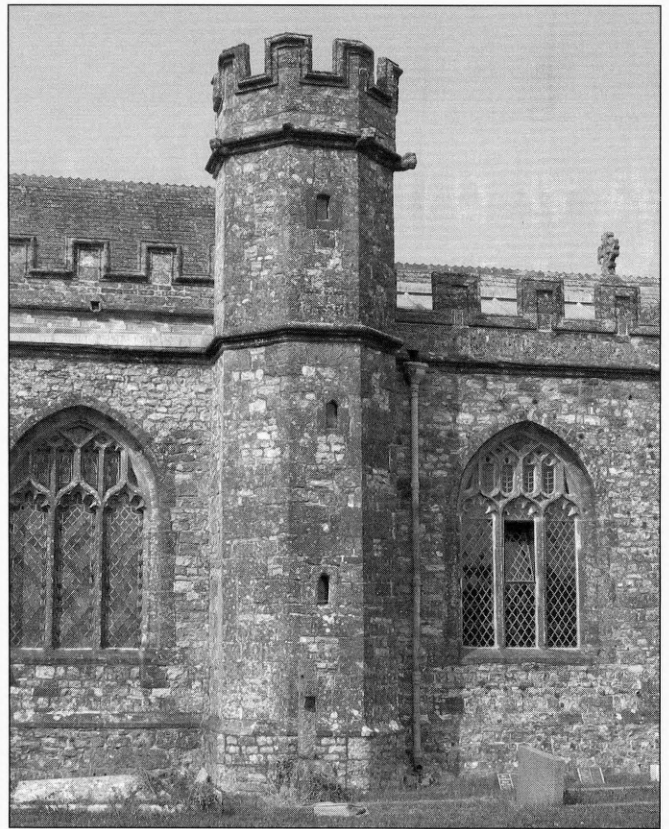
Plate 8: Combe St Nicholas, Somerset - multi-angular tower

In larger churches a newel stair may be housed in a finely built multi-angular turret such as that at Combe St Nicholas, Somerset (Plate 8). This is normally a half octagon, but may occasionally be hexagonal as at Terrington St John, Norfolk or round as at Worsted, Norfolk. When the stair rises at the junction of nave aisle and transept, or at that of a nave aisle and aisle-less chancel, the turret may be reduced to a quarter-turret as at Curry Rivel, Somerset (Plate 9). In one very unusual case at Sedgeford, Norfolk, a complete multi-angular turret stands just to the south of the chancel arch totally enclosed by the south transept.

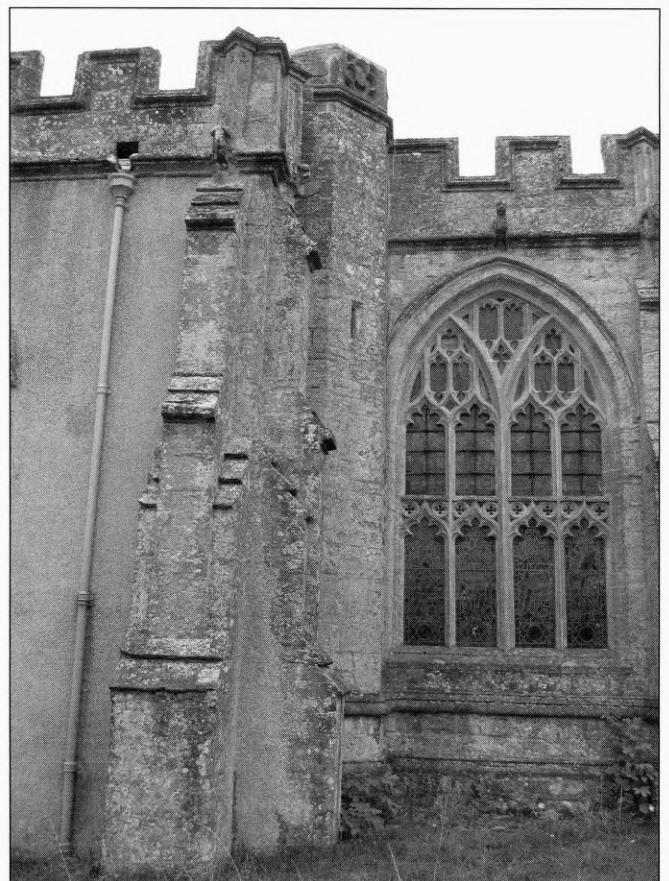
Plate 9: Curry Rivel, Somerset - quarter turret

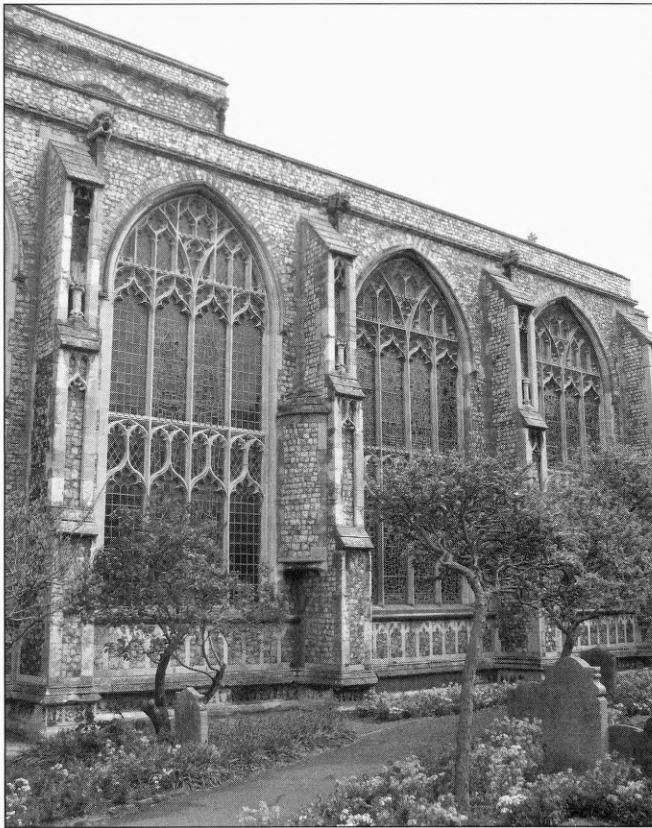
Plate 10: Cromer, Norfolk - shallow multi-angular turret below buttress

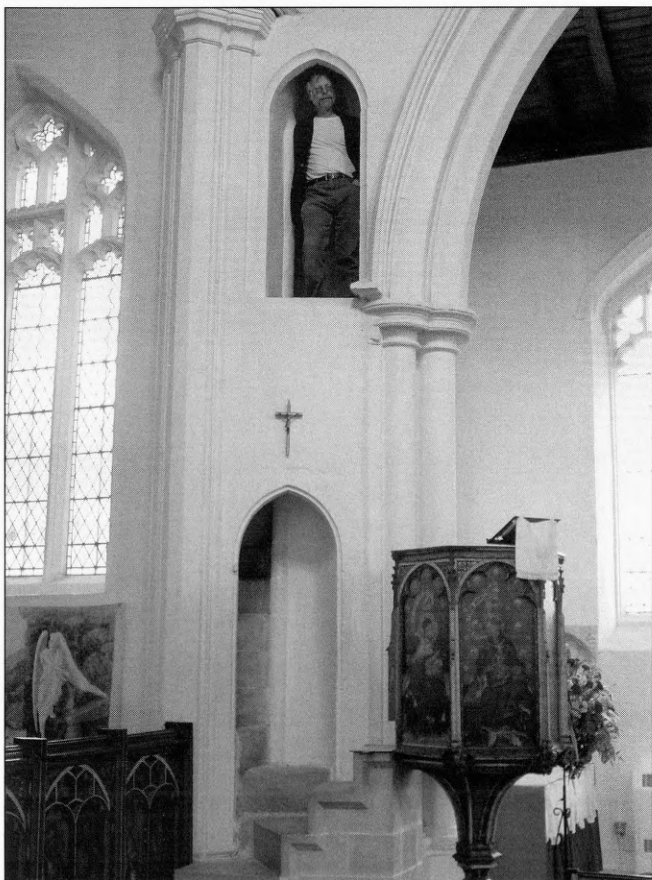
Plate 11: Castle Acre, Norfolk - pier stair with upper & lower doors

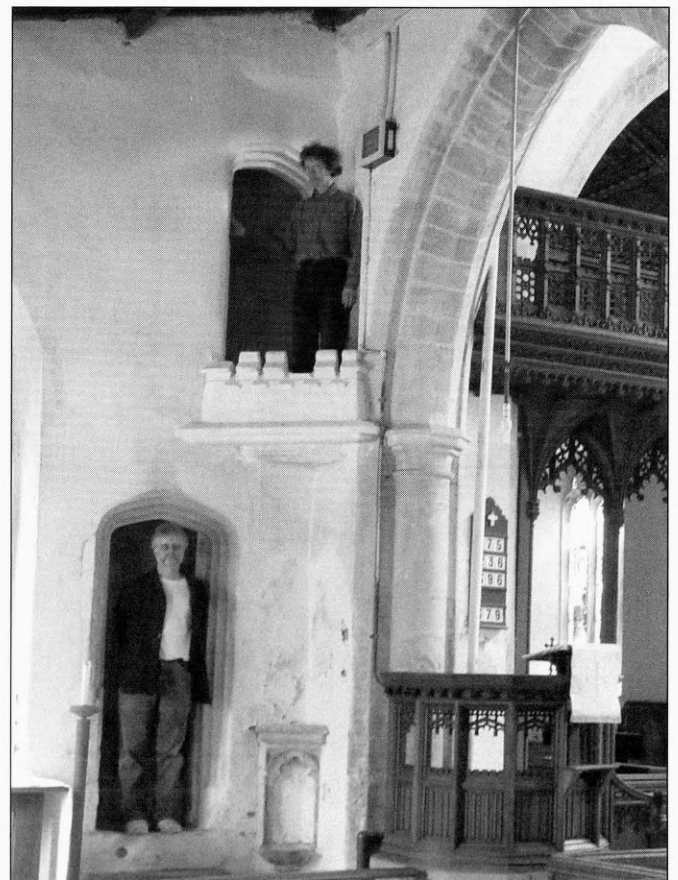
Plate 12: Newton, Norfolk - pier stair with upper & lower doors & balcony

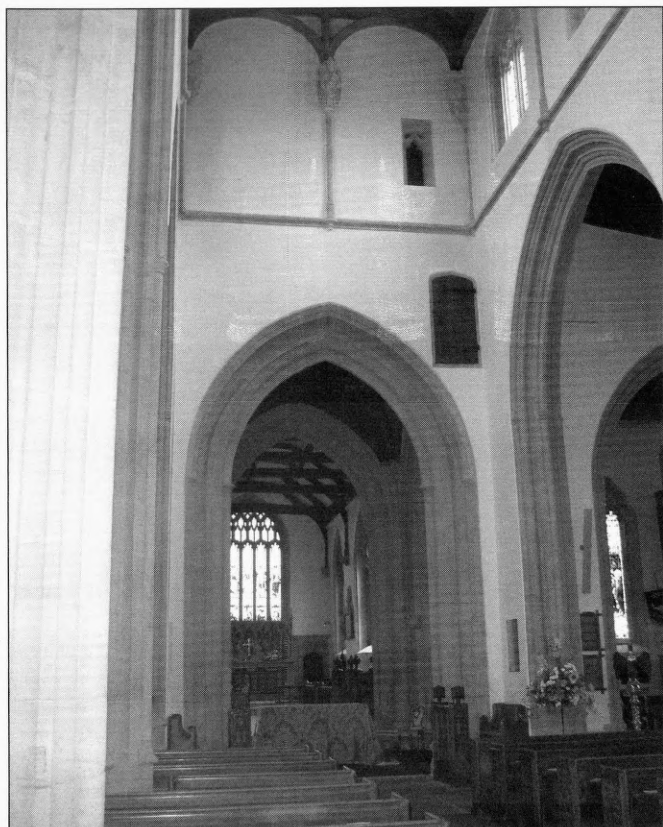
Plate 13: Crewkerne, Somerset - high second door (one of the brackets for the lower loft can be seen on the rear right lower pier)

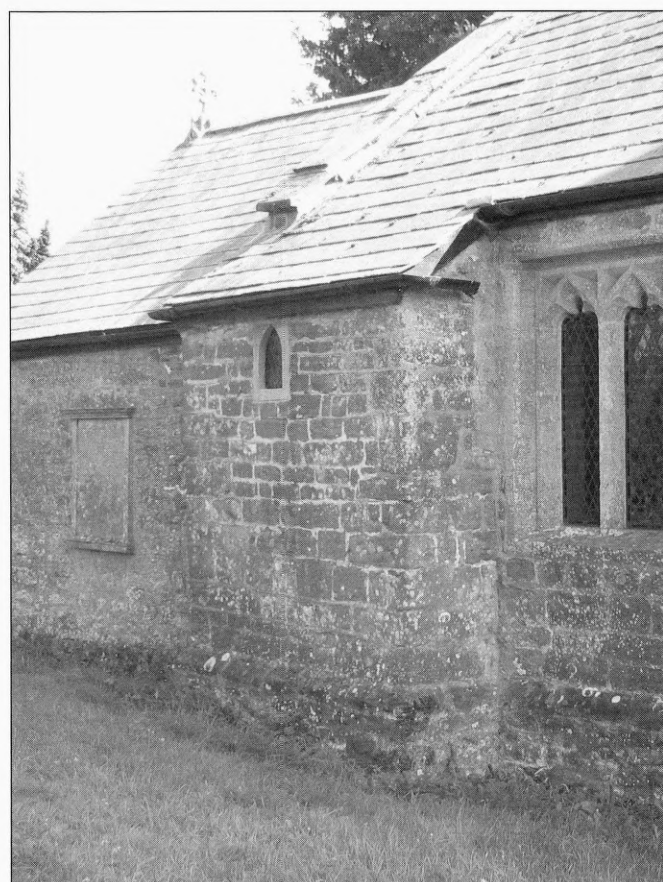
Plate 14: Runnington, Somerset - buttress stair with window

In the smaller buttress stairs there is often only one window, placed near the top as at Runnington, Somerset (Plate 14). Multi-angular turrets on aisles typically have more than one window, usually placed on the outermost face of the turret so as to light the two doors. Where the stair continues to a door to the roof there may be a further window to light that door from the rear as at Combe St Nicholas. Finally a few Somerset turrets have larger, traceried, windows, most notably the very large turret at Minehead which has six windows (Plates 15 & 16). This extraordinary structure contains a very substantial stair with large doors to top and bottom. It is more like a domestic oriel than a rood turret.

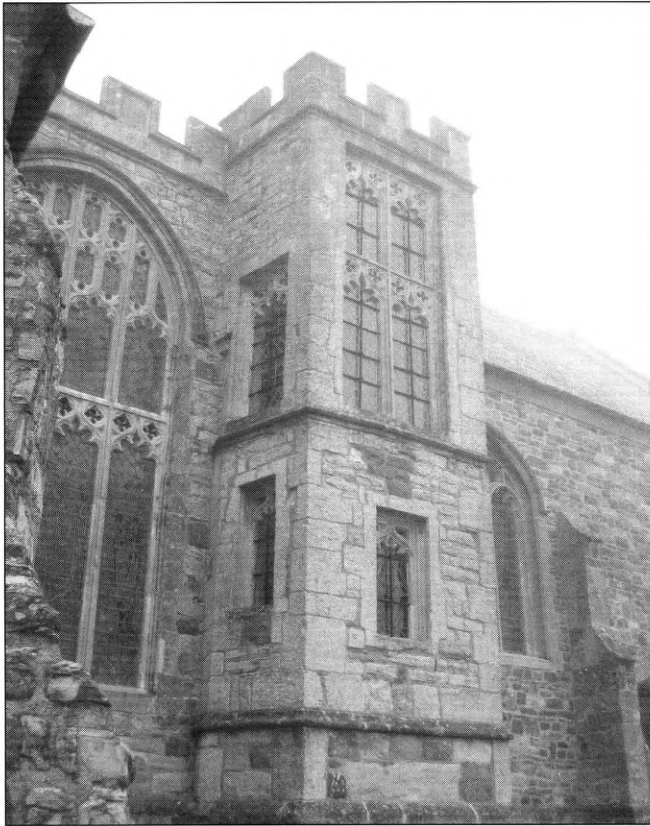
Plate 15: Minehead, Somerset - many-windowed turret

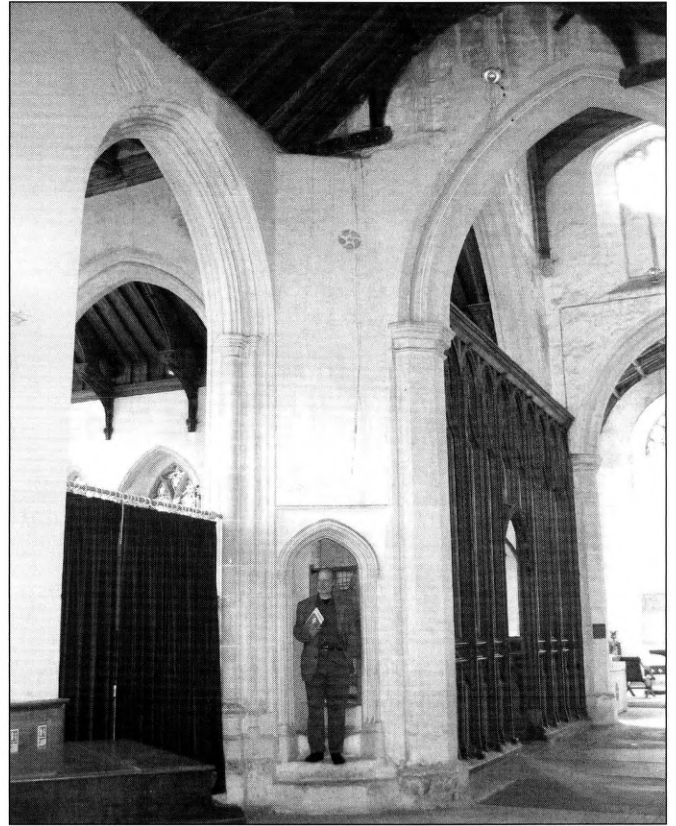
Plate 17: Cawston, Norfolk - lower door of pier stair with small internal window & screen

Pier stairs, multi-angular or rectangular turrets at the nave/chancel junction, and central tower stairs frequently have tiny internal windows, which may be the standard loop but which can be delightful miniature quatrefoils, or roundels of mouchettes as at Cawston, Norfolk (Plate 17).

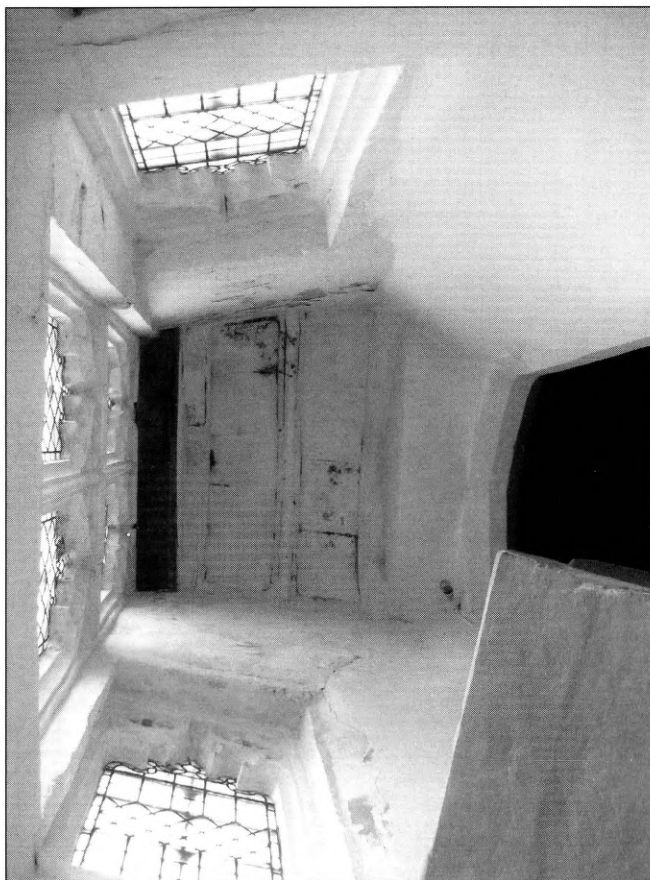
Plate 16: Minehead, Somerset - view of vault of turret & upper door, from stair

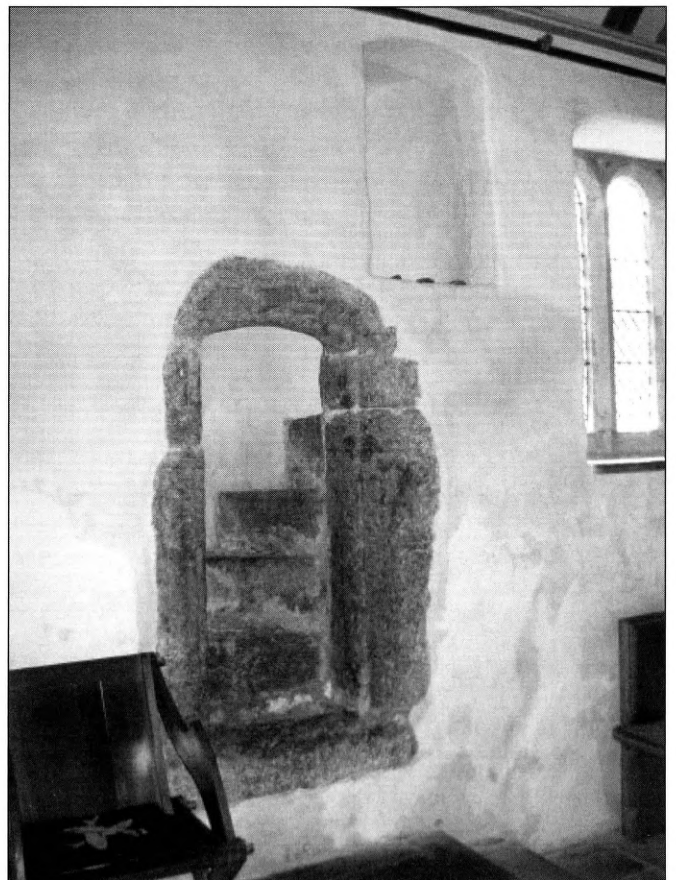
Plate 18: St Levan, Cornwall - roughly formed upper & lower doors
