# An Analysis of Ecclesiastical Stone Cut Backs

John F Potter

*A recent analysis of the geological orientation of stones used in the construction of the quoins, pilasters and arch jambs of British ecclesiastical buildings (Potter 2005), clearly indicated the very distinctive techniques of stone use employed by Anglo-Saxon craftsmen. The work demonstrated that Anglo-Saxon builders possessed a significant understanding of the quality of the stones which they incorporated into their churches. Their appreciation of the physical properties of the rocks enabled them to use certain stones for building purposes in selected ways. These techniques were not copied by others that followed. In the analysis, reference was made to the stones of quoins, pilasters, and in one instance, jambs, occasionally being cut back. This paper examines the phenomenon of cut back in more detail.*

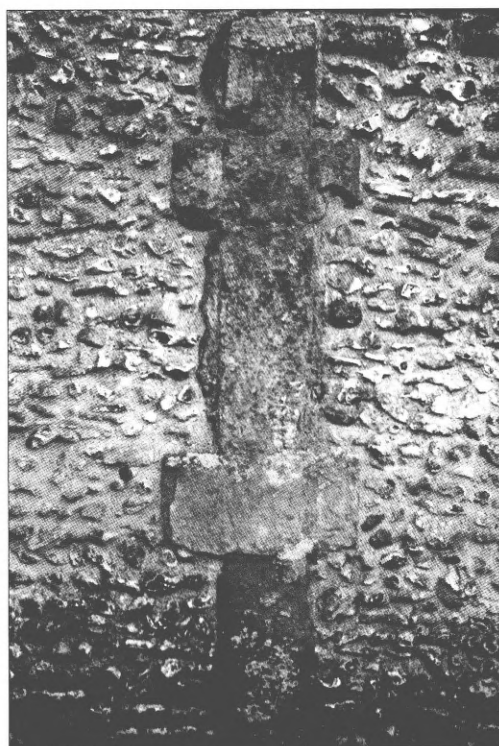
*Fig 1 – The partial pilaster strip of long and short stones on the north wall of the nave at Breamore chosen by Brown (1903) to be illustrative of cut back stones. Both ‘long’ and ‘short’ stones can be observed to be cut back, although Brown made the case that only the ‘short’ (‘flat slabs’) were cut back ‘to provide a stop for plaster’. Note that the lower ‘short’ stone has traces only of a possible cut back, and that the strip width relates to the width of the lowest stone which is not cut back*

Only in one pilaster (that on the north wall, west end) do three successive stones exemplify the Taylors' statement (Fig 1). A fourth stone shows faint vertical lines where a cut back would, if completed, have been cut. In the main, the Anglo-Saxon preserved quoins and pilaster strips fail to stand proud of the walls of quarried and generally unbroken, flint cobbles. The quoins and strips might be described as relatively untidy for there are a fair proportion of replaced stones. There are a number of additional stones (stones 2 and 6 above the pedestal of the south nave west pilaster; stone 2, east face of the south-east quoin of the south transept; lowest stone, east face south-east tower quoin) where cut backs appear to have been initiated with a shallow vertical incision but not completed. In each case, the incisions can be related to the width of a higher, narrower stone and were, therefore, made subsequent to the construction of the quoin or strip. The south face of the lowest stone in the south-east tower quoin exhibits a cut back which is set well behind the wall face (probably indicating that

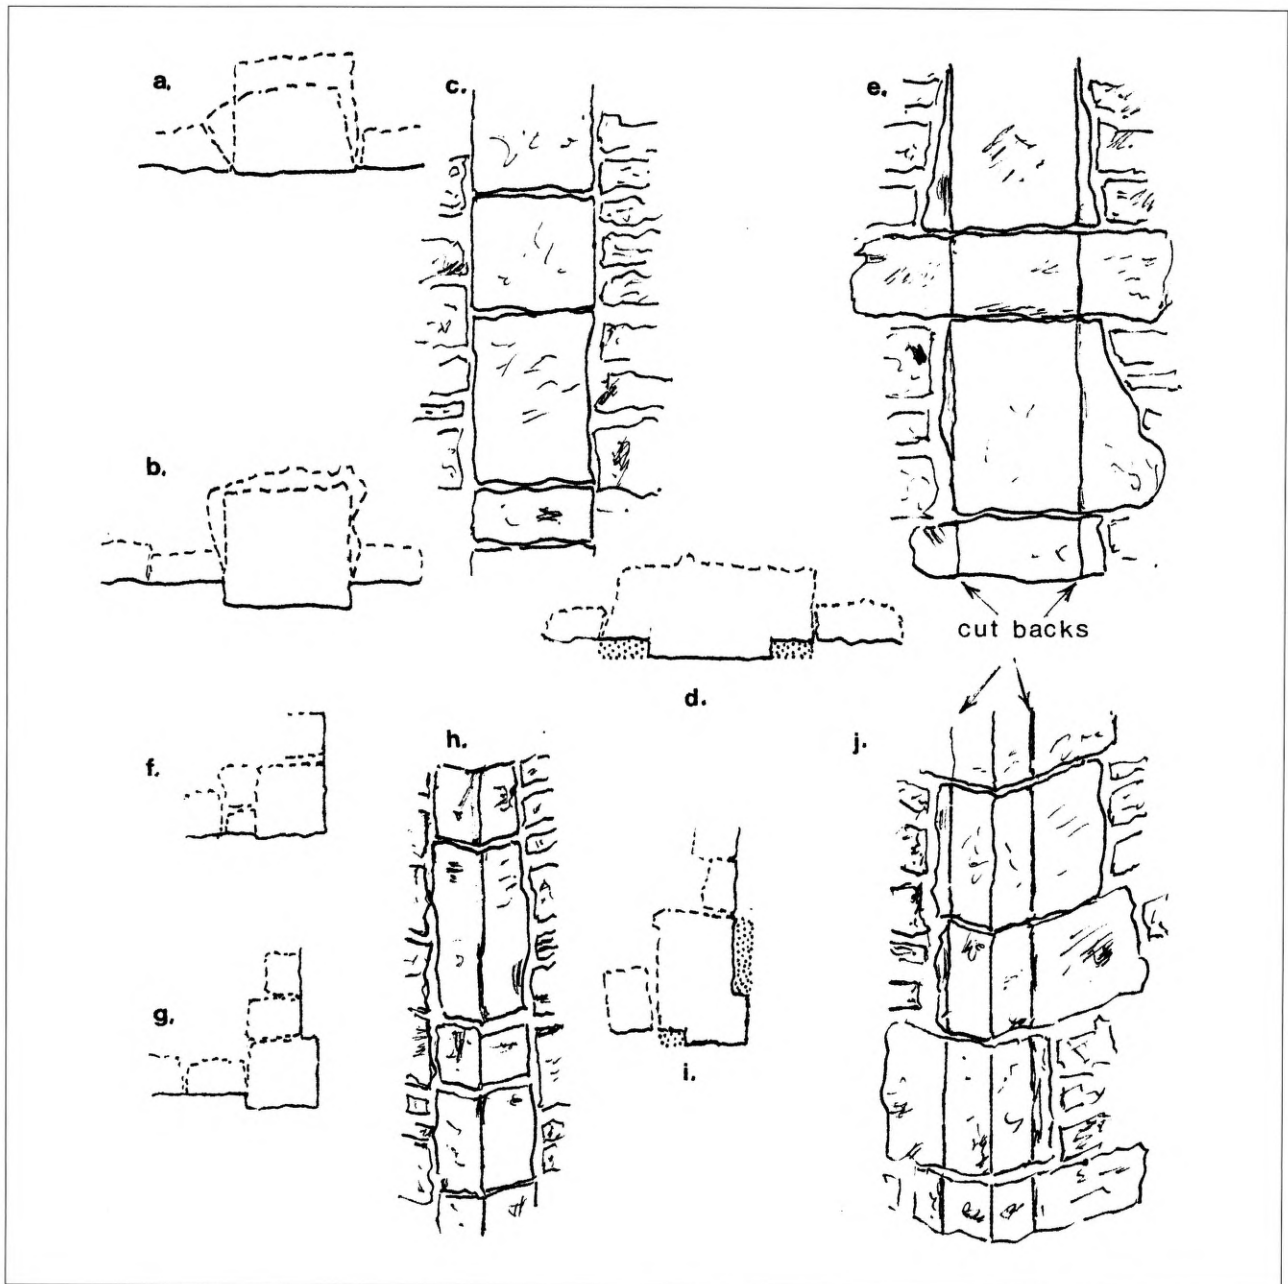
Fig 2 – Plans and elevations of pilaster strips and quoins without and with cut backs:

- a. Plan of a pilaster stone set in a wall so as not to stand proud of the wall
  - b. Plan of a pilaster stone set in a wall so as to stand proud of the wall

- c. Elevation of a pilaster strip created from pre-cut stones
  - d. Plan of a pilaster stone (typically) cut back after insertion in a wall to give a proud strip

- e. Elevation of a pilaster strip created by cut backs
  - f. Plan of a stone set in a wall quoin so as not to stand proud
  - g. Plan of a stone set in a wall quoin so as to stand proud

- h. Elevation of a quoin, viewed obliquely, and created to provide a pilaster matching strip effect from pre-cut stones
  - i. Plan of a stone (typically) cut back after insertion in a wall to give proud faces

- j. Elevation of a quoin, viewed obliquely, and created by cut backs
- In a, b, d, f, g, and i, the possible shapes of the stones behind the wall faces are shown by dashed lines: in a, and b, two alternative shapes are shown. In d, and i, the stippled areas indicate the stone removed by the cutting back process

employed to create the pilaster strip, each stone would have to have been dressed to the pilaster face dimensions prior to insertion in the wall (Fig 2b). Less commonly, the same technique was used for wall quoins, two of the corner stone faces standing proud of their respective wall faces. To achieve this, if ashlar stone was used, each of the quoin stones required an approximately square shape of equal size, in a horizontal cross-section (Fig 2, g–h). In these cases, the appropriate stones of both the pilaster and the quoin were set forward rather than being cut back, although it is in circumstances such as these that the term ‘cut back’ has been erroneously used to describe their projection as a band beyond the wall surface. As early as 1836, Rickman (p 28) had noted ‘a peculiar sort of quoining’ of this nature and suggested that these quoins were raised ‘to allow for the thickness of the plaster’.

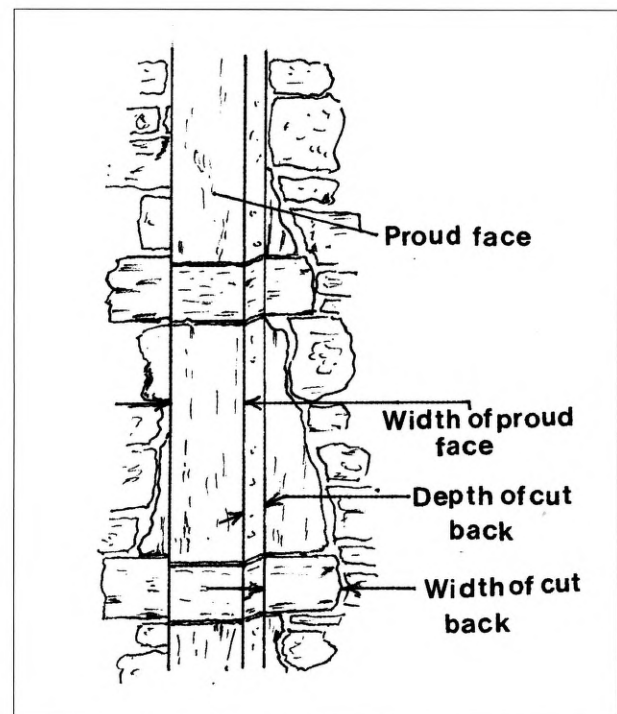
Fig 3 – The cut back nomenclature used in Table 1 and throughout this paper, as illustrated on a pilaster strip

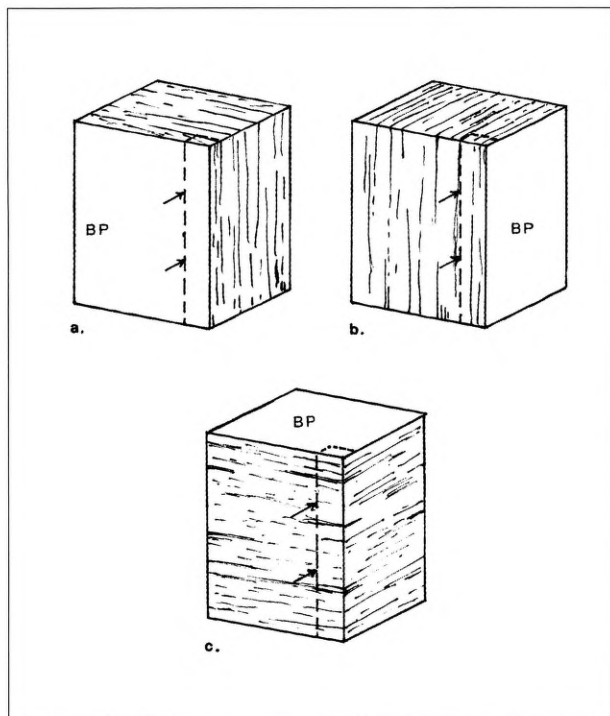
Fig 4 – Rock bedding planes and cut backs. Three ashlar stones of identical size and shape are shown; their bedding planes (BP) and the traces of these have been illustrated in the three different orientations that are possible. The potential success in trying to create a clean vertical arris and smooth cut back (by chiselling in the direction of the arrows) will differ in each case

- Will produce the best result. Having chiselled into the rock to the depth required the cut back should 'fall away', parting along its bedding planes
- Chiselling will tend to weaken the rock and the cut back portion will be difficult to remove
- A complicated chiselling task and difficult to achieve smooth cut back surfaces

of the rocks on which they were working. They appreciated that a rock would split more easily and provide a smoother surface if cut back parallel to the rock bedding planes (Fig 4). Although not universally applied, presumably because the shape of the rocks available to the mason was variable, the majority of cut backs reveal this knowledge in the method in which they have been fashioned. Quoin stones, if cut back on both faces, automatically were more difficult to cut back on one of the two faces, if the bedding orientation was vertical (Fig 4a or 4b). Where the stone was set with its bedding planes horizontal (Fig 4c) it would have been equally difficult to create cut backs on either face.

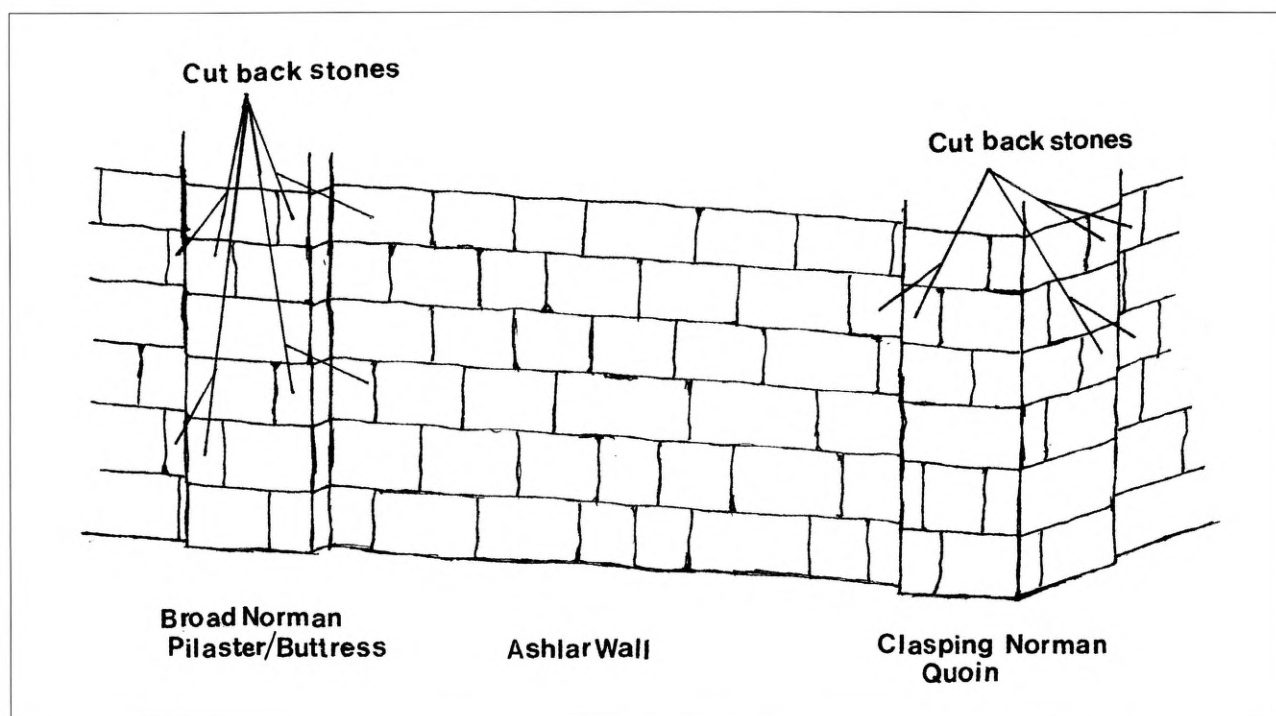
Fig 5 – A typical post-Conquest, bonded ashlar wall with a broad shallow pilaster and clasping quoin. Where they overlap the proud faces, stones will have been, of necessity, cut back. The vast majority of the stones in the wall and the structures will have been placed with their bedding orientation horizontal

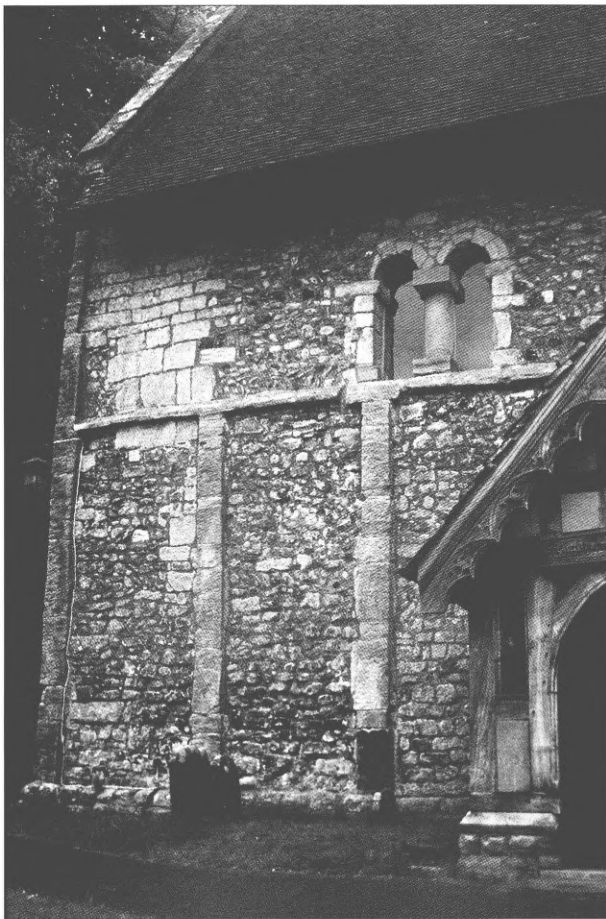
Fig 6 – The south wall of the nave at St Nicholas, Worth, showing a number of cut back stones in the pilaster strips and also the south face of the south-west quoin. In the upper portion of the quoin, where the proud face suddenly changes in width, the quoin and the adjoining wall are of post-Conquest age and the cut back stones are of a different style

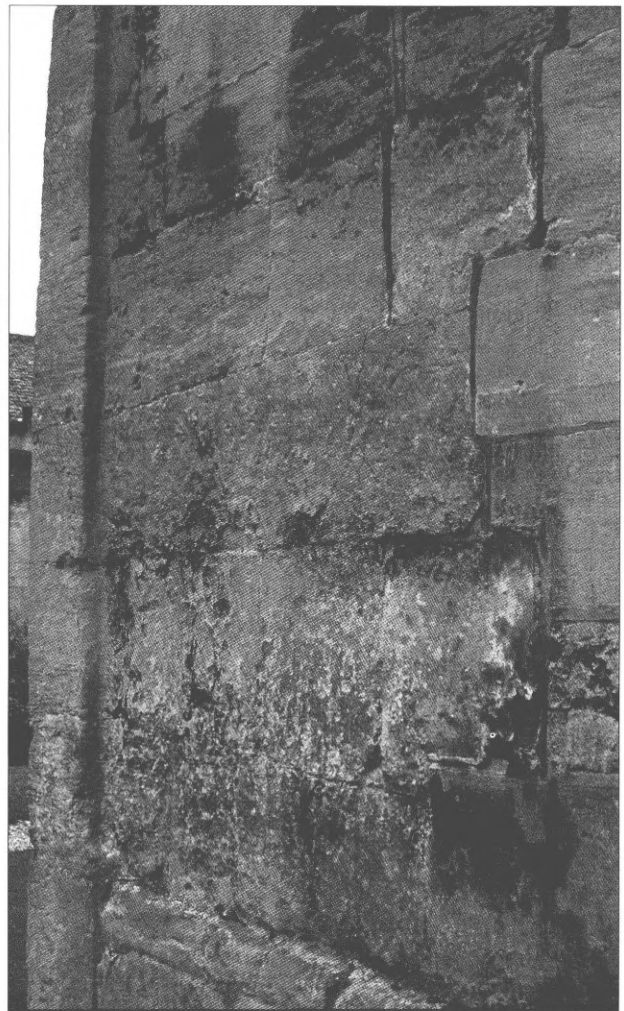
Fig 7 – The east wall of the chancel of St Laurence, Bradford on Avon to show the post-Conquest style of cut back stones. Stones at the extreme right of the photograph are of more recent insertion in the wall

Examples of Norman cut backs can be observed in churches such as St Mary, Dymock in the broad pilaster strips and the south-east nave clasping quoin, and St Nicholas, Worth, the higher stones in the south-west nave quoin (Fig 6). These examples have been included in this paper since the churches incorporate both Anglo-Saxon and Norman work, and where the structures of the two periods are sometimes confused. Parts of the decorative workmanship at St Laurence, Bradford on Avon exhibit great similarities to this Norman style of cut back (Fig 7).

Externally, possibly the eastern wall of the chancel has been least modified. A count of the stones comprising the two quoins, the central pilaster and the two inset panels shows that it is composed of 22 cut back stones (three being 'modern' replacements), and

64 panel stones (nine being 'modern') which would have required no modification if set to the building line (Fig 7). Relatively 'modern' workmanship in the southern panel of the west wall of the nave portrays four stones exhibiting cut backs that are horizontal. These replacement stones appear to have been sawn to shape to fit into the lower edge of the panel. Within the lower parts of the church only three areas display work that appears to be principally Anglo-Saxon, these are the north doorway to the nave, and the south-east quoins to the nave and the chancel (Potter 2005). Some areas are closely comparable in style to those seen in the early Norman craftsmanship at Dymock church.

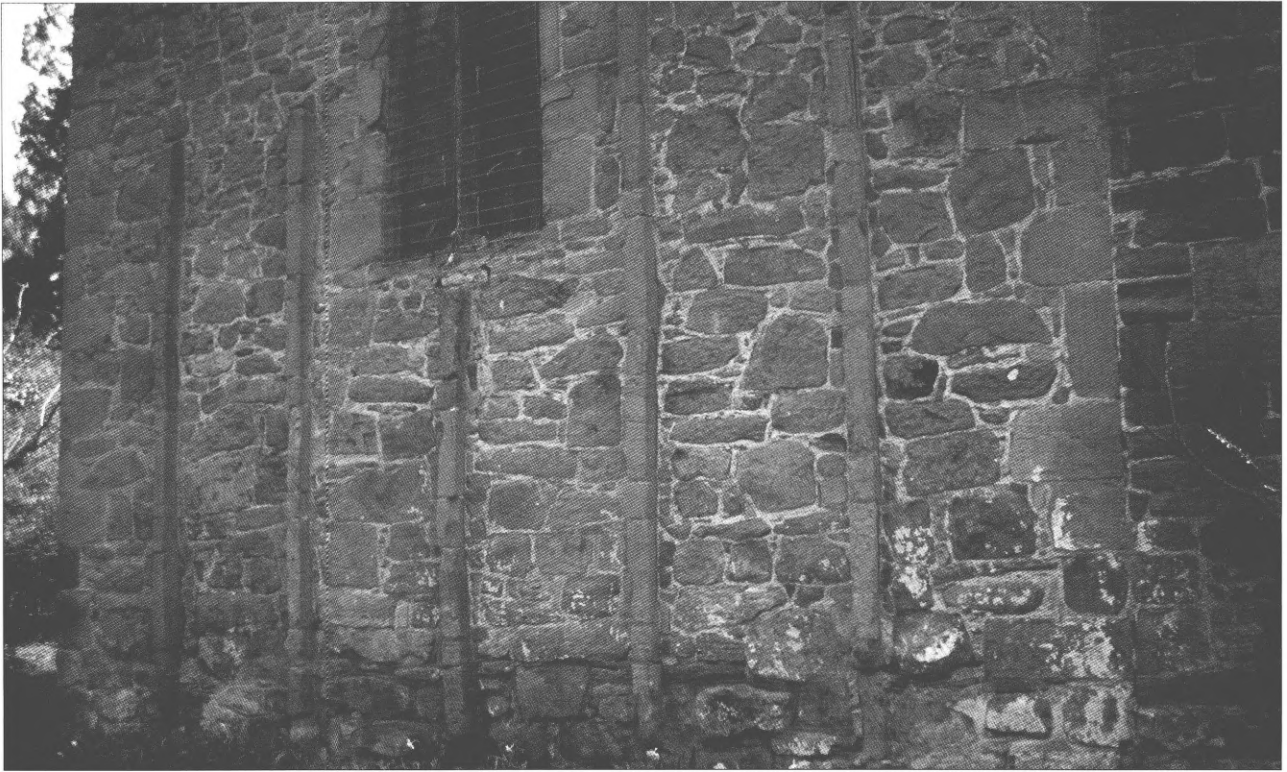
*Fig 8 – The west end of the nave at Stanton Lacy church showing five proud, partial pilaster strips, in which a few stones exhibit small cut backs. It should be noted that the quoins, although of Anglo-Saxon age, are flush with the wall; evidence that originally the wall was unlikely to have been rendered*

As many as 16 pilaster strips can be observed at this church. Each stands proud of the wall and, in contrast, the four Anglo-Saxon quoins (west wall of nave and north wall of transept) are flush with the wall surface (Fig 8). The stones of the pilaster strips appear to have been shaped and inserted into the wall as it was built. None of the strips is preserved over its full original height and, exclusive of the basal corbel-like plinth stones upon which some strips stand, 130 stones in total remain in the strips. Subsequent to the wall construction, a number of stones required cut back trimming to preserve the neat vertical lines of their respective strips. Eighteen stones (14%) have small cut back portions on one side, and a further two stones are cut back on both sides.

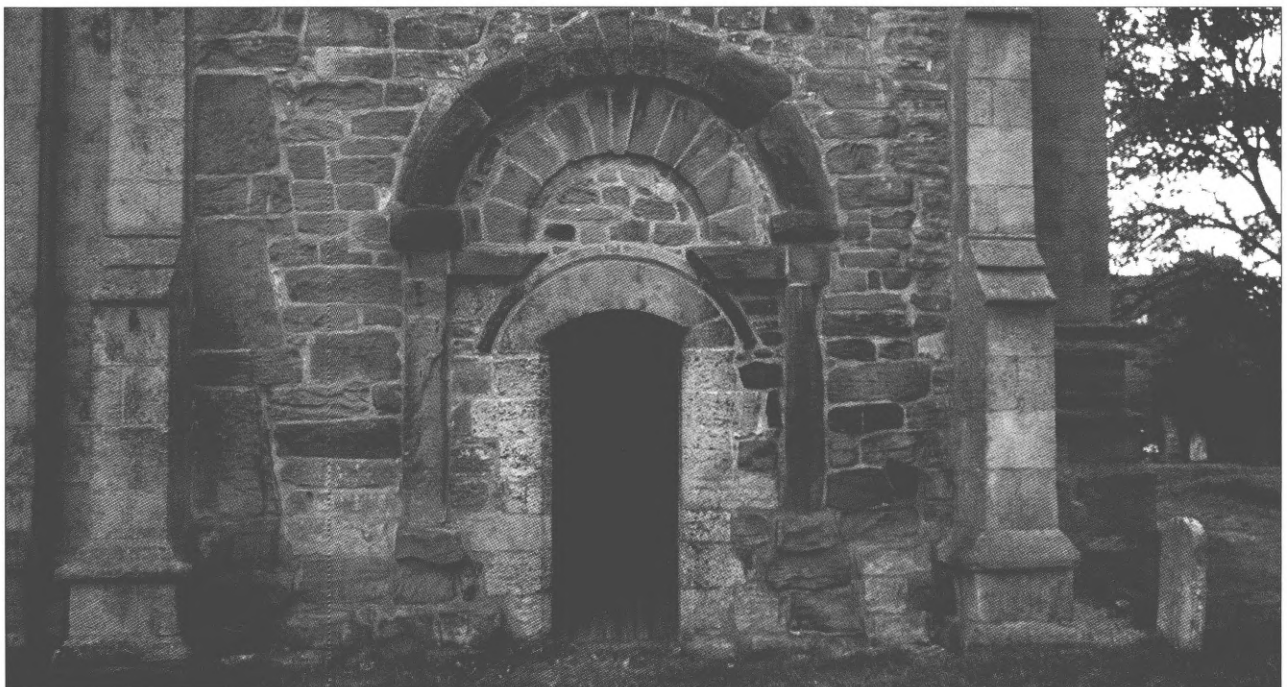
*Fig 9 – The north door to the Anglo-Saxon porticus at Laughton-en-le-Morthen church. The north face to the north-east quoin of the porticus in long and short style remains and is noticeably flush to the north wall. The hood-moulding and the voussoirs of the arch to the Anglo-Saxon doorway are constructed of cut back stones to provide both structures with a constant ornamental width. A later medieval door now fills the entrance*

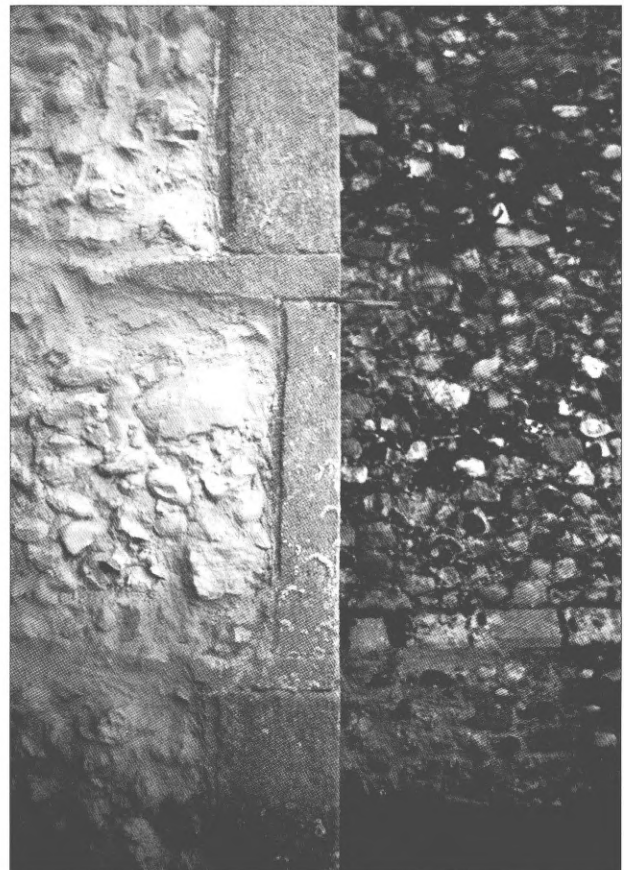
Fig 10 – Detail of part of the north-west quoin, north face, of St Peter, Claydon. Only the 'long' stones have been cut back, apparently to make the sides of the stones parallel for they do not line up vertically in the face. The neighbouring churches of Debenham and Hemingstone possess similar quoins of Barnack Stone and it is possible that all three obtained their stone already worked in this way directly from the quarry. The inserted pen is 145mm long

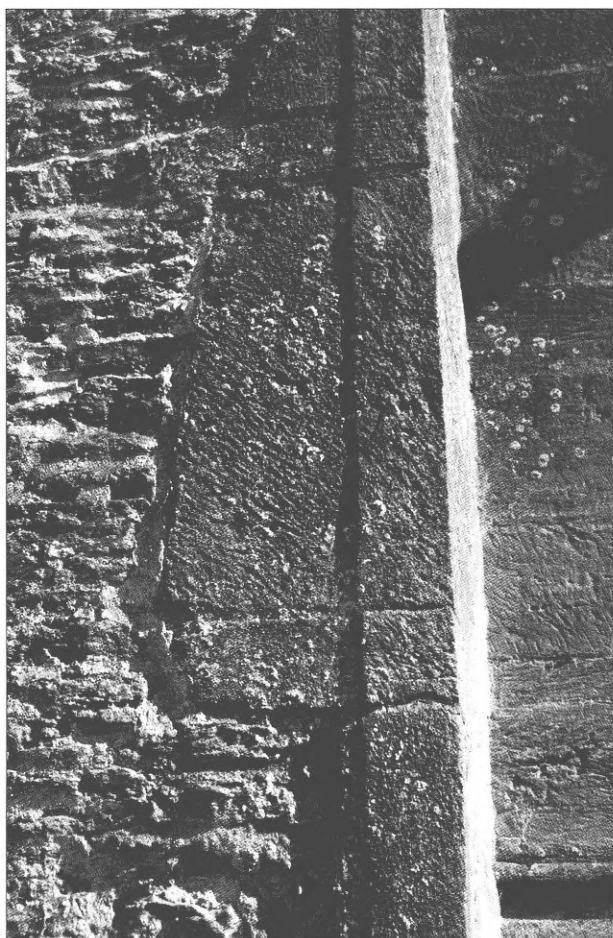
Fig 11 – Typical cut back tooling marks seen in the north-west nave quoin (north face) of Daglingworth church. In many of the churches examined the work seems to have been undertaken with a small pointed chisel

In three churches, Claydon, Debenham and Hemingstone, of very close proximity in Suffolk, quoins constructed of Barnack Stone appear to have had their cut backs (in 'long' stones only) worked prior to their placement in their respective walls. Their varied style and amount of cut back suggests that the work was undertaken off-site where there were no guidelines as to the requirements of the quoins. The work was certainly executed with care, as can be seen particularly well at Claydon (Fig 10). There, the cut backs were achieved with a pointed chisel rather than with a wedge as might have been expected. The same technique can be observed at other churches such as Coln Rogers and Daglingworth (Fig 11).

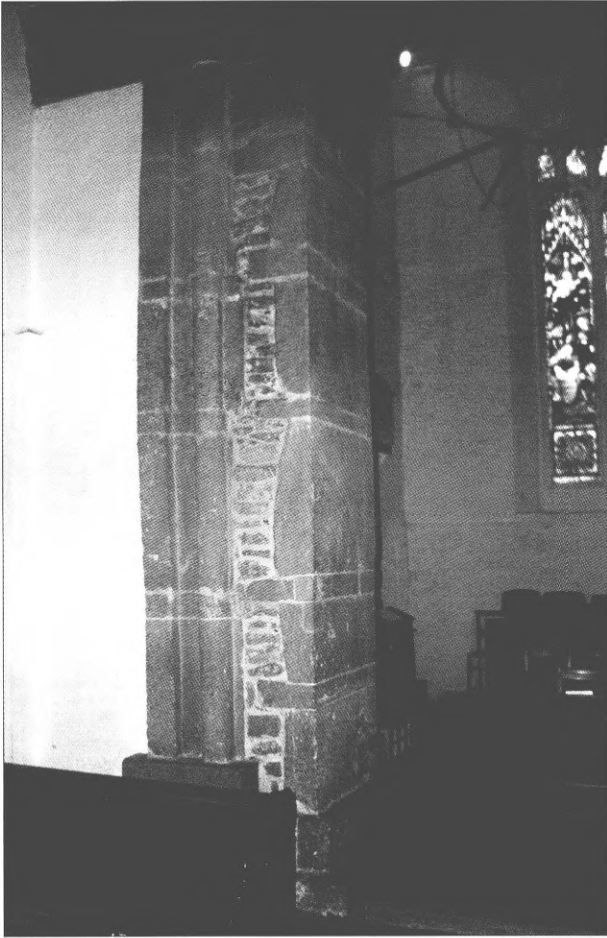
*Fig 12 – The south jamb of the Anglo-Saxon tower arch of St Bene't, Cambridge viewed from the east side. Certain stones on the inner side of the strip-work have been cut back to bring them in line with the width requirements of the narrowest stones*

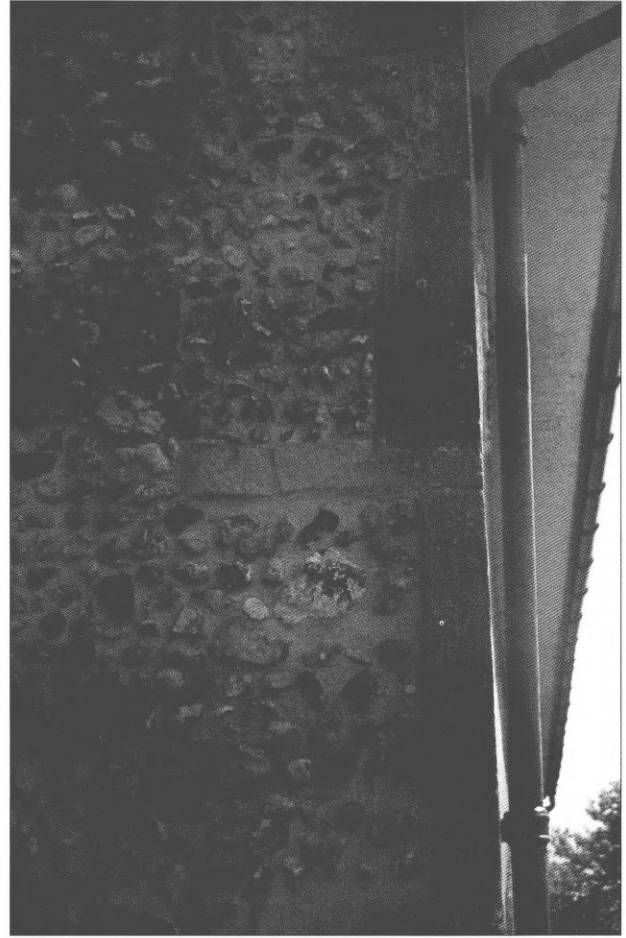
*Fig 13 – Detail of an unusually cut back, 'long' stone in the west face of the south-west nave quoin at Hemingstone church. The cut back has been worked parallel to the 'wrong' edge of the stone. It is possible the stone (from Barnack) was cut in the quarry originally for another purpose*

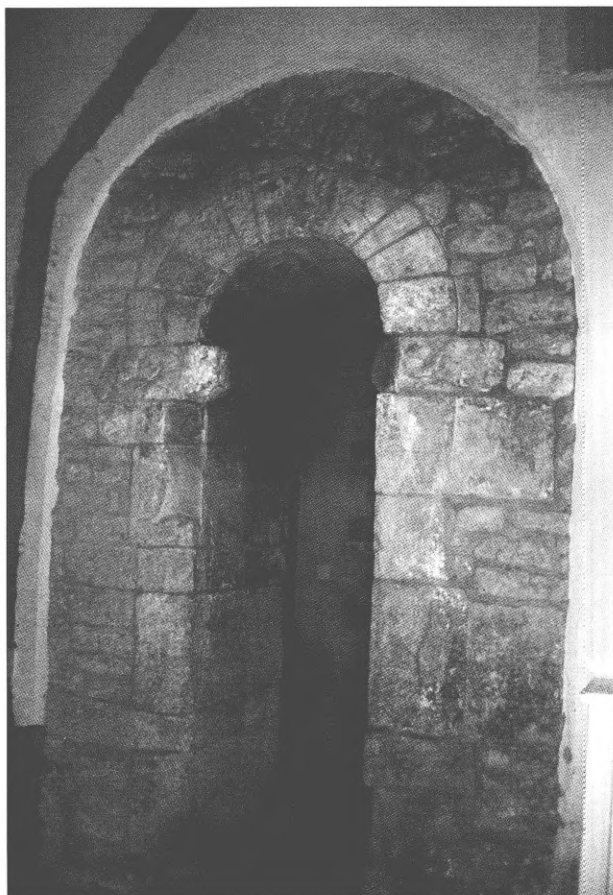
Fig 14 – The east face of the Anglo-Saxon doorway on the west wall inside the north transept at Stow church. The voussoirs have been cut back on their external circumference to the width of the smallest stone. Some of the jamb stones are slightly cut back but this has failed to produce a continuous vertical arris through the height of the jambs. Note that the wall plaster has not been brought up to the cut back arrises. The west face of the same doorway has no cut back stones

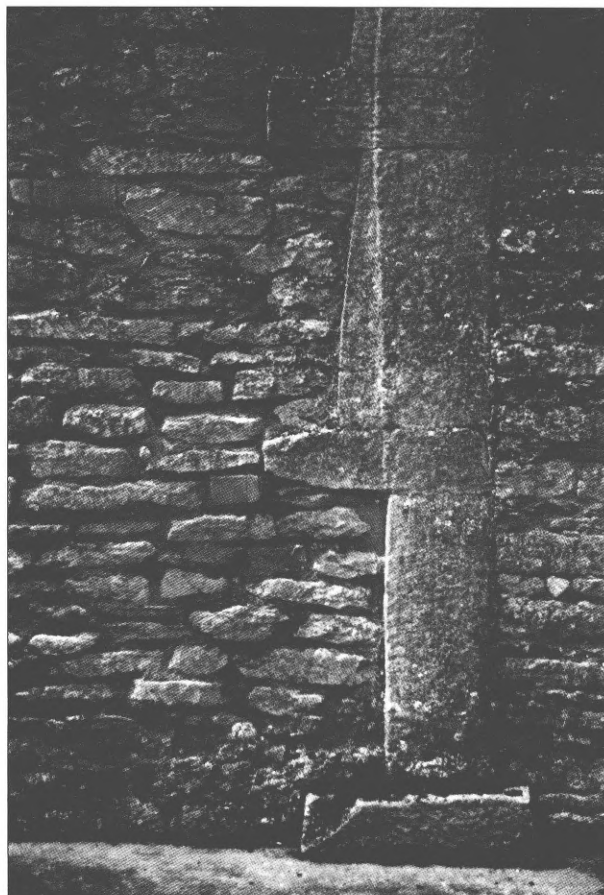
Fig 15 – The east face of the north-east chancel quoin of All Saints, Wittering. Stone 3 above the pediment to the quoin shows the typical 'pear shape' (Jackson & Fletcher 1945) of the 'long' stone prior to cut back. The stones are cut back to meet the width of the narrowest stone in the pilaster strip – in this case the lowest stone

Of the various examples of quoins with cut back stones, those at Wittering church most readily illustrate the manner in which the work was completed. As explained in the description of this church in the Appendix, the two proud faces of each individual quoin are generally of dissimilar widths, differing by as much as 25mm, and each proud face is cut to the width of the narrowest stone in the quoin. The trimming back would be most effectively performed with the stones set in the wall and with the assistance of a plumb-line. Very similar quoins occur at Cambridge, Coln Rogers, Hannington and Ropsley churches. As with the cut backs seen in arches, the work was performed after installation in the wall. In the vast majority of other quoins and pilasters the amount of cutting back can be associated with the width of the narrowest stone or stones. In a few instances, whether this was done subsequent to the stones’ installation in the walls has to remain uncertain.
