A Hidden Medieval Door and Graffiti at the Church of SS Mary and Andrew, Whittlesford, Cambridgeshire

The unexpected survival of a medieval door became apparent during building works at the Church of SS Mary and Andrew, Whittlesford. Removal of the door blocking also exposed a group of graffiti which led to a survey of other markings within the building, including the 'Whittlesford Archer'.

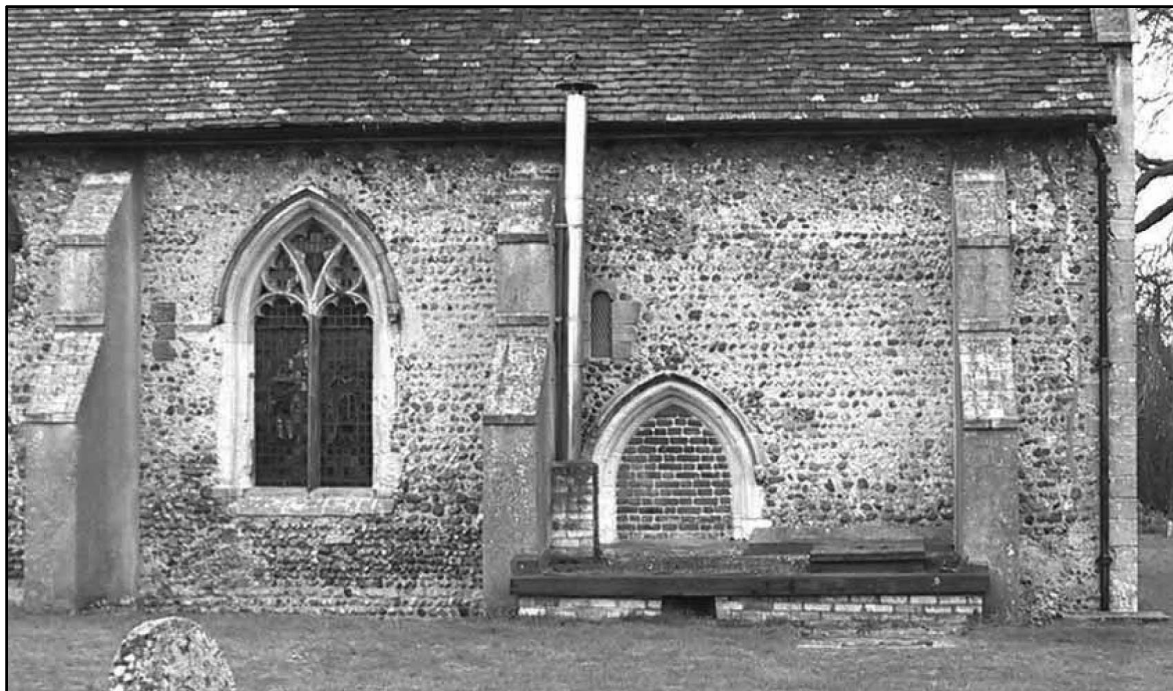
Fig 2a

The north wall of the church, showing the doorway before removal of the brickwork;

The north doorway has a two-centred arch with a moulded profile continuous with the jambs, probably late 13th or 14th century. Only the western (right hand) stop of the hoodmould survives. It is a carved head but exposure to the elements means that the features are now too worn to distinguish. The

The bricks used to block up the doorway were laid in a Flemish bond with a white sandy lime mortar. Most of the bricks, which date to 1800-1850, were hard-fired, orange-red, un-frogged and measured on average 220 x 105 x 65mm. Once the buttress and

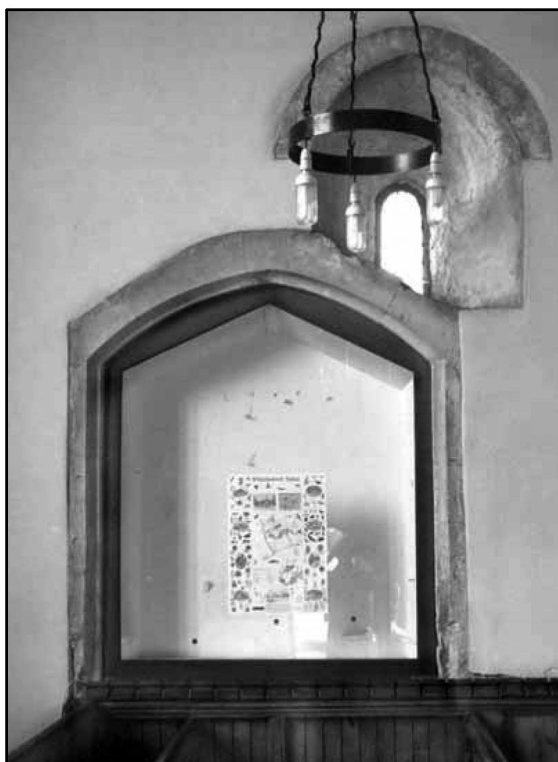
Fig 2b

The blocked doorway from the interior of the church, showing its relationship to the Norman window

moulding profile part way down the jambs on the exterior has also deteriorated due to weathering. Viewed from inside, it is clear that the rerearch truncates a deeply splayed Romanesque window (Fig 2b).

Located on the right-hand side of the newly opened doorway on the north wall of the church (on the right as you enter) is a collection of graffiti (G1-G3 on the west jamb and G4 on the east jamb) previously covered up by the blocked doorway and a built-in 19th-century display cabinet (Fig 2b). Figure 4 shows the location of this and other graffiti recorded throughout the church, as described below.

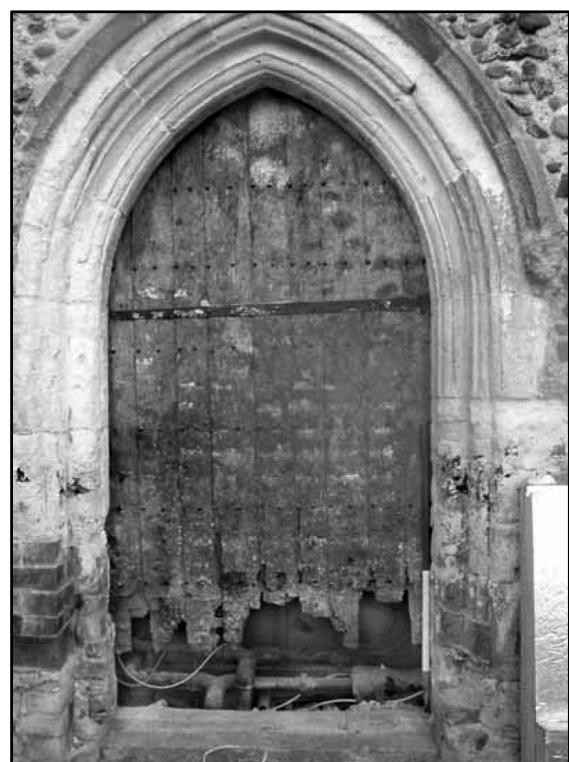
Fig 2c

The wooden door, exposed on removal of the brickwork (photography by Taleyna Fletcher)

below ground store had been removed, the bricks were removed, revealing a wooden door, hanging *in situ* (Fig 2c).
