‘...a small but convenient House of Brick’: A Tale of the St Paul’s Parsonage House, Hollywood, South Carolina, USA

Kimberly Pyszka, Nathan Fulmer, Maureen Hays and Kalen McNabb

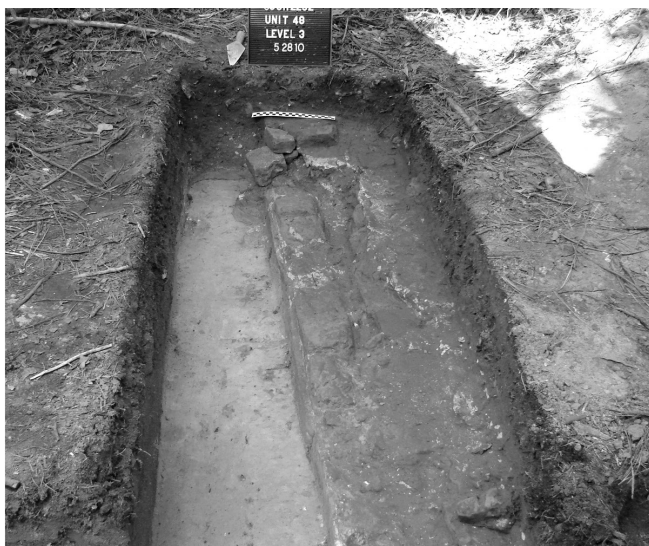
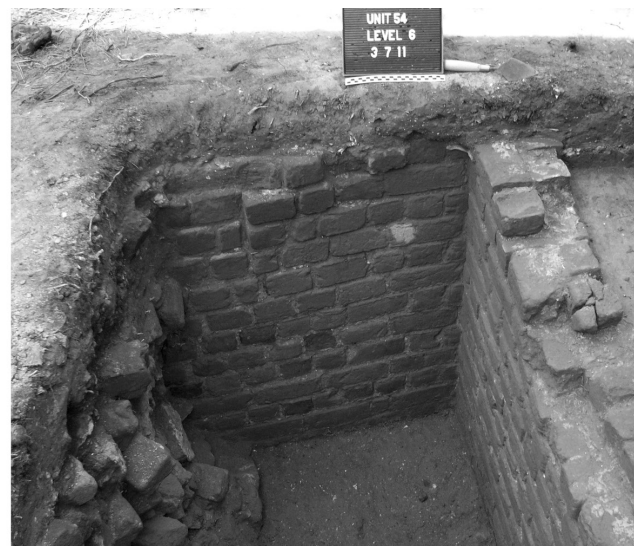
Fig 3
Left hand side: parsonage foundation two bricks wide; right hand side: cellar foundation one brick wide
(Photo: Pyszka)

The bricks and the mortar were similar to those found at the church site (Pyszka et al 2010). The foundation walls were two bricks in width and the bricks were laid in the English bond pattern with alternating rows of headers and stretchers, a typical bonding pattern used in early 18th-century structures and known for its stability (Fig 3).

Within the eastern portion of the structure, we identified a brick-lined cellar. Unlike the two-brick wide foundation walls, the cellar walls were only one brick in width, suggesting they were not substantial load-bearing foundations as seen elsewhere at the site. The cellar had a clay floor and measured approximately 11 x 11ft (3.3 x 3.3m) with a depth of approximately 4ft (1.2m). Evidence of a 3ft (0.9m) wide exterior access to the cellar was identified along the east wall by the presence of a soil colour change and a recessed brick sill on the cellar wall. A wooden ladder or small staircase would have likely rested upon this sill. Architecturally, this cellar is consistent with other late 17th- to mid-18th-century brick-lined cellars located within and under single-storey residential brick structures excavated at Williamsburg, VA, nearby Fort Dorchester, SC, and Willtown, SC (Agbe-Davies 1999; Bell 1995; Zierden and Anthony 2010). Similar to the St Paul's parsonage cellar, the Fort Dorchester cellar also allowed approximately 4ft (1.2m) of headroom and had a clay floor (Bell 1995).
