Recent Archaeological Work and Research at St Paul's Cathedral

John Schofield

This article is a summary of archaeological work at St Paul's Cathedral, that is the present building of 1675–1711 by Christopher Wren. The cathedral is now 300 years old and has gone through several periods of change to its fabric and surroundings. During the 18th and 19th centuries St Paul's assumed more and more of the role of the nation's church, which had been enjoyed by its medieval predecessor. The most important 19th-century change, during the long Surveyorship of Francis Penrose, was an opening up of the access and surroundings so that St Paul's is now the iconic architectural centre of the City of London. From day to day, the cathedral poses management questions just like any other.

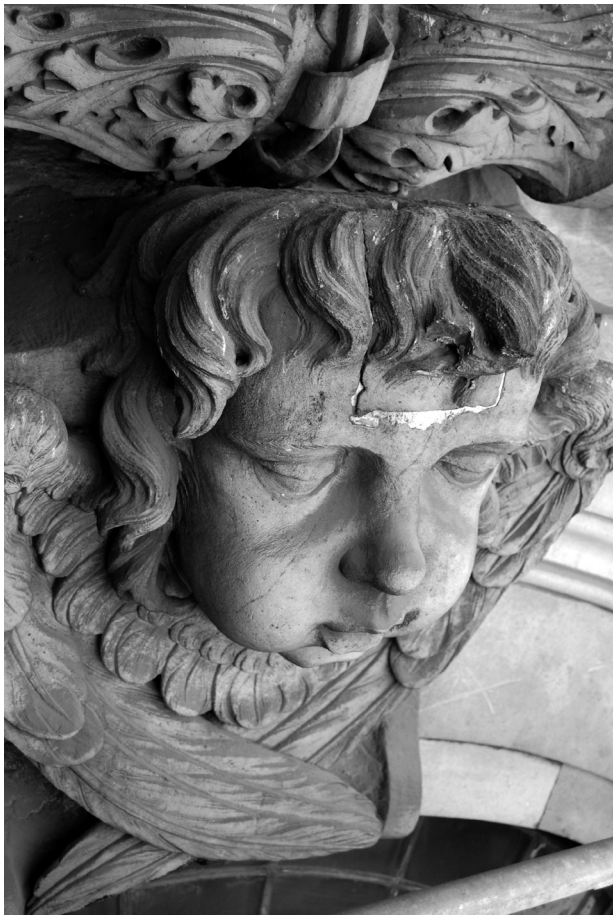
Fig 5
A cherub carving above one of the windows of the choir, before cleaning. In several cases the head has this odd feature, as though part of the stone has been replaced. Or is this to do with the method of attachment of the heavy piece to the wall? (Photo: Author)

Only one feature is reported here, a question for which the author would appreciate answers. Several of the cherubim above the main windows have square stone inserts in their heads (Fig 5). This was evident when the sculptures were dirty but is far less visible now after cleaning, especially as it is in the top of the head and therefore not visible from ground level below. The purpose of this cut in the cherubs' heads is not clear, but there is a late reference (of 1710) in the accounts to readjustment of carving above the windows (WS XV, 188–90), and it may be that there had been difficulty with their original fitting. It is a feature of several of the cherubim, especially on the north side of the choir.
