## WINCHESTER CATHEDRAL CLOSE Electricity Substation Project

# Report on an Archaeological Evaluation in the forecourt of No. 8 The Close Winchester, SO23 9LS

# Local Reference ElecSubSta Eval 2017

## Scheduled Monument Ref. SM HA 585, HA1005520 National Grid Reference SU 48118 29173

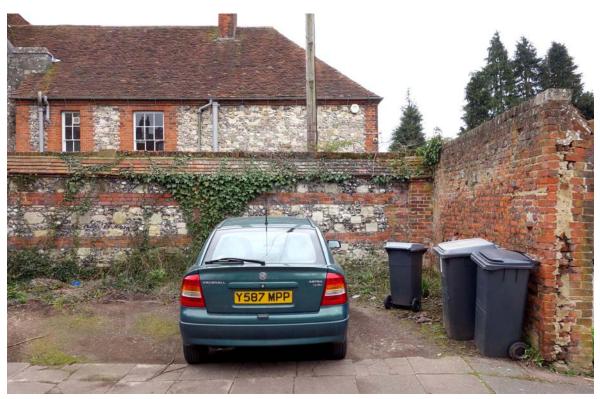
Figure 4. View east in forecourt of No. 8 The Close, the site of the proposed new sub-station.

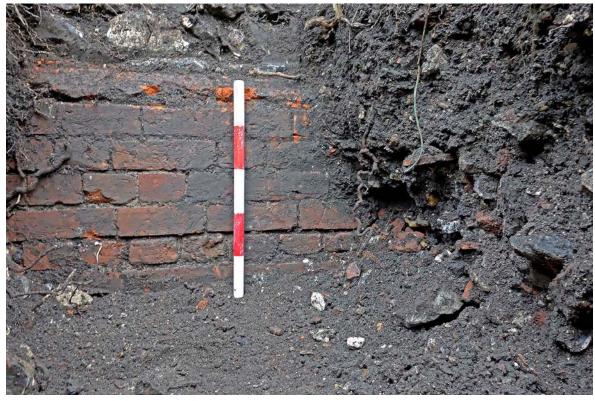
- 4.1 The evaluation was carried out on 14 February 2017 in dry but cold conditions.
- 4.2 A trench running east-west measuring 2m long by 700mm wide was excavated using a mechanical digger fitted with a 700mm toothless bucket.
- 4.3 Beneath a rough surface of miscellaneous flints and remains of gravel *c*.100mm thick (Context 01). the uppermost layer comprised 250mm of garden loam (Context 02).
- 4.4 This was followed by a deep layer of loose build-up (Context 03), mostly consisting of building debris (brick, tile etc) in a loam matrix, and including datable artefactual material as described below.
- 4.5 The loose build-up (Context 03) was followed at 700mm by a harder layer of loam containing brick and roofing tile fragments. Although no surface was discerned, is likely that this represented ground level before Context 03 was deposited—as discussed more fully below.

Figure 5. ESE view in trench showing (right) contexts 02 (garden loam) and 03 (rubble).

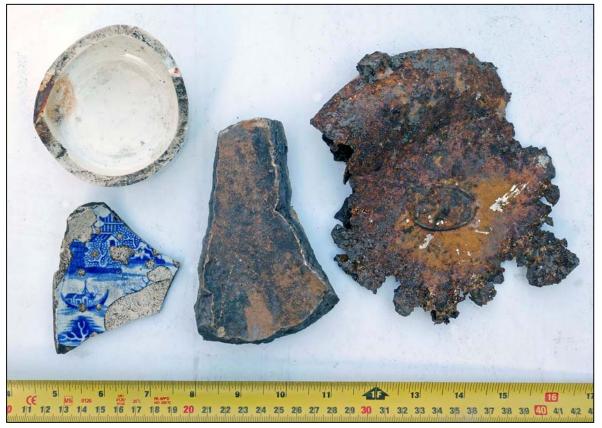
- A fragment of ceramic drain. Mains drainage arrived in Winchester only in the 1880s, therefore providing a *post-quem* date for the build-up in which the piece occurred.
- A piece of a white glazed jar. C19/20
- A fragment of blue ware with a chinoiserie design, possibly the popular 'Willow Pattern'.
- The remains of a tin-plate receptacle.

Figure 6. Artefactual material from Context 03 (late C19 fill layer).

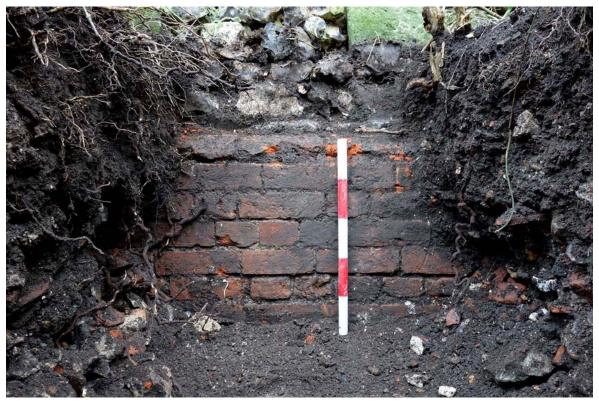
- 6.1 The wall on the east side of the yard is built of stone and flint, with bands of brickwork. This style suggests that the wall is probably of eighteenth-century date, though a *terminus post quem* is the construction of the houses in Dome Alley (including No. 8) in the 1660s.
- 6.2 The wall face below ground on the east side of the area of the trench was exposed. To a depth of 230mm below the surface this was identical to that just described. 230mm below the present ground surface was the top of a chamfered plinth of brickwork. Below the plinth were the brick footings of the wall, constructed in a very random bond.
- 6.3 The bricks measured 225 x 101 x 65 mm with narrow joints of lime mortar. These dimensions are consistent with the eighteenth-century date proposed for the wall.

Figure 7. East end of trench showing wall footings.

6.4 The plinth shows that the brick footings were intended to be visible above ground level, and are therefore broadly consistent with an earlier ground level about 600/700mm below the present level yard surface.

8.3 In order to link the sub-station with the cable that has already been laid running down the passage on the east side of the garden wall, the brick footings of the wall will be drilled.
