WINCHESTER CATHEDRAL CLOSE

Report on an archaeological watching brief maintained during the installation of a timber fence at the end of the Deanery garden

Winchester UAD Site Code WINCM:AY 539
Scheduled Monument Hants 585 585, HA 1005520
Local Site Code DeanFence 2019
SMC dated 30 April 2018, reference No. S00189552

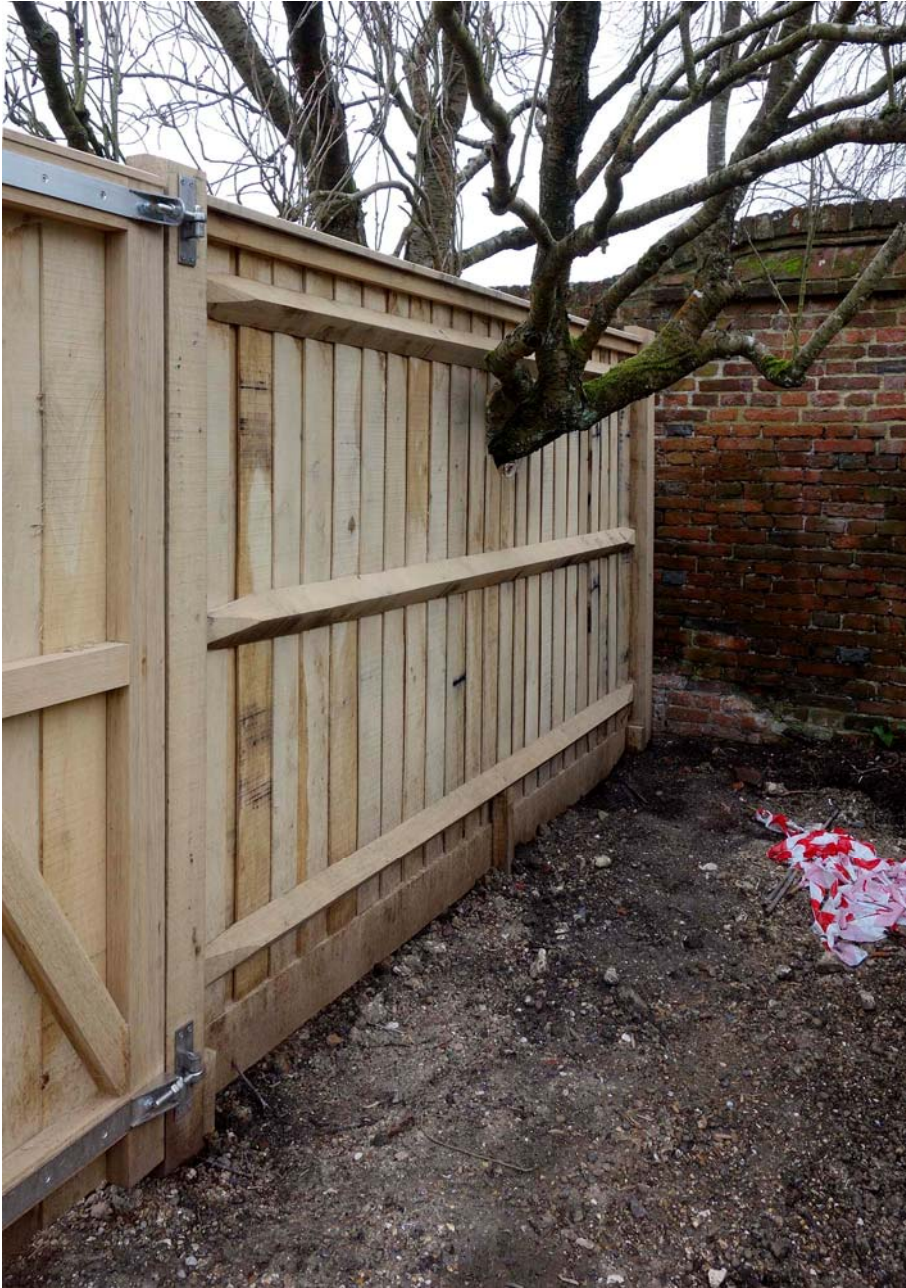
Figure 18. Fence completed. Accommodation of cherry tree.
