Archaeological Monitoring  
at Smallbridge Hall, Suffolk  
NGR: TL 9290 3310  
SHER #: BSM 064

Felix Reeves Whymark  
2015

## Summary

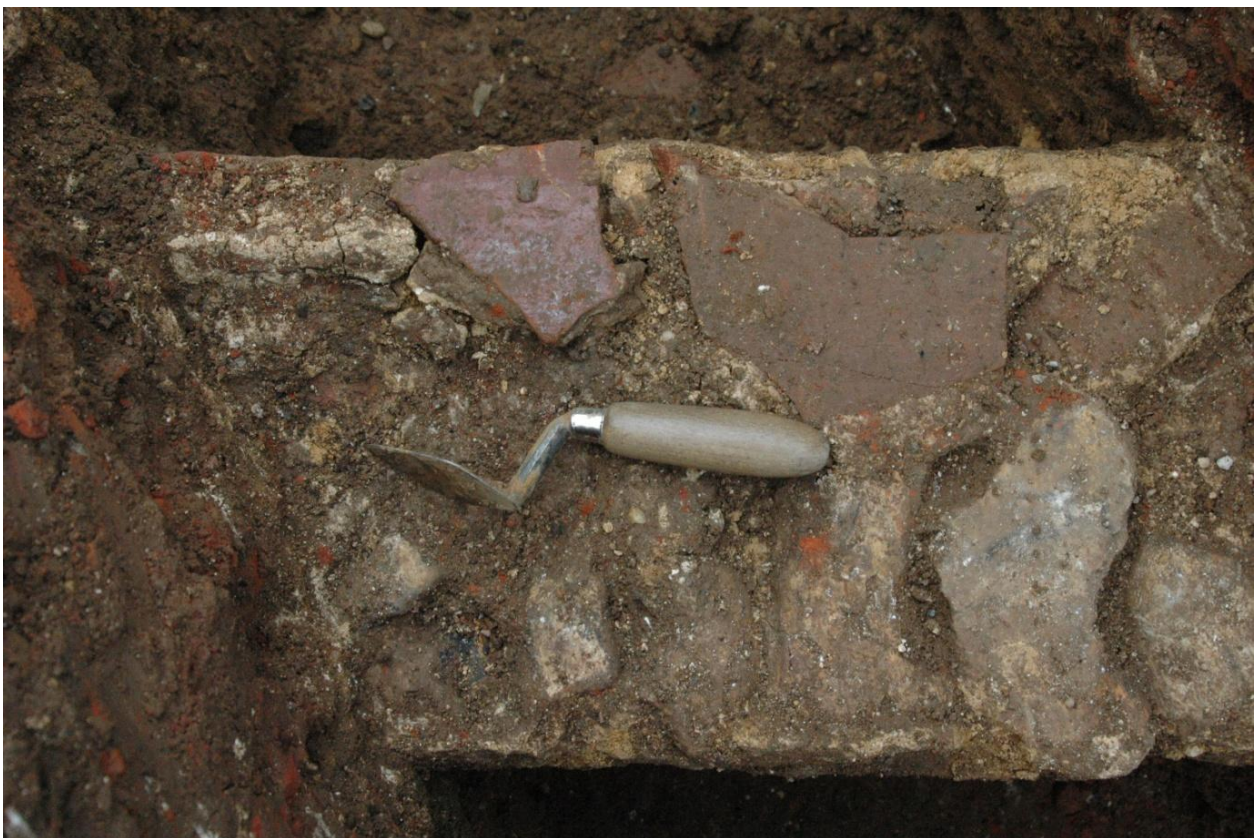
Plate 2: Wall plinth [0087] with glazed peg tile and upstanding mortar.

[0084] was 0.54m wide, and identical to [0066] in size and orientation (though without a footing). Lime mortar render was patchier on the east side of the wall, with each bed of mortar/flint clearly visible. Another thinner flint and lime mortar plinth 0.35m wide [0087] was recorded running parallel to [0084] 3.26m to the east. This likely supported an internal partition wall within the timber frame as opposed to an external wall. As [0084], flint courses could be seen through the mortar render, which was thinner to the west side and thicker to the east side. A glazed piece of peg tile was observed among other fragments to the inner level surface of the wall, adjacent to a partially preserved piece of upstanding mortar with the impression of the removed chamfered edge of the timber beam visible (plate 2).

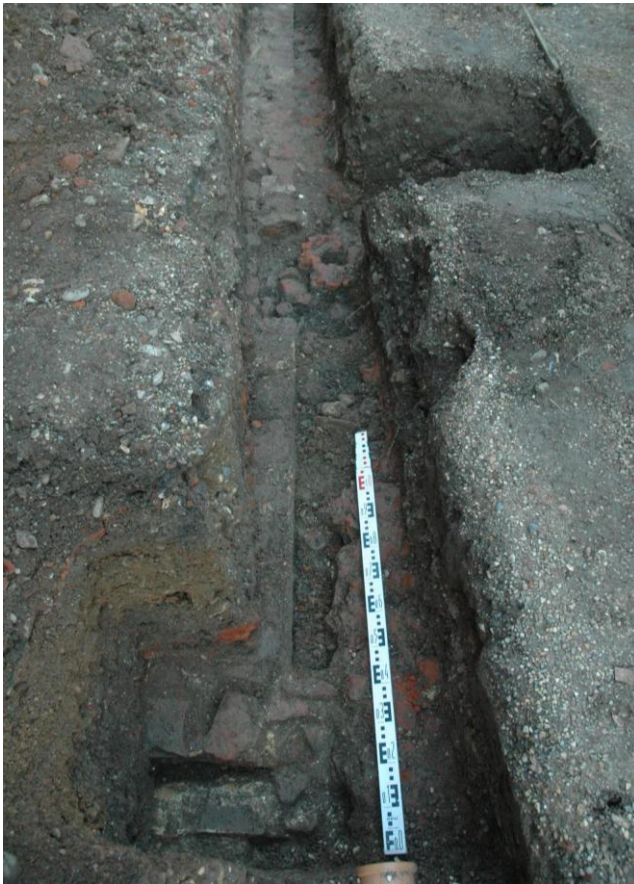
Plate 3: Wall footings [0028] and [0031] looking north

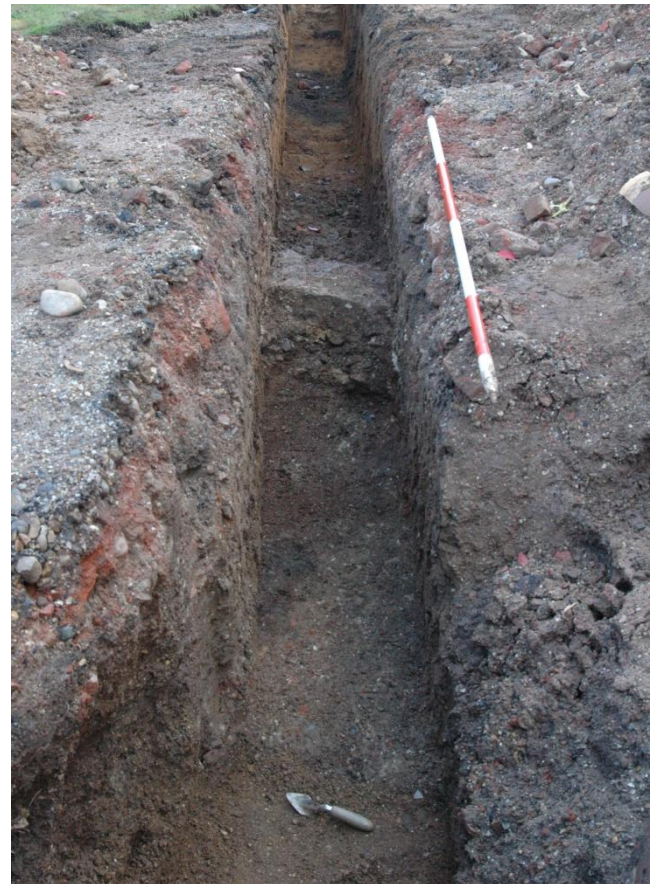
Plate 4: Wall plinth [0066] and basal features looking east

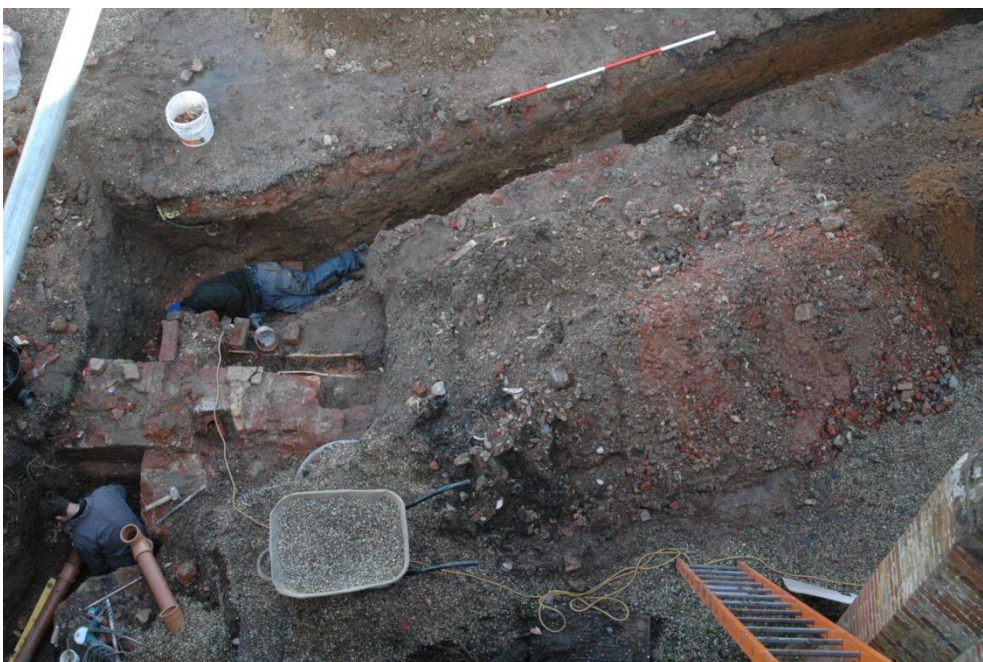
Plate 5: Wall [0046] abutting wall [0047] with wall plinth [0066] in the background. Working shot, looking north

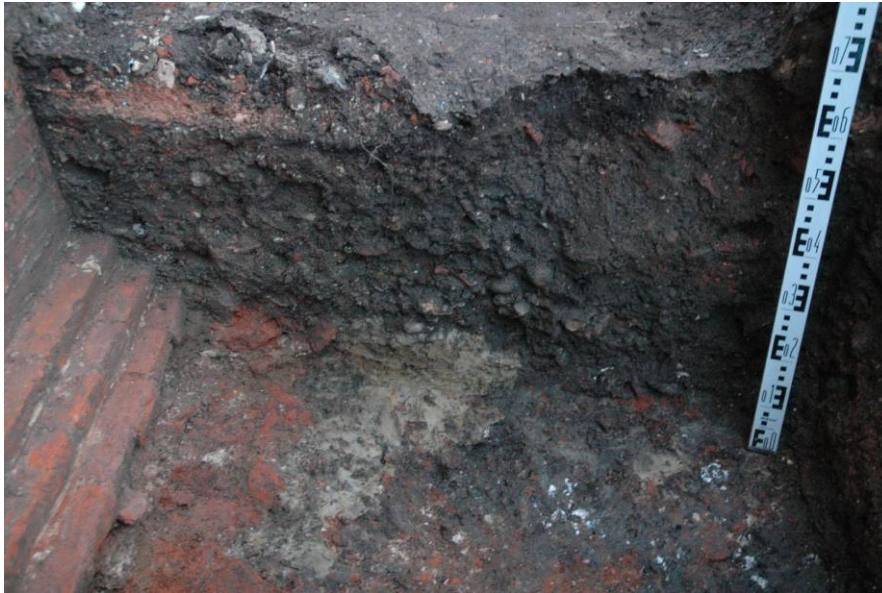
Trench three was a works trench excavated against the side of the west wall of the hall to enable drainage replacement. 0.35m below ground level the west wall footing was exposed, (three courses each stepped out a brick width), under which brick filled wall foundation trench [0037] lay. [0037] cut a clay layer 20cm+ thick (0036), which extended 0.7m from the west wall. Due to the size of the trench and truncation the nature of this was unclear, but its volume suggests it may represent either a sizeable dump of clay or a much truncated thick clay floor as seen to the east and north. Cutting (0036) to the west and overlying the west wall trench was the east side of a possibly north - south aligned feature [0039], though this was not clear. The lower of its two fills had a large rectangular posthole [0044] cut into its surface, which, although the function of both remains unclear, may suggest [0039] to be some kind of works trench. The upper surface was level with the base of the footing, suggesting the feature is contemporary with the construction of the house. A homogeneous loamy silt layer (0042) 0.40m thick overlying (0041) and the wall footing probably represents a reworked topsoil/levelling layer. This was overlain by modern loam.

Plate 6 (Left): South section of trench 3, with stepped west wall footing, rubble wall foundation, clay deposit (0036) and basal trench like feature [0039]

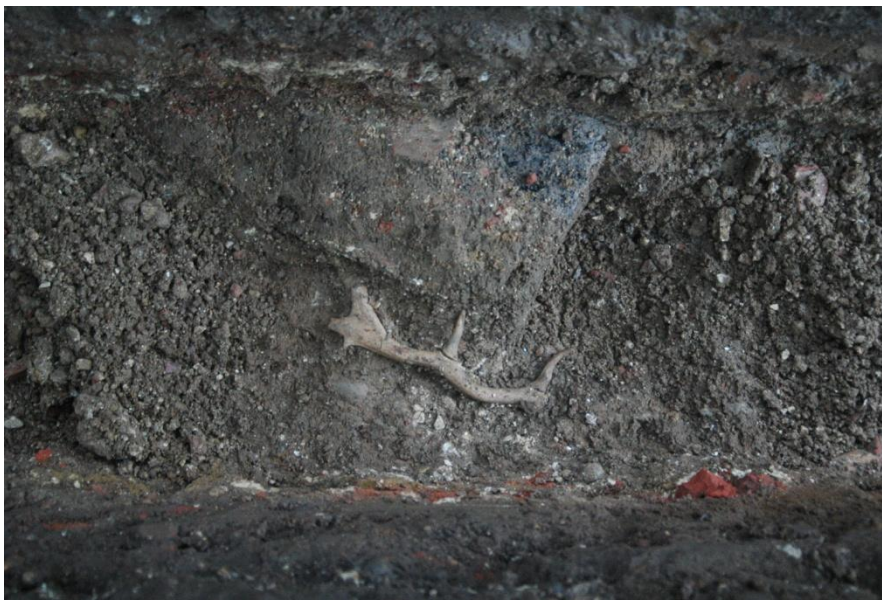
Plate 7 (Middle left): Roe deer antler upon base of levelling cut for floor 0105. Mid excavation, looking south

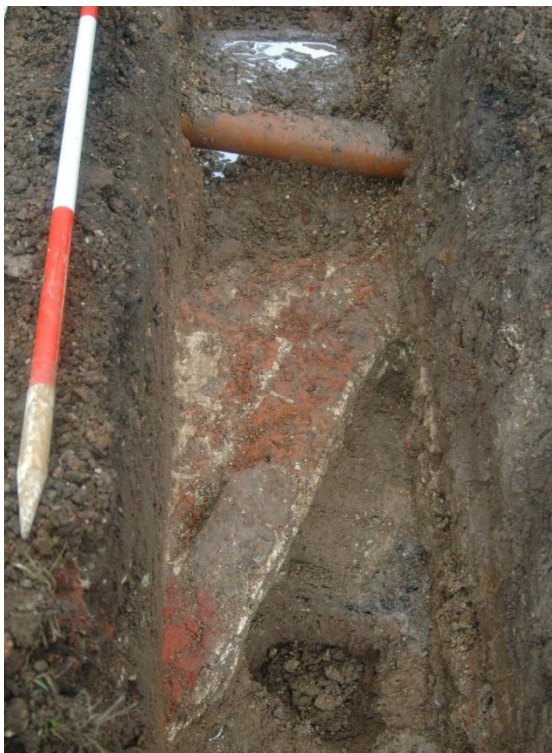
Plate 8 (Bottom left): Floor 0105 looking north east, with posthole [0099] mid excavation. Collapsed beam slot [0097] visible in plan to south side of floor.

4 - Central	0105	Floor	Brick floor within shallow trench [0101]. Single course two brick widths thick composed of wide half bricks laid alternately. 5 inches width by 5 inches length. Surface partially destroyed by demolition. 1cm of mortar render on south side. This not seen on north side (probably poor survival, damaged by above modern services). Remnants of mortar on part of surface (?) to north of timber partition [0097]/[0099].
4 - Central	0106	Layer	Firm dark yellow boulder clay with occasional small angular - round flints. Probably clay floor remnant overlying beam slot [0097], abutting posthole [0099] and abutting?/cut by floor [0105].
4 - Central	0107	Layer	Dark grey/yellow brown firm friable sandy silt with clay. Round - sub angular small - medium flints moderate to frequent. CBM fragments occasional. Very similar in character to deposits seen in trench 5 to the north of (and outside) this phase of building. Underlies demolition layer [0108] from the east of wall [0087] to wall 0126). Buildup layer.

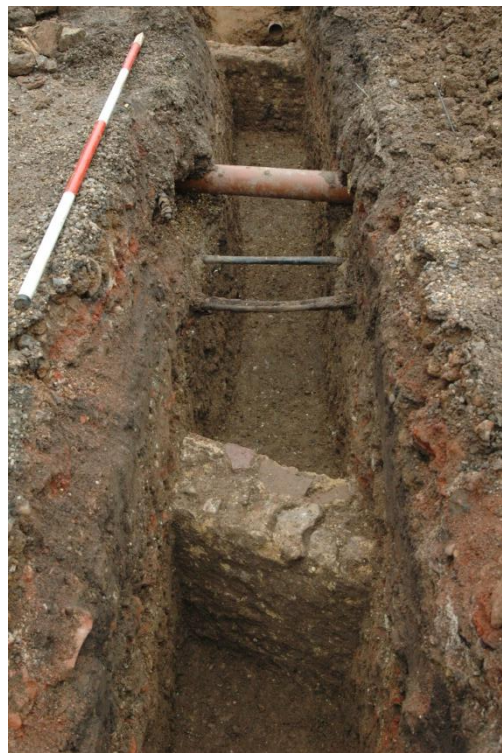
Plate 9 (Bottom right): Wall plinths [0087] (foreground) and [0084] looking south west

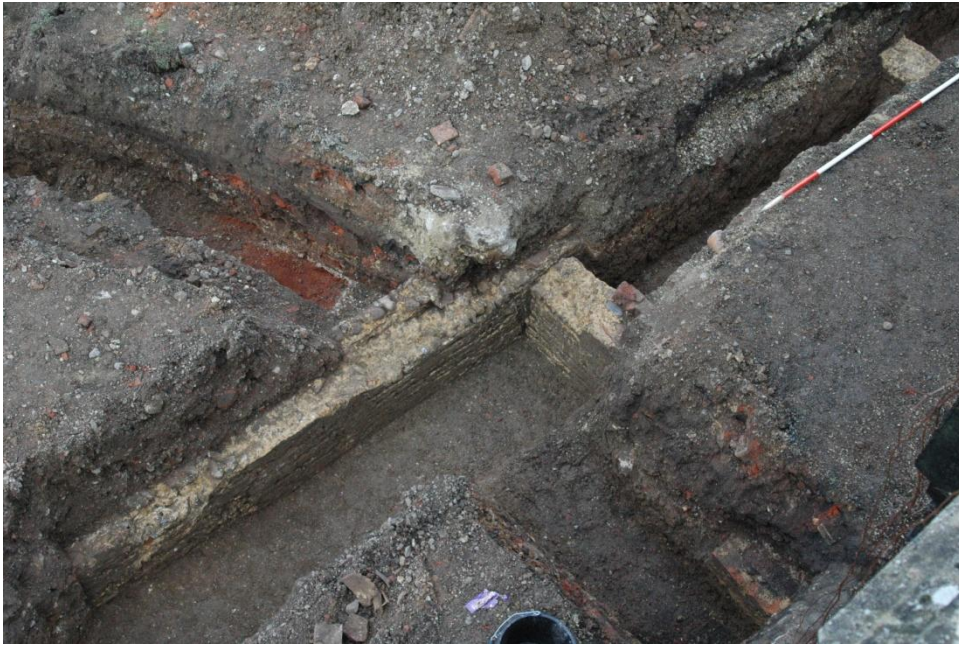
Plate 10: Wall plinths [0127] [0125] and [0126] looking north east, with rubble filled trench [0129] (middle left) and brick feature [0110] (lower right)

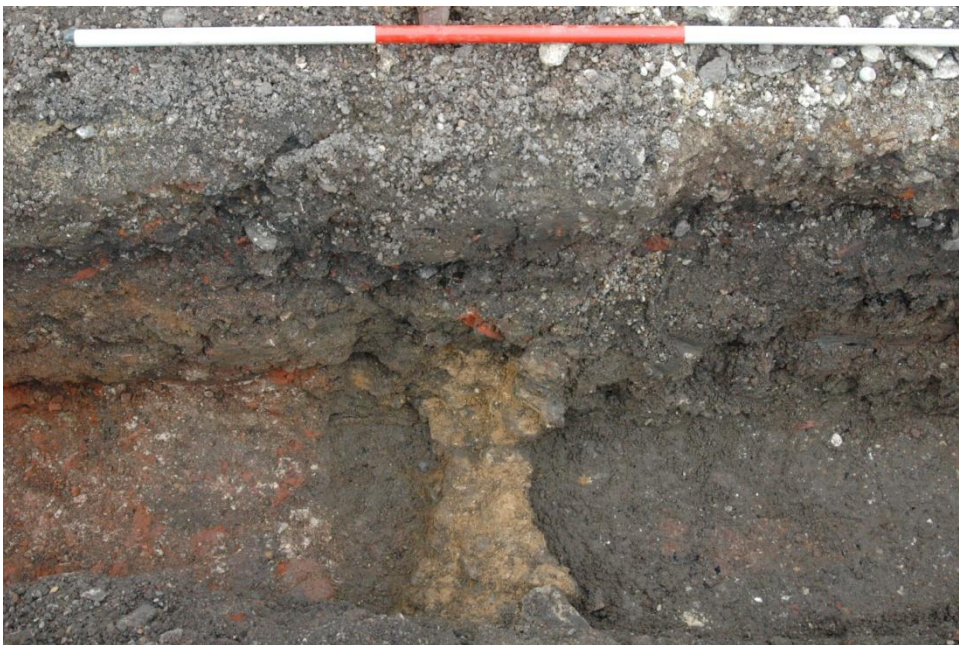
Plate 11: Wall plinth [0114], truncated by pits [0117] (left) and [0115] (right), and rubble filled trench [0121] (left), looking north.

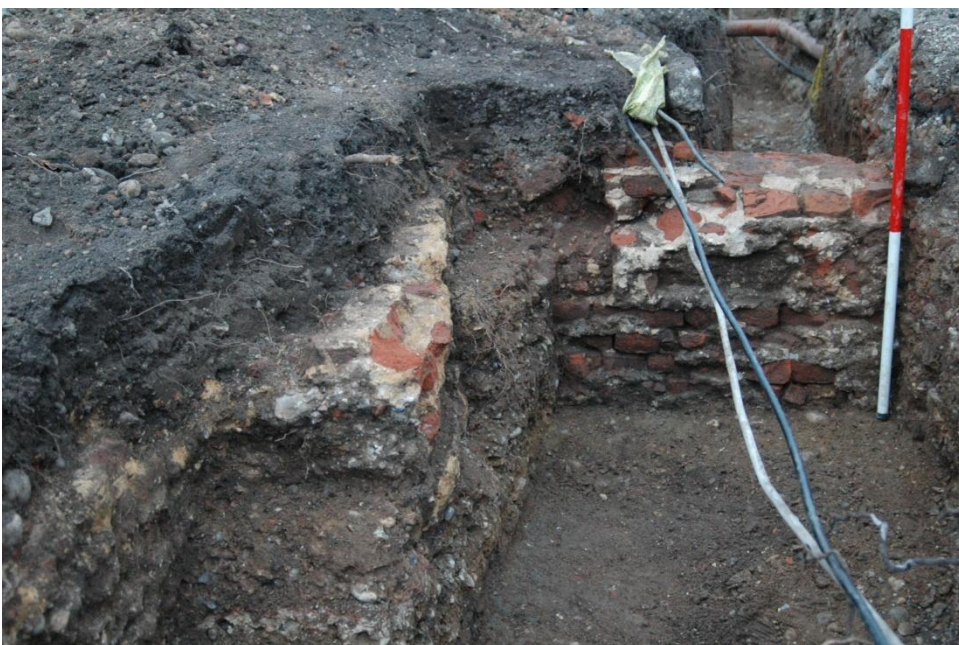
Plate 12: Walls [0153] (right) and [0154] (left) looking north

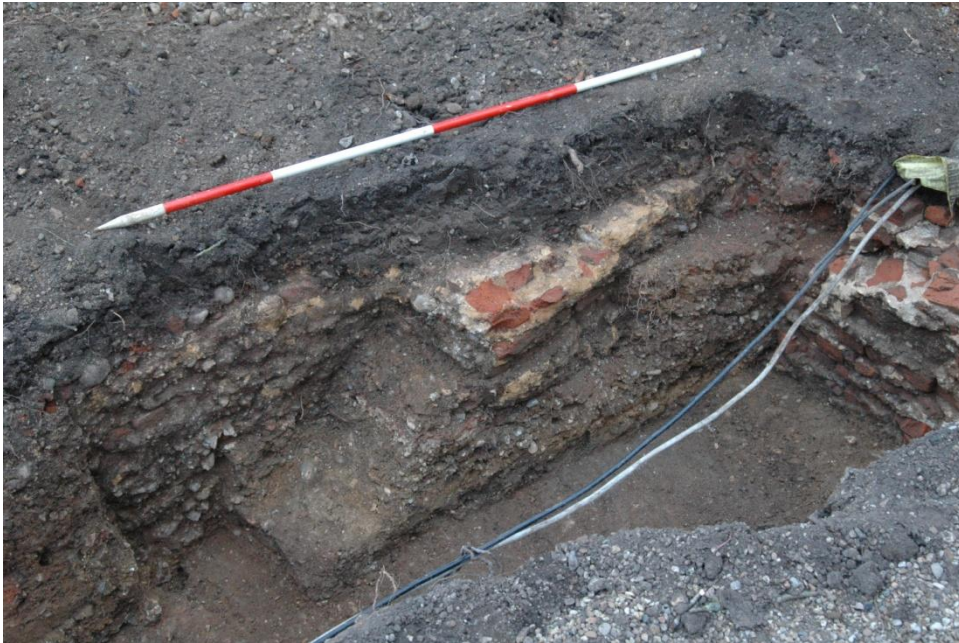
Plate 13: Walls [0154] and [0153] looking north west

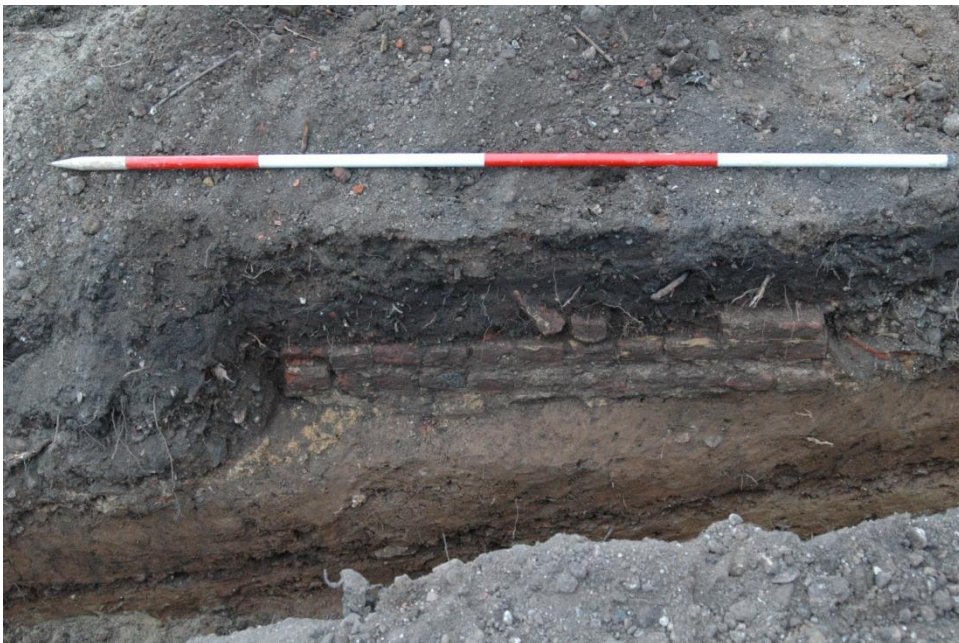
Plate 14: Brick feature [0155] overlying clay floors and layers (0139) - (0141)

5 - Mid	0155	Wall	North - south brick feature 1.34m wide. East face exposed in west side of trench 5 south of [0153]. Chimney? Stacked/partially overlapped header bond - decorative? Overlies possible clay floor/surface (0141), so probably later than [0153] and [0154], but difficult to see due to uncertainty of relationships of layers to walls. Set in mortar.
5 - Mid	0156	Cut	Small pit seen in section, cutting [0153] and [0154]. Or side of trench? Not apparent in plan. Vertical sides, brick either side partially damaged, partially removed. Demolition damage rather than cut feature? Fill very similar to layer (0148) - filling void left by demolition? Void left by removed column or ornament?
5 - Mid	0157	Fill	Fill of pit [0156]. Dark grey brown sandy silt with clay. Frequent cbm and mortar fragments.
5 - North	0158	Layer	Dark brown grey firm - friable sandy silt with clay. Moderate charcoal and gravel. Organic accumulation. Layers (0158) - (0162) seemingly represent early surfaces to the outside of the moat, probably part of the northern approach.

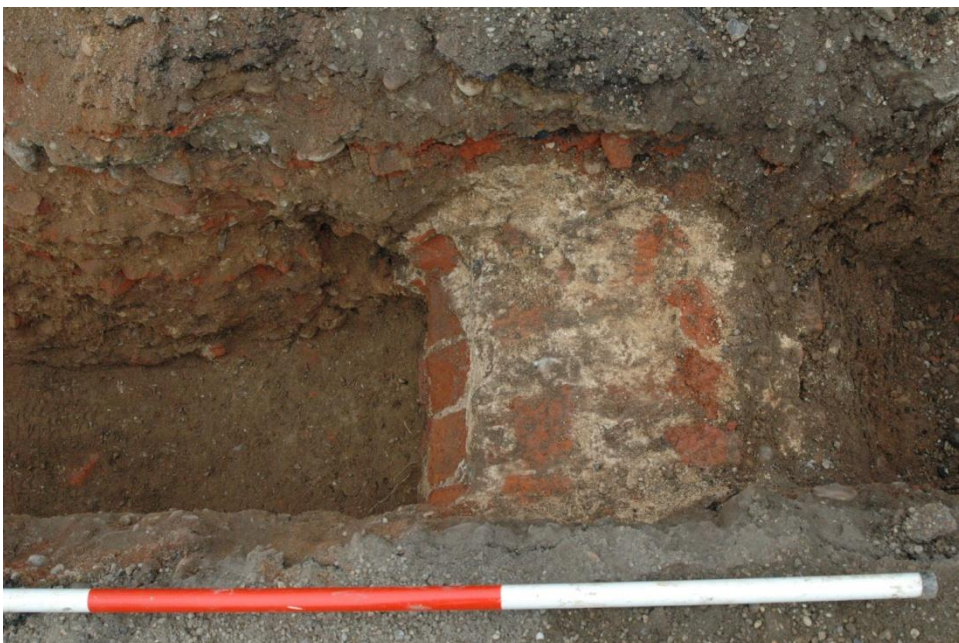
To the north of the causeway, remains of a brick built bridge [0165] were excavated, beneath/abutted by causeway infill (0170). Basally was a plinth/footing 12cm wide (from which a long (and incomplete) 38cm by 15cm by 5.5cm brick was recovered), above which an abutment 0.72m in height by 0.73m breadth was recorded. To the south of this a partially demolished brick 'rise' 3 courses high, (each course stepping out up to 6cm) was visible, below the base of a demolished arch, of which part of 2 courses of brick and 1 course of tile were recorded. A mottled yellow-grey sandy silt deposit (0168) overlay the south side of the abutment beneath (0170). A large fragment of modern glass observed between (0168) and (0170) suggested the demolition of the bridge and erection of the north causeway occurred in the modern period. Additionally, several bricks from (0170) were almost identical in size to those observed in [0165], suggesting that at least some of this was material from demolition of the bridge.

Plate 15: Demolished arch and abutment of bridge [0165] looking west, overlain by causeway infill to the south and abutted by gravel surfaces to the north
