Report 1268

### **Archaeological Watching Brief on repairs to the Rollesbrook culvert in Wilton Avenue, Southampton SOU 1698**

Client: Southampton City Council

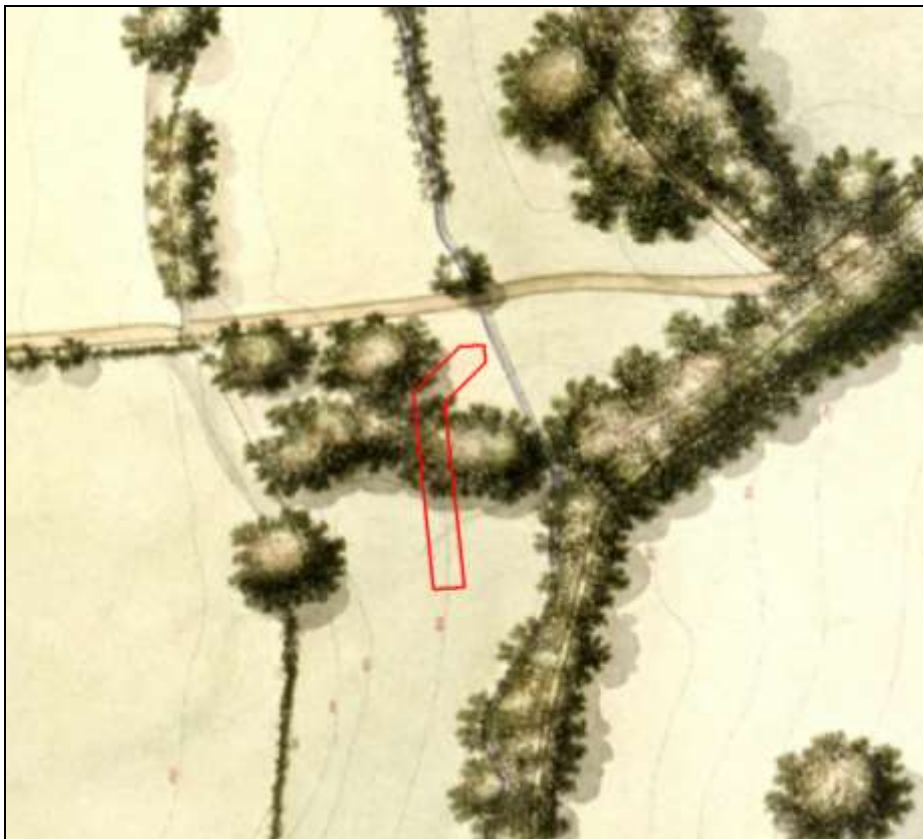
**Fig 2. Extract from the 1846 Royal Engineers Map overlaid with the approximate extent of the excavation observed.**

4.2 The area of the site was agricultural land until the end of the 19<sup>th</sup> century. The 1846 Royal Engineers map shows a footpath from Hill Lane to Bedford Place crossing the Rollesbrook stream by bridge (or ford) (fig 2). This footpath is on the line of what became the west end of Milton Road then continued east alongside a field boundary that survives as the footpath between and parallel with Milton Road and Wilton Avenue. The site of the bridge is now close to the garage at 115 Wilton Avenue. The footpath and bridge were still shown on the 1870 Ordnance Survey map. It is possible that the conduit from Conduit Head followed the contours and crossed the stream at the bridge but it is more likely that it followed a more direct route to Conduit House and crossed the stream much further south.

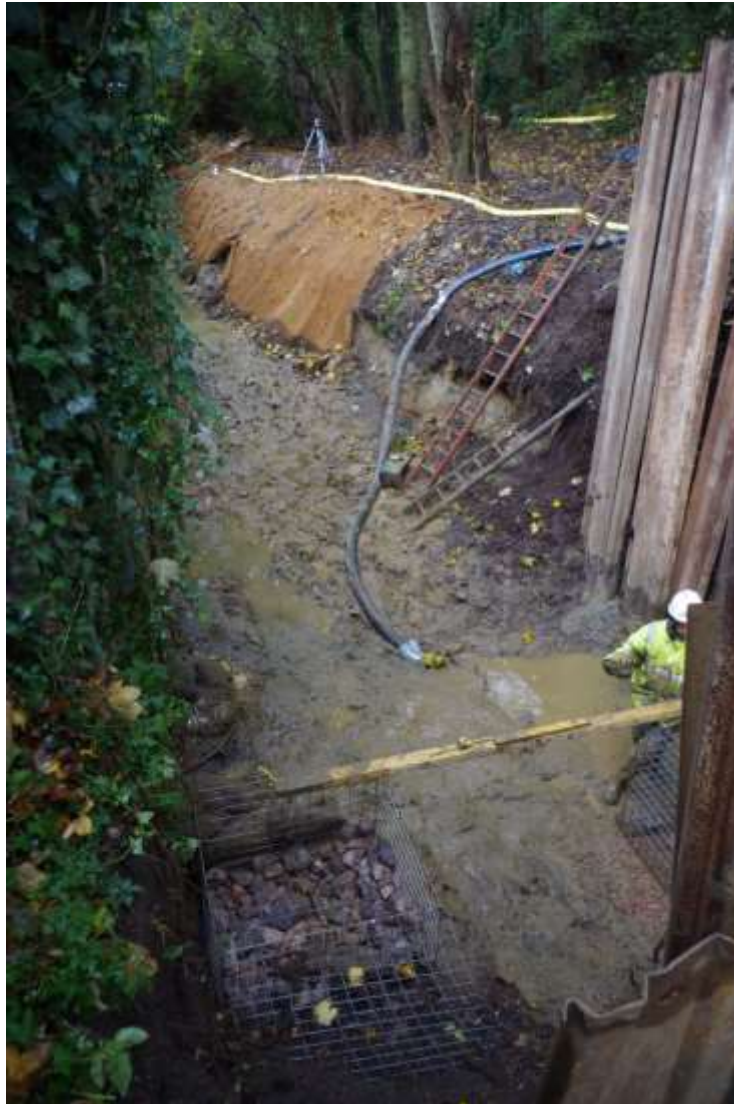
**Plate 1. Work in progress in November 2015 at the commencement of the watching brief. The southern part of the excavation has been completed and the sides lined with textile to prevent erosion. The natural Wittering Formation can be seen in the base and side of the excavation. The trench was not safe to enter.**

7.1.1 The natural, context 5, was the Wittering Formation. It lay between 2.1m and 2.7m below the ground level. It consisted of orange and grey mottled clay with sand lenses. It ranged from 10YR 6/6 to Gley 2 5BG 6/1. It was seen throughout the excavation (Plates 1 & 6). It was the only deposit observed in the manhole excavation in Wilton Avenue which was fully excavated to the natural before the archaeologists were informed (Plate 6).

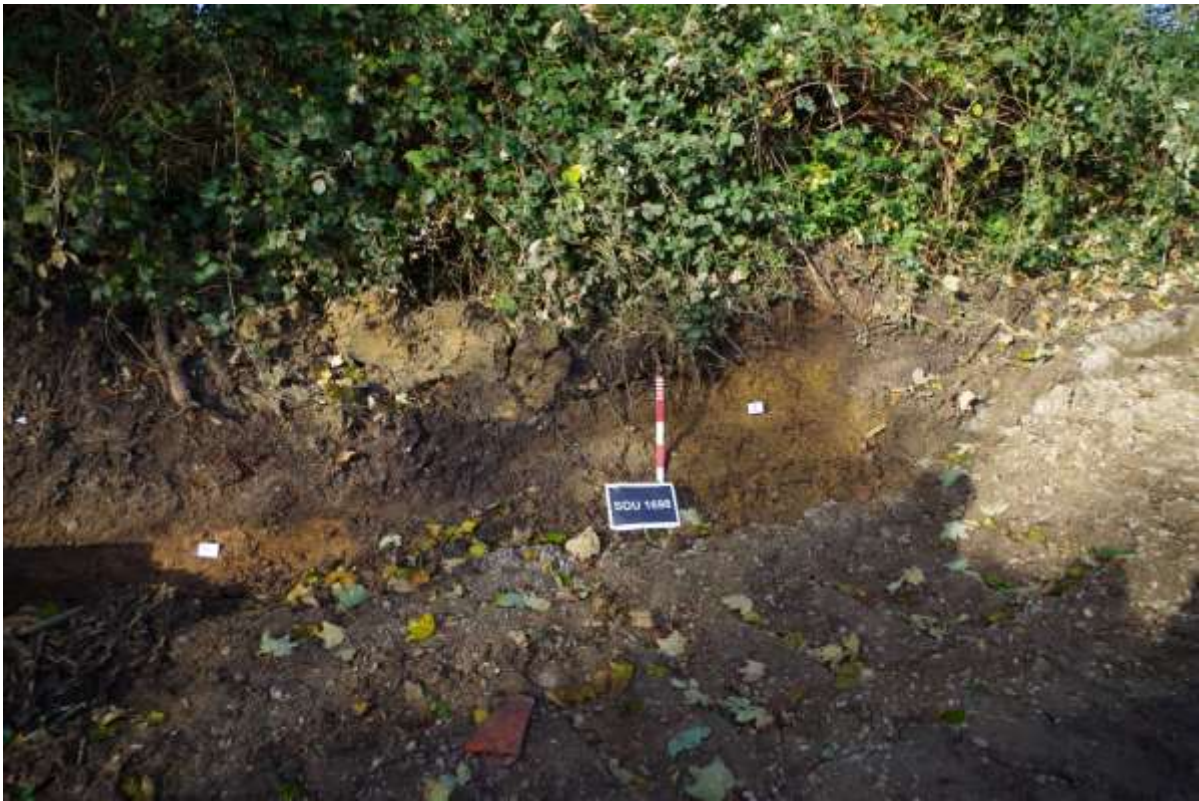
**Plate 2. Layers 1 and 2 exposed in the valley side to the west of the excavations.**

7.1.2 Context 1 was a deposit of natural brickearth exposed in the valley side to the west of the stream (Plate 2). It may well have slipped down the side of the valley. It was exposed in the side of the access route made by the excavation team.

7.2.1 Context 2 was allocated to an exposure of redeposited Wittering Formation that lay above context 1 on the west side of the valley (Plate 2). It contained a burnt flint and a fragment of West County roof slate. It was probably post-medieval in date.

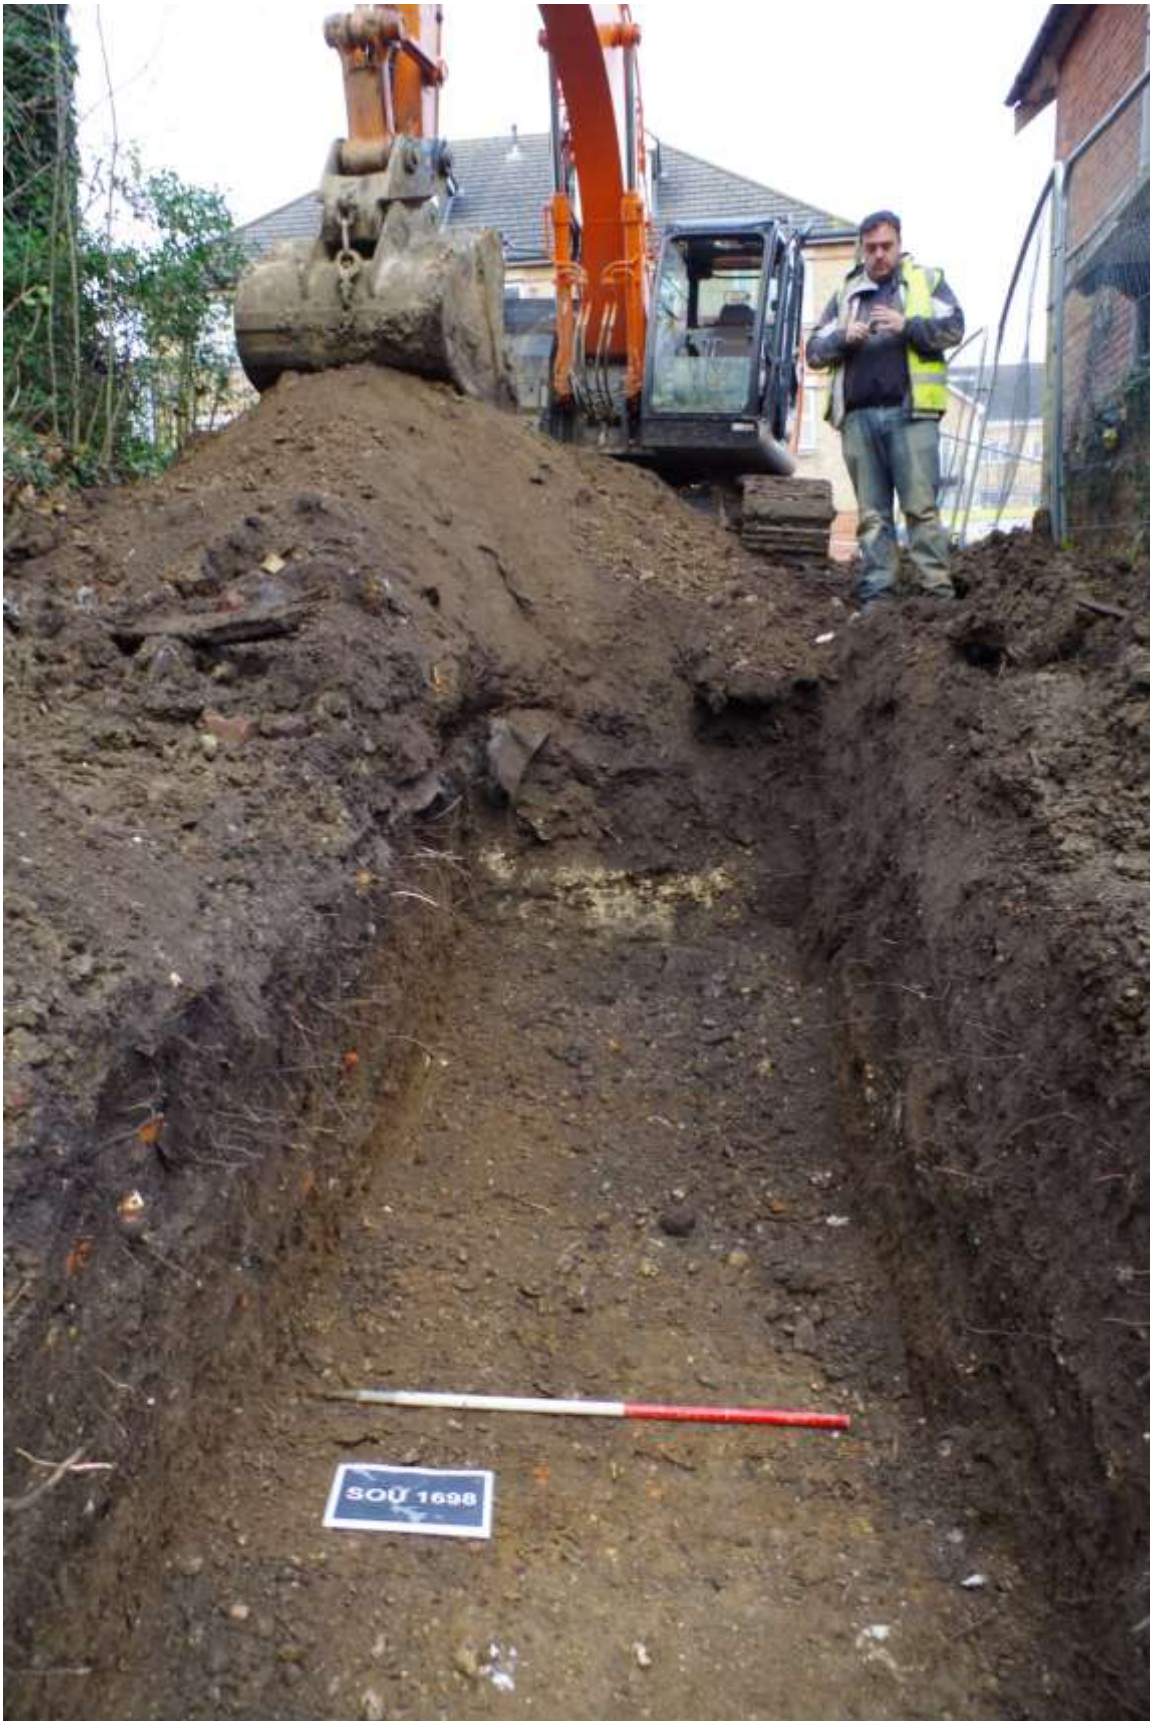
**Plate 3. Excavation of layer 3 in the central part of the trench.**

7.3.1 Overlying 4 was context 6, a deposit of sandy clay loam some 2m thick containing abundant brick fragments, glass bottles, china and concrete. Further north, and very similar, was context 3, a deposit of silty clay loam some 2m thick (Plate 3). It contained brick, concrete, fragments of wood, glass bottles (Plate 4), and roof slates and was also present throughout the excavation. Ordnance Survey maps suggest this deposit was dumped after 1908 and before 1931. The inclusion of a Coca-Cola contour bottle suggests after 1916, but more refuse may have been added in later years and churned in by the machine.

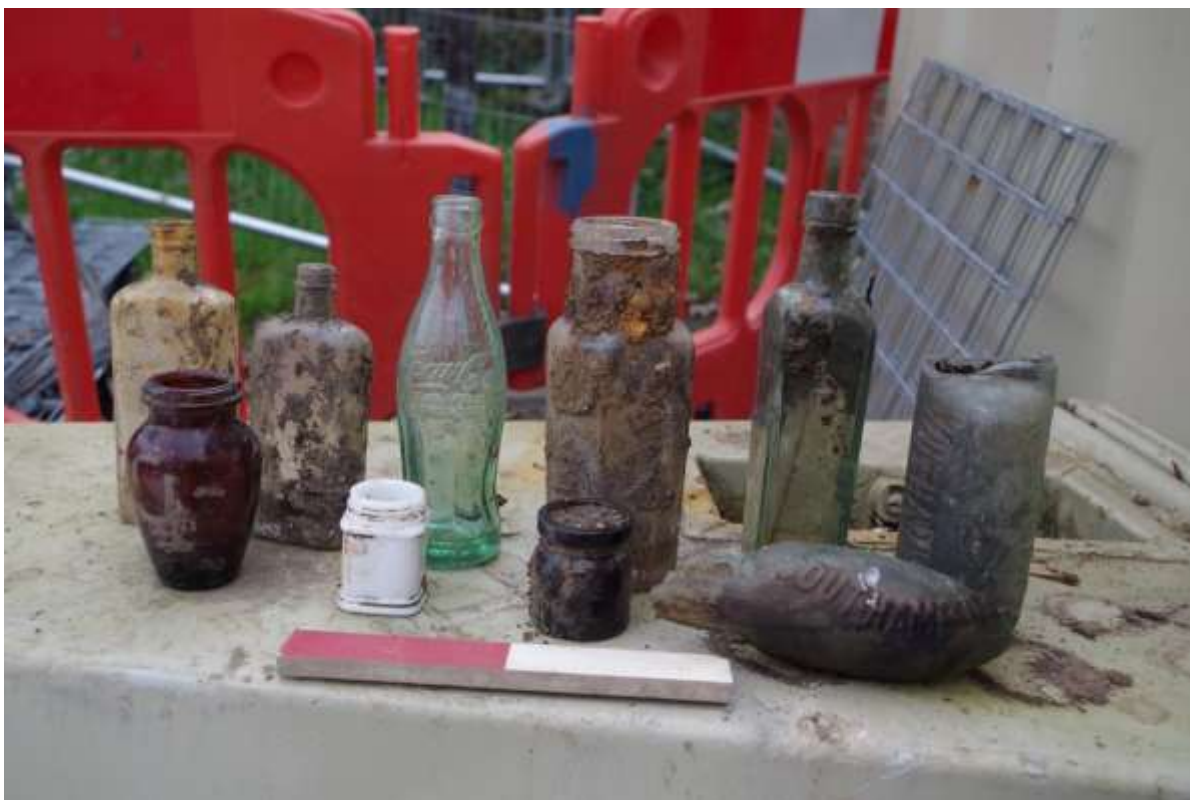
**Plate 4. Bottles from context 3.**

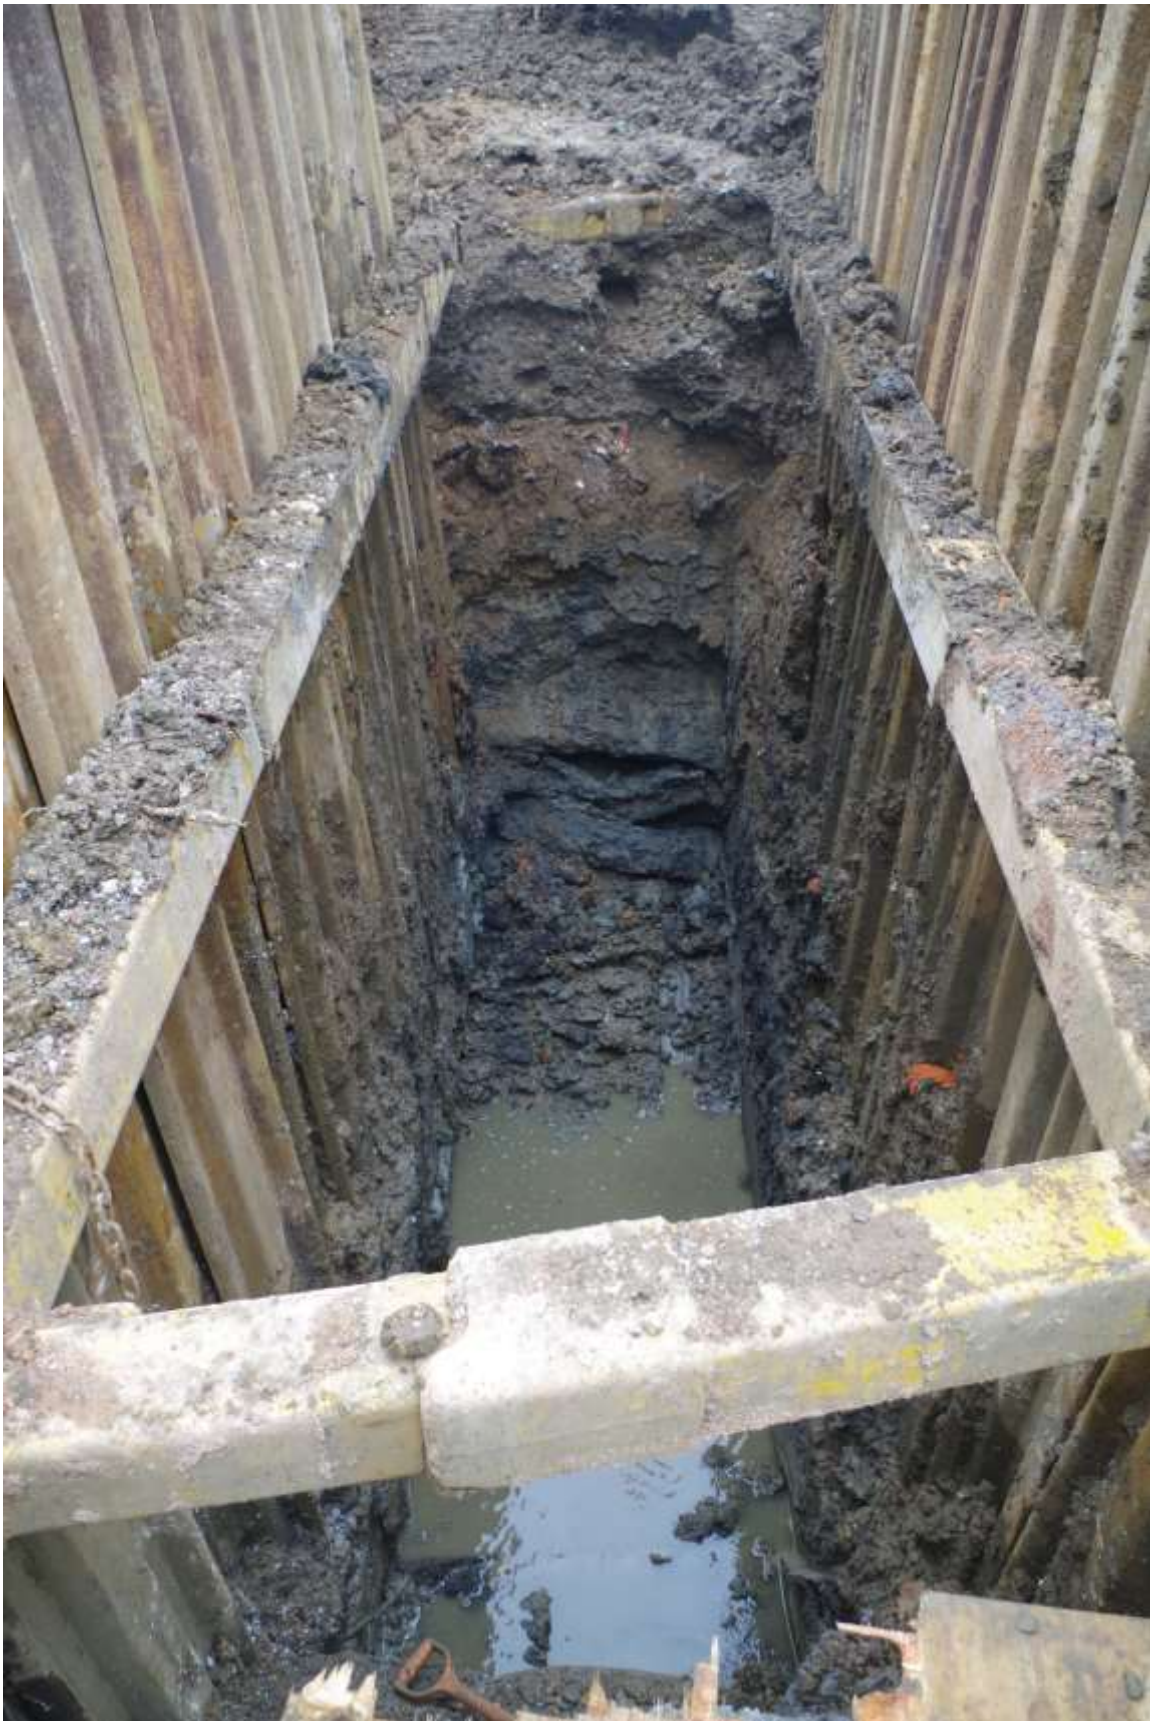
**Plate 5. Excavation of context 7.**

7.2.2 Context 4 was allocated to a deposit of dark grey (10YR3/1) sandy clay at the south end of the trench, overlying the natural 5. It was wet and odoriferous with fragments of wood and brick, and contained partially decayed twigs and branches. It continued north and was seen along the entire length of the excavation. It may relate to the tree cover seen on the 19<sup>th</sup> century maps. Context 7 was probably the same deposit of grey clay observed at the north end of the trench, just south of Wilton Avenue. It was between 3.5 and 4m below ground level and was below the water table. It contained numerous rotten roots. It may have been natural affected by tree roots, or redeposited natural (Plate 5).

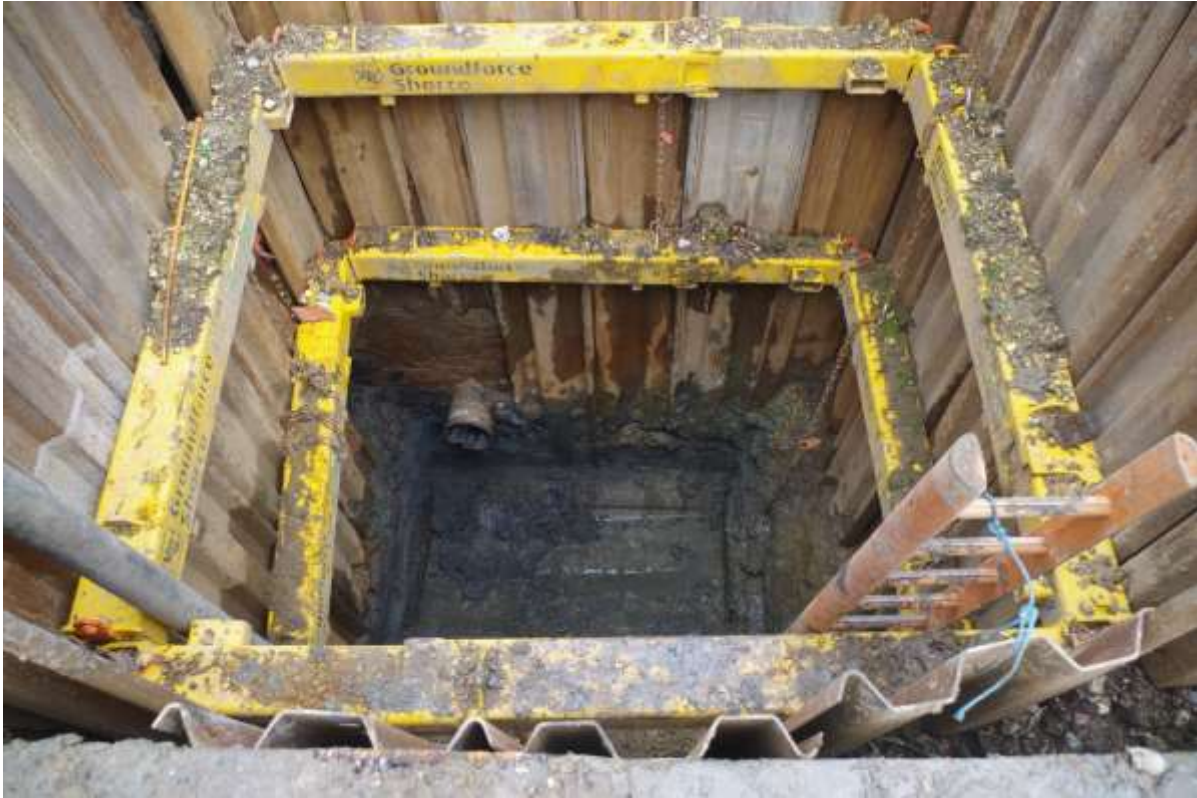
**Plate 6. Natural deposits in base of northern manhole.**
