Southampton Archaeology Unit Report 1247

Archaeological Watching Brief at the rear of 1 Padwell Road, Southampton. SOU 1712

Report on the Archaeological Watching Brief at the rear of 1 Padwell Road, Southampton. SOU 1712

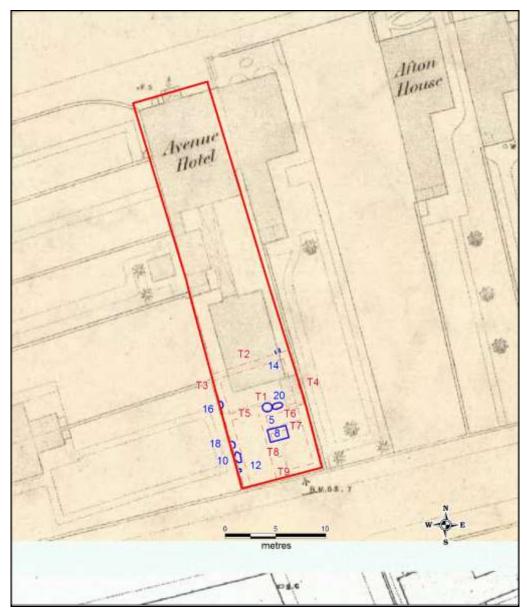
- 5.2 The present building and land is first mentioned in Cox's Southampton directory of 1869, when the landlord was C Burch, and it is shown on the 1870 edition of the OS map, (surveyed in 1868-70) as the Avenue Hotel (fig 3). The 1870 map shows the main pub building sitting back from the pavement with a porch arrangement in the centre of the frontage. Behind the pub are a collection of smaller buildings on the west boundary, with a long covered way leading to a rectangular building towards the south of the plot.

Figure 3. Trenches and features plotted on the 1870 Ordnance Survey map. © Crown Copyright. All rights reserved Southampton City Council. LA 1000 19679 2016.

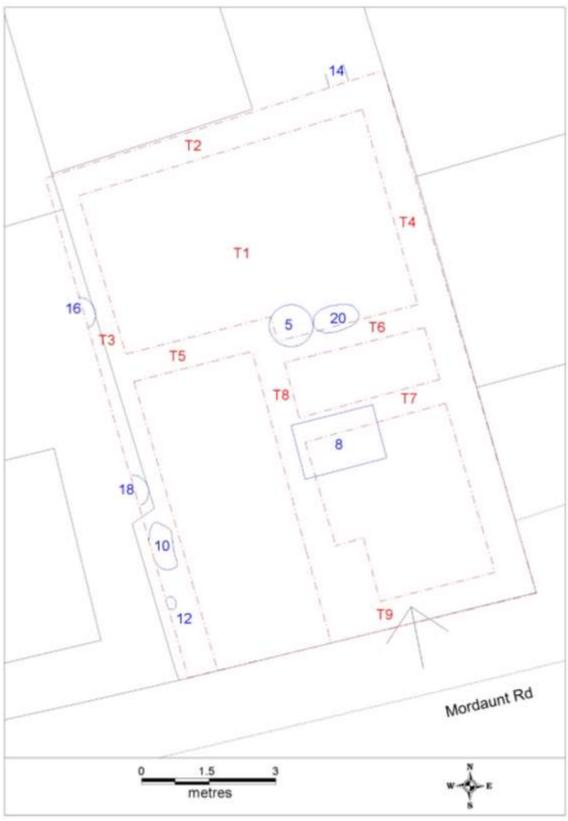
7.1 The methodology followed that specified in the Written Scheme of Investigation (Southampton Archaeology 2016). A total of 9 trenches were excavated (fig 7). A level reduction of the footprint of the proposed building (Trench 1) was dug before the archaeologist was notified of the works having started, removing the topsoil and subsoil. Although the bottom of this trench had been driven over several times by a dump truck and mechanical excavator, the archaeologist was able to identify several features. These features were then investigated further when deeper trenches were dug through them.

• Trench 1 was a level reduction matching the footprint of the purposed building, it was 12m long, 8m wide and 0.6m deep.

Trenches 2-9 were footings dug for the concrete foundations.

- Trench 2 was to the north of the site and ran east-west. It was 8m long, 0.6m wide and 0.7m deep.
- Trench 3 was to the west of the site and ran north-south. It was 12m long, 0.6m wide and 0.7-1.1m deep.
- Trench 4 was to the east of the site and ran north-south. It was 12m long, 0.6m wide and 0.7-1.1m deep.
- Trench 5 was in the middle of the site running east-west. It was 3m long, 0.6m wide and 0.6m deep.
- Trench 6 was in the middle of the site running east-west. It was 3m long, 0.6m wide and 0.6m deep.
- Trench 7 was in the south of the site running east-west. It was 3m long, 0.6m wide and 0.6m deep.
- Trench 8 was in the south of the site running north-south. It was 7.5m long, 0.6m wide and 0.6m deep.
- Trench 9 was in the south of the site running north-south. It was 3m long, 0.6-1.3m wide and 0.6-1.1m deep.

Figure 7. Plan of the watching brief trenches, trenches in red and features in blue. © Crown Copyright. All rights reserved Southampton City Council. LA 1000 19679 2016.

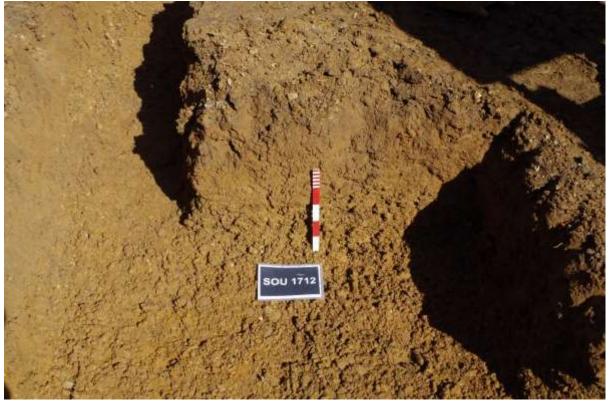
8.1.1 Natural gravel 4 was observed in trenches 2-9 some 1.1m below the surface (fig 8). It was a brownish yellow (10YR6/6) silty clay loam and was at least 100mm thick. This would appear to deposits of River Terrace 4 (Sand and Gravel). Above the gravel was natural brickearth, 3, observed 600mm below the surface in all trenches (fig 8). It was a brownish yellow (10YR6/6) silty clay loam and was 400-500mm thick. This would appear to deposits of River Terrace 4 (Clay and Silt).

Figure 8. Southeast facing section trench 9, showing layers 3 and 4.

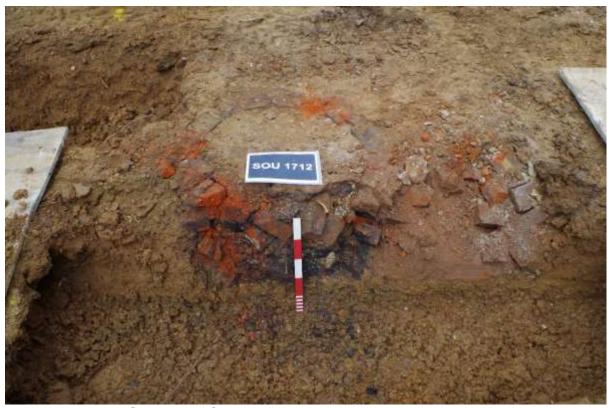
8.3.1 Soakaway 5 was observed in the middle of the site (fig 9). It was 0.9m in diameter and 0.45m deep. It was circular in plan, had vertical sides and a flat base. It contained three fills. The soakaway was built of red bricks in a brickearth matrix, context 6. The bricks had shallow frogs, were of varying sizes, were fairly irregular and were probably wasters. The soakaway had been backfilled with context 22, a

very dark greyish brown (10YR3/2) silty clay loam. This backfill was 0.25m thick and contained fragments of brick and Welsh slate. Above was fill 7, a light yellowish brown (10YR6/4) silty clay loam. It was 0.2m thick and contained abundant fragments of brick and Welsh slate.

Figure 9. Southeast facing section trench 6, showing soakaway 5.

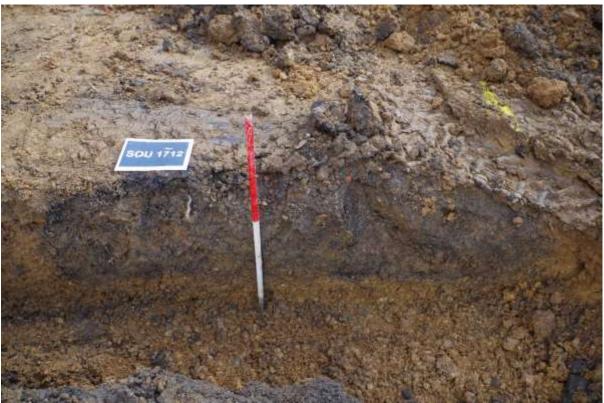
- 8.2.2 Large pit 8 was situated near the middle of the site and was seen in trenches 1, 7 and 8 (fig 10). It was rectangular in plan, had near vertical sides and a flat base. It was 1.9m long, 1.7m wide and 0.5m deep. It was filled with context 9, a dark greyish brown (10YR4/2) silty clay loam. The fill contained fragments of brick, Welsh slate, charcoal and one burnt flint.

Figure 10. Northwest facing section trench 7, showing pit 8.

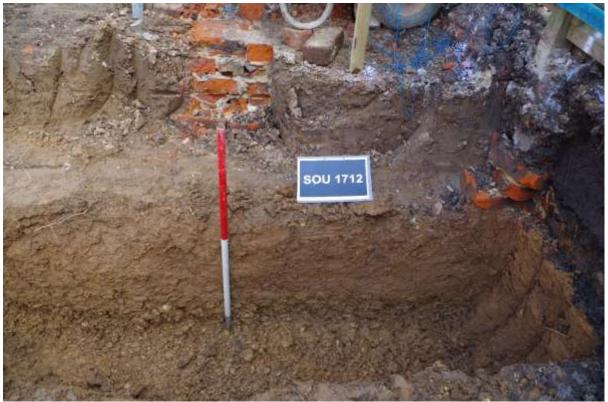
- 8.2.4 Construction trench 14 was observed in the east end of trench 2 (fig 11). This was probably the foundation for the large building shown in the garden on the 1870 map. It was not possible to trace the extent of this feature as its northern end went beyond the trench edge and its southern end was removed by the level reduction for trench 1. It was filled with a brick wall in a sandy, lime-mortar matrix. The bricks had shallow frogs and were 521mm long, 108mm wide and 64m deep.

Figure 11. Southeast facing section trench 2, showing construction trench 14.

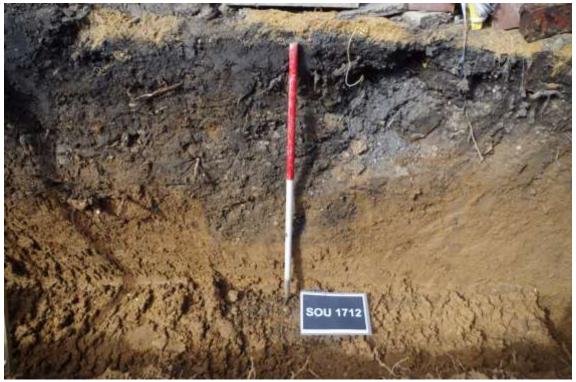
- 8.2.5 Pit 16 was observed at the northern end of trench 3 (fig 12). It was 0.59m long, at least 0.3m wide and 0.2m deep. The sides were near vertical and the base was

flat. It was filled with a greyish brown (10YR5/3) silty clay loam, context 17, which contained fragments of bricks, coal, Welsh slate and burnt flint.

Figure 12. Northeast facing section trench 3, showing pit 16.

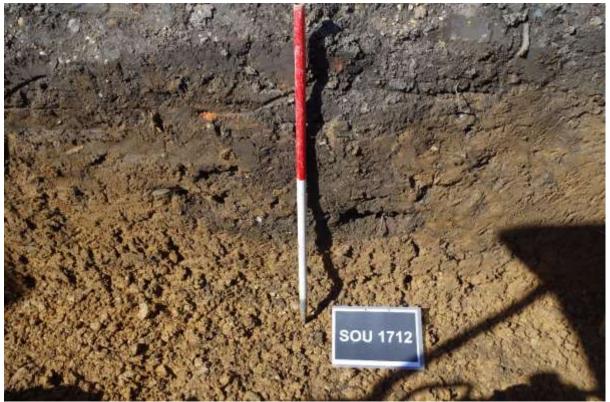
8.2.6 Pit 18 was observed in the south end of trench 3, north of feature 10 (fig 13). It was 0.7m long, at least 0.3m wide and 0.6m deep. The north side was nearly vertical and the south side sloped steeply, the base was nearly flat. It was filled with a dark greyish brown (10YR4/2) silty clay loam, context 17. It contained fragments of bricks, china dating to the latter half of the 19th century and coal.

Figure 13. Northeast facing section trench 3, showing pit 18.
