Report 1253

Building Recording at Avondale House, Southampton. SOU 1706

**Building Structure Recording at
Avondale House, 33 Carlton Crescent,
Southampton
SOU 1706**

Archaeology Unit report	1253
Site Code	SOU 1706
Ordnance Survey grid reference	442009 112770

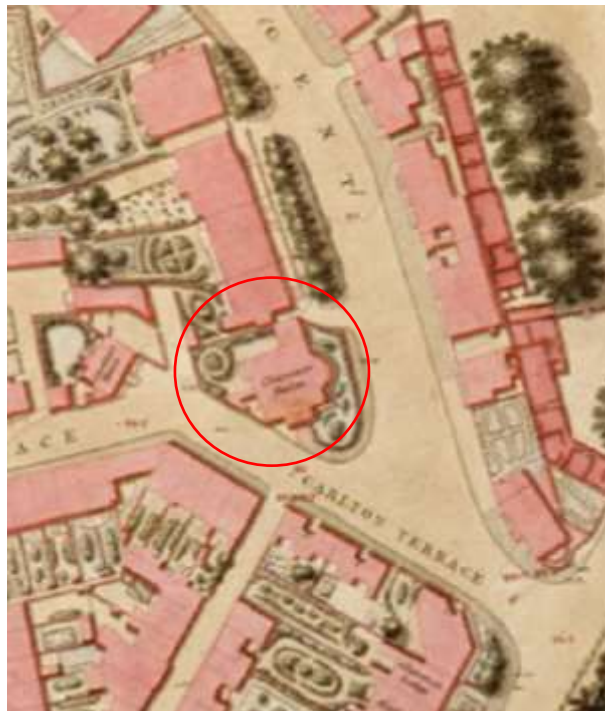
Figure 2. The Royal Engineers Map 1846, showing Clarence House.

5.1 Historic maps show the building from 1846 to 1946 (figs 2 to 7). They suggest the house remained as built until after 1908. By 1932 extensions had been built on the north and south elevations, probably by Brown Bros Ltd.

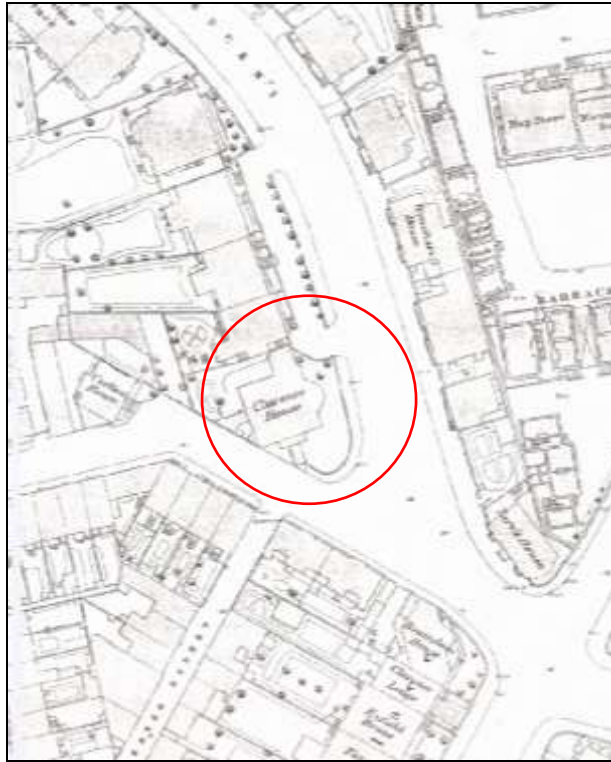
Figure 3. The 1870 Southampton town map scale 1:500 showing Clarence House.

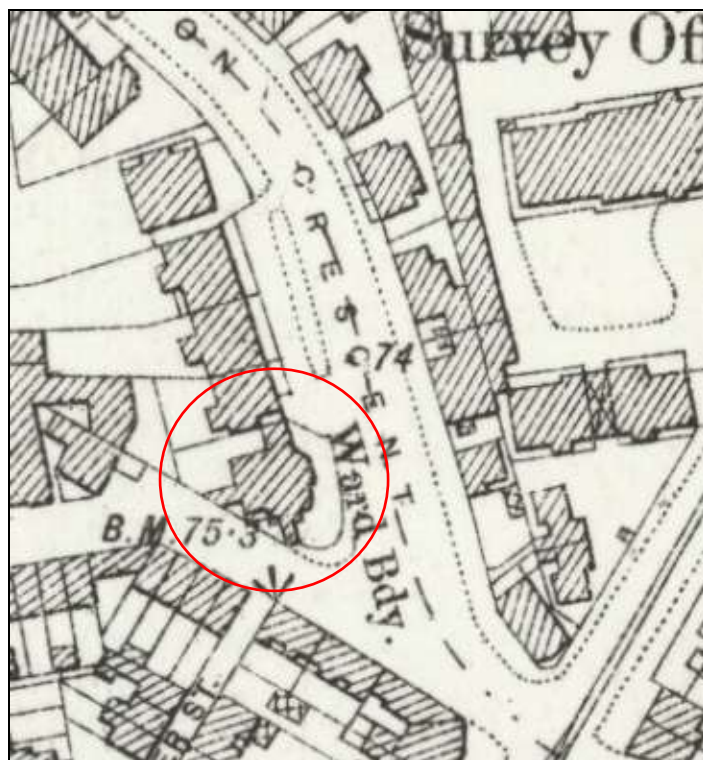
Figure 4. The 25 inch to the mile Hampshire and Isle of Wight map sheet LXV.7 revised 1895-1896, published 1897, showing Clarence House.

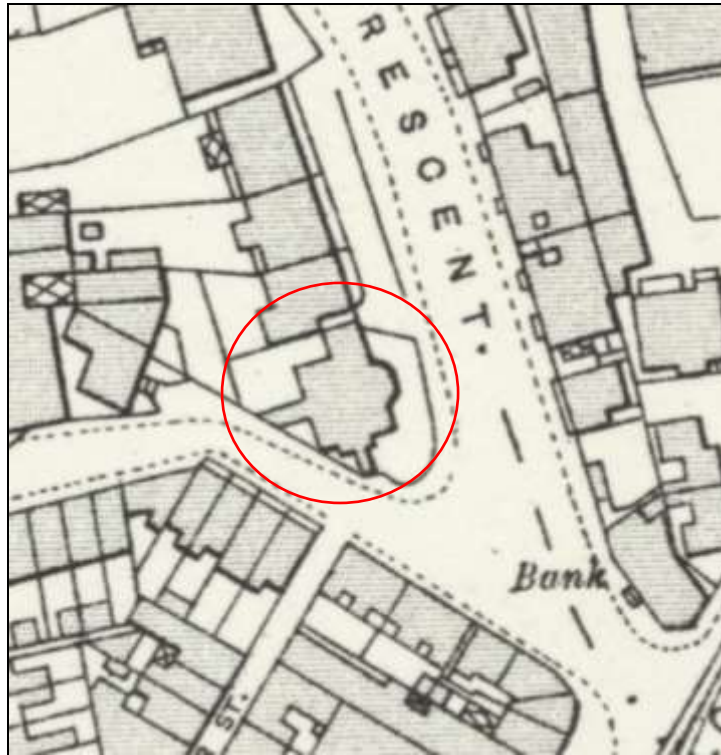
Figure 5. The 25 inch to the mile Hampshire and Isle of Wight map sheet LXV.7 revised 1908, published 1910, showing Clarence House.

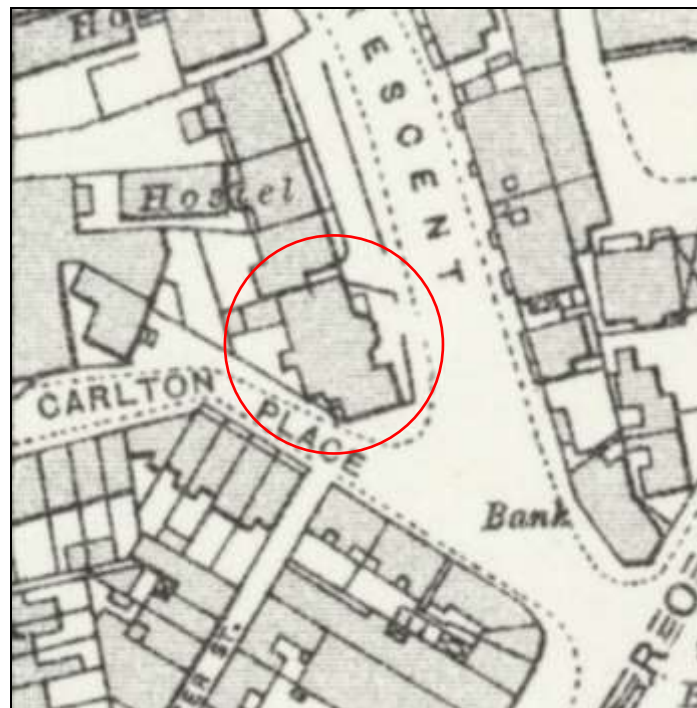
Figure 6. The 25 inch to the mile Hampshire and Isle of Wight map, sheet LXV.7 revised 1932, published 1933, showing Clarence House, with extensions, probably added by Brown Bros Ltd.

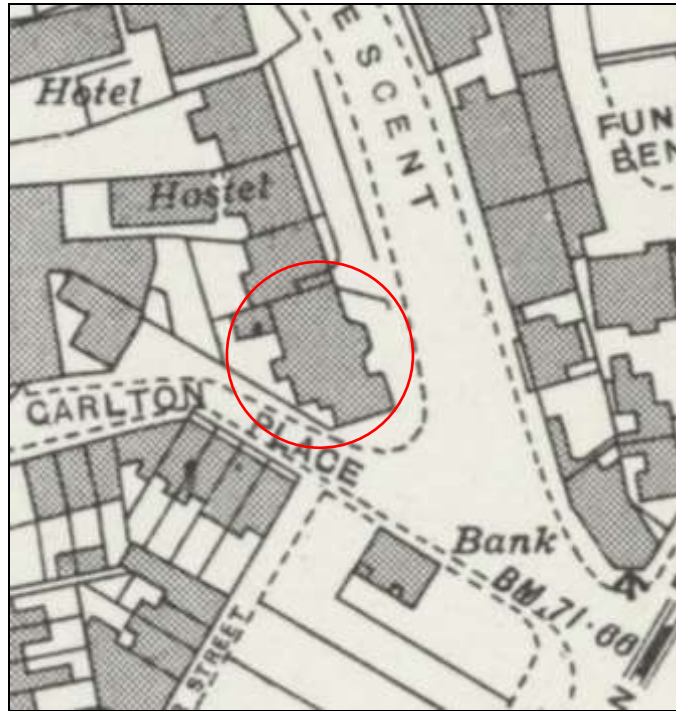
Figure 7. The 25 inch to the mile Hampshire and Isle of Wight map, sheet LXV.7 revised 1941 to 1943, published 1946, showing Clarence House, by then renamed Avondale House by its owners Braziers.

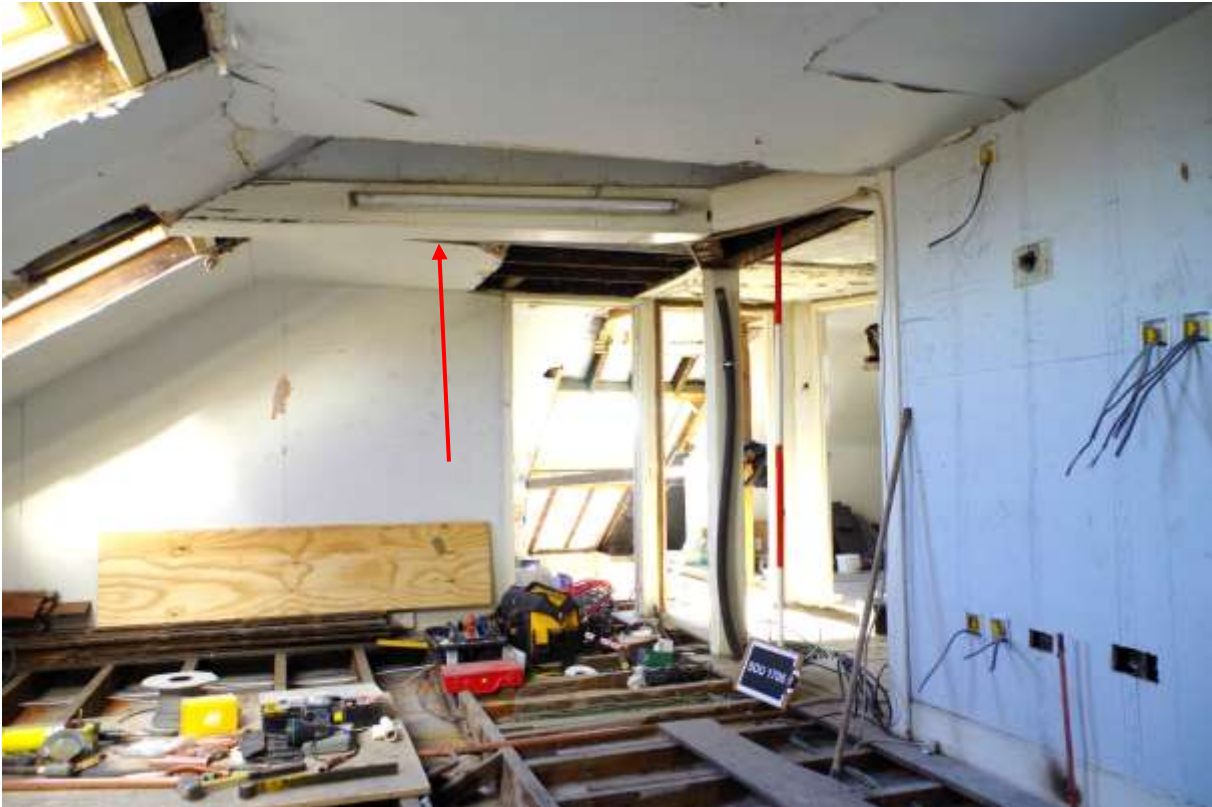
8.1.1 The original roof of Clarence House appears to have consisted of a number of pitched roof slopes. If they had met at an apex or ridge, the upper part of the roof would have been visible above the decorative cornice, detracting from the classical lines of the building. In order to prevent this the roof slopes stopped short and a sunken roof area/light well was built just above head height in the attic space. The weight of this was supported on single thickness brick walls that rose above eaves level from the main structure below (fig 13). Rooms were created in the attic by building stud walls lined with lath and plaster between the floor and the sloping underside of the roof (figs 10, 11, and 16).

Figure 10. The attic space on first visit. Red arrow points to the boxed-in lead pipe.

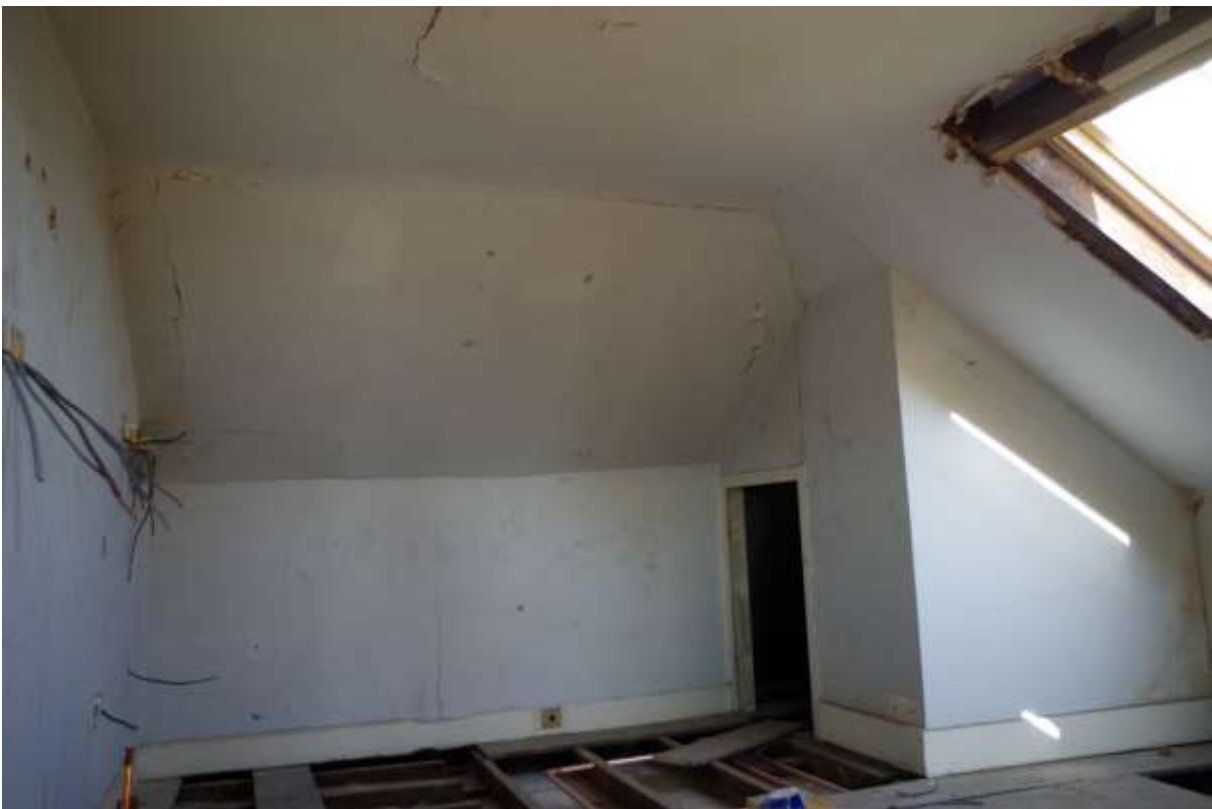
Figure 11. View of north part of attic showing typical construction before opening up.

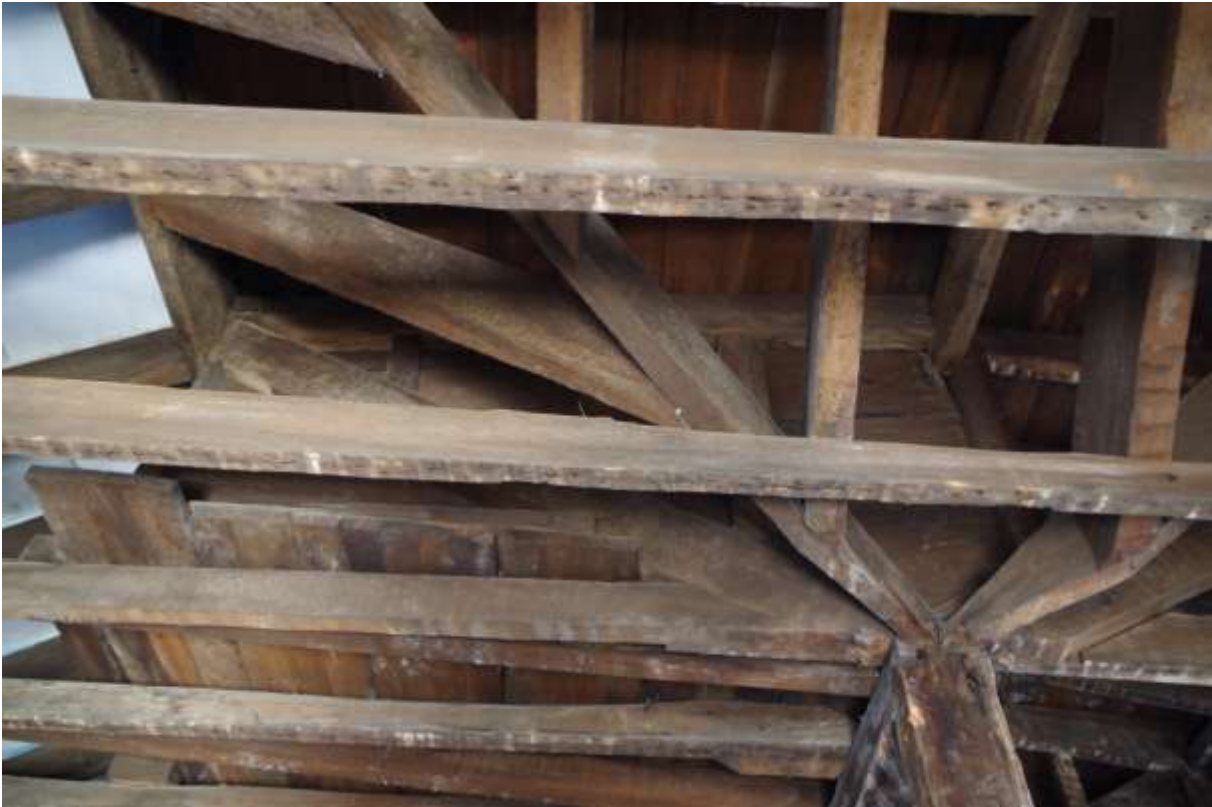
8.1.2 Plank walls were built around the four sides of the flat roof (fig 12). These probably supported lead sheets. The east wall was pierced by a two small barred windows which lit the attic (fig 13). The flat element of the roof was probably waterproofed with a lead sheet covering, and this drained the rain water into a lead hopper set in the ceiling of the attic, after which it flowed through a lead pipe that ran towards the east elevation, probably emptying into the gutter behind the parapet above the bay window. The lead pipe probably was encapsulated in a studwork and lath and plaster wall. A housing on the main beam probably marks the junction of this wall (fig 14). There might have been signs on the attic floor to confirm this but the floorboards had been removed before the recording work took place.

Figure 12. The attic roof structure after removal of ceilings. The original flat roof/light well structure formed from softwood planks can be seen above the joists.

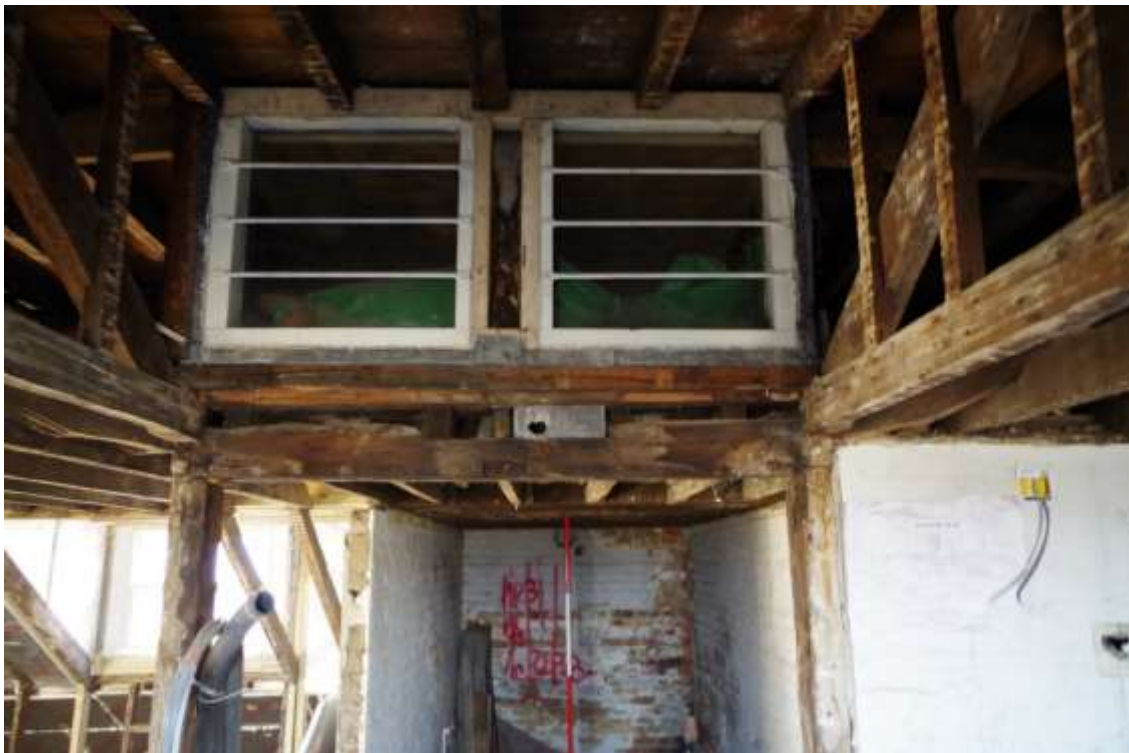
8.1.4 As part of the 2016 conversion works the lead pipe and its enclosure was removed. This revealed the soldered sheet-lead hopper 200mm (8 inches) square in plan, which sat upon the main north-south roof beam (figs 13 and 14). The hopper was at least 155mm deep; the upper parts were hidden in the revised roof structure. To the east of the main beam two timbers met in a Y-shape to support a timber 127mm by 95mm that itself supported the lead pipe (figs 14 and 15). The pipe was 40mm in diameter and ran for 2.4m before it reached the underneath of the roof slope. It continued another 280mm between the rafters but had been removed beyond that.

Figure 13. The window openings (with more recent frames and bars) in the east wall of the flat roof/light well, with lead hopper beneath them, after removal of the lead pipe, supporting beam and its enclosure.

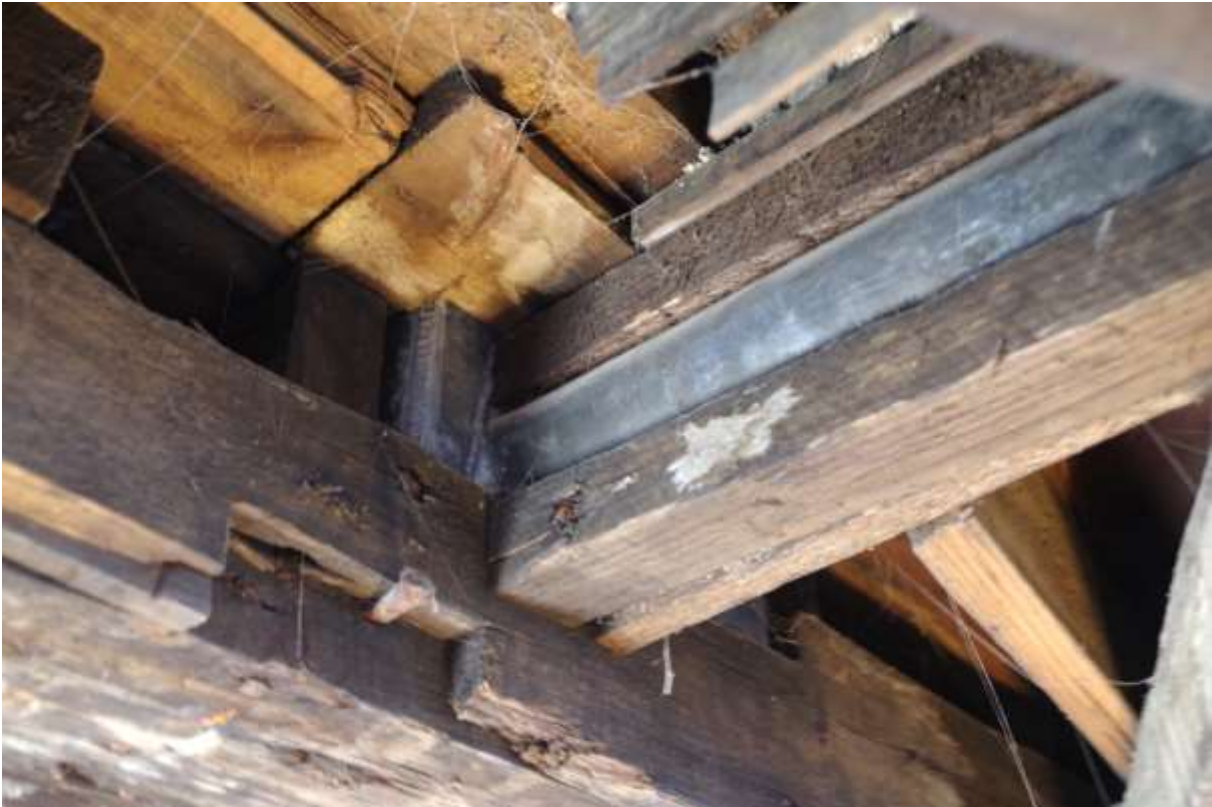
Figure 14. The base of the lead hopper, with lead pipe exiting to the right (east). Note housing with protruding nail below the hopper which probably relates to an earlier layout of the attic space.

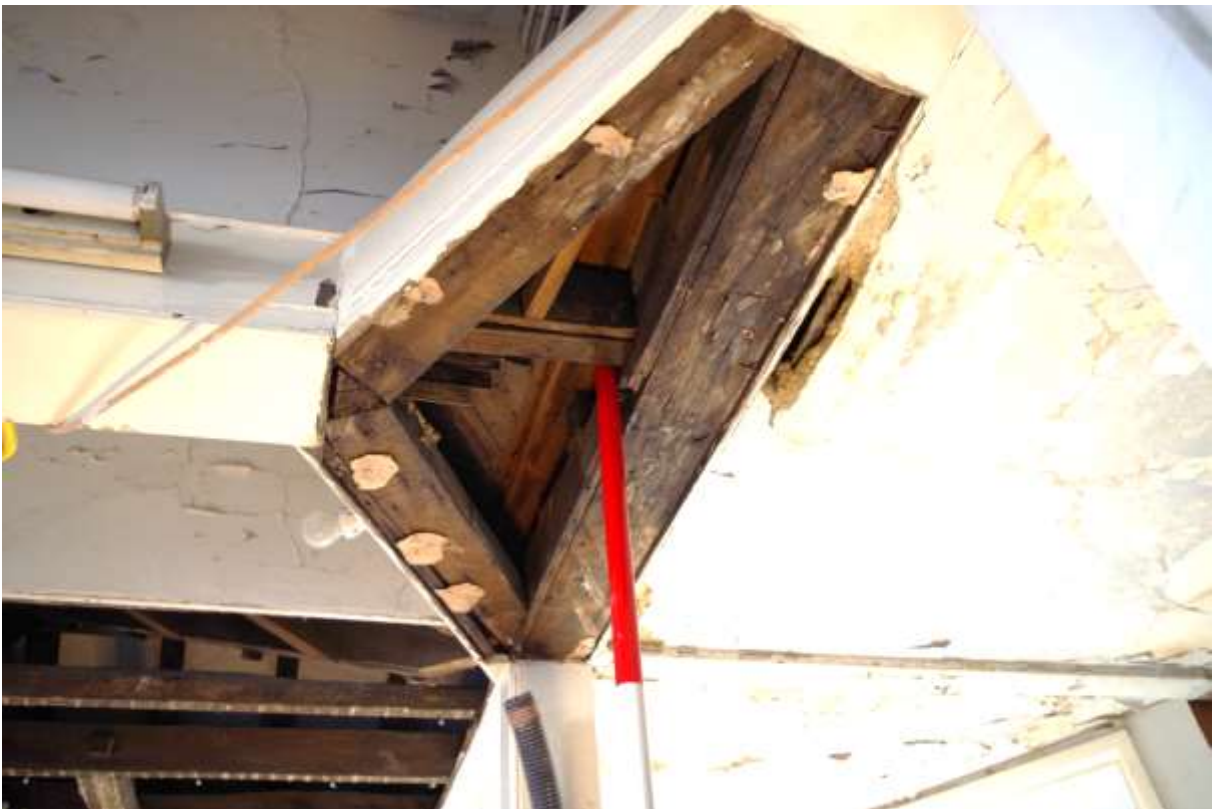
8.1.3 At a later date, the lower part of the encapsulating wall was removed and three beams in a Y arrangement were used to support the pipe. Perhaps at the same time, the flat roof/light well arrangement was altered, probably in response to water ingress, and the roof slopes were continued up to an east-west ridge that still exists, encapsulating the flat roof/light well to which there is now no access. The date of this work is not clear, but the underside of the Y arrangement did not bear marks of lath and plaster, and instead had traces only of nailed-on fibreboard (fig 15), a common sheet material in between the wars, when the building was owned by Braziers. The revised roof covering can be seen on an RAF air photograph of 20/4/53 (0161 V 82RAF 765).

Figure 15. The Y-shaped arrangement of timbers supporting the lead pipe.

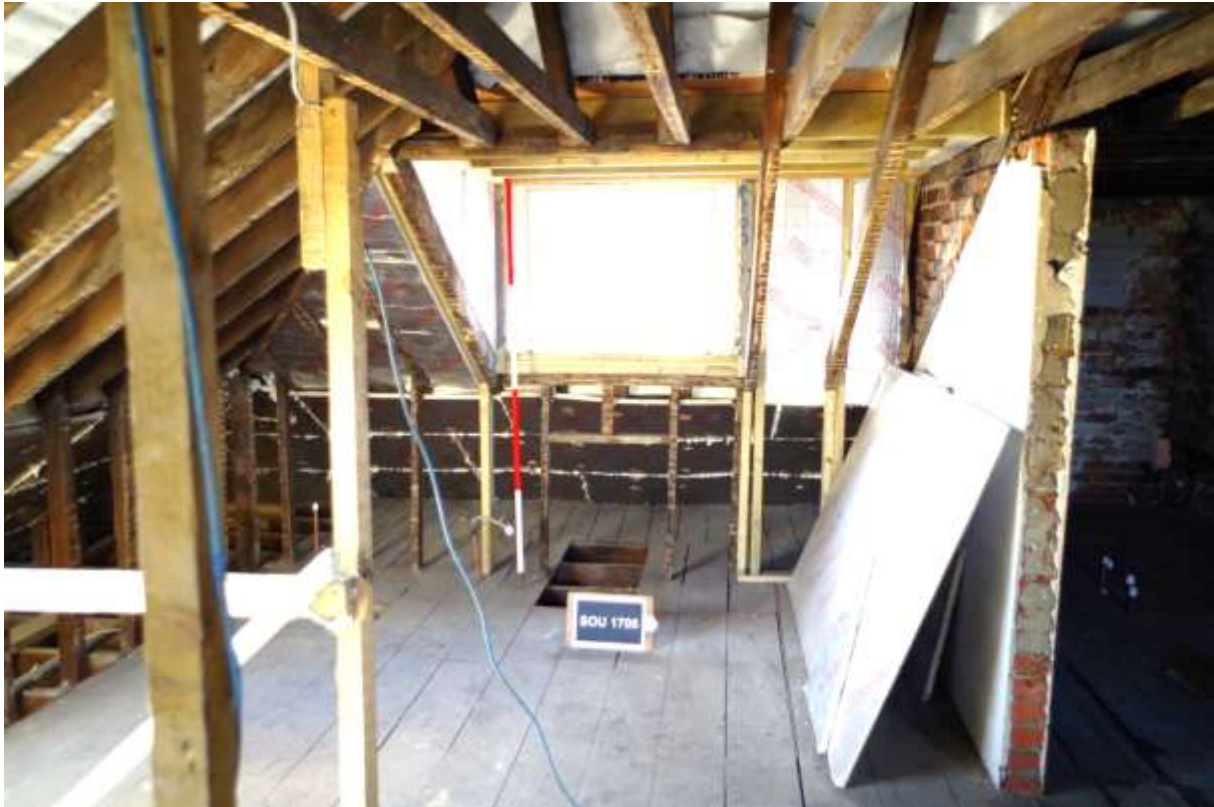
8.1.5 Removal of the lathe and plaster ceilings exposed the ceiling joists. These ranged from 33mm to 45mm thick by 80mm deep and they were at approximately 380mm centres. The studs in the lathe and plaster walls in the attic were 30mm by 96mm. The rafters were 55mm by 125mm.

Figure 16. View showing studwork in the attic after removal of lath and plaster.

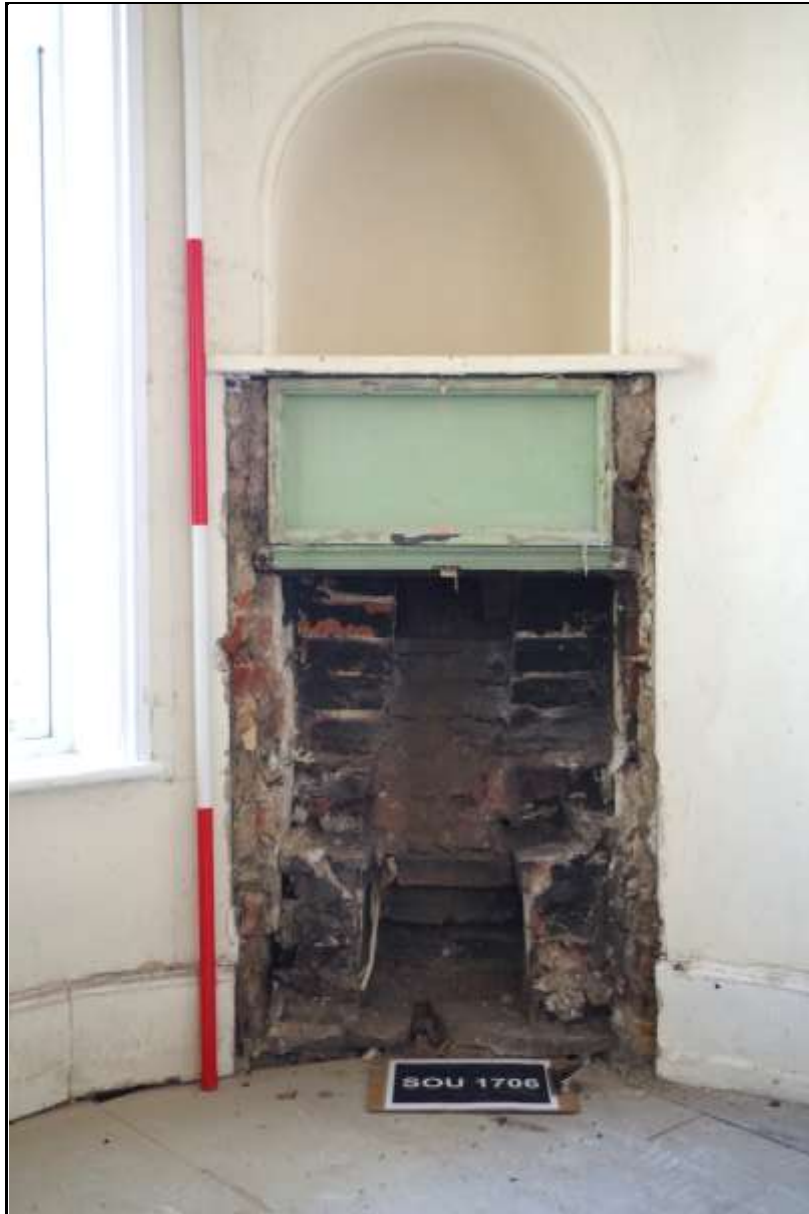
8.2.1 A fireplace on the first floor in what was to become flat 6 was opened up. The fireplace formed an angle in the southeast corner of the room (fig 17).

8.2.2 The opening was 620mm wide. The brick fireback was built on slabs of York stone. They had originally protruded further into the room but had been removed at an earlier date. The fireback was built of bricks, 64mm thick, laid in a sandy lime mortar. The form of the fireback suggests that a cast-iron grate that incorporated a small hob on each side was used. The central flue was 240mm wide. The flue exited to the top right hand side where a cast-iron register plate was let into the brickwork. This would have led to a flue in the south wall of the room which lead to the chimney stack above.

8.2.3 At a later date the cast iron fire surround was removed and a cement-mortar shelf was inserted, supported on a mild steel bar set into the brickwork. Above this a sheet of wood with mouldings around the edges was applied. This phase perhaps related to the insertion of a gas fire.

8.2.4 The gas fire was later removed and an electric fire in a purpose made surround was glued into place.

8.2.5 Above the fireplace was an alcove with a moulding around it run in the plaster. At the base of the alcove was a stone shelf. The alcove, moulding and shelf were probably original.

Figure 17. The fireplace in Flat 6 first floor.
