Archaeological watching brief, Old Place of Monreith, Dumfries and Galloway

July 2017

**ARCHAEOLOGICAL WATCHING BRIEF, OLD PLACE OF MONREITH, GLASSERTON,
DUMFRIES & GALLOWAY**

DGC planning application: 16/P/1/0148

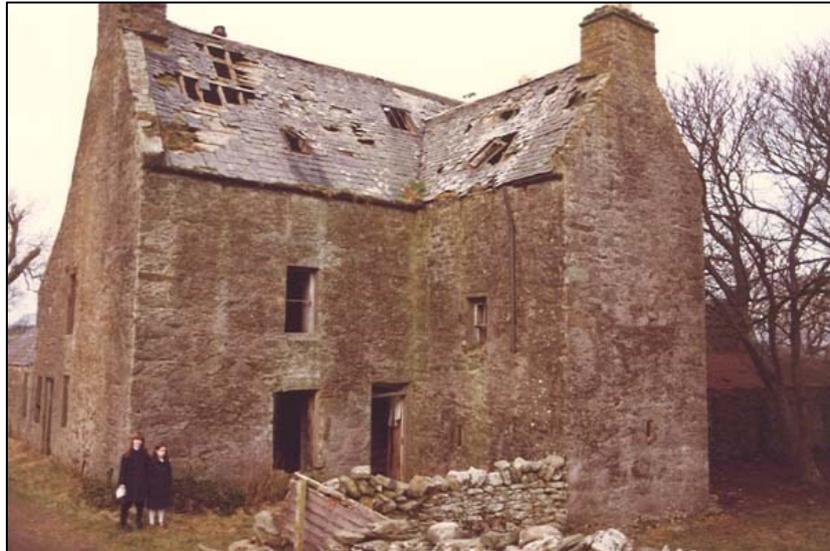
Fig. 3. Pre-restoration view showing a now-demolished two-storey structure against the west corner of north face. Image: The Landmark Trust - <https://www.landmarktrust.org.uk/search-and-book/properties/old-place-of-monreith-10102>

In its current form the Old Place is a free-standing structure within a lawned enclosure with a 19-20th century cart shed to the north-east. Historic maps show that the house was once at the centre of a larger building complex (Fig. 2). The First Edition six-inch OS map, surveyed in 1848, depicts the house at the south-western end of a long building range; there is a single building to the north-west and a walled orchard to the south-east. The First Edition twenty five-inch map survey of 1894 shows the same layout and also marks an L-shaped building to the north and the 1906 edition marks an extension on the south side of the L-shaped building. By the time The Landmark Trust acquired the house in 1983 the majority of the surrounding buildings had been removed but a contemporary pre-restoration photograph shows an attached building against the west side of the house's north face (Fig. 3).

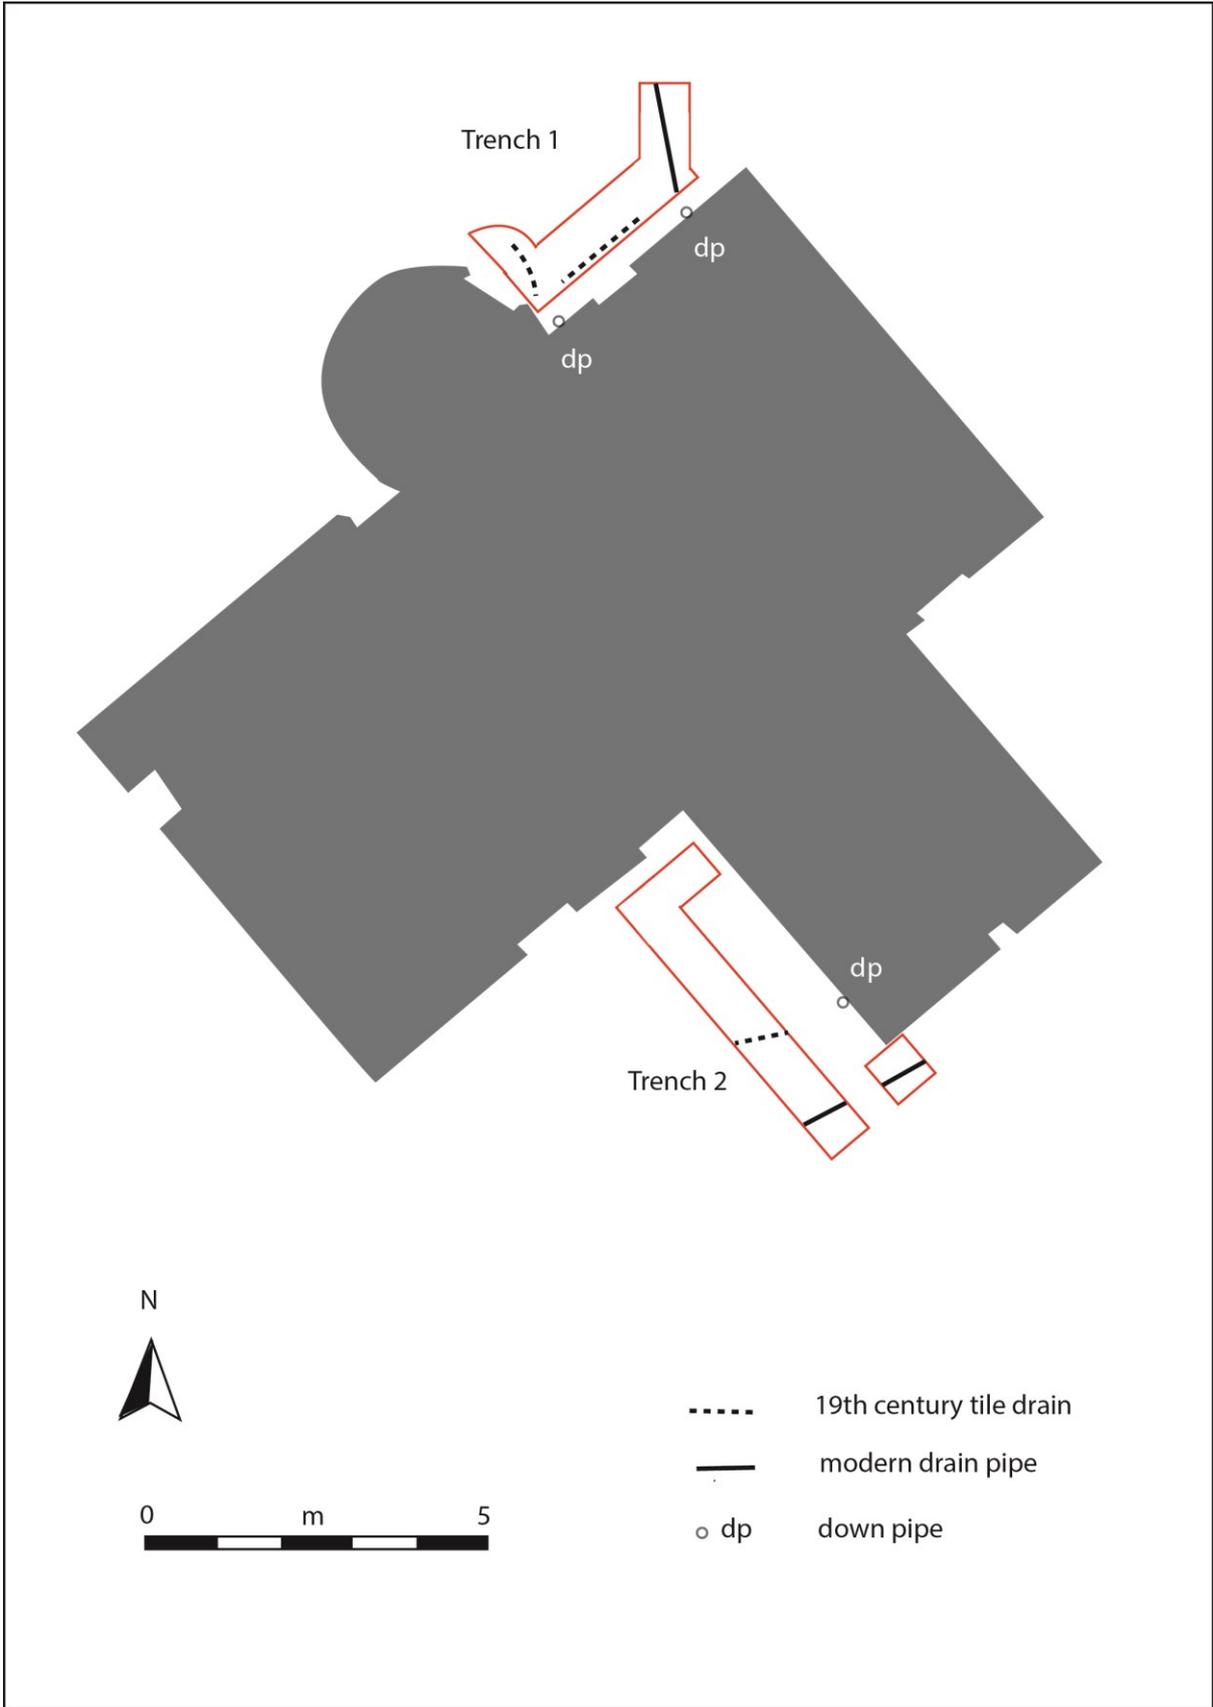
Fig.4. External ground plan of Old Place of Monreith showing the location of Trenches 1 and 2.

3.1 The watching brief was carried out over two days, 3-4 July 2017. Small hand-dug pits were excavated close to the north and south-west walls to locate the existing ground drains and then two machine trenches were excavated for drains connecting the new down pipes with the existing services (Fig. 4).

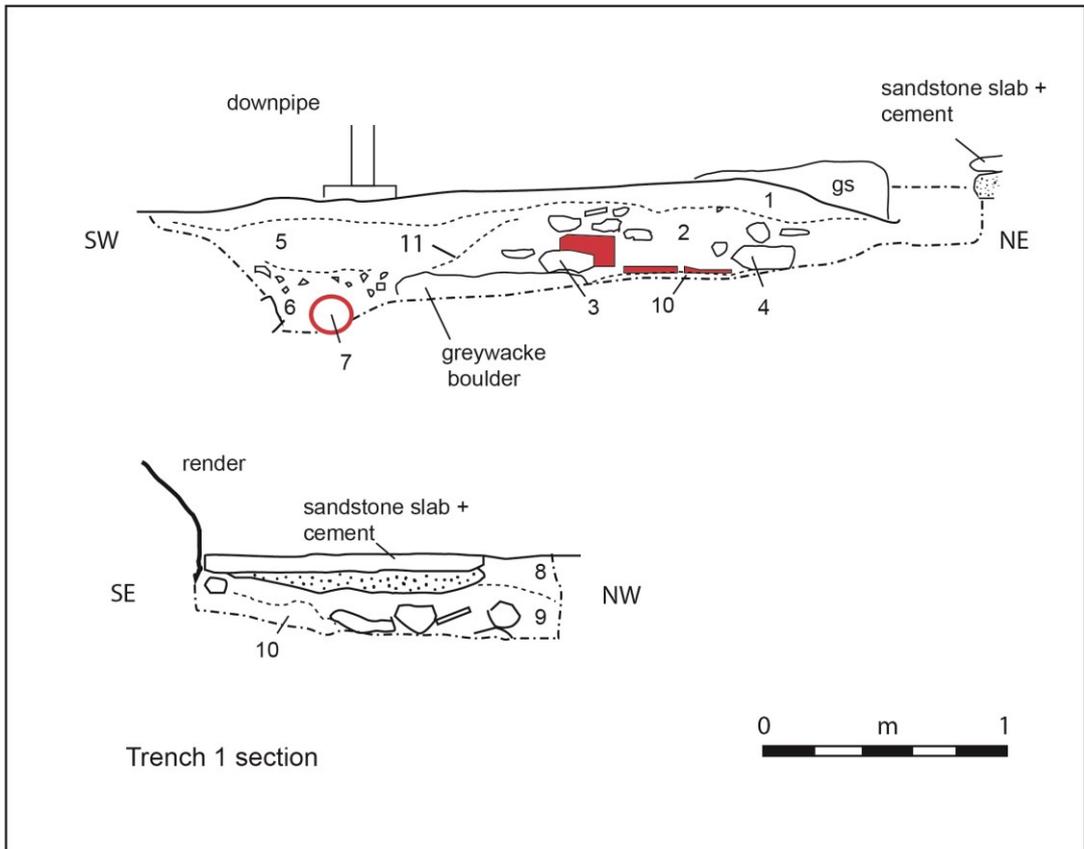
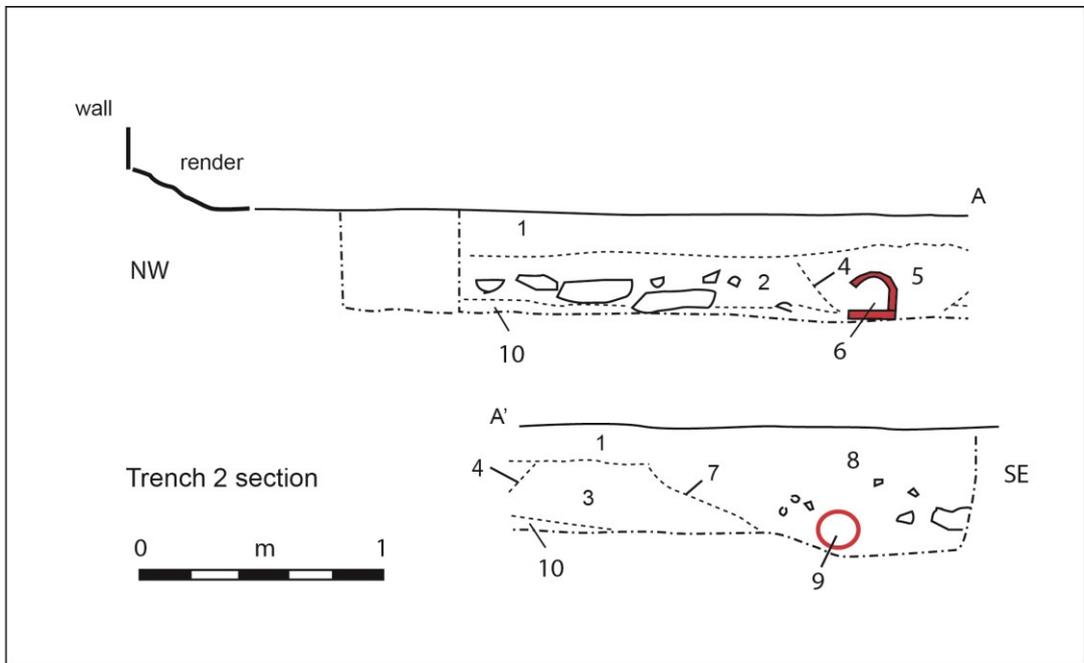
Fig. 5. Sections of Trenches 1 and 2.

4.1.2 The central section of the trench had a dark, loamy top soil layer (1 and 8) up to 0.25 deep. To the north-east it was cut by an angle-sided trench (11) which had been dug to take a salt-glazed drain pipe (7) connected to the existing down pipe on the wall. This trench

was filled with a layer of soil and broken cement (5) above a deposit of black soil and small stones (6). The trench, pipe and backfill deposits must belong to the 1980's restoration.

4.1.3 To the south-west a thin top soil sealed a layer of dark soil with small stones (9) that contained the remains of a ceramic horseshoe drain with base tiles (12) which had probably been disturbed and damaged when the paving slabs (see 4.1.1 above) were laid; this layer and the top soil above contained some sherds of 19th century white-glazed ceramic plates. Layer (9), observed in the south-west end of the trench appeared to be the same deposit as layer (2) in the section's long face but disturbance from the paving slabs meant a direct relationship between the two could not be confirmed. Layer (2), dark soil with stones, contained a horse shoe drain with tile base (3) surrounded by the remains of stone side packing and a stone cover (4); the drain ran parallel to the wall and probably connected at an angle with drain (12). Layer (2) sealed a deposit of compact orange clay (10); only a small part of this deposit was exposed in the trench but it may a natural glacial clay. Layer (2) also appeared to rest against the top of a large greywacke boulder but it could not be ascertained if this was a natural feature or part of a boulder foundation course for the building.

4.2.3 To the south-east deposit (2) was cut by a large trench (4), 0.60m wide at the top and tapering to 0.40m, which contained a clay horseshoe drain set on a clay tile base (6); the fill of the trench was a dark soil (5) similar in colour and composition to the topsoil above. The south-east side of trench (4) cut through a deposit of black soil with lenses of orange clay (3) which was cut further to the south-east by another pipe trench (7). This trench, filled with a black-grey soil with small angular stone fragments (8), contained a modern drain pipe (9); it probably dates from the restoration work of the 1980s.

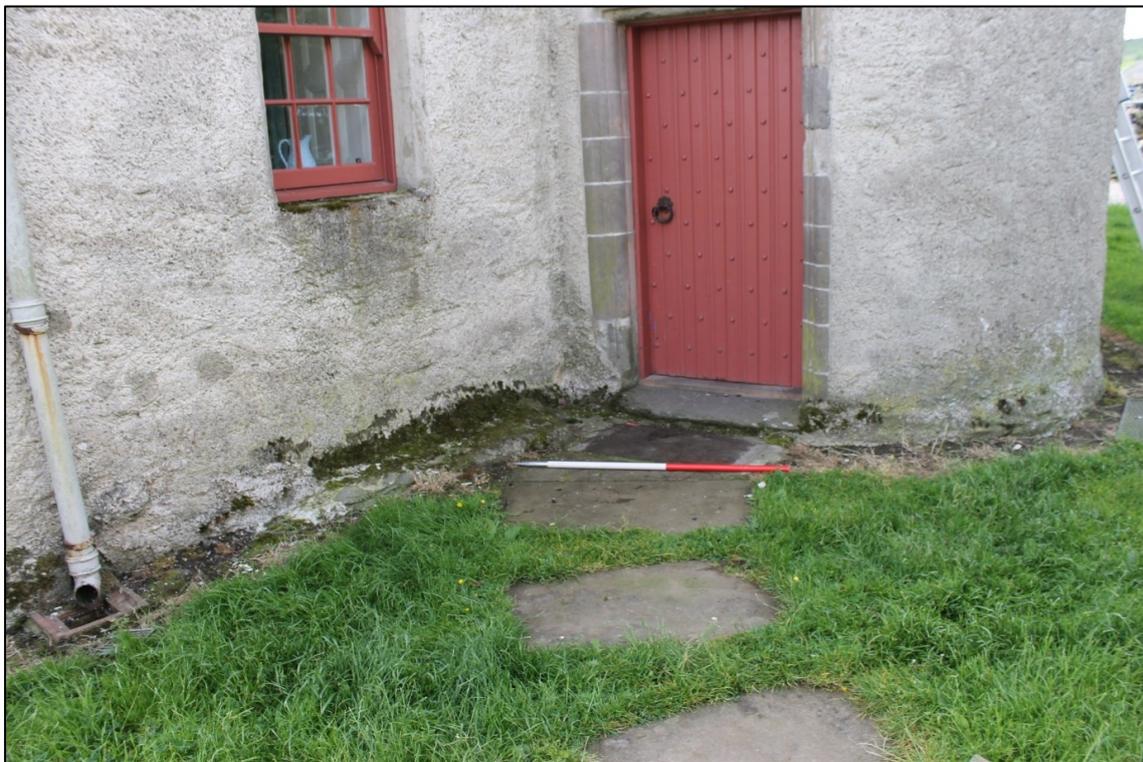
Fig. 6. Trench 1, pre-excavation view.

4.1.1 Trench 1, 3.4m long x 0.8m wide, ran parallel to and 0.4m in front of the north side of the house's north-west facing wall; the trench's south-west end was directly outside the ground floor doorway into the stair turret and at this point was 1.3m wide. Before machine excavation began three sandstone paving slabs leading to the doorway were lifted; these slabs, set in a concrete base and inserted into the top soil layer (1), are probably a modern feature and part of the 1980s restoration work. Between the trench and wall were a number of large greywacke boulders, presumably part of the building's original foundation course. The trench was approximately 0.45m deep but reached a depth of 0.60m at the north-east end where a modern drain cut (see feature (11) below) was exposed.

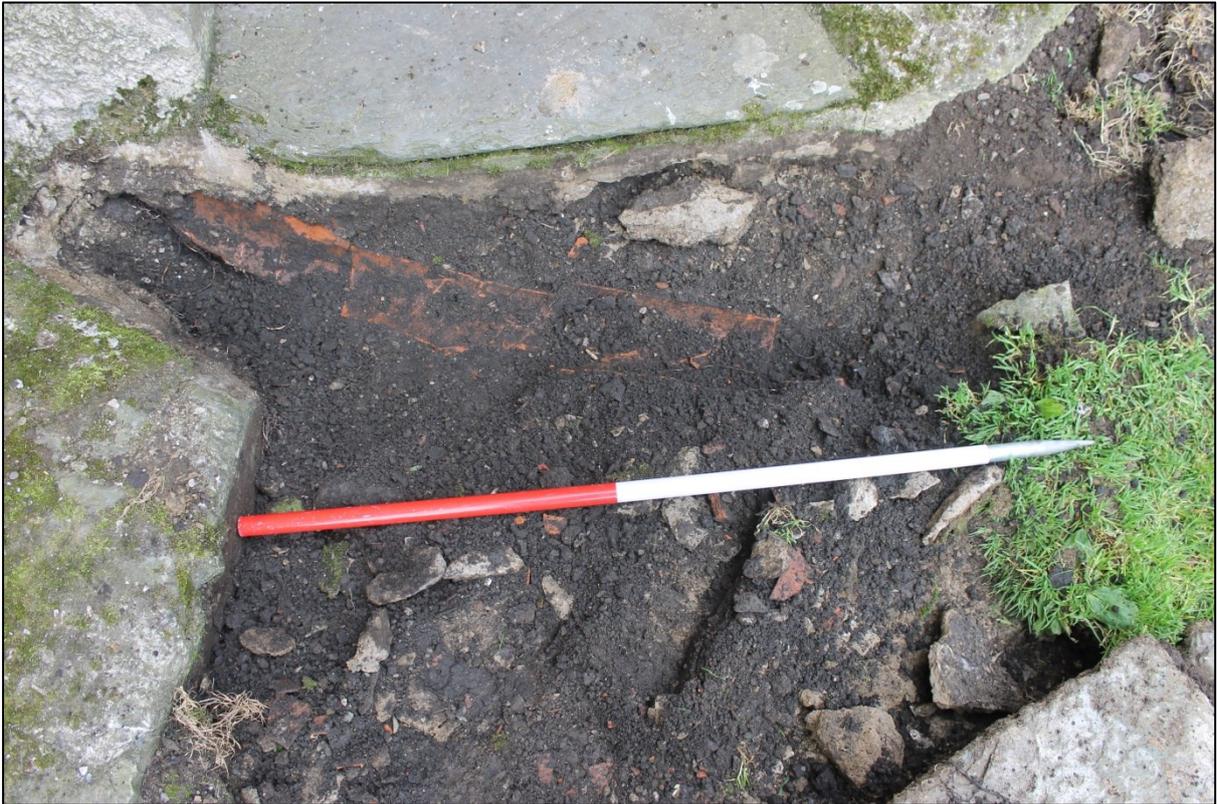
Fig. 7. Trench 1, drain (12).

5.1 The principal features exposed in Trench 1 were the two sets of horseshoe drains. The only complete horseshoe drain was 105mm wide x 105mm wide X 320mm long and the associated tiles or platelets were approximately 110mm 320mm; both the drains and tiles were hand-made. Tiles of this type were manufactured as land drains and became

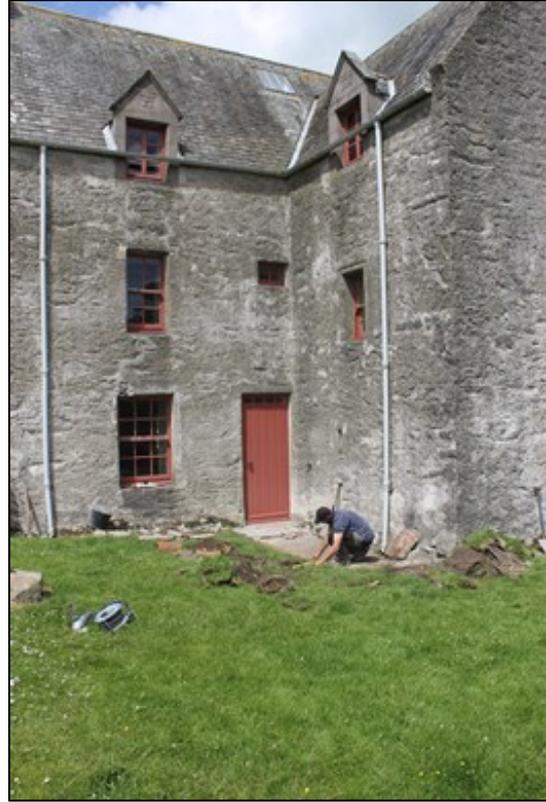
Fig. 10. Trench 2, pre-excitation view.

4.2.1 Trench 2, 4.6m long, was excavated against the lawn side of a set of modern paving slabs running parallel with the wall and south-east of the kitchen door. Two of the slabs were lifted to provide a 90 degree connection between the new down pipe and the main pipe trench. The trench had a maximum depth of 0.50m at the south-eastern end.

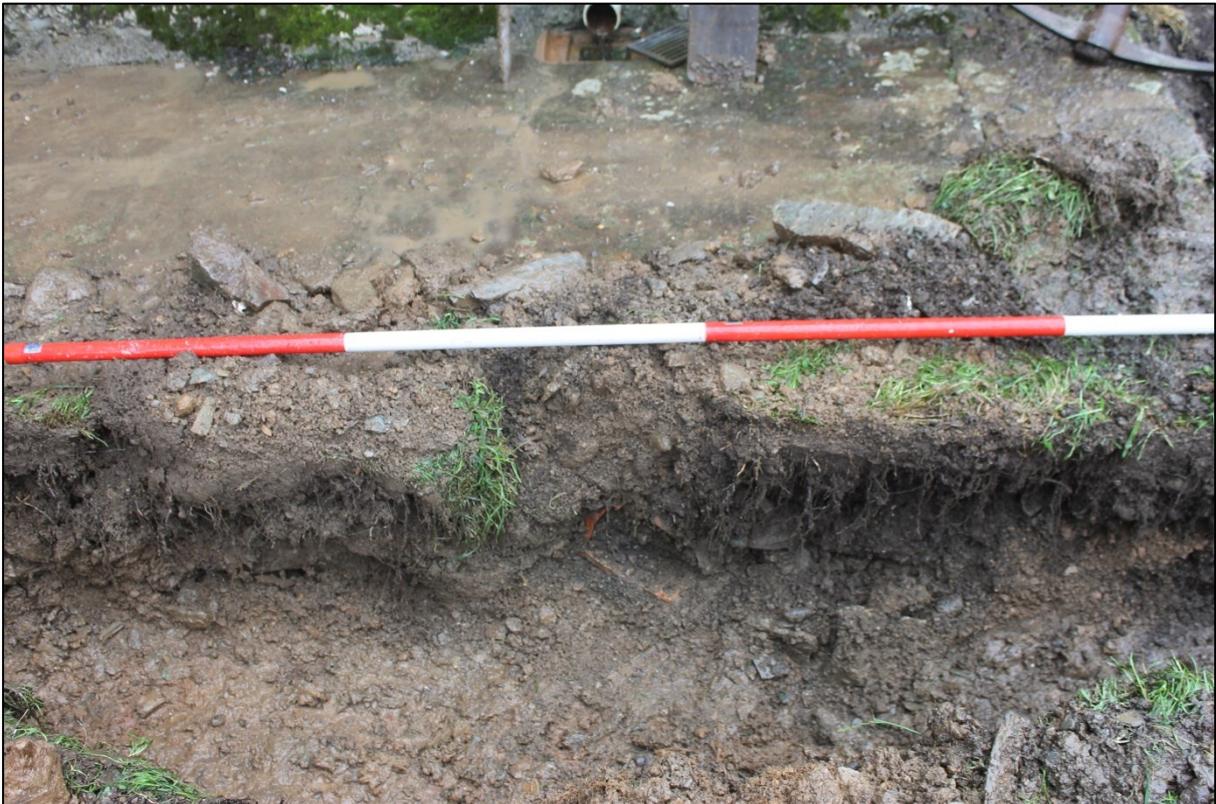
5.2 The horseshoe field drain (5) in Trench 2 has the same form to those in Trench 1 and must be of a similar date. Layers (2) and (3) were both cut by pipe trench (4) and must pre-date the trench. No datable material was recovered from these layers but the orange clay and large stones in (2) suggest that it comprises redeposited natural deposits and so may possibly be part of the building's original construction or foundation trench. The dark soil composition of layer (3) suggests a more disturbed deposit but its stratigraphic and chronological relationships with layer (2) are unknown.

Fig. 11. Trench 2. Drain (6) centre with layer (2) to left and layer (3) to right.

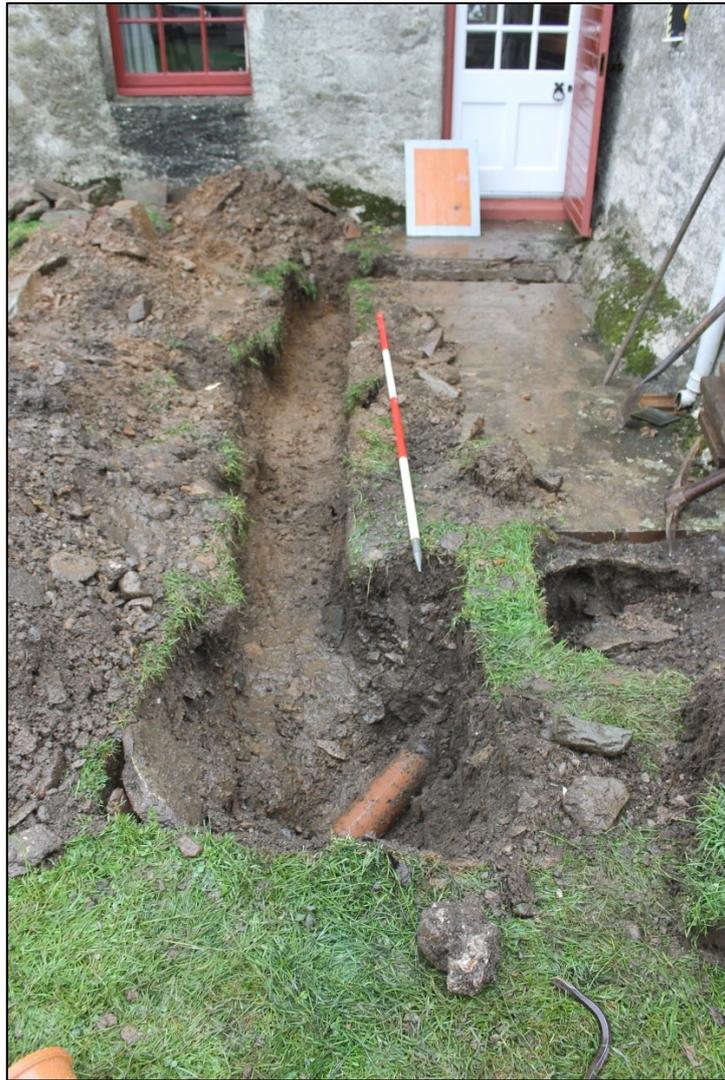
Fig.12. Trench 2. General post-excavation view with pipe (9) in foreground.
