Friars Carse Stable Block West, South and East Wings

Friars Carse, Dunscore, Dumfries and Galloway

Building Record April 2017

John Pickin
Archaeology and Heritage
Services

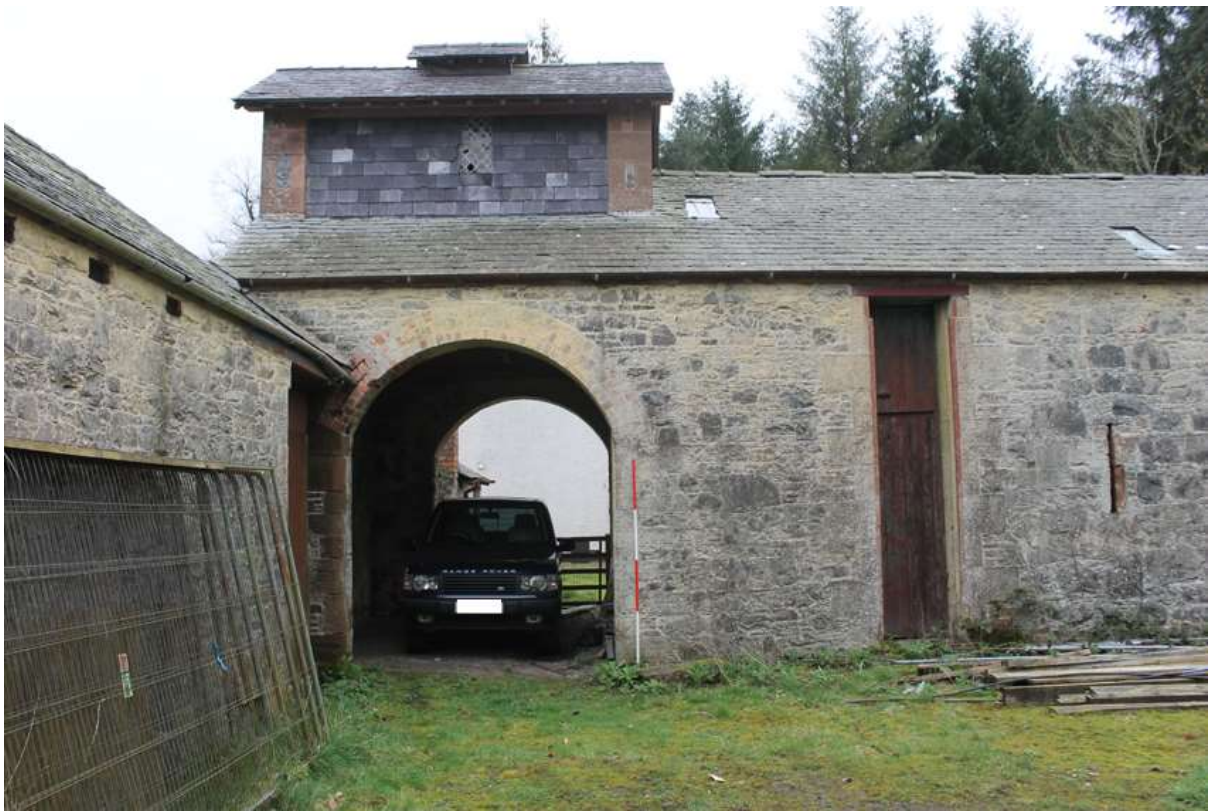
5.3.4 The middle unit (WW2) is a narrow space accessed by a tall two-section door opening into the courtyard. The south side of WW2 forms the inner wall of the pend and the room is separated from WW1 by an eaves-height cross wall. A blocked doorway in the south wall leads to the pend and above is a rectangular opening accessing the pend's loft space and the doocot. It is probable that WW2 once had an eaves-level loft.

5.3.5 The southern unit (WW3) comprises a round-arched pend beneath a loft space and doocot. The doocot has slated flanks and a slated gable roof with a gabled ventilator above. The north facing gable of the doocot is dressed sandstone. There are five rectangular flight holes in the south facing side of the doocot and below, in the upper section of the wing's south gable, is a rectangular window with diamond panes lighting the loft space. At ground level in the south gable wall is an offset door with a brick-arched head leading into the pend and at eaves level are a series of joist holes. At the same level as the joist holes is a single rectangular opening with a stone lintel and a concave base stone – this may be a sluice hole or drain for the doocot.

Fig. 6. West Wing – pend, slated doocot and entrance to WW2.

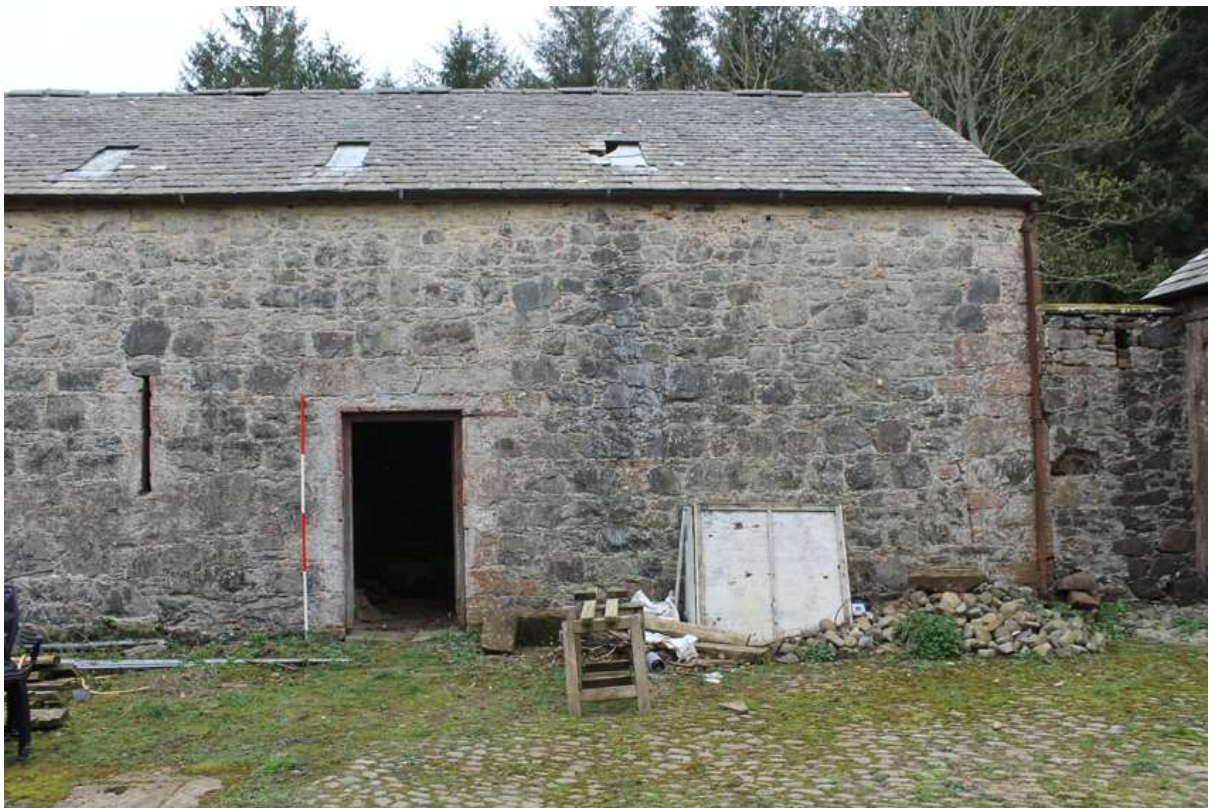
5.3.3 The northern unit (WW1) is a rectangular space with a central entrance or cartway in the outer face and stone ventilator slits in both long walls. The cartway entrance is square-headed with a massive stone lintel beneath a stone relieving arch and on the inner side it is supported by a wooden lintel. Opposite, facing the courtyard, is a single square-headed door. A square-headed door in the north gable leads to a partially covered passageway connecting with the North Wing. Externally, the north gable shows evidence of rebuilding and this is discussed below (6.2). At the north end of the outer wall the scar of a sloping roofline and a rectangular concrete patch mark the location of a now-demolished structure built against the West Wing.

Fig. 7. West Wing – slit ventilator and entrance to WW1.

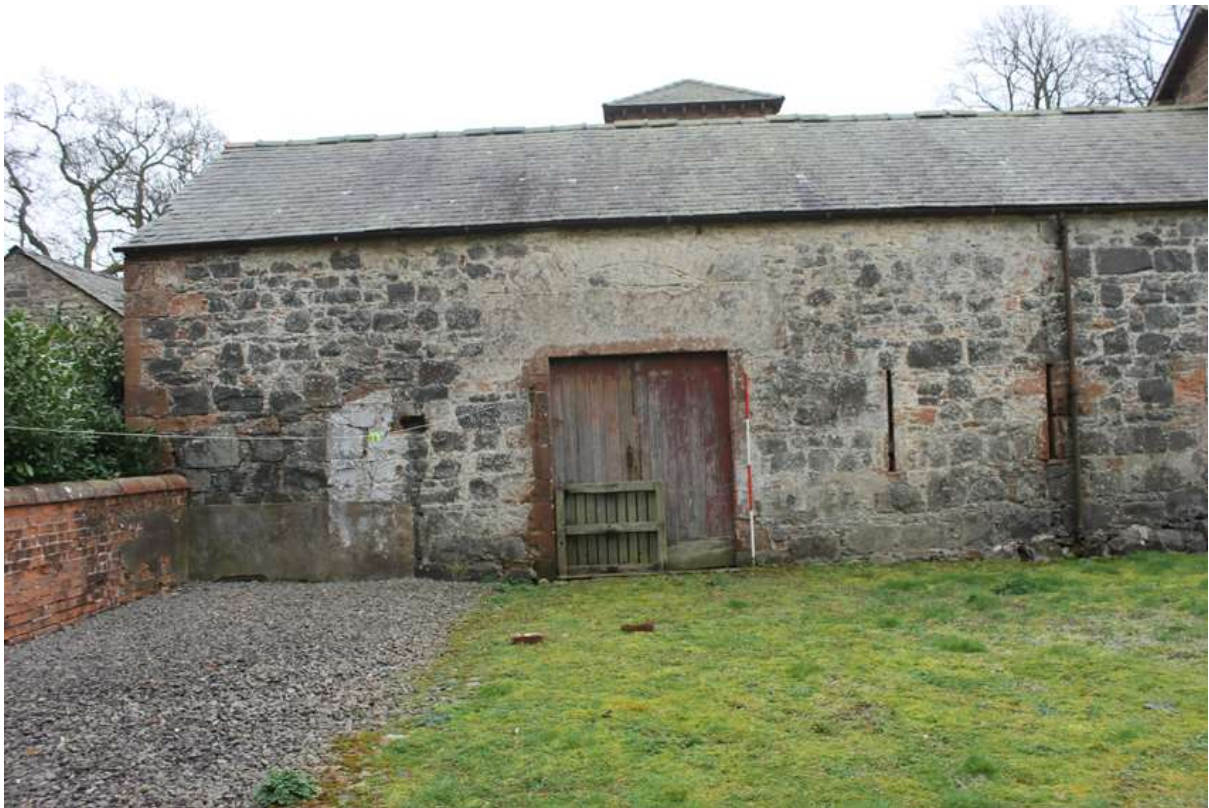
Fig. 9. West Wing – outer face of WW1 with cartway and slit ventilators.

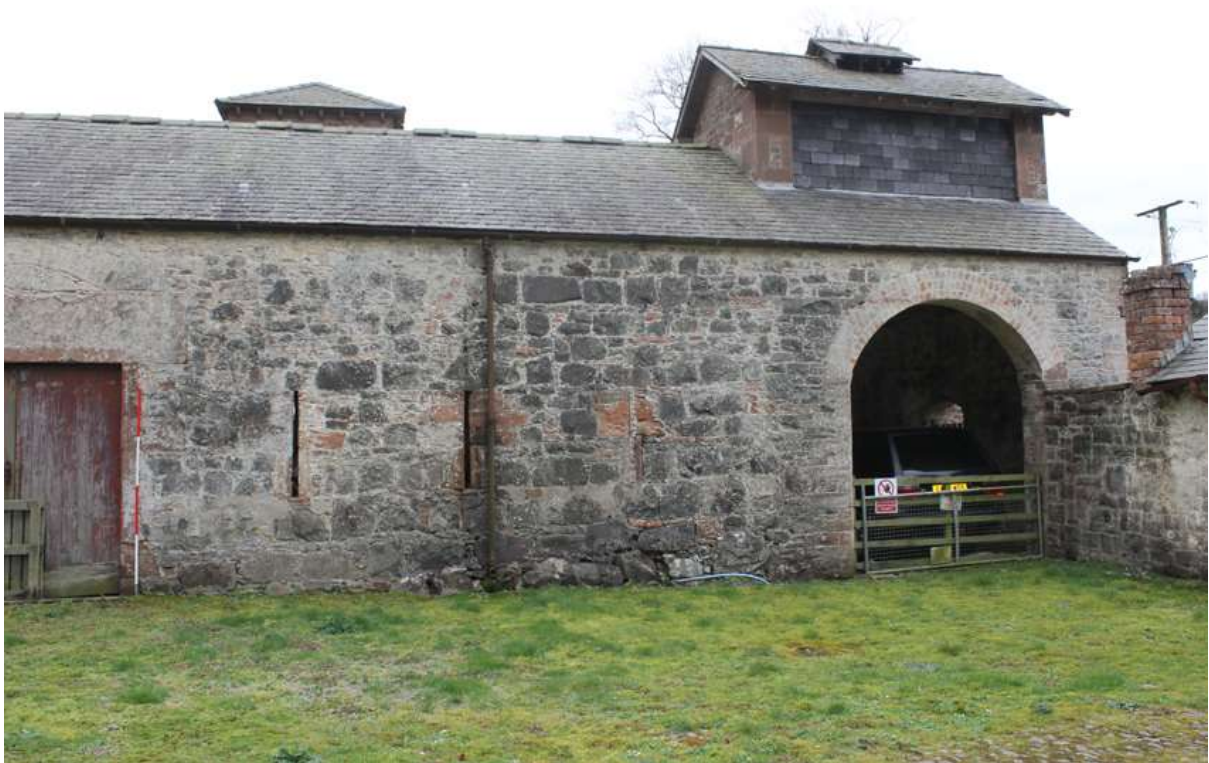
Fig. 10. West Wing – outer face showing pend and doocot.

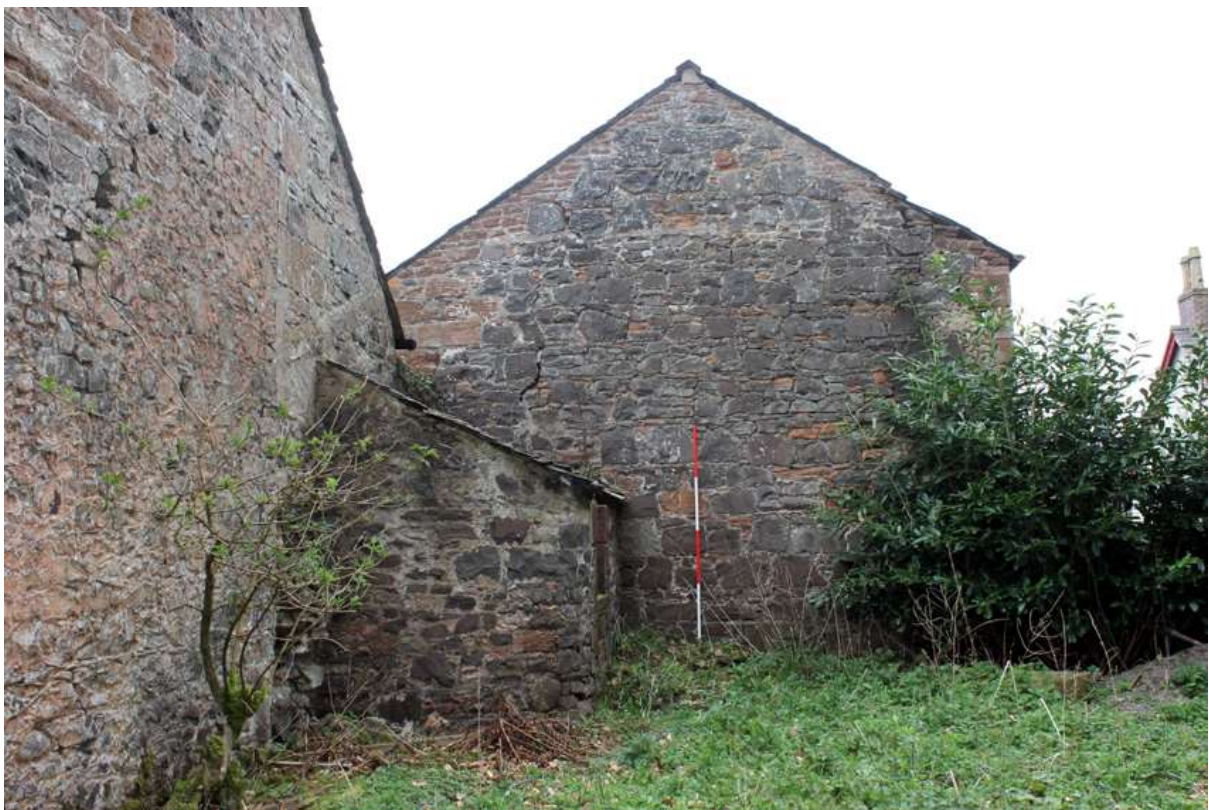
6.2 The north gable of the West Wing shows clear evidence for the roof having been rebuilt and heightened (see Fig. 5). The main, lower section of the gable is rubble whinstone construction (1) and the later heightening episode is marked by the use of smaller sized rubble sandstone (2). A similar building sequence can be seen on the south gable of the South Wing where the original wall (3) has been rebuilt and heightened in whinstone and sandstone (4); this rebuilding included the construction of the present roof and the erection of the doocot. The adjacent west gable of the South Wing also shows evidence for two building phases (5 and 6) which are probably contemporary with those in the West Wing. There is also evidence here in the form of joist holes and a roof scar for a now demolished structure between the south end of the West Wing and the west end of the South Wing; the position of the roof scar suggests that this structure is contemporary with or later than the main rebuild phase in this part of the stable complex. The relative phasing of the brick infill in

Fig. 11. West Wing – north gable.

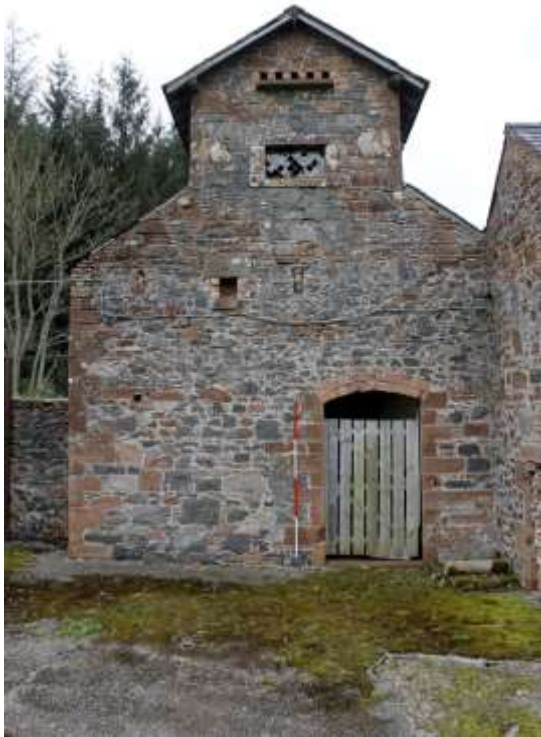
Fig. 12. West Wing – south gable with doocot and flight holes.

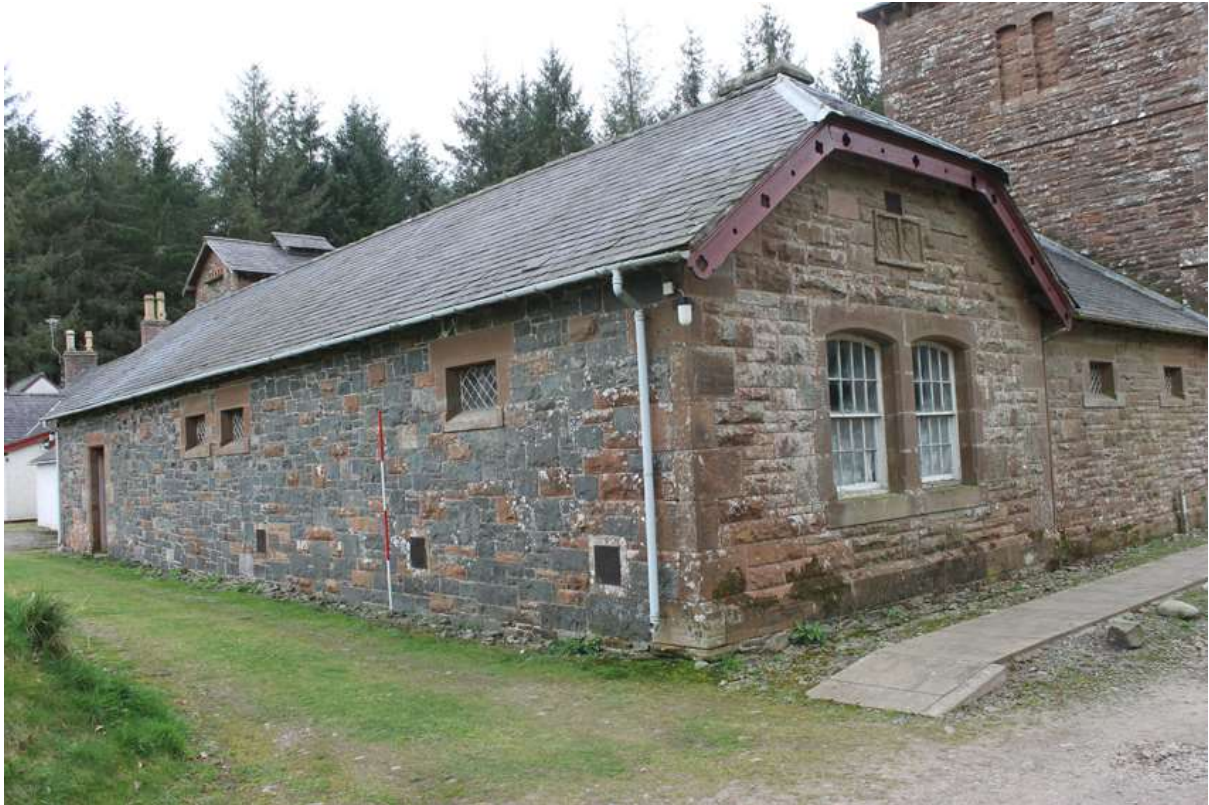
5.4.5 Unit SW4 is of similar dimensions to SW3 and is also accessed by a single doorway from EW1. The walls are limewashed, the floor is concrete and the ceiling is slatted timber with a central light fitting. Against the north wall is a fireplace with a wooden board above and a wooden coat rack to the right hand side. There is a single window in the south wall and a segmental bipartite window with timber sashes in the east wall.

Fig. 14. South Wing – re-used armorial plaque above bipartite windows in SW4.

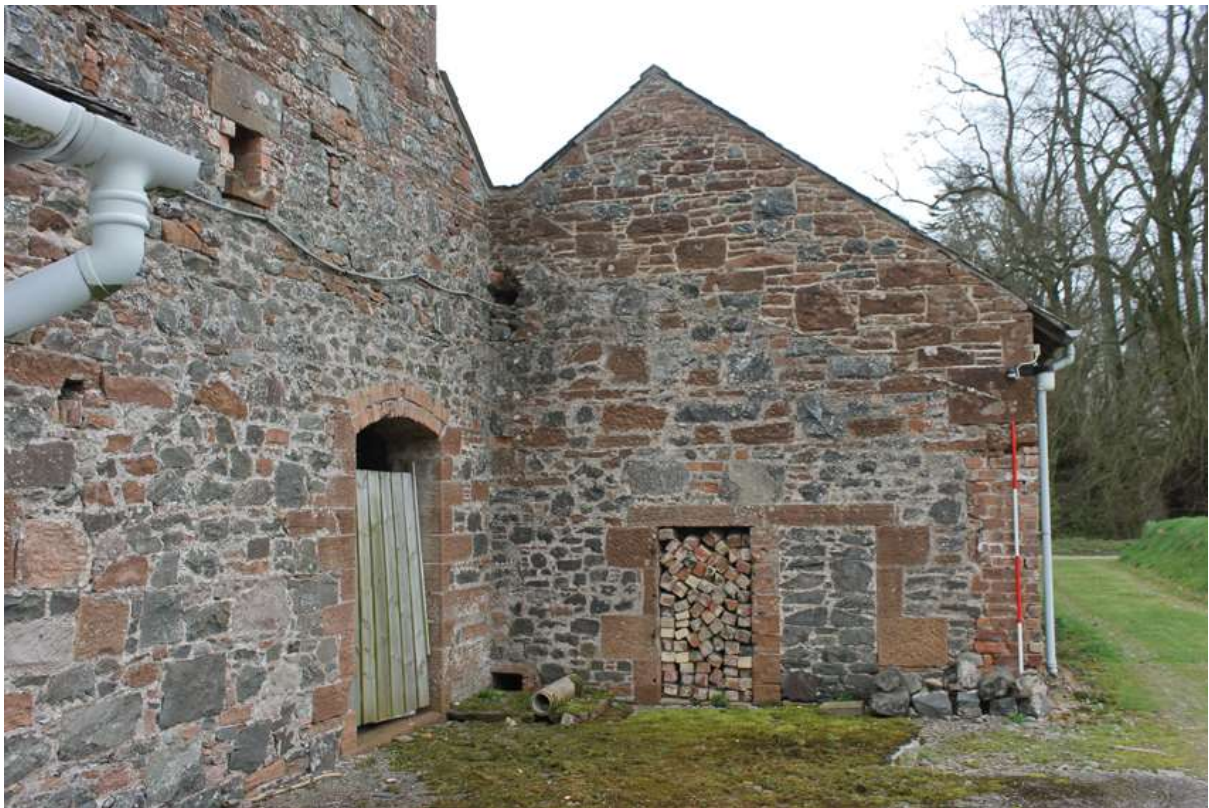
Fig. 15. South Wing – west gable.

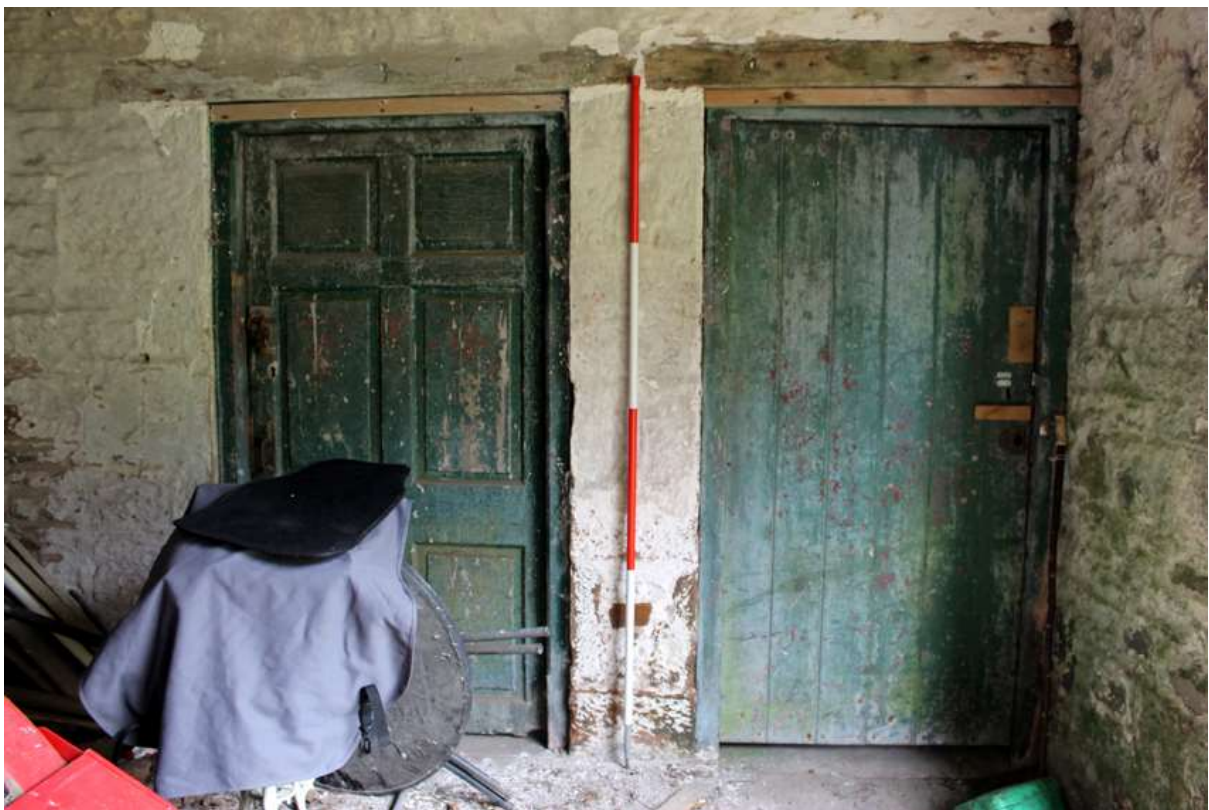
5.4.4 Unit SW3 is a rectangular space with a concrete floor and limewashed walls and is accessed via a doorway from room EW1 in the East Wing. Against the south-east corner is a redundant (early 20th century?) timber-framed electricity unit and junction box with some related pencil graffiti on the east wall. In the south wall is a window of the same design as the one in SW2 and there is an eight-pane timber sash window in the north wall.

Fig. 17. South Wing – doors to SW3 and 4 from EW1.

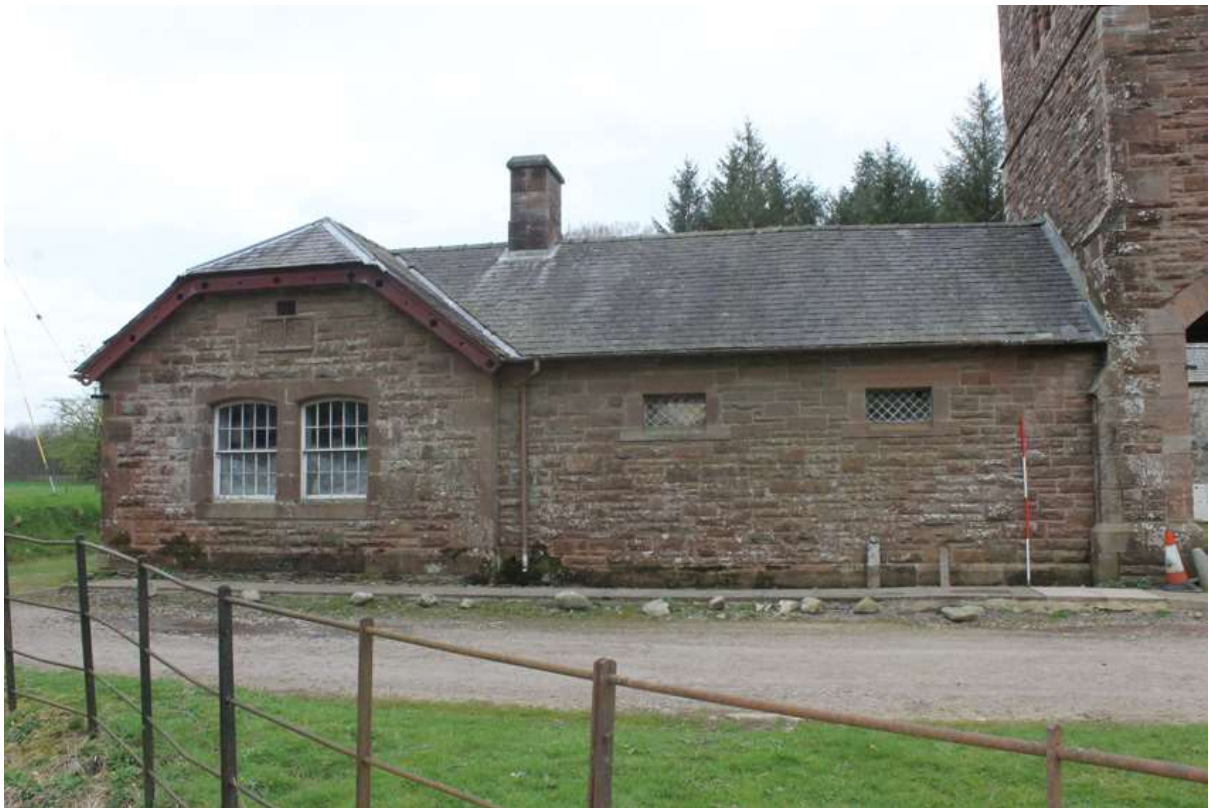
windows in units EW1 and 2 are rectangular with ashlar sandstone surrounds and cast iron lights and are the same design as the windows in the outer face of the South Wing.

Fig. 19. East Wing – outer face of EW1 and 2.

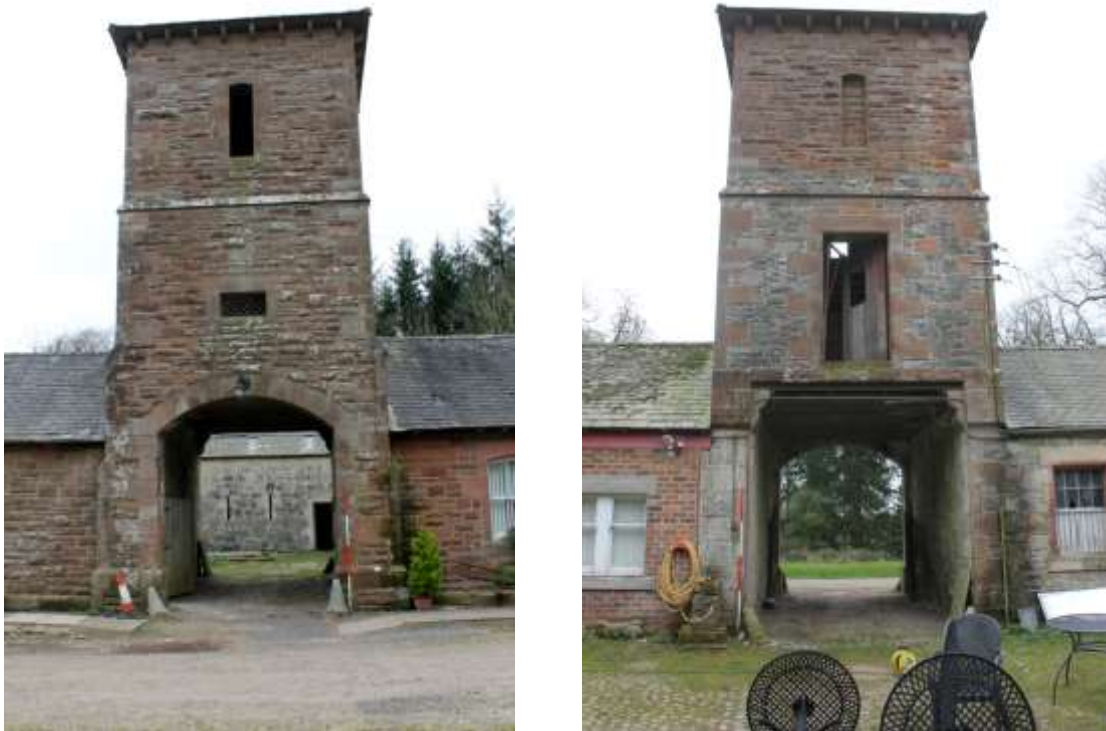
5.5.4 Unit EW3 comprises the pend and tower. The outer face of the pend has a segmental arch with finely finished ashlar surrounds. Internally the pend has a flat timber top and on the inner face are opposing half-round stone corbels support an RSJ lintel. The floor of the pend is cobbled and there is an inset cast iron downpipe on the north wall. The tower is in two stages, the lower stage being the taller. In the outer face of the lower stage is a single rectangular window with iron panes which echoes the windows in EW 1 and 2. On the inner face is a timber door with a hinged sack lift to one side. The tower's second stage is off-set and has a single, narrow round-headed blind opening in the outer face and similar paired blind openings in the side faces. The single opening in the inner face is not blocked but there is no evidence for window framing. The tower has a slated piend roof with stone-bracketed eaves.

Fig. 20. East Wing – EW3 pend and tower (left: outer face; right: inner face).

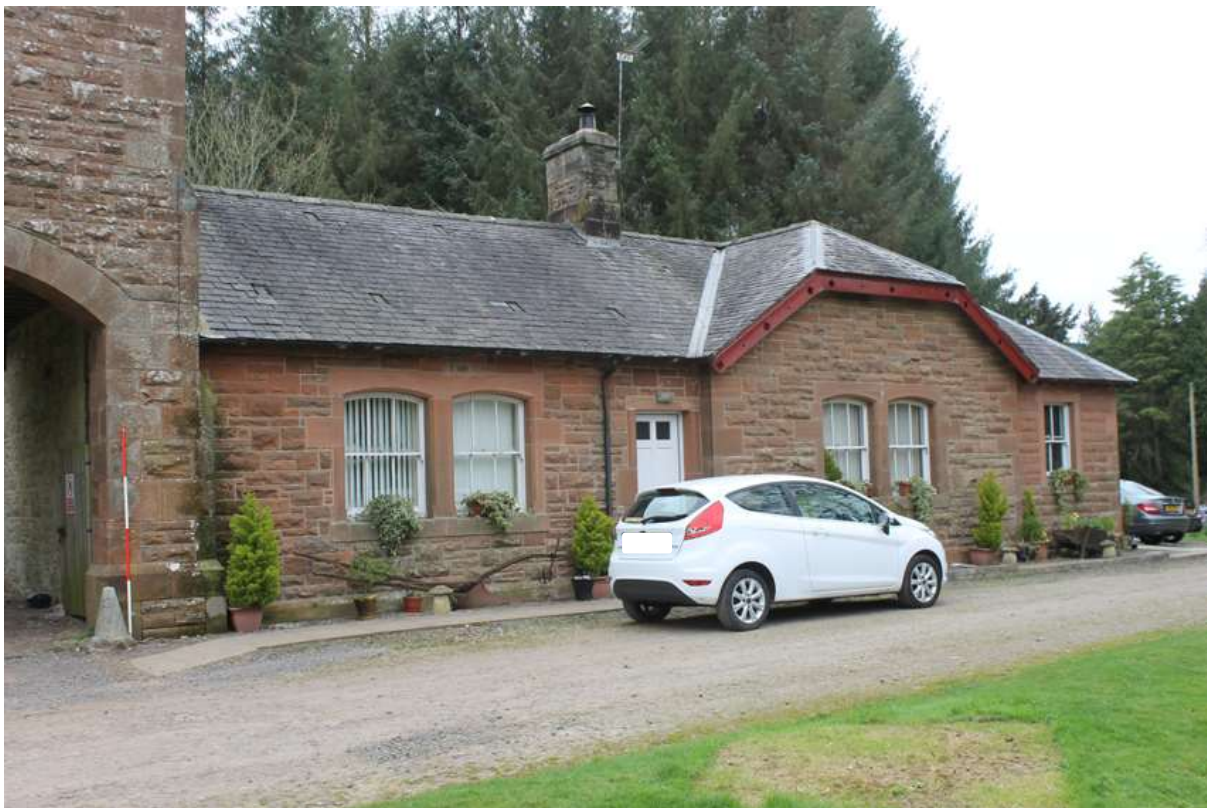
Fig. 21. East Wing – Beech Cottage. Bargeboard roof over right bay.

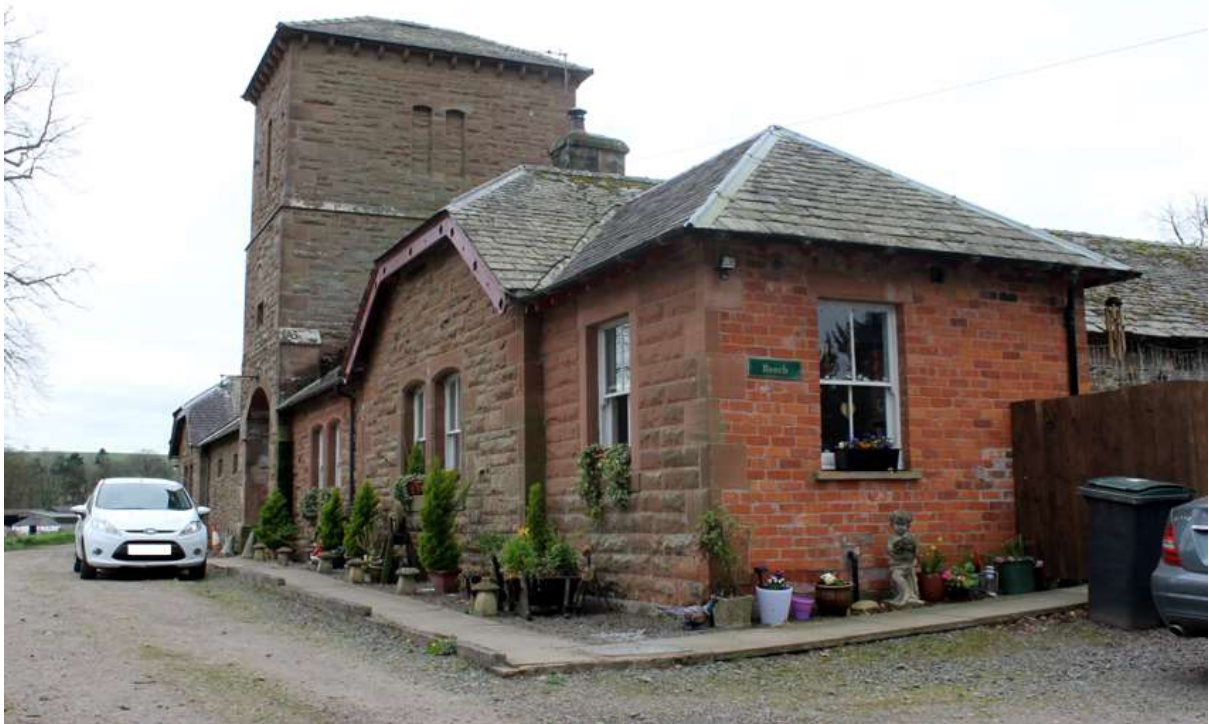
6.4 A final phase of building is marked by Beech Cottage’s north bay and the refacing in brick of the cottage’s inner wall facing the courtyard.

Fig. 22. East Wing – Beech Cottage showing modern bay with brick side wall.

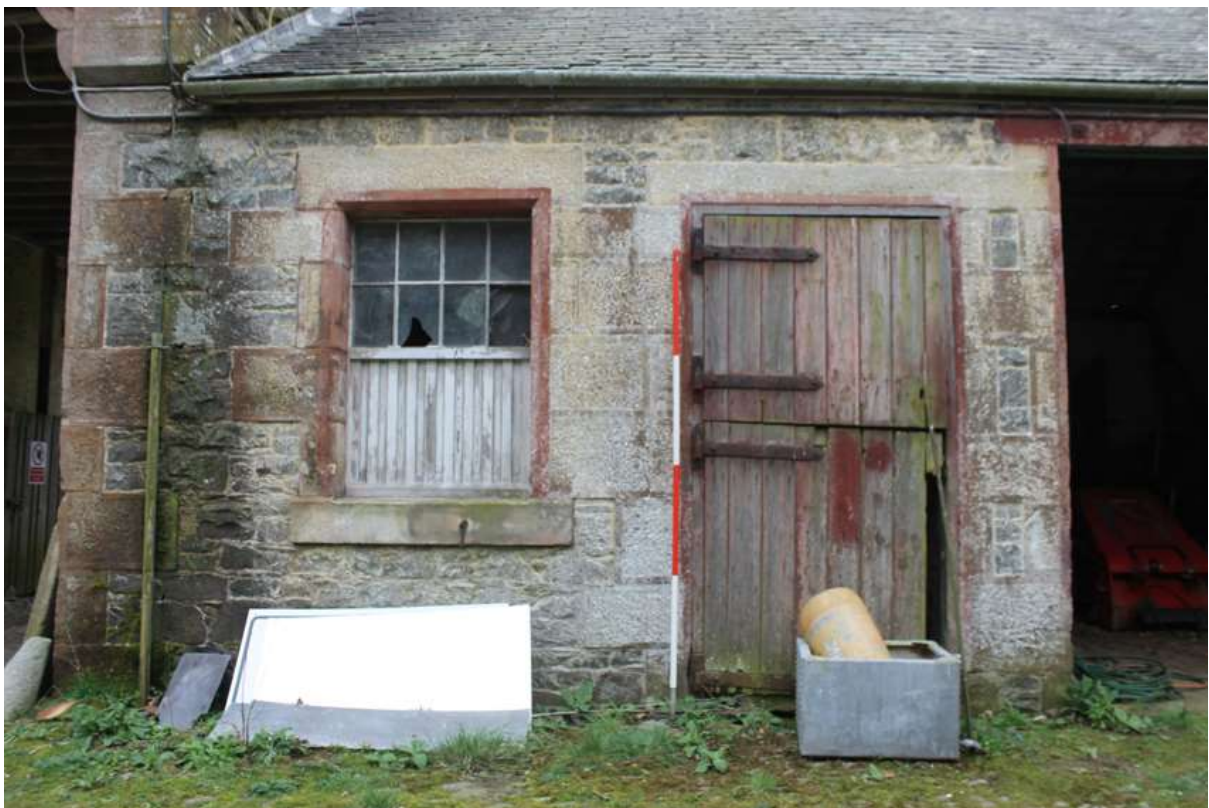
5.5.3 Unit EW2 has a wide entrance opening directly onto the courtyard. The walls are limewashed and the floor has stone flags. In the south wall are two doors leading into units SW3 and 4. There are no other internal features in this unit.

Fig. 23. East Wing – courtyard entrance to EW2.

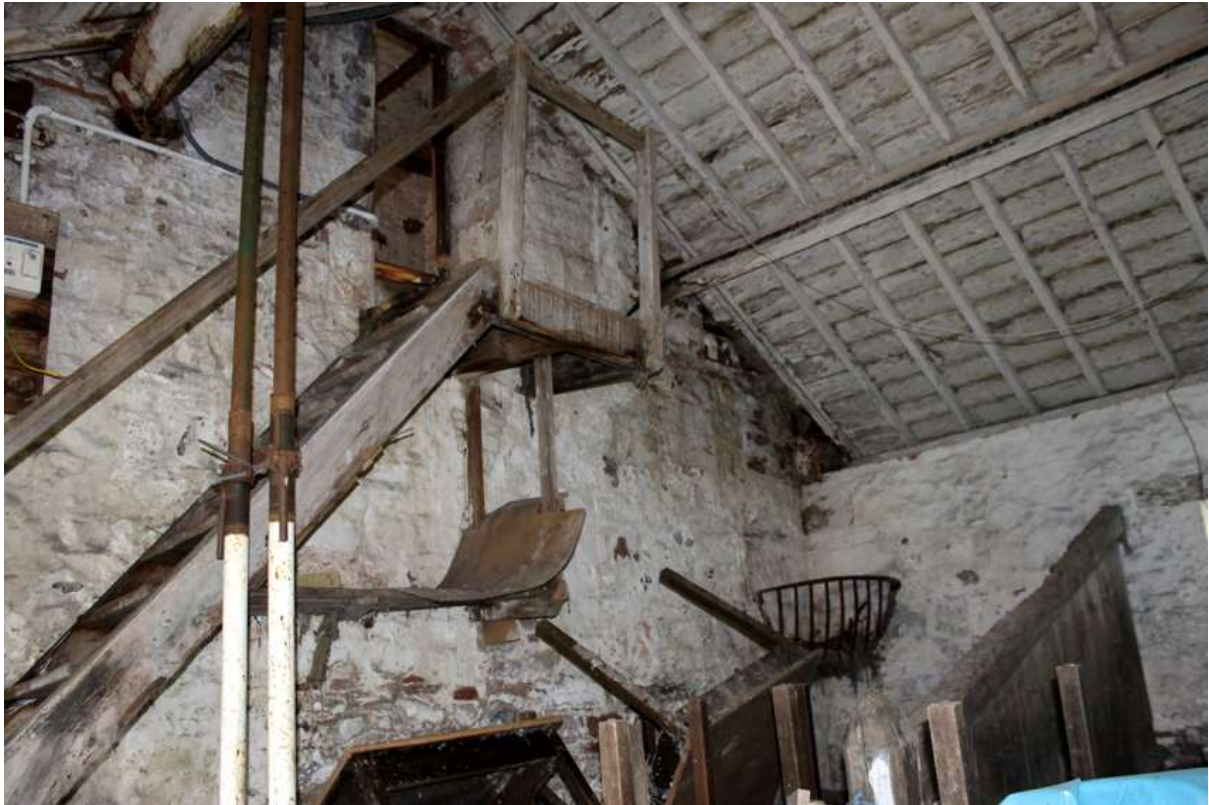
Fig. 22. East Wing – EW2 with stalls, feed boxes and stairs to tower,
