Friars Carse Stable Block North Wing

Friars Carse, Dunscore, Dumfries and Galloway

Building Record April 2017

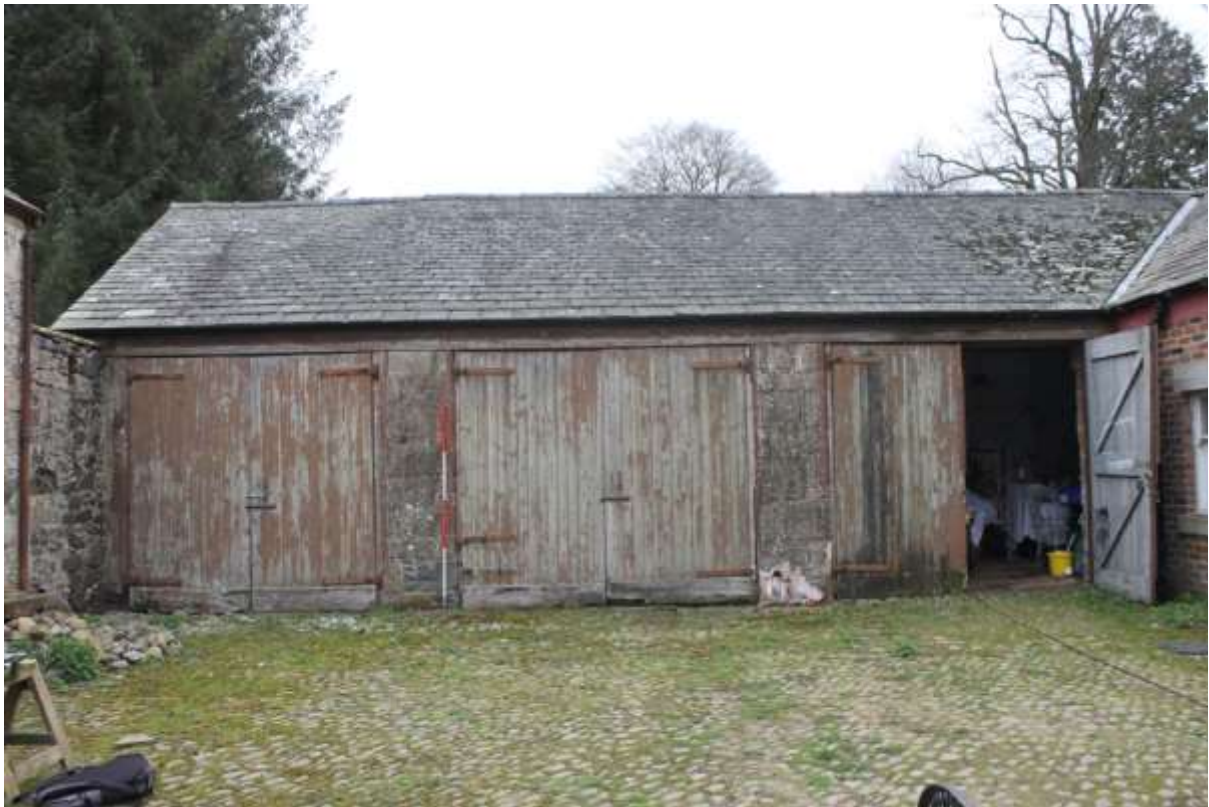
5.3.1 The south wall of the north wing faces the enclosed cobbled courtyard . It comprises three sets of equal-sized wooden slatted double doors with kick boards which open into the courtyard. The doors hang from pillars of pick-dressed sandstone set on whinstone base courses; the external edges of the pillars are chamfered and defined by vertical stripes of red paint. In front of the central and west door and set into the cobbled courtyard surface are remnants of a carved sandstone drain. Above the doors and supported by the stone pillars is a massive three-section wooden lintel which acts as a wall-plate for the roof structure. The roof is in graded grey slate with grey ceramic ridge tiles.

Fig. 6. South face of north wing.

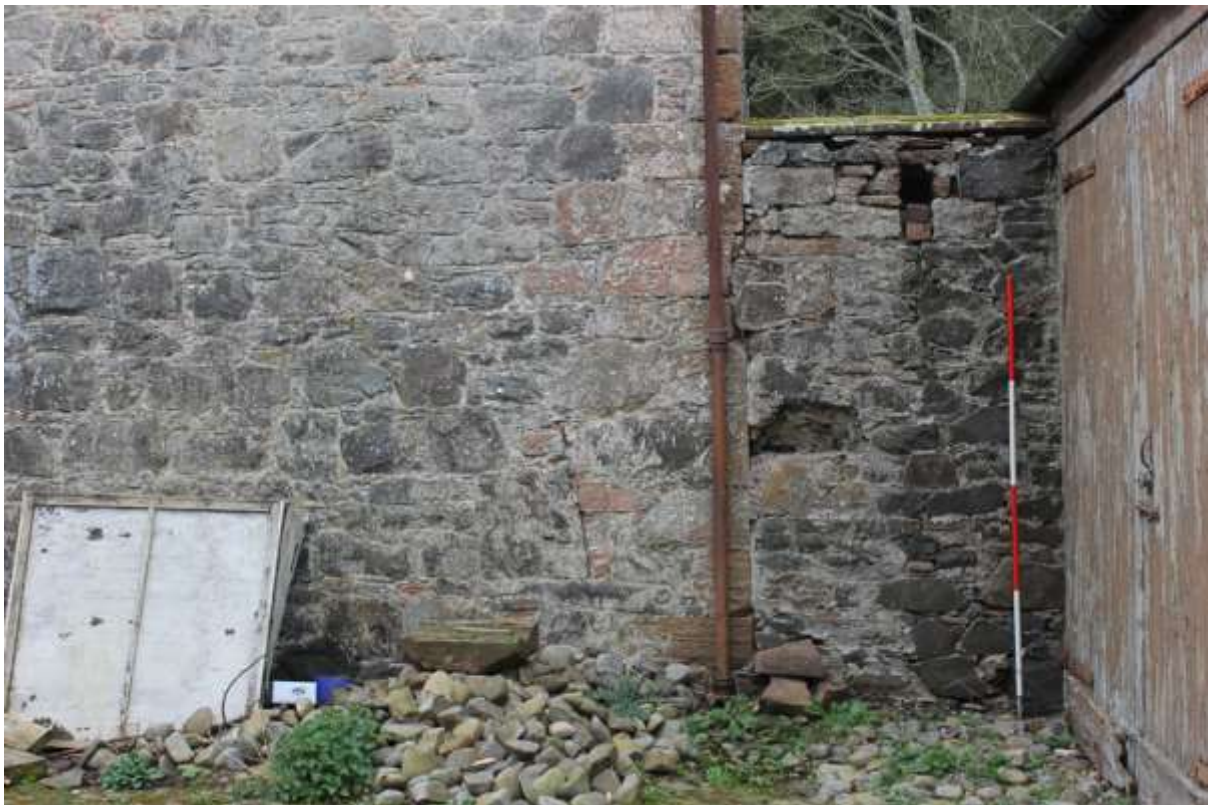
5.3.2 The corners of the south wall are obscured by surrounding structures. The west corner is overlapped by a length of rubble whinstone wall which forms part of a covered passageway between the west wing and a door in the west wall of the north wing. The east corner and the internal east gable are incorporated within the west wall of Beech Cottage.

Fig. 7. Joining wall between west wing (left) and north wing (right).

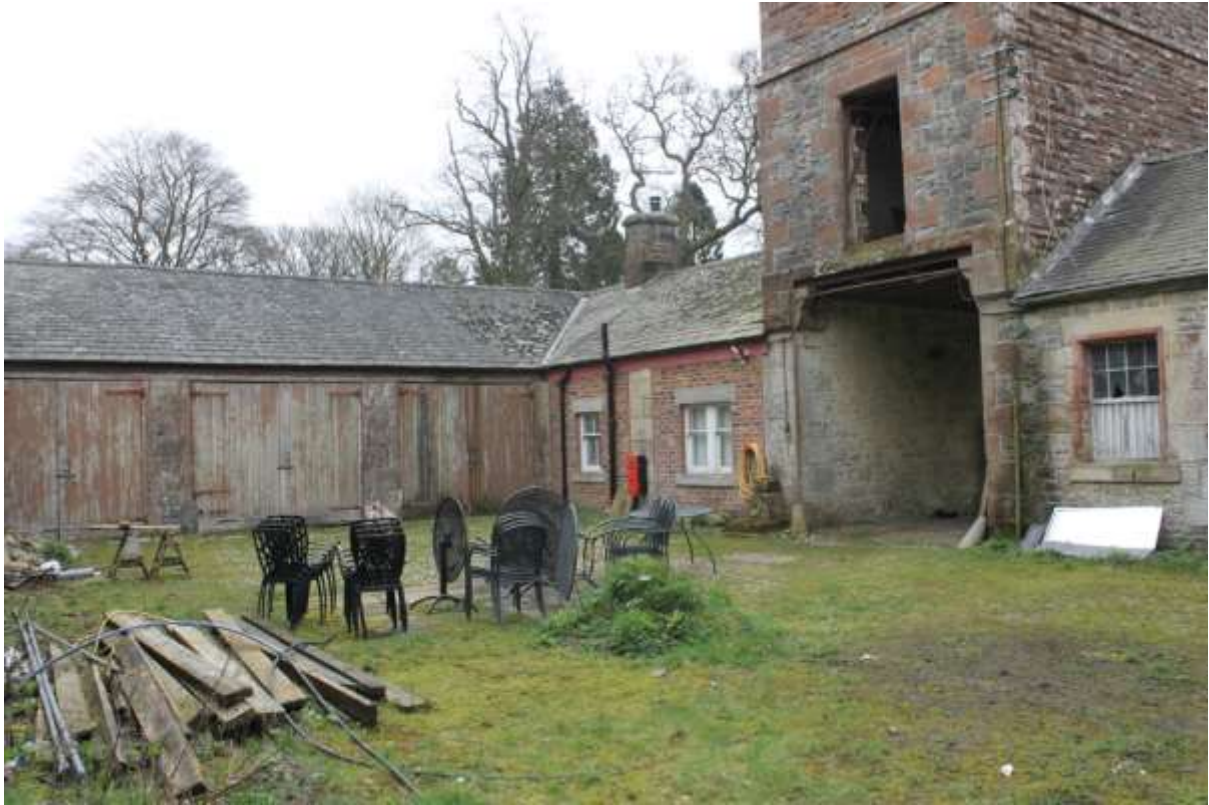
Fig. 8. General view showing north and east wings and pend entrance.

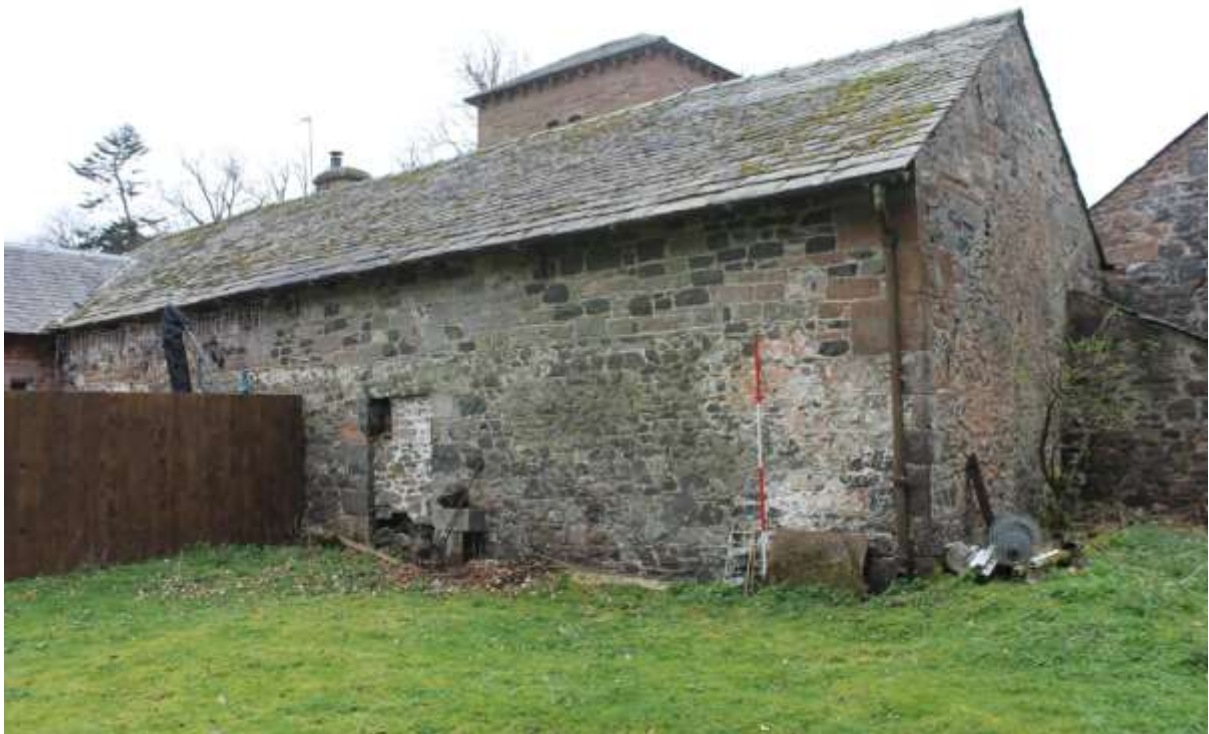
5.3.3 The north wall of the north wing exhibits two constructional phases. The lower 1.8m of the wall is whinstone rubble in lime mortar with angular blocks towards the base and water-rounded cobbles above; the quoins are square-cut whinstone blocks. The lower section of wall incorporates two rectangular ground-level openings approximately 1m wide and 1.8m high. The western opening has a large whinstone lintel and square-cut whinstone margins and has been infilled with a rough wall of lime-mortared whinstone rubble (the eastern opening lies within the fenced garden of Beech Cottage and could not be inspected in detail but appears to be similar to the western opening). The upper section of the north wall is made with dressed sandstone and occasional whinstone blocks set in rough courses and the quoins are dressed sandstone. The wooden eaves-line lintel seen in the south wall has not been used in the north wall and the roof structure sits in joist holes below the stone wall-head. There are cast iron rhones and, at the west end, a cast iron downpipe.

Fig. 9. North wall showing two-phase construction and blocked opening.

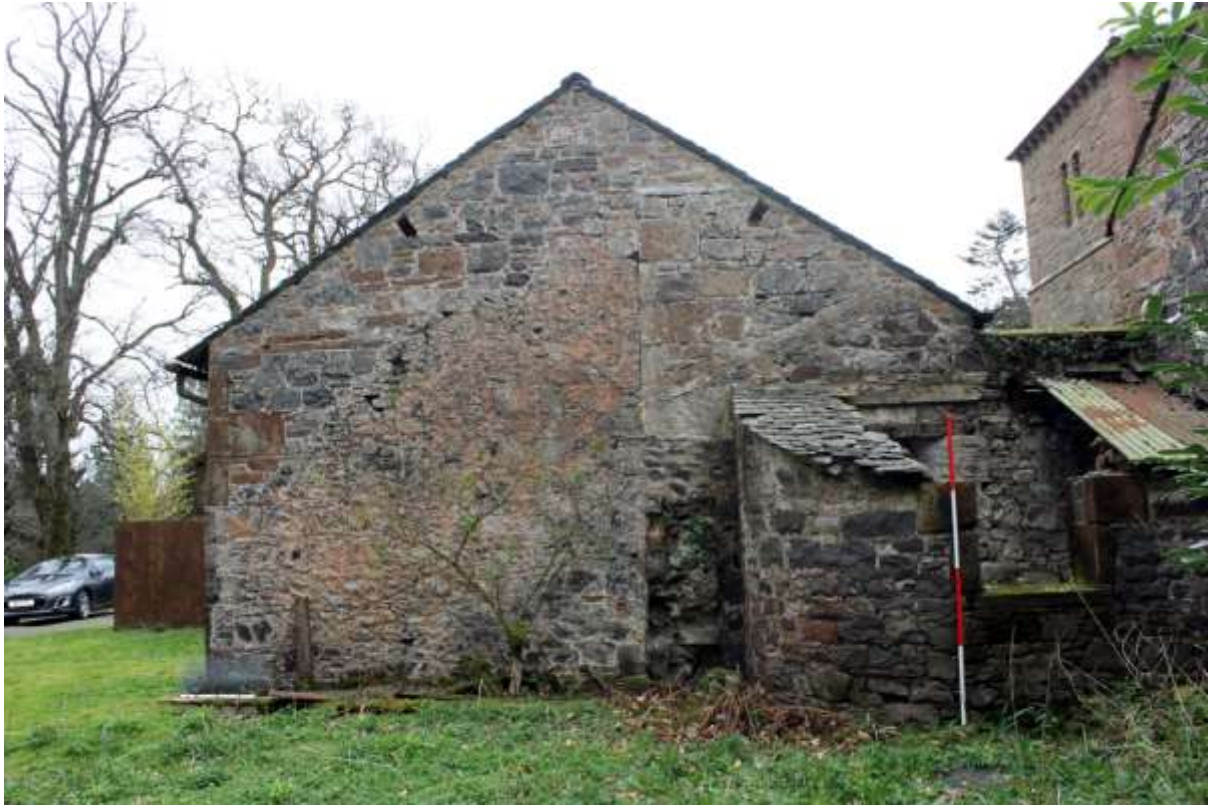
5.3.4 The west wall, the gable end of the north wing, also has evidence for more than one phase of building. The northern section exhibits the same two-phase construction of random whinstone rubble topped by coursed sandstone as seen on the north wall; the junction between the two follows a diagonal line that may preserve an earlier, lower gable. Towards the centre of the west wall the whinstone rubble section butts against a vertical wall line of dressed sandstone quoins below which is a demolished extension to the west; a diagonal mortar line indicated the position of the roof line above this extension. Built against the south section of the north wall is the external face of a passage way from the west wing

Fig. 10. West gable wall showing building phases. The angled slots are for the Phase 3 roof purlins.

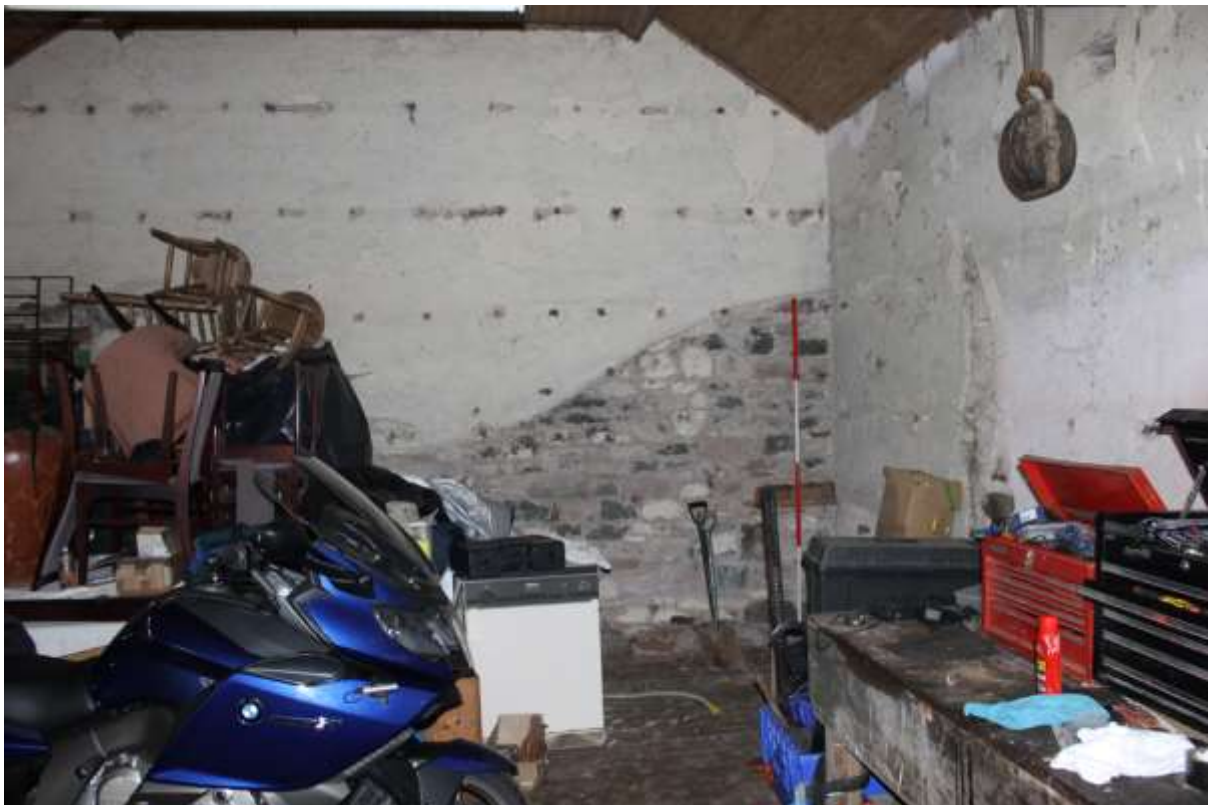
5.4.1 The central and east doors give access to a single rectangular room measuring 5.4m x 9m internally. The walls are random rubble with a white-painted plaster coat and a series of parallel peg holes show where wall coverings have been held in place. An area of brown varnished narrow-slat panelling survives against the central pillar and it must be assumed that this covering once extended throughout the interior. The curving outline of stall surrounds can be seen at the north ends of the east and west walls. Corresponding cement divisions in the brick floor indicate the position of four box stalls set in front of the north wall. There is an iron box-drain at the south end of the brick floor and beyond this the floor is covered with rectangular sandstone slabs. A blocked ground level opening in the west section of the north wall corresponds with the opening observed on the exterior of the wall (5.3.3) above and there is a door in the south section of the west wall leading to a smaller room to the west. At the south end of the east wall there is a blocked ground level opening with a another opening above at roof level; these openings presumably connect with what now is Beech Cottage. Immediately below the north wall head is a row of vertical ventilator slots. The roof is a wooden kingpost structure with the tie-beams set into joists on the north wall and jointed with the eaves-level lintel to the south. The tie-beams and the lower section of the king posts are exposed but the upper part of the roof structure is concealed by a slat-panelled ceiling. A void in the centre of the ceiling probably held a light fitting.

Fig. 11. Interior view showing outline of stable stall and support holes for wall panelling.

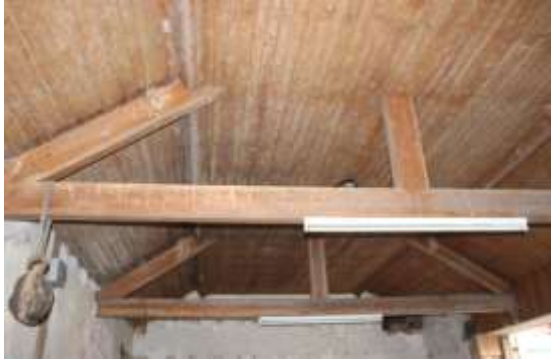
Fig 12. Roof structure.

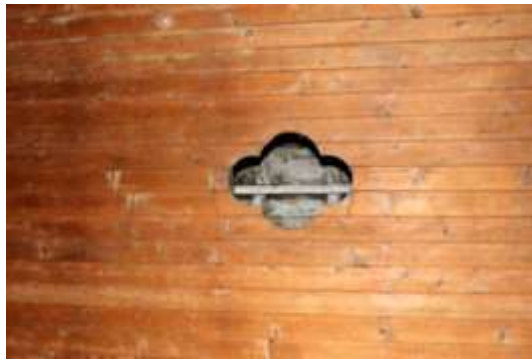
Fig. 13. Ceiling void for light fixture.

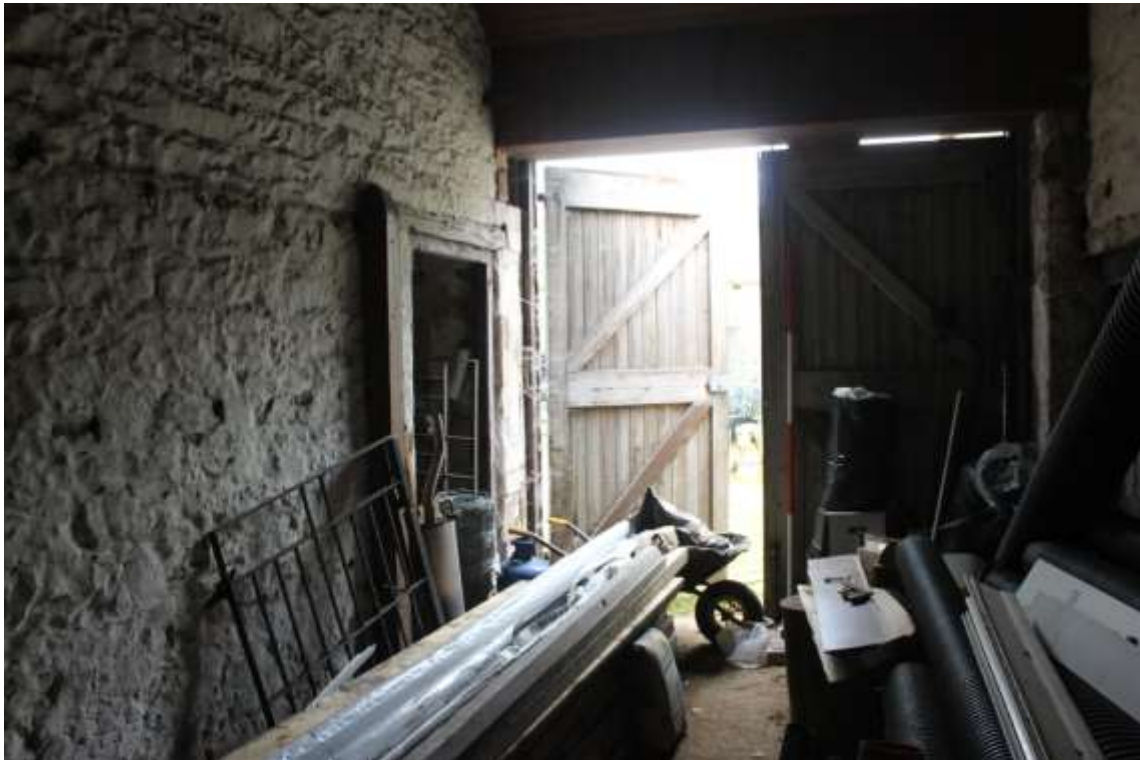
5.4.2 The west door leads to a rectangular room, 3m x 5.4m, with a concrete floor and whitewashed, plastered walls. Peg holes in the plaster show that the walls once had a wooden covering. A door in the east walls leads to the adjacent room and an opposite door in the west wall leads to the passageway connecting with the west wing. There is a single ventilator slot in the north wall.

Fig. 15. West room showing door on left to main room.
