Archaeological watching brief, Enoch Castle, Durisdeer, Dumfries and Galloway

March 2016

John Pickin
Archaeology and Heritage
Services

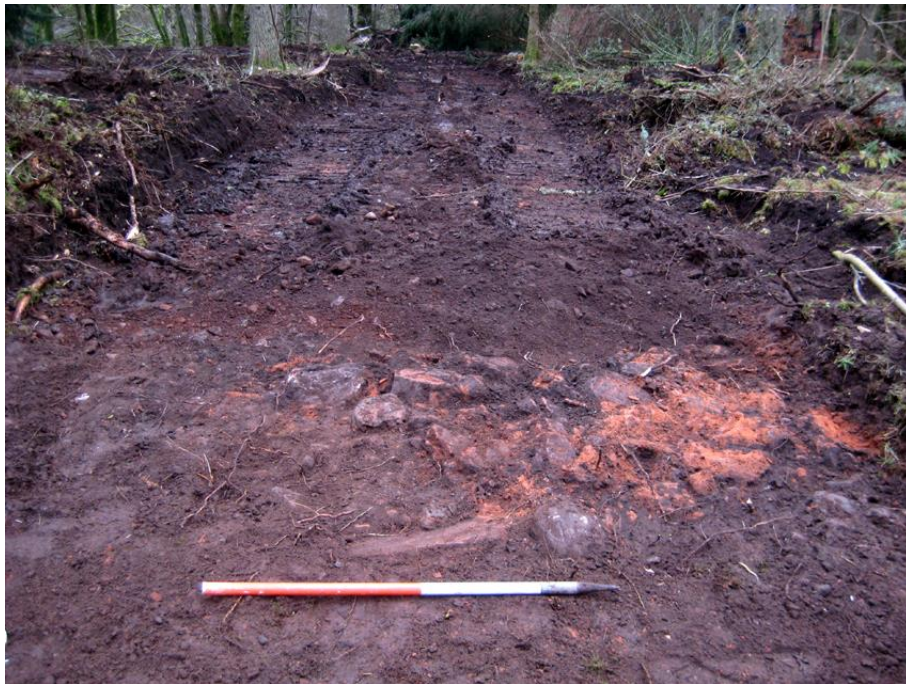
4.1.3 At the far north-west end of the trench the natural deposit 001 was cut by a linear feature (005) filled with grey clay, charcoal and sandstone fragments (003). Within or abutting this feature was a short length of wall core (002) composed of rough-cut red sandstone with a grey-white mortar matrix (002). The wall was 0.80m wide and had an excavated length of 1.30m.

Fig 4. Area 1, wall core 002. View from NW.

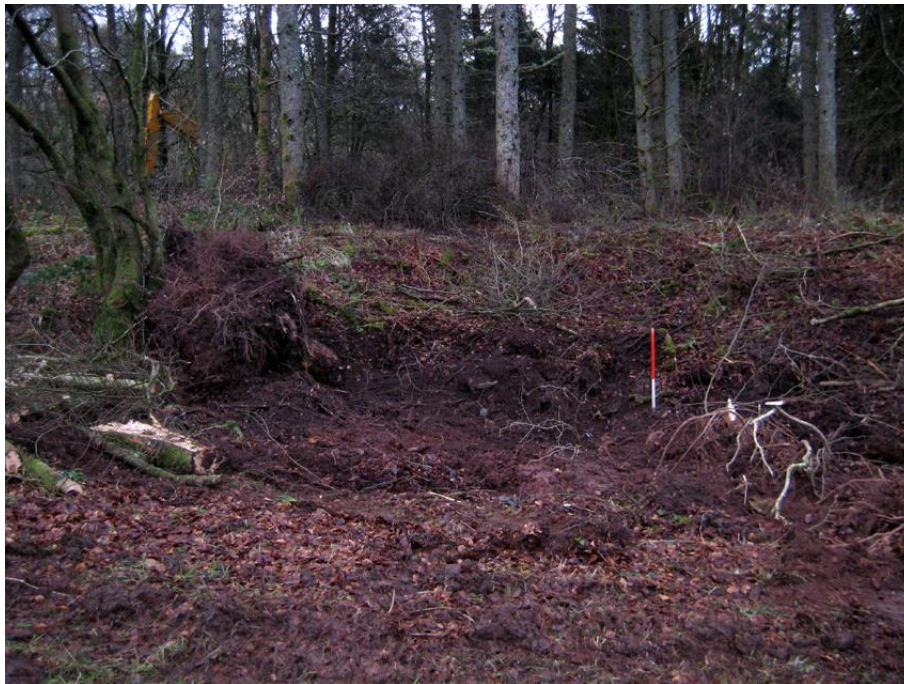
4.2.1 A machine cutting some 7m long was excavated against the north-east outer slope of the bailey to create a roadside loading area. This part of the site appears to have been previously disturbed, possibly for an access track.

4.2.2 A north-west facing section was exposed with a maximum height of 1.3m. A black humic topsoil overlay a natural deposit of orange-pink clay which contained concentrations of rounded cobbles towards the west. No archaeological features were observed.

Fig 5. Area 2 after scrub clearance and before machine excavation.

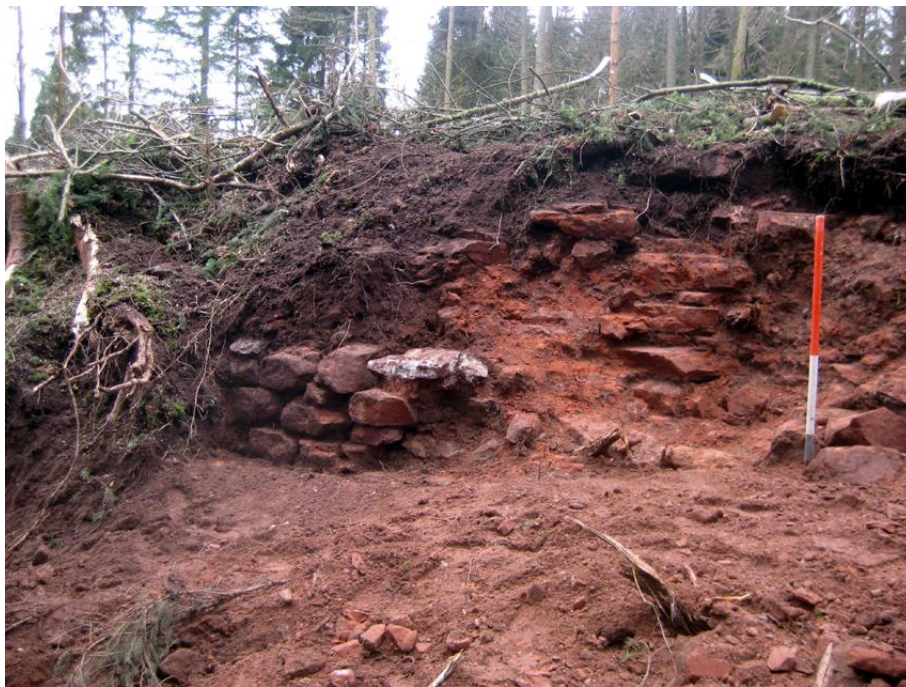
4.3.2 The only archaeological feature in Area 3 was a 5.8m length of stone walling exposed on the top north-east corner of the motte mound. It comprised a stretch of rough dressed facing stone (020), four courses high in grey sandstone, with a rubble wall core of decomposed red sandstone in a mortar matrix (021). The inner or west facing side of the wall was constructed with rough dressed red sandstone blocks (022). At no point was the full width of the wall exposed but projecting the outer faces of 020 and 022 indicates a probable width of 1.50m. The exposed wall section had a maximum height of 1.00m. The wall appears

Fig 7. Enclosure wall from NE showing facing stones 020 and wall core 021.

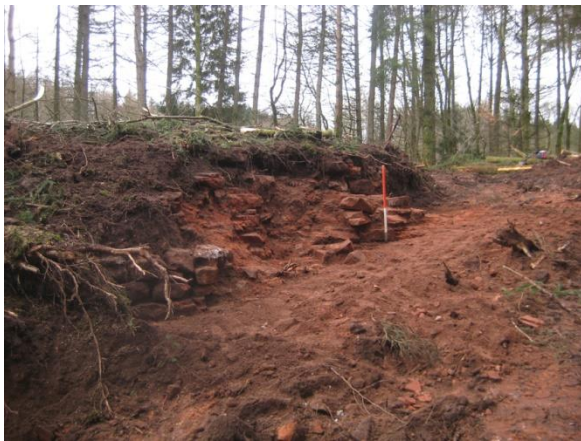
Fig 9. Enclosure wall from SE.

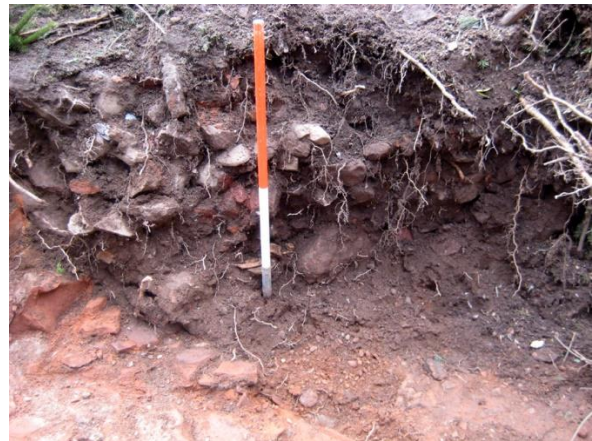
4.3.4 Deposit 024 and wall face 022 were both sealed by a 0.80m deep layer of loose black soil with large cobbles and occasional blocks of angular (building?) stone (023); this layer had been heavily disturbed by tree roots and contained a small deposit of animal

Fig 10. Deposit 023 from E.

bones (probably sheep or goat) at its base. Layer 023 and the top of the wall core wall were covered by a loose, root-disturbed top soil deposit (019) around 0.20m deep.

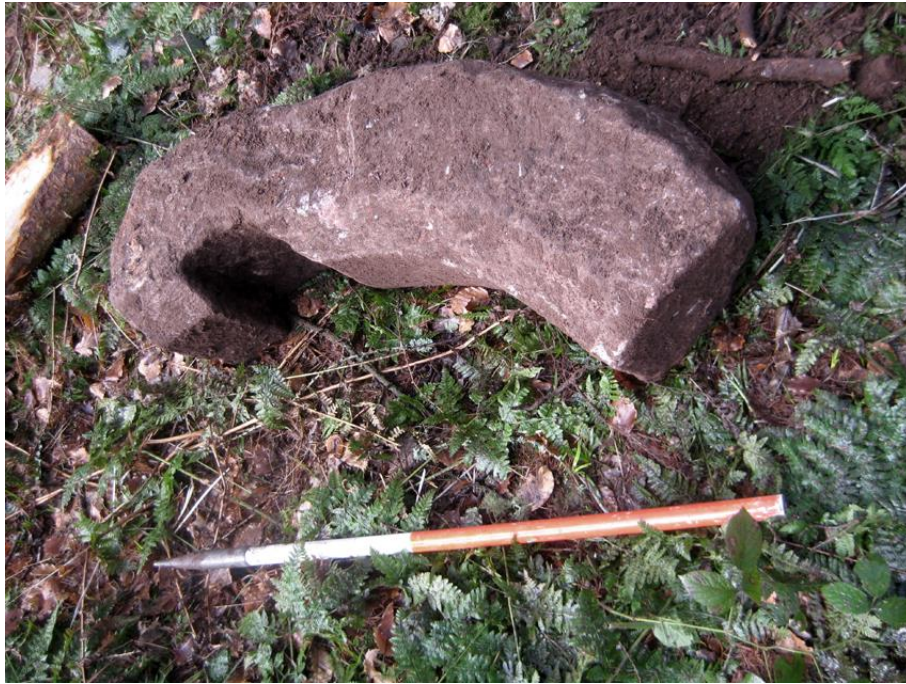
4.3.5 Within the surface top soil close to the north end of the wall was a large architectural fragment of dressed, compact grey sandstone (Figs. 11 and 12). It has a curving profile with a chamfered inner edge and an irregularly cut channel or slot; it is 110cm long. It may be part of a window or door surround or possibly part of a well head. The chamfered detail indicates a probable date within the sixteenth century.

Fig 11. Architectural fragment from Area 3.

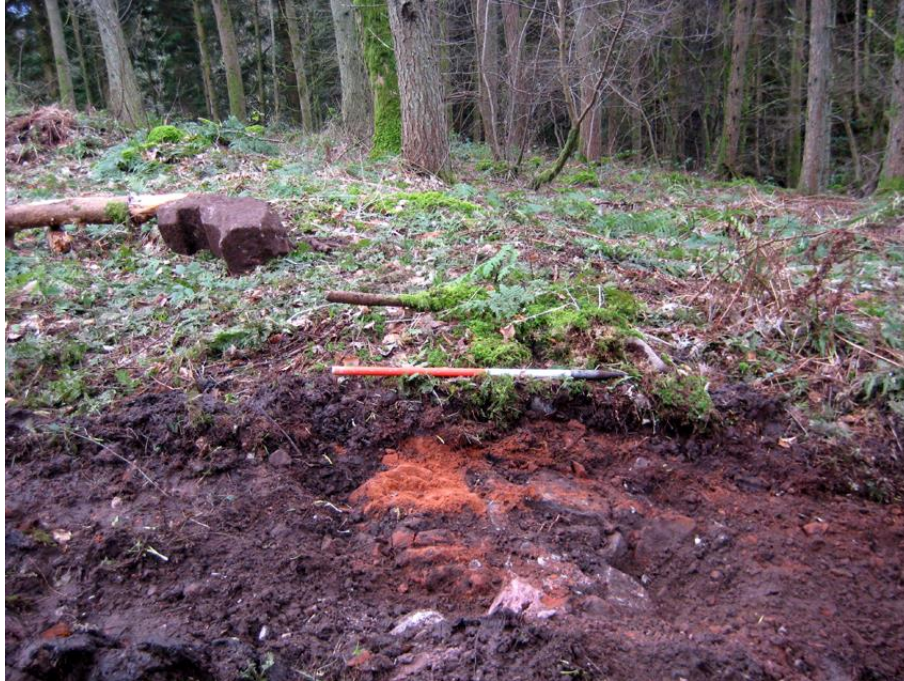
4.4.1 Part of a stone wall core was exposed by machine tracks on the north-west top edge of the motte mound. The section was 1m long and approximately 0.5m wide and comprised

red and blue-grey sandstone in a mortar. No facing stones were exposed. The wall section – which was photographed but not planned - appears to be associated with the same low earthwork bank observed in Area 3. It is also likely that this and the wall feature in Area 3 are part of the same stone enclosure located in 1930s on the northern edge of the motte (see 2.3 above).

Fig 13. Area 4, wall core exposed by machine tracks.
