# Thornton Wood Limeworks, Fife

Industrial  
Archaeological Survey  
February 2017

Report for  
Forestry Commission Scotland  
by  
John Pickin Archaeology and  
Heritage

## **Thornton Wood Limeworks, Fife Industrial Archaeological Survey**

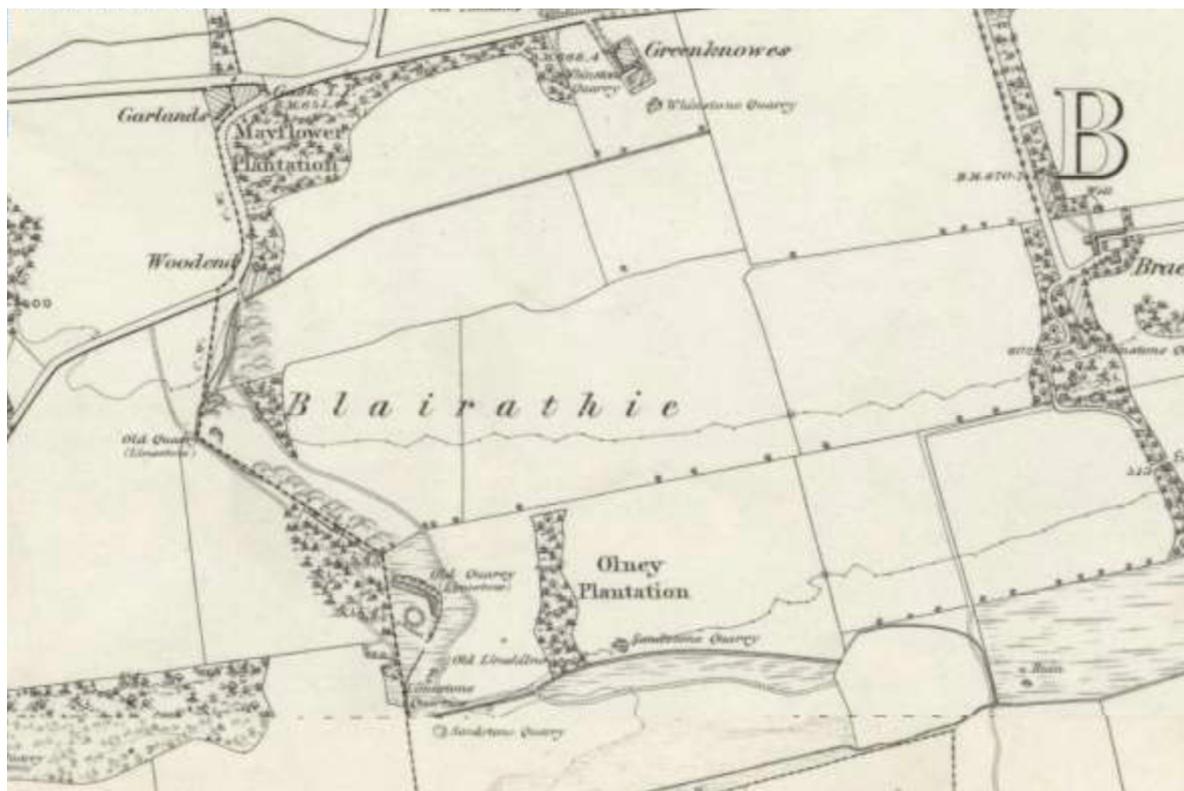
Fig. 2. OS First Edition six inch (parts of Fife 30 and 35), published 1856.

The First Edition Ordnance Survey (Fig. 2), surveyed in 1854 and published 1856, marks a large abandoned limestone quarry and old limekilns in the southern part of the survey area. The OS Name book, compiled at the same time, defines the general area as Blairathie with the comment: '*(Blairathie) Small farm name part of the nether portion of Lassodie and at one time belonging to Dumfermline Abbey. Formerly a farmhouse stood on the summit of this farm which has been wholly removed. Consequently the proprietor Mr Dewar recommends the name [Blairathie] to be written across the farm*' (OS Name books Fife and Kinross-shire: OS1/13/16/54). The proprietor, John Dewar, was the owner of the Lassodie Estate.

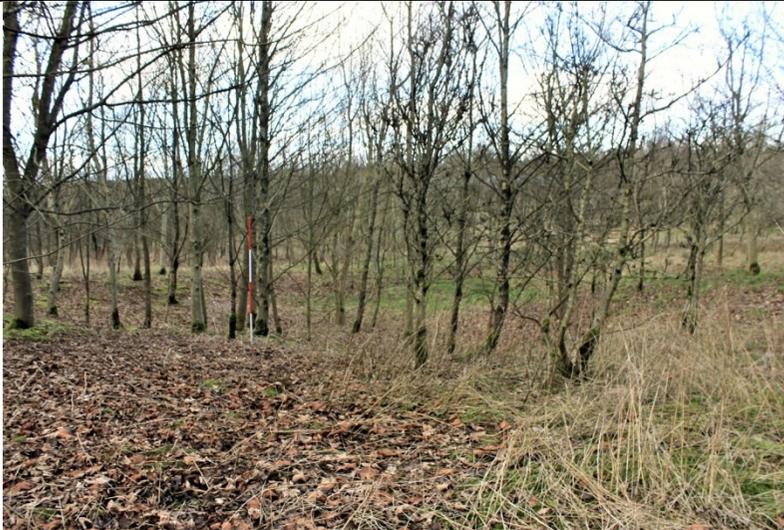
ID No	Description	Image
1	<p><b>Quarry</b> NGR: NT 11320 93086</p> <p>Description: Partly in-filled quarry pit excavated into shallow N facing slope. Survives as a circular hollow, approximately 20m in diameter and up to 1.5m deep. Not marked on First or Second edition OS six inch maps.</p> <p>Condition: Fair. In deciduous woodland. No threat.</p> <p>Significance: Moderate. Provides evidence for early industrial activity.</p>

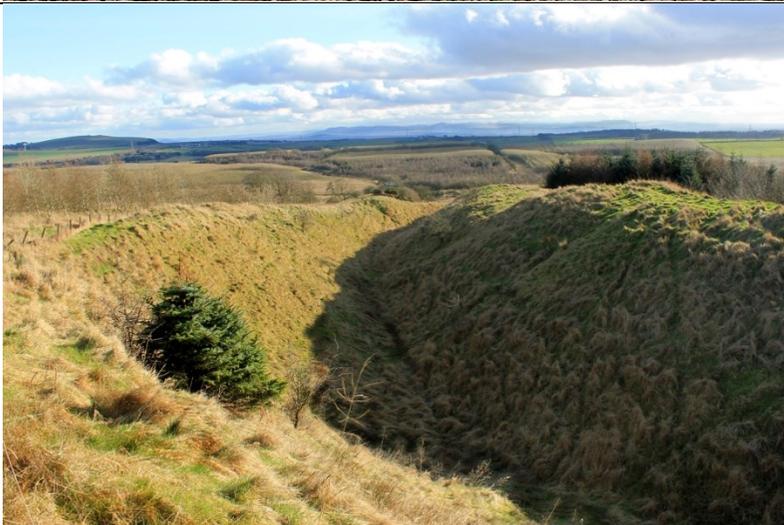
2	<p><b>Quarry</b> NGR: 10893 92848 – 10939 92700</p> <p>Description: Substantial linear limestone quarry, 150m x 30m and up to 8m deep, excavated into S facing hillside. The quarry has a V-shaped profile, the result of post-abandonment slumping and natural infill, and there are spoil tips (ID Nos 3 and 4) on the W and E flanks. Above the quarry at the N end is a shallow excavation, perhaps the result of initial ground stripping to extend the quarry. At the S end of the quarry is a tramway cutting (ID no 5). The quarry is not on the First Edition OS map but is shown as 'Old Quarry' on the Second.</p> <p>Condition: Good. Mostly grass covered with a single conifer on the NE side. No threat.</p> <p>Significance: High. Evidentially significant in in terms of understanding quarrying process. Also a key visual element.</p>

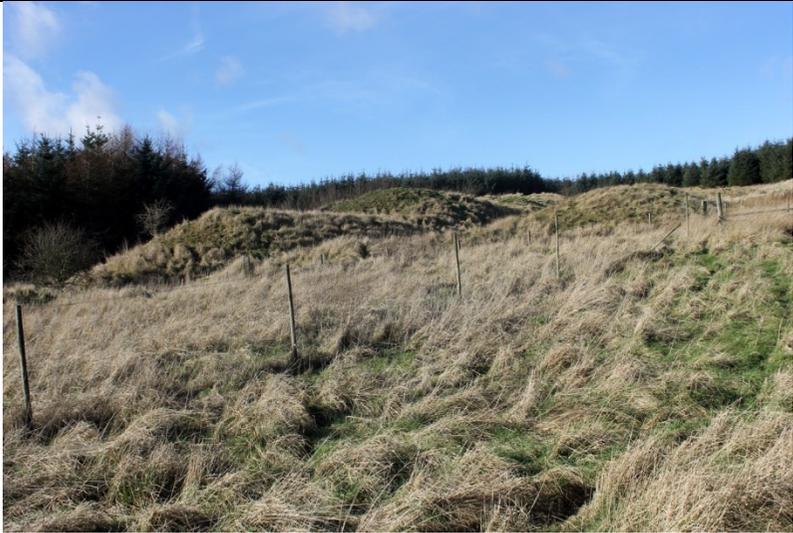
3	<p><b>Spoil tips</b> NGR: NT 10883 92827 – 10923 92715</p> <p>Description: A series of stepped spoil tips up to 18m wide along the W flank of quarry (2). The tips overlie each other sequentially with the earliest being at the S or downslope end. Depicted on Second Edition OS map.</p> <p>Condition: Good. Mostly grass-covered. No threat.</p> <p>Significance: High. Evidentially significant in in terms of understanding quarrying process. Forms a linked element with quarry (02).</p>

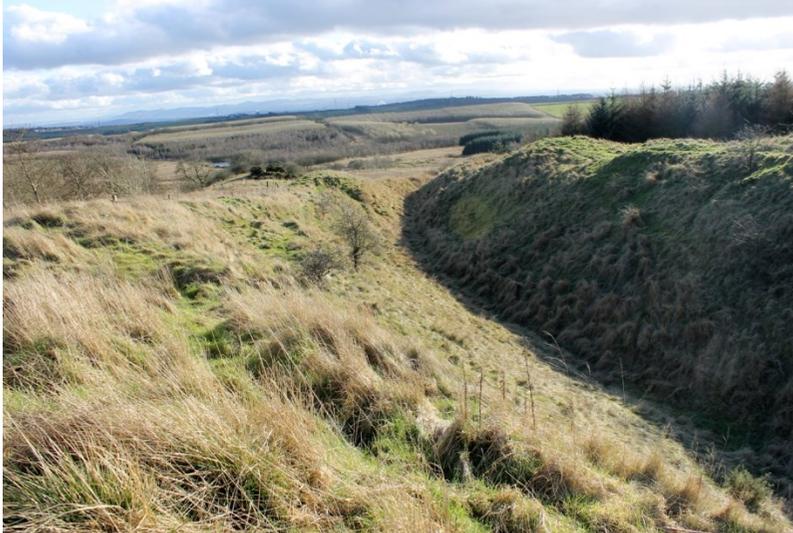
A photograph showing a series of shallow spoil tips along a valley. The tips are covered in tall, dry grass and are arranged in a series of shallow depressions along the valley. The background shows a wide landscape with hills and a cloudy sky.

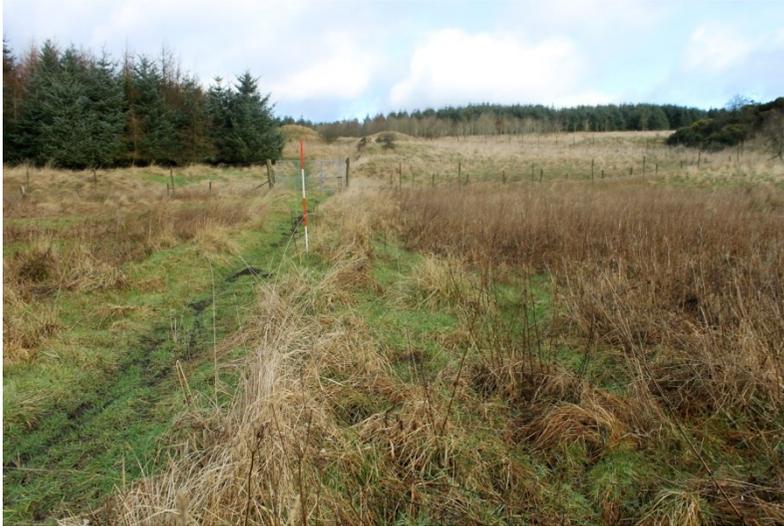
<p>5</p>	<p><b>Tramway</b> NGR: NT 10939 92700 – 10926 92575</p> <p>Description: A probable tramway running S from the S end of quarry (2). At the quarry it survives as a narrow earthwork cutting but to the S it is a low embankment approximately 1.5m wide and 0.3m high. The tramway is aligned on but stops N of clamp kilns (15a-c)..</p> <p>Condition: Fair. Grass-covered. Some small scale erosion from track which runs parallel with the embankment.</p> <p>Significance: High. Evidentially significant in terms of understanding how site transport systems operated.</p>

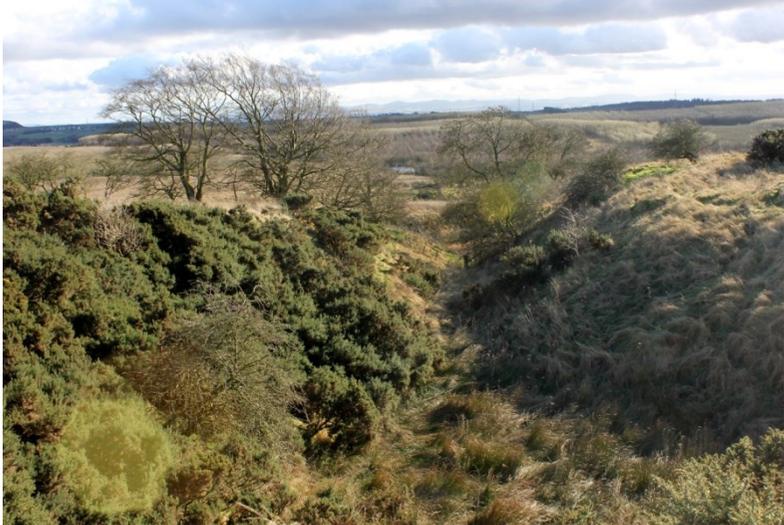
<p>6</p>	<p><b>Quarry</b> NGR: NT 10987 92704 – 11006 92531</p> <p>Description: Substantial linear limestone quarry, 140m x 25m and up to 7m deep, excavated into S facing hillside. The quarry has a V-shaped profile, the result of post-abandonment slumping and natural infill, and there are spoil tips (ID No 7) on the W flank. A quarried limestone face is exposed at the NW end of the quarry. The quarry is not on the First Edition OS map but is shown on the Second.</p> <p>Condition: Good. Most of the quarry is grass covered with gorse bushes on the E slope and mature trees on the S flanks. No threat.</p> <p>Significance: High. Evidentially significant in in terms of understanding quarrying process. Also a key visual element.</p>

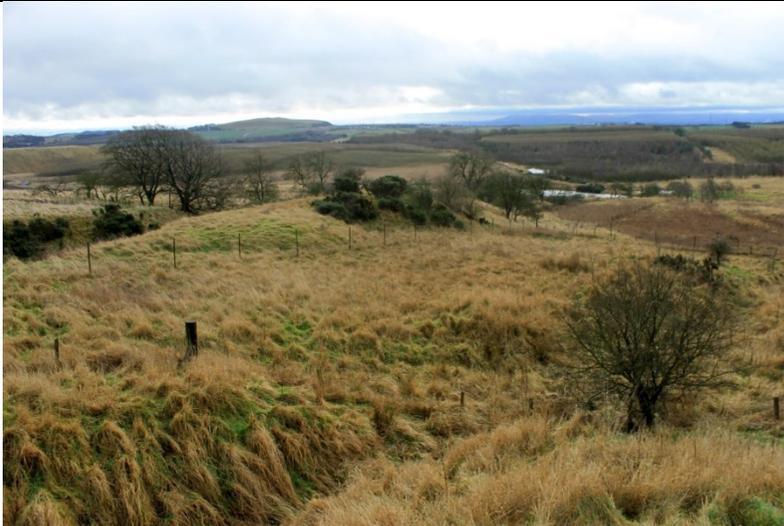
<p>7</p>	<p><b>Spoil tips</b> NGR: NT 10990 92626 – 10999 92534</p> <p>Description: A series of linear spoil tips on the W flank of quarry (6). A dumping sequence can be identified with a narrow spoil tip at the S overlain to the N by a broader, angular section tip which in turn is covered further N by low tips up to 16m wide.</p> <p>Condition: Good. Mostly grass covered with occasional gorse bushes and, to the S, some mature trees. No threat.</p> <p>Significance: High. Evidentially significant in terms of understanding quarrying process. Forms a linked element with quarry (06).</p>

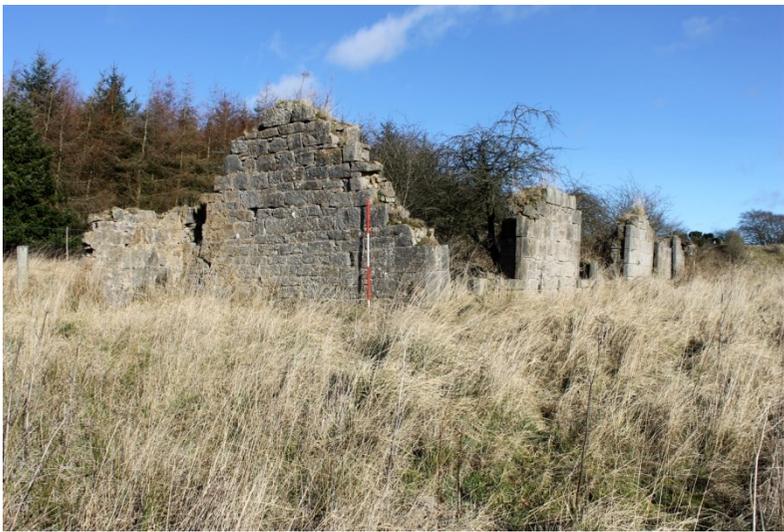
<p>8</p>	<p><b>Building (Fig)</b> NGR: NT 10873 92617</p> <p>Description: Ruins of a small terraced row known as 'Kiln Houses.' Constructed with coursed, pick-dressed sandstone blocks, the row measures 5.7m x 22m and the W gable stands to a height of 3.4m; the E gable is ruinous and survives only as a rubble spread. The two cottages at the W end are separated by a rubble party wall incorporating back-to-back fireplaces constructed from vertically set sandstone slabs; both cottages have a single door and window in the south wall. To the E is a larger space with a central door and flanking windows in the S wall. A vertical face at the S end of the E gable wall indicates another doorway and it is possible that this space may have been a workspace (possibly a smithy?) rather than a domestic dwelling.</p> <p>Condition: Poor. E end overgrown and inaccessible. Major structural crack at NW corner and both N and S long walls leaning out.</p> <p>Significance: High. Evidentially significant in terms of understanding social conditions of quarry workers. Visually important as the only surviving standing building.</p>

The only standing structure, Kiln Houses, is in poor condition and may be at risk. There is a major structural crack in the west gable and both the north and south long walls are leaning out. The condition of the building should be monitored. Bramble and shrub clearance within the building would aid future recording and interpretation.

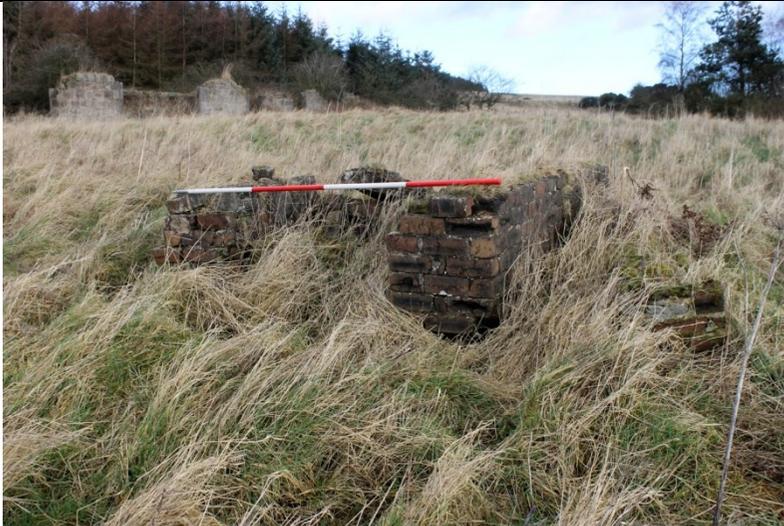
9	<p><b>Structure</b> NGR: NT 10858 92580</p> <p>Description: The remains of a brick-built rectangular structure, 2.2m x 2.8m, with a 1.10m wide entrance in the SW wall. Fallen brickwork obscures the NE wall and a vertical face at the NE corner indicates another entrance. The structure, which is cement rendered internally, stands to a height of 0.7m and is constructed with mortar-set bricks stamped LOCHSIDE. The structure is not shown on any OS maps and may be comparatively recent, perhaps a lavatory block connected with the final occupation of Kiln Houses (ID No 8).</p> <p>Condition: Poor but stable. No threat.</p> <p>Significance: Medium. Potentially important in understanding later use of site and final occupation of Kiln Houses (08)</p>

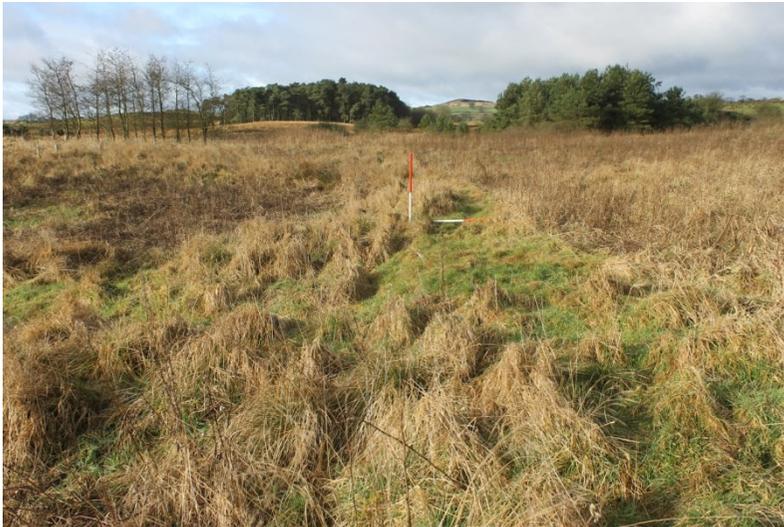
10	<p><b>Tramway</b> NGR: NT 10923 92492 – 10943 92494 – 10951 92499 – 10981 92507 – 10984 92535</p> <p>Description: Curving earthwork embankment, approximately 1.3 m wide, running WSW from the S end of quarry (6); probably a tramway. The embankment leads towards but appears to stop short of clamp kilns (15). Aerial photography shows rig cultivation immediately upslope of and apparently respecting the tramway embankment; this suggests that the embankment defined the southern end of an area of later rig cultivation.</p> <p>Condition: Good. Grass-covered. No threat.</p> <p>Significance: High. Evidentially significant in terms of understanding how site transport systems operated. Important to understanding site chronology because of association with later rig cultivation.</p>

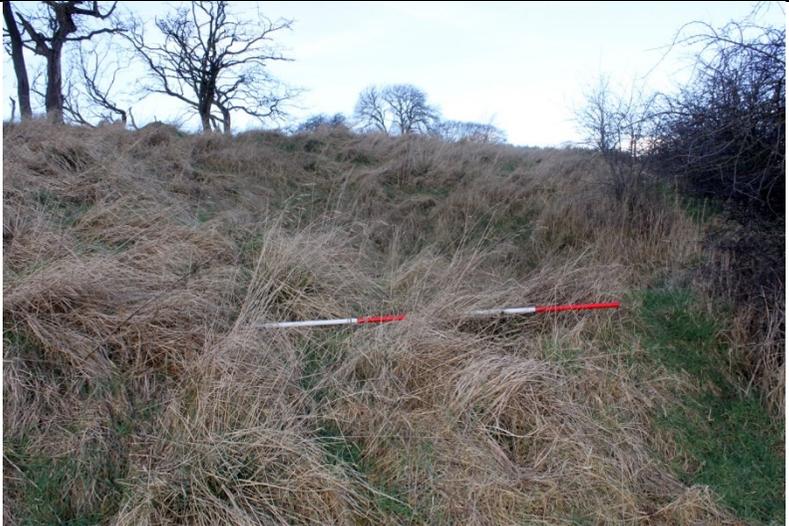
11	<p><b>Quarry</b> NGR: NT 11002 92506 Description: Circular depression on SE slope. Approximately 6m diameter and up to 2m deep at N side; shallow bank (probably spoil) to the S.  Condition: Fair. Grass covered. No threat.  Significance: High. Evidentially significant in in terms of understanding quarrying process (trial or prospection pit on Blackhall Limestone).</p>

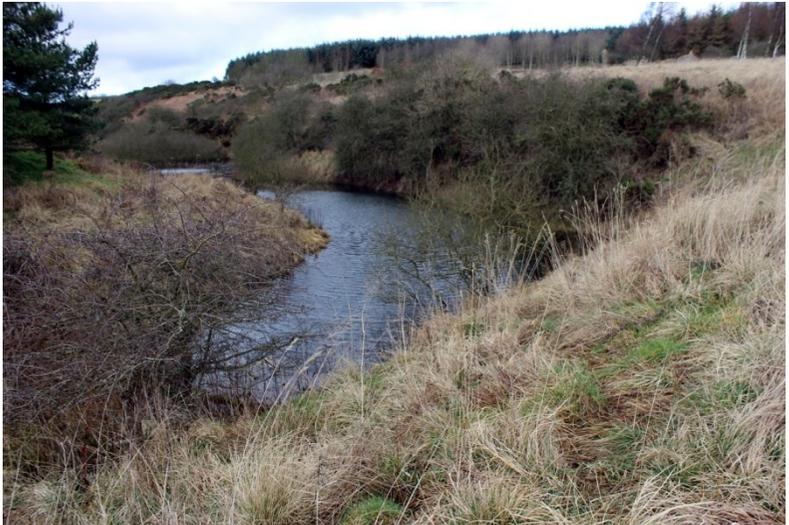
12	<p><b>Quarry</b> NGR: NT 10835 92549 Description: Substantial flooded limestone quarry excavated into the S facing hillside. The quarry has two joined working faces, the NW-SE face is 60m long and the SW-NE face is approximately 50m long (although the full extent of the latter may be obscured by dumping from spoil tip (13) and the construction of clamp kiln (14)). The quarry is about 30m wide and there is an associated spoil tip (13) to the S. Marked as 'Old Quarry' (Limestone) on the First Edition OS map.  Condition: Fair. Partially flooded and the NW-SE face has tree and gorse cover. No bedrock is exposed. No threat.  Significance: High. Evidentially significant in in terms of understanding quarrying process. Also a key visual element.</p>

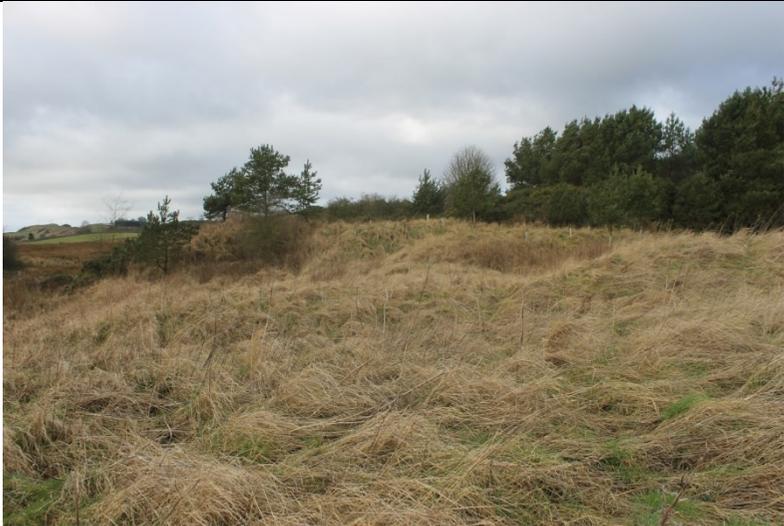
13	<p><b>Spoil tip</b> NGR: NT 10839 92525</p> <p>Description: Spoil tip associated with the working of limestone quarry (12). The tip, which measures approximately 45m x 60 x 4m high, has a flat top. There are suggestions of conjoined, linear tip lines on the S side.</p> <p>Condition: Fair. Much of the top of the tip has been planted with conifers and this masks the visual association between the tip and associated quarry.</p> <p>Significance: High. Evidentially significant in in terms of understanding quarrying process. Forms a linked element with quarry (12).</p>

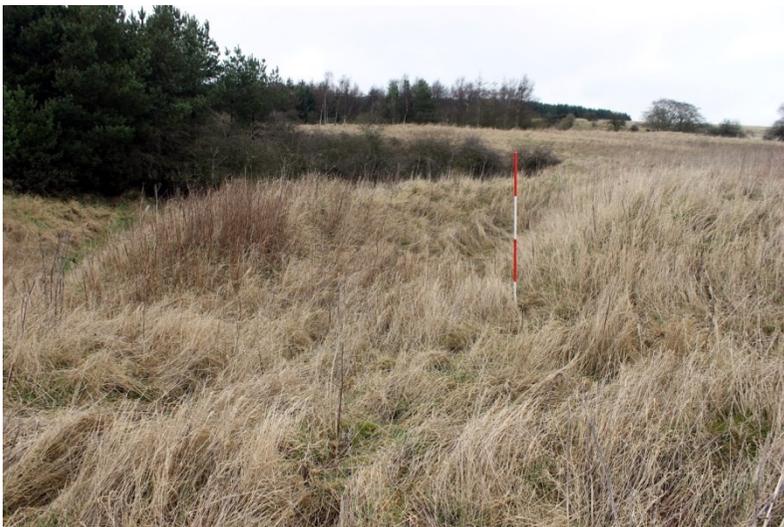
14	<p><b>Clamp kiln (Fig. )</b> NGR: NT 10862 92484</p> <p>Description: Earthworks of a rectangular clamp kiln constructed into the S facing slope. The interior measures 1.5m x 10m and the flanking banks are approximately 3m wide and 1.5m high. The bank on the NW side appears to have been constructed on the SW lip of quarry (12) and the SE bank runs parallel with trackway (22). To the SW of the kiln there is a probable spoil tip but it could not be ascertained if this was associated with the kiln or derived from quarrying. The kiln is not shown on any OS maps.</p> <p>Condition: Good. Grass covered. No threat.</p> <p>Significance: High. Evidentially significant in in terms of understanding lime burning technology. Chronologically important because of relationship with earlier quarry (12).</p>

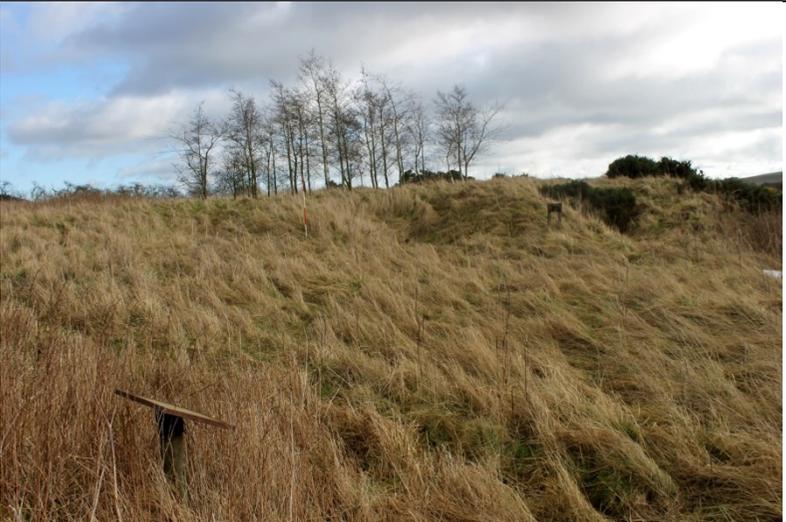
<p>15</p>	<p><b>Clamp kilns</b>            NGR: NT 10885 92472            Description: A group of three rectangular clamp kilns (IDs 15a-c) constructed into a shallow W facing slope with a flat activity or loading area immediately to the E. Kiln (15a), the most southerly of the group, measures 1m x 8m internally and is 1.5m deep; the flanking bank to the S may have been partially destroyed by the excavation of the railway cutting (ID 16). Kiln (15b) shares flanking banks with kilns (15a) and (15c) and measures 2m x 11m with a slightly flared entrance. Kiln (15c) is 1m x 8m and 1m deep. The kilns are not shown on the First or Second edition OS maps.             Condition: Good. Grass covered. No threat.             Significance: High. Evidentially significant in terms of understanding lime burning technology. Chronologically important because of relationship with later railway cutting (16).</p>

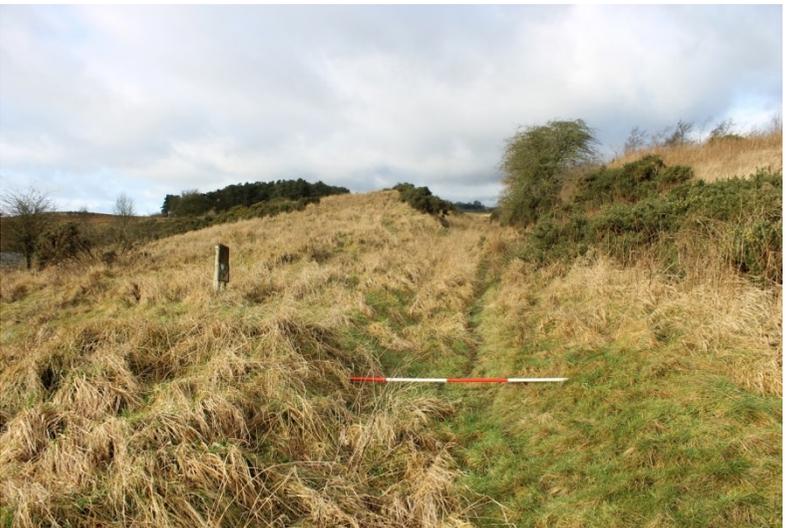
<p>16</p>	<p><b>Former railway and railway cutting</b>            NGR: NT 10812 92467 - 10984 92430             Description: A 130m length of a branch line of the West of Fife Mineral Railway survives as a cutting and short embankment; at track level the line is approximately 1.8 wide. The cutting truncates quarry (18) and may also truncate part of kiln (15a). A causeway carrying the footpath between the two ponds at the SE corner of the survey area is a continuation of the mineral line. Not marked on the First Edition OS map and shown as abandoned on the Second Edition.             Condition: Good. NW section somewhat overgrown. No threat.             Significance: High. Evidential and chronological significance in terms of understanding relationship between railway and earlier quarrying (18) and lime burning (14,15) activities.</p>

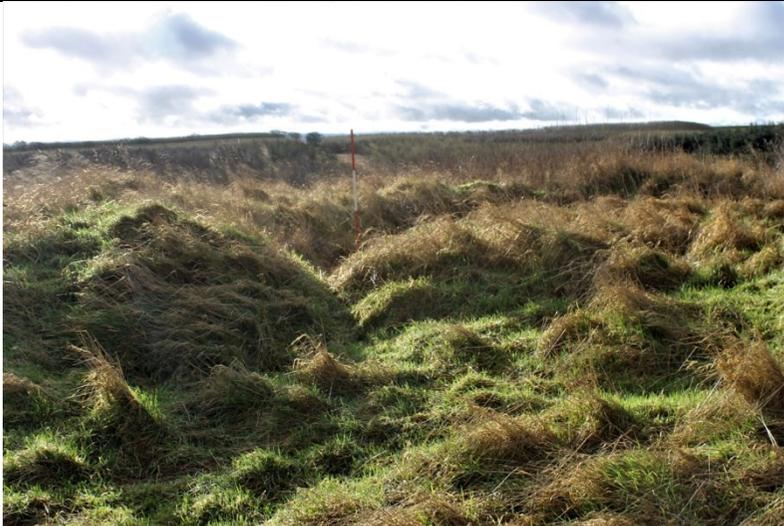
17	<p><b>Quarry pit</b> NGR: NT 10951 92476</p> <p>Description: Arc-shaped hollow, approximately 6m x 2m x 1.4m deep; low spoil bank to E and S. Probably a trial excavation to test the position of the limestone outcrop. Not shown on any OS maps.</p> <p>Condition: Fair. Grass-covered. No threat.</p> <p>Significance: High. Evidentially significant in in terms of understanding quarrying process (trial or prospection pit on Blackhall Limestone).</p>

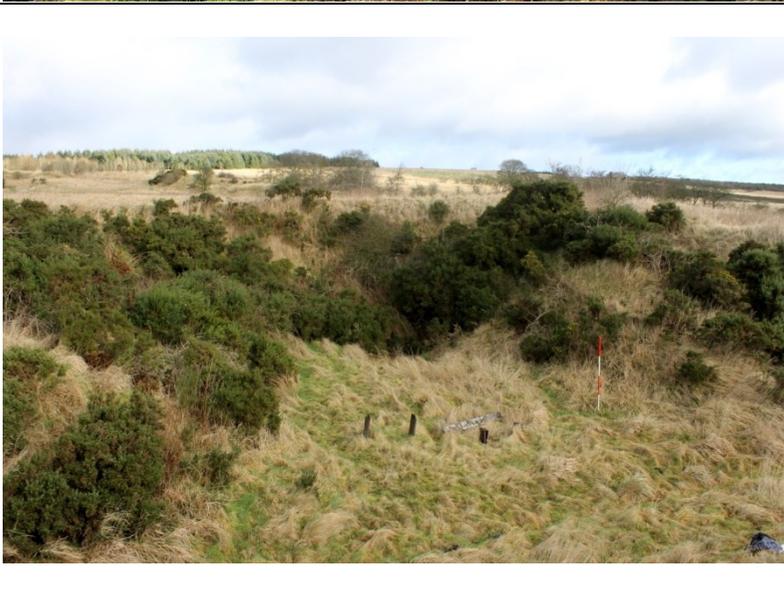
18	<p><b>Quarries</b> NGR: NT 10923 92449</p> <p>Description: A group of small limestone quarries. In the W section is an area of shallow quarrying (18a) some 1.7m deep which has been truncated by the construction of the railway cutting (ID 16) and has also been cut by quarry (18c); SW of quarry 18a is an area of spread spoil that may mask other quarrying features. In the E section is a narrow linear quarry (18b) approximately 7m x 15m and 3m deep which has been truncated to the S by railway cutting (16). Between these two quarries is another quarry (18c) measuring 11m x 20m and 5m deep; its base is at the same level as the railway and the relationship between the two cannot be established. Not shown on the First Edition OS map and shown as probably abandoned on the Second Edition.</p> <p>Condition: fair, stable. Obscured by gorse to NE. No threat.</p> <p>Significance: High. Evidentially significant in in terms of understanding quarrying process. Important in terms of understanding site chronology (evidence for phases of quarry working and relationship with later railway (16)).</p>

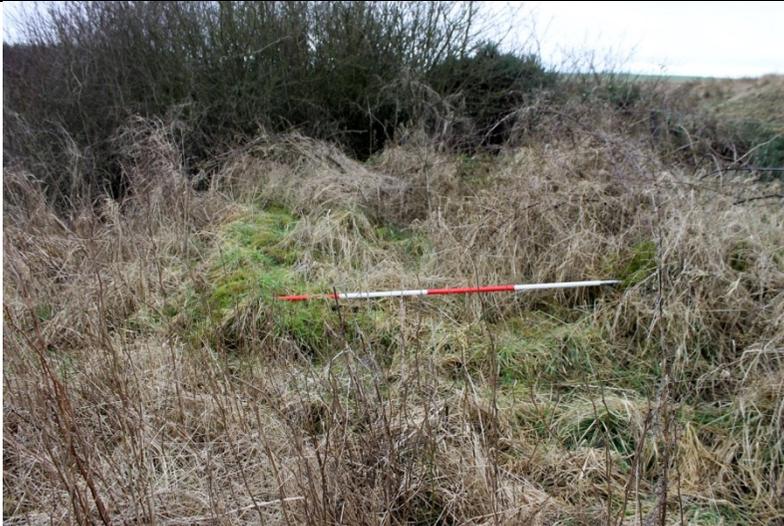
19	<p><b>Building</b> NGR: NT 10818 92457</p> <p>Description: On the S side of the former railway (ID 16) are the foundations of rectangular brick-built rectangular structure measuring 2.9m x 4.7m internally. There is a central entrance, 1.3m wide, in the N face. The foundations are 0.25m (3 brick courses) high in a combination of red and refractory bricks. The refractory bricks are stamped ORD. ADAMS – HILL OF BEATH – CROSSGATE). Shown as a roofed structure on Second Edition OS map.</p> <p>Condition: Poor. Foundations are grass-covered and the interior is overgrown with brambles. No threat.</p> <p>Significance: Medium. Of value in terms of understanding operation of railway (16).</p>

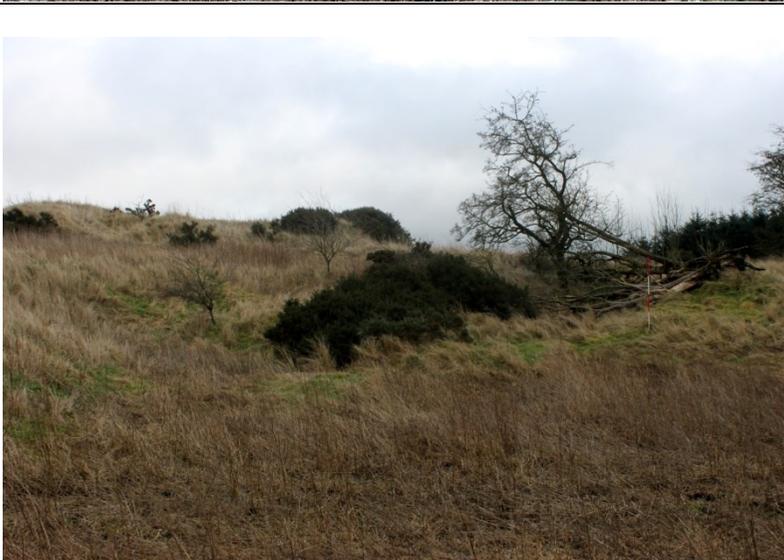
20	<p><b>Clamp kiln(s)</b> NGR: NT 10852 92423</p> <p>Description: A rectangular kiln (20a), 5.5m x 4m and 1.5 deep, excavated into a shallow E facing slope; the kiln has a flanking bank to the S some 5m wide. Immediately N is an area of disturbed ground (20b) comprising a group of interlinked hollows excavated into the E and S facing slope; this may be a damaged kiln but is more likely to be surface quarrying. Adjoining the kiln(s) to the E is a short section of possible trackway. Not shown on any OS maps although the First Edition marks a group of clamp kilns to the NNE which may be hidden by spoil dumped from quarry (18).</p> <p>Condition: Fair. Quarry (20a) is covered by a fallen tree and there is thick gorse cover to the N. No threat.</p> <p>Significance: High. Evidentially significant in in terms of understanding lime burning technology.</p>

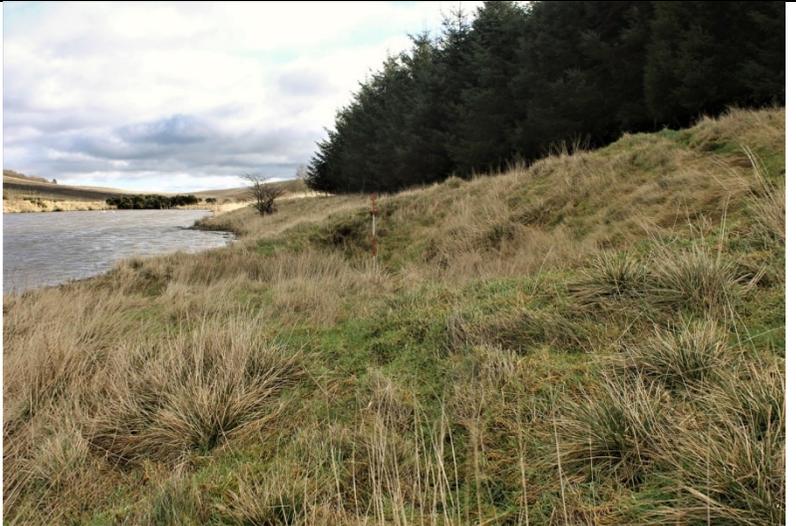
21	<p><b>Quarry</b> NGR: NT 10877 92363</p> <p>Description: Rectangular quarry, 6m x 14.5m and 2.5m deep, excavated into N facing slope below modern conifer plantation. No evidence for a spoil tip but this might have been to the N and is now flooded. Small area of exposed bedrock on S side. Marked 'Sandstone Quarry' on first Edition OS map and not shown on subsequent editions.</p> <p>Condition: good. Grass covered. No threat.</p> <p>Significance: Medium. Provides evidence for quarrying for materials other than limestone. Of value as an example of associated rural industry.</p>

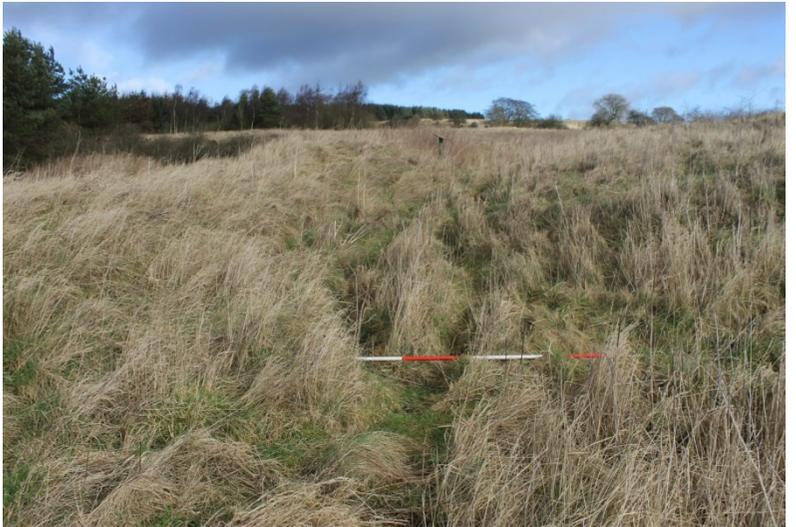
22	<p><b>Track</b> NGR: NT 10625 92882 – 10855 92618 and 10862 92477</p> <p>Description: A trackway from Woodend Cottage running NW-SE across the survey area and passing Kiln Houses (ID 8). Shown on the First Edition OS map and, with slight variations in course, on subsequent editions.</p> <p>Condition: Fair to poor. The NW section between Woodend Cottage and Kiln houses can still be traced and survives in places as a earthwork. Further SE it is discontinuous although a short section survives by kiln (14).</p> <p>Significance: High. Evidentially significant in in terms of understanding access routes across the site. Chronologically important as it continues in use as a post-industrial feature.</p>

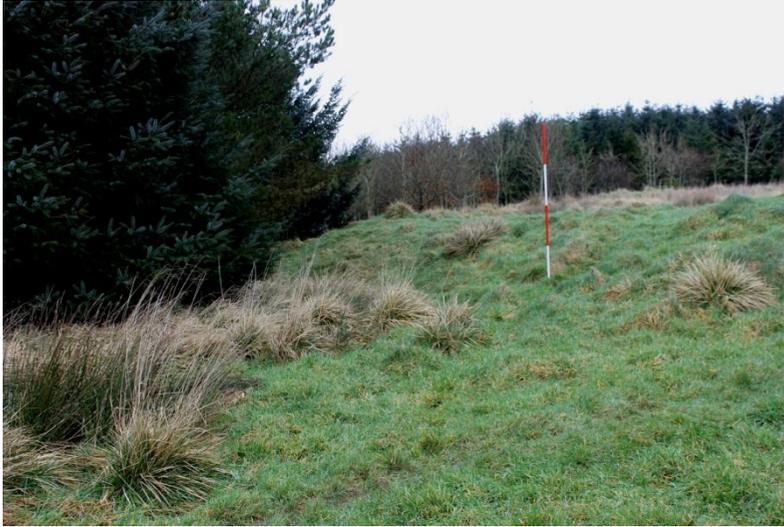
23	<p><b>Enclosure</b> NGR: NT 11115 92842 (approx.)</p> <p>Description: nothing survives of a rounded enclosure recorded during the 1998 survey. The site is now within a mature conifer plantation.</p> <p>Condition: Presumed destroyed.</p>	No image
24	<p><b>Turf dyke/enclosure</b> NGR: NT 11006 92916</p> <p>Description: A series of irregular field banks, possibly associated with linear dyke (25).</p> <p>Condition: Poor. Grass covered and within a clearing. No threat.</p> <p>Significance: High. Evidentially significant in in terms of understanding pre-industrial use of the site.</p>

The modern tree plantations were designed to avoid the known archaeological features. The only feature affected by forestry is enclosure (23) which is now within an area of conifer plantation; this feature should be located and its condition assessed in advance of any future felling.

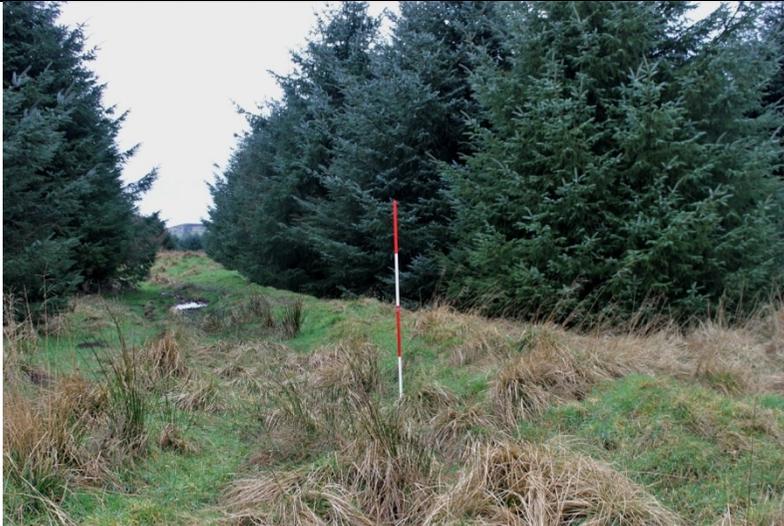
25	<p><b>Turf dyke</b> NGR: NT 10598 92791 – 10649 92804 and 10831 92868 – 11261 92956</p> <p>Description: A turf and stone bank running E along the ridge for some 680m.</p> <p>Condition: Fair. The dyke survives in good condition between the N end of quarry (2) and NT 11261 92956. The W section is less well preserved and lies within a conifer plantation and is also cut by track (22). The extreme W end is in better condition. Possibly at risk during future felling.</p> <p>Significance: High. Evidentially significant in terms of understanding pre-industrial use of the site.</p>

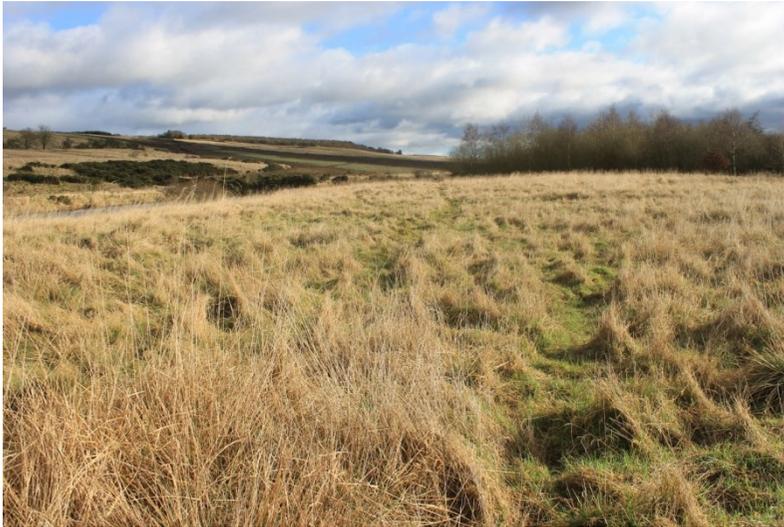
26	<p><b>Rig cultivation</b> NGR: NT 10958 92354</p> <p>Description: An area of curved rig cultivation recorded during the 1998 pre-forestation survey.</p> <p>Condition: Poor. No rig cultivation was observed but it may well be masked by thick, tussocky grass.</p> <p>Significance: Medium - High. Evidentially significant in terms of understanding pre-industrial use of the site. Chronologically important as the earliest archaeological feature within the site.</p>
