**Refurbishment of Block A
County Hall
Taunton
Somerset**

Written Scheme of Investigation for Level 3 Historic Building Recording

for
Heritage Places

BBHC Project: 1814
BBHC Report: 18005

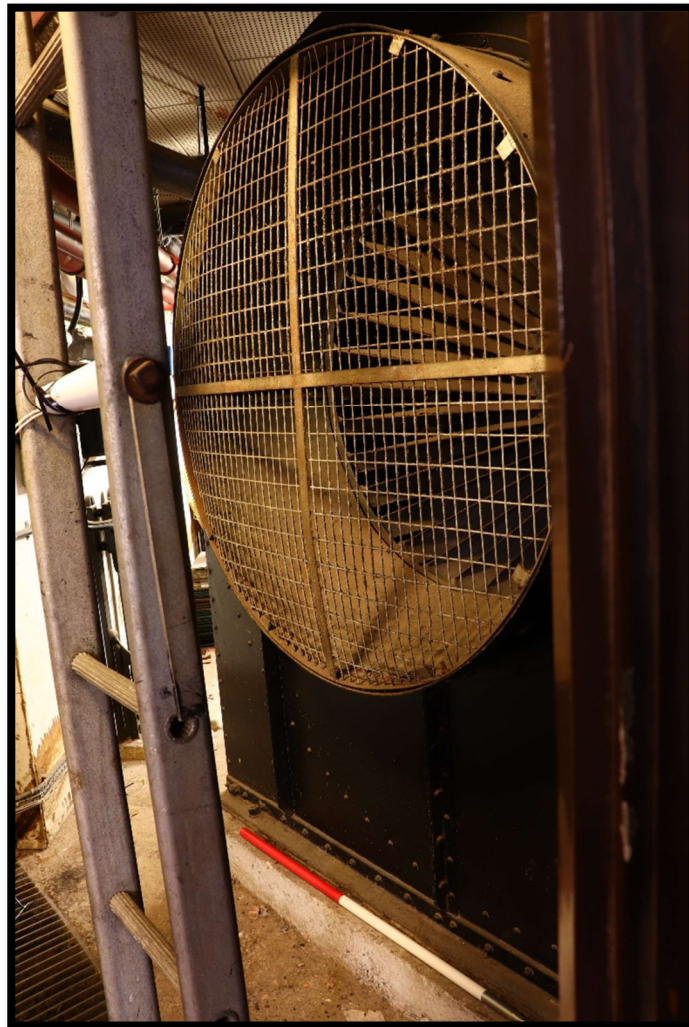
Figure 1 basement - 1930s heating ventilation fan, scale 1m

The redundant heating ventilation fan believed to be from the original 1930s plant equipment and associated ducts will remain *in situ*.

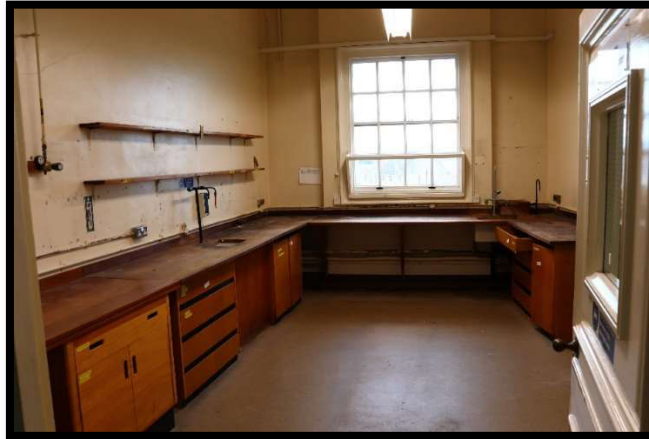
General views of the laboratories were recorded, along with a series of representative photographs intended to illustrate typical fixtures and fittings (i.e. not every piece of scientific equipment was recorded in detail (the images below illustrate Room 302 general view and sample detail). Much of the lab equipment dates to the early 1980s.

Figure 2 Room 302 lab - typical general view
