# London Gateway Project River Thames

Archaeological Diving Investigation

Technical Report

**Ref: 61205.01**

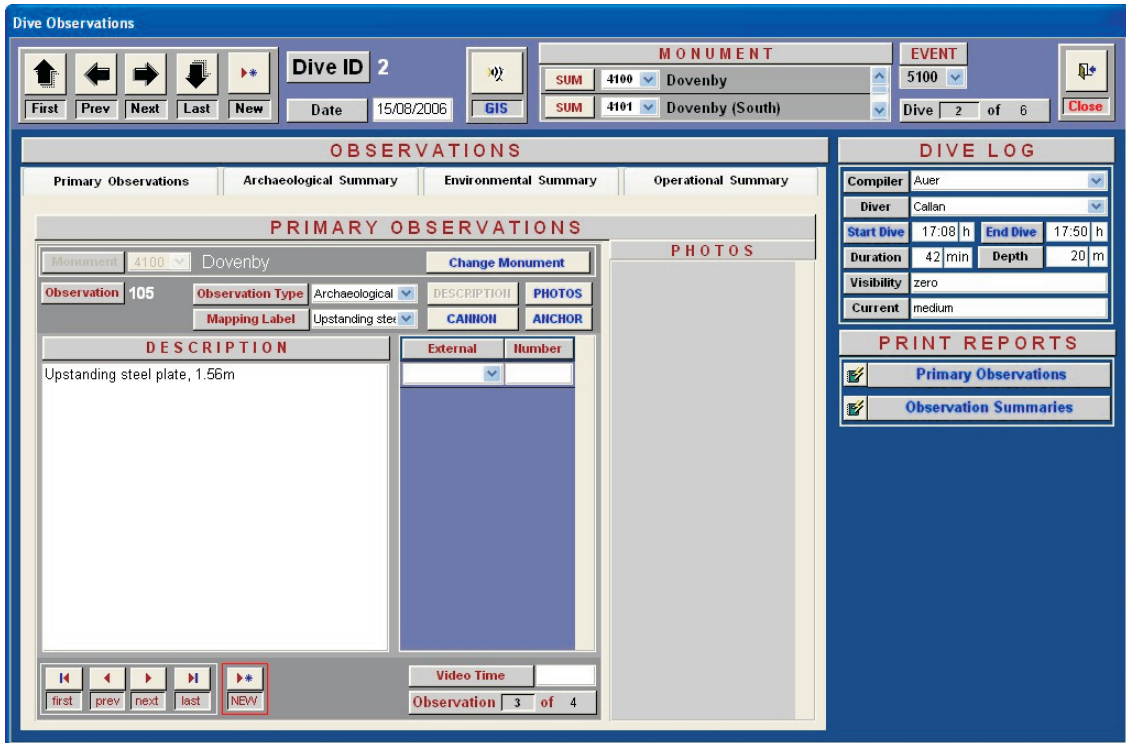
| <b>Figure 3</b> | DIVA Diver Recording System and ARC GIS visual interface. |

- 3.3.1. Archaeological recording was undertaken using WA's 'in-house' recording system known as 'DIVA'. This system comprises a Microsoft Access database integrated with ESRI ArcGIS 9.0 (**Figure 3**). The position from the acoustic tracking system is interfaced into the GIS.

- 3.3.2. Georeferenced geophysical images and background mapping can be displayed in the GIS and therefore the diver's position in relation to these images can be tracked. The diver's track can be saved and logged separately.

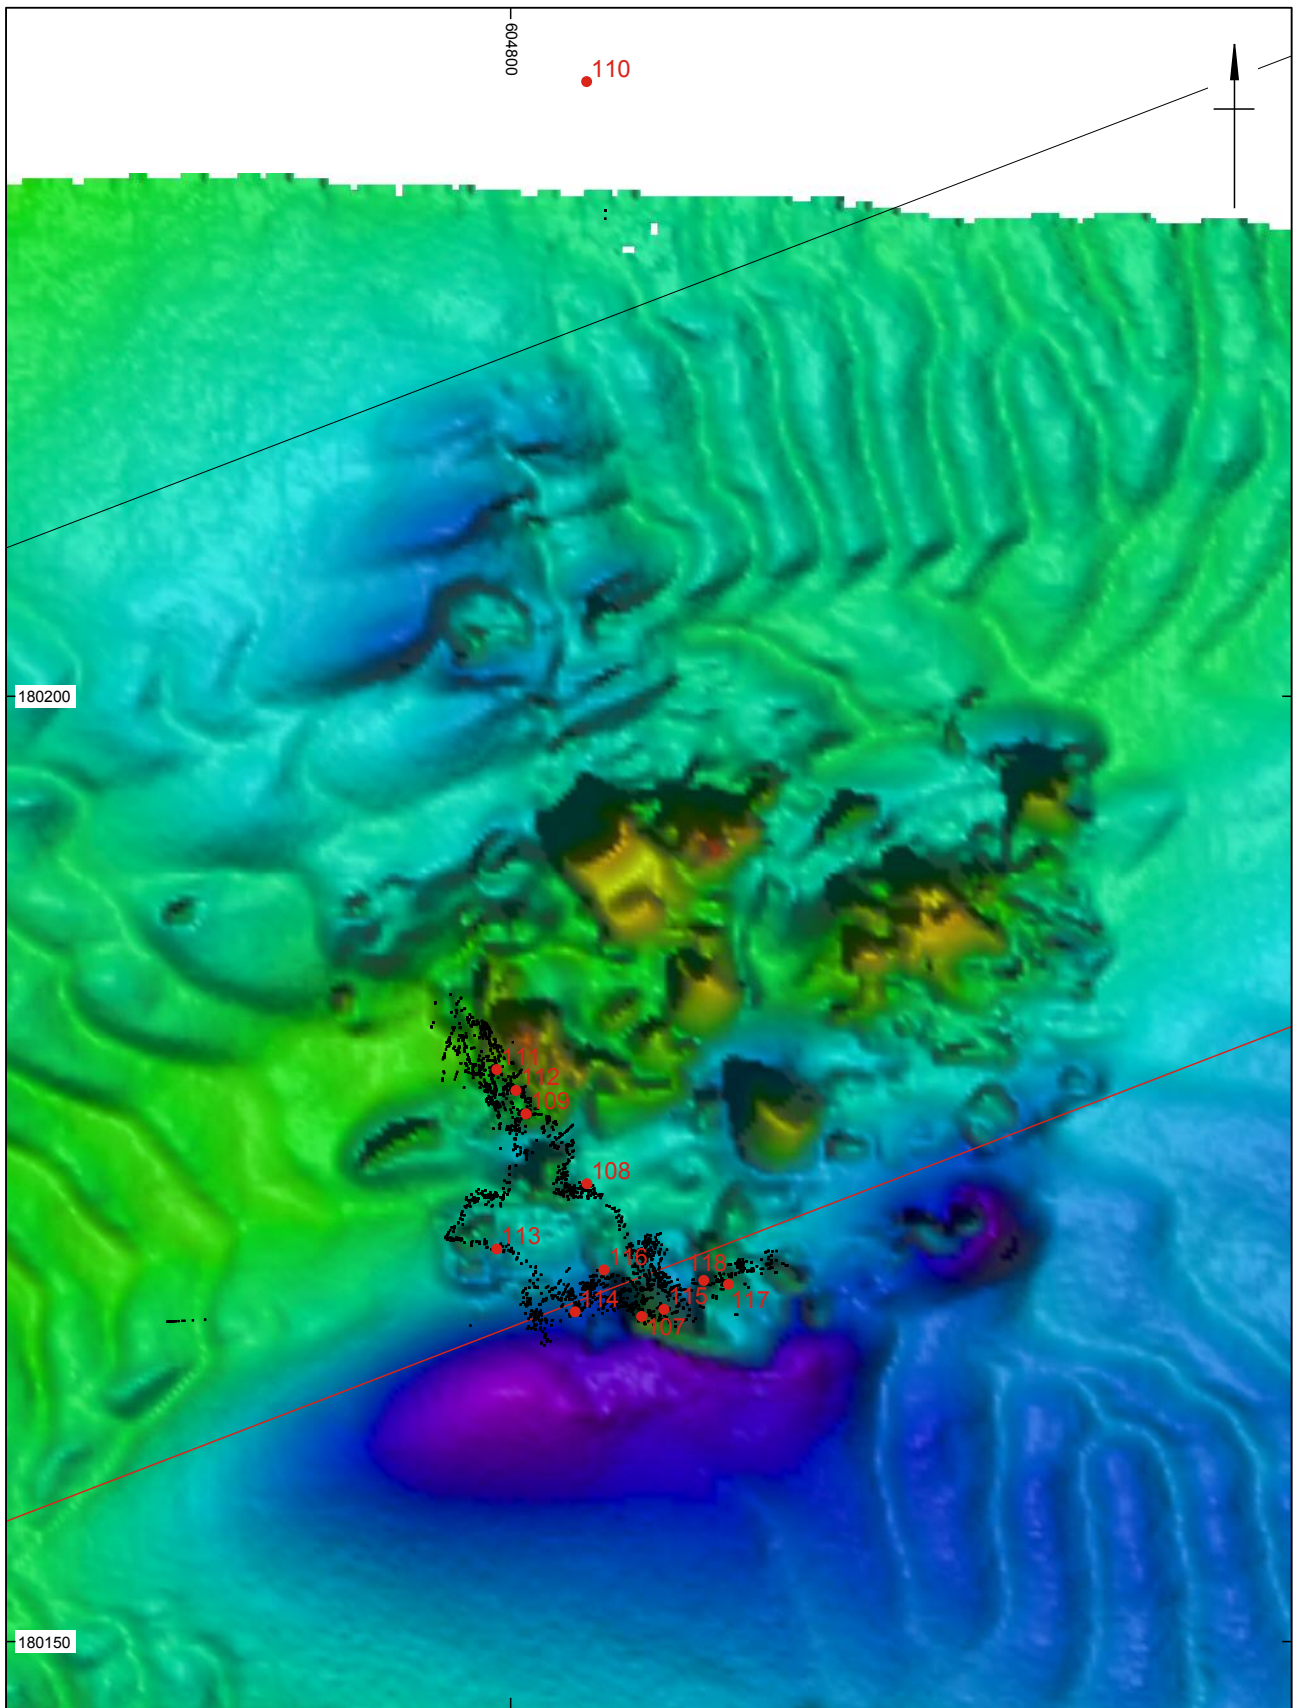
Figure 5

- 4.2.3. The diver proceeded along the western edge of the site towards a large upstanding object visible in the multibeam data (**Figure 5**). Travelling northwards, metal structure, consisting of bent plates upstanding by 0.5 metre, was noted on the seabed (**Obs 107**). The structure became progressively less apparent, until it was almost flush with the seabed (**Obs 108**). The large object visible on the geophysical image was found to be a circular steel structure, approximately three metres in diameter (**Obs 109**), and was interpreted as a boiler. It was heavily damaged, probably by explosives.

- 4.2.4. Further steel plates were observed north of the boiler (**Obs 111, 112**). The diver then proceeded to the south-western edge of the site (**Obs 113**) and reached a relatively intact section of outer hull structure, standing up to three metres proud of the seabed in the south of the site (**Obs 114, 115, 116**).

- 4.2.5. Another circular steel section was found to the east of the outer hull structure (**Obs 117, 118**). This section was about 2.5 metres long and stood about two metres proud of the seabed. It could not be interpreted.

- 4.2.7. Although a number of high sections remain on the seabed, the wreck of the *Letchworth* seems to be very broken up. Sharp edges and bent or buckled steel plates and frames indicate explosion damage, caused either by the bomb that sank the vessel or by clearance attempts.

Diver track and observations superimposed on multibeam image on site 5005 (Letchworth)
