**LONDON GATEWAY
WRECK CLEARANCE: ARCHAEOLOGY**

**CLEARANCE MITIGATION STATEMENT
Second Draft**

**WA Ref: 61209.5005.02
December 2007**

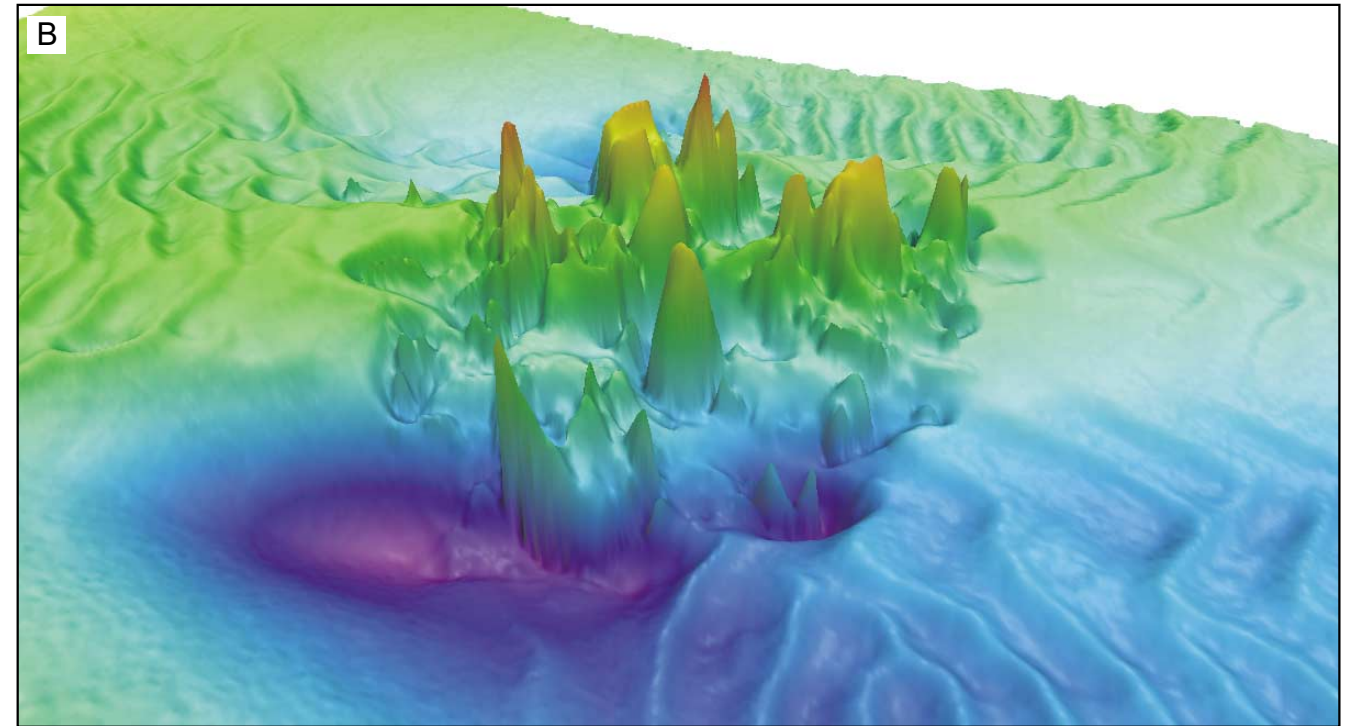
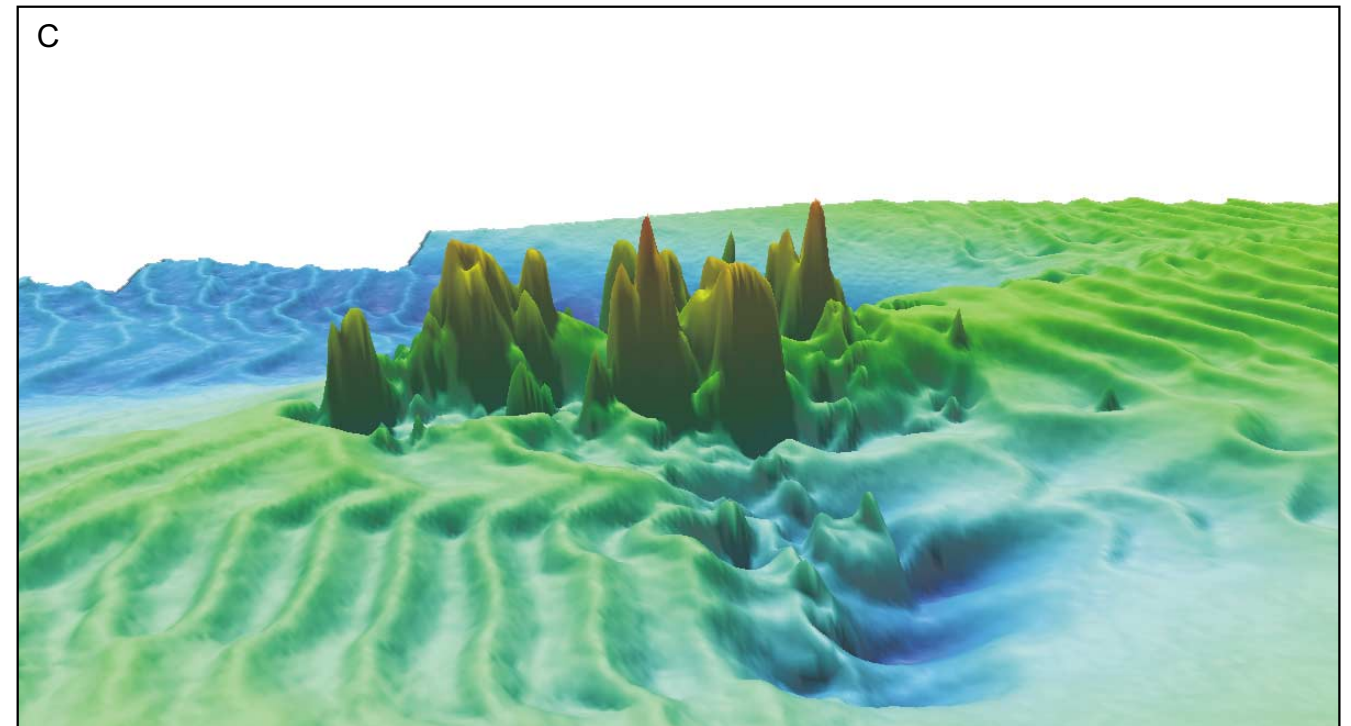
Figure 1

Location: The site is located seaward of Sea Reach No. 1, 32 metres from the northern edge of the existing dredged channel (**Figure 1A**).

Oblique view from south.

Oblique view from north.

Location and Multibeam data for Site 5005.

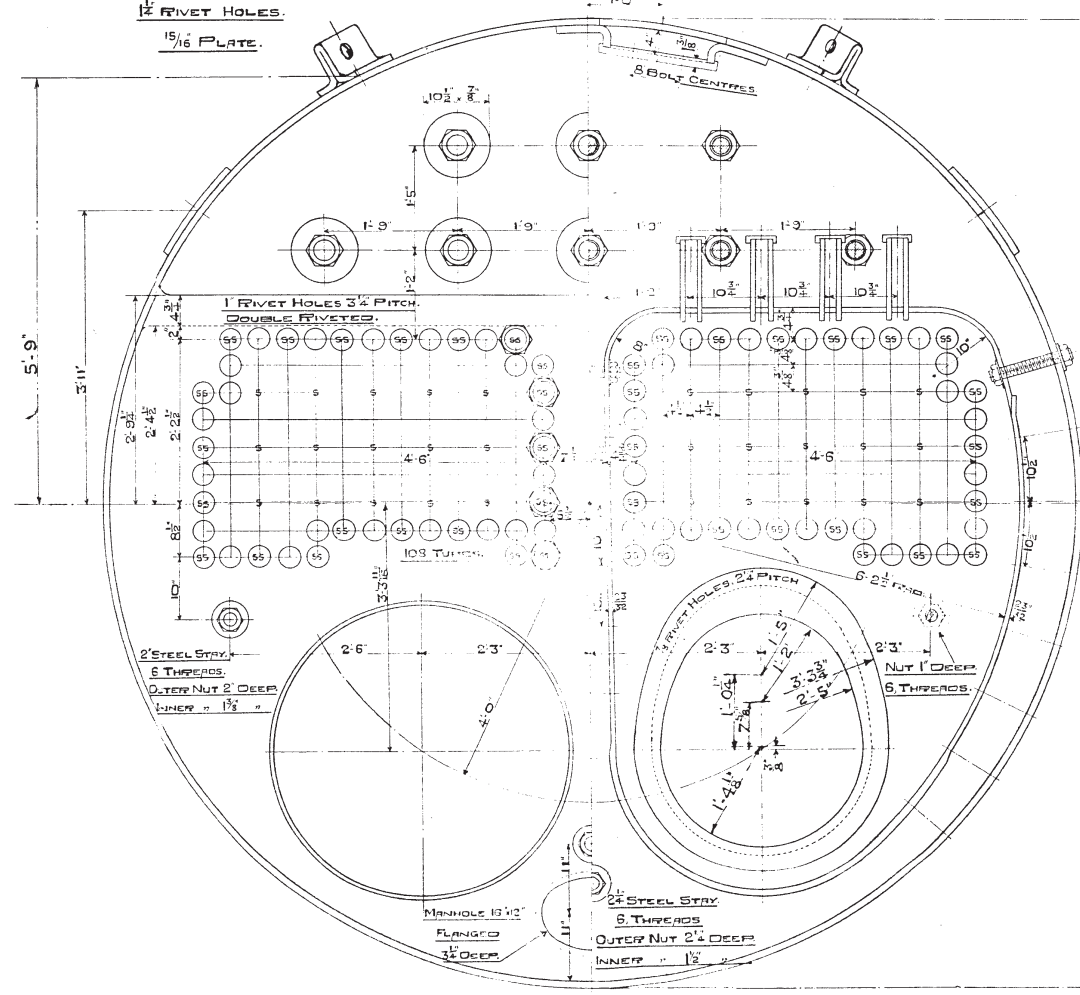
Figure 3

Further details of the *Letchworth* can be found in the book *The Steam Collier Fleets* (MacRae and Waine 1990) and in the *Lloyds Survey Report* (Lloyds Survey Reports 1924), which also contains the following plans (**Figure 3**):

Plan of boiler of SS Letchworth

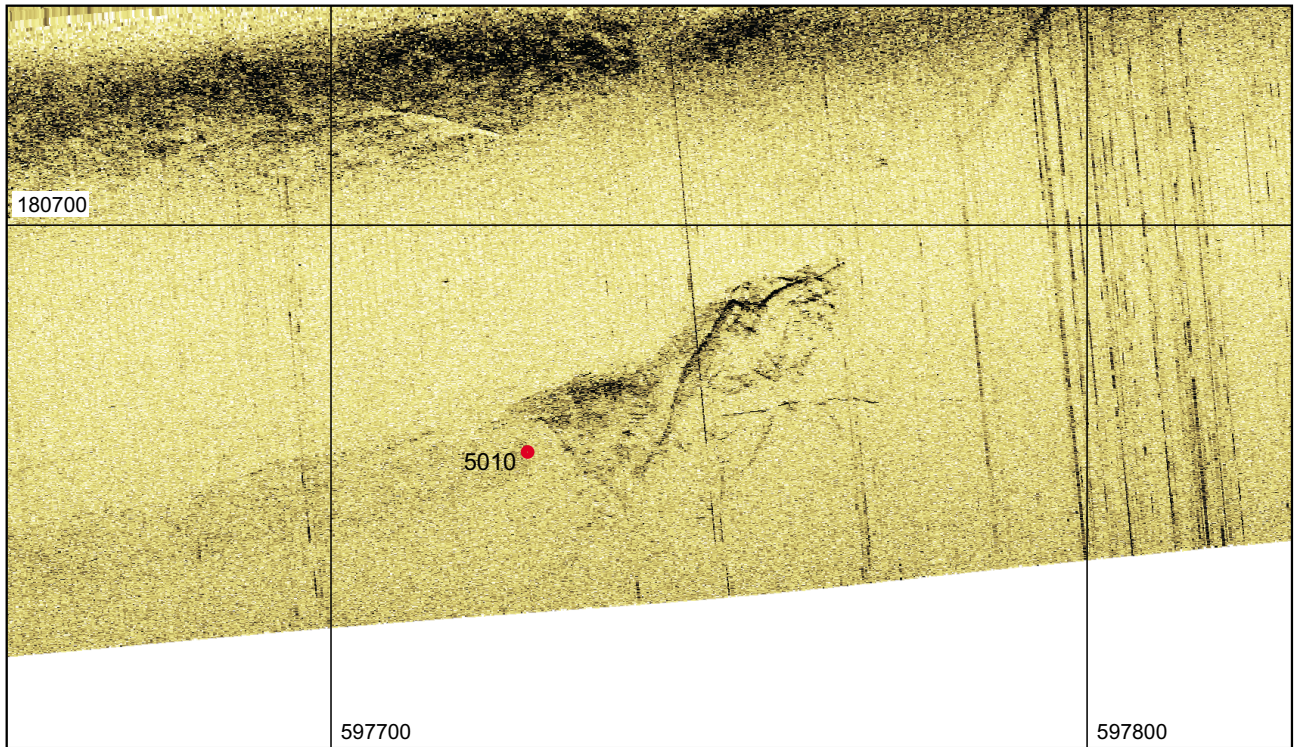
Figure 2

In 2002 the site was identified during a sidescan sonar and magnetometer survey, it is noted as corresponding to the southern part of the *Dovenby* (**Figure 2**). The NGR recorded from this survey was 597657 E 180788 N. The anomaly is 20 metres long and 35 metres wide and no length of shadow was recorded. The tiff file created was labelled 288. The NGR recorded for the magnetometer survey was 597736 E 180652 N. The magnetic hit registered a max reading of 276nT. The tiff file created was labelled 415.

Plan view.

Site 5010 - Sidescan Sonar 2002 survey data.

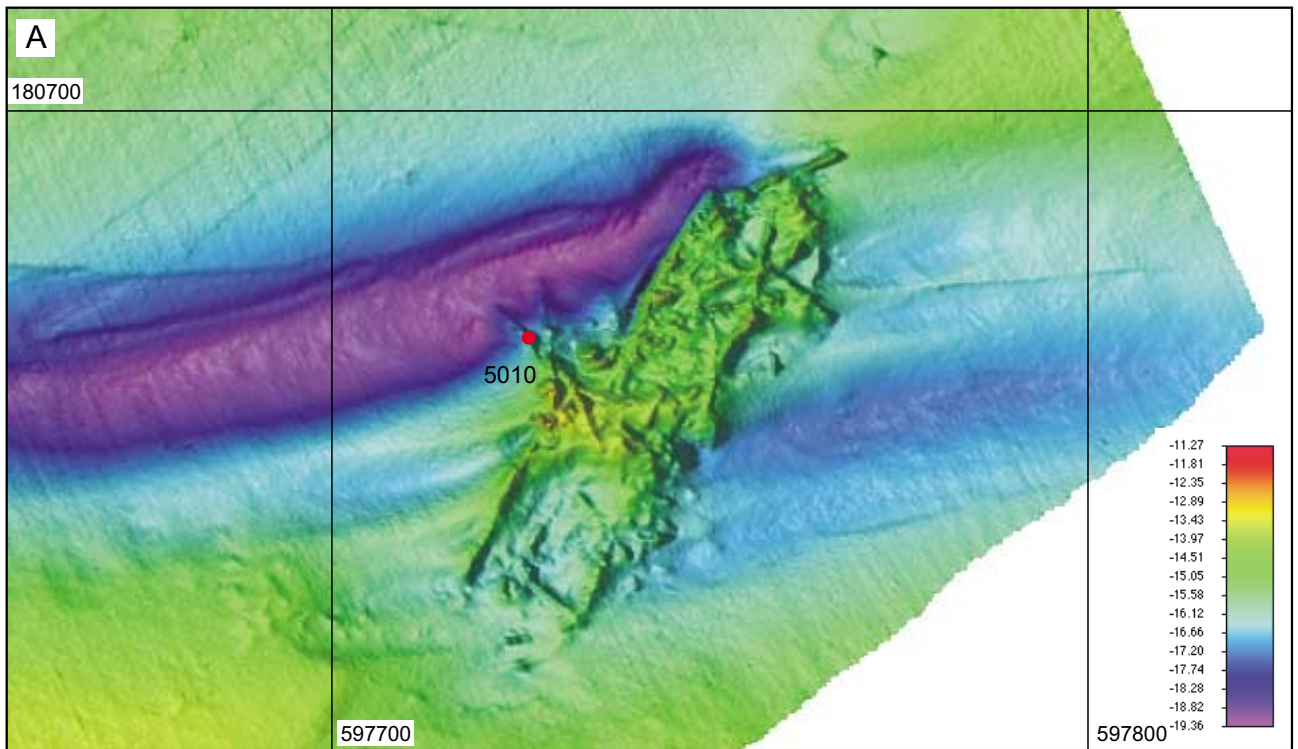
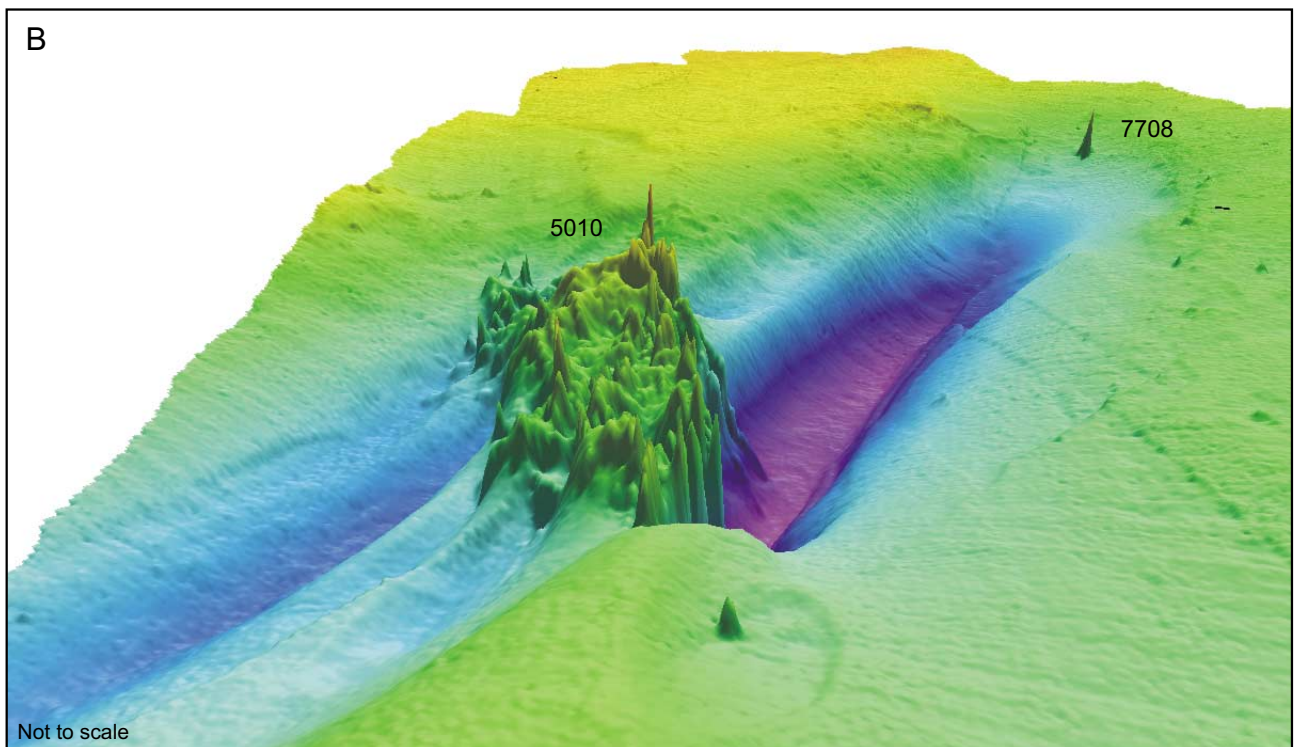
Figure 3

Plan view.

Oblique view from north.

Multibeam data for Site 5010.

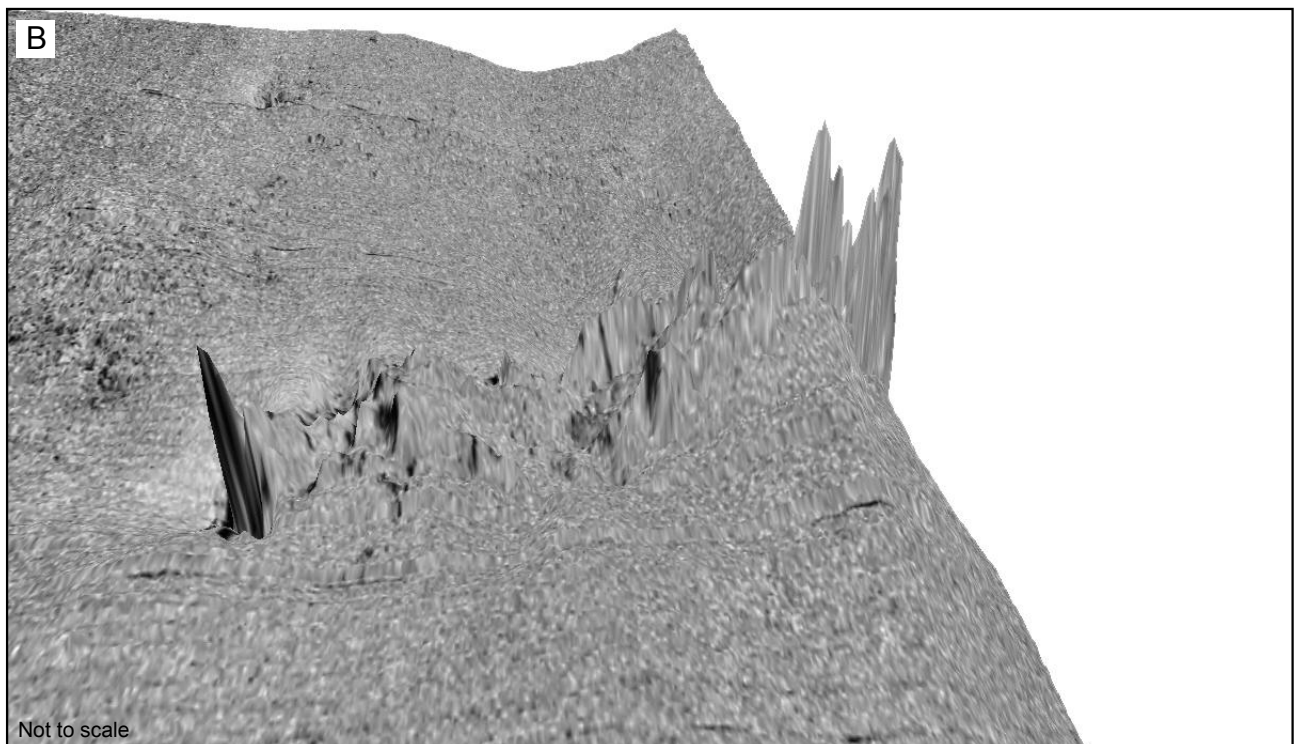
Figure 4

Plan view (2002 survey data).

Oblique view from east.

Sidescan Sonar image of Site 5012.

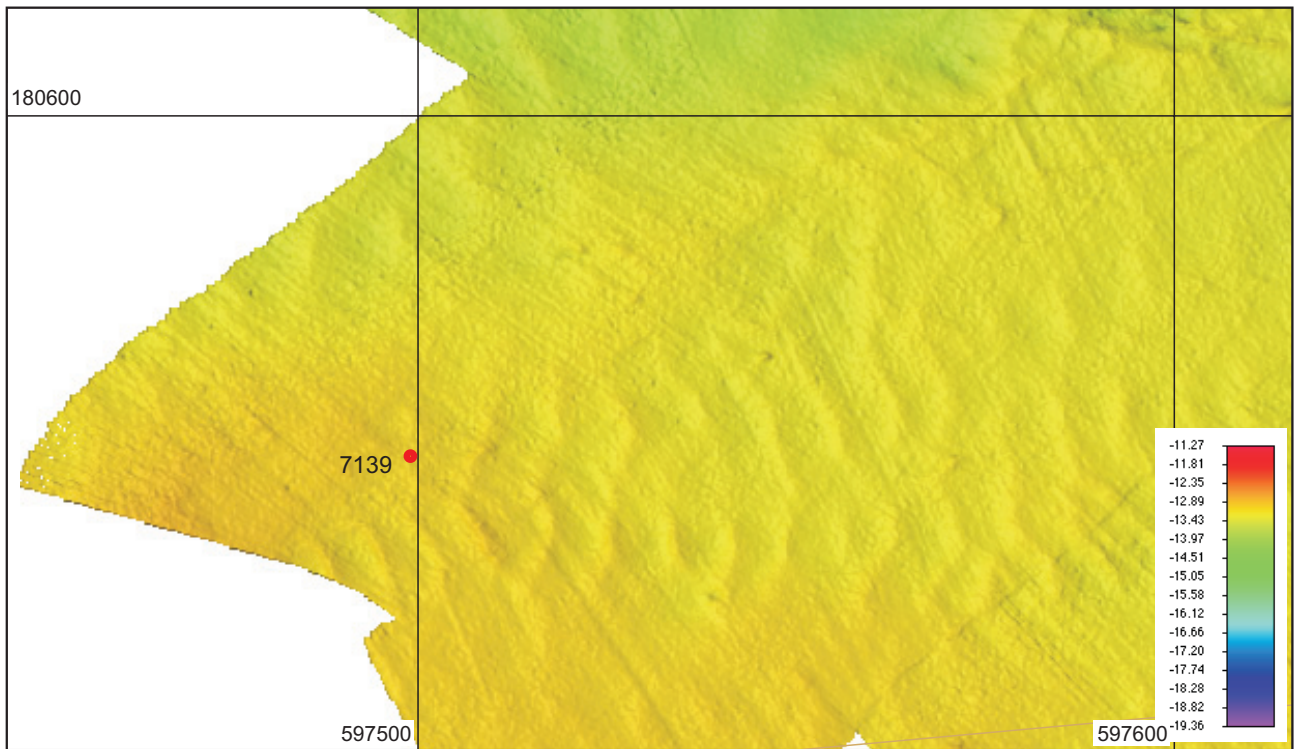
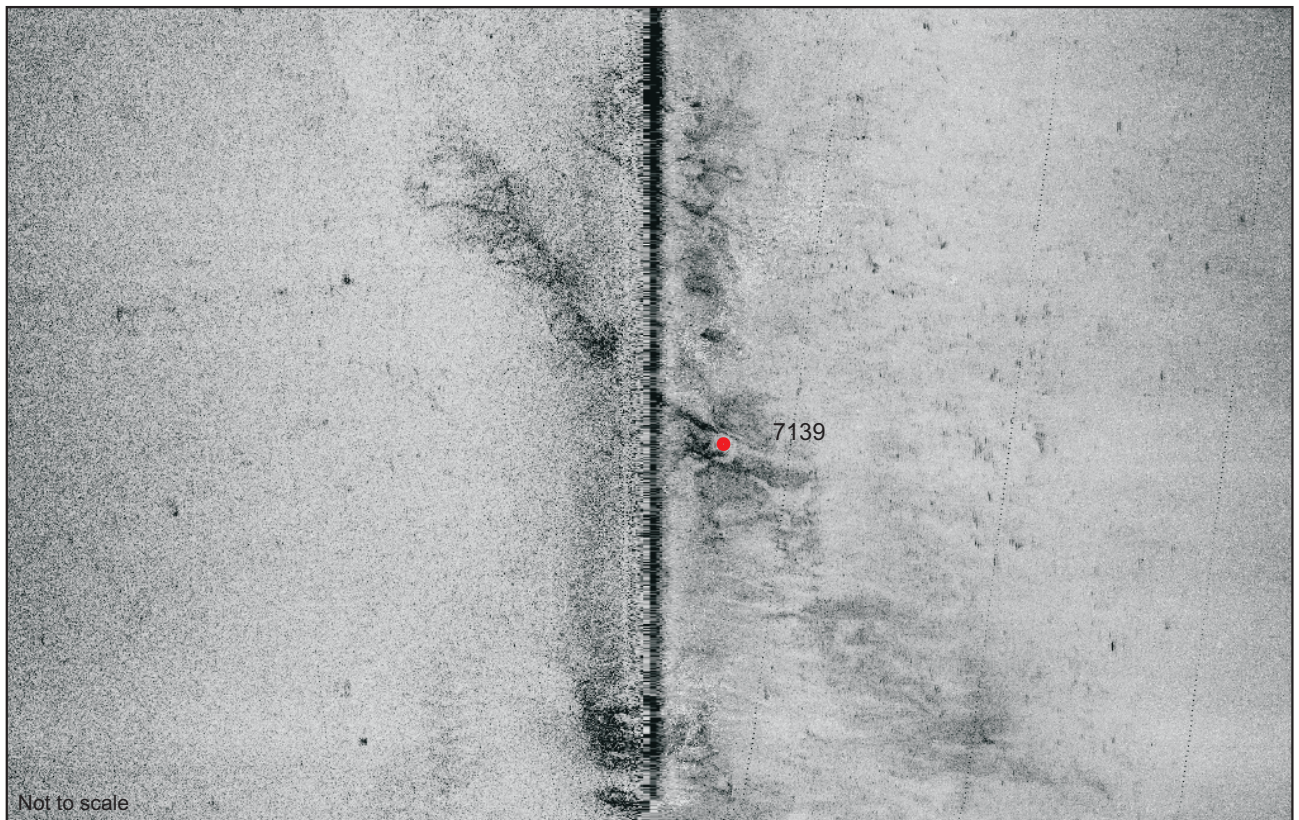
Figure 7

Multibeam data - plan view.

Sidescan Sonar data - plan view.

Multibeam and Sidescan Sonar data for Site 7139.

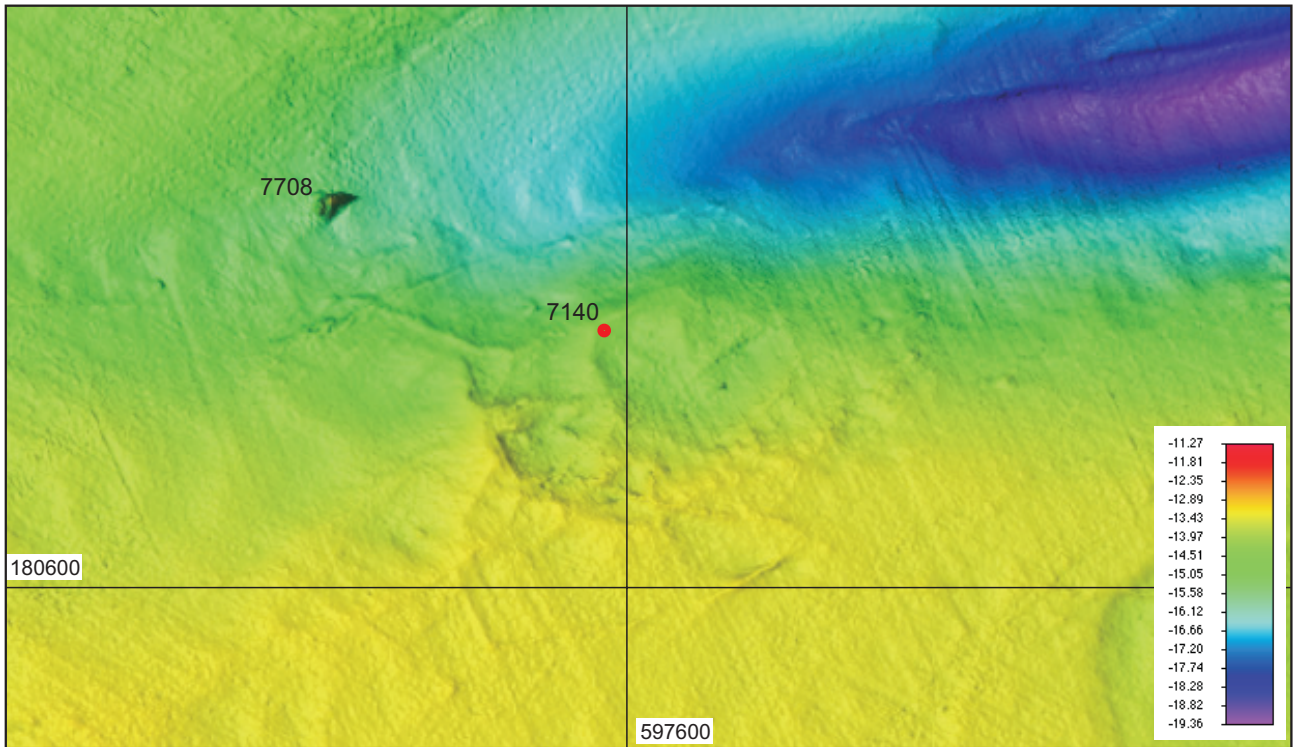
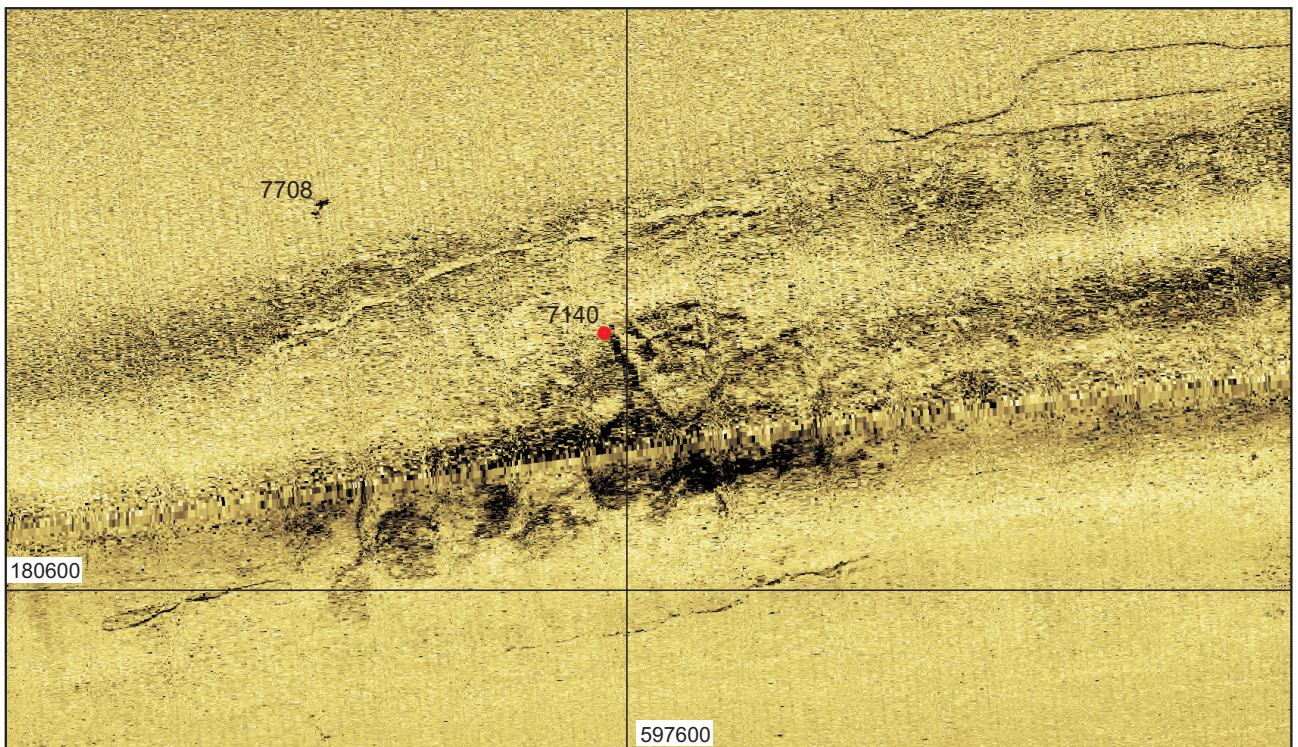
Figure 8

Multibeam data - plan view.

Sidescan Sonar 2002 survey data - plan view.

Multibeam and Sidescan Sonar data for Site 7140.

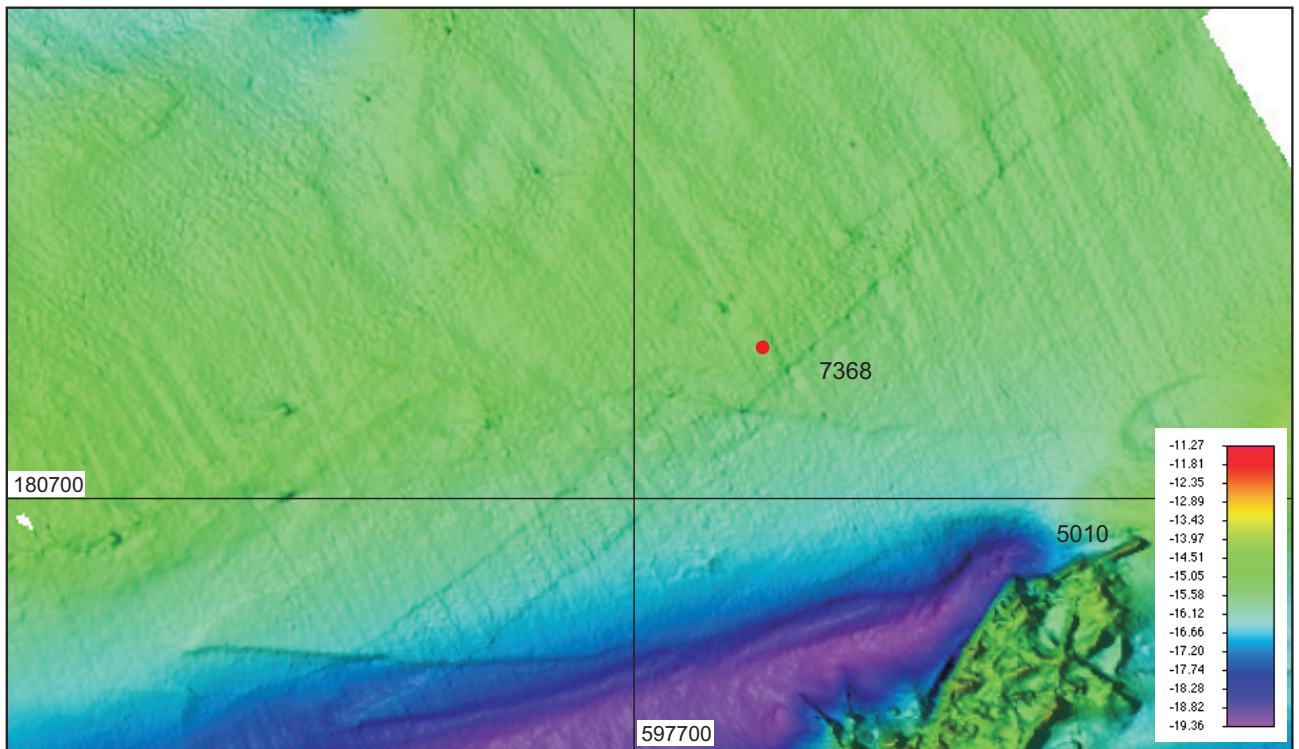
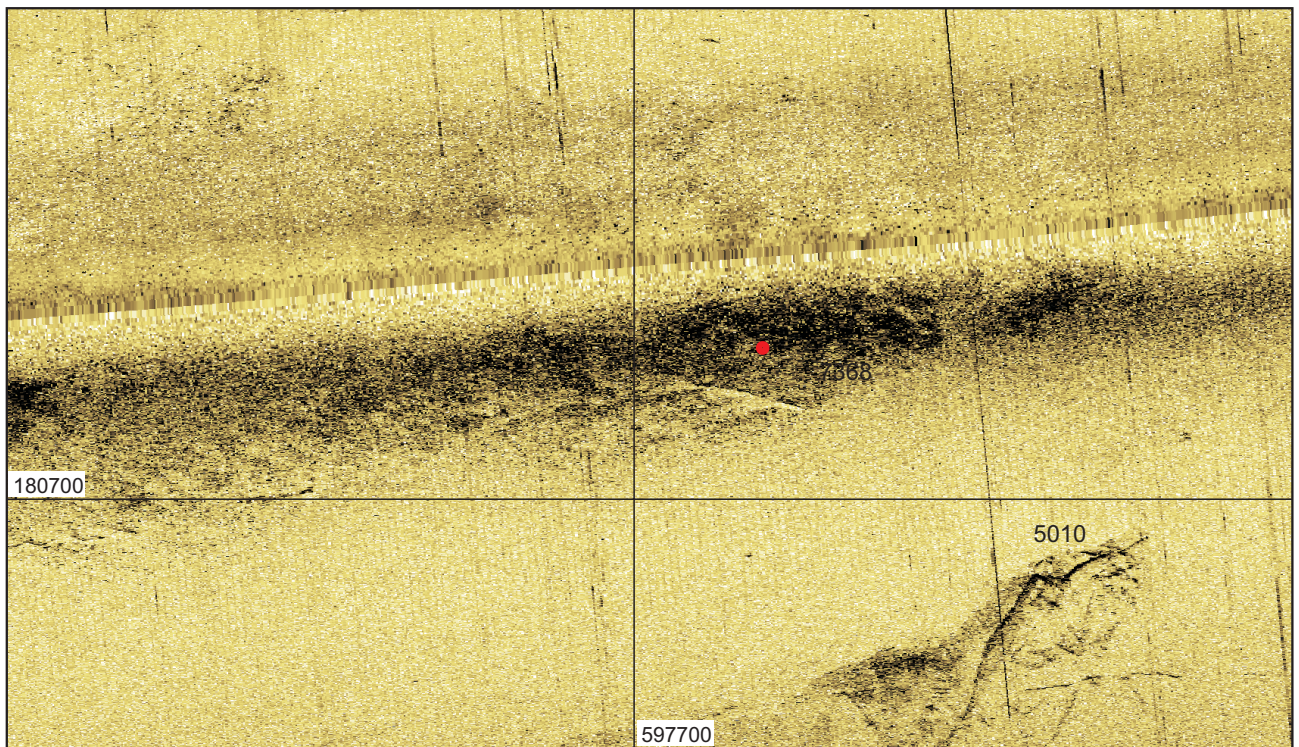
Figure 9

Multibeam data - plan view.

Sidescan Sonar 2002 survey data - plan view.

Multibeam and Sidescan Sonar data for Site 7368.

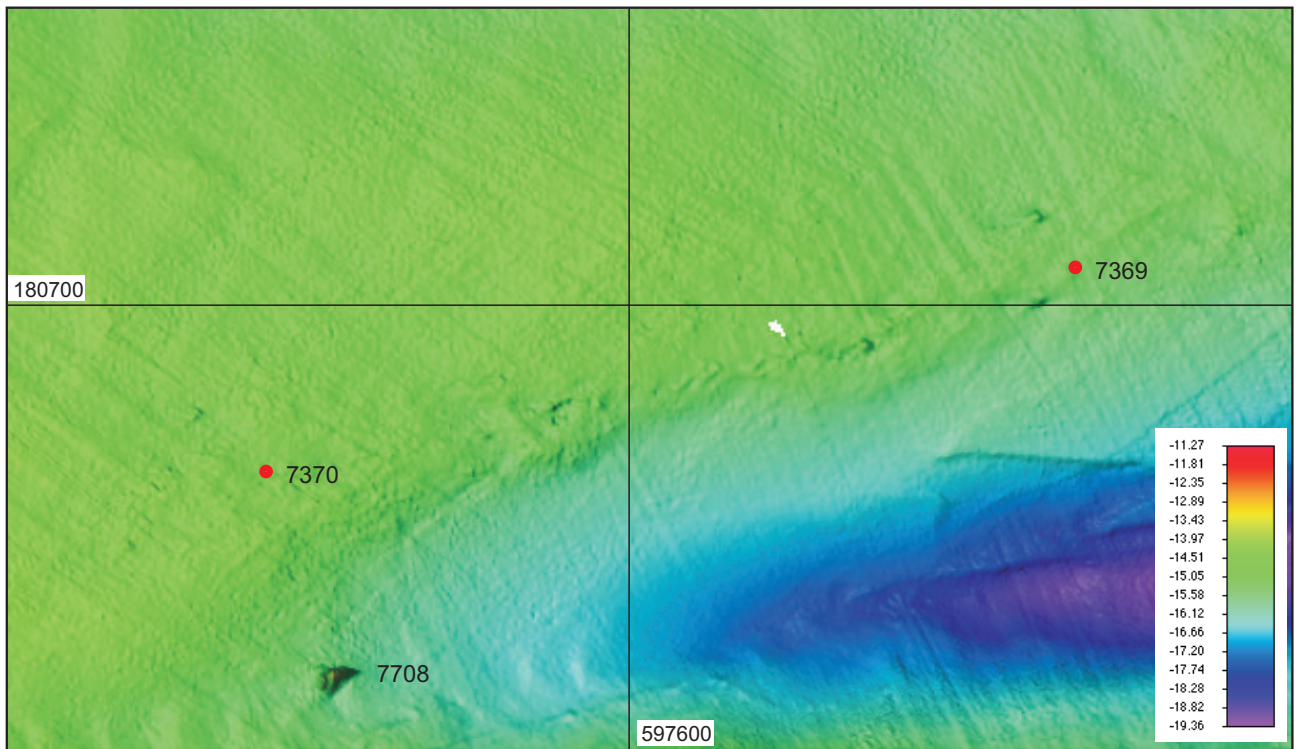
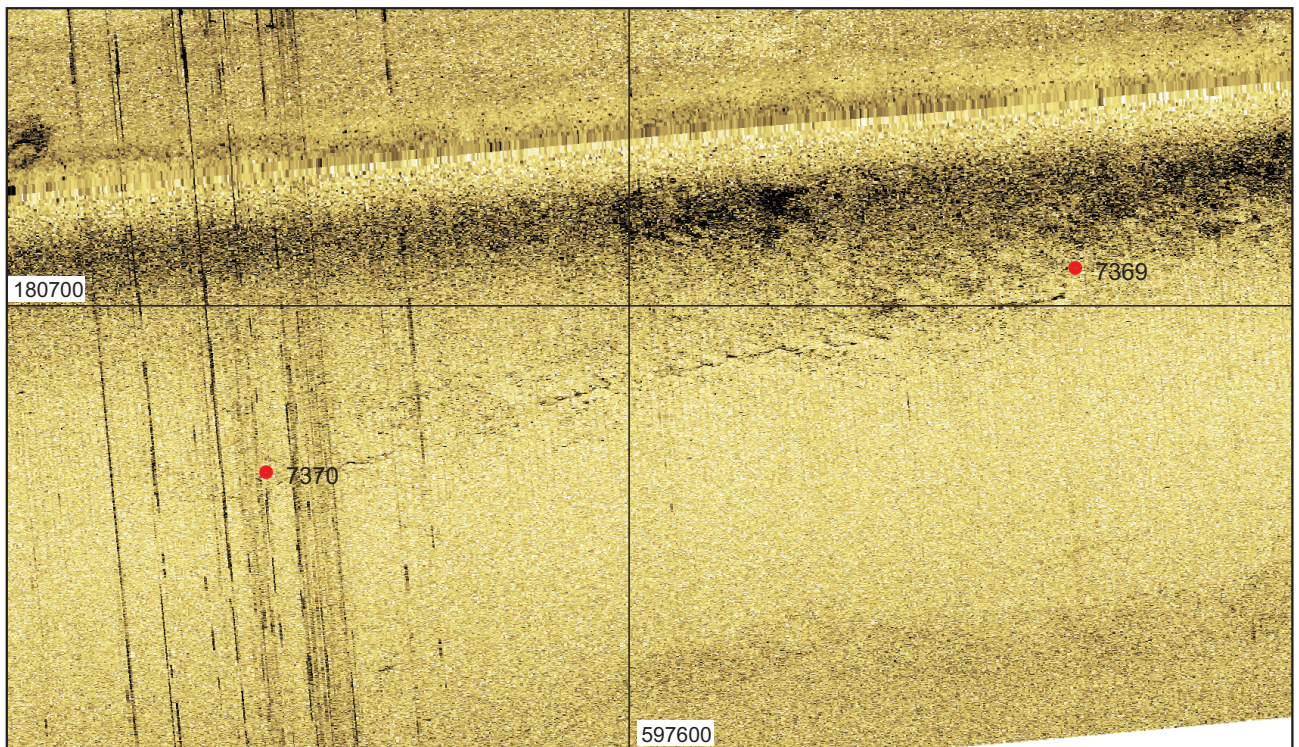
Figure 10

Multibeam data - plan view.

Sidescan Sonar 2002 survey data - plan view.

Multibeam and Sidescan Sonar data for Sites 7369 and 7370.

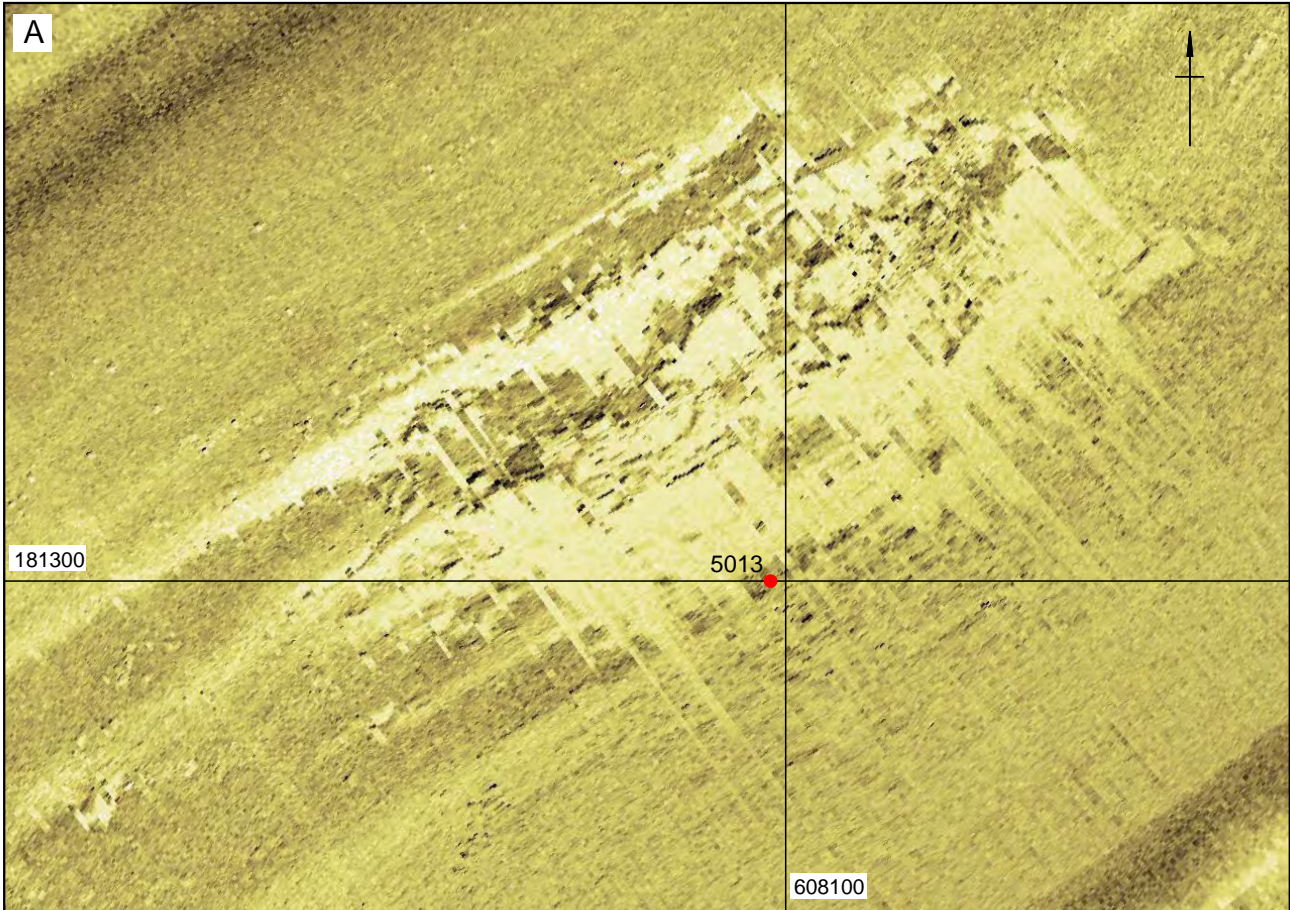
Figure 2

Sidescan Sonar image of Site 5013.

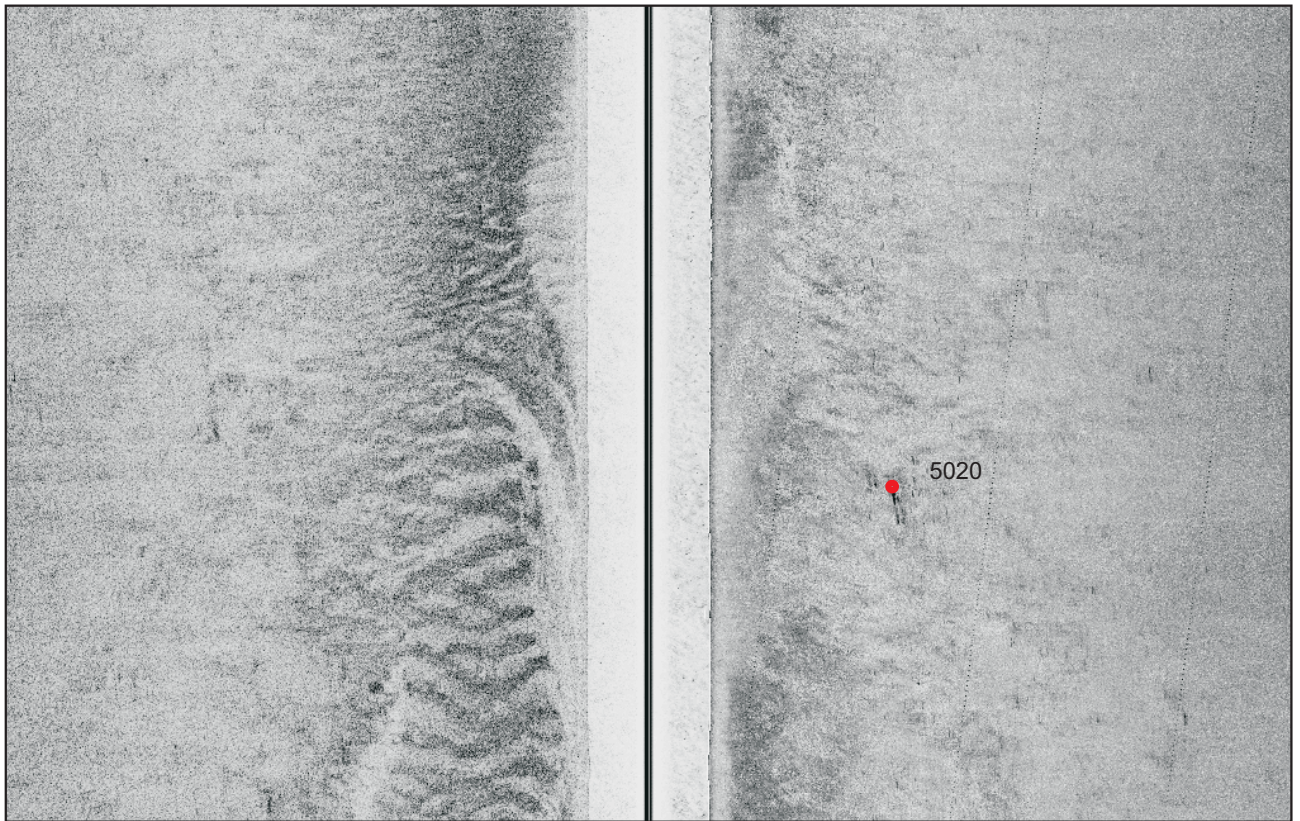
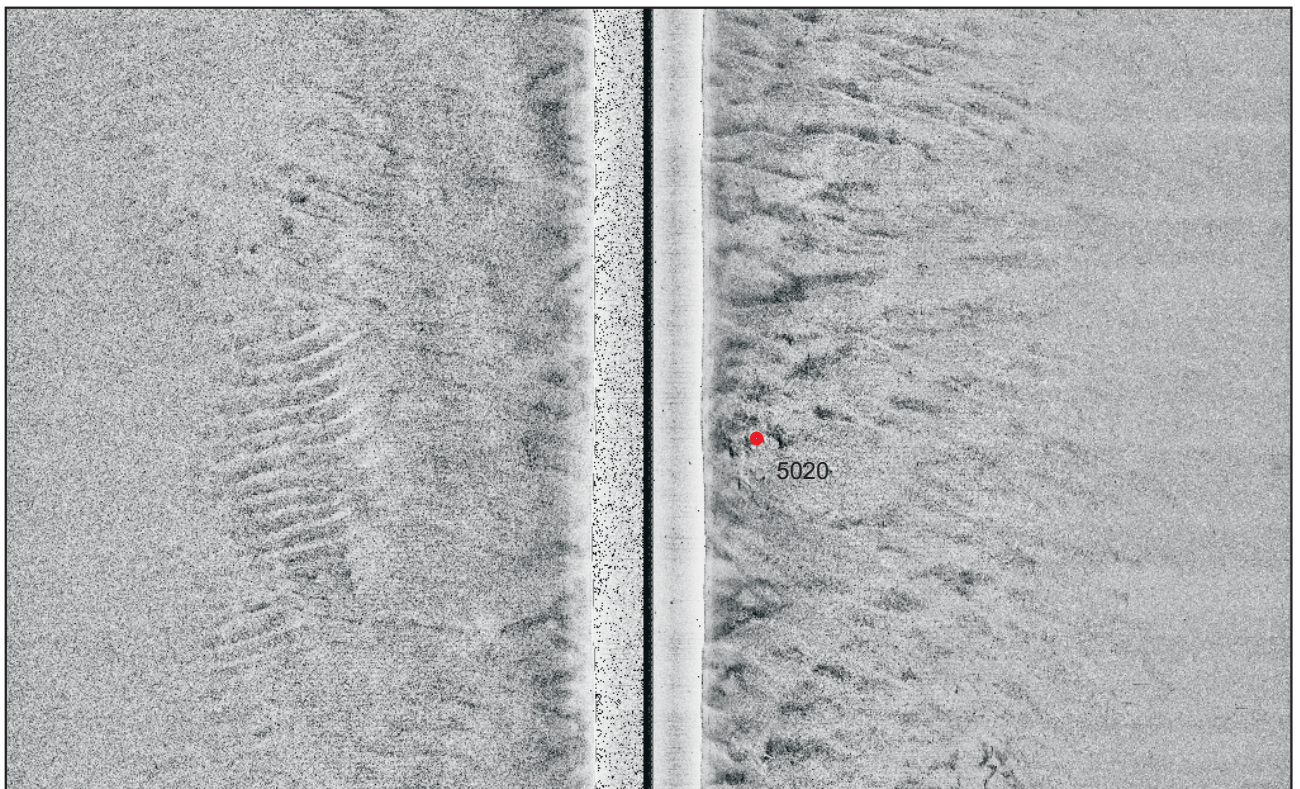
2001 Sidescan Sonar image of Site 5020.

2002 Sidescan Sonar image of Site 5020.

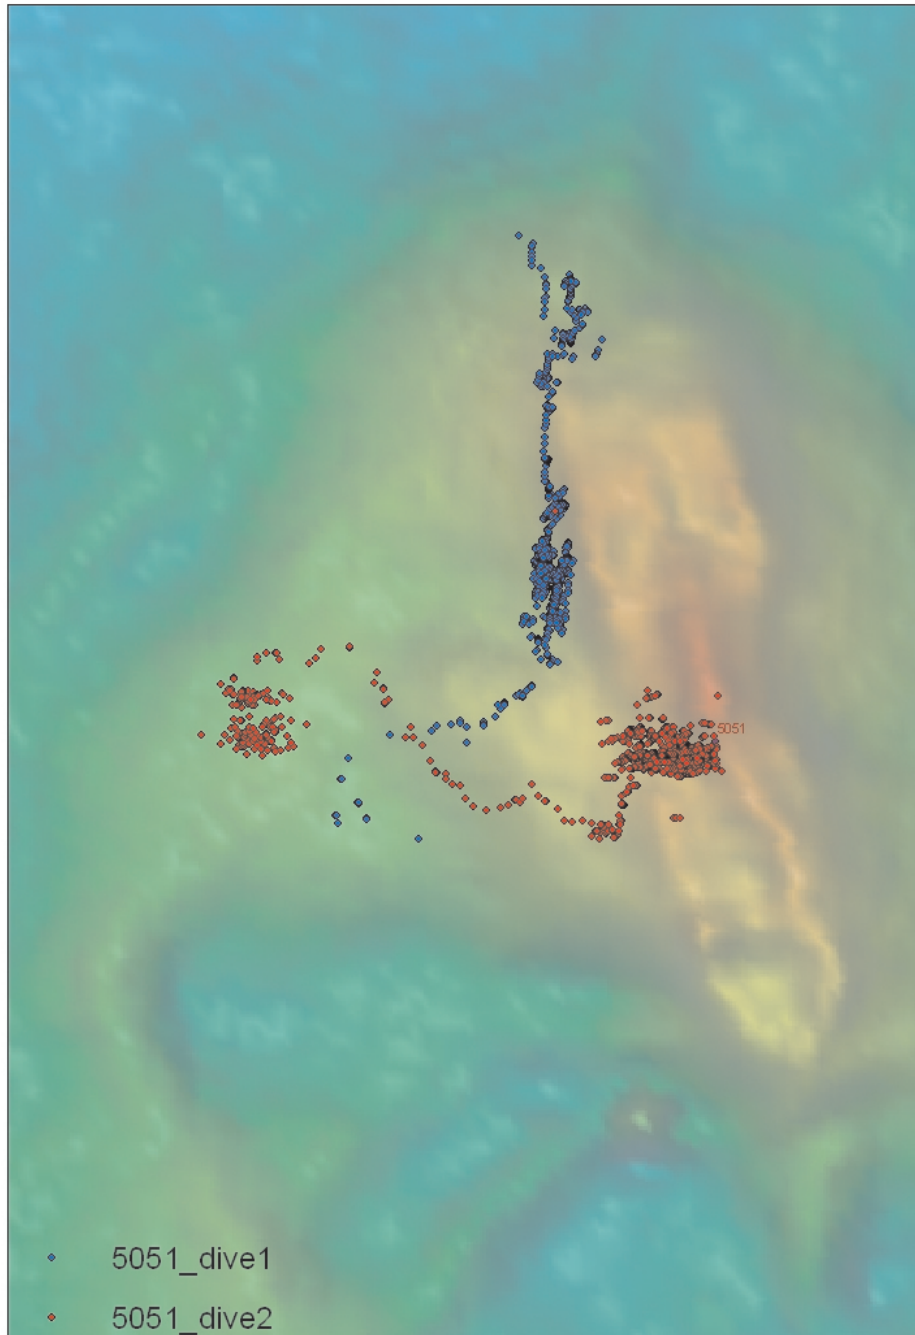
Figure 2

2002 Sidescan Sonar image of Site 5051.
