London Gateway Port: Channel Clearance and Dredging

In-water Archaeological Observation and Recording

Final Report

Wreck 5051 (Unknown)

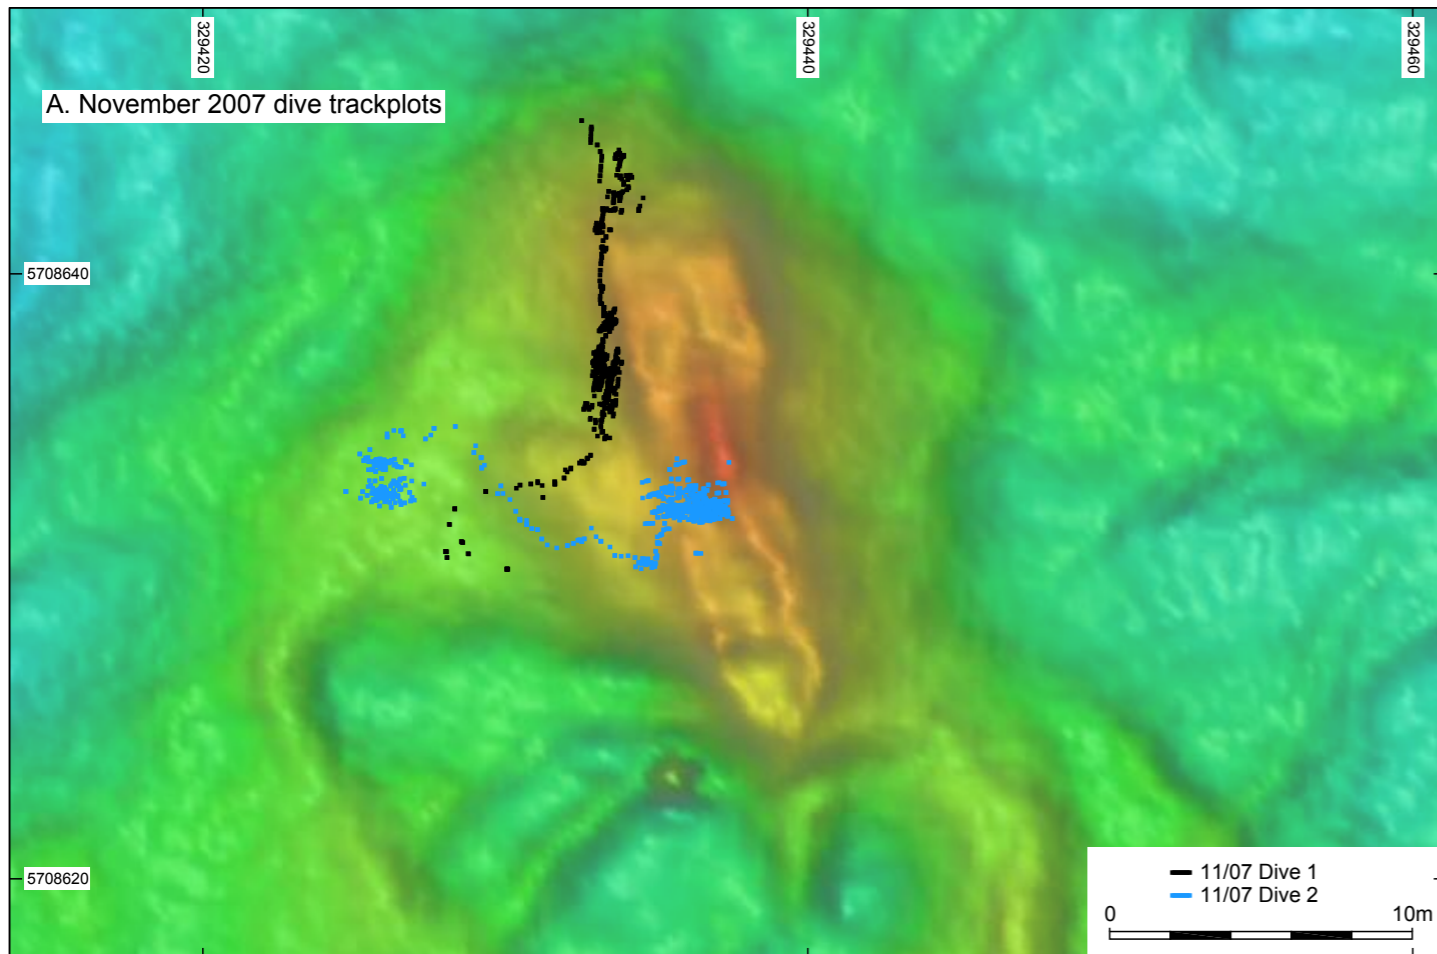
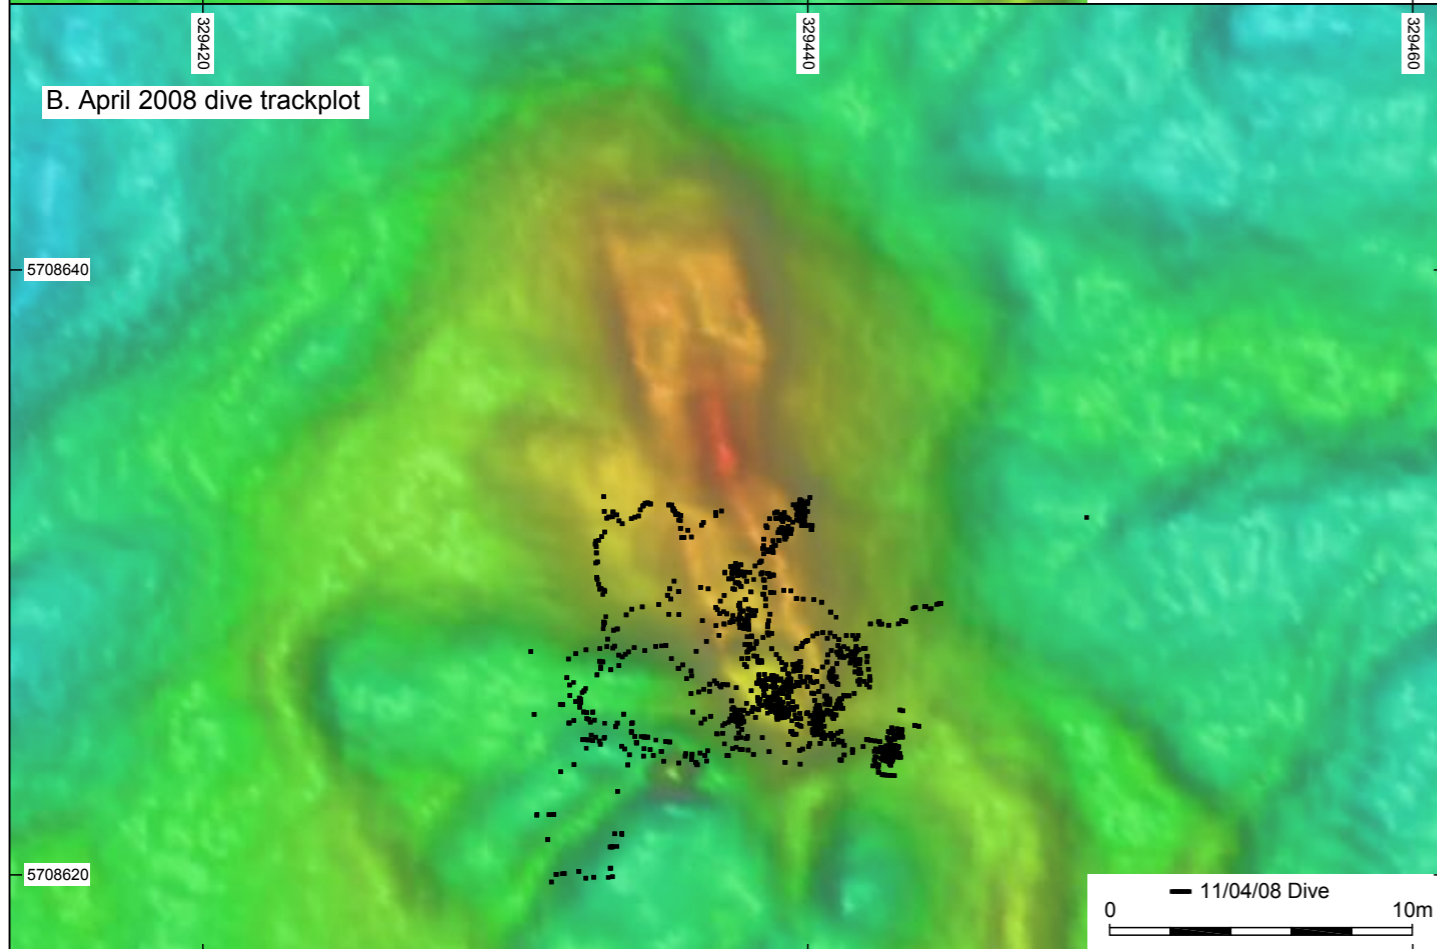
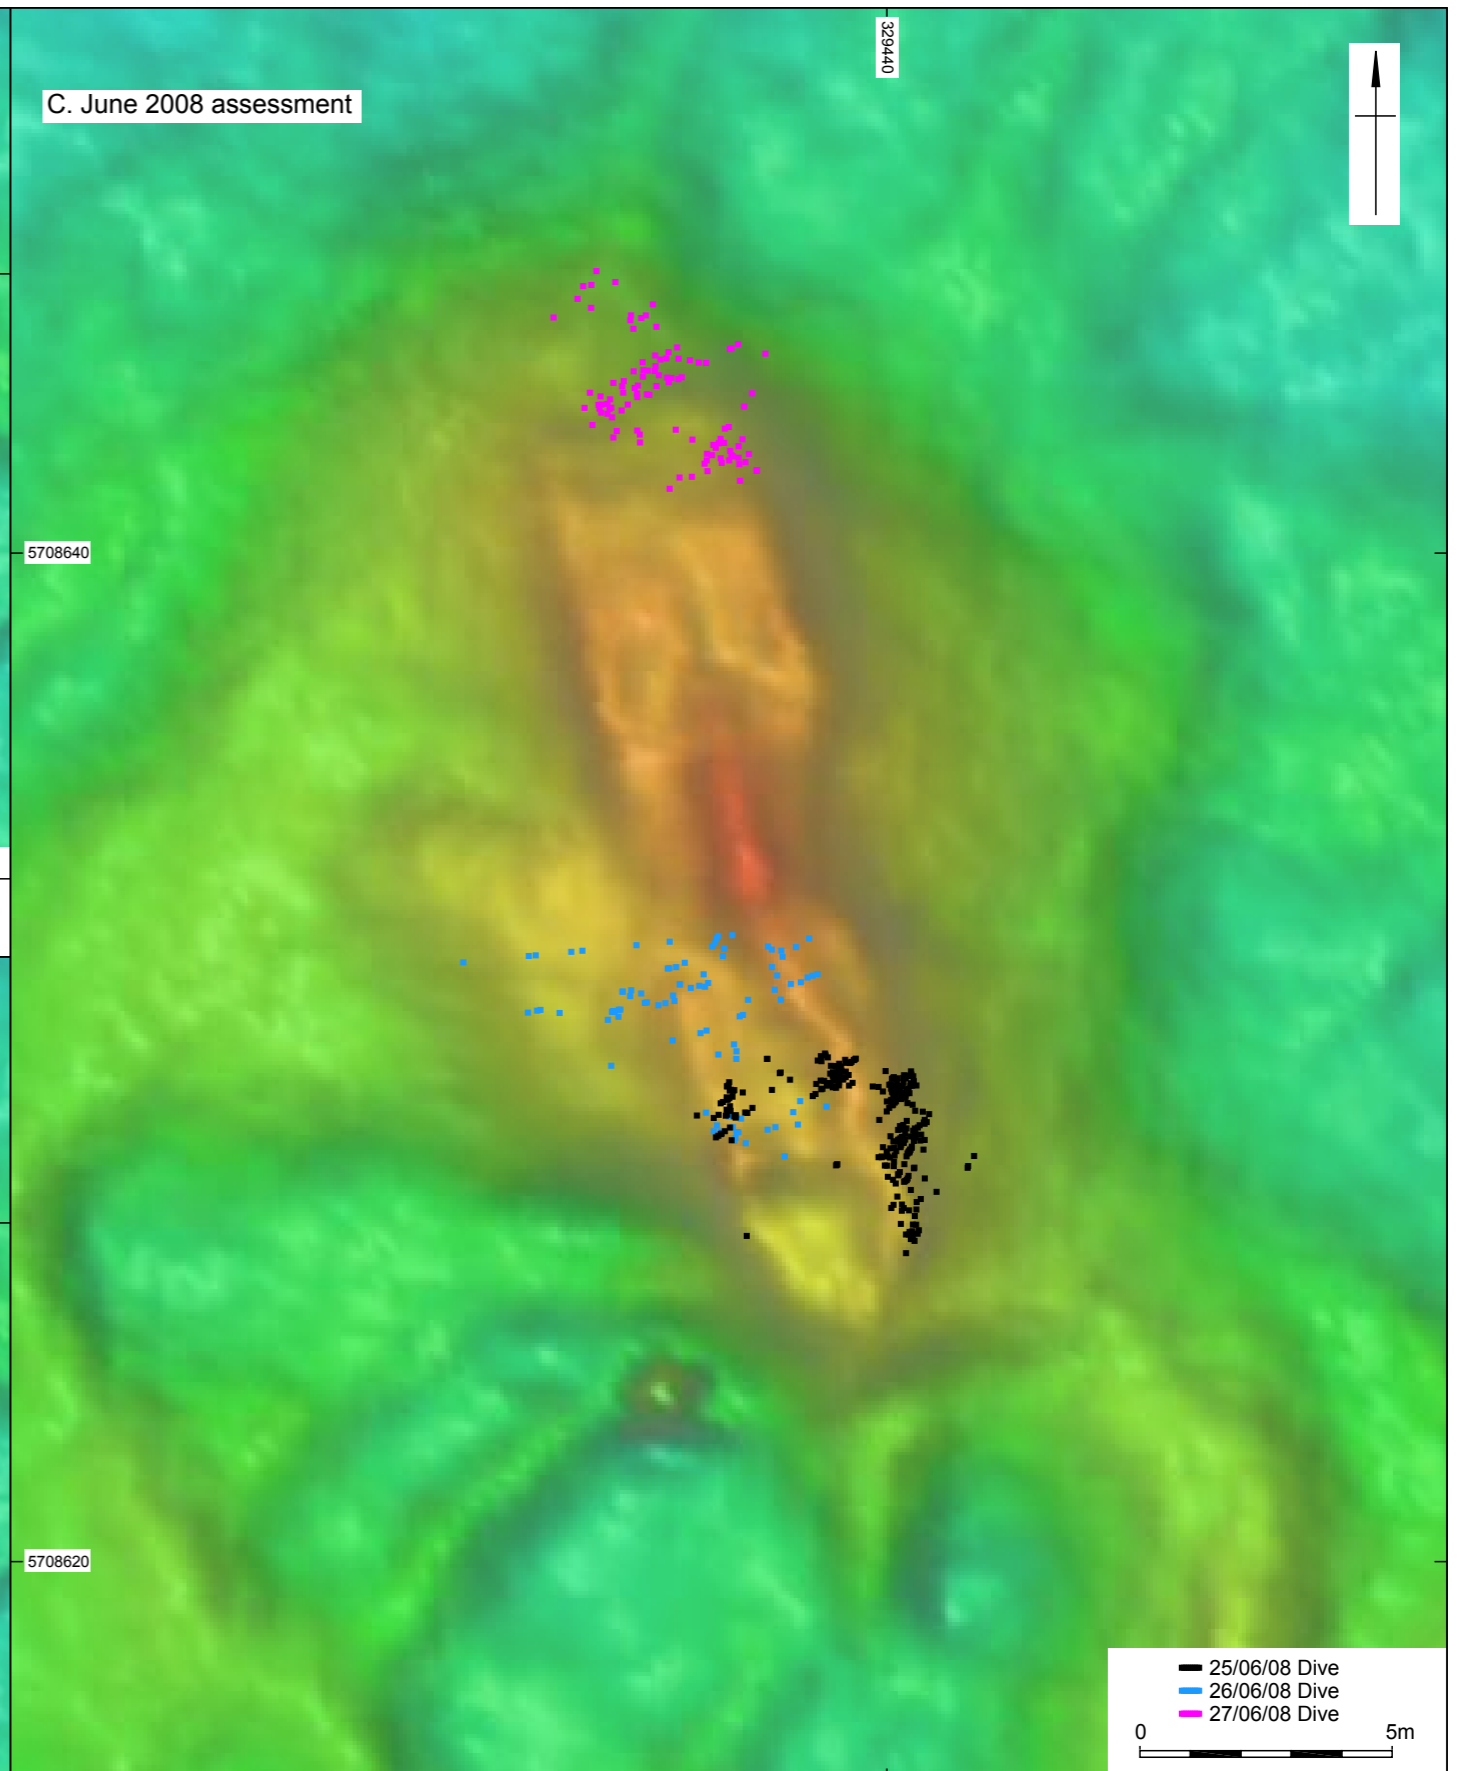
- 1.2.4. In November 2007, Wreck 5051 was assessed by Wessex Archaeology as part of the Phase I Diving Investigation (Wessex Archaeology 2007) (**Figure 2a**). Two dives were carried out on the site with a dive time totalling 49 minutes. The site was

- 3.1.2. Diving operations began on 25 June 2008 and ended 27 July 2008. One dive per day was planned for the Low Water slack tide period, and three dives were conducted, with a total dive time of 204 minutes (**Figure 2c**).

- 3.1.3. The first dive took place on 25 June 2008. The objectives of this dive were to ascertain whether the site conditions had changed since the April investigation and to begin clearing the wreck for recording. The dive took place on the southwest section of the wreck, and wooden structure was identified that corresponded with the raised relief from the multibeam image in the diver tracking system. The diver excavated the wreck with an airlift and a large volume of flint was recovered. The dive lasted for 64 minutes, and is represented by the black dots in **Figure 2c**.

- 3.1.4. The second dive took place on 26 June 2008. The objective of this dive was to continue excavating the south-western section of the wreck. Excavation continued alongside the structural remains, and a wooden chest or locker was discovered. The box was not stable enough to be lifted, because although the sides appeared well-preserved, they were no longer held together. Within the area there were small fragments of wood in soft loose silt, and amongst this, a number of pots, lids, a bottle and a spoon were found and recovered to the surface. The dive lasted for 74 minutes, and is represented by the blue dots in **Figure 2c**.

- 3.1.5. The objective for the third dive was to leave the concentration of artefacts in the southern section of the wreck and to investigate the northern part of the wreck. The third dive took place on 27 June 2008 and lasted for 80 minutes. An extensive complicated structure was identified and was excavated. A range of finds were identified and recovered by the diver, and additional finds were discovered in the airlift spoil. The vast majority of finds recovered from the wreck were discovered in this northern section of the wreck. A sample of context 1000 (sand and flint) was recovered to analyse whether it is natural material or part of the vessel's cargo or ballast. The pink dots on **Figure 2c** illustrate the diver observation points.

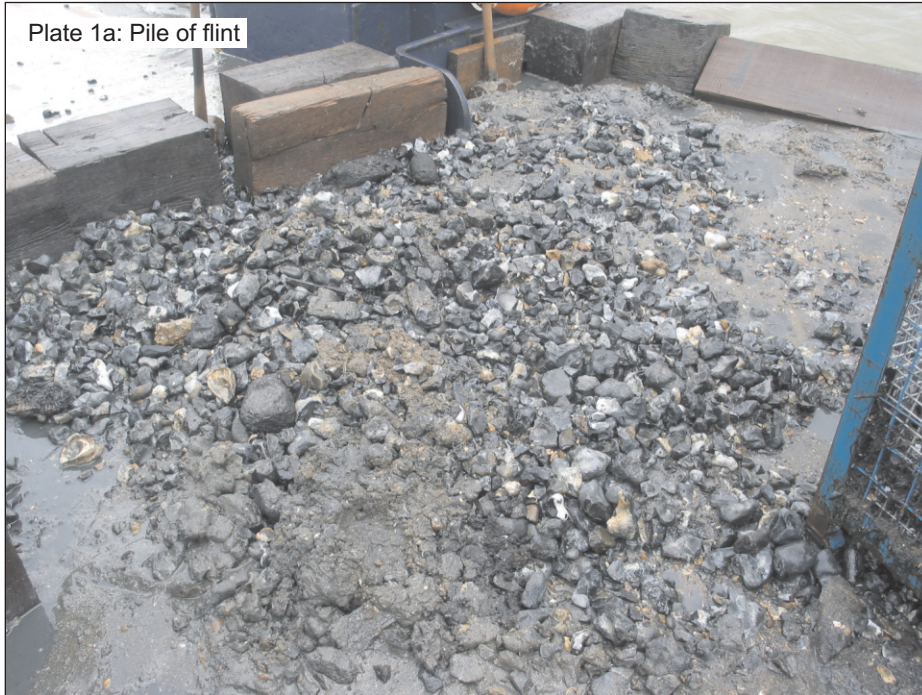
Plate 1a: Pile of flint

- 4.2.4. The large volume of flint that was recovered by airlift is thought to be ballast / cargo (**Plate 1**). The flint nodules are all of similar size and as the surrounding seabed is

comprised of sandy silt on clay; it is unlikely that the flint is naturally occurring. A sample was recovered for further analysis.

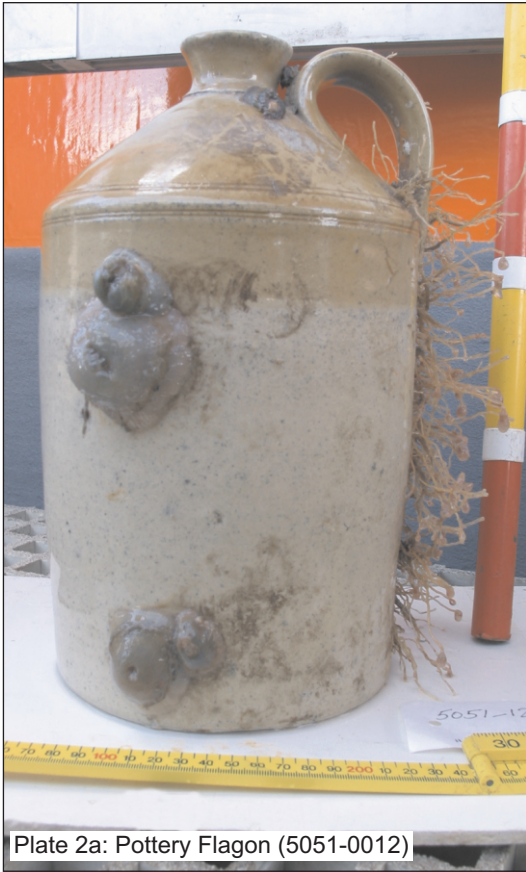
Plate 2a: Pottery Flagon (5051-0012)

- 4.2.7. A pottery flagon (5051-0012) was discovered during the April 2008 dives (**Plate 2a**); it was found partially buried within the site close to the wooden structure. There are three stamps on the neck of the flagon (**Plate 2b**). The first stamp indicates that the manufacturer was Doulton and Watts Lambeth Pottery. A similar bottle is shown in the Doulton & Watt's price list of 1873 (DD/655/21, Hammersmith and Fulham Archives), and this particular stamp was used from the 1820's until 1854 when 'Doulton Lambeth' became the standard impressed mark (www.thepotteries.org/mark/d/doulton.html). The second stamp identified the owner as F. White of the Crown & Anchor Hotel, Woolwich. The owner's stamp can be dated, and the 1855 Essex, Herts, Kent and Sussex Publican Directory lists F. White as the publican of the Crown & Anchor Hotel. The Post Office Directory lists Matilda Hanneford-Pigots as the publican in 1834, and in 1874, L & J Carter are listed as the publicans. From the names of the publicans, the flagon cannot date before 1835, and as this particular manufacturer's stamp was only used until 1854, the flagon must date between 1835 and 1854. In addition, the flagon suggests a local connection for the vessel, as research undertaken by Touch Productions Ltd. has indicated that the Crown & Anchor Hotel was located on a dockside that was only used by Thames barges. The third stamp provides a volume for the vessel: one gallon. The vessel appears to be a gin jar.

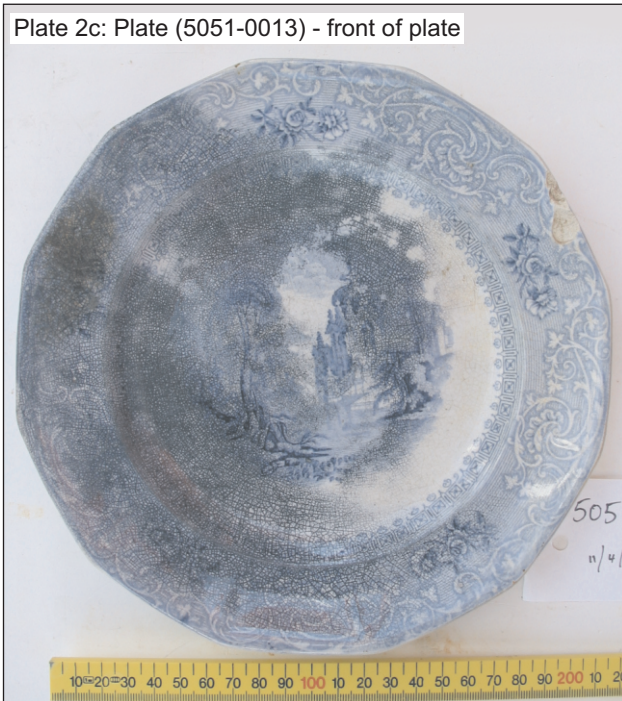
Plate 2c: Plate (5051-0013) - front of plate

- 4.2.8. Also from the April 2008 dives, a plate (5051-0013) was discovered buried within the site adjacent to the wooden structure. The plate has been identified as a refined whiteware ironstone Montilla plate manufactured in Davenport (**Plate 2c & d**). The plate is transfer printed in blue and white with the Montilla pattern. Ironstone was a high fired white pottery characterised by heavy weight for size and dense fabric; it was popular for every day use due to its robust nature. It is stamped with a typical incised Davenport mark, an anchor with the word 'Davenport' above and two numerals, indicating the date of manufacture, on either side of the anchor. Although the numerals are not quite clear, it is probable that the plate was manufactured in 1862, although it could be as late as 1882.

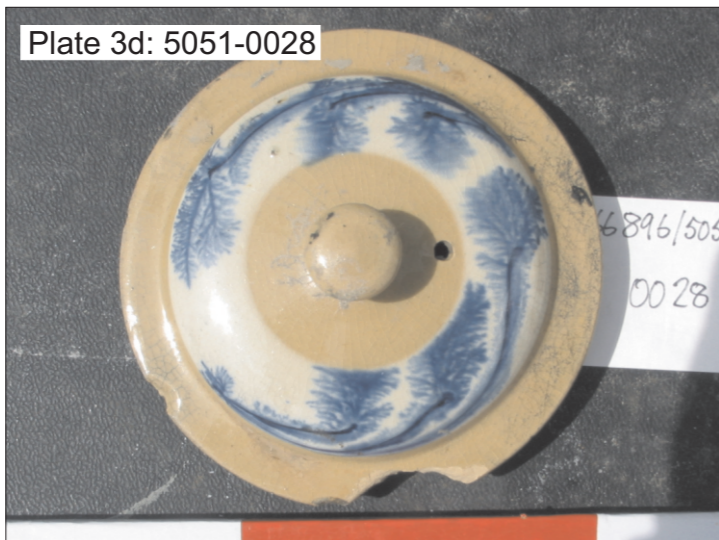
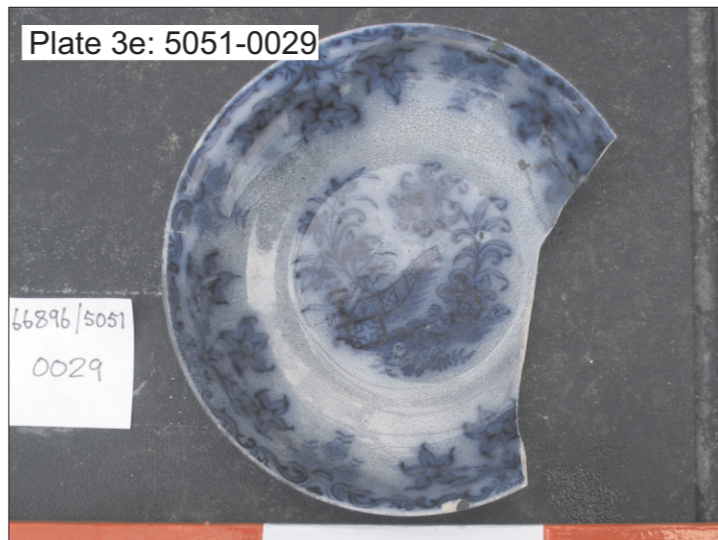
- 4.2.9. A brown glazed stoneware jar with an intact cork is similar to a 'porter bottle' from the 1873 Doulton catalogue (5051-0025) (**Plate 3a**). A complete stoneware jar (5051-0036) is similar to a 'bung jar' from the same catalogue (**Plate 3g**). The shoulder of the 'porter bottle' is stamped 'R&I White Sittingbourne', and could suggest a connection with Kent.

- 4.2.10. Other ceramics (**Plate 3**) also indicate a 19th century date, such as the possible cup handle base of bone china (5051-0019), and various yellow ware straight sided squat jars and lids (5051-0026, 5051-0027, 5051-0028). A number of pieces of refined whiteware were on board (5051-0029), including what appears to be sherds from a treacle glazed teapot (5051-0033; 5051-0049).

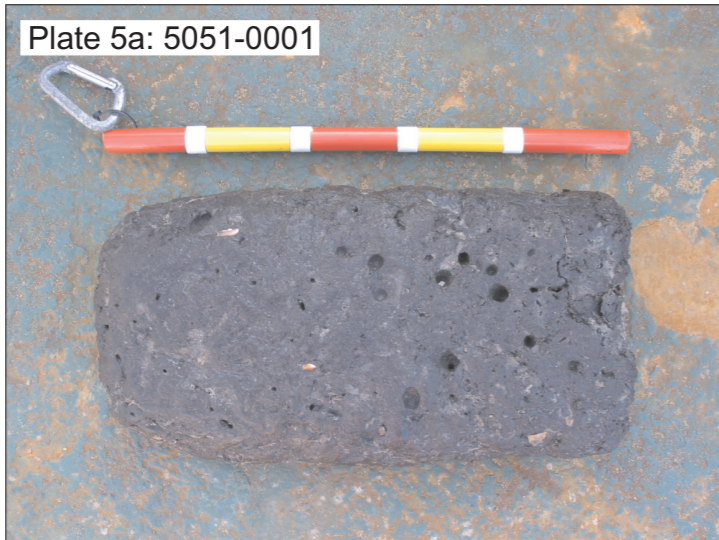
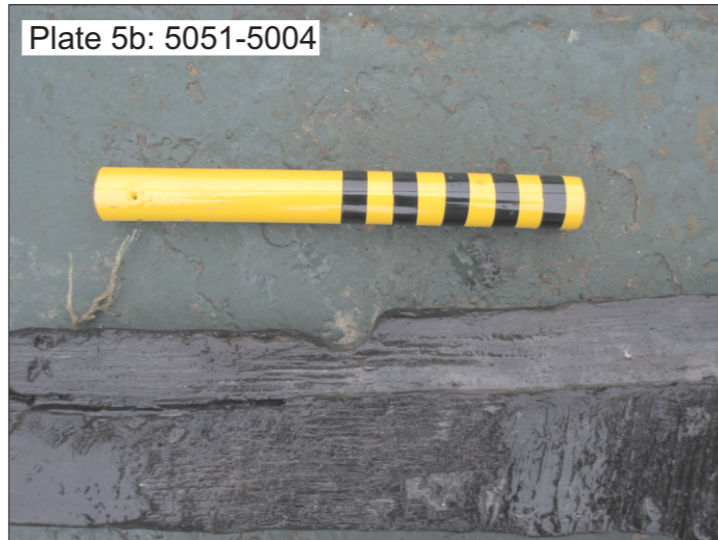
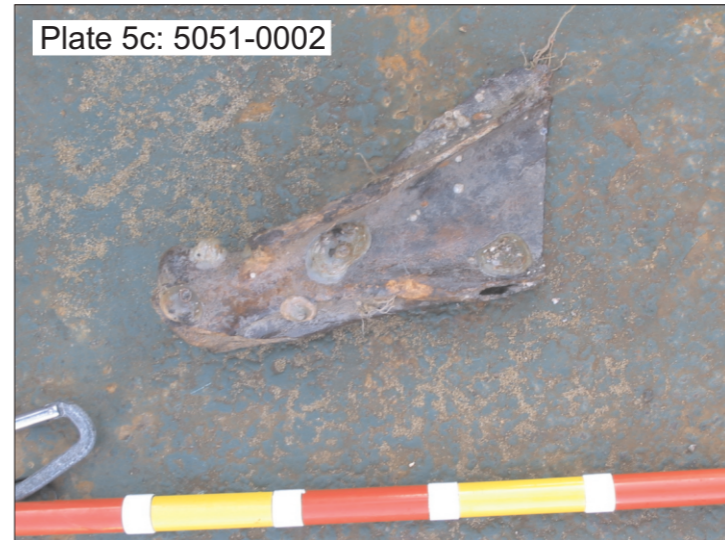
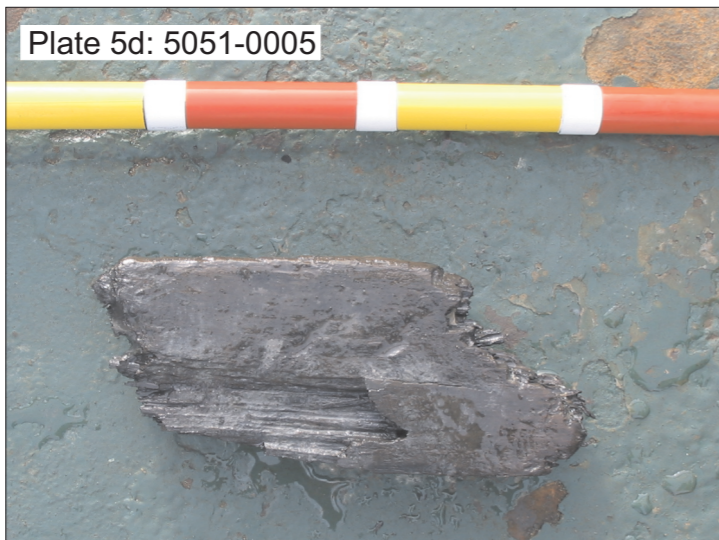
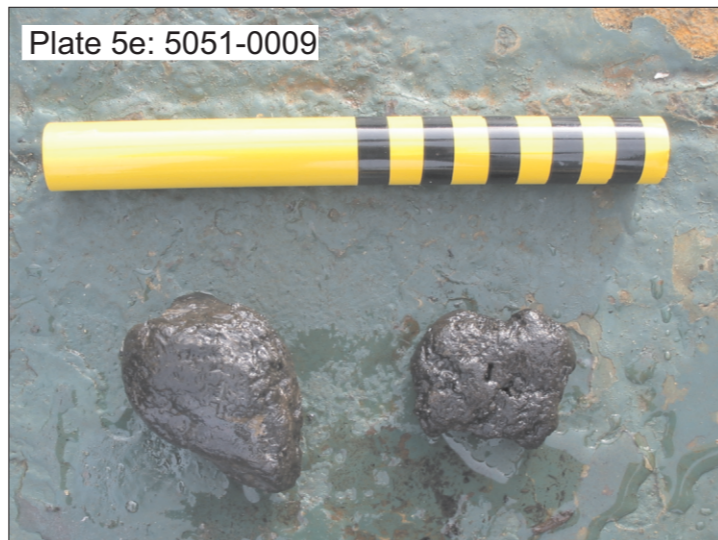
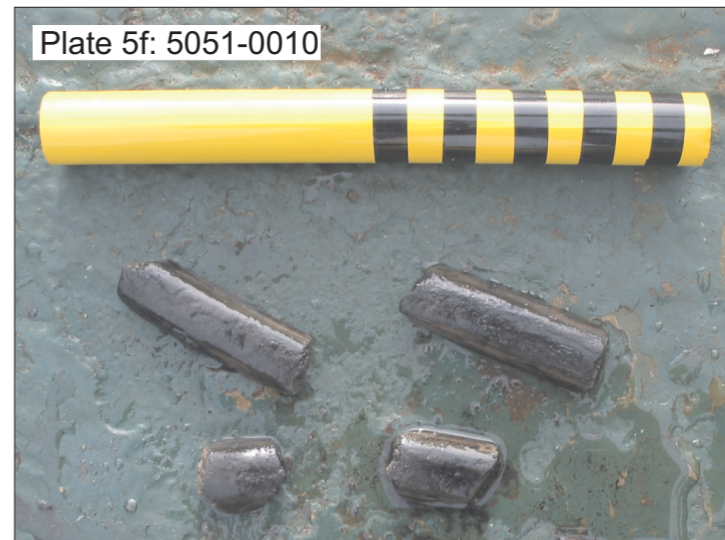
- 4.2.17. Images of the organic finds can be found on **Plates 5a-I** and **Plates 6a-c**. They are in order by artefact number.
- 4.2.18. A number of small fragments of water worn wood were recovered (**Plate 5a, 5d, 5e, 5f**), and a recovered piece of timber from the ship's hull shows evidence for possible treenail holes (5051-0004) (**Plate 5b**).
