London Gateway Port: Channel Clearance and Dredging

In-water Archaeological Observation and Recording

Final Report

Wreck 5204 (Pottery Wreck)

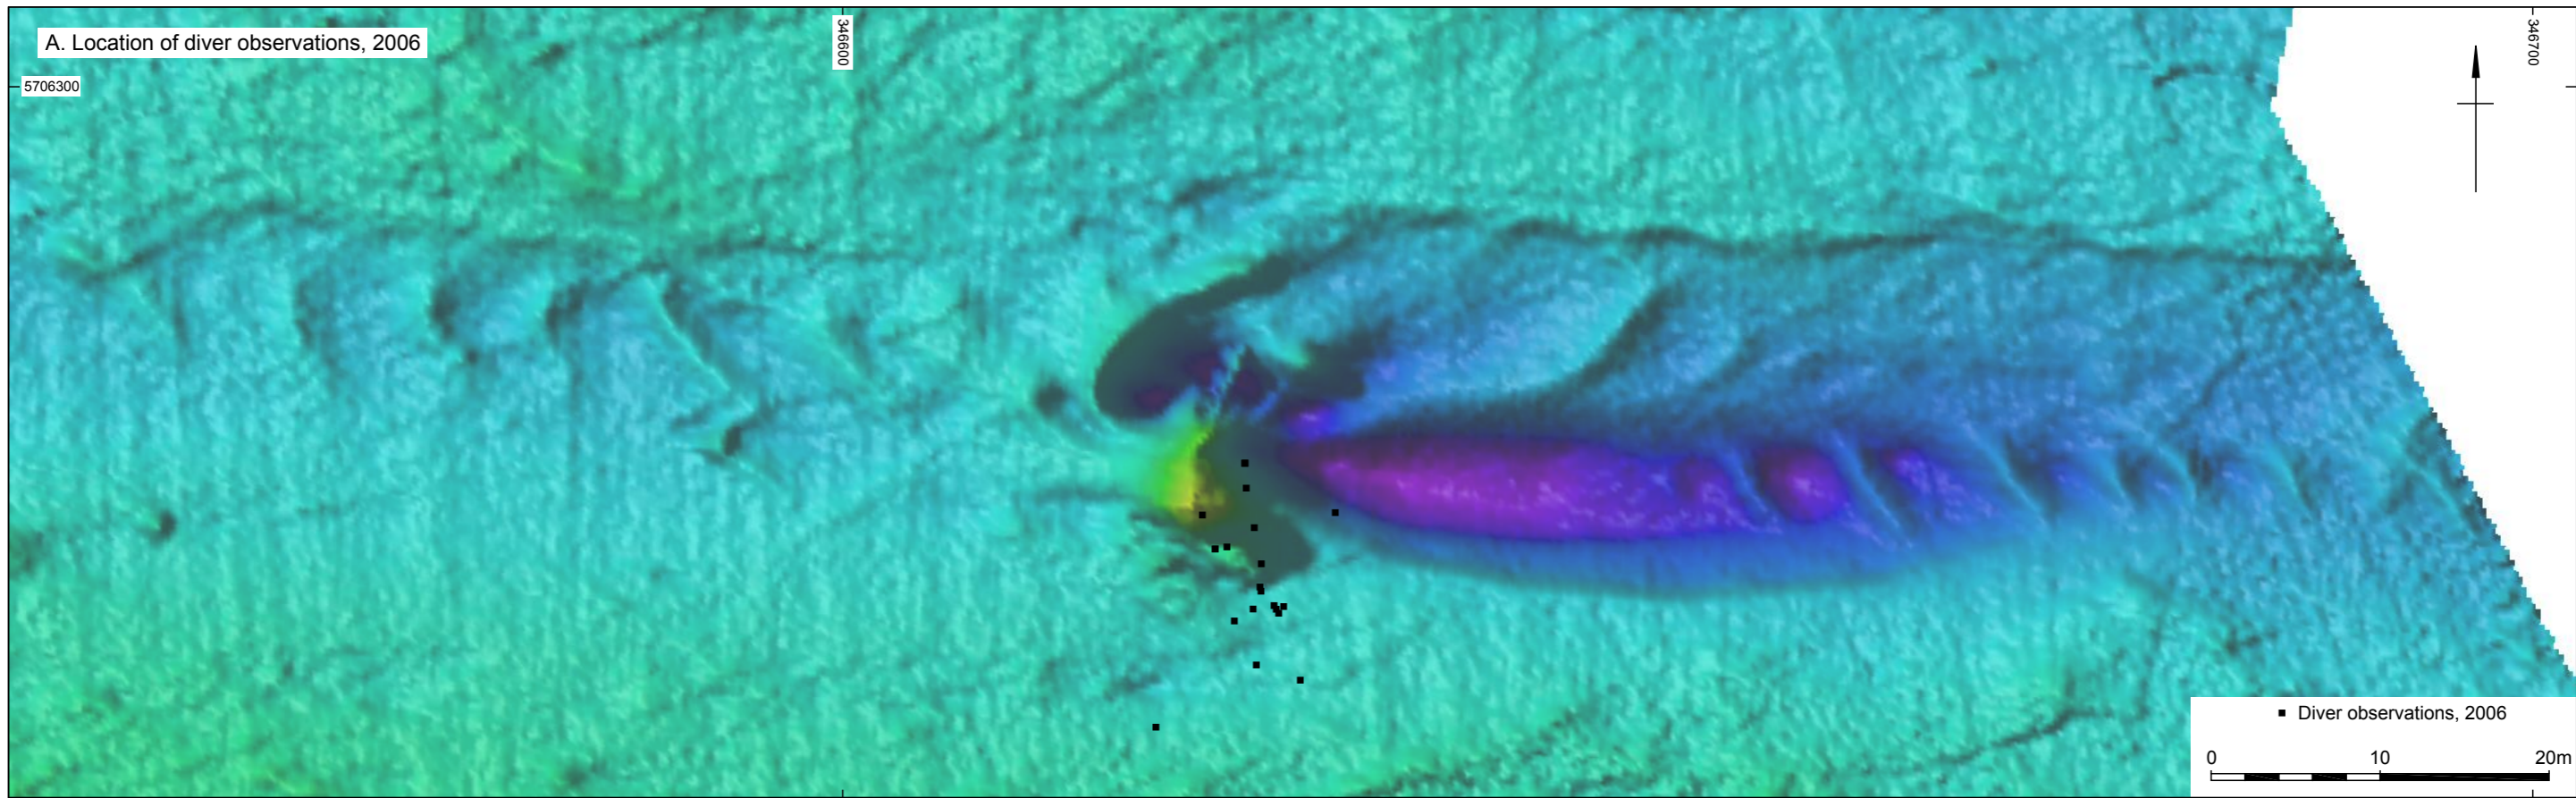
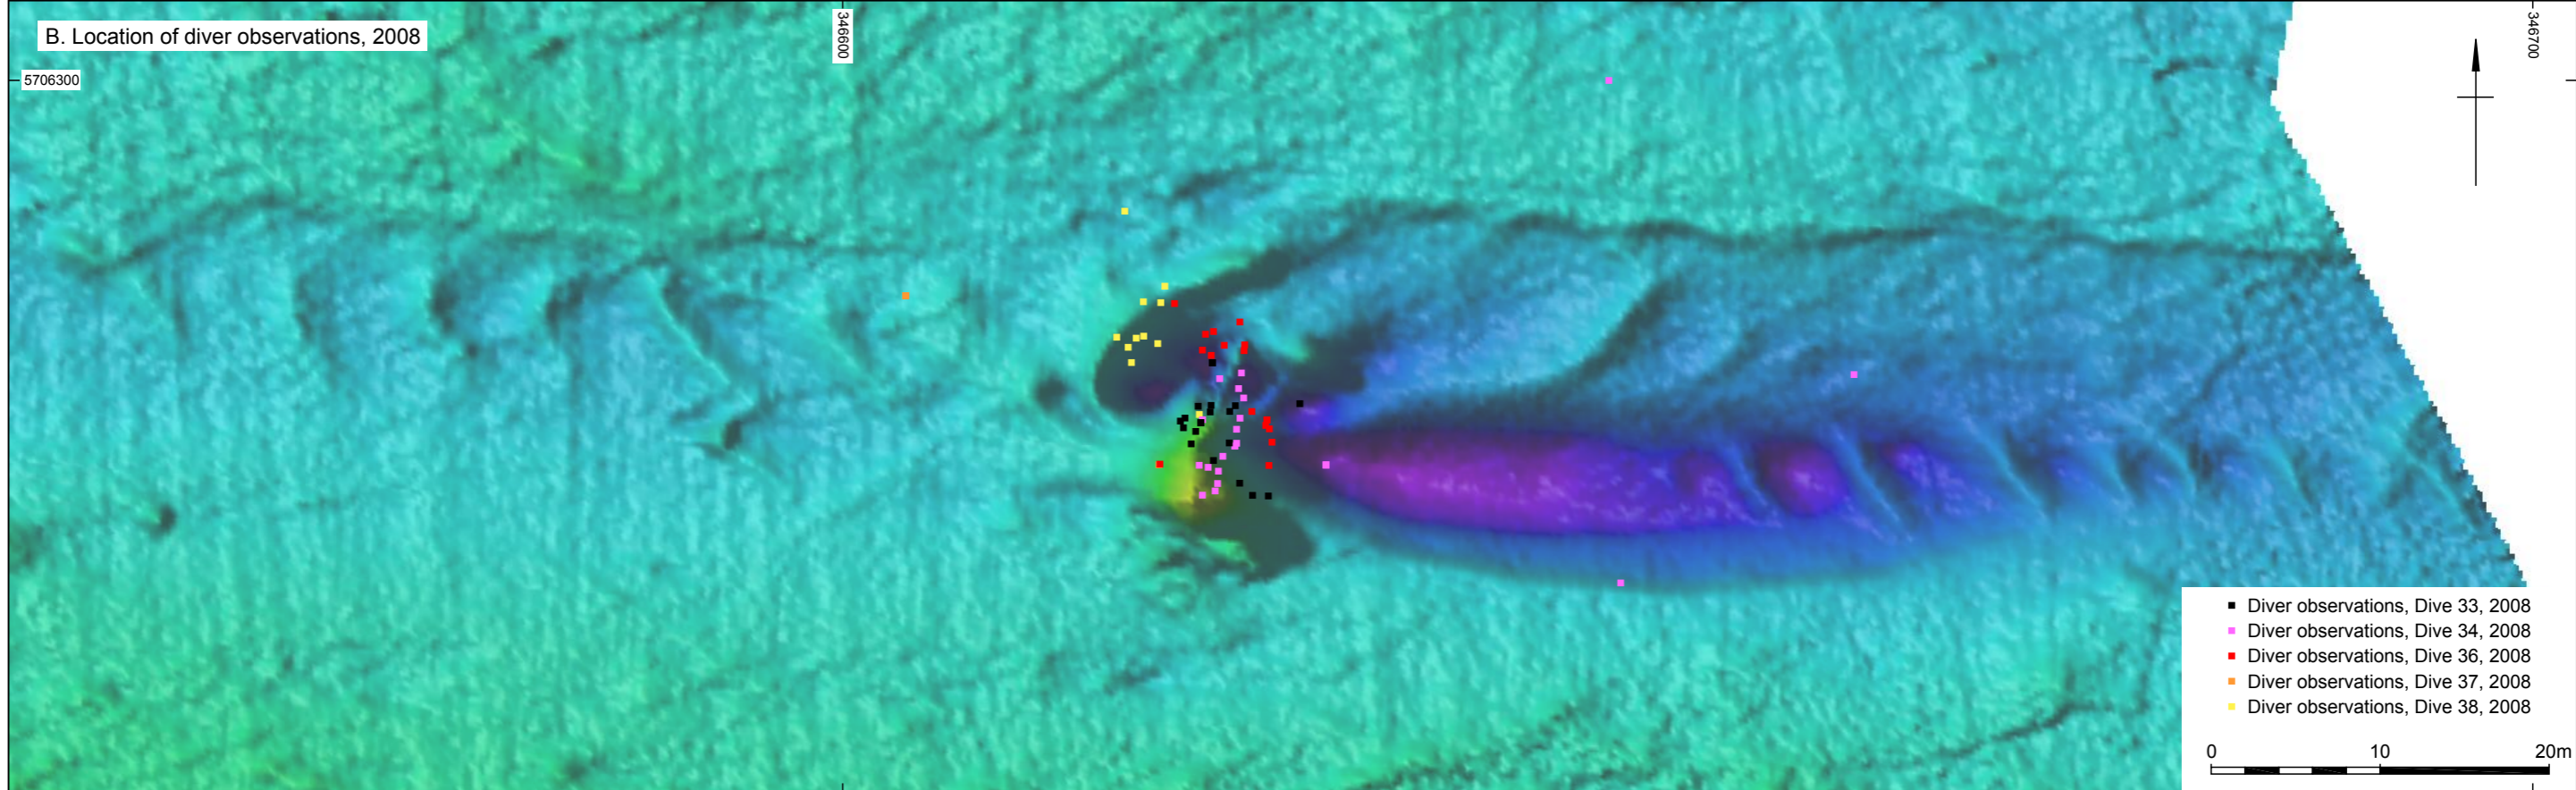
- 3.1.3. The first dive was carried out on the 11th June 2008 and had a duration of 90 minutes. The objectives of the dive were to ascertain whether the site conditions had changed since the investigation in 2006 and to begin clearing the wreck for recording. The airlift was used to remove sediment overburden from within and around the wreck, and resulted in revealing the hull structure. The dive took place on the centre of the wreck, with a focus on the northern half. A mixed assemblage of artefacts was recovered from the airlift outwash, including glass, a small sherd of pottery and modern material. A frame from the vessel was recovered to the surface, and it appeared to be consistent with structural elements recovered in 2005. It was a clinker frame measuring approximately 1.2 metres long with a thickness of 0.10 metres. The dive is represented by the black dots in **Figure 2b**.

- 3.1.4. No diving took place on 12th June 2008 due to inclement weather conditions and problems with the diving vessel.
- 3.1.5. The next dive was undertaken on 13th June 2008. The diver worked along the eastern side of the wreck and continued clearing the sediment overburden with an airlift. On this dive, the diver verified the nature of the outlying material around the wreck. The finds assemblage recovered from the airlift spoil was similar in nature to the previous dive. The dive duration was 70 minutes, and the diver observations are represented by the pink dots in **Figure 2b**.

- 3.1.8. The first dive was undertaken on 23rd June 2008, with an objective to assess the condition of the site following the removal of sediment overburden with an airlift. The airlift was then used to excavate areas around the hull structure to facilitate recovery. Both ends of the keel were identified and a strop was placed around the west end. This dive is represented by the red dots in **Figure 2b**.

- 3.1.10. On 24th June 2008, a third dive was undertaken with an objective of examining the site for any further upstanding material and to recover any loose structural material remaining on the seabed. It was determined that a section of planking and framing remains on the seabed, Some frames and hull planks were discovered in the previously excavated area and were recovered to the surface. The dive duration was 92 minutes, and is represented by the yellow dots in **Figure 2b**.

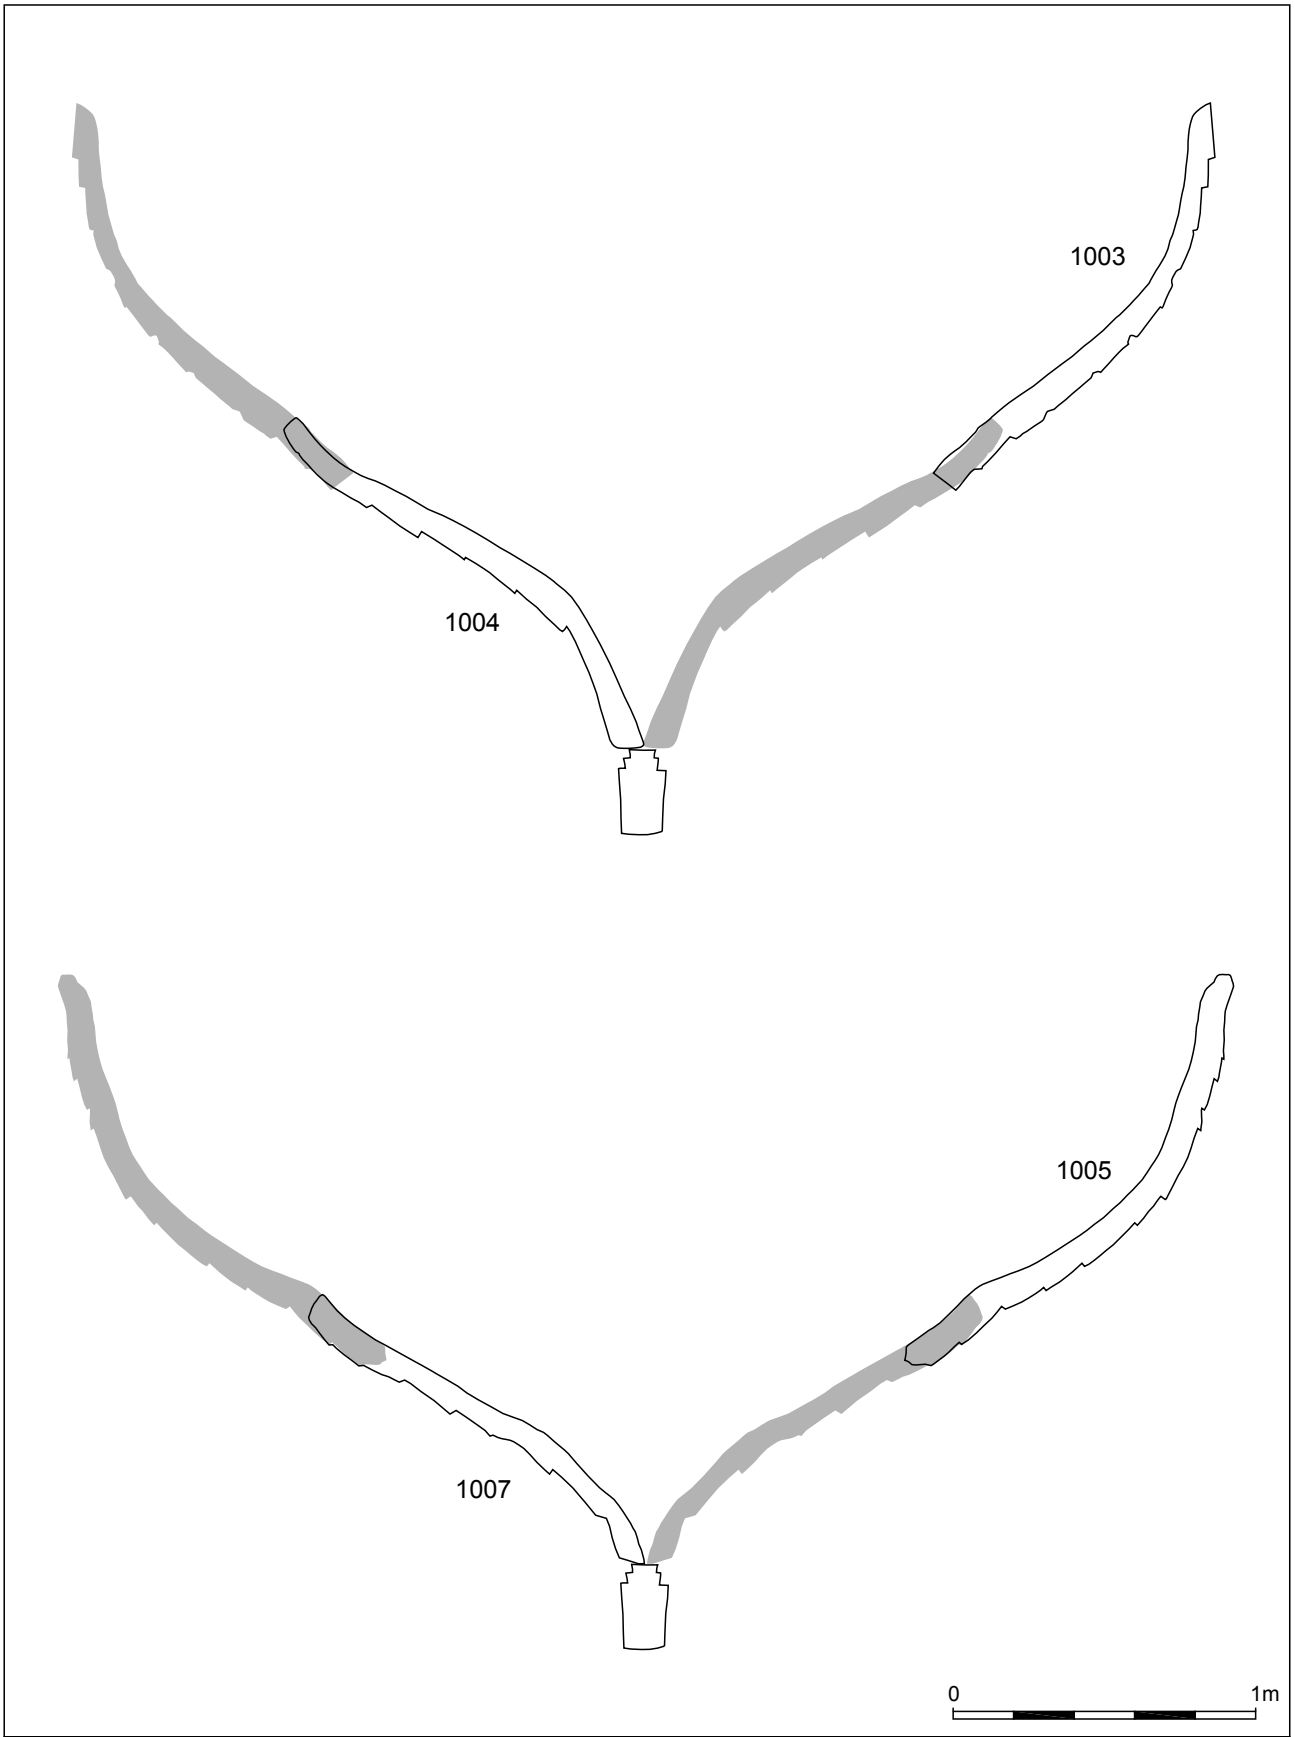
Figure 3

- 5.14. The remains of the keel of Wreck 5204 were broken and eroded at both ends, making it impossible to determine the vessel's original length. However, the reconstructed hull section in **Figure 3** indicates a beam of at least 3.75 metres. Since this section was taken from frames located close to the stern, it is likely that this vessel was considerably beamier, and possibly similar in size to the *Monarch*, *Doris*, *Bona* or *Saxonia*, with a length of 10 to 12 metres.

Possible arrangement of frames at the stern of the vessel

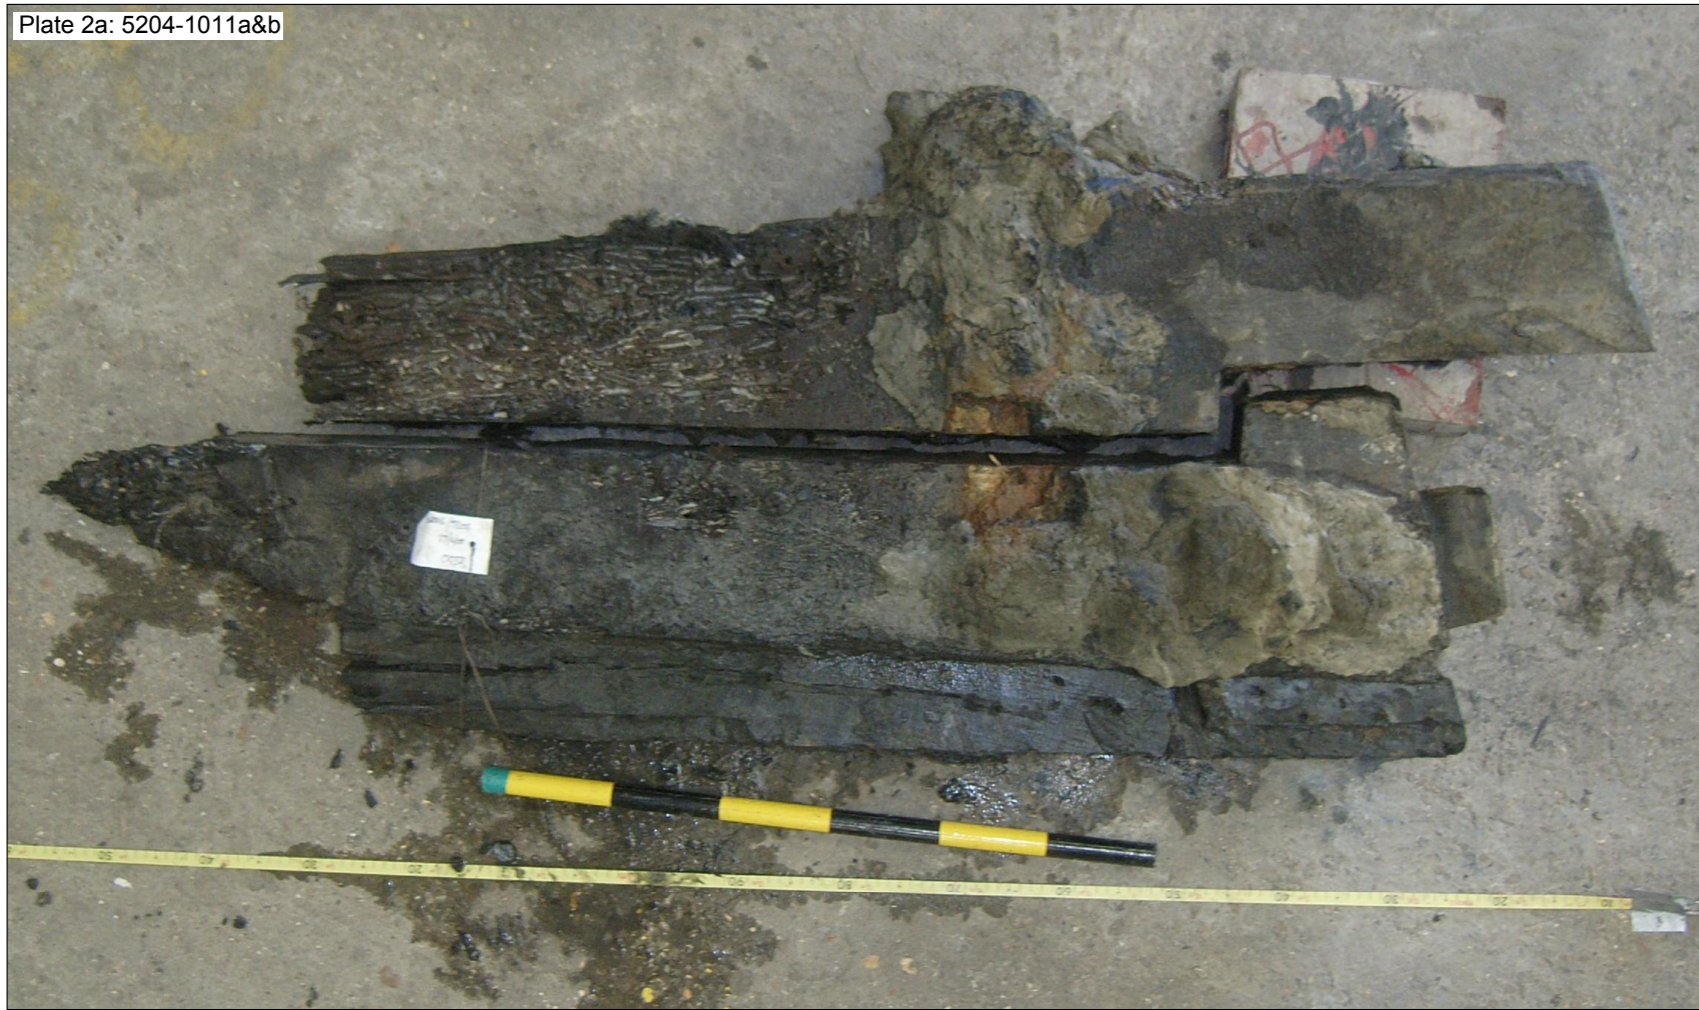
Plate 2a: 5204-1011a&b

- 4.1.12. Piece 5204-1011a would have been located fore of 5204-1011b. The end where this piece joined the keel or keelson is in good condition, suggesting it may still have been connected before being raised (**Plate 2c**). The upstanding end has been eroded by marine borers. The timber measures 1.30 metres in length, 0.25 metres in width, and 0.11 metres in depth. Numerous square and round holes were located along the side of the timber.

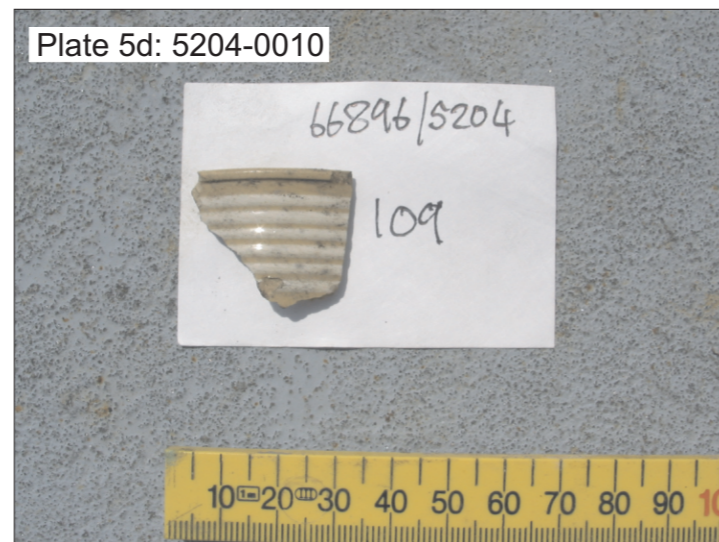
Plate 6b: 5204-0007

- 4.2.14. Two brick fragments were discovered (504-0007) (**Plate 6b**). One is stamped with an L or a T, and the fragments exhibit possible frogging. The frogging indicates that the bricks were produced after the early 1800's.
