London Gateway Clearance Programme:  
Ju 88 Aircraft Crash Site,  
Black Deep, Outer Thames Estuary

Post-clearance  
Assessment Report

Ref: 72435.03  
February 2013

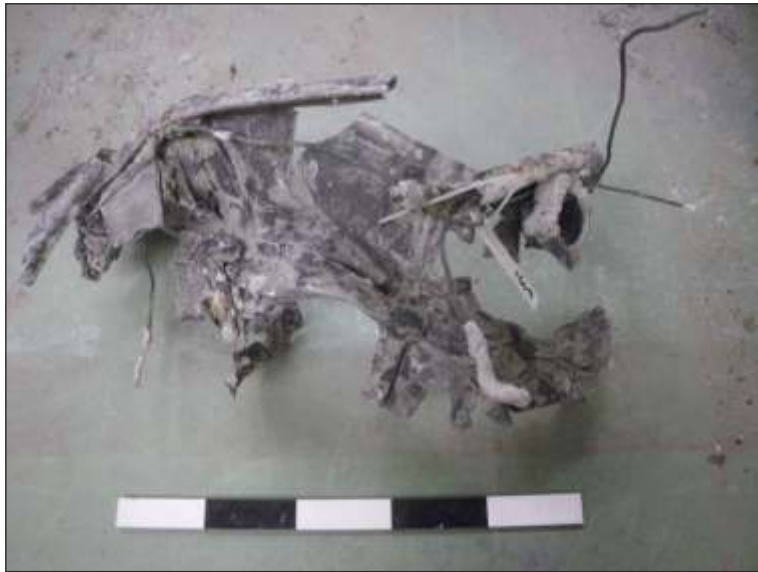
Plate 1: Damaged cockpit instrument console

- 4.2.1 A total of 21 finds were identified as cockpit fittings or equipment (Appendix 1). These included:
- The badly damaged cockpit instrument console and electrical wiring (Plate 1).

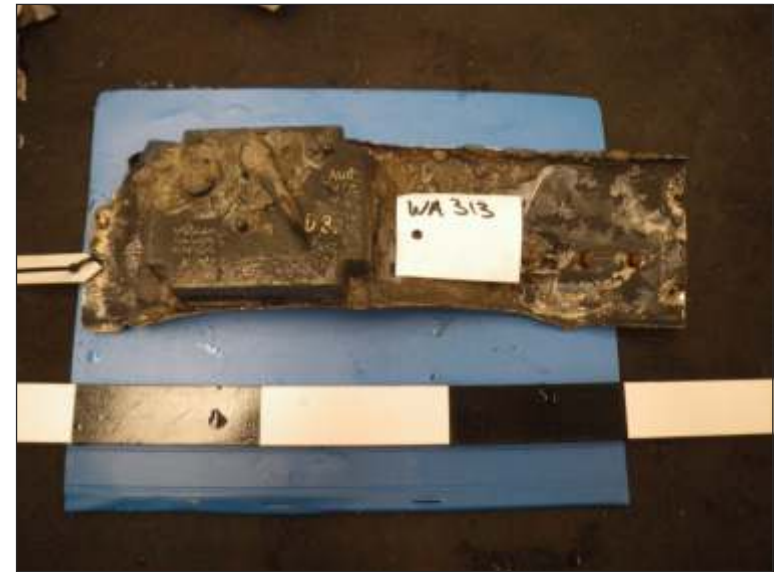
Plate 2: Control for heated flying clothing

- 5.1.8 The presence of a heated clothing control unit suggests that the aircraft was intended for very cold flying conditions, which normally means high altitude. This component was introduced by the *Luftwaffe* in 1943, which indicates that the aircraft was not lost before 1943. This is consistent with the Ju 88, which was capable of high altitude use and with the in-service dates of the S and T versions.

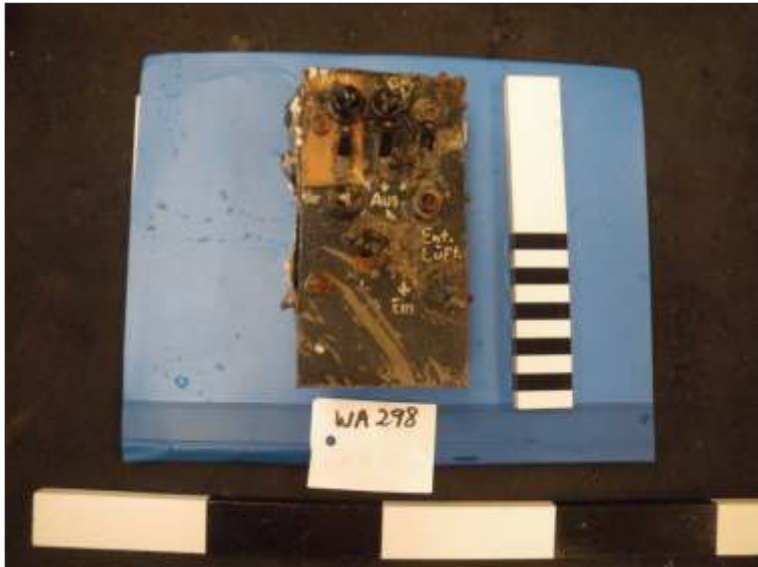
Plate 3: GM-1 boost control unit

The archaeological fieldwork produced significant amounts of aircraft structure and certain components that demonstrated the uniqueness of the find. It utilised a gas boost system consuming nitrous oxide to increase engine power and speed at altitude in an attempt to allow it to outrun enemy fighters. This system, used on the BMW 801 power-plant, was only used on a limited number of late-war variants of the Ju 88. In addition, camera equipment recovered from the site was of a type that was only used on a very few Ju 88 variants, including this T prototype. Study of contemporary documentary sources also corroborates the identification of the aircraft variant.

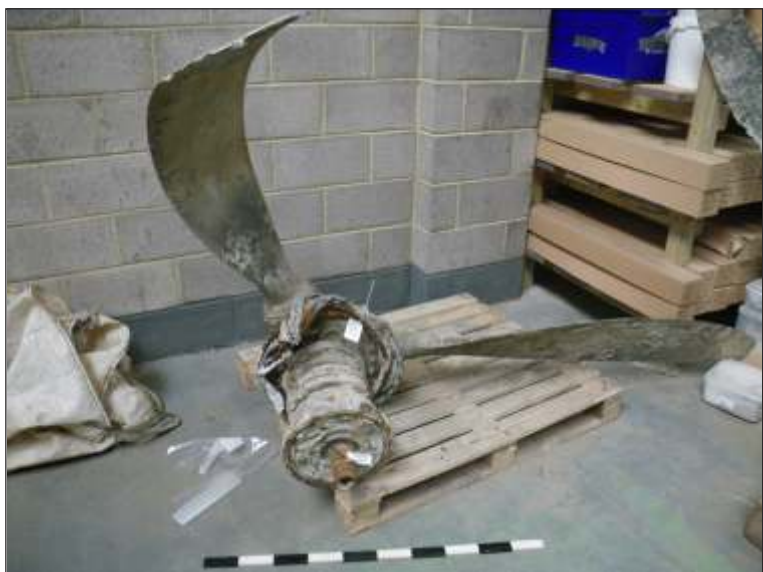
Plate 5: VDM propeller

- A cowling fragment stamped with the stamped number '9-801.824-894.12'.
  - Various oil cooler components.
  - Part of the engine bearers.
  - A three aluminium bladed Vereingite Deutsche Metallwerke (VDM) all metal propeller unit, fitted with reduction gears (Plate 5). One propeller blade is missing except for the stub and may have broken off. Another is bent irregularly backwards. The other appears to be approximately straight.

- 5.4.3 It has previously been observed that whilst one of the two surviving VDM propeller blades was bent backwards, the second was not and that this suggests that the engine was stopped (WA 2012). Given that the pilot bailed out rather than ditch, this suggests that battle damage was the cause of the engine failure. It also suggests that the aircraft hit the water at a shallow angle, although it is also possible that it was bent during a subsequent impact such as the dredge strike.

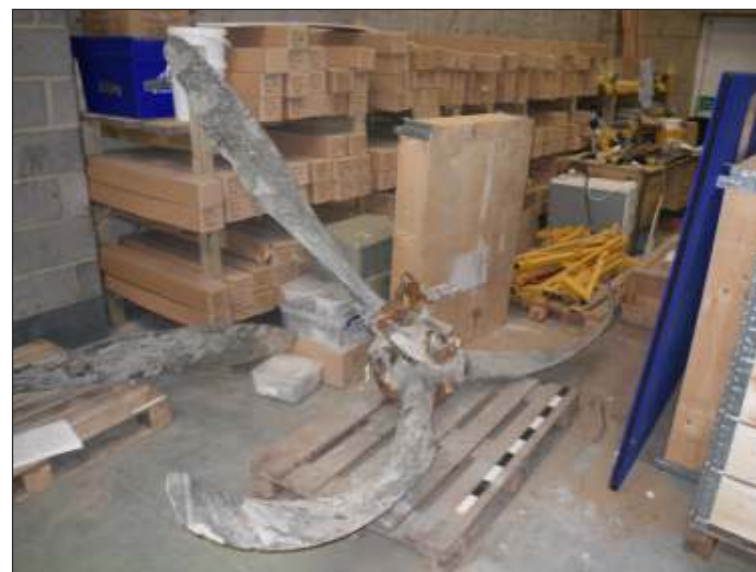
Plate 6: Possible Lysander propeller

Other material found at the crash site appears to be the remains of another aircraft. A propeller and other items point to the remains of a British aircraft, possibly a Westland Lysander.

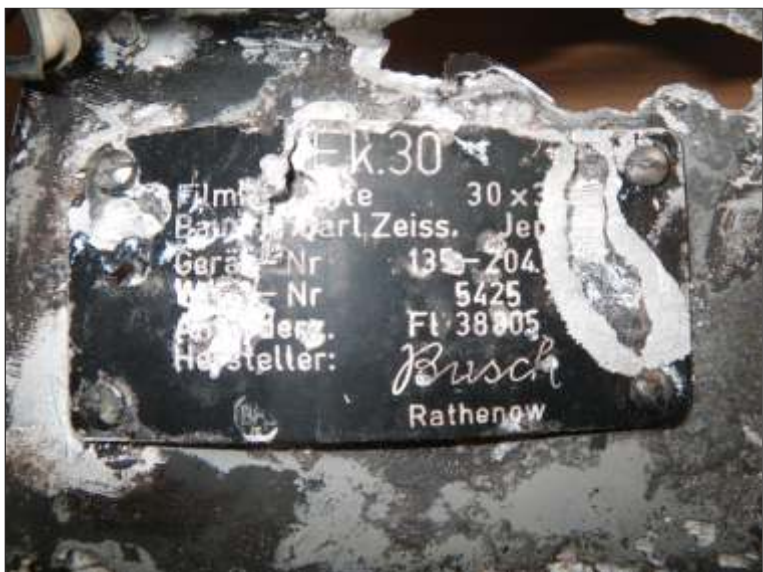
Plate 7: Rb50/30 data plate

4.8.1 Parts of a camera system were found. These included the data plate from a German FK 30 photo-reconnaissance camera (Plate 7), utilising the Rb 50/30 lens system, ultra-large format film and bespoke camera apertures for the fuselage.

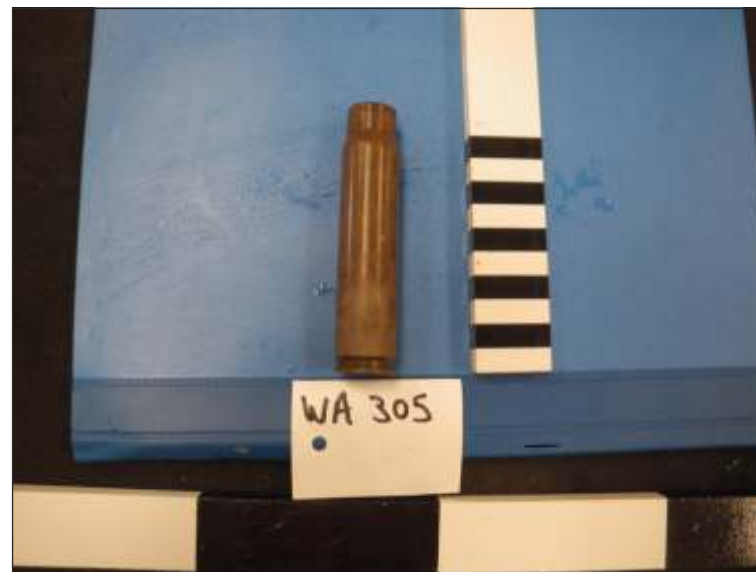
Plate 8: Expended British 20mm cannon shell, stamped 1952

- 5.4.8 The presence of a British 20mm cannon round manufactured in 1952 is clearly co-incident.
- 5.4.9 There is too little information about the second aircraft to reach any conclusion. As noted above the fact that the dredger master observed the relevant propeller to come from near 7535 suggests that there may have been two distinct wreck sites. This is problematic because, on a balance of probability basis, two aircraft are extremely unlikely to crash separately within 25m of each other, even in such a fought-over location as the Thames Estuary.

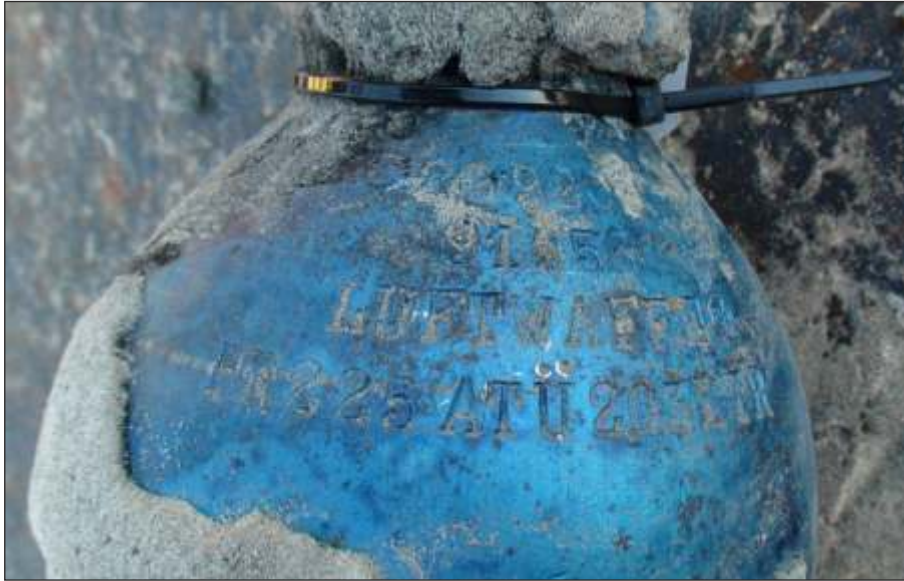
Plate 9: Luftwaffe stamp on oxygen cylinder

4.7.1 Parts of the oxygen delivery system were found. These included seven early war German oxygen cylinders, some still attached to their mountings on the fuselage wreckage and marked 'Luftwaffe' (Plate 9), oxygen pipes and an oxygen monitoring gauge.
